**Preliminary Foundation Investigation
Report
Stewart Boulevard Underpass
Replacement - Site No. 16X-0121/B0**

Highway 401 Rehabilitation
Brockville, ON

G.W.P. 4003-19-00

Prepared for:
Ministry of Transportation Ontario

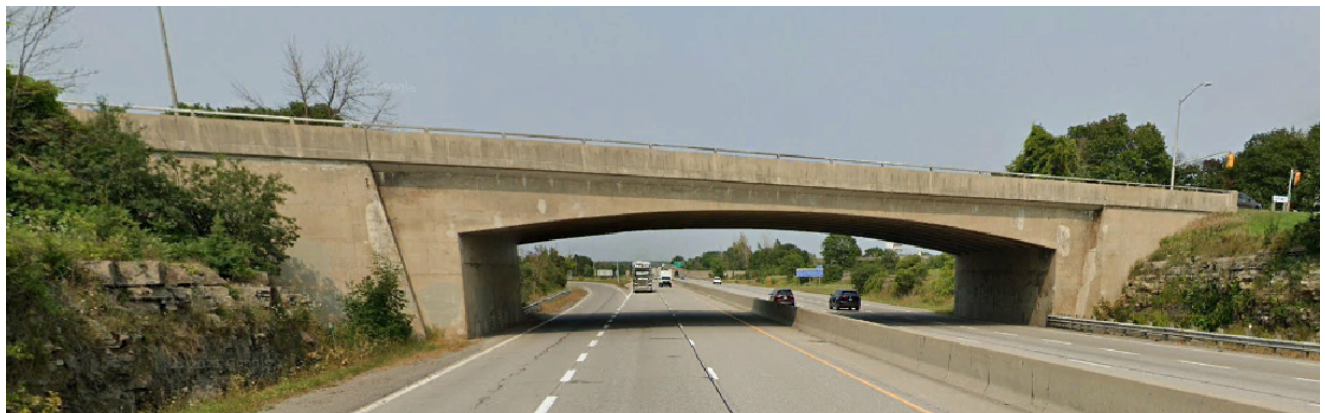
The existing bridge is a single-span, T-beam rigid frame structure constructed in 1958 (Contract 57-53) with a span length of 38.4 m and a width of approximately 18.3 m. The centerline of the structure is on an 18°49' skew to Highway 401 and traverses over six lanes of traffic (4 through-lanes and 2 on-ramp/entrance speed change lanes). There are concrete barrier walls with railings and sidewalks on both the west and east side of the structure. A photo of the bridge looking towards the west is provided below.

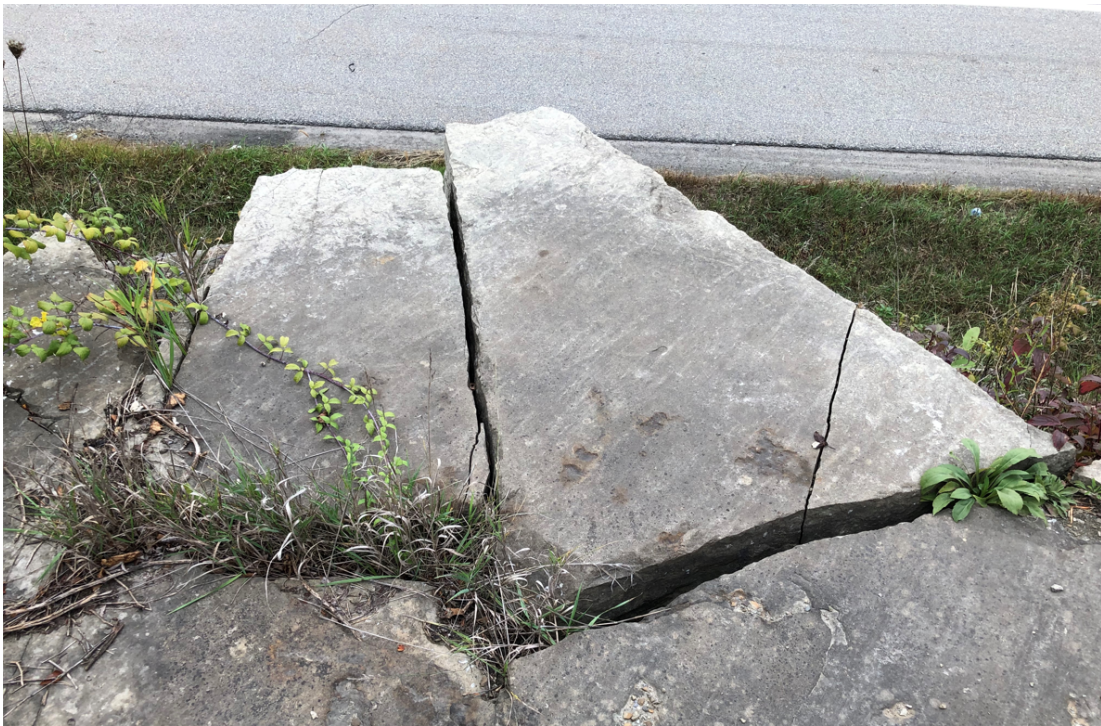
- No visible signs of settlement or deformation of the existing structure was noted. Areas of delamination and spalling with exposed rebar were visible at numerous locations.
- The asphalt wearing surface on the bridge exhibits longitudinal and transverse cracks and patched potholes.
- No signs of embankment settlement or instability were observed.
- The bedrock in the cut faces to the east and west of the bridge is typically thinly bedded and heavily fractured with loose blocks present on the face/near the crest of the cut slopes (see photo below) and displaced/fallen rock visible in the ditches.

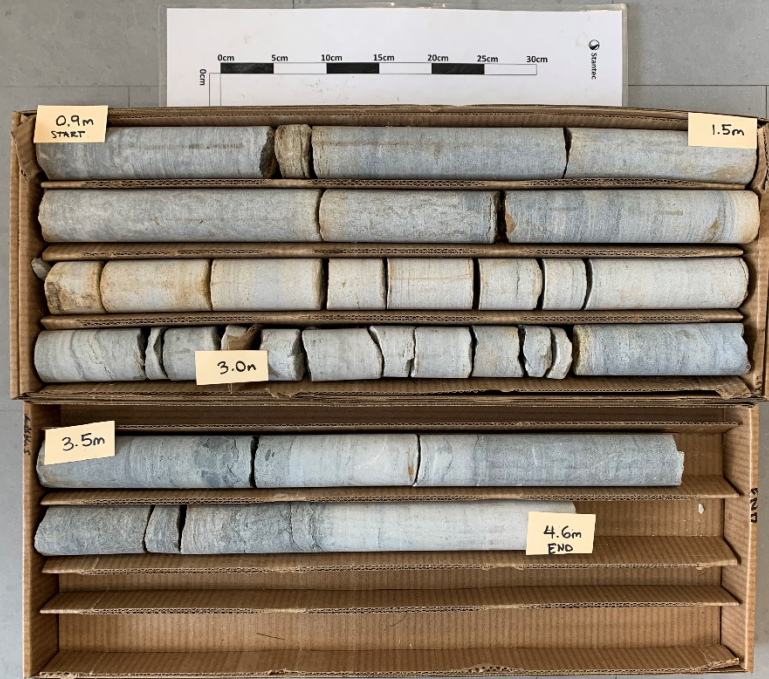
Rock Core Photo No.: 1

Borehole: SB21-1

Depth: 0.9 m to 4.6 m

Table 5.2 provides a summary of the rock core data. Photographs of the rock cores from each of the boreholes are included in Appendix C.

Borehole No.	Run No.	Rock Description	Depth below ground (m)	Geodetic Elevation (m)	Total Core Recovery, TCR (%)	Solid Core Recovery, SCR (%)	Rock Quality Designation, RQD (%)	Weathering Degree (W1=Fresh, W2=Slightly Weathered)	Fracture Index (fractures per m)
SB21-1	3	Slightly weathered to fresh, tan to dark grey Dolostone to Sandy Dolostone	0.9-1.5	103.3-102.7	100	100	92	W2	5
	4		1.5-3.0	102.7-101.2	98	96	50	W2	9
	5		3.0-4.6	101.2-99.6	99	98	68	W2/W1	8
SB21-2	6	Slightly weathered to fresh, tan to dark grey, Dolostone to Sandy Dolostone	3.4-4.7	101.5-100.2	100	100	77	W2	5
	7		4.7-6.2	100.2-98.7	97	93	54	W1	13
	8		6.2-7.2	98.7-97.8	97	97	67	W1	9

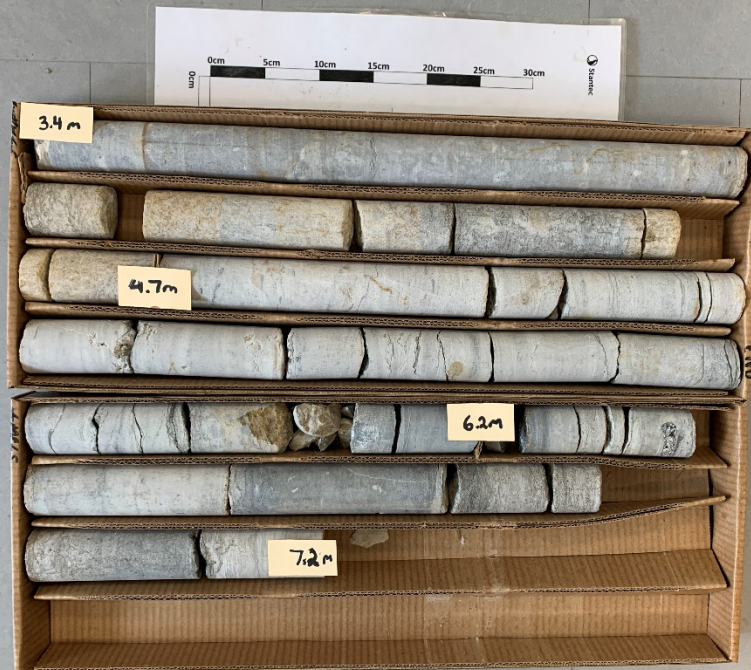
Rock Core Photo No.: 2

Borehole: SB21-2

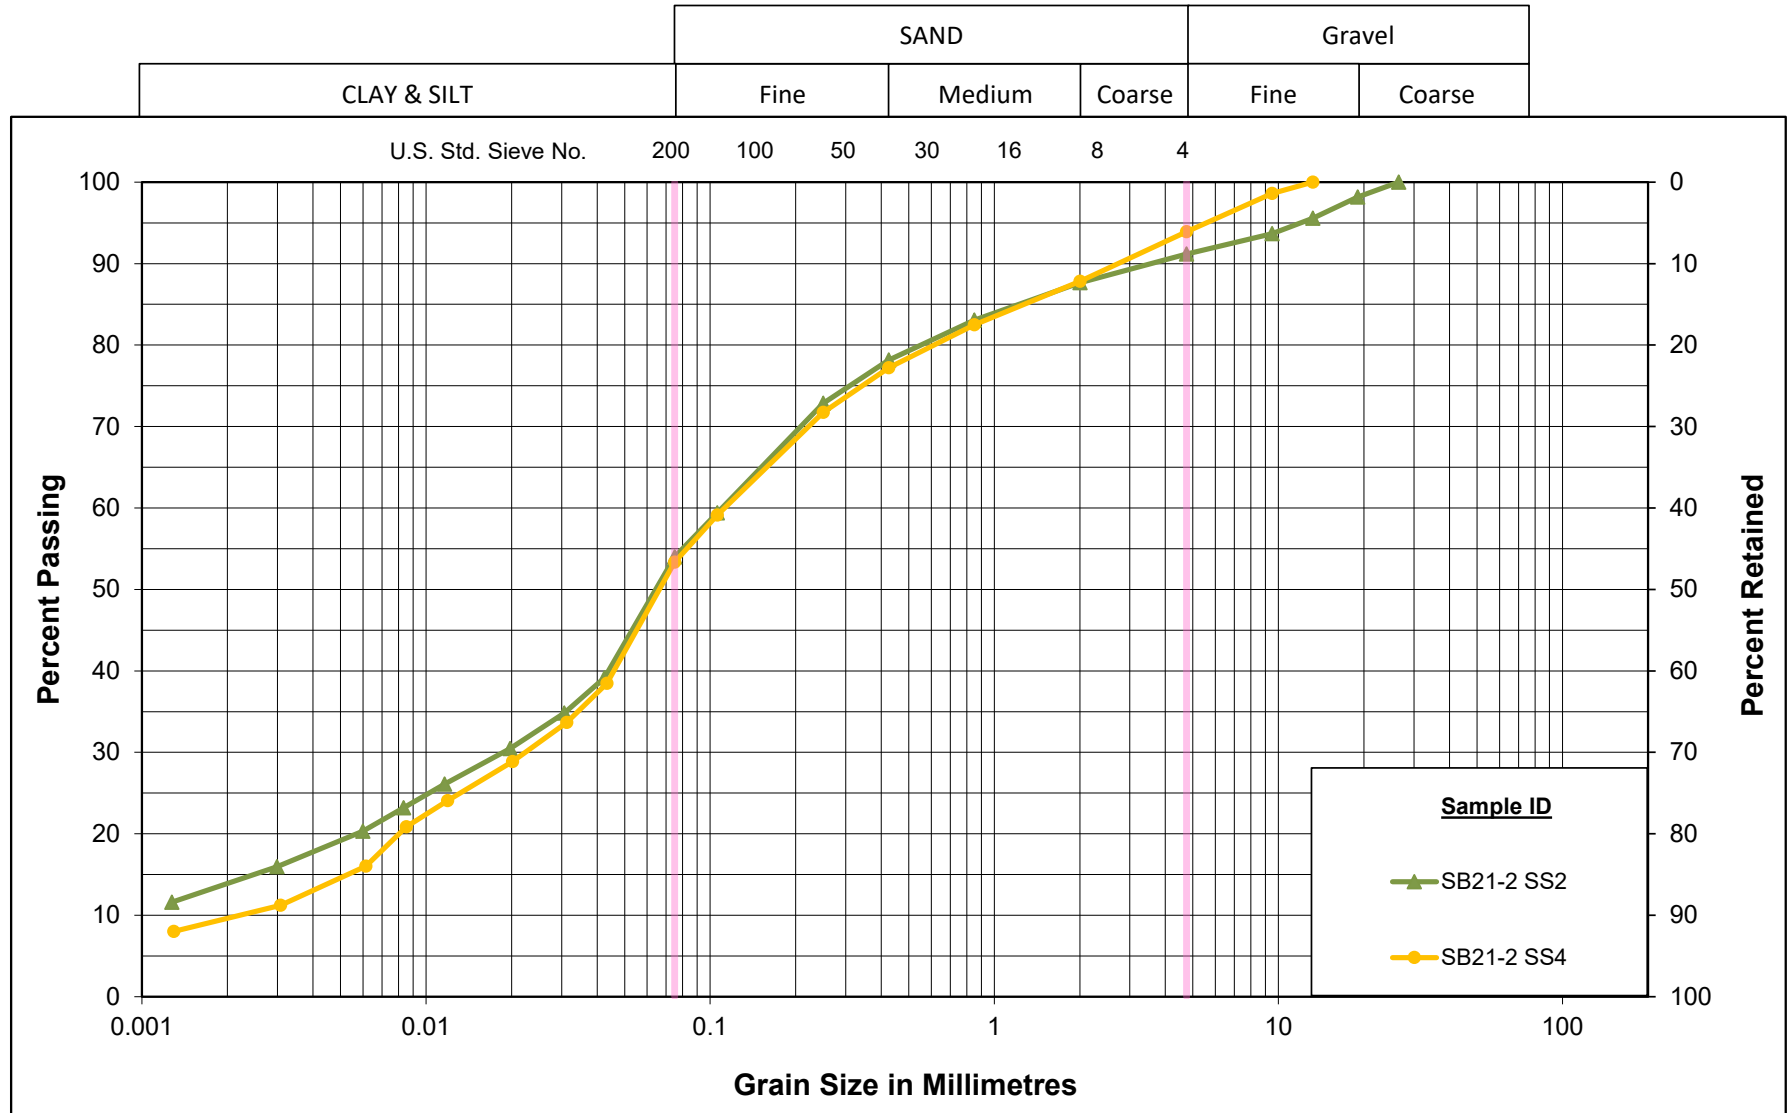
GRAIN SIZE DISTRIBUTION

Sandy CLAYEY SILT (CL) to SANDY SILT (ML) (TILL)

Gradation analyses were carried out on two (2) representative samples of the till deposit. The test results are illustrated on the borehole records in Appendix C and on the gradation curves on Figure No. D1 in Appendix D.
