Preliminary Foundation Investigation Report

Highway 401 - Proposed Widening of Deep
Cut Adjacent to 164 Skyview Road, Grafton,
Ontario

Highway 401 Planning Study
Cobourg to Colborne, Ontario

Project No. 165001231

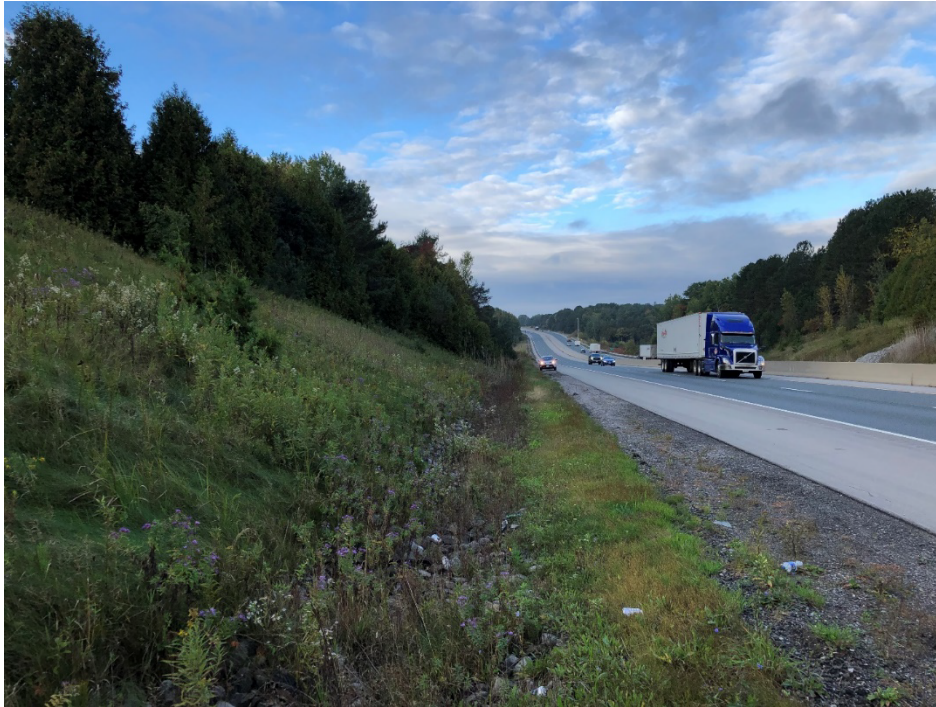
Photo No. 1: Existing slope looking west from toe of slope.

- The roadside drainage ditch was lined with rip rap in most areas (see Photograph 1 below). Rip-rap, or rockfill drainage ditches are present at the base of the cut slopes on both sides of Highway 401, east and west of the Shelter Valley crossing.

- The slope was generally covered by a variety of vegetation including trees, brush and grasses. In localized areas, generally just above the drainage ditch, the vegetative and surficial topsoil coverage was sparse (for example, see Photograph 2 below) and the mineral overburden soils were visible on the slope face. No signs of significant erosion were noted in these areas.

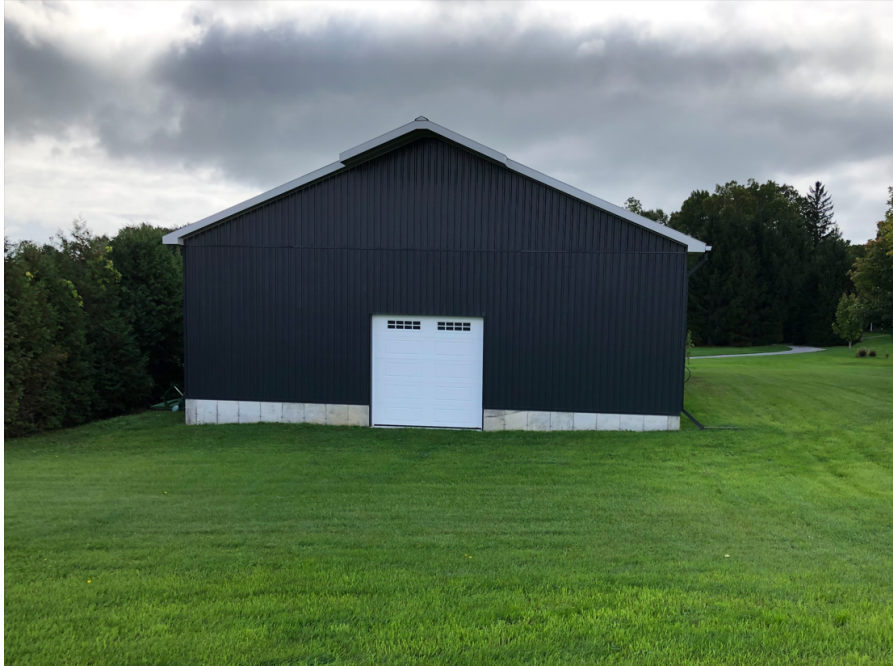
Photo No. 4: Existing building at 164 Skyview Road viewed from the north.

Photograph 4 below displays the existing, single-storey garage building present near to the MTO ROW on the property at 164 Skyview Road. The north face of the building is located approximately 22 m south of the current MTO ROW boundary and has a vehicle entrance/exit door facing the highway.

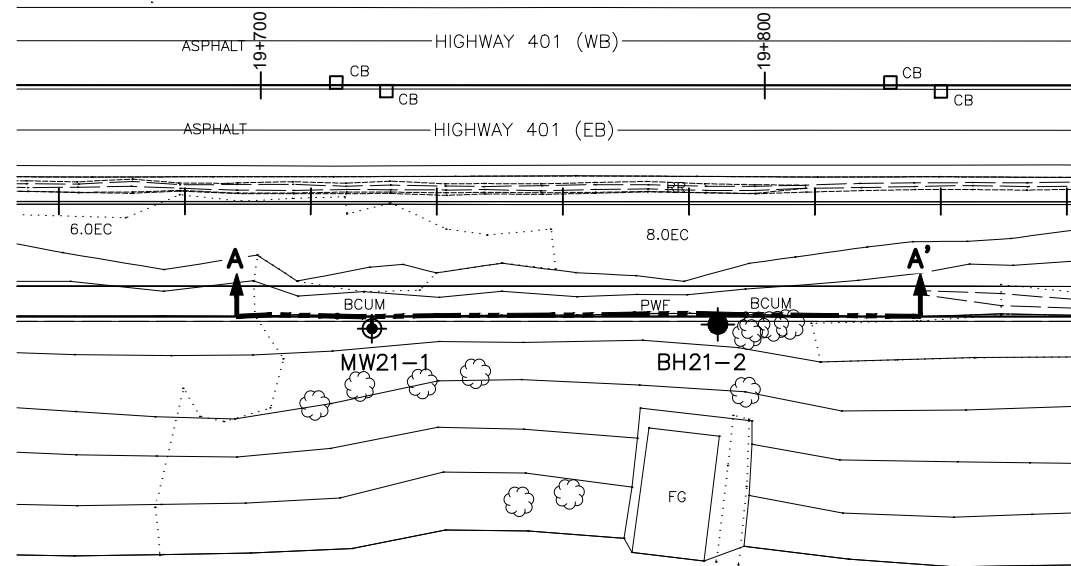
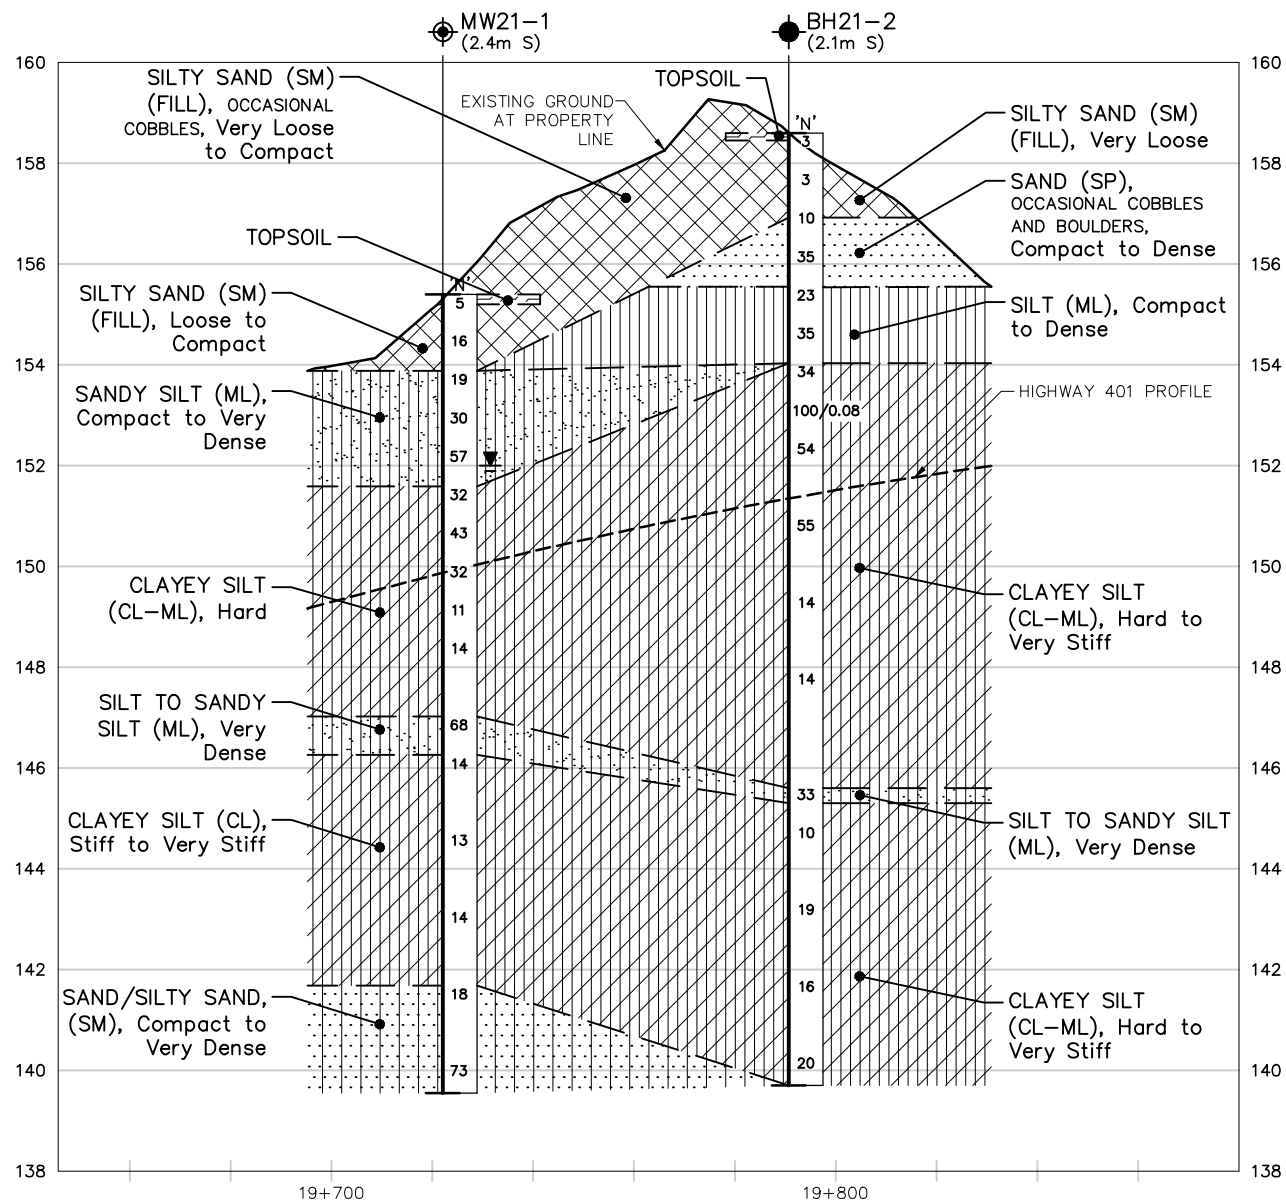
A.1 DRAWING NO. 1 – BOREHOLE LOCATIONS AND SOIL STRATA DRAWING

CROSS SECTION A-A'

HWY 401 WIDENING
164 SKYVIEW RD., COBOURG, ON
BOREHOLE LOCATIONS & SOIL STRATA

The foundation investigation program consisted of advancing two boreholes, designated as MW21-1 and BH21-2, between October 18 and 21, 2021. The two boreholes were advanced within the property at 164 Skyview Road directly south of the MTO ROW boundary. Borehole BH21-2 was located immediately north of the building recently constructed at the site. The borehole locations are displayed on the Borehole Location and Soil Strata Plan, Drawing No. 1, in Appendix A.

The subsurface conditions observed in the boreholes are presented in detail on the Borehole Records provided in Appendix B. Also, an explanation of the symbols and terms used to describe the Borehole Records is also provided in Appendix B. A borehole location plan and a stratigraphic profile of the soils encountered within the boreholes is provided on Drawing No. 1 in Appendix A.

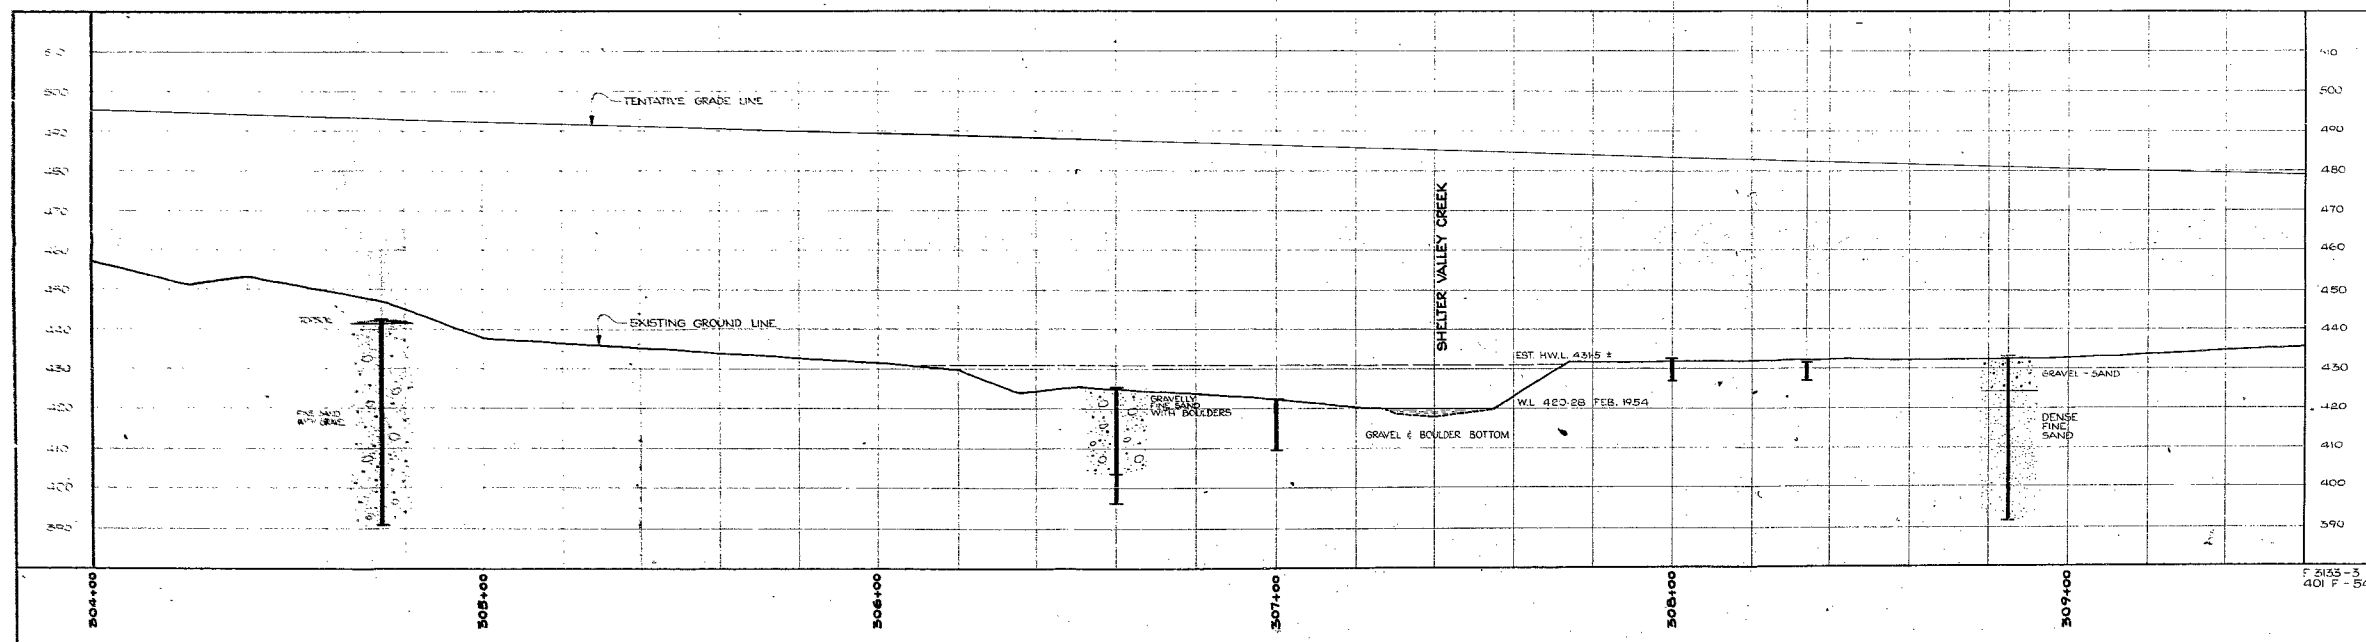
PLAN SCALE 1 IN = 20 FT

PROFILE SCALE HOR VER 1 IN = 20 FT

LEGEND			
BORE HOLES			
PENETRATION HOLE			
BORE & PENETRATION HOLE			
HOLE NO.	ELEVATION	STATION	DISTANCE FROM #
1	425.65	306+60'	50' LT
2	442.5	304+74'	20' RT
3	437.25	308+65'	4
4	431.4	308+34'	45 RT
5	422.5	307+00'	51' RT
10	432.6	308+00'	44' LT

Relevant borehole records and a site plan displaying the 1957 borehole locations are included in Appendix B for reference.

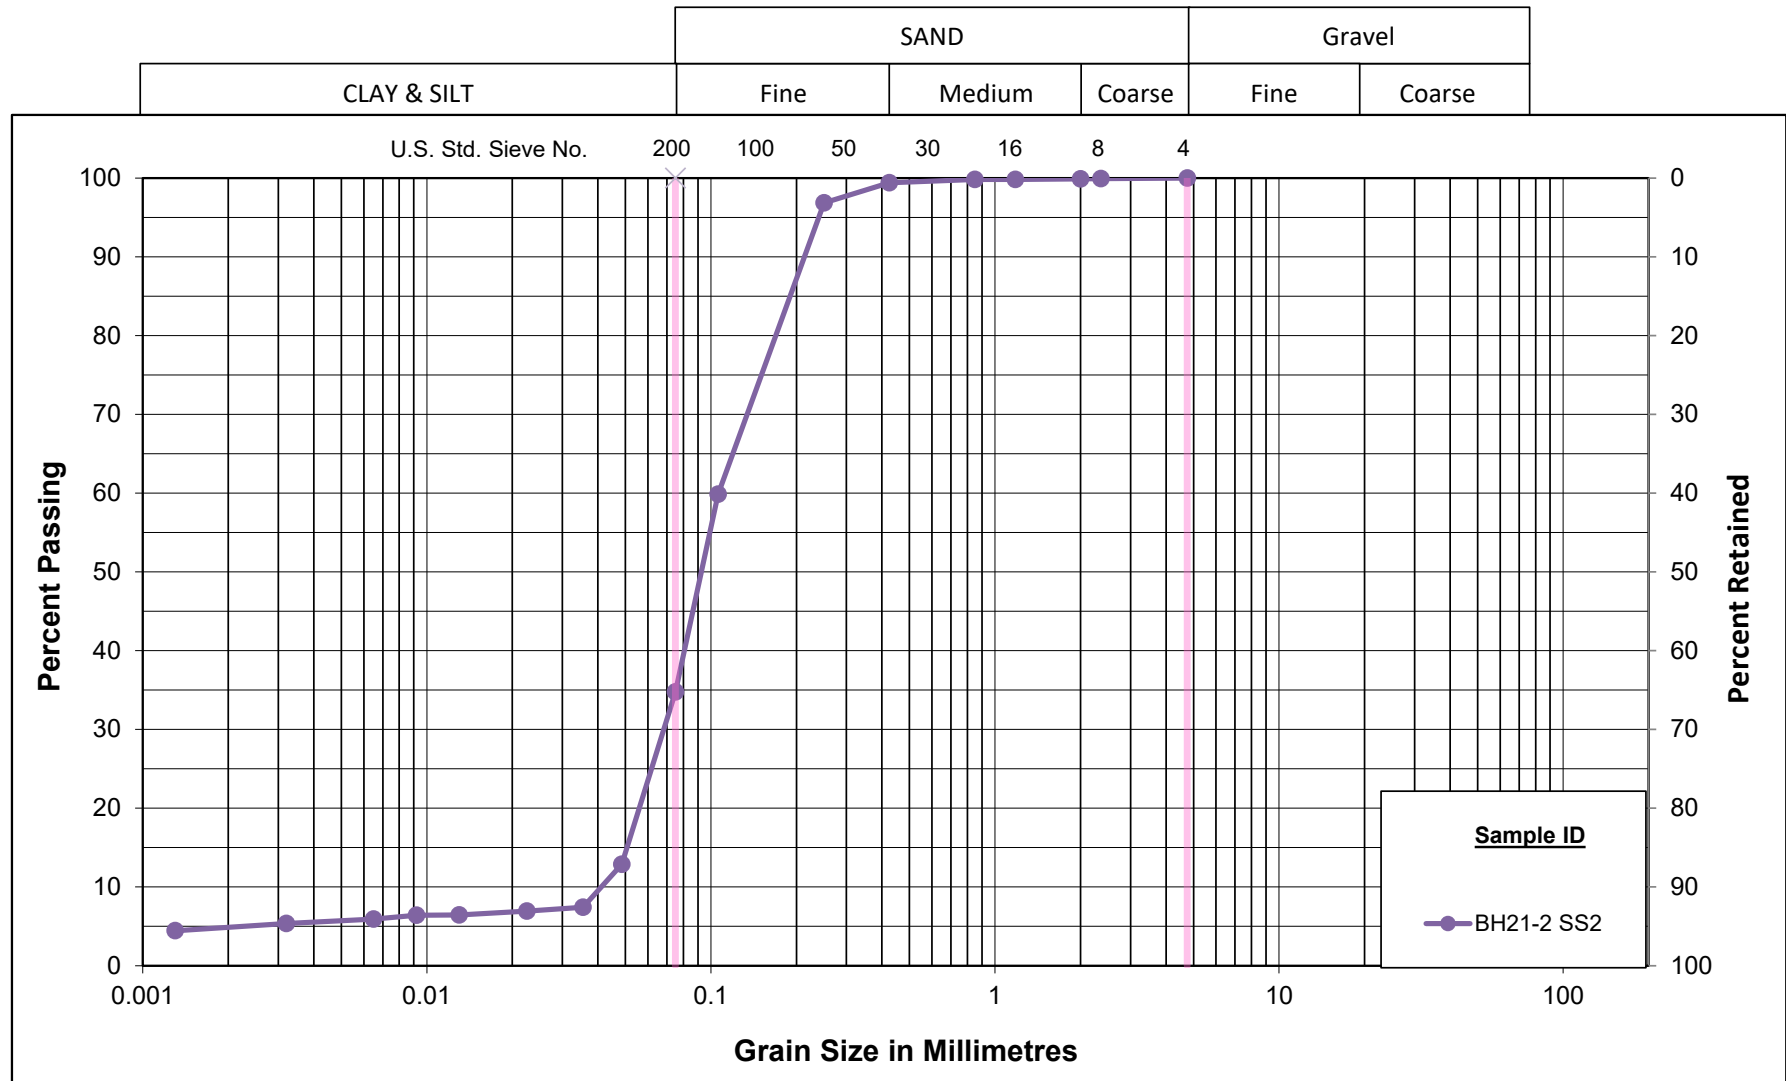
GRAIN SIZE DISTRIBUTION

FILL: Silty SAND (SM), trace clay
Highway 401 Cobourg to Colborne

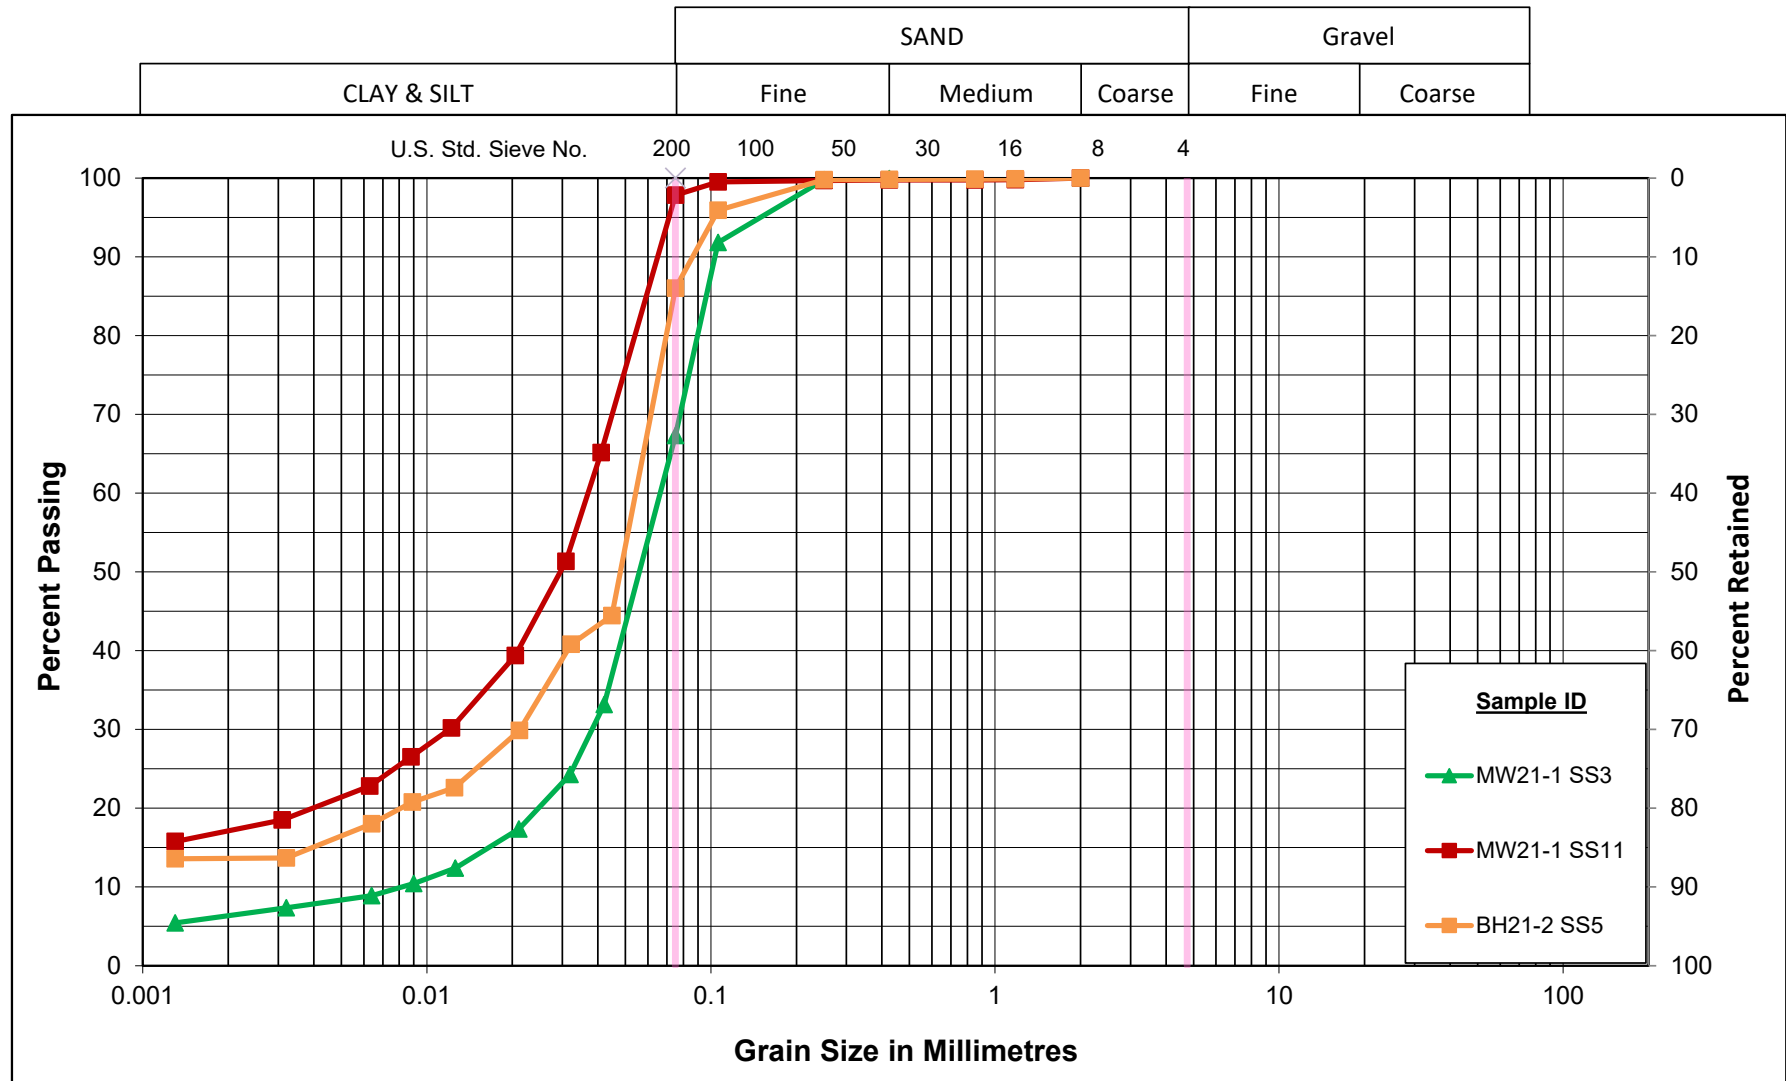
Figure No. C2

GRAIN SIZE DISTRIBUTION

SILT (ML), trace sand to sandy
Highway 401 Cobourg to Colborne

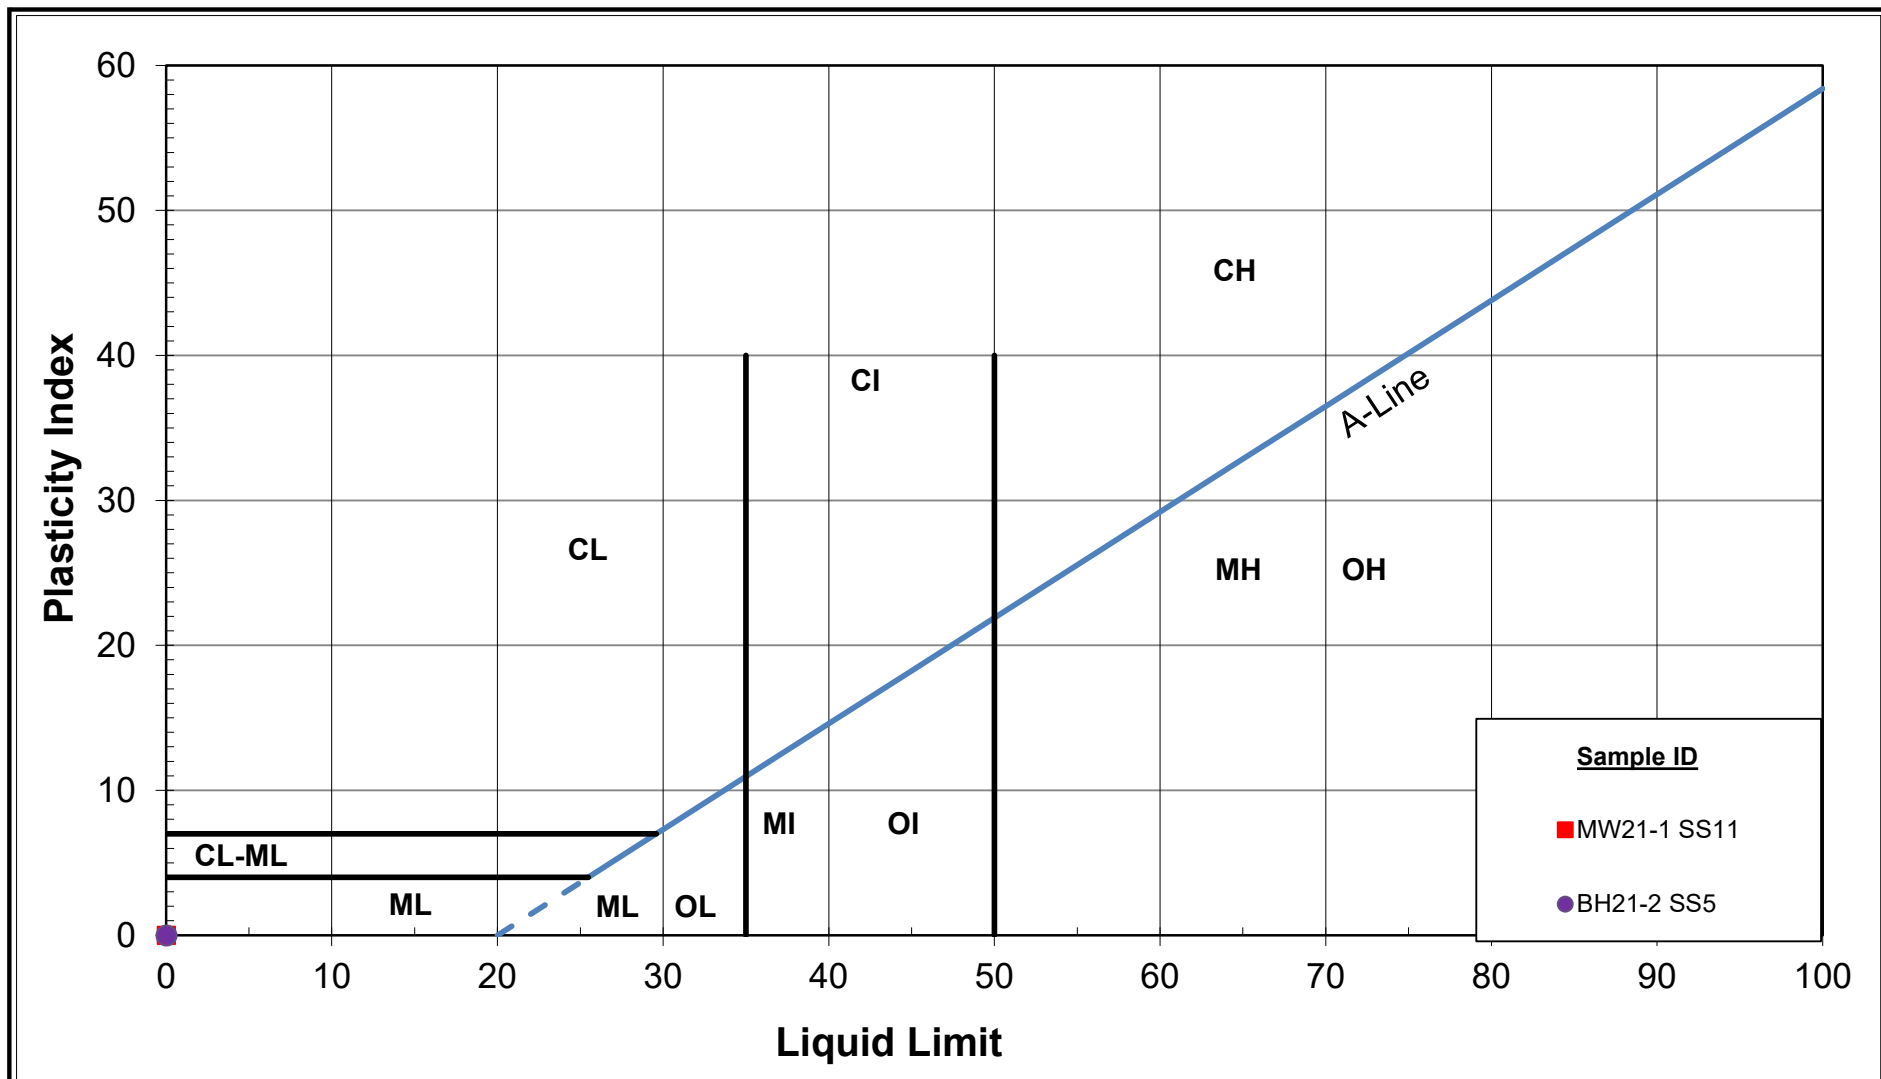
SILT (ML), trace to some sand, some clay

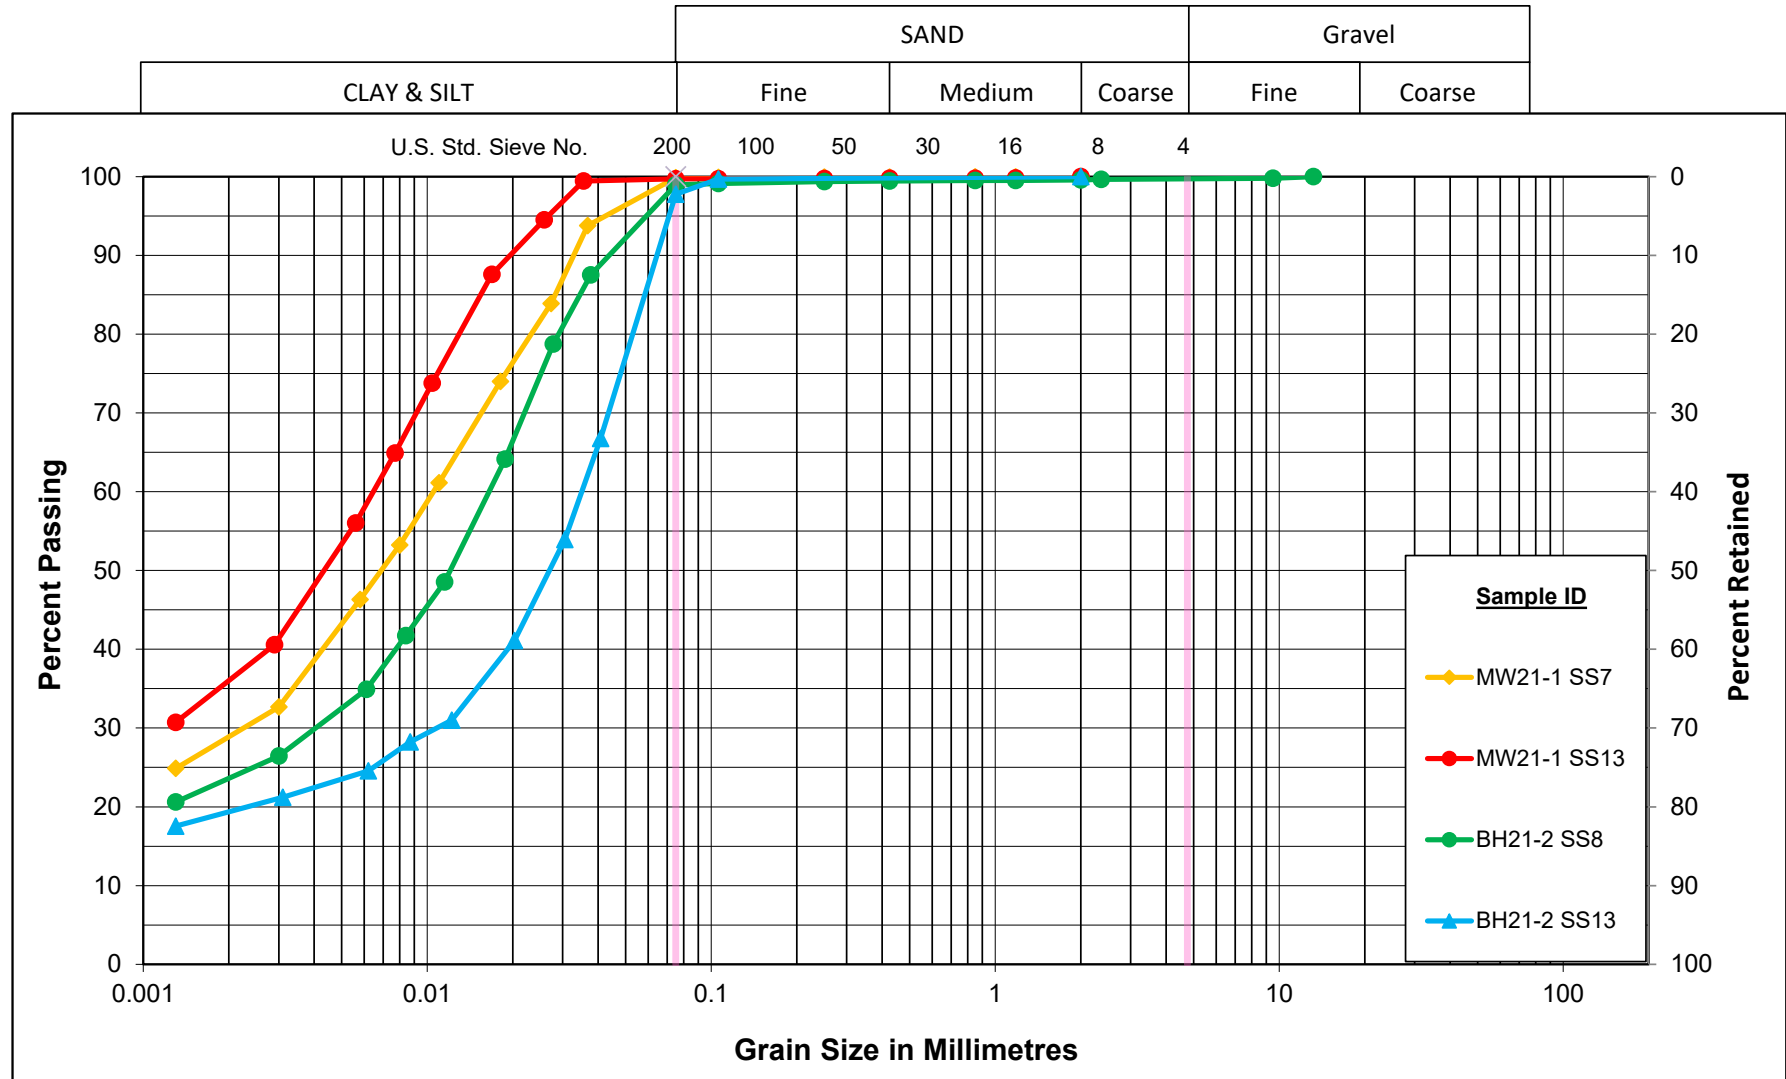
Figure No. C4

GRAIN SIZE DISTRIBUTION

CLAYEY SILT (CL to CL-ML)
Highway 401 Cobourg to Colborne

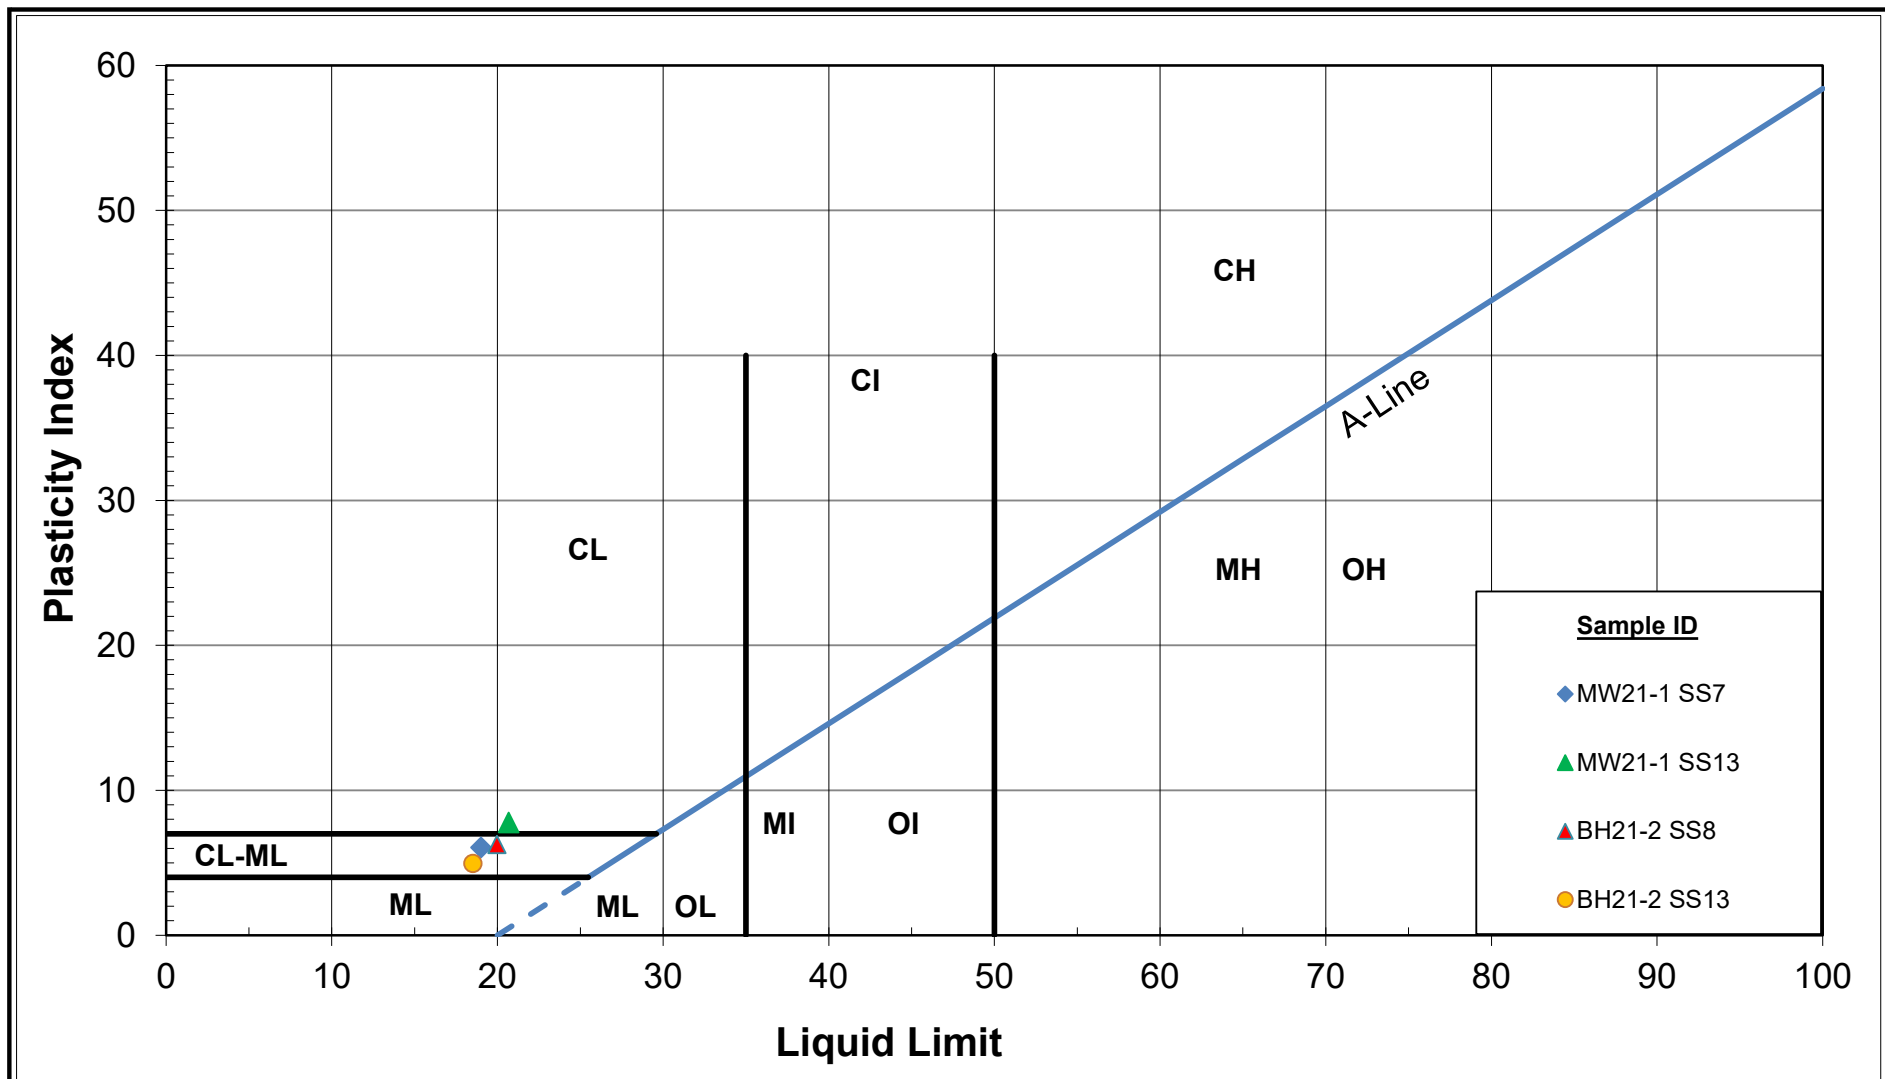
Figure No. C5

CLAYEY SILT (CL to CL-ML)
 Highway 401 Cobourg to Colborne
PLASTICITY CHART

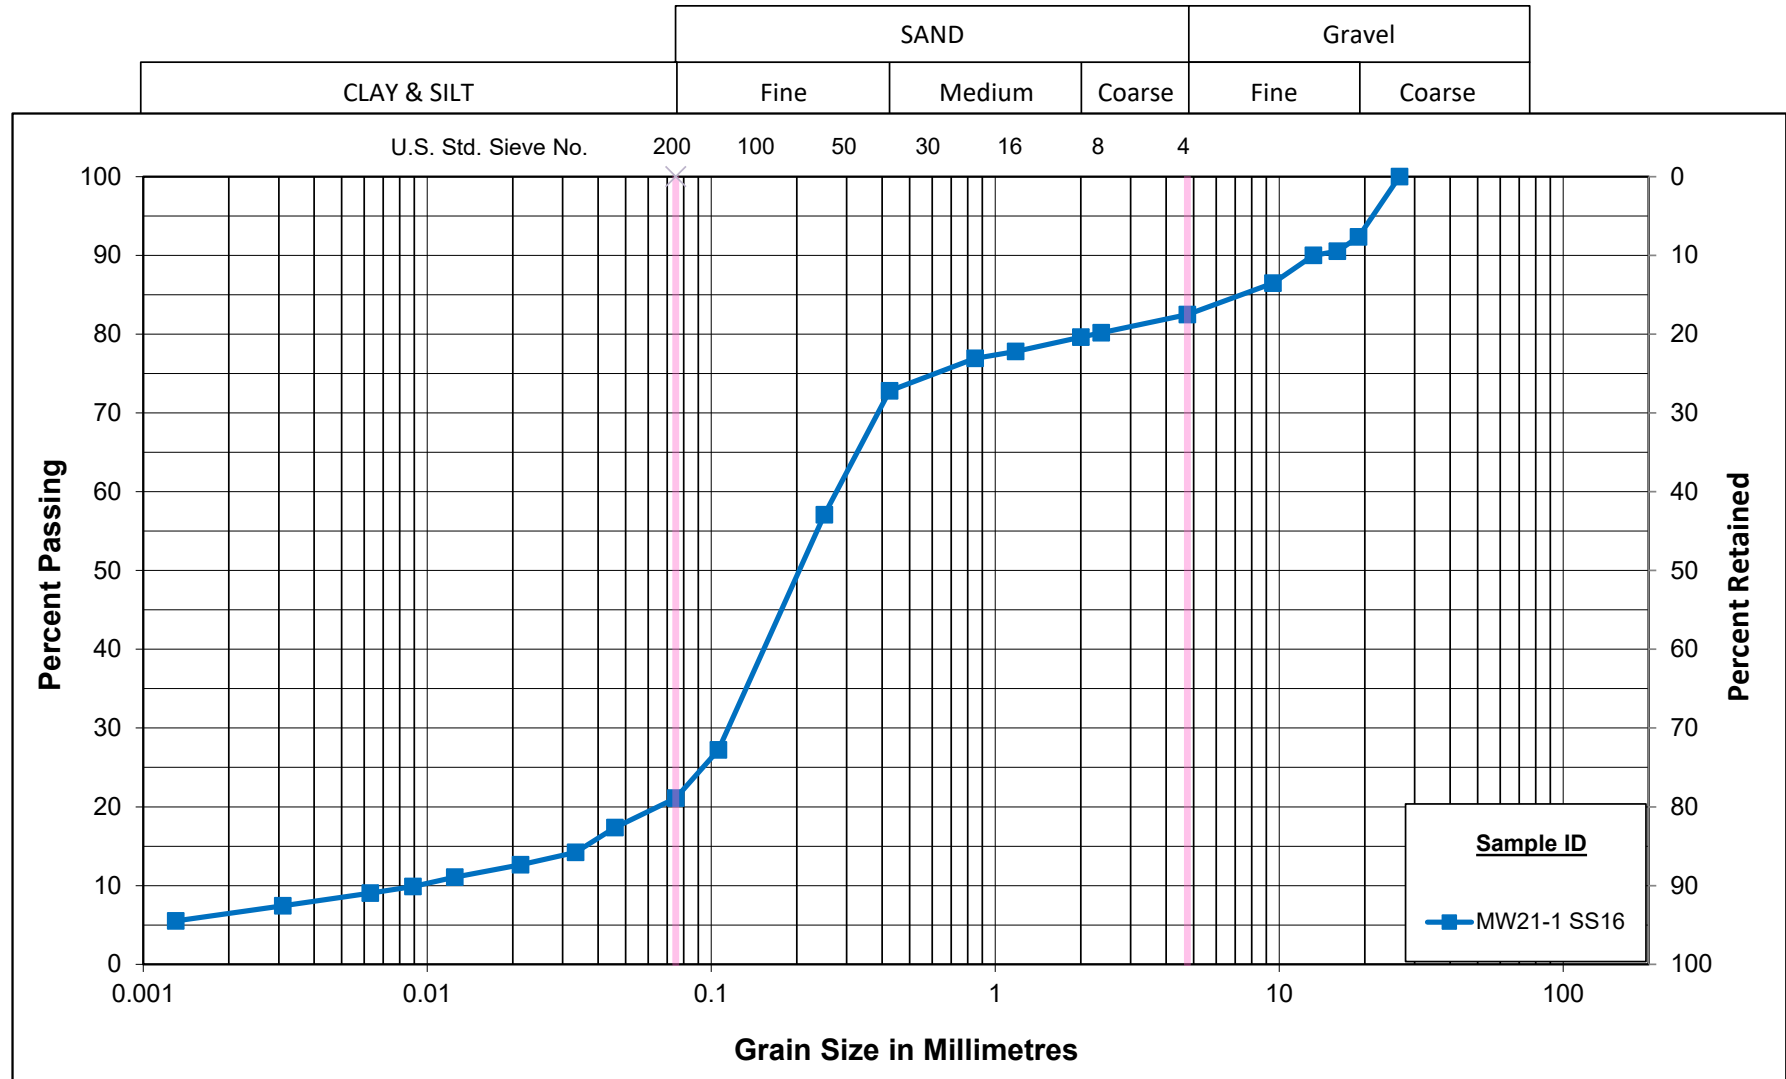
GRAIN SIZE DISTRIBUTION

SAND (SM), some silt, some gravel, trace clay
Highway 401 Cobourg to Colborne
