## FOUNDATION INVESTIGATION REPORT

*Queen Elizabeth Way (QEW) - Credit River Bridge, Structure Site No. 24-203,  
QEW Widening from West of Mississauga Road to West of Hurontario Street,  
Mississauga, Ministry of Transportation, Ontario, GWP 2002-13-00*

1662333-5

February 12, 2019

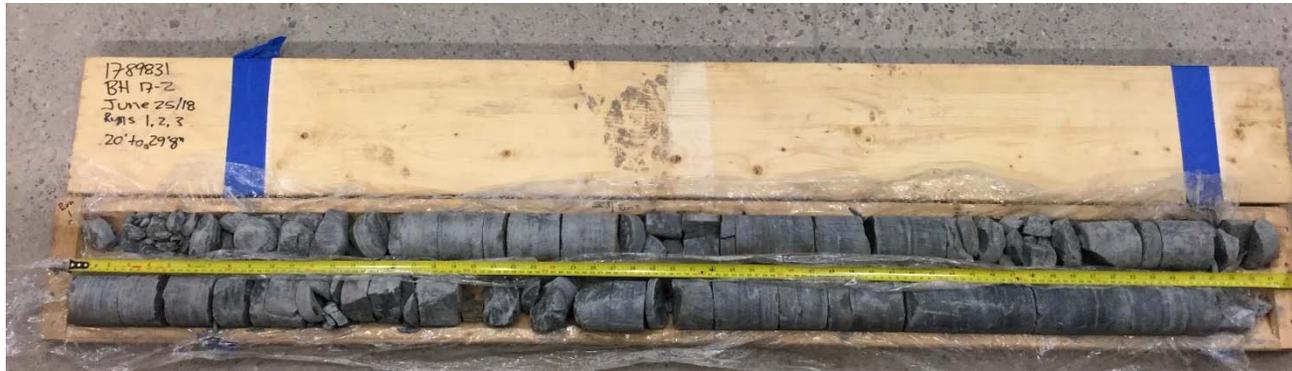
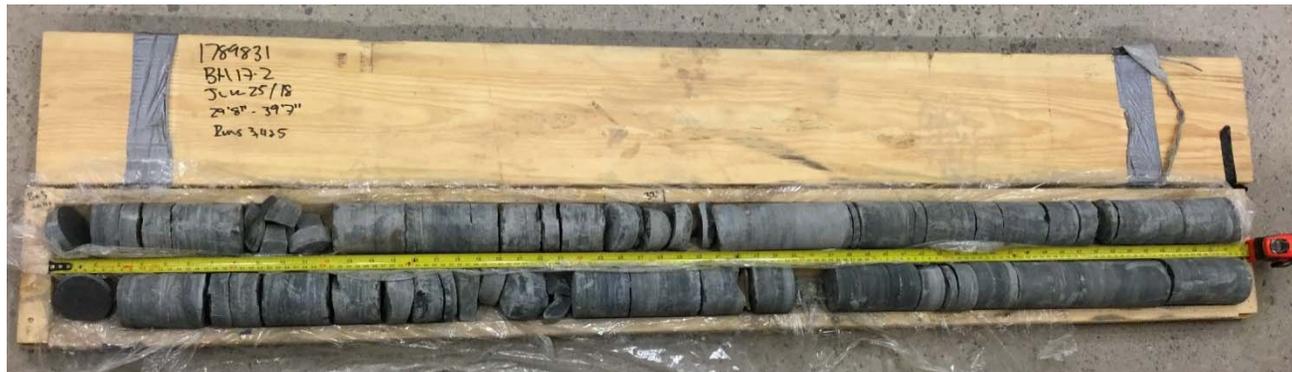
PROJECT				
<b>Proposed Electrical Transmission Line Monopoles at Credit River and QEW</b>				
TITLE				
<b>Bedrock Core Photograph Borehole BH17-2 (6.1 m to 12.1 m)</b>

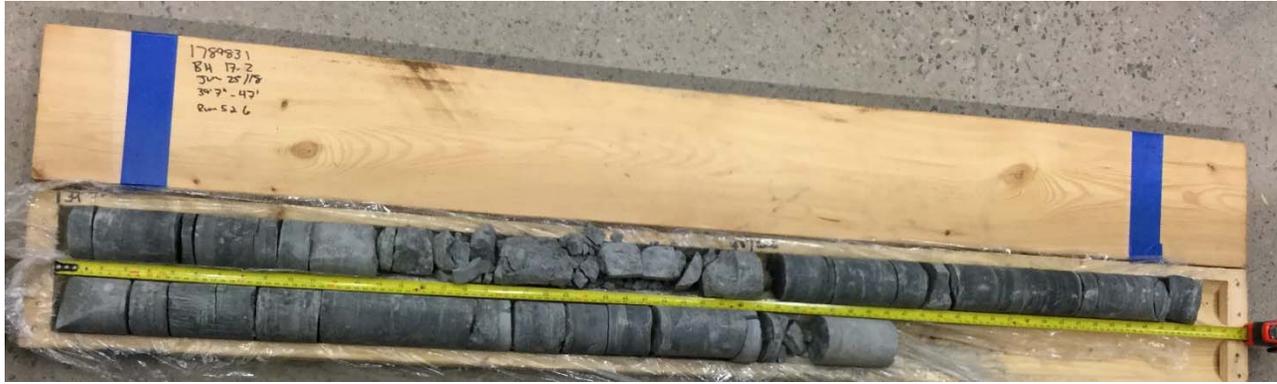
PROJECT				
<b>Proposed Electrical Transmission Line Monopoles at Credit River and QEW</b>				
TITLE				
<b>Bedrock Core Photograph Borehole BH17-2 (12.1 m to 17.1 m)</b>

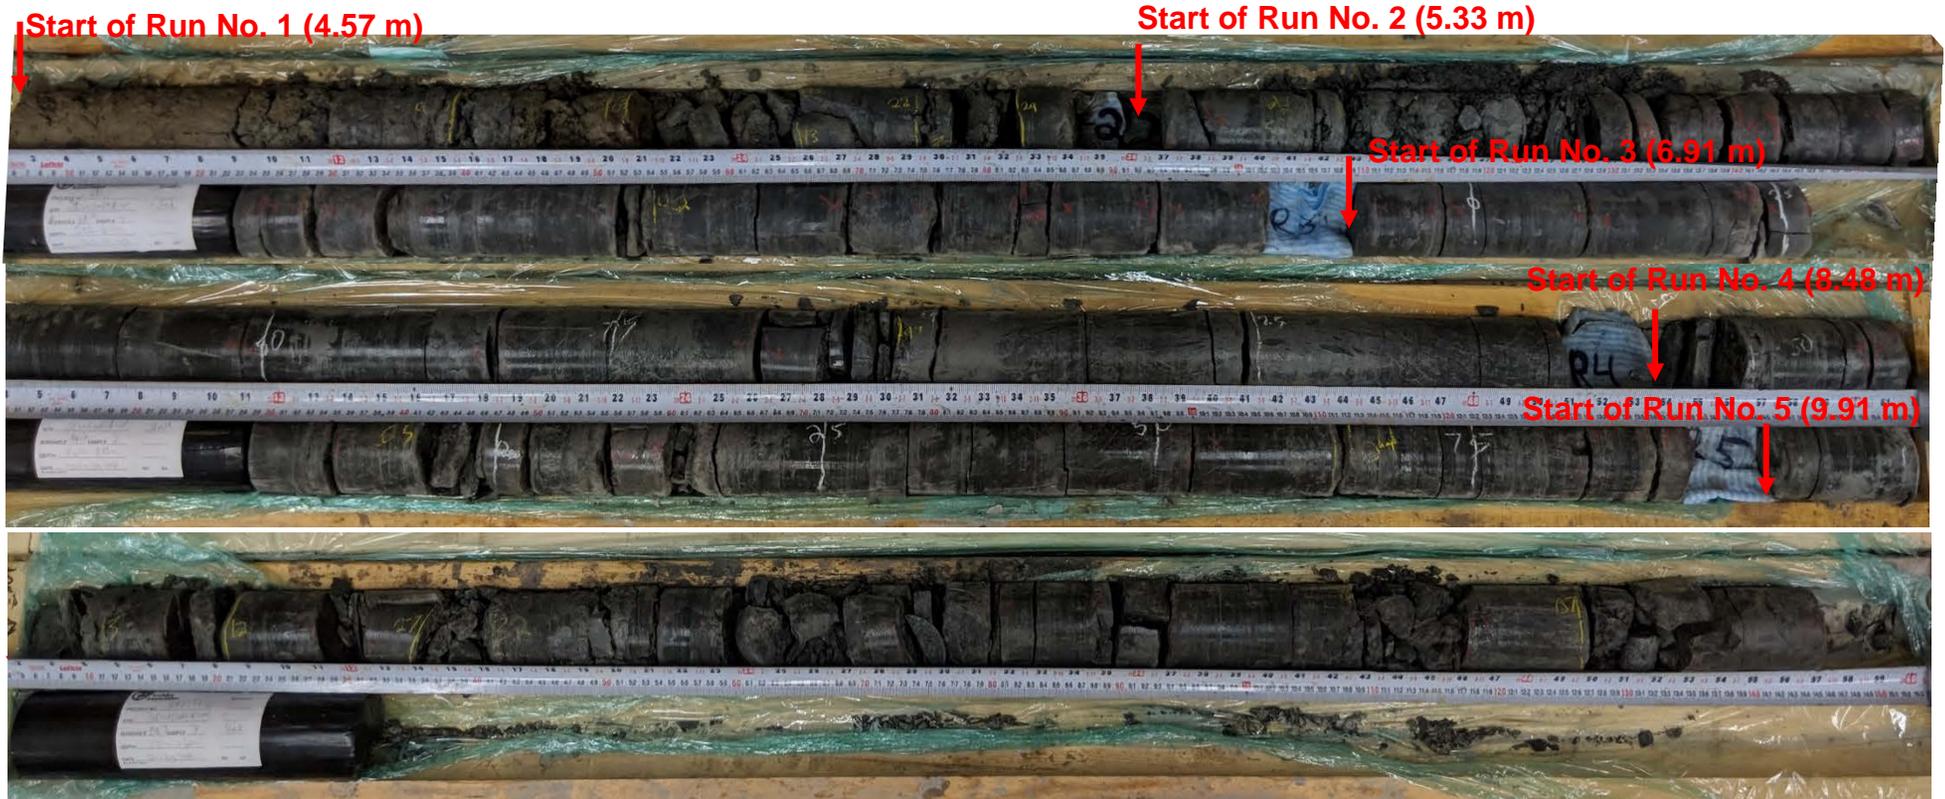
PROJECT	<b>MTO Assignment 2015-E-0033 QEW Widening Between Mississauga Road and Hurontario Street</b>					
TITLE	<b>Bedrock Core Photograph Borehole AR-2 (4.57 m to 11.60 m)</b>

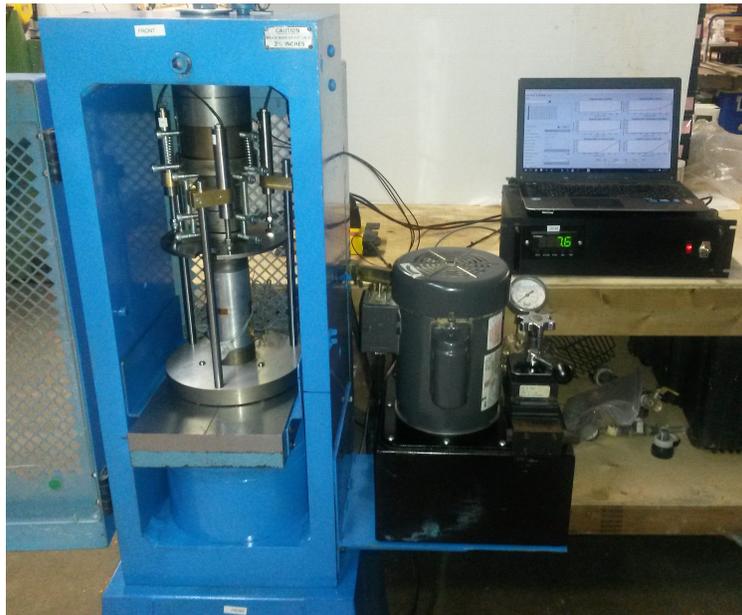
1. Unwrapping of the core sample, inspecting it for damage, and re-wrapping it in electrical tape to minimize exposure to moisture during subsequent specimen preparation.
2. Diamond cutting of core samples to obtain cylindrical specimens with an appropriate length (length:diameter = 2:1) and nearly parallel end faces.
3. Diamond grinding of specimens to obtain flat (within  $\pm 0.025$  mm) and parallel end faces (within  $0.25^\circ$ ).
4. Placement of the specimen into the loading frame, applying a 1 kN axial load, and removing the electrical tape.
5. Axial loading to rupture while continuously recording axial force and axial deformation to determine the peak strength (UCS) and (tangent) Young's modulus ( $E$ ).

Figure 1: UCS test setup.

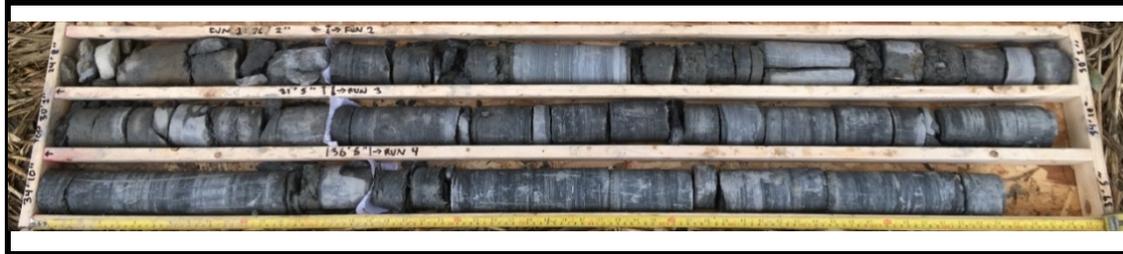
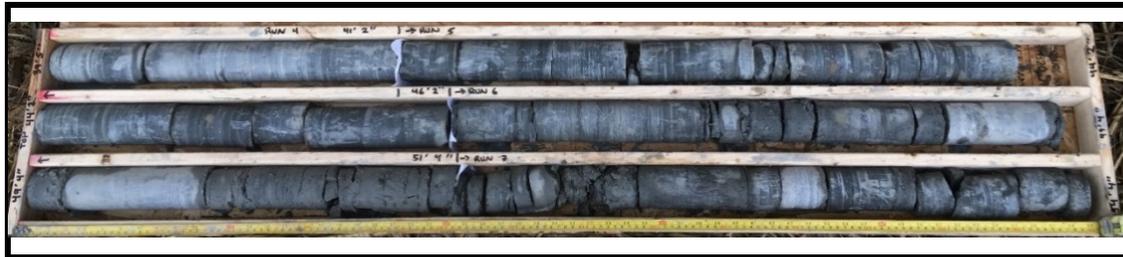
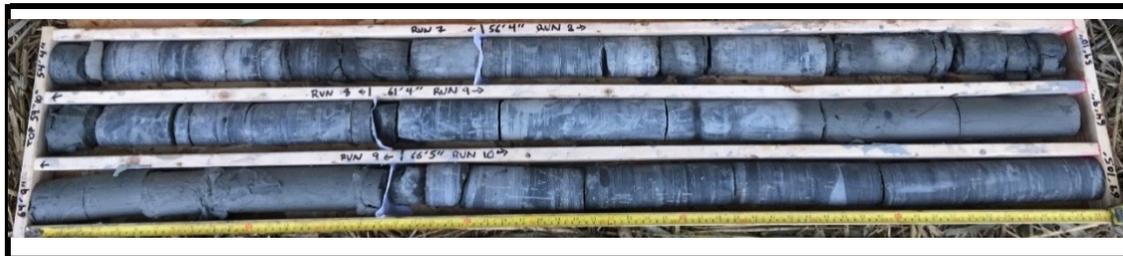
<b>Project:</b>	ESA Drilling Credit River & QEW		
<b>Project Number:</b>	160950937		
<b>Location:</b>	Mississauga, ON		
<b>Borehole:</b>	BH3	<b>Depth (m):</b>	7.52 - 30.94

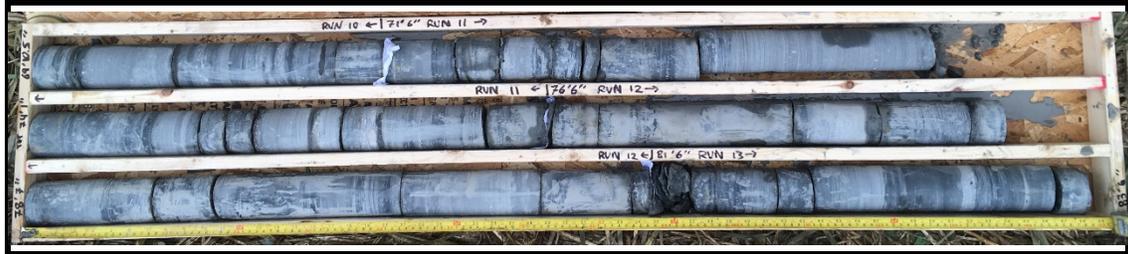
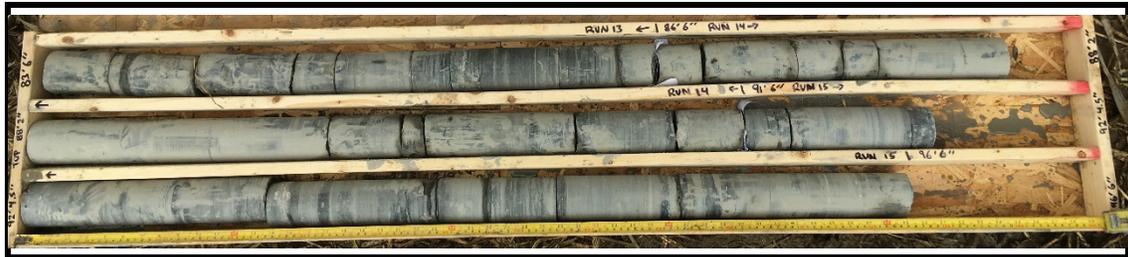
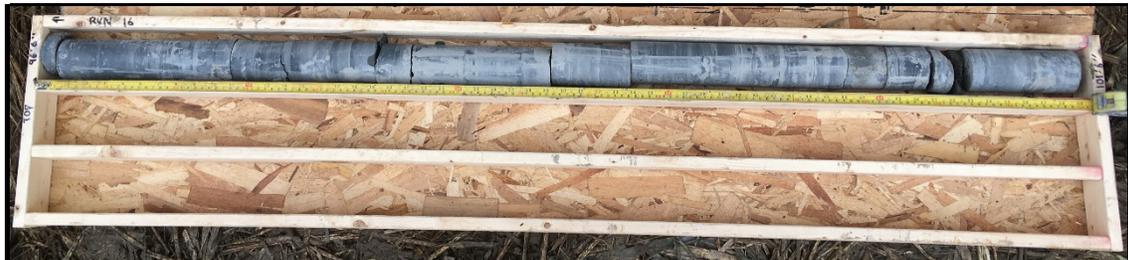
<b>Project:</b>	ESA Drilling Credit River & QEW		
<b>Project Number:</b>	160950937		
<b>Location:</b>	Mississauga, ON		
<b>Borehole:</b>	BH3	<b>Depth (m):</b>	7.52 - 30.94

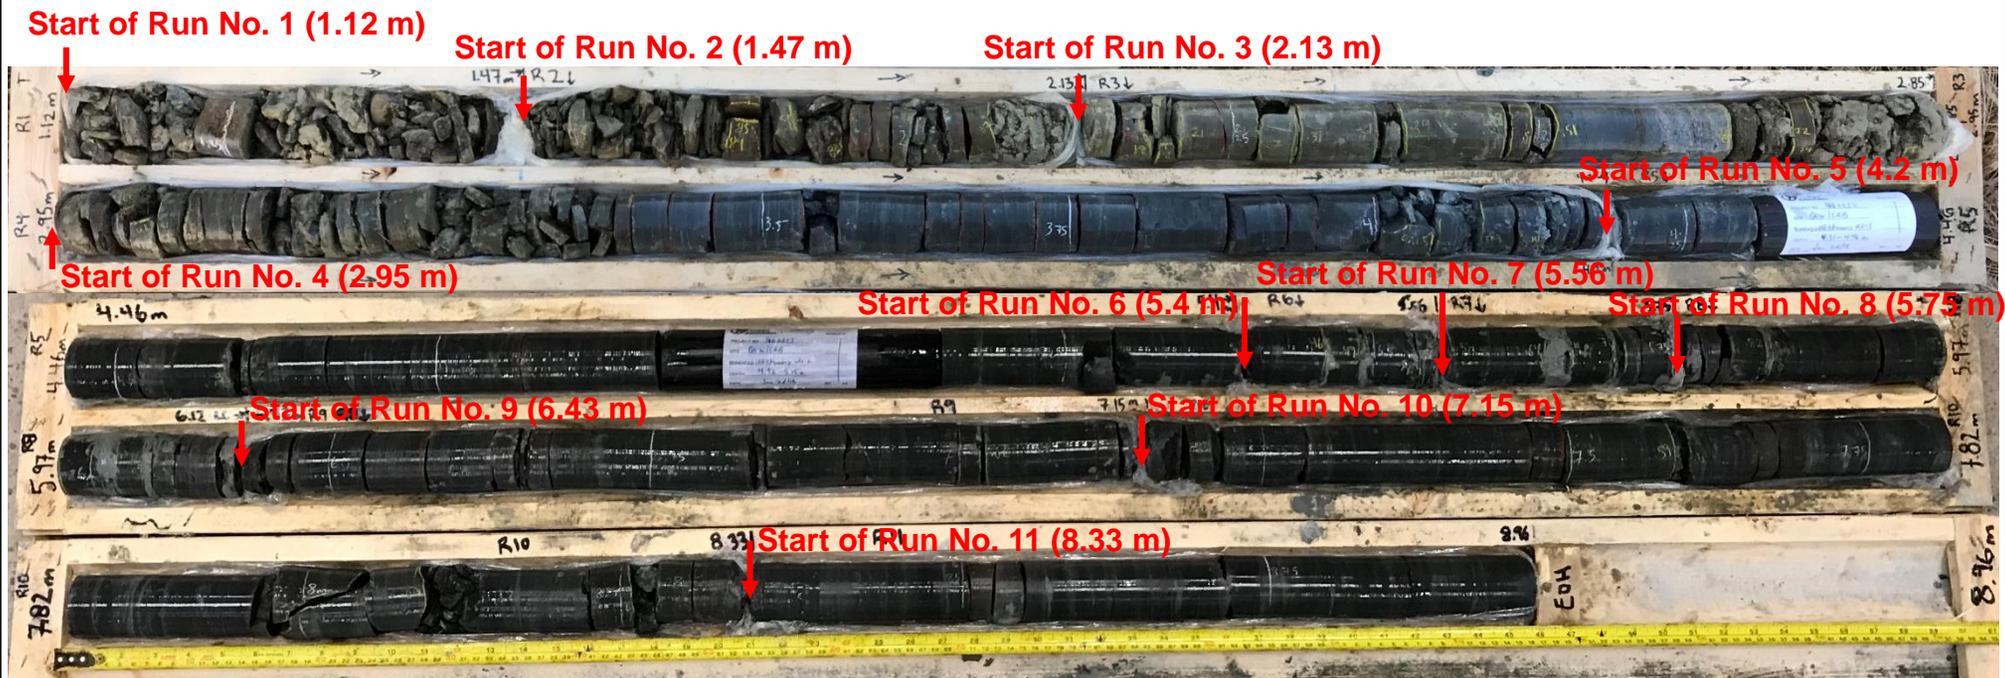
PROJECT						<b>MTO Assignment 2015-E-0033: Detail Design for the widening/rehab/realignment of QEW Between Mississauga Road and Hurontario Street</b>					
TITLE						<b>Bedrock Core Photograph Borehole CRB-2A (1.12 m to 8.96 m)</b>

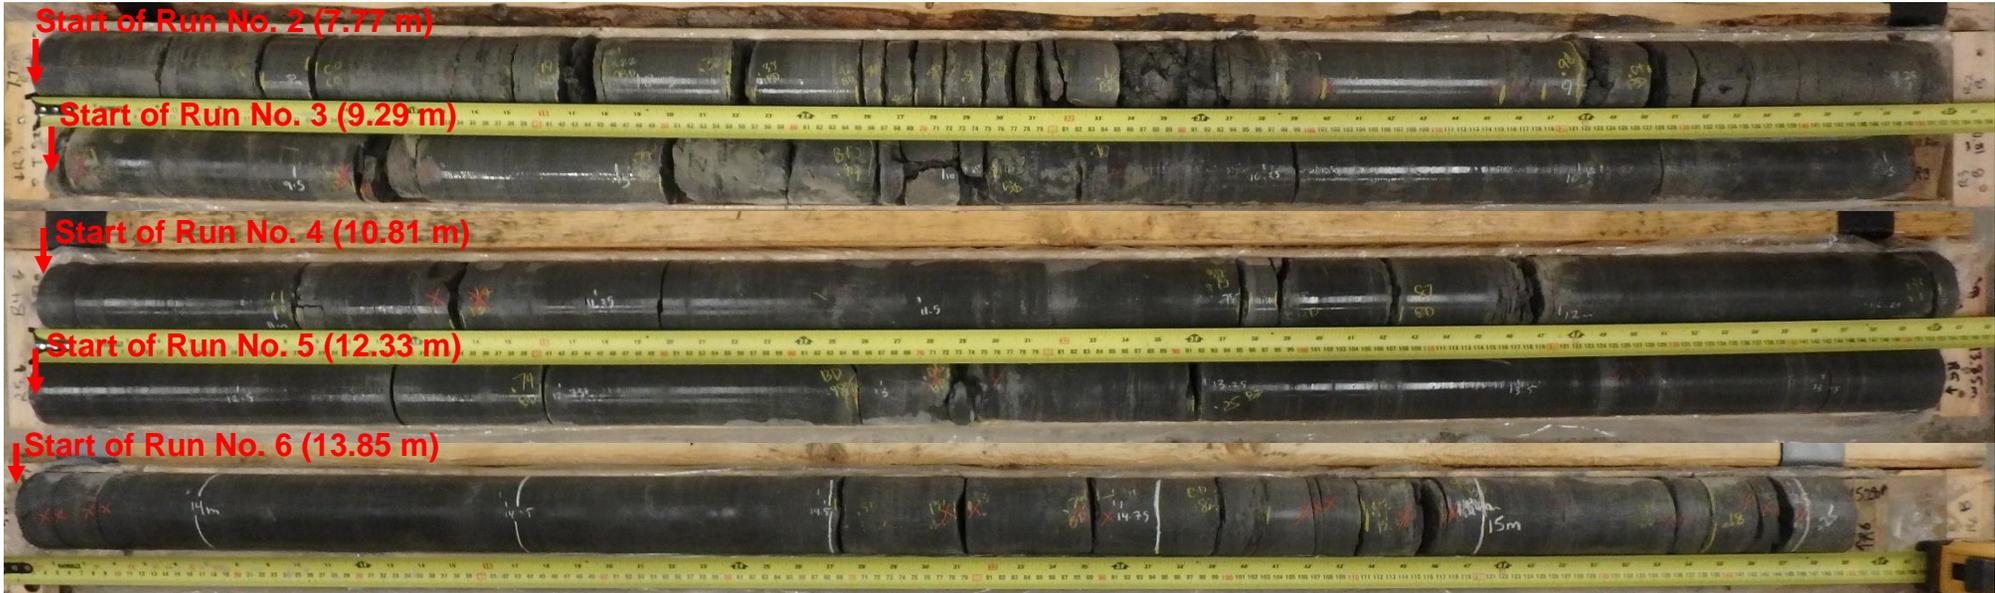
PROJECT		<b>MTO Assignment 2015-E-0033: Detail Design for the widening/rehab/realignment of QEW Between Mississauga Road and Hurontario Street</b>				
TITLE		<b>Bedrock Core Photograph Borehole CRB-3 (7.77 m to 15.28 m)</b>

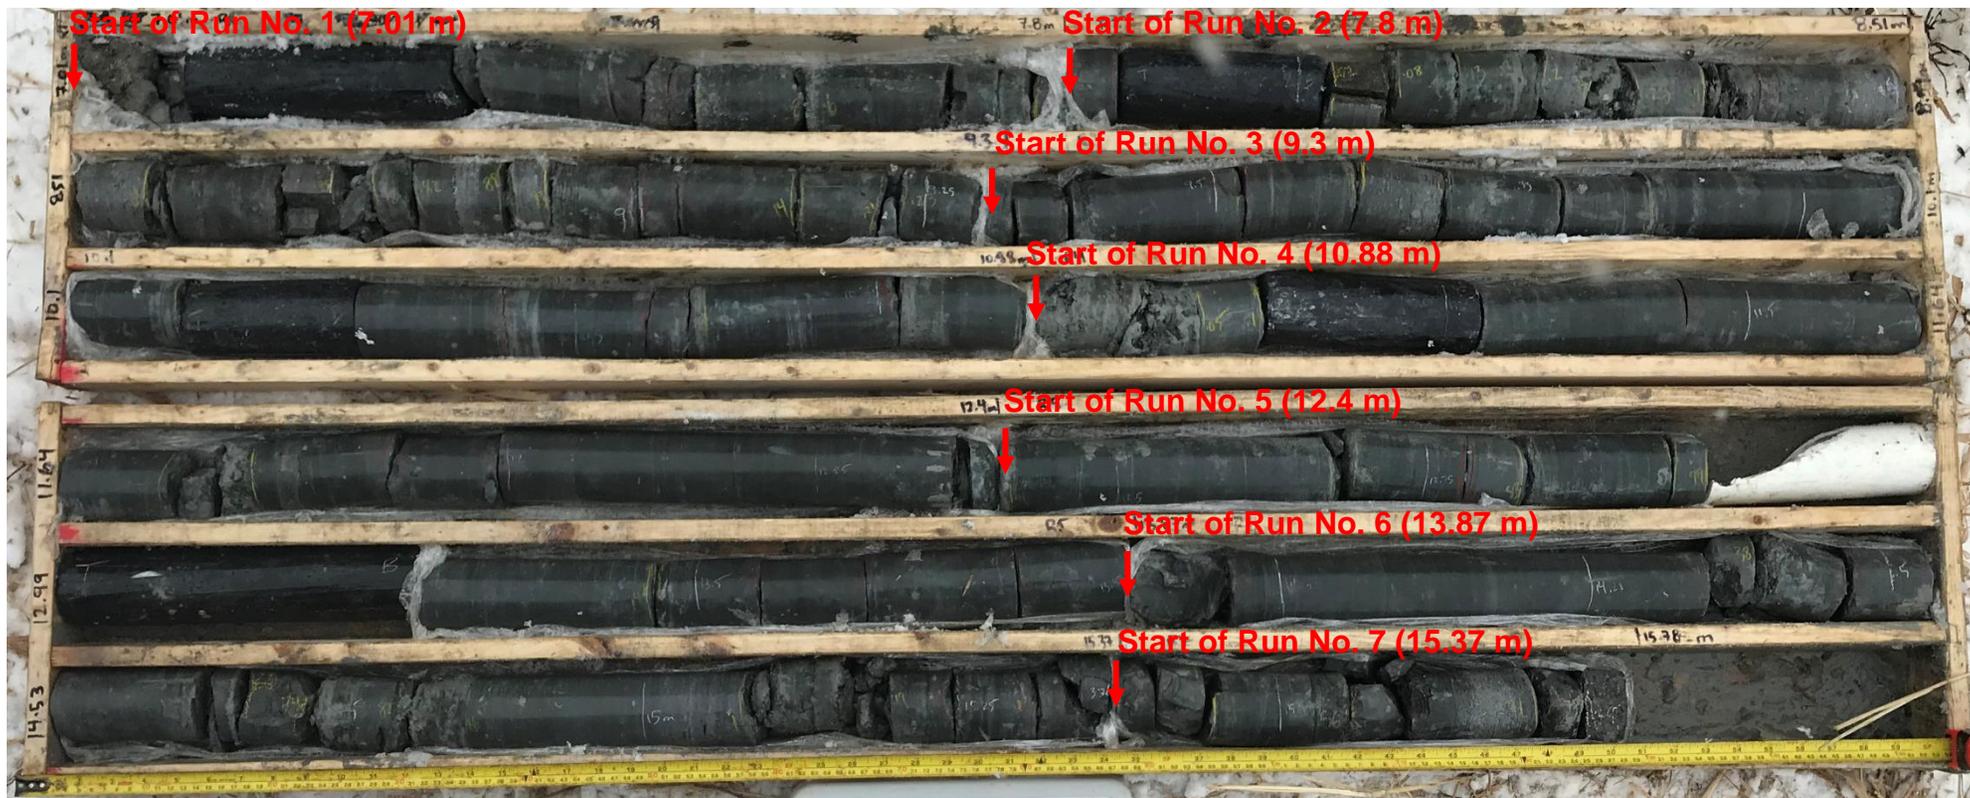
PROJECT						<b>MTO Assignment 2015-E-0033: Detail Design for the widening/rehab/realignment of QEW Between Mississauga Road and Hurontario Street</b>					
TITLE						<b>Bedrock Core Photograph Borehole CRB-3A (7.01 m to 15.78 m)</b>

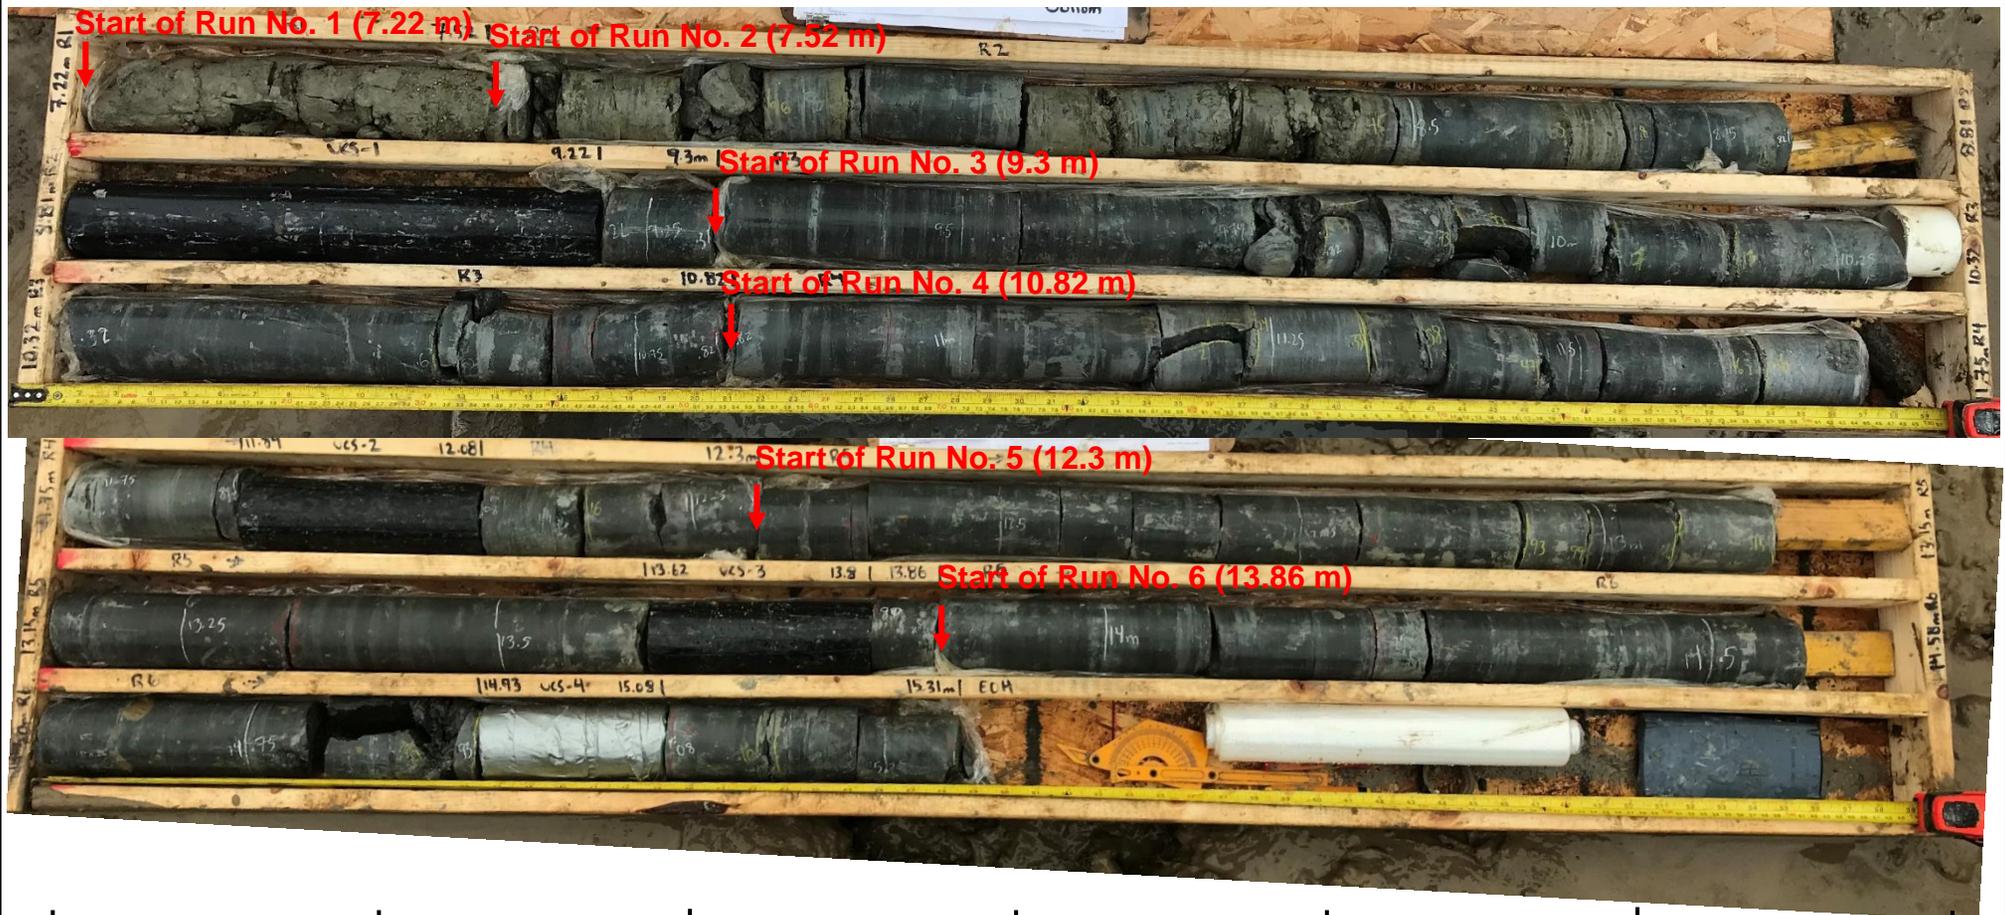
PROJECT							<b>MTO Assignment 2015-E-0033: Detail Design for the widening/rehab/realignment of QEW Between Mississauga Road and Hurontario Street</b>				
TITLE							<b>Bedrock Core Photograph Borehole CRB-4 (7.22 m to 15.31 m)</b>

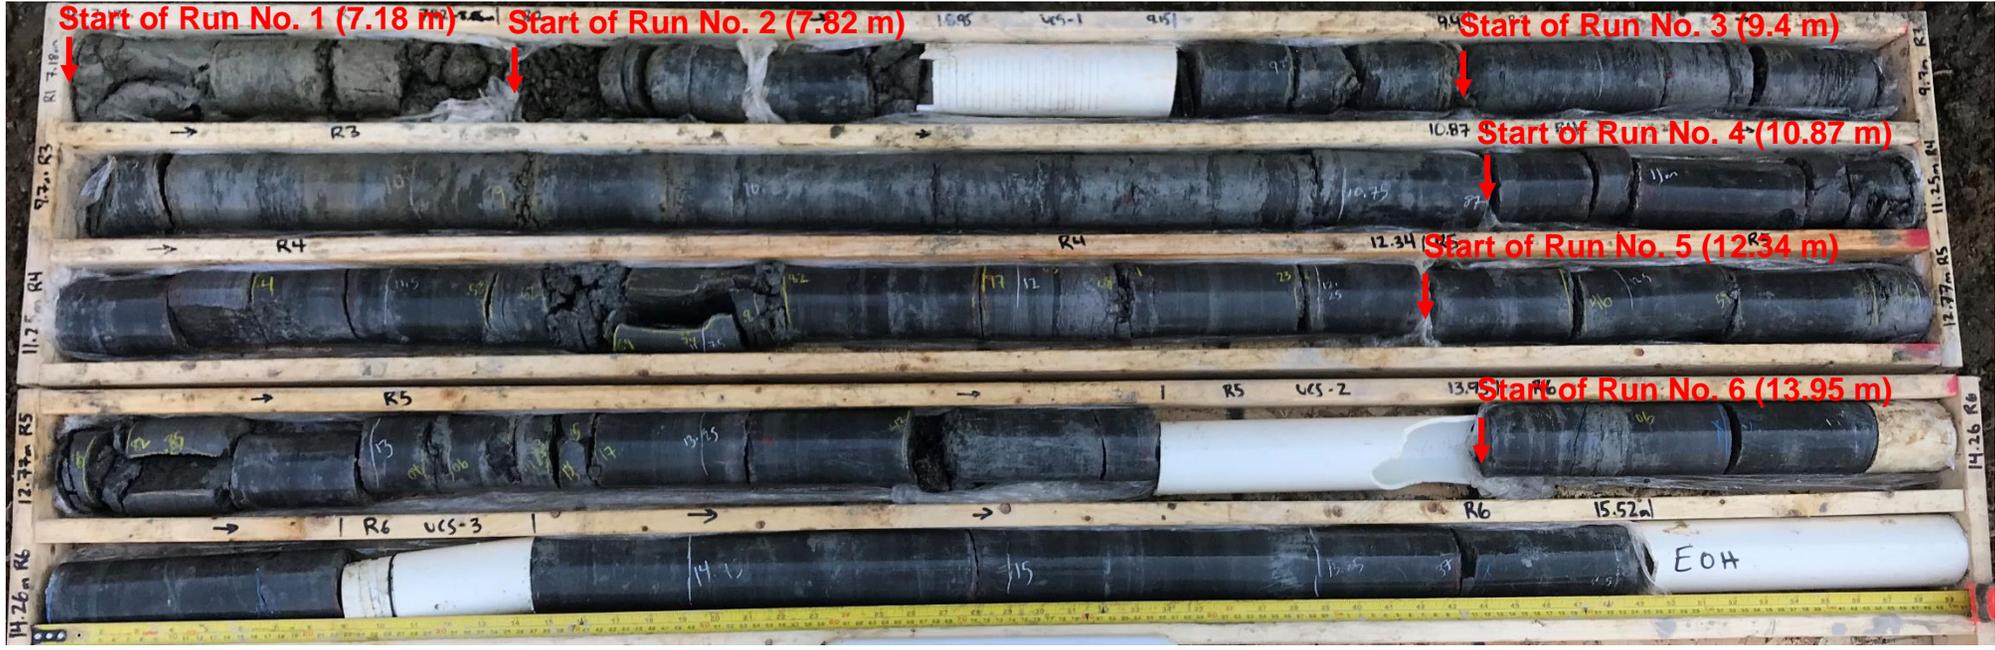
PROJECT		<b>MTO Assignment 2015-E-0033: Detail Design for the widening/rehab/realignment of QEW Between Mississauga Road and Hurontario Street</b>			
TITLE		<b>Bedrock Core Photograph Borehole CRB-5 (7.18 m to 15.52 m)</b>

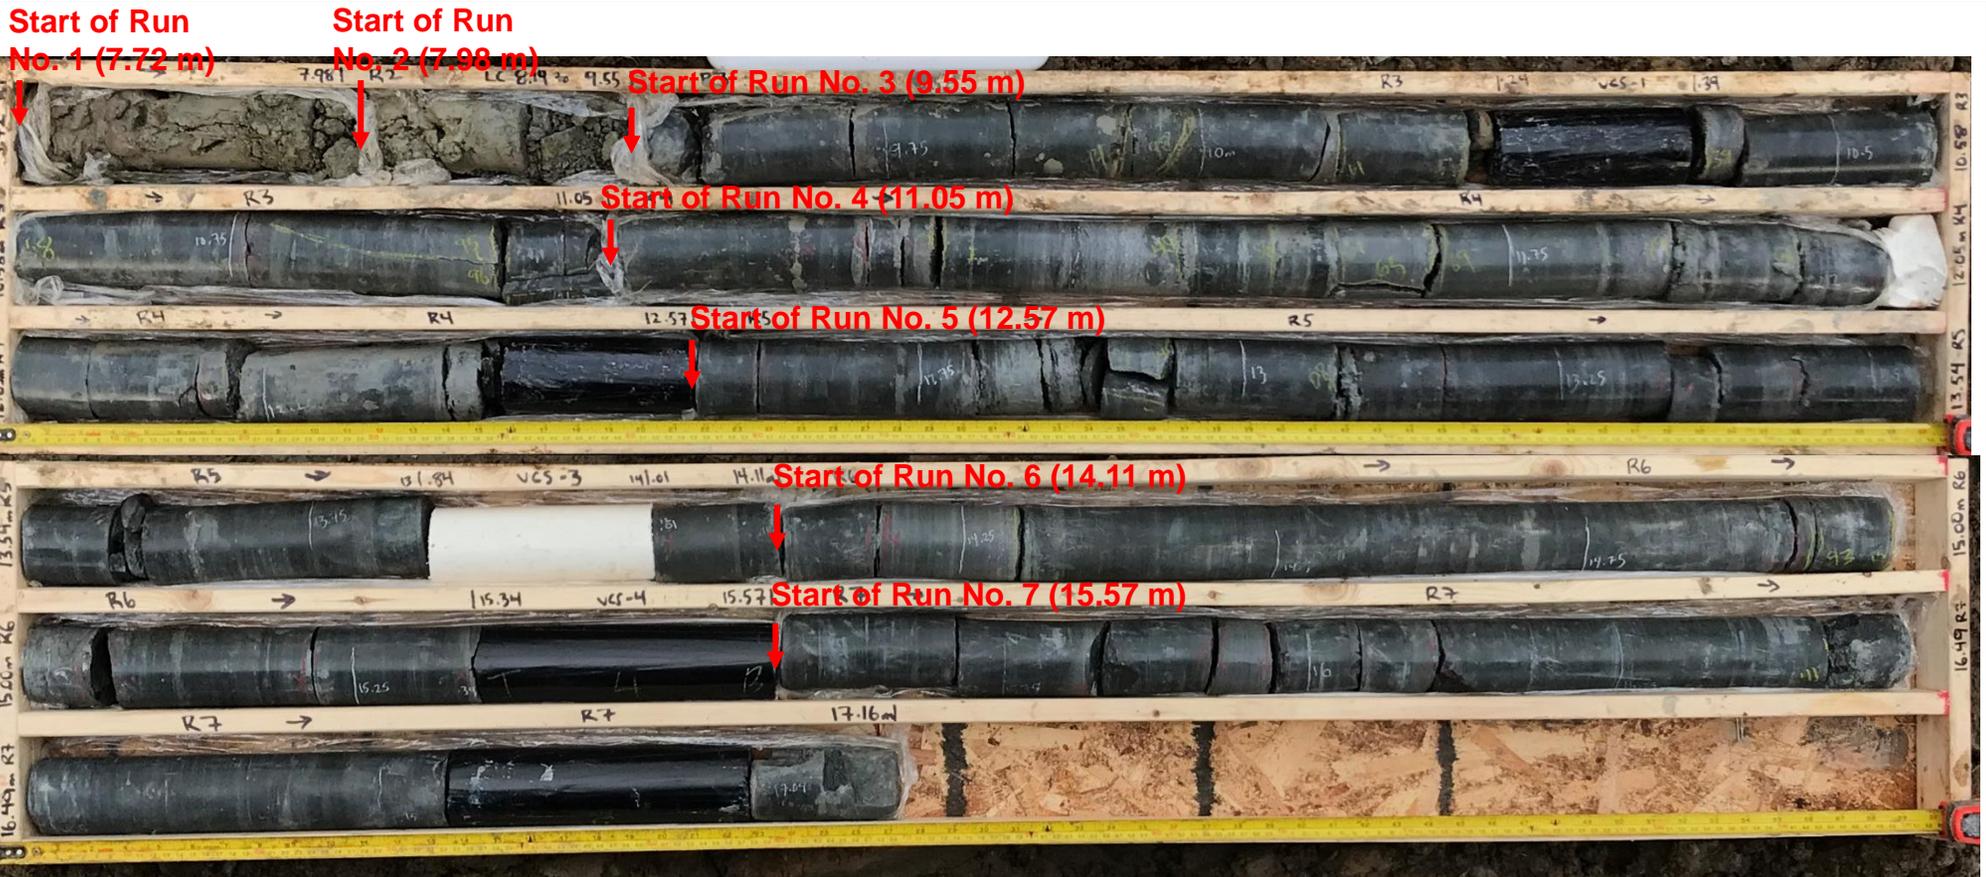
PROJECT							<b>MTO Assignment 2015-E-0033: Detail Design for the widening/rehab/realignment of QEW Between Mississauga Road and Hurontario Street</b>					
TITLE							<b>Bedrock Core Photograph Borehole CRB-5A (7.72 m to 17.16 m)</b>

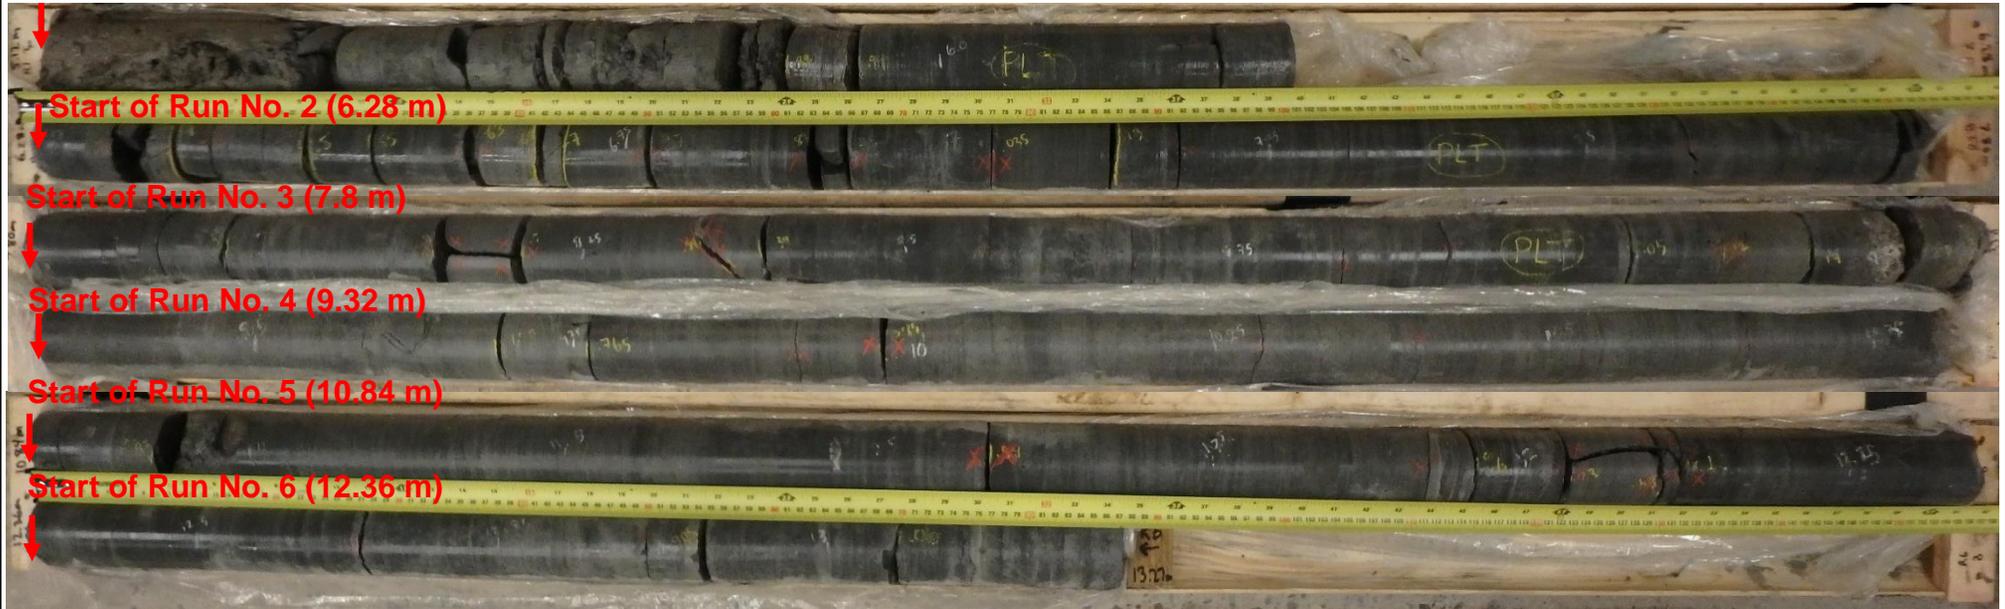
PROJECT No. 1662333			FILE No. ----		
	DRAFT	JIL	Mar 2018	SCALE	AS SHOWN	VER. 1.
	CADD	--		<b>FIGURE B-10</b>		
	CHECK	DM	June 2018			
REVIEW	SMM	June 2018

PROJECT		<b>MTO Assignment 2015-E-0033: Detail Design for the widening/rehab/realignment of QEW Between Mississauga Road and Hurontario Street</b>				
TITLE		<b>Bedrock Core Photograph Borehole CRB-6 (5.12 m to 13.27 m)</b>

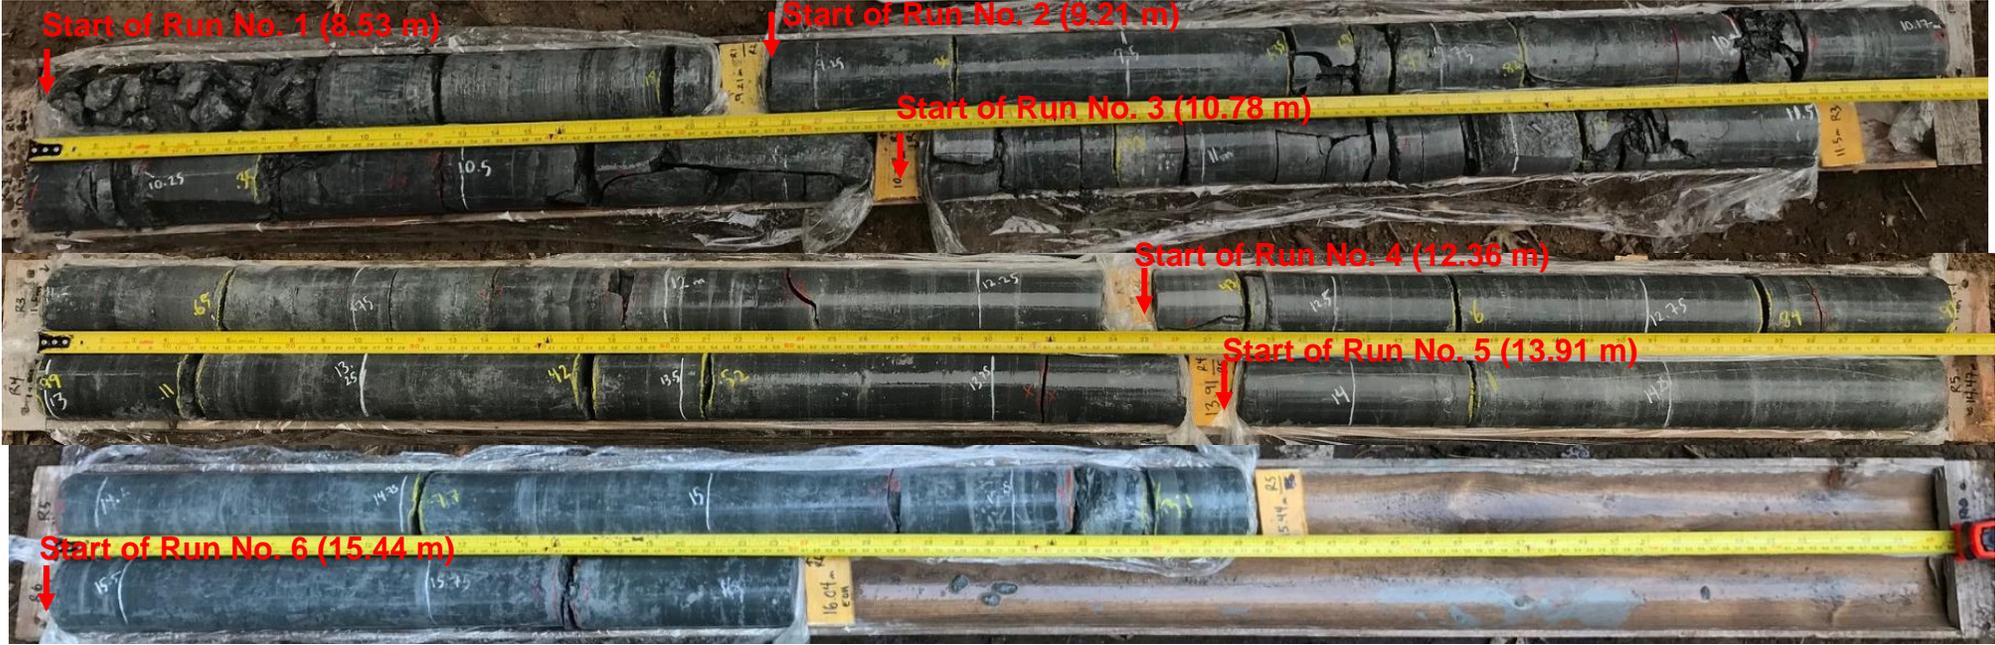
PROJECT	<b>MTO Assignment 2015-E-0033: Detail Design for the widening/rehab/realignment of QEW Between Mississauga Road and Hurontario Street</b>					
TITLE	<b>Bedrock Core Photograph Borehole CRB-7 (8.53 m to 16.04 m)</b>

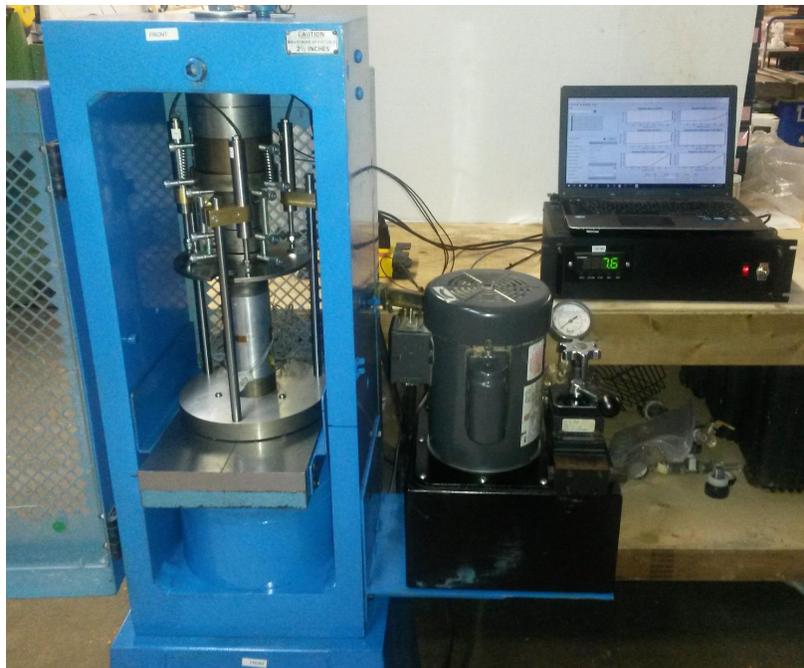
1. Unwrapping of the core samples, inspecting them for damage, and re-wrapping them in electrical tape to minimize disturbance during subsequent specimen preparation.
2. Diamond cutting of core samples to obtain cylindrical specimens with an appropriate length (length:diameter = 2:1) and nearly parallel end faces.
3. Surface grinding of specimens to obtain flat (within  $\pm 0.025$  mm) and parallel end faces (within  $0.25^\circ$ ).
4. Placing each specimen into the loading frame, applying a 0.5-1.0 kN axial load, removing the electrical tape, and subsequently increasing the axial load gradually to cause rupture while continuously recording axial force and axial deformation to determine peak strength (UCS) and (tangent) Young's modulus.

Figure 1: UCS Test setup.

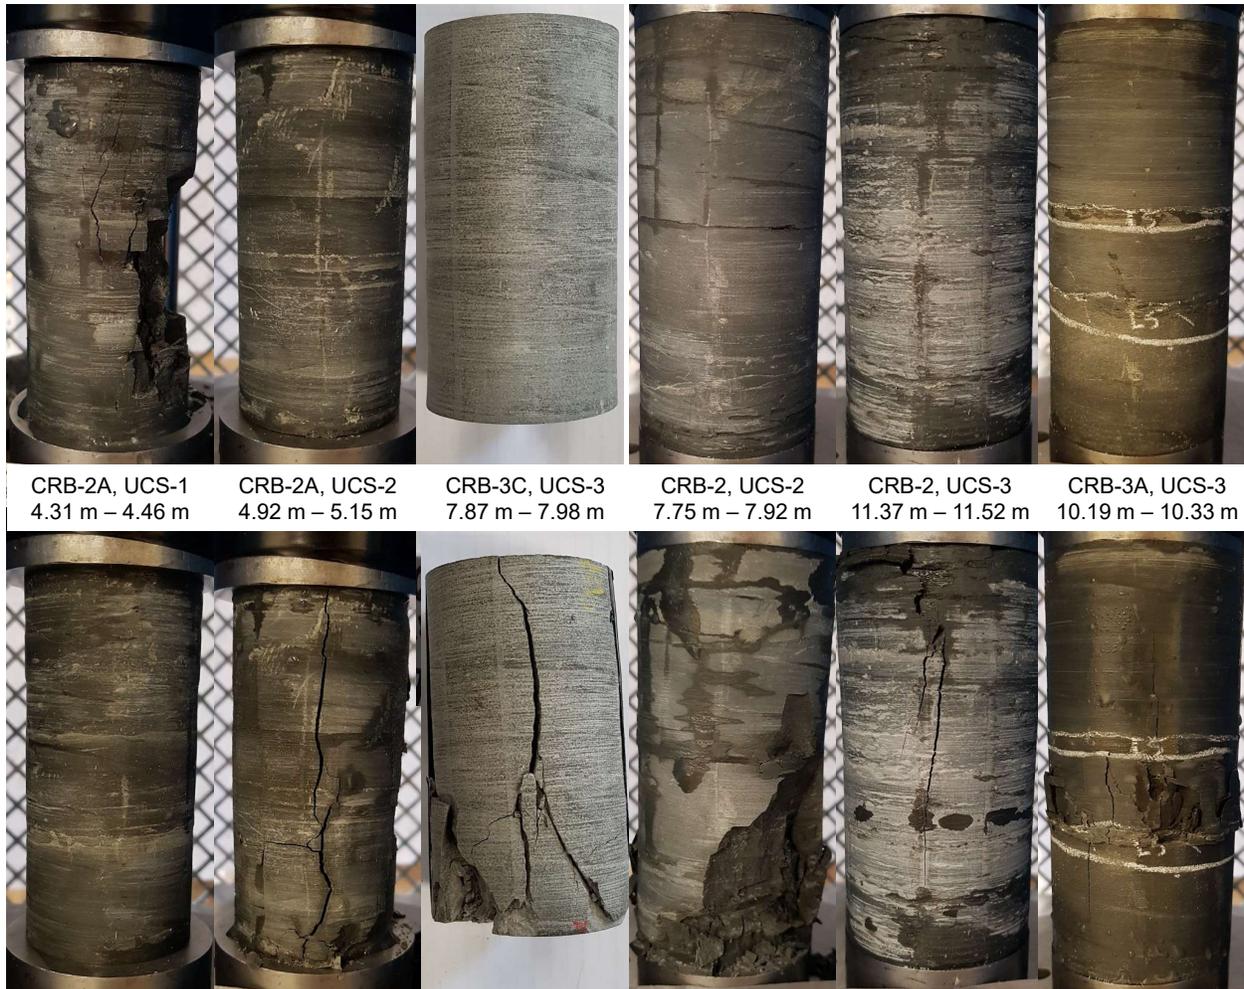
Figure 3: Photographs of specimens prior to testing.

Photographs of the specimens before and after testing are presented in Figure 3 and Figure 4

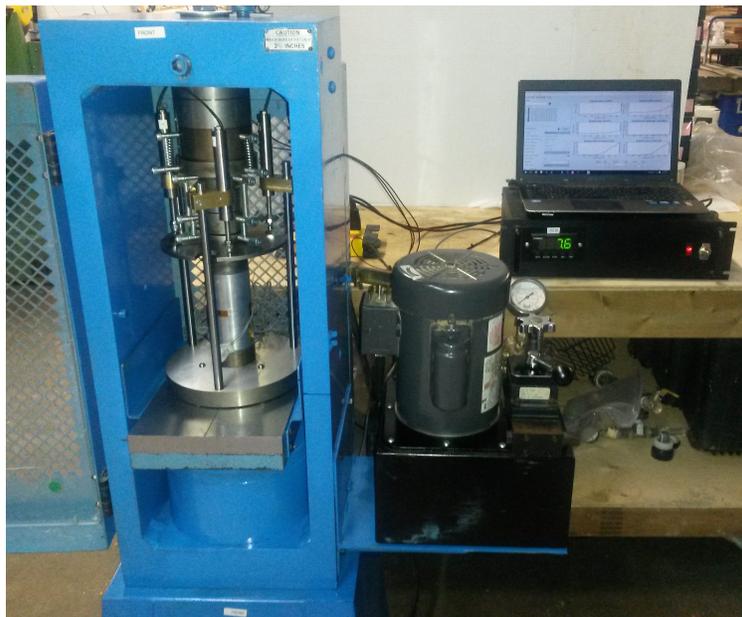
1. Unwrapping of the core sample, inspecting it for damage, and re-wrapping it in electrical tape to minimize exposure to moisture during subsequent specimen preparation.
2. Diamond cutting of core samples to obtain cylindrical specimens with an appropriate length (length:diameter = 2:1) and nearly parallel end faces.
3. Diamond grinding of specimens to obtain flat (within  $\pm 0.025$  mm) and parallel end faces (within  $0.25^\circ$ ).
4. Placement of the specimen into the loading frame, applying a 1 kN axial load, and removing the electrical tape.
5. Axial loading to rupture while continuously recording axial force and axial deformation to determine the peak strength (UCS) and (tangent) Young's modulus ( $E$ ).

Figure 1: UCS test setup.
