## Foundation Investigation Report

*East-West Active Transport Bridge Along Credit River Bridge, QEW Widening from West of Mississauga Road to West of Hurontario Street, Mississauga Ministry of Transportation, Ontario, GWP 2002-13-00*

1662333-6

February 8, 2019

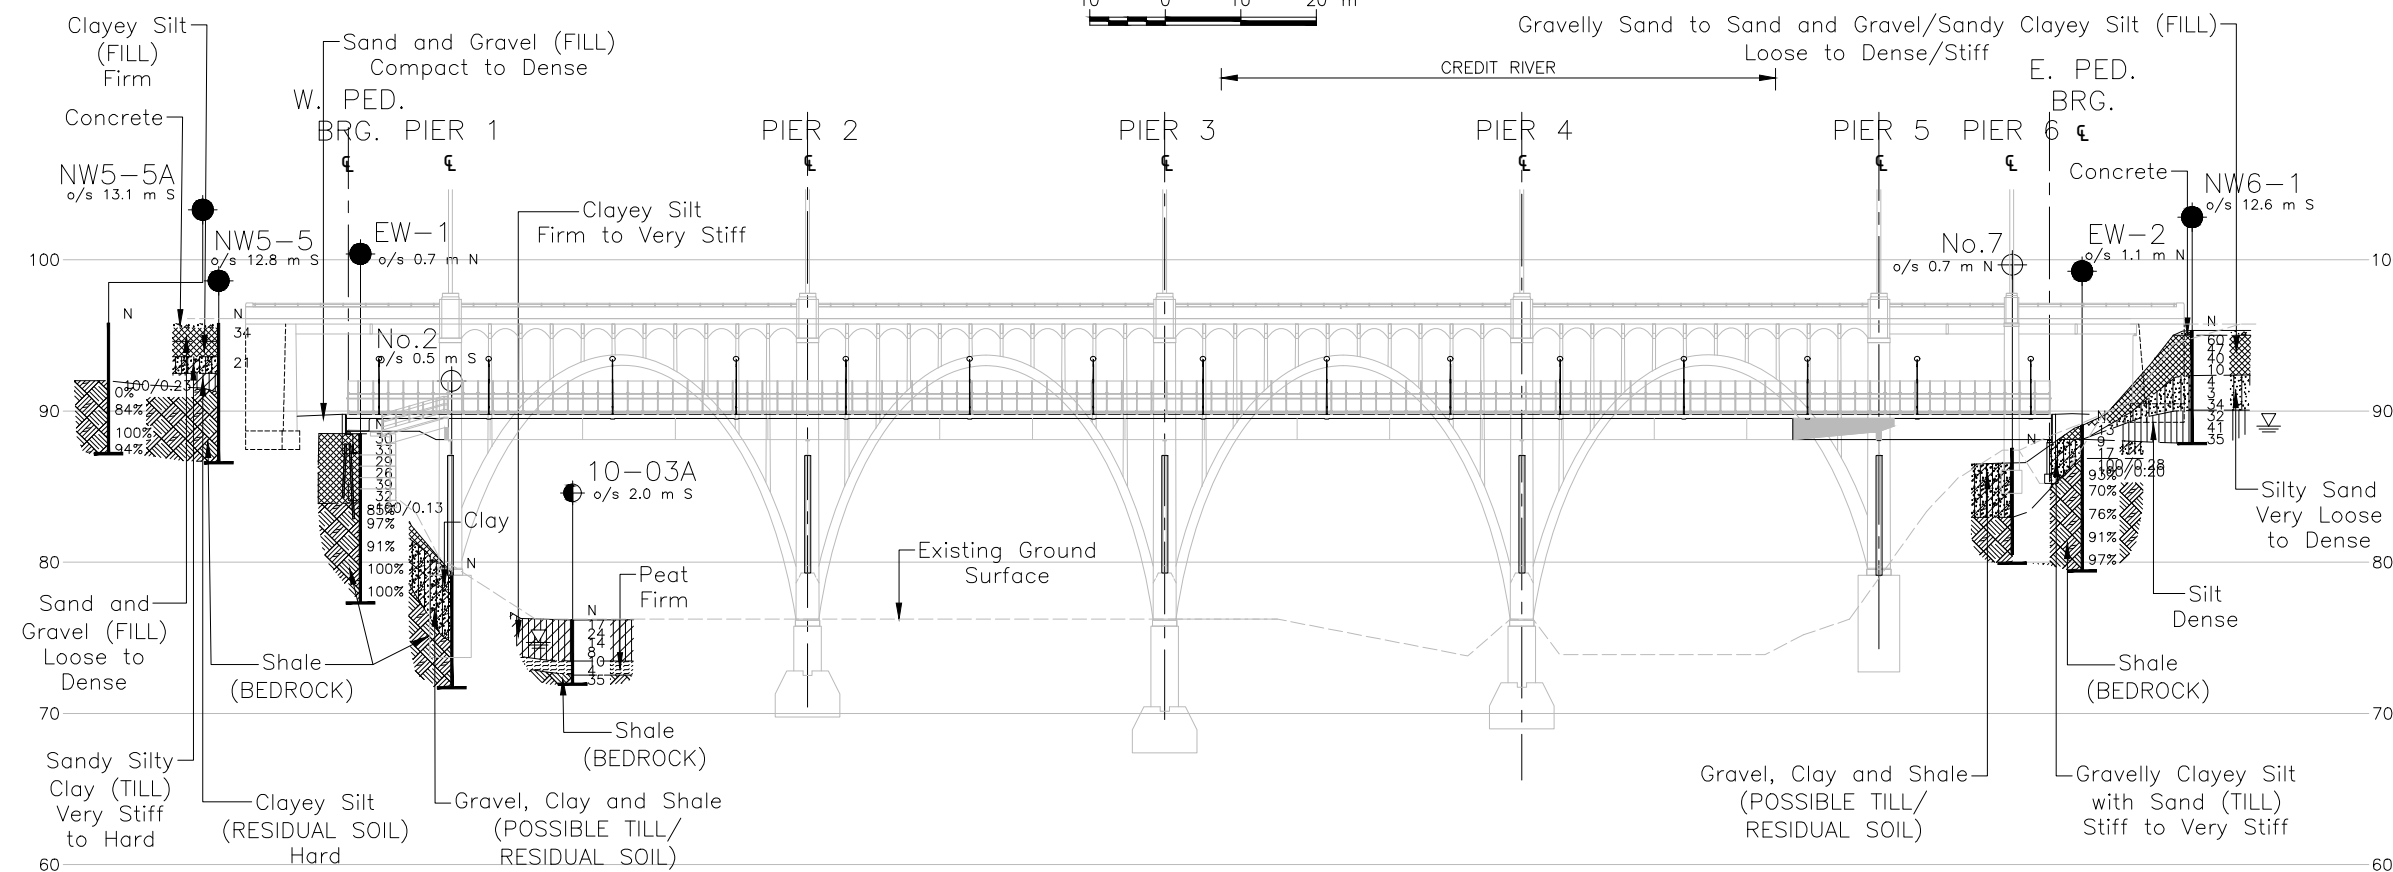
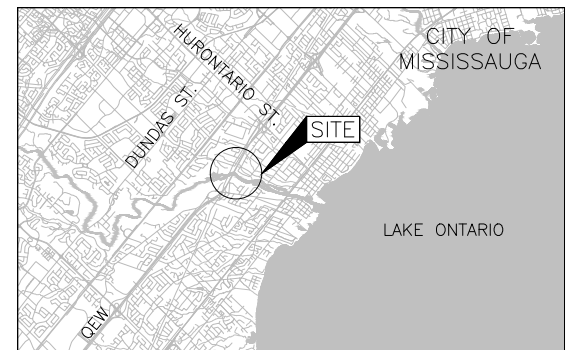
NO.	DATE	BY	REVISION
Geocres No. 30M12-438			
HWY. QEW	PROJECT No. 1662333	DIST. CENTRAL	
SUBM'D. JL	CHKD. DM	DATE: 02/08/2019	SITE: .
DRAWN: DD/MR	CHKD. SMM	APPD. JMAC	DWG. 1

QEW WIDENING MISSISSAUGA RD TO  
HURONTARIO ST  
E-W AT BRIDGE  
BOREHOLE LOCATIONS  
AND SOIL STRATA

A preliminary foundation investigation for the new Credit River Bridge was carried out by Thurber in May and June 2011, during which time a total of two boreholes, designated as Boreholes 11-01 and 11-02, were advanced at the proposed west abutment and west pier for the proposed Credit River bridge, respectively at the locations shown on Drawing 1.

The stratigraphic boundaries shown on the Record of Borehole sheets and on the stratigraphic profiles on Drawings 1 and 2 are inferred from non-continuous sampling, observations of drilling progress and the results of Standard Penetration Tests. These boundaries, therefore, represent transitions between soil and rock types rather than exact planes of geological change. Furthermore, subsurface conditions will vary between and beyond the borehole locations; however, the factual data presented on the record of Borehole and Drillhole sheets governs any interpretation of the site conditions. It should be noted that the interpreted stratigraphy shown on Drawings 1 and 2 is a simplification of the subsurface conditions.

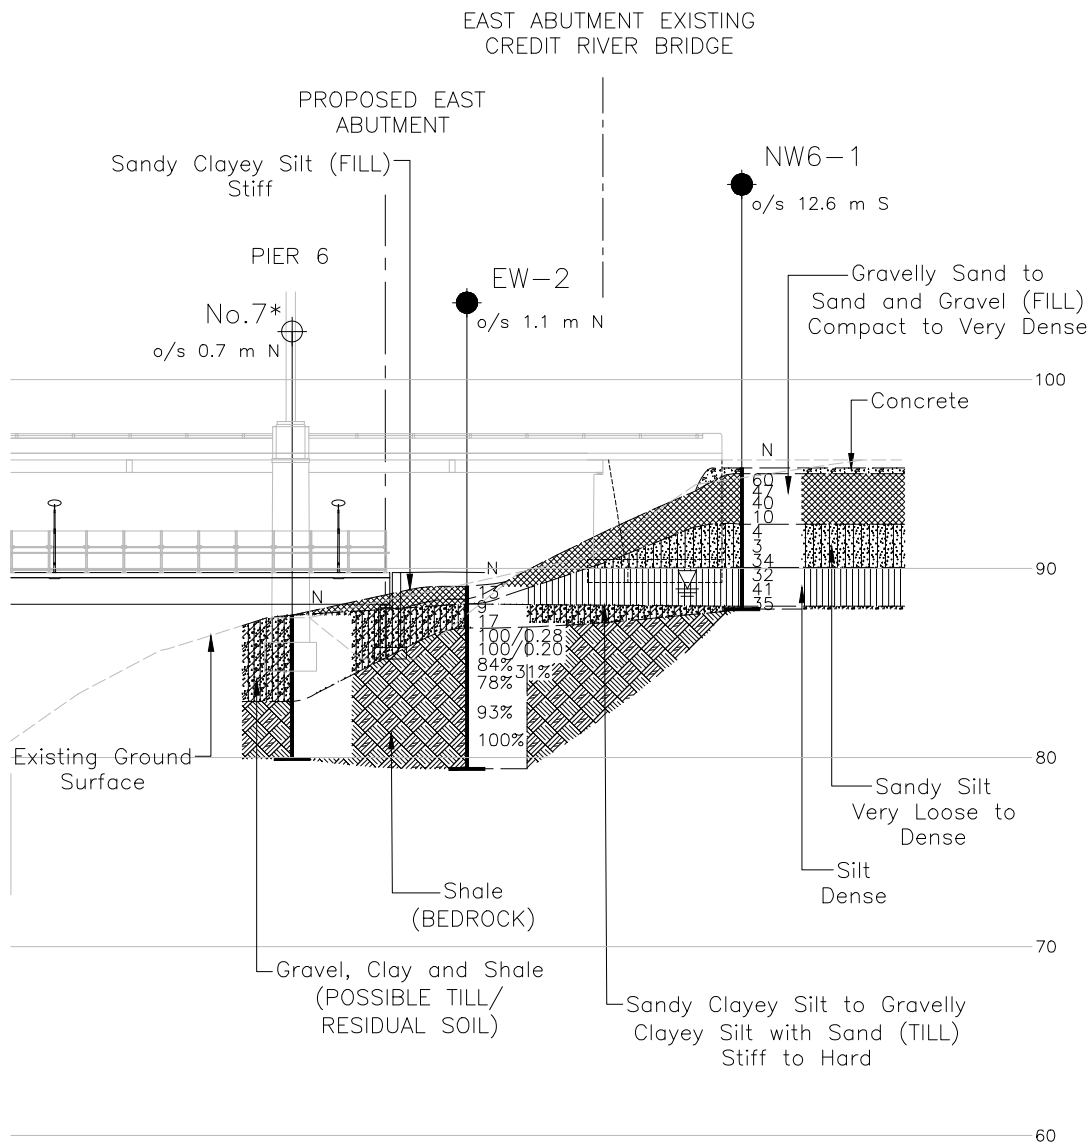
NO.	DATE	BY	REVISION
Geocres No. 30M12-438			
HWY. QEW	PROJECT NO. 1662333	DIST. CENTRAL	
SUBM'D. ACM/JIL	CHKD. DM	DATE: 02/08/2019	SITE: .
DRAWN: DD	CHKD. SMM	APPD. JMAC	DWG. 2

A-A' E-W AT BRIDGE WEST ABUTMENT  
1

A-A' E-W AT BRIDGE EAST ABUTMENT  
1

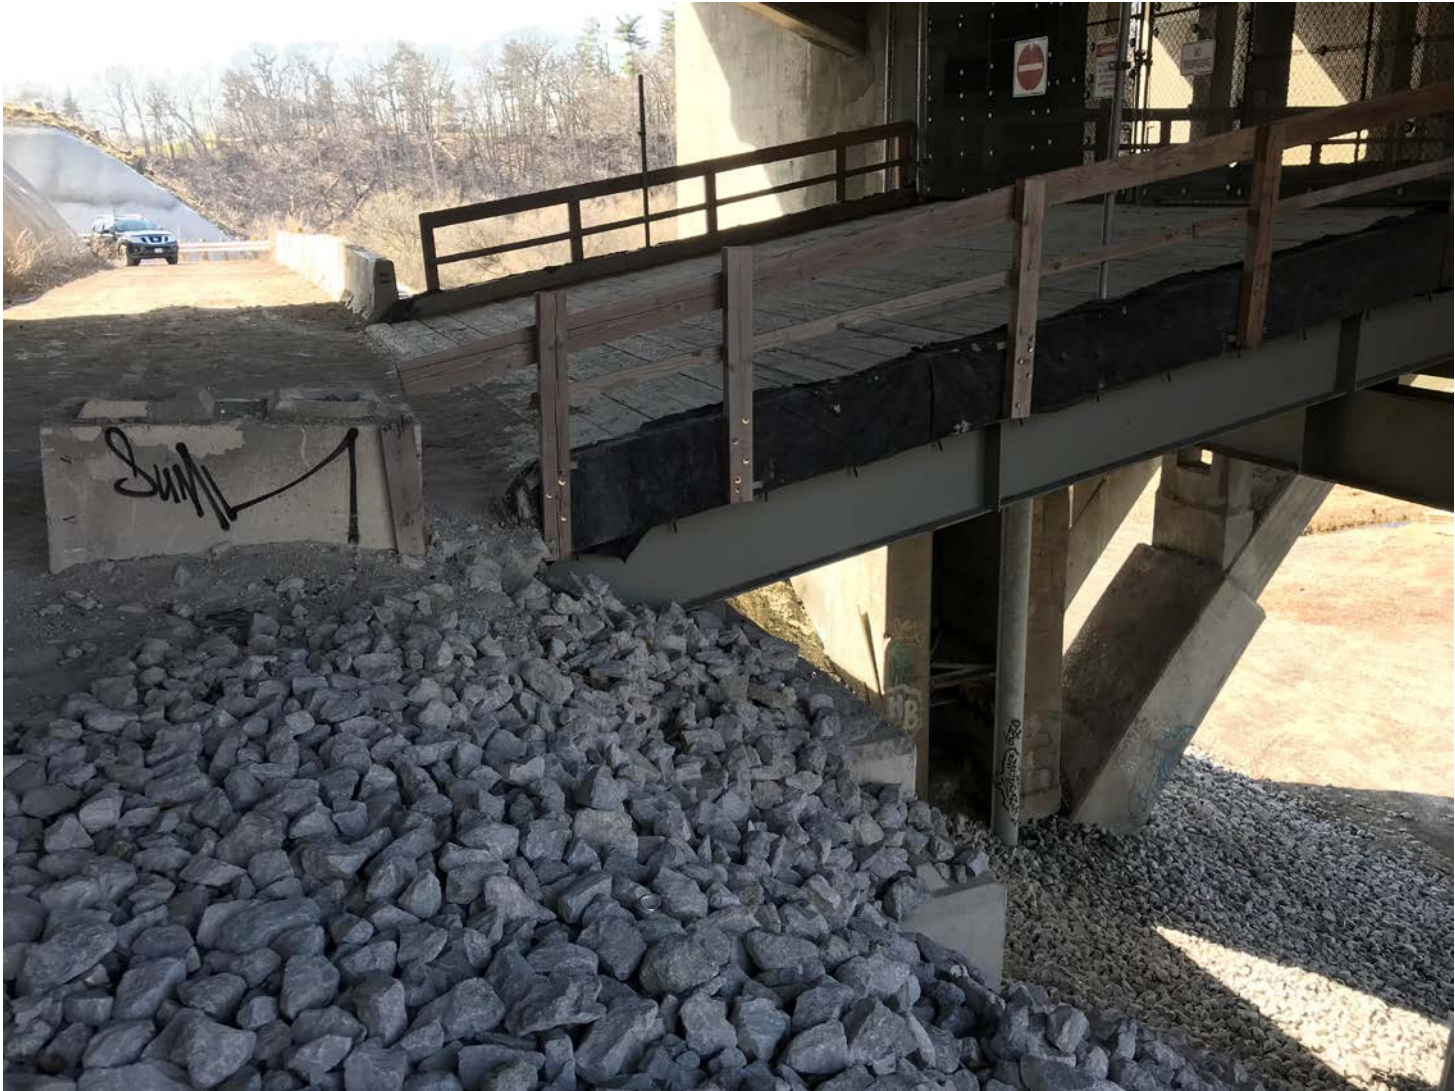
PROJECT No. 1662333			FILE No. ----		
	DRAFT	SMM	12/10/18	SCALE	AS SHOWN	VER. 1.
	CADD	--		<b>Photograph 1</b>		
	CHECK	SMM	12/10/18			
	REVIEW	JMAC	12/10/18

TITLE  
**EXISTING E-W AT BRIDGE WEST ABUTMENT LOOKING  
NORTH**

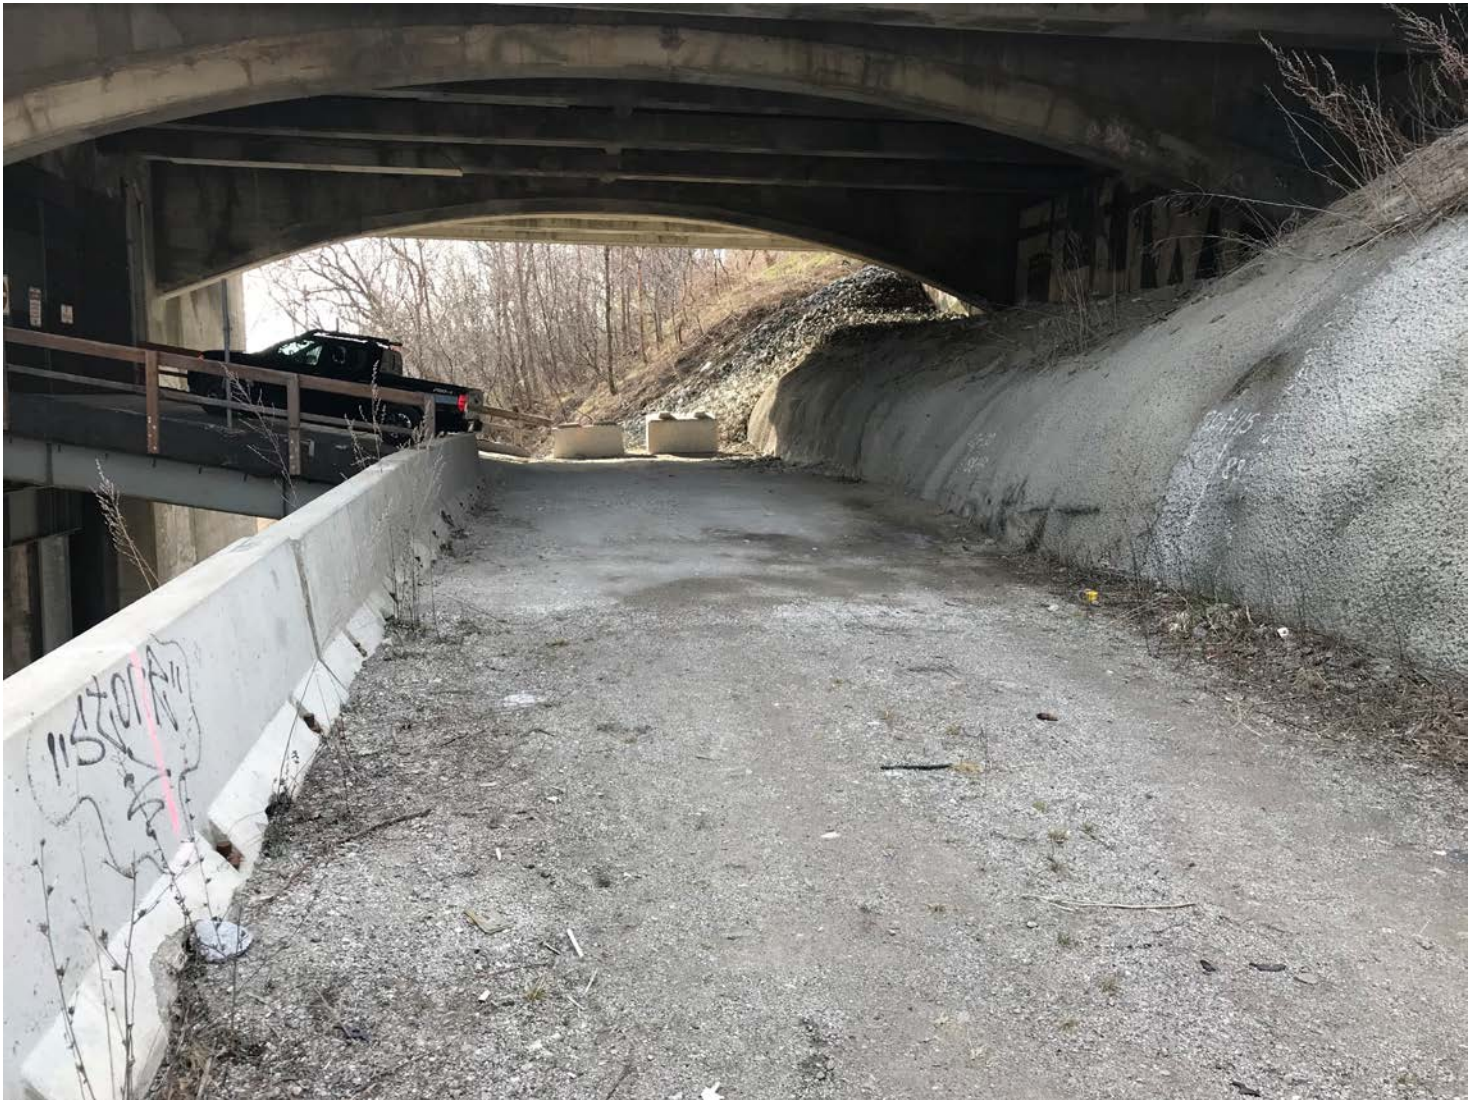
PROJECT No. 1662333			FILE No. ----		
DRAFT	SMM	12/10/18	SCALE	AS SHOWN	VER. 1.
CADD	--		<b>Photograph 2</b>		
CHECK	SMM	12/10/18			
REVIEW	JMAC	12/10/18

TITLE  
**EXISTING E-W AT BRIDGE WEST ABUTMENT LOOKING  
SOUTH**

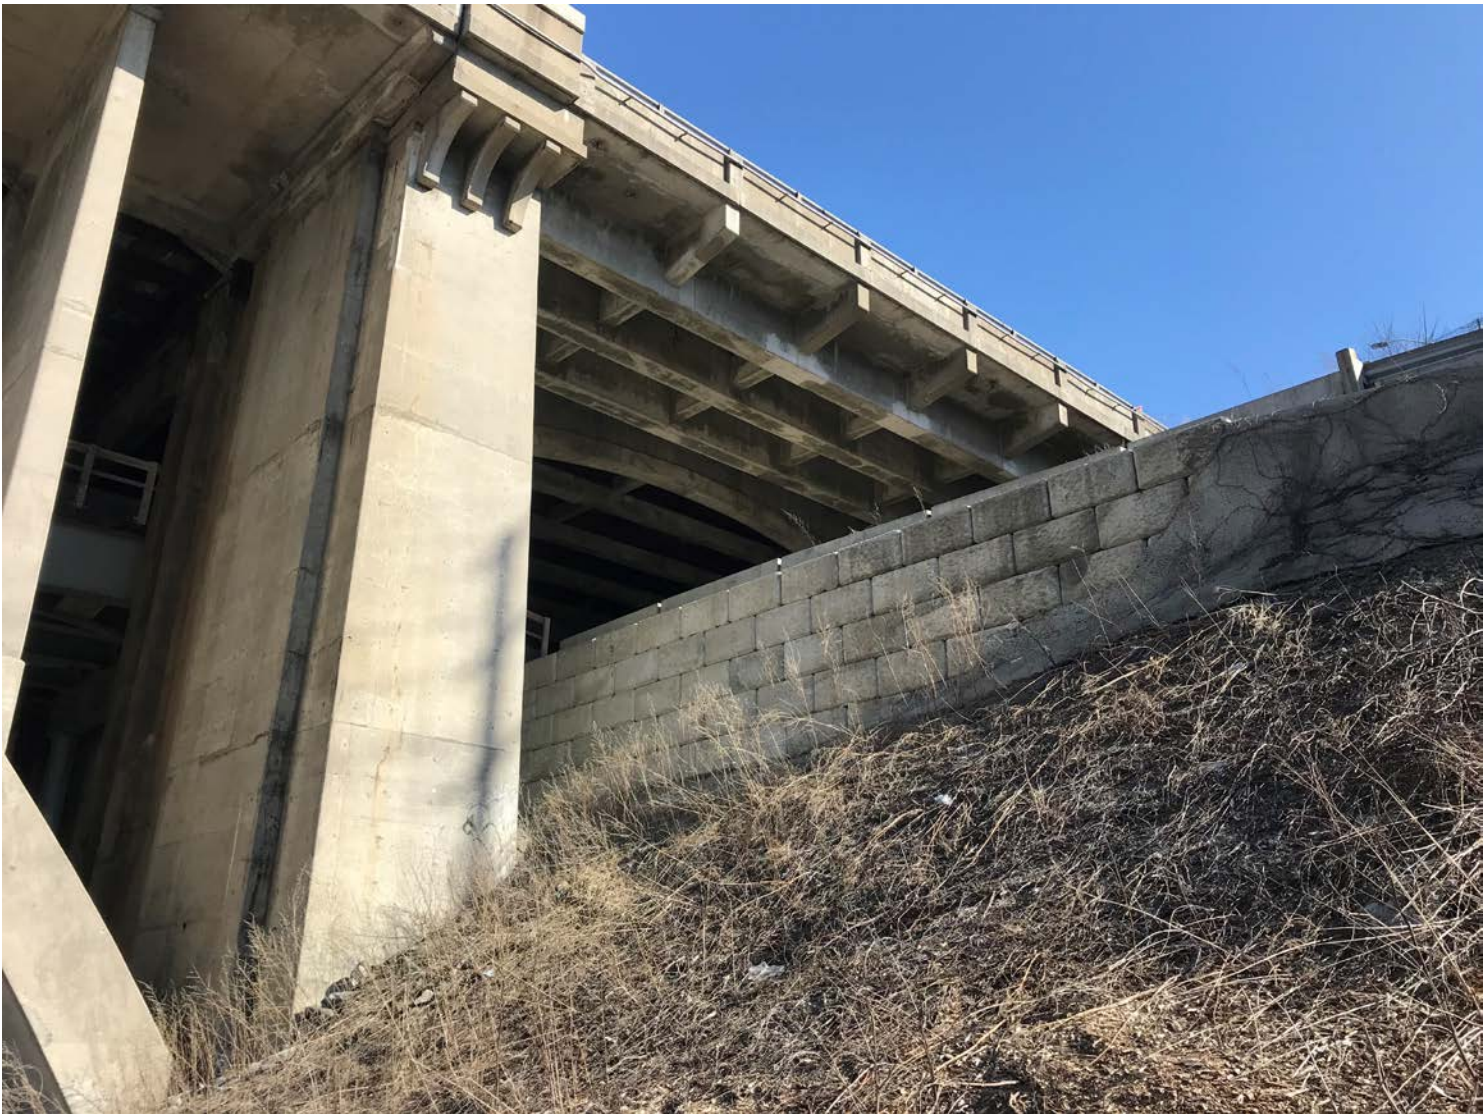
PROJECT No. 1662333			FILE No. ----		
DRAFT	SMM	12/10/18	SCALE	AS SHOWN	VER. 1.
CADD	--		<b>Photograph 3</b>		
CHECK	SMM	12/10/18			
REVIEW	JMAC	12/10/18

TITLE  
**LOCK-BLOCK RSS WALL WEST ABUTMENT AND PIER 1**

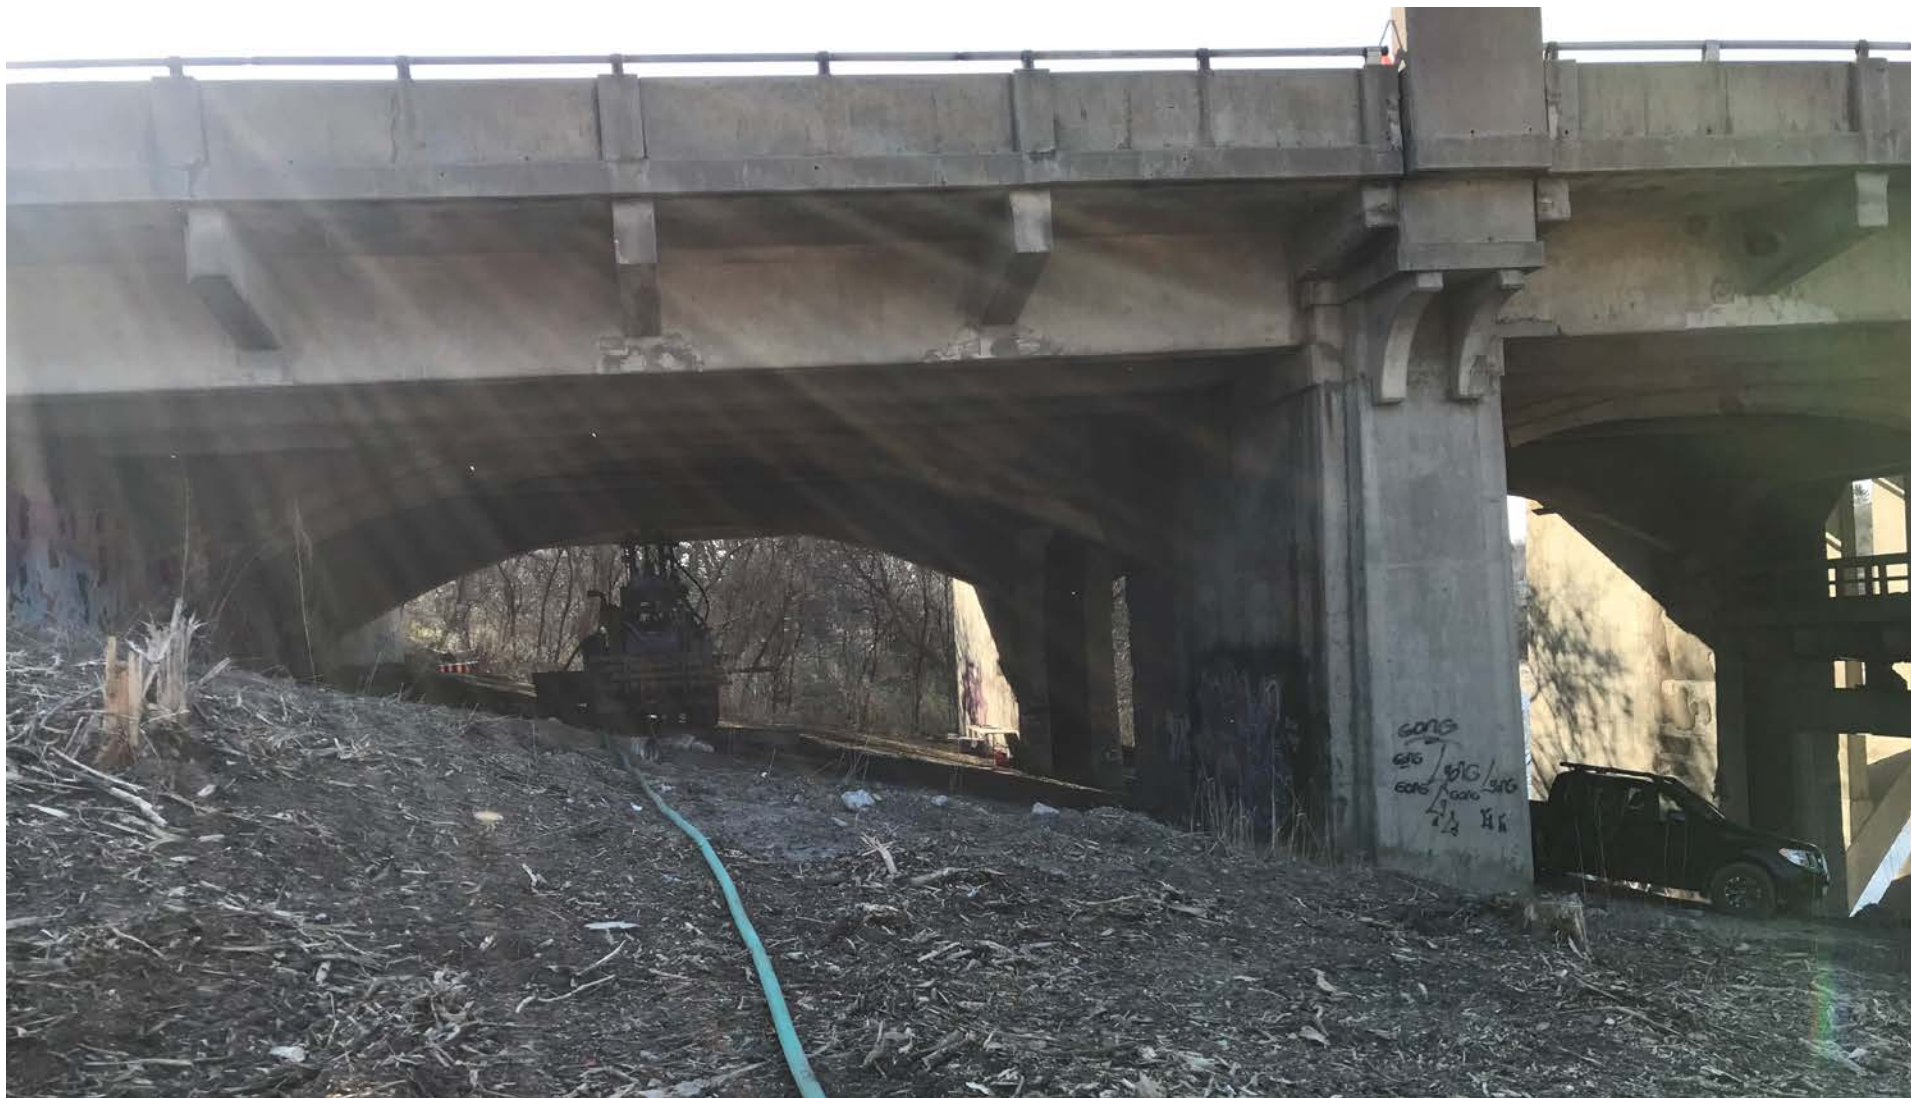
TITLE  
**BOREHOLE EW-2 BETWEEN EAST ABUTMENT AND PIER 6**

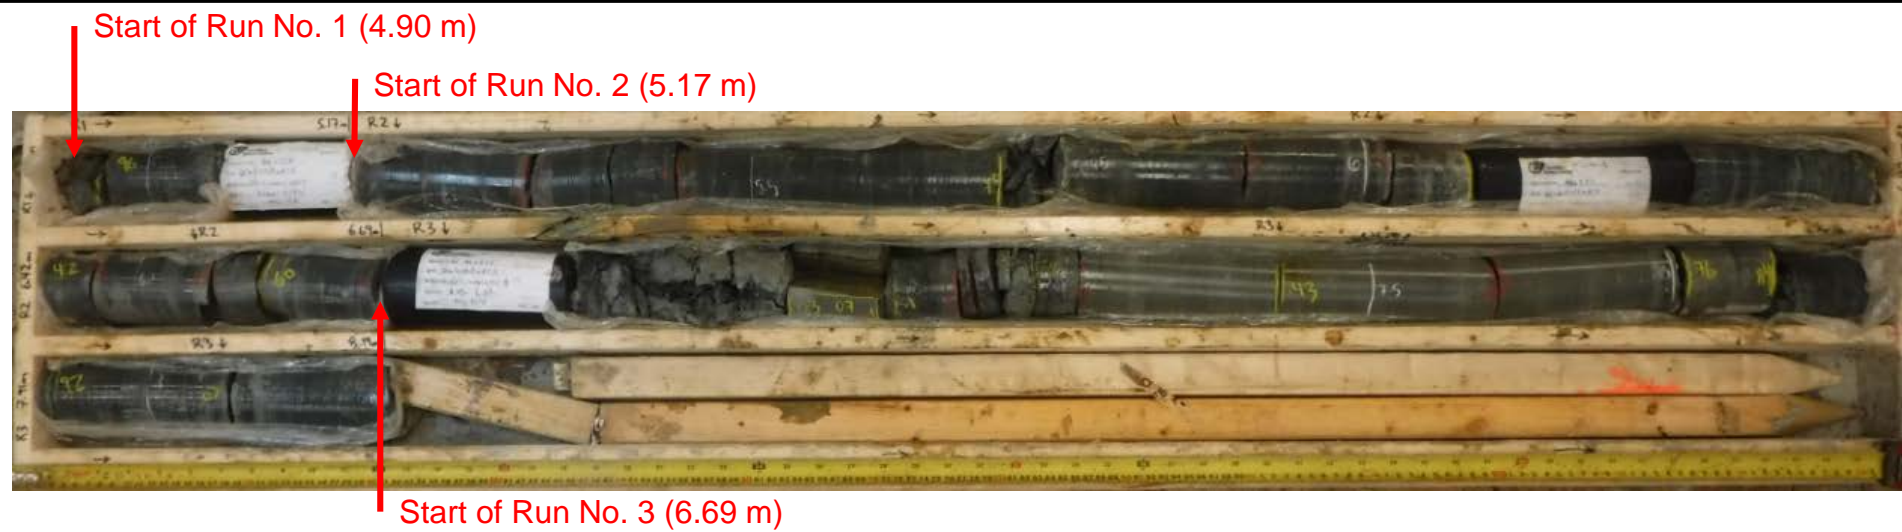
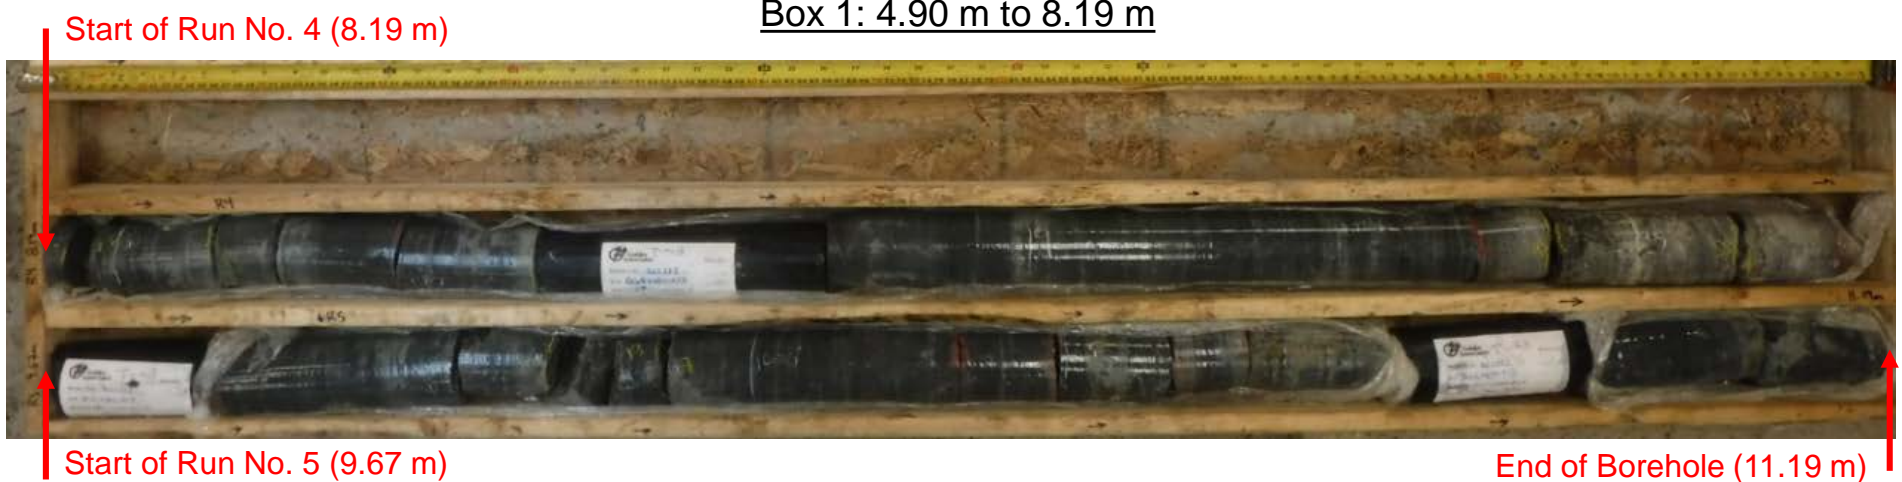
<b>GOLDER</b>	PROJECT No. 1662333			FILE No. ----	
	DRAFT	SK	20180628	SCALE	NTS
	CADD	--		<b>FIGURE B-1</b>	
	CHECK	SMM			
	REVIEW	JMAC	20181108		
			VER. 1.

Box 1: 4.90 m to 8.19 m

Box 2: 8.19 m to 11.19 m

84.2			6	SS	32													
83.9	Gravelly Sandy CLAYEY SILT (TILL) Grey to brown Moist to wet		7	SS	100/0.1													
4.6	SHALE (BEDROCK) Grey		1	RC	REC 100%													RQD = 78%
	Bedrock cored from a depth of 4.9 m to 11.2 m		2	RC	REC 100%													RQD = 97%
	For bedrock coring details, refer to Record of Drillhole EW-1		3	RC	REC 100%													RQD = 75%
			4	RC	REC 100%													RQD = 100%
			5	RC	REC 100%													RQD = 97%

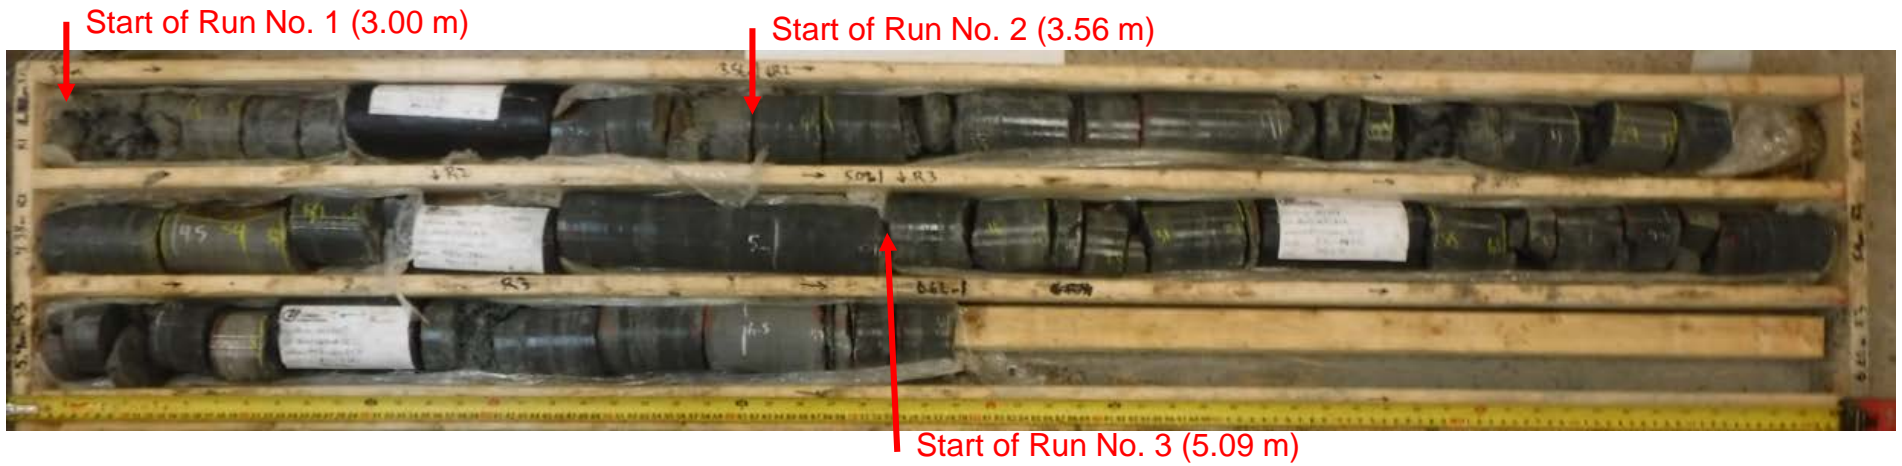
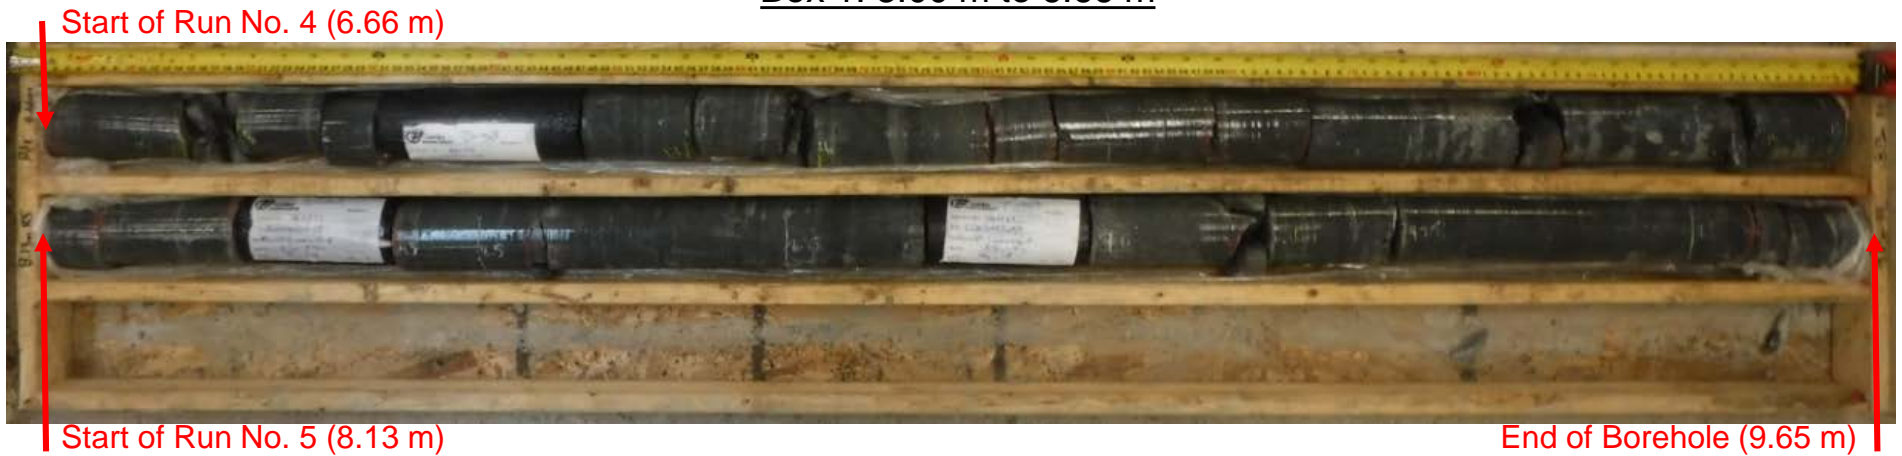
<b>GOLDER</b>	PROJECT No. 1662333			FILE No. ----	
	DRAFT	SK	20180628	SCALE	NTS
	CADD	--		<b>FIGURE B-2</b>	
	CHECK	SMM			
	REVIEW	JMAC	20181108		
			VER. 1.

Box 1: 3.00 m to 6.66 m

Box 2: 6.66 m to 9.65 m

PROJECT <b>EAST-WEST ACTIVE TRANSPORT PEDESTRIAN BRIDGE ALONG CREDIT BRIDGE</b>					
TITLE <b>Bedrock Core Photographs Borehole EW-2 (3.00 m to 9.65 m)</b>

86.9	Stiff to very stiff		4	SS	100/0.28												
2.2	Brown Moist		5	SS	100/0.20												
	SHALE (BEDROCK), with limestone interbeds		1	RC	REC 100%												
	Grey		2	RC	REC 100%												
	Bedrock cored from a depth of 3.0 m to 9.7 m		3	RC	REC 100%												
	For bedrock coring details, refer to Record of Drillhole EW-2		4	RC	REC 100%												
			5	RC	REC 100%

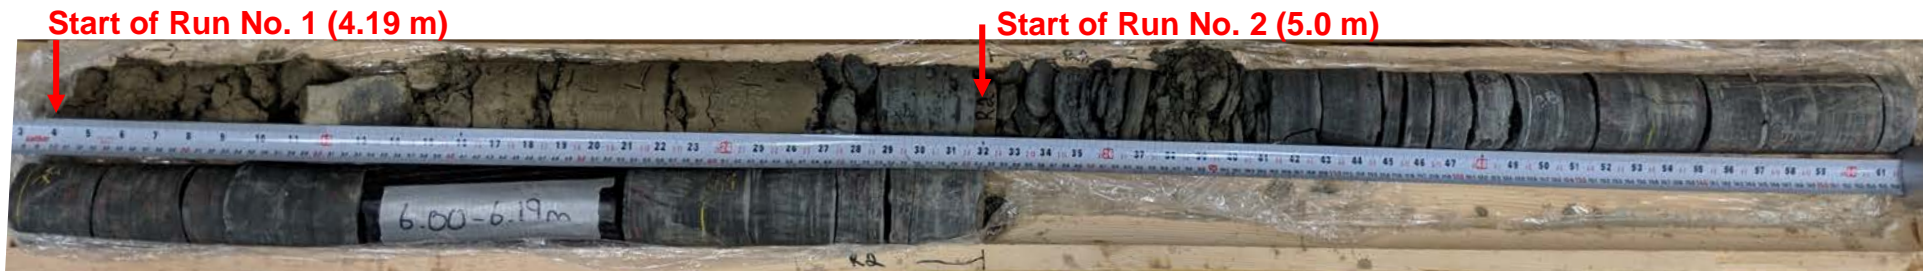
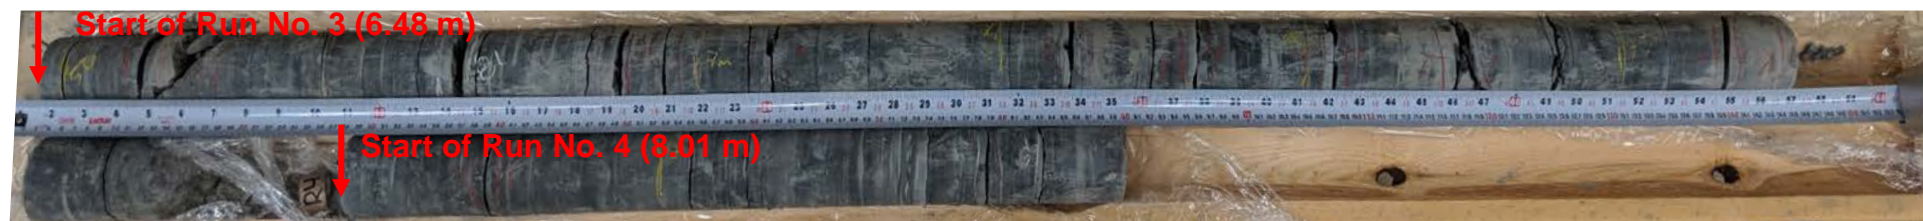
PROJECT <b>EAST-WEST ACTIVE TRANSPORT PEDESTRIAN BRIDGE ALONG CREDIT RIVER BRIDGE</b>					
TITLE <b>Bedrock Core Photograph Borehole NW5-5A (4.19 m to 8.63 m)</b>

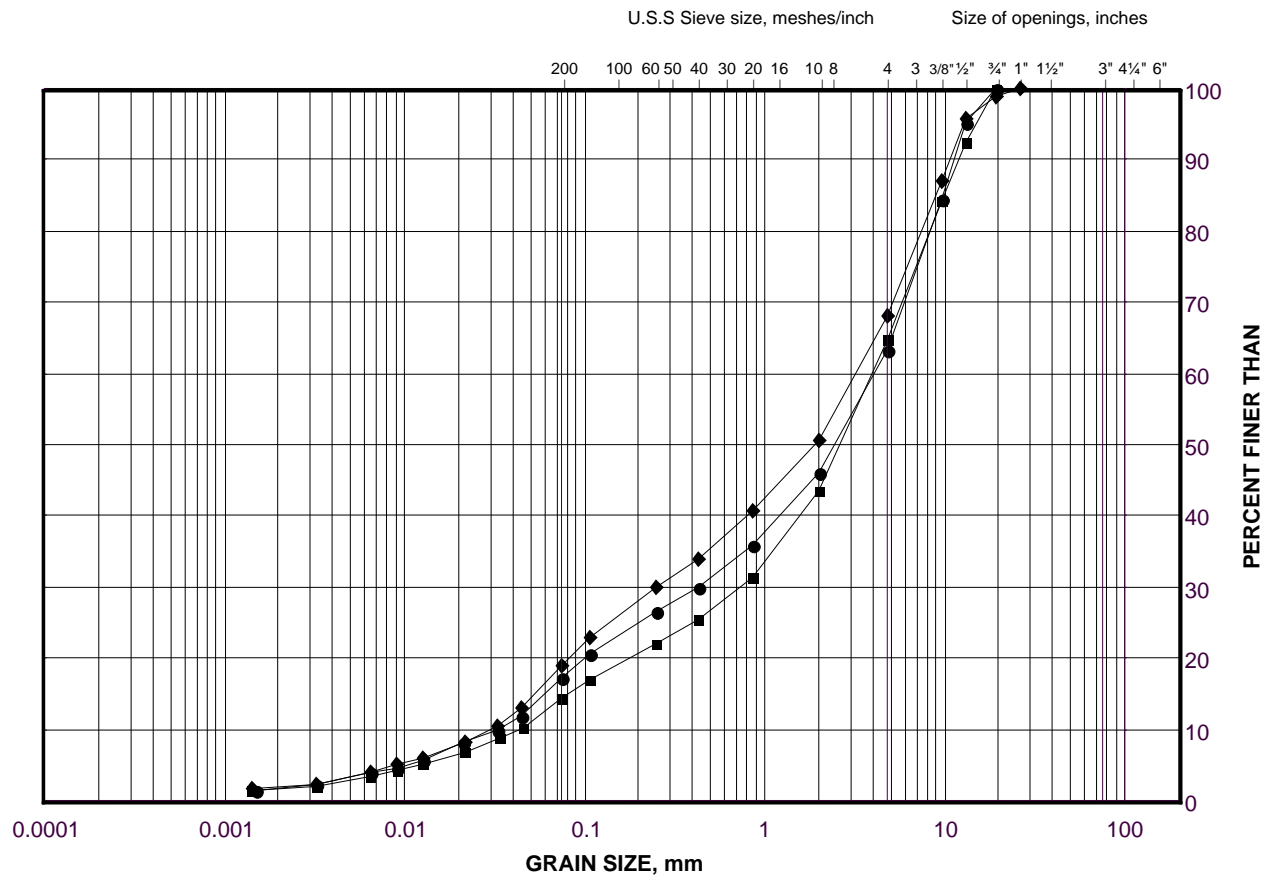
FIGURE C-1

Sand and Gravel (FILL)

SYMBOL	Borehole	SAMPLE	ELEVATION(m)
●	EW-1	2	87.5
■	EW-2	2A	88.2
◆	EW-1	4	85.9

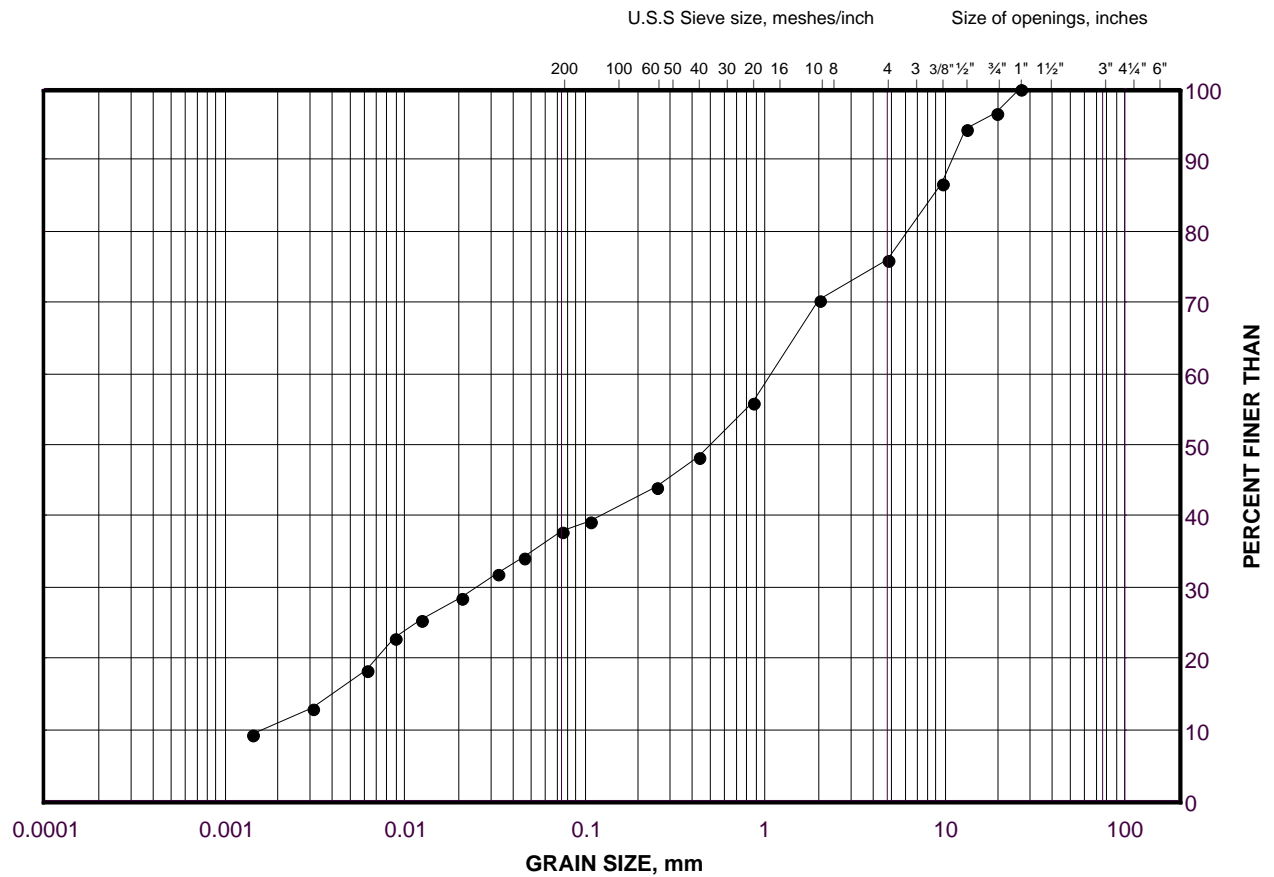
FIGURE C-2

Gravelly Clayey Silt with Sand (TILL)

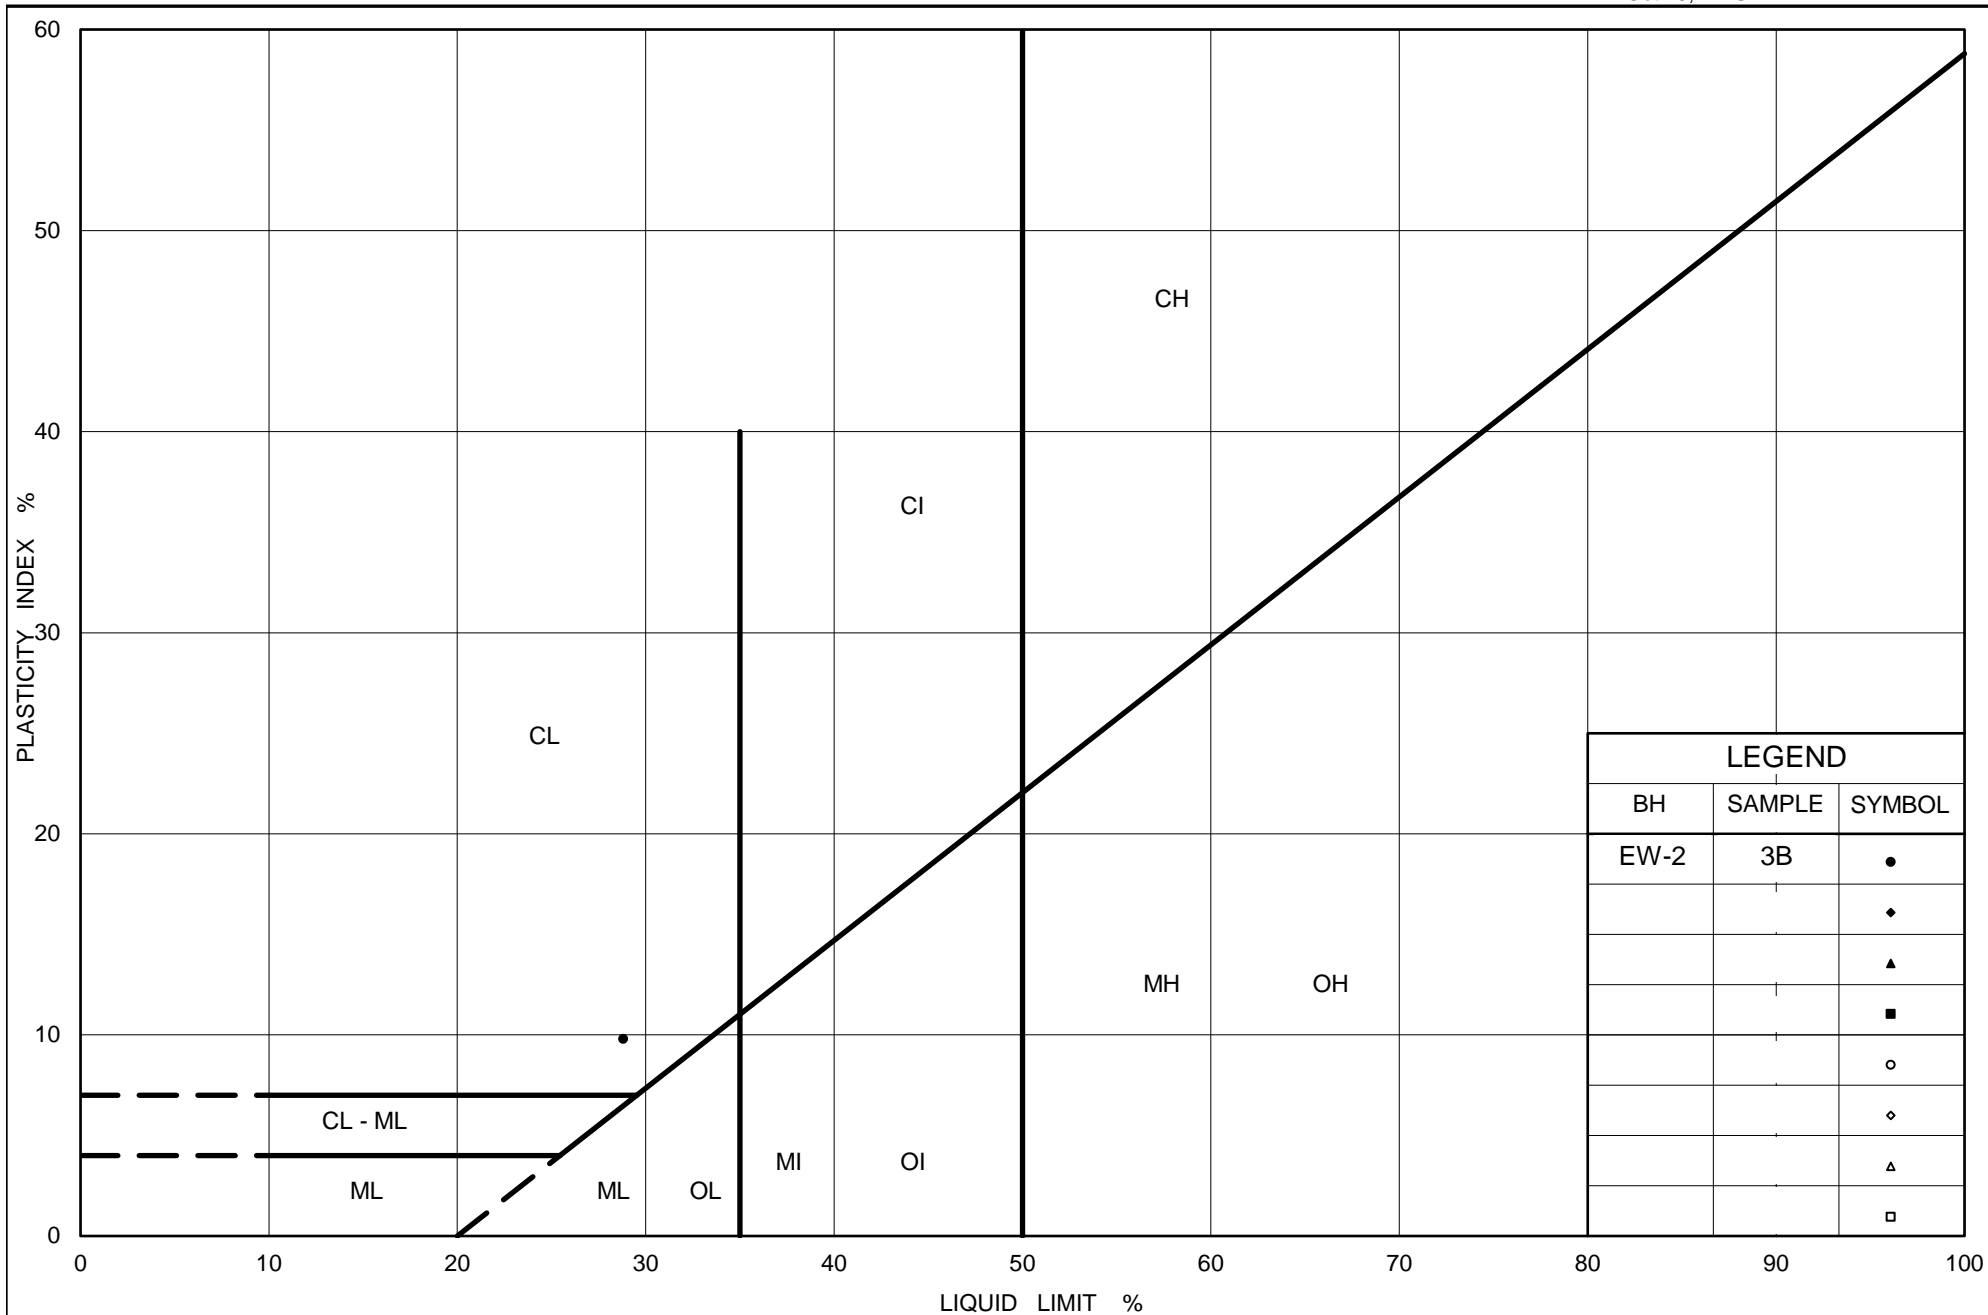
# PLASTICITY CHART Gravelly CLAYEY SILT with Sand (TILL)

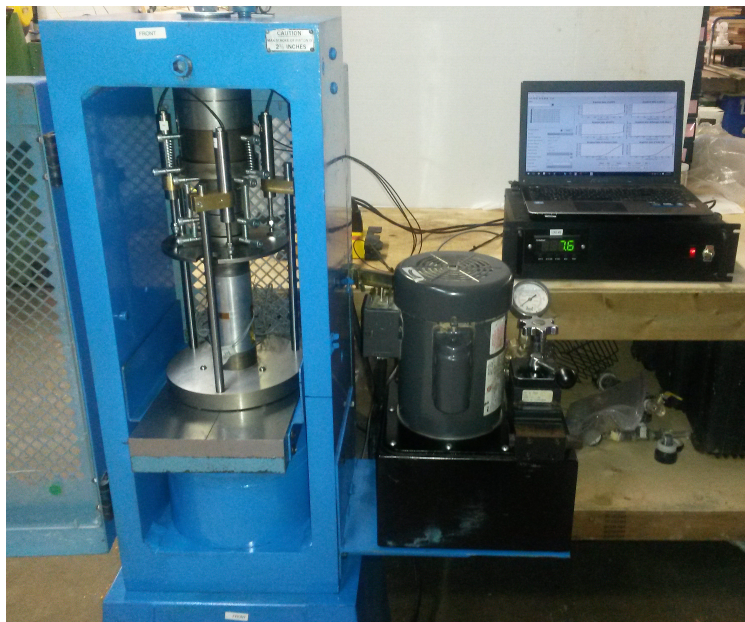
Figure 1: UCS test setup.

1. Unwrapping of the core sample, inspecting it for damage, and re-wrapping it in electrical tape to minimize exposure to moisture during subsequent specimen preparation.
2. Diamond cutting of core samples to obtain cylindrical specimens with an appropriate length (length:diameter = 2:1) and nearly parallel end faces.
3. Diamond grinding of specimens to obtain flat (within  $\pm 0.025$  mm) and parallel end faces (within  $0.25^\circ$ ).
4. Placement of the specimen into the loading frame, applying a 1 kN axial load, and removing the electrical tape.
5. Axial loading to rupture while continuously recording axial force and axial deformation to determine the peak strength (UCS) and (tangent) Young's modulus ( $E$ ).

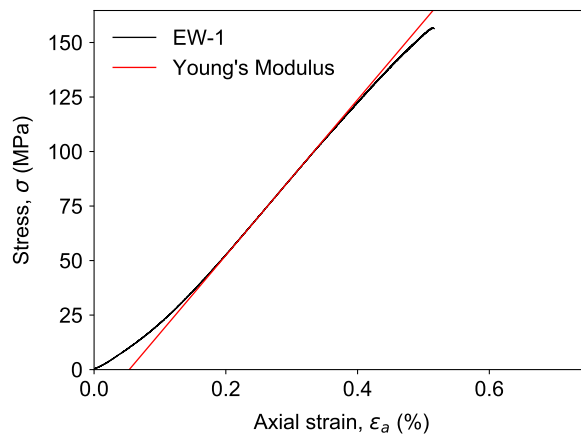
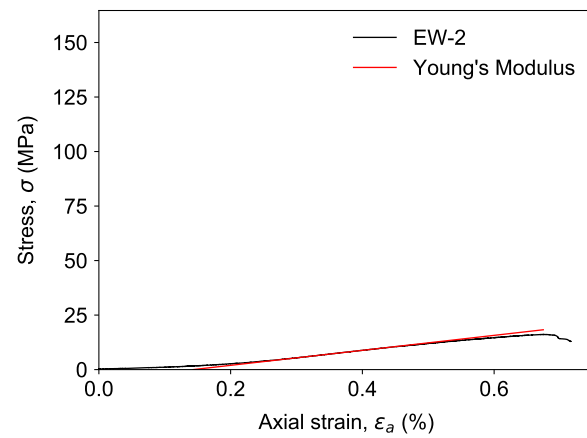
(a) EW-1 - Limestone

(b) EW-2 - Inter-bedded shale/limestone

Figure 2: Measured stress-strain curves.

Sample	Depth (m)	Lithology description	Bulk density $\rho$ (g/cm <sup>3</sup> )	UCS (MPa)	Young's Modulus $E$ (GPa)	Failure description
EW-1	7.26 - 7.43	Limestone	2.66	156.8	35.7	Axial splitting
EW-2	4.89 - 5.09	Inter-bedded shale & limestone	2.62	16.1	3.4	Axial splitting

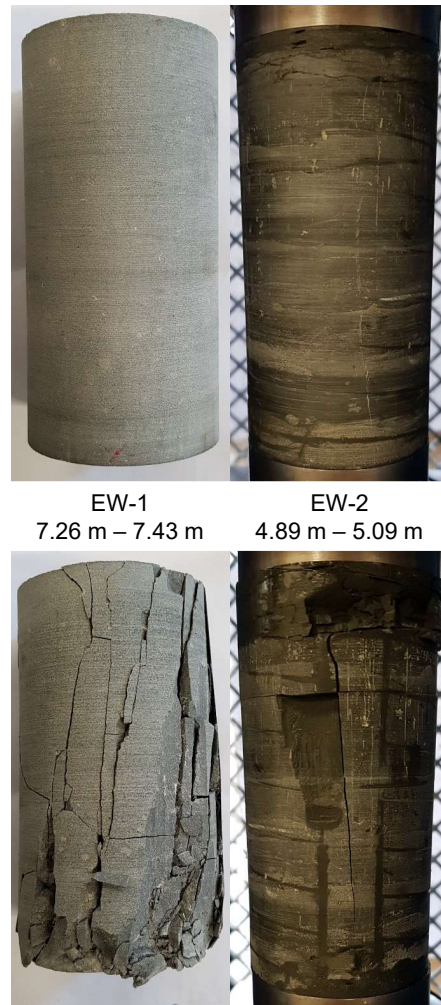
Figure 3: Photographs of specimens before and after testing.

Photographs of the specimens before and after testing are presented in Figure 3.
