FOUNDATION INVESTIGATION REPORT

**Thorold Tunnel Rehabilitation, Site No. 34-177/T
Highway 58, City of Thorold,
Ministry of Transportation, Ontario
G.W.P. 2370-16-00**

Report Number: 1668652-2

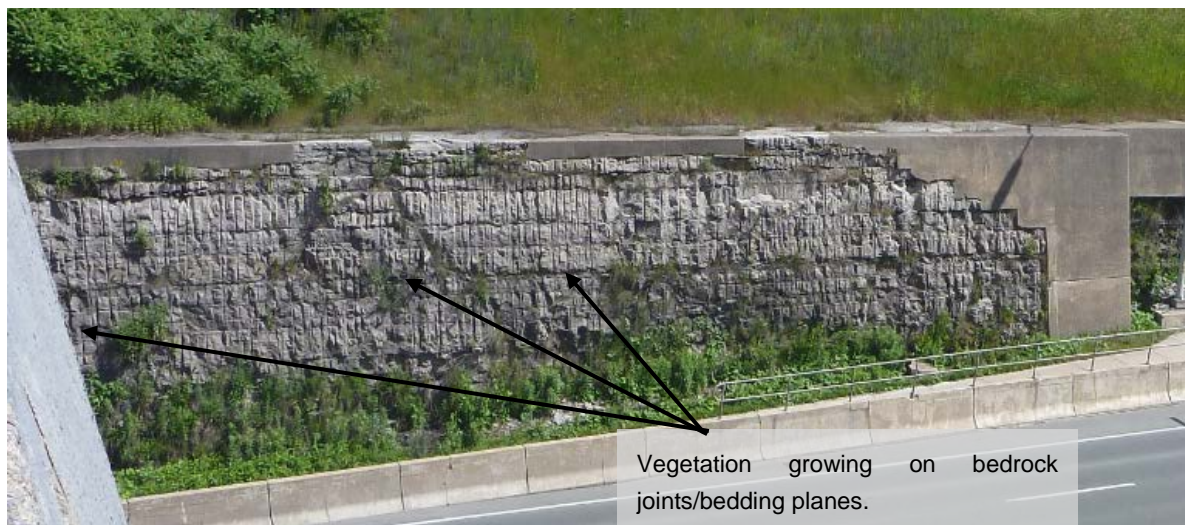
An area of exposed bedrock along the rock cut immediately east of the East Portal on the northern side of Highway 58 was examined. Based on bedrock mapping, the bedrock at the exposed rock face consists of dolomitic limestone of the Goat Island Member overlying the Gasport Member, both of which are part of the Lockport Formation. The rock face was observed to be damp with diffuse seepage occurring along the bedrock surface, and from a horizon midway up the rock cut. Vegetation (grass and small shrubs) was noted to be present along the bedding partings suggesting that seepage commonly occurs at this location. In addition, a damp rock surface and emanation of a low rate of seepage were observed at the interface of the bedrock cut and the northeast edge of the East Portal. During the winter the water seepage on the rock face freezes and forms icicles and water also seeps onto the sidewalk and freezes. There are wet swampy areas present behind the rock cut as well as standing water further north, which are inferred to be the source of the seepage water observed on the rock cut face. Rock bolts installed into the north rock cut face close to the East Portal are evident and there is also evidence of formed concrete near the crest of the slope. Rock debris has accumulated at the base of the rock face indicating that rock has fallen from the face. Selected photographs of these observed conditions are presented in Photographs 3 and 4.

Photograph 3: Looking north at rock face east of the East Portal.

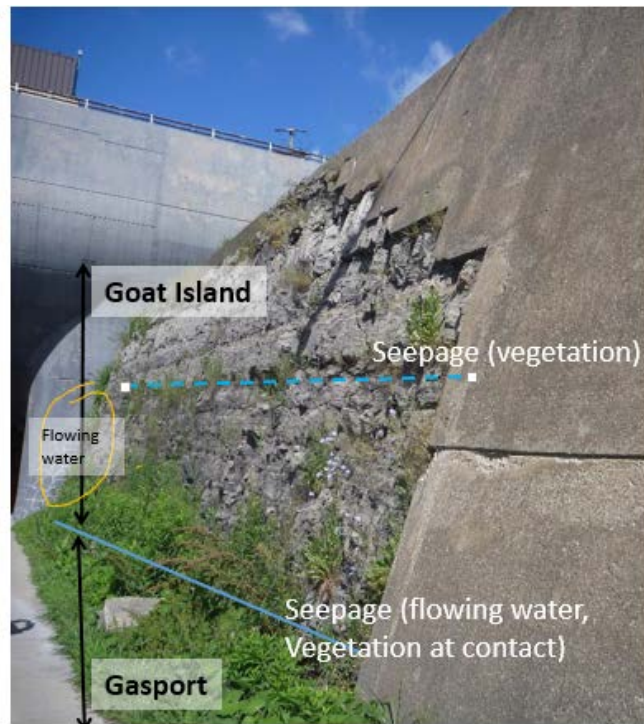
Photograph 4: Looking westward at rock face on north side of Highway 58 east of the East Portal.

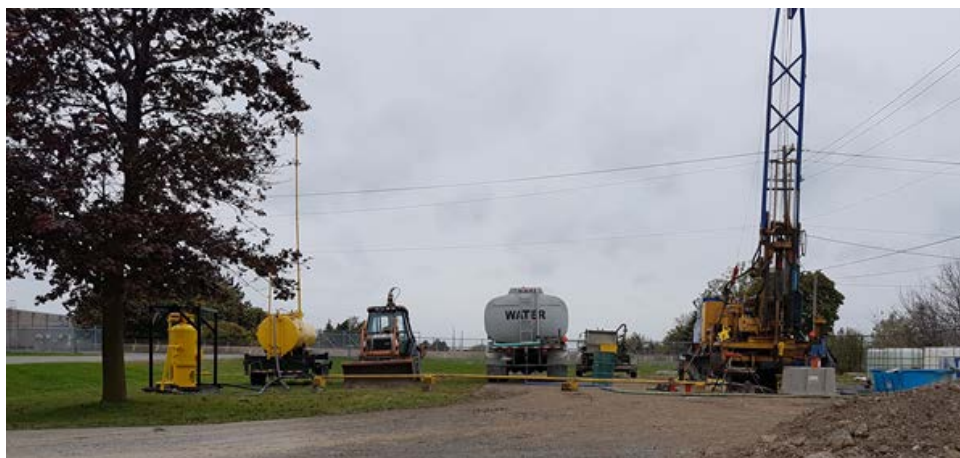
Photographs 6 and 7 illustrate the BOP system setup. The annular BOP, which is attached to the borehole casings, is connected to the degasser and the control unit. In the event of a blowout when drilling, the drill was immediately stopped and the annular BOP was initiated. This would seal the space around the drill rods and force the gas and water to come up around the drill rods and towards the degasser. Once separated, the gas vented out through a 7 m stack and the water accumulated in a holding basin.

Photograph 6: Blow-out prevention system showing the degasser and venting stack (left) and drill (right)

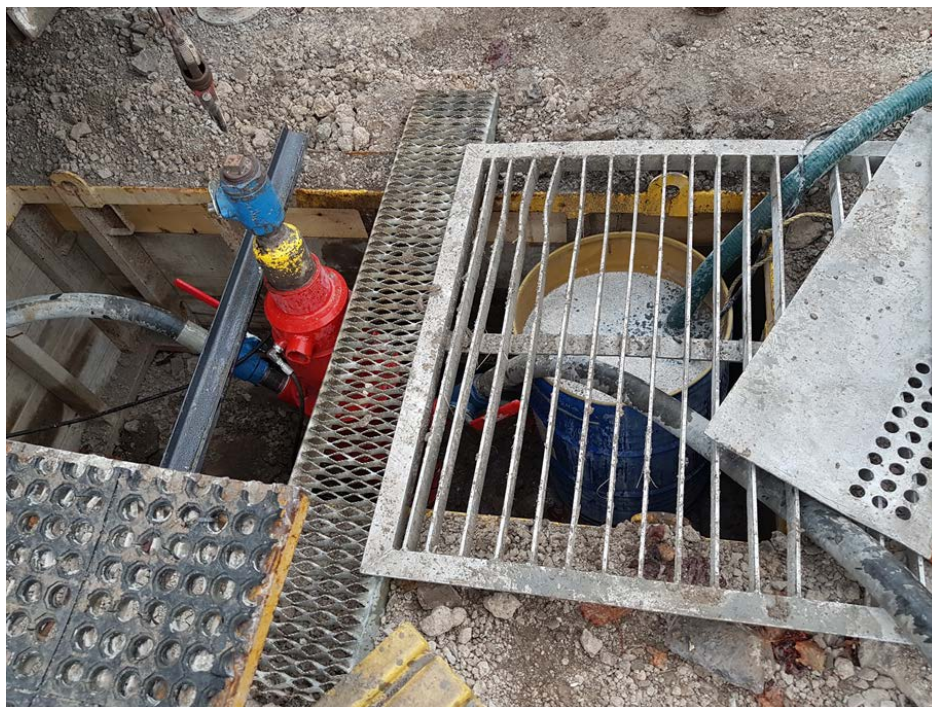
Photograph 7: Blow-out prevention system on the borehole

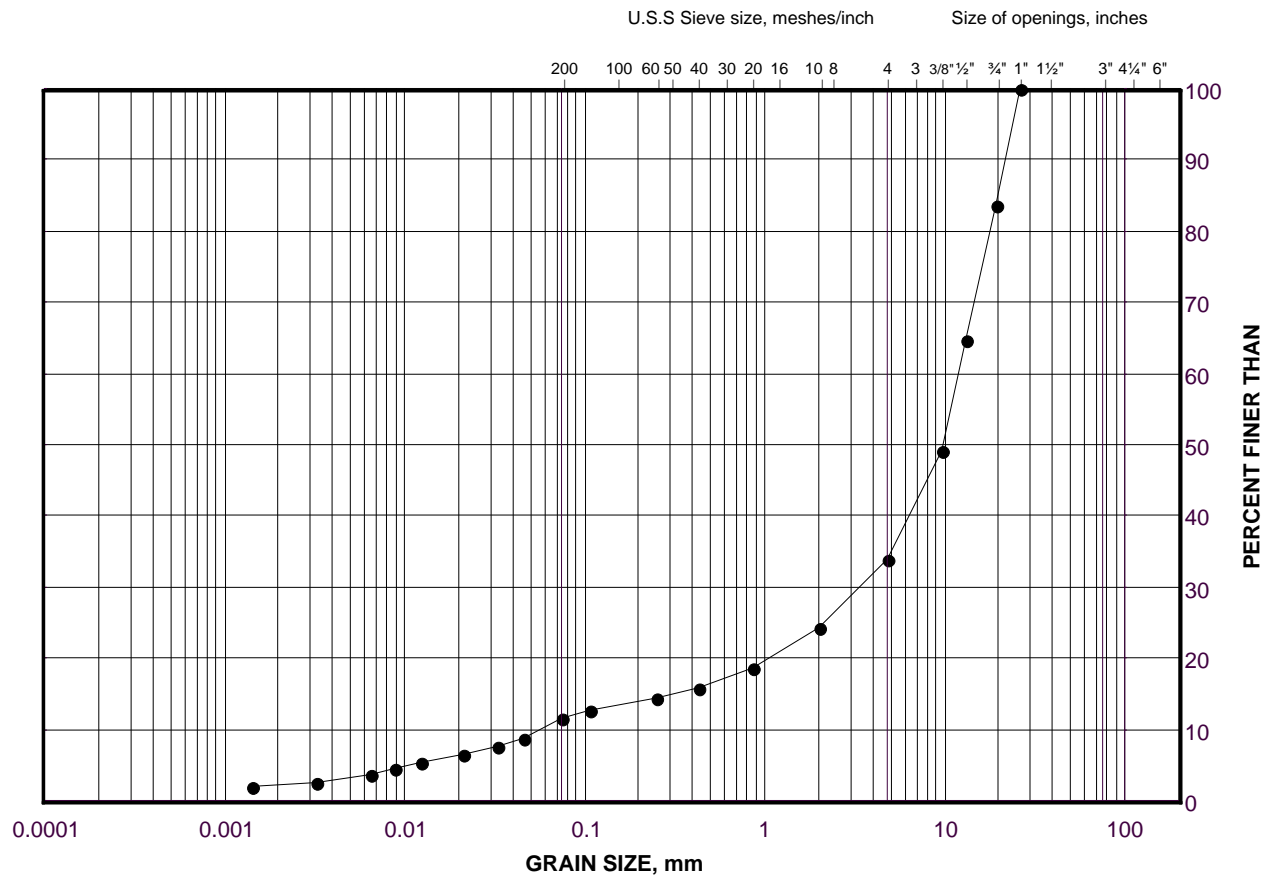
FIGURE B1

Sandy Gravel Fill

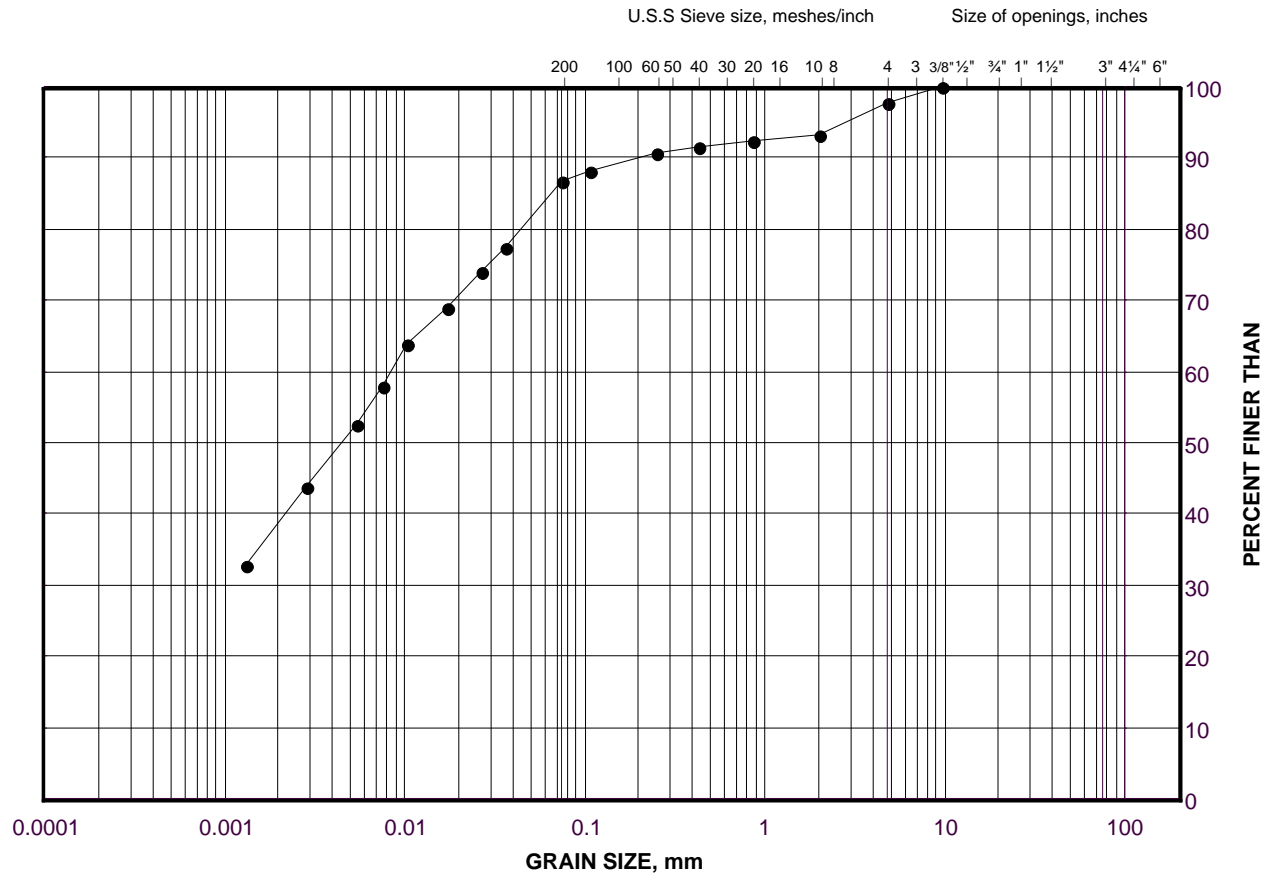
FIGURE B2

Silty Clay Fill

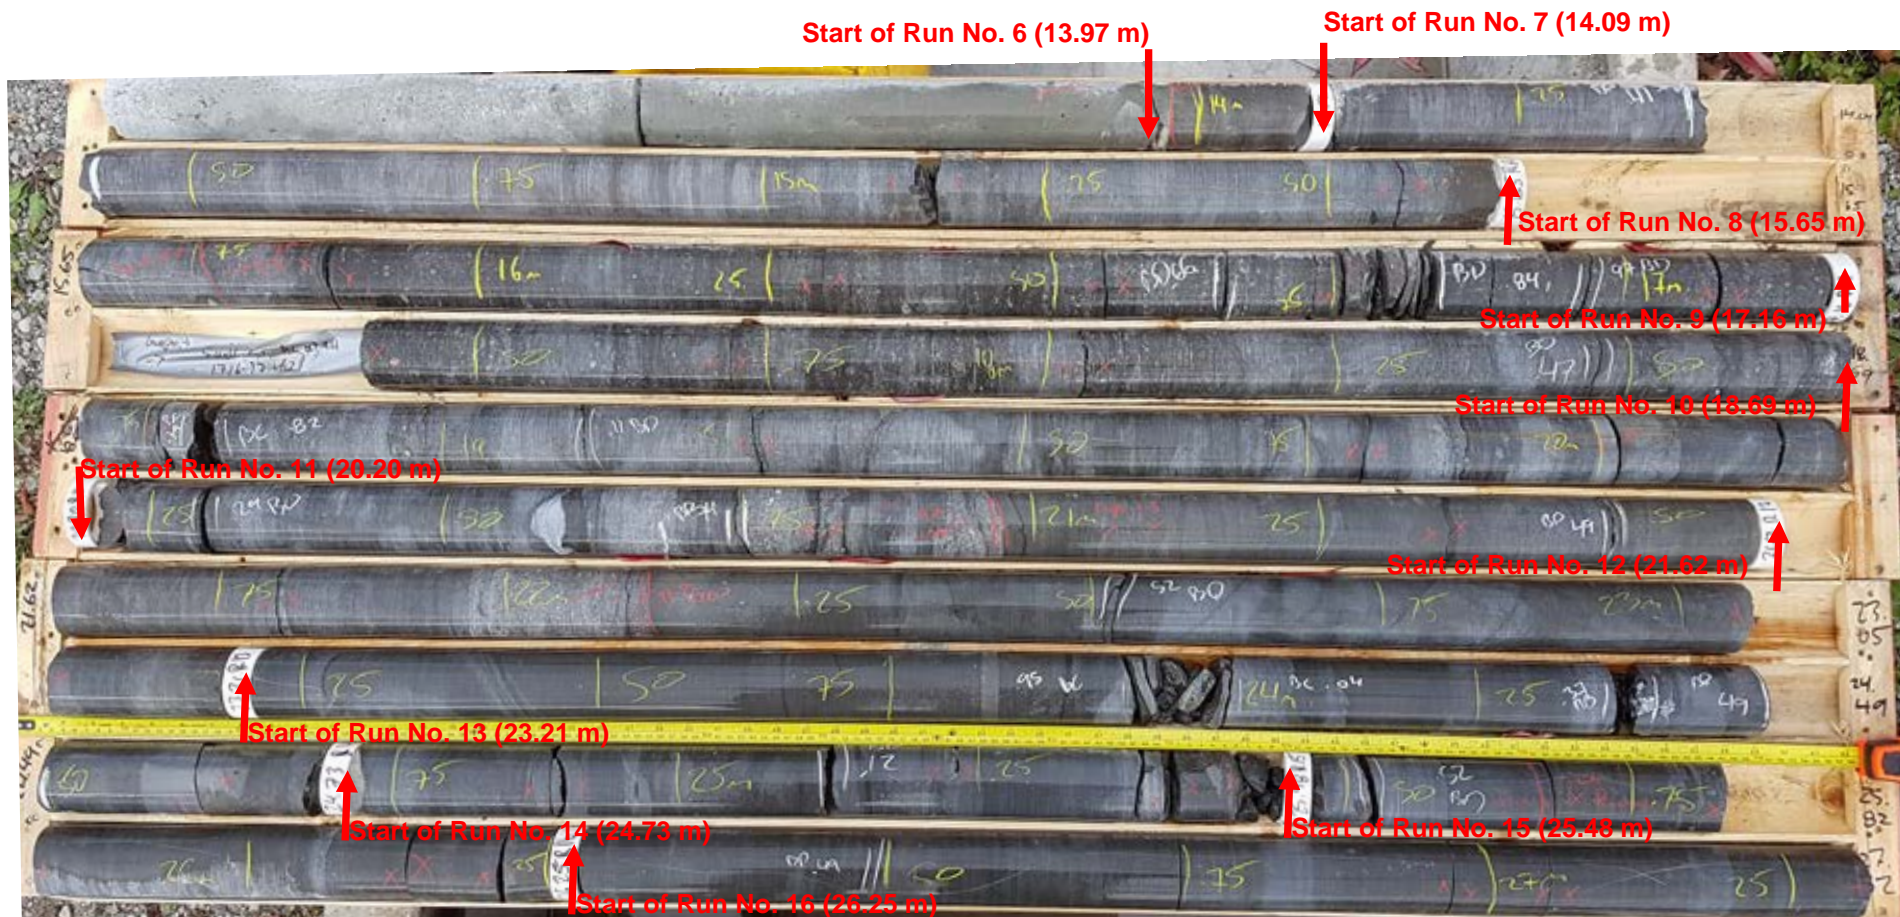
FIGURE B4- A

Box 4-8: 13.97 m to 27.32 m

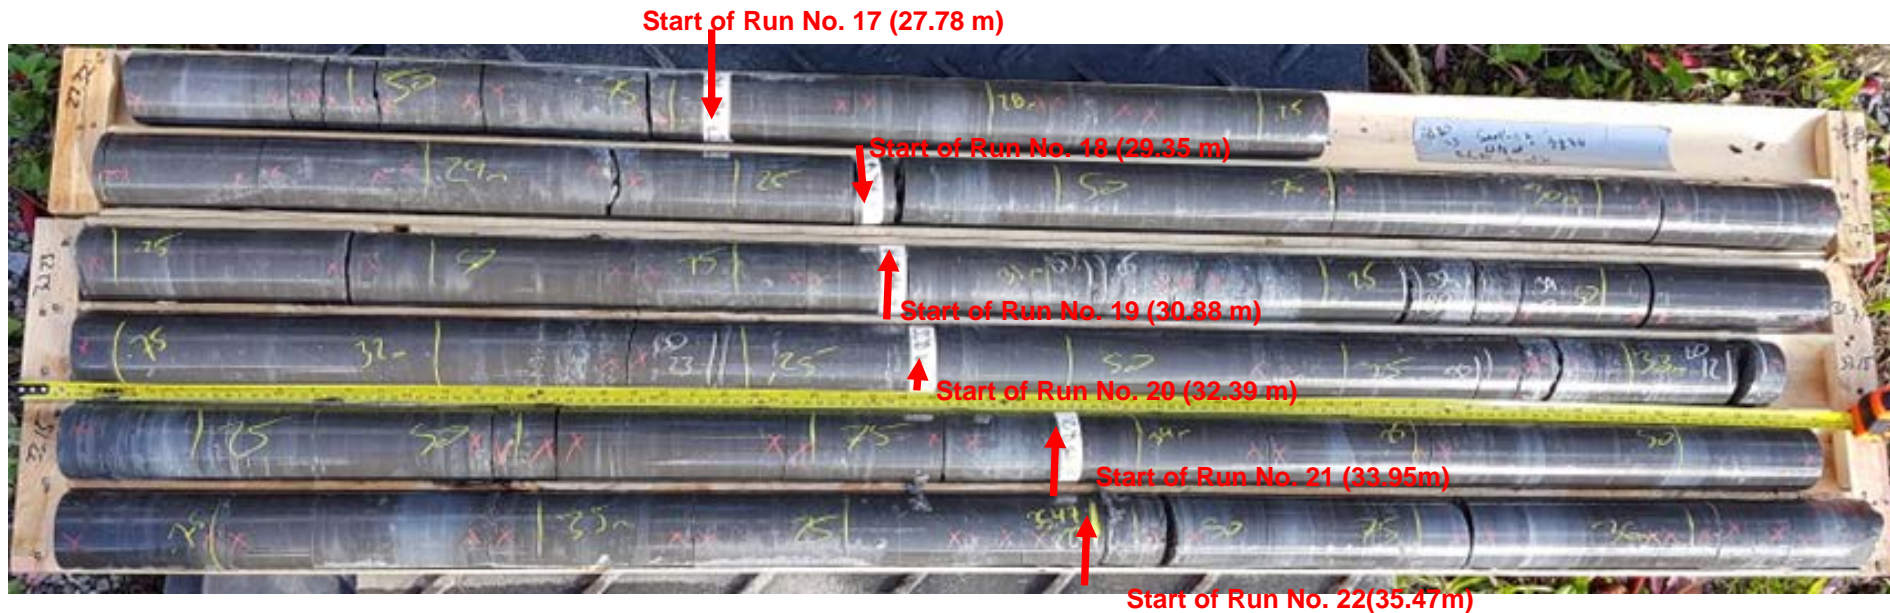
Box 9-11: 27.32 m to 36.18 m

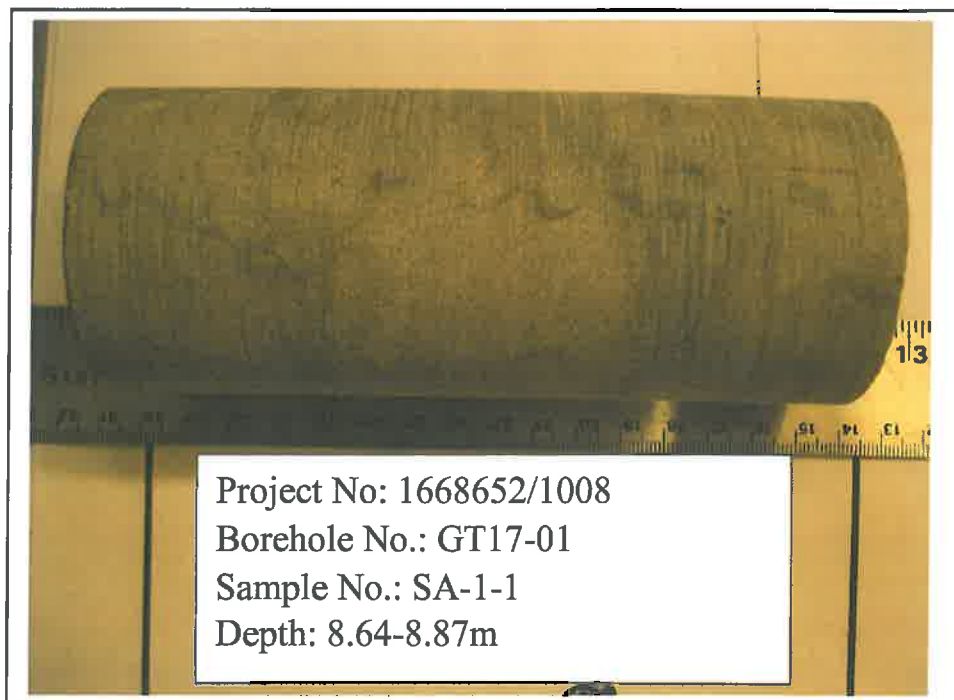
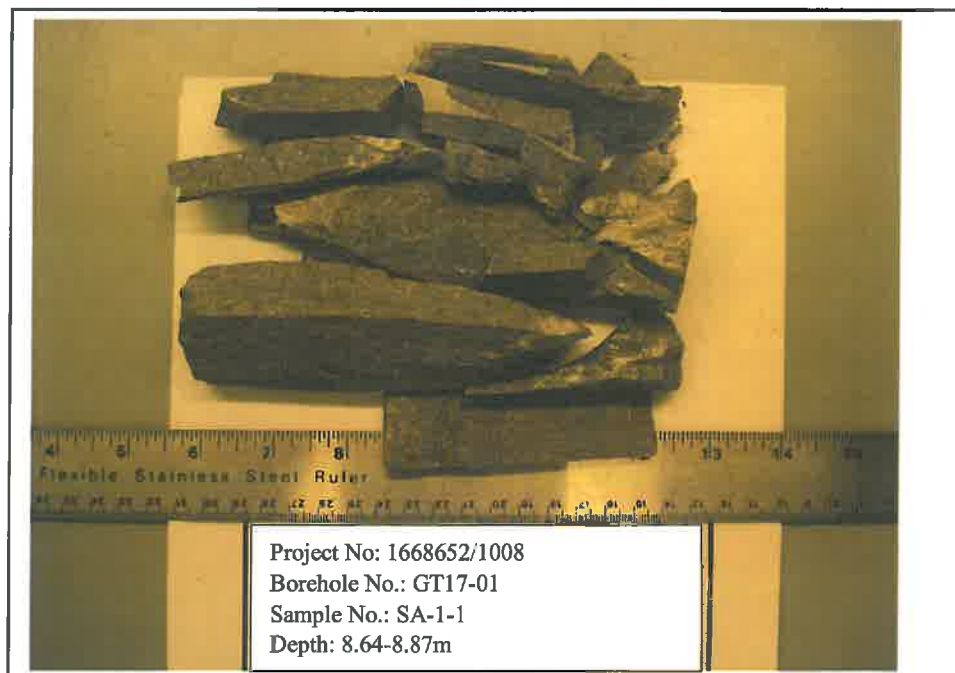
STRAIN AT FAILURE, %	N/A	COMPRESSIVE STRENGTH, MPa	101.4
----------------------	-----	---------------------------	-------

BEFORE COMPRESSION

AFTER COMPRESSION

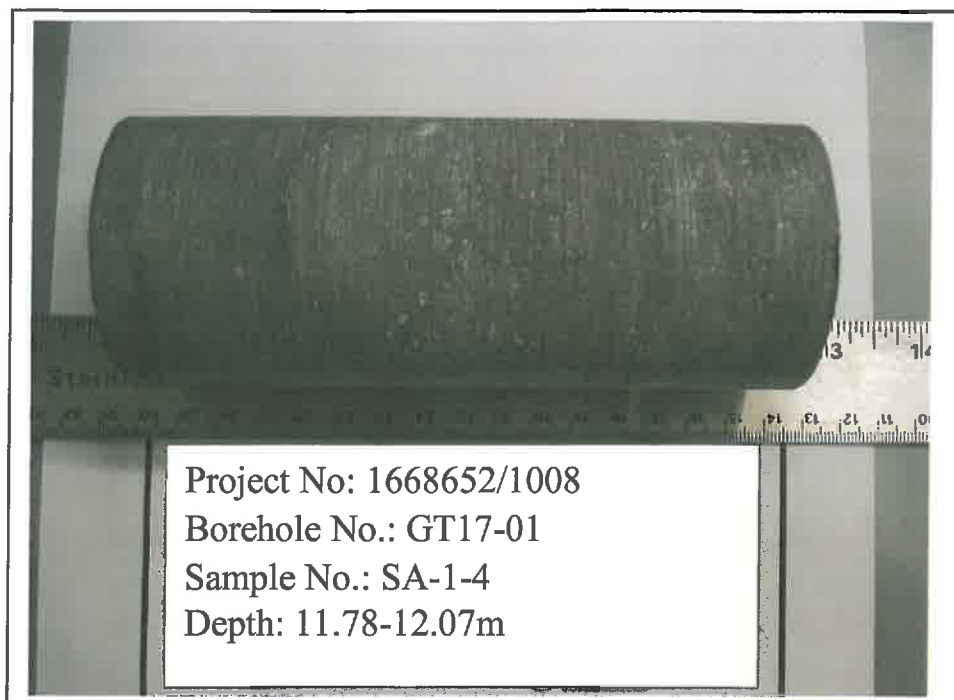
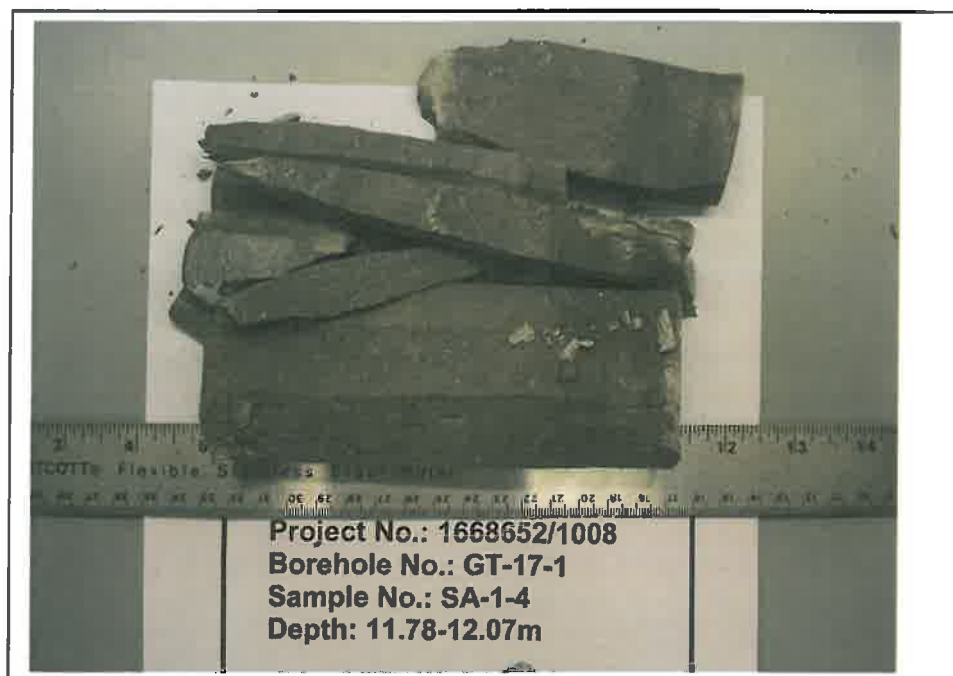
STRAIN AT FAILURE, %	N/A	COMPRESSIVE STRENGTH, MPa	70.9
----------------------	-----	---------------------------	------

BEFORE COMPRESSION

AFTER COMPRESSION

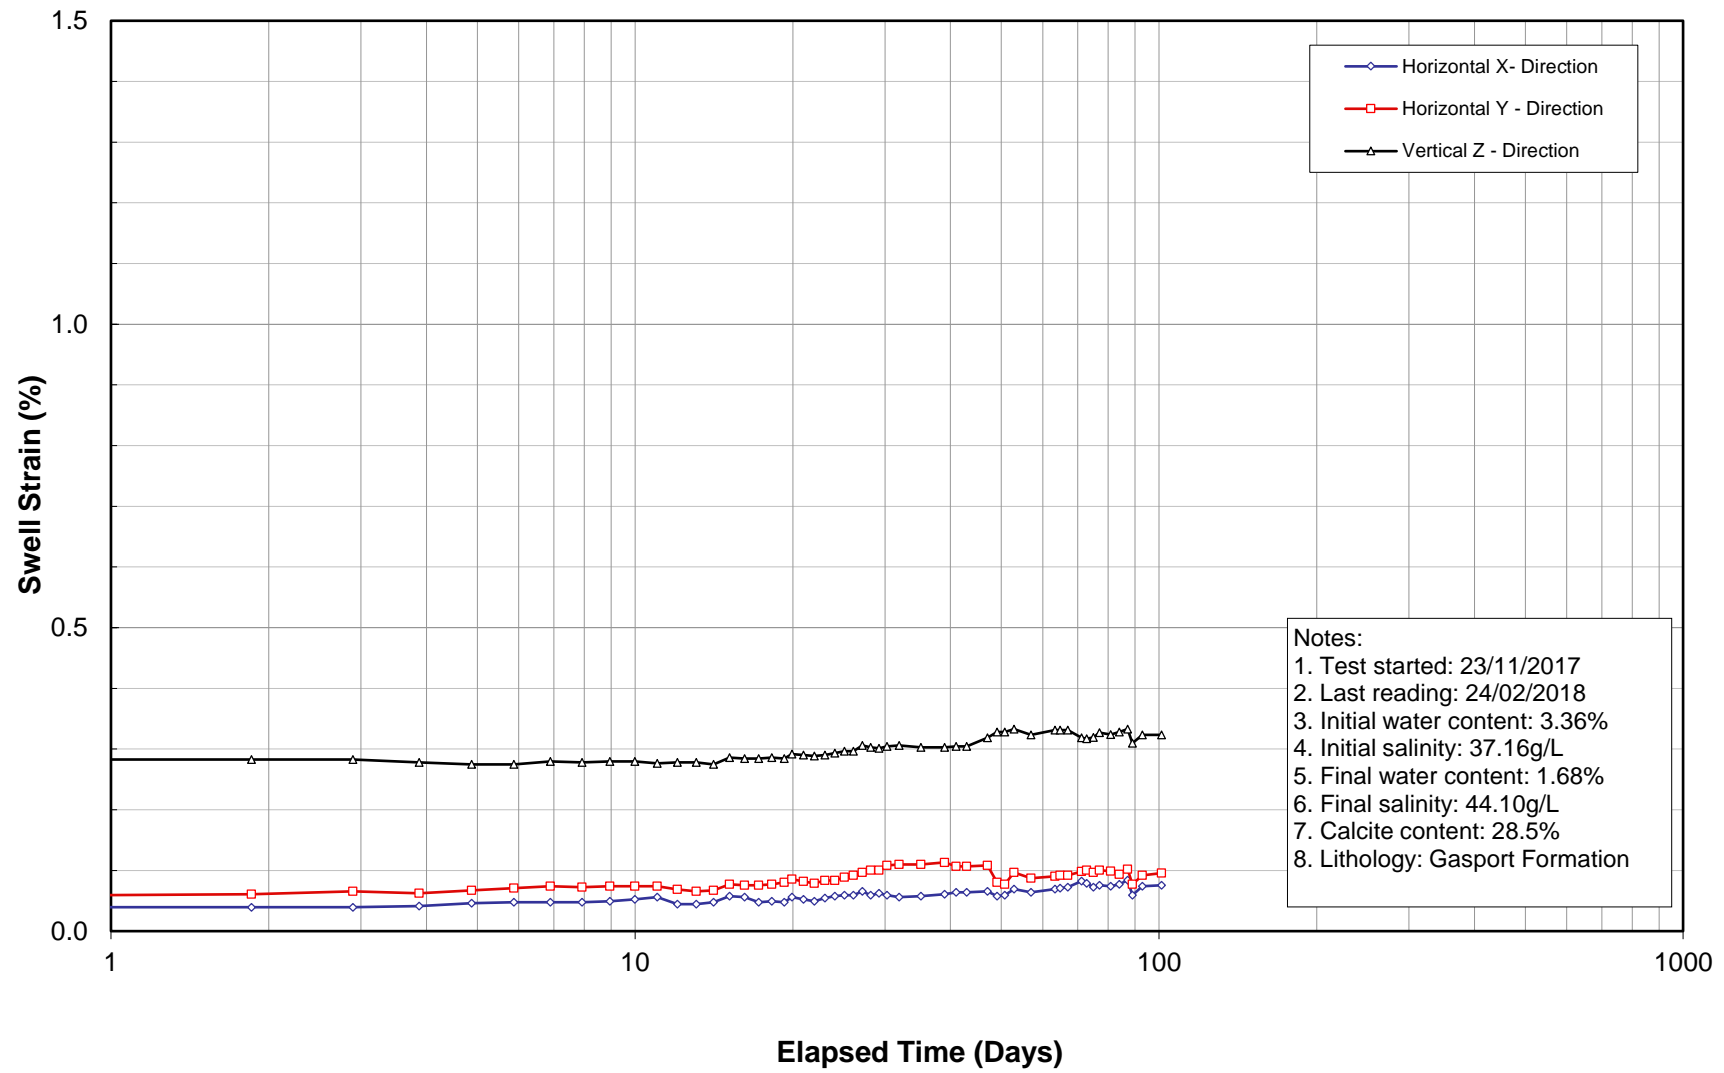
For the free swell tests, the bedrock core samples are tested without any applied pressure and are allowed to swell freely in all directions. Free swelling was tested on rock samples in vertical and horizontal direction (sample axis perpendicular to the bedding planes). The testing also included the determination of the moisture content, salinity of the pore fluid in the test specimen, and calcite content of the samples. The swell testing results for the free swell tests are given as swelling strains (in %) versus time (in log scale to base 10) curves. The results are presented in Appendix B.

Free Swell Test
Geotechnical Investigation at Thorold Tunnel
SA-1-1-FST-1
BH: SA-1-1, Depth: 17.19 m - 17.25 m

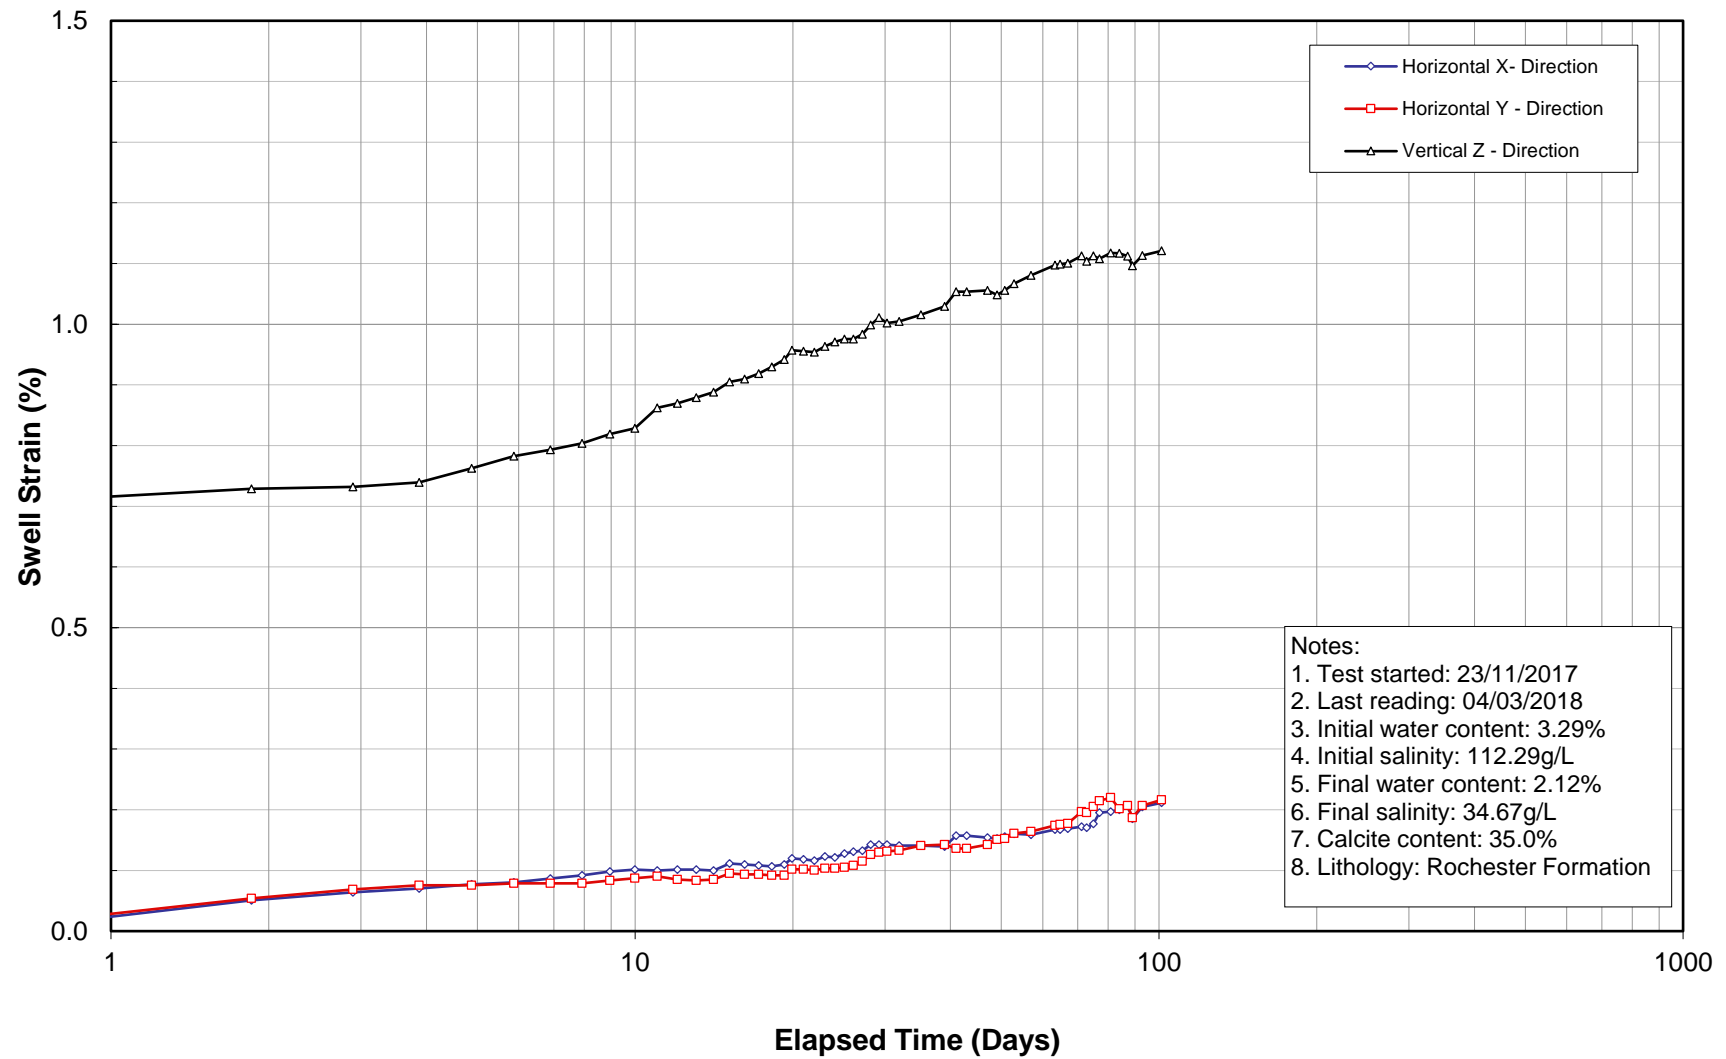
Free Swell Test
Geotechnical Investigation at Thorold Tunnel
SA-1-2-FST-2
BH: SA-1-2, Depth: 28.33 m - 28.39 m
