FOUNDATION INVESTIGATION AND DESIGN REPORT

**STRUCTURAL BUNDLE - 11 STRUCTURES ON HIGHWAYS 129, 532
AND 556
HIGHWAY 129 - WENEBEGON RIVER TRIBUTARY CULVERT
REHABILITATION, 37.8 KM NORTH OF HIGHWAY 556 (SITE NO. 46-
331/C) - LAT. 47.126965 ; LONG. -83.142217
LANE TOWNSHIP, ALGOMA DISTRICT, ONTARIO
GWP 5272-14-00 ; WP 5272-14-01**

Report Number: 1670846 ; GEOCREs No. 410-36

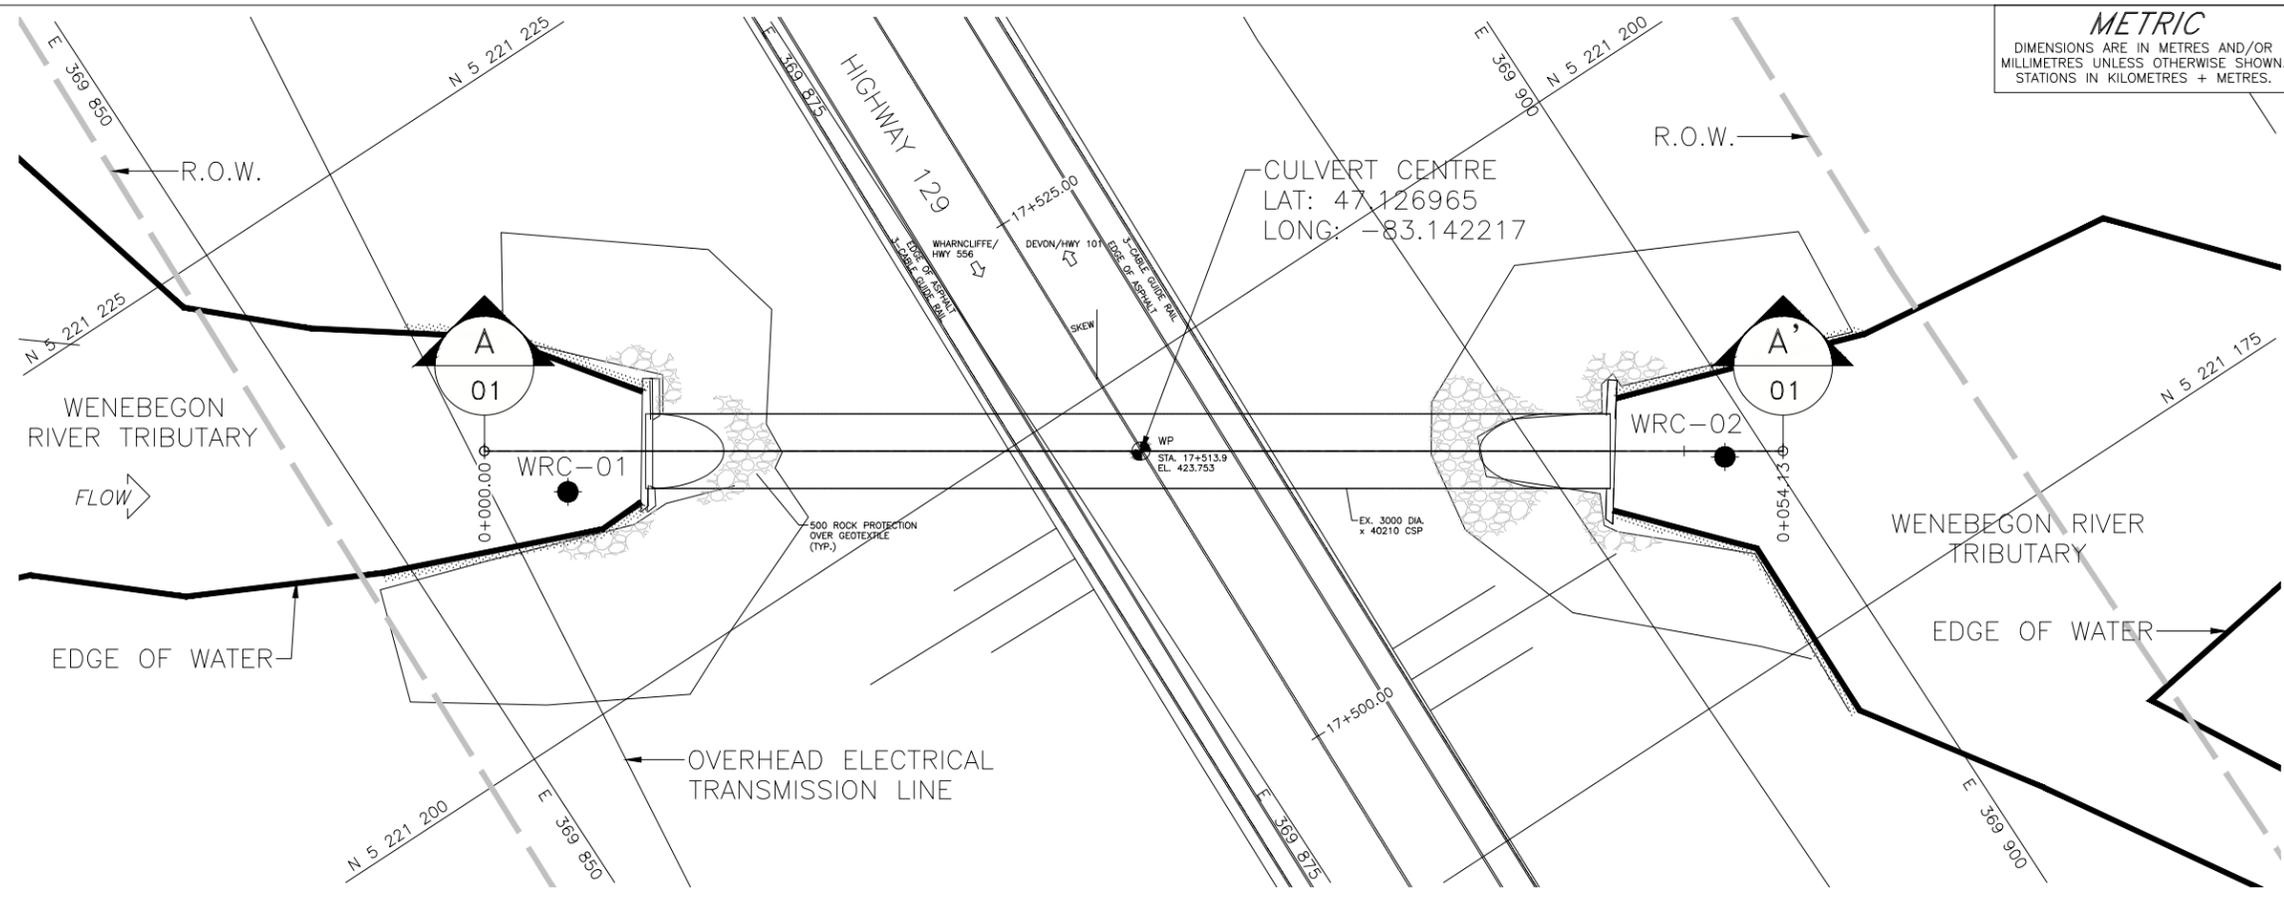
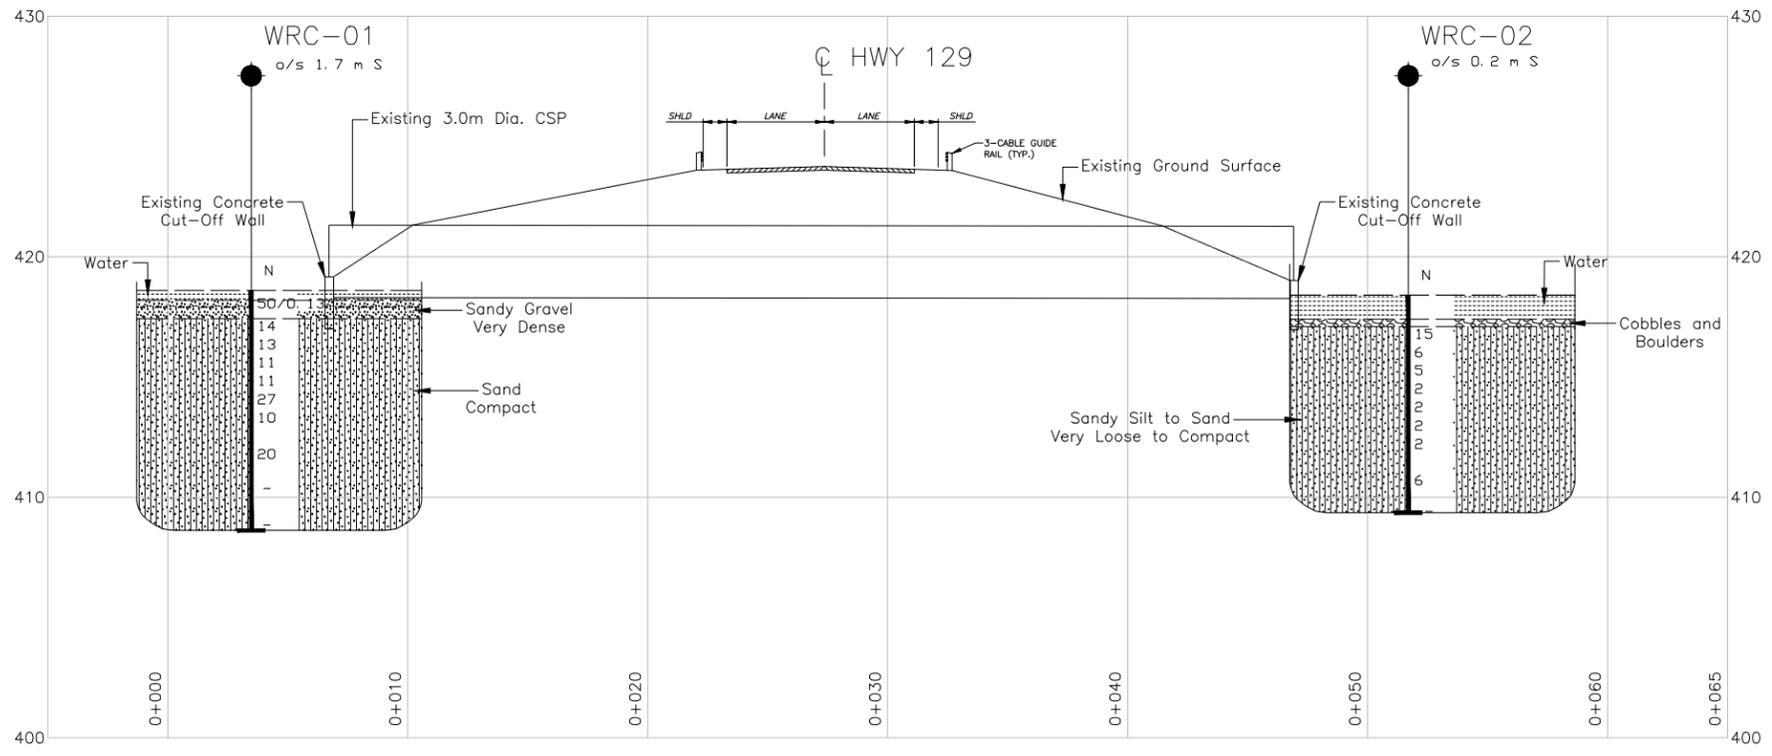
HIGHWAY 129
WENEBEGON RIVER TRIBUTARY CULVERT
BOREHOLE LOCATION AND
SOIL STRATA

The subsurface soil conditions encountered in the boreholes are shown in detail on the Records of Boreholes in Appendix A. Lists of abbreviations and symbols are also provided in Appendix A to assist in the interpretation of the borehole records. The locations of the as-drilled boreholes are shown in plan on Drawing 1.

The stratigraphic boundaries shown on the borehole records and on the soil strata profile (i.e., Drawing 1) are inferred from observations of drilling progress, non-continuous sampling, and in-situ testing and therefore, represent transitions between soil types rather than exact planes of geological change. Further, subsurface conditions will vary between and beyond the borehole locations.

Temporary benchmarks were established and surveyed near the existing culvert by Callon Dietz Inc. prior to the drilling crew mobilizing to site. Upon completion of drilling, borehole offsets and corresponding ground surface elevation changes were recorded and tied-in to the surveyed benchmark locations to determine the as-drilled borehole locations and ground surface elevations. The borehole survey information, including northing and easting coordinates (presented in the MTM NAD83 Zone 13 and latitude / longitude coordinate systems) and the ground surface elevations referenced to Geodetic datum, are provided on the borehole records in Appendix A, presented on Drawing 1, and summarized below.

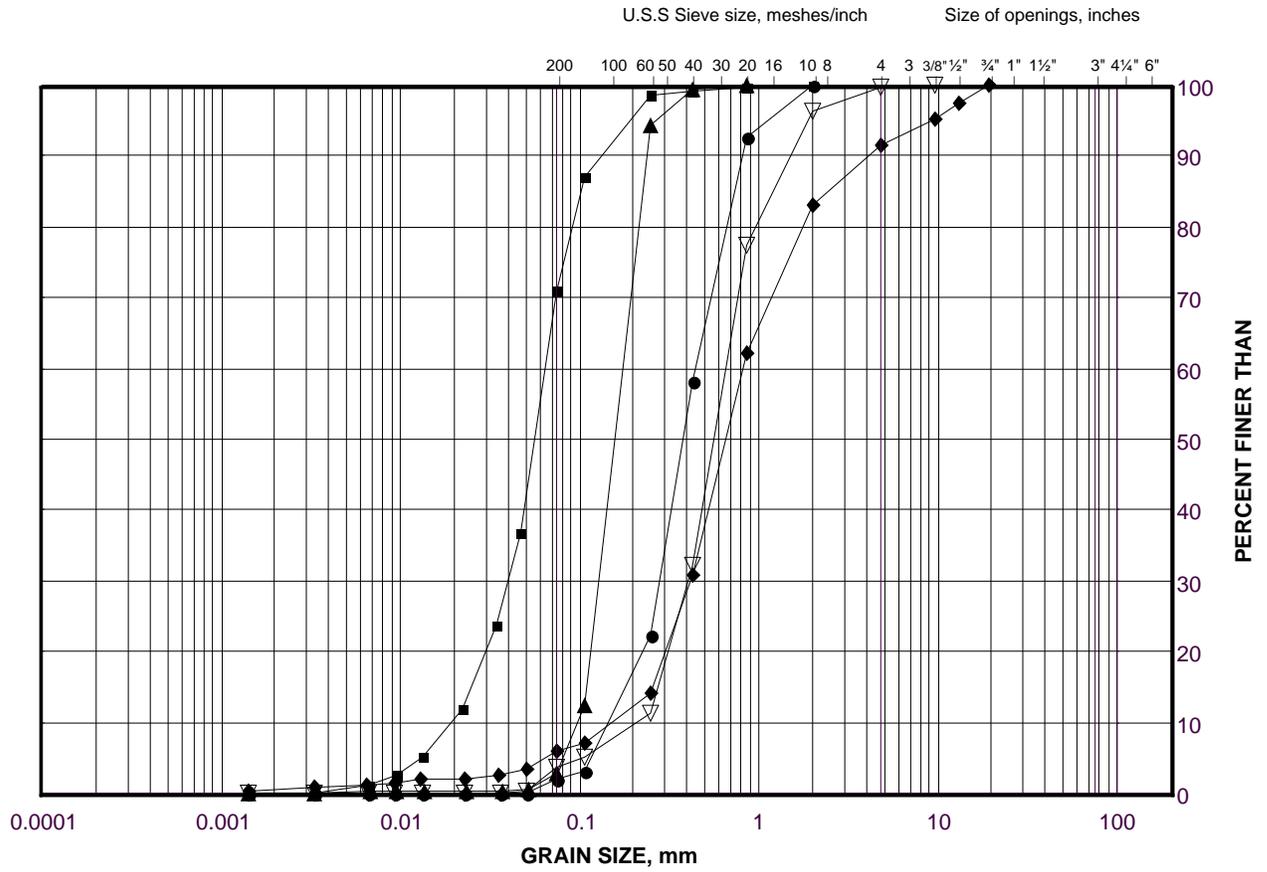
FIGURE B1

Sandy Silt to Sand

Geotechnical classification testing (i.e., water content and grain size distribution) was carried out on selected soil samples. The results of the geotechnical laboratory testing are summarized on the borehole records in Appendix A and the details of the geotechnical testing are provided in Appendix B. All of the laboratory tests were carried out in accordance with MTO Laboratory and/or ASTM Standards, as appropriate.
