## FOUNDATION INVESTIGATION AND DESIGN REPORT

**STRUCTURAL BUNDLE - 11 STRUCTURES ON HIGHWAYS 129, 532,  
AND 556  
HIGHWAY 532 - ACHIGAN CREEK BRIDGE REPLACEMENT, 5.1 KM  
NORTH OF HIGHWAY 556 (SITE NO. 38S-041)  
LAT. 46.789744° ; LONG. -84.054775°  
HODGINS AND GAUDETTE TOWNSHIPS, ALGOMA DISTRICT,  
ONTARIO  
MINISTRY OF TRANSPORTATION, ONTARIO  
GWP 5378-11-00 ; WP 151-97-01**

**Report No.: 1670846 ; GEOCREs No. 41K-108**

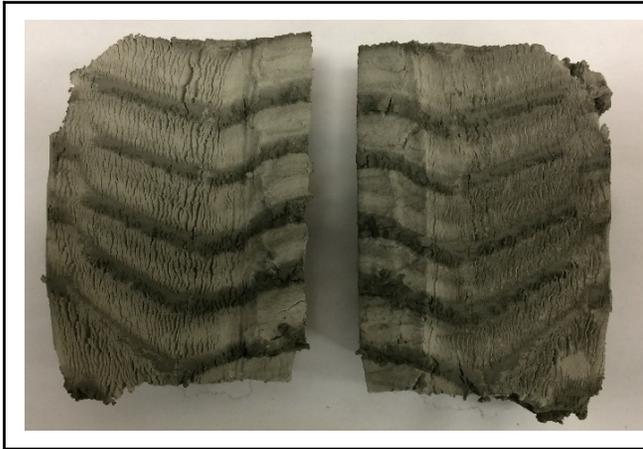
**Photograph 1:** Soil sample from Borehole ACB-01  
Sample 8

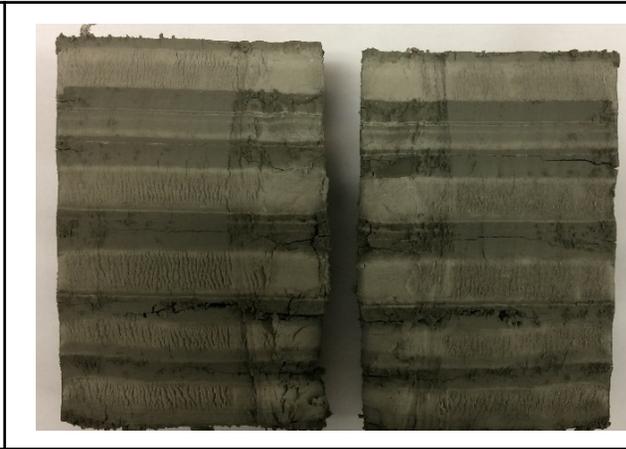
**Photograph 2:** Soil sample from Borehole ACB-02  
Sample 9

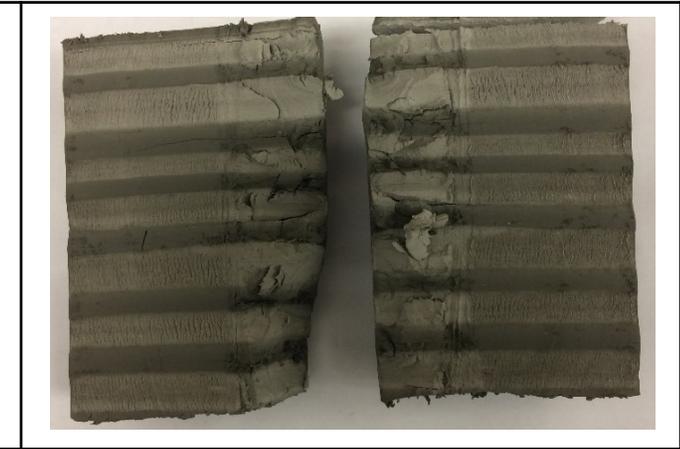
**Photograph 3:** Soil sample from Borehole ACB-03  
Sample 10

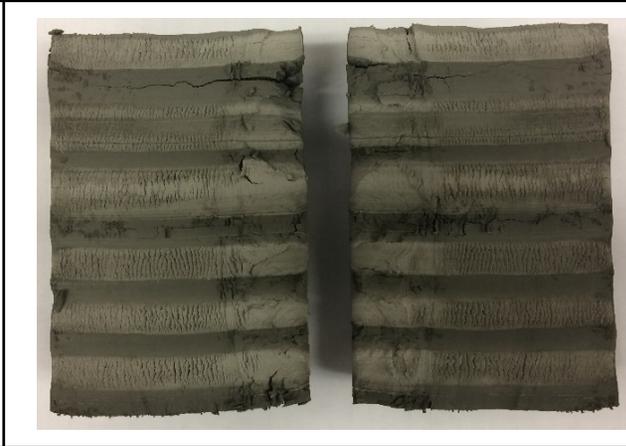
**Photograph 5:** Soil sample from Borehole ACB-07  
Sample 9

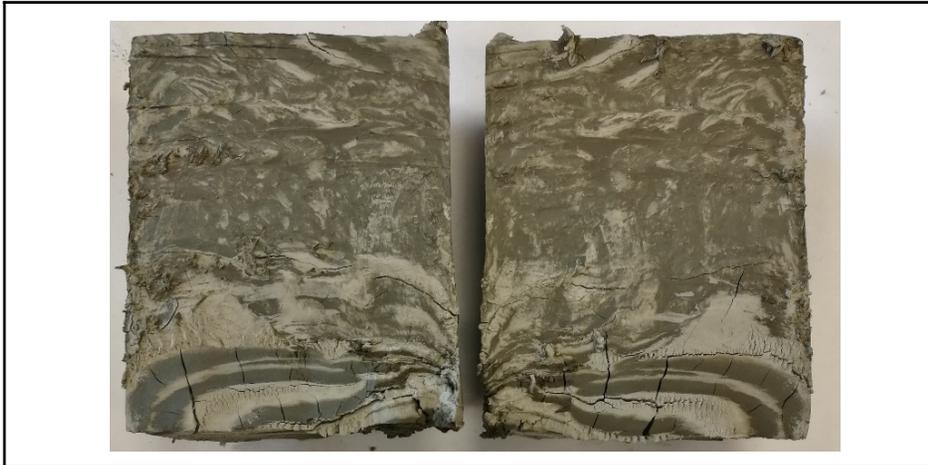
**Photograph 1:** Soil sample from Borehole ACB-04 Sample 12

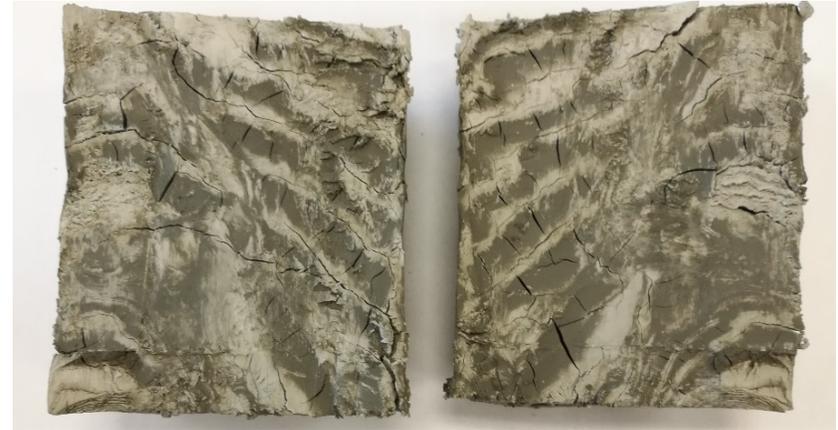
**Photograph 2:** Soil sample from Borehole ACB-04 Sample 18

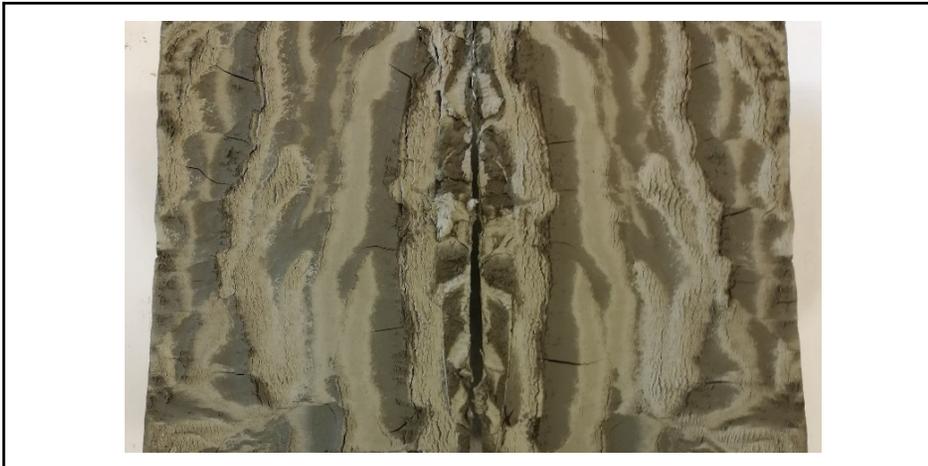
**Photograph 3:** Soil sample from Borehole ACB-05 Sample 11

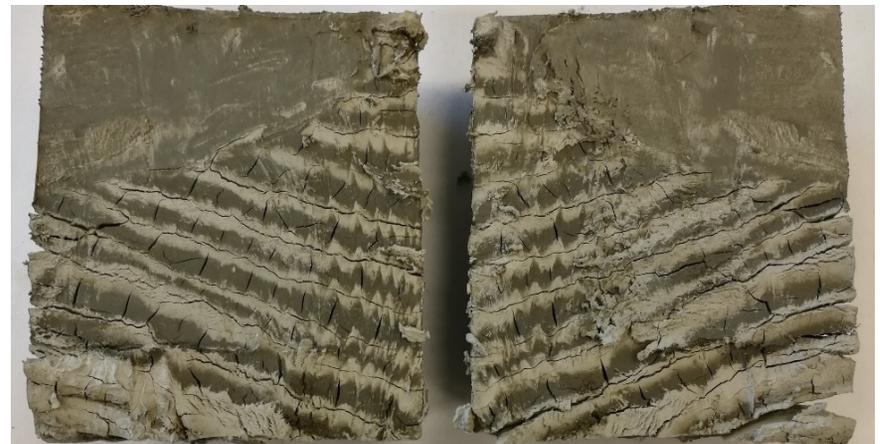
**Photograph 4:** Soil sample from Borehole ACB-05 Sample 14

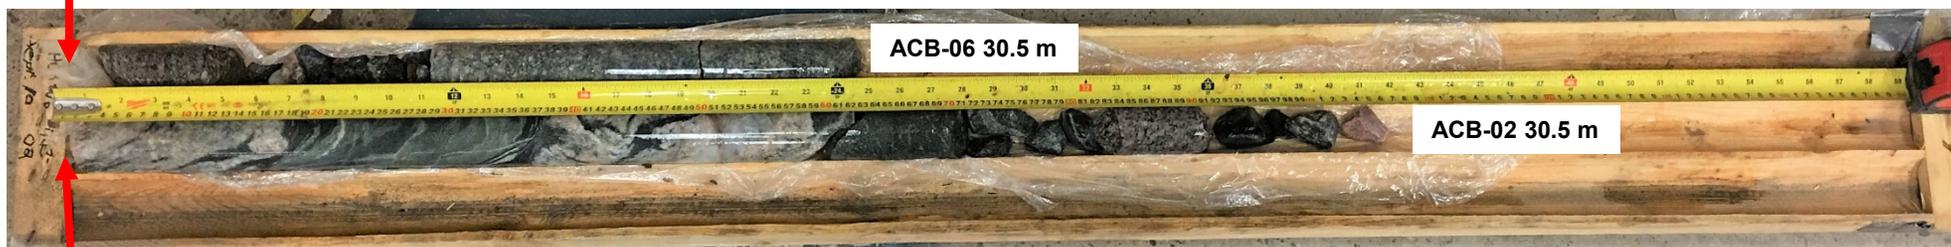
**Borehole ACB-03:** Cobbles and boulders cored between 28.3 m and 32.0 m

**Borehole ACB-06:** Cobbles and boulders cored between 29.3 m and 30.5 m

Frequent rock fragments, cobbles, and boulders were encountered within this lower granular deposit. The size of the cobbles and boulders recovered from zones which required rock coring to advance the boreholes were noted to range between about 100 mm and 620 mm. Frequent gravel pieces and rock fragments ranging in size from about 20 mm to 70 mm were also recovered. Photographs of the recovered rock fragments, cobbles, and boulders are shown on Figure C10 in Appendix C. The top of this deposit was encountered at depths ranging between about 27.1 m and 30.0 m below existing ground surface (between Elevations 211.2 m and 208.2 m). Boreholes ACB-02 to ACB-07 were terminated with the lower granular deposit at depths ranging from about 30.6 m to 32.5 m (between Elevations 207.6 m and 205.5 m). In Borehole ACB-07, a DCPT was also carried out between depths of about 30.6 m (Elevation 207.6 m) and 32.4 m (Elevation 205.8 m).
