**FOUNDATION INVESTIGATION AND DESIGN REPORT
CAMERA POLE RELOCATION
HIGHWAY 417 NICHOLAS STREET INTERCHANGE
OTTAWA, ONTARIO**

GWP 4048-11-00

Geocres No.: 31G5-298

January 2019
Thurber File: 17532

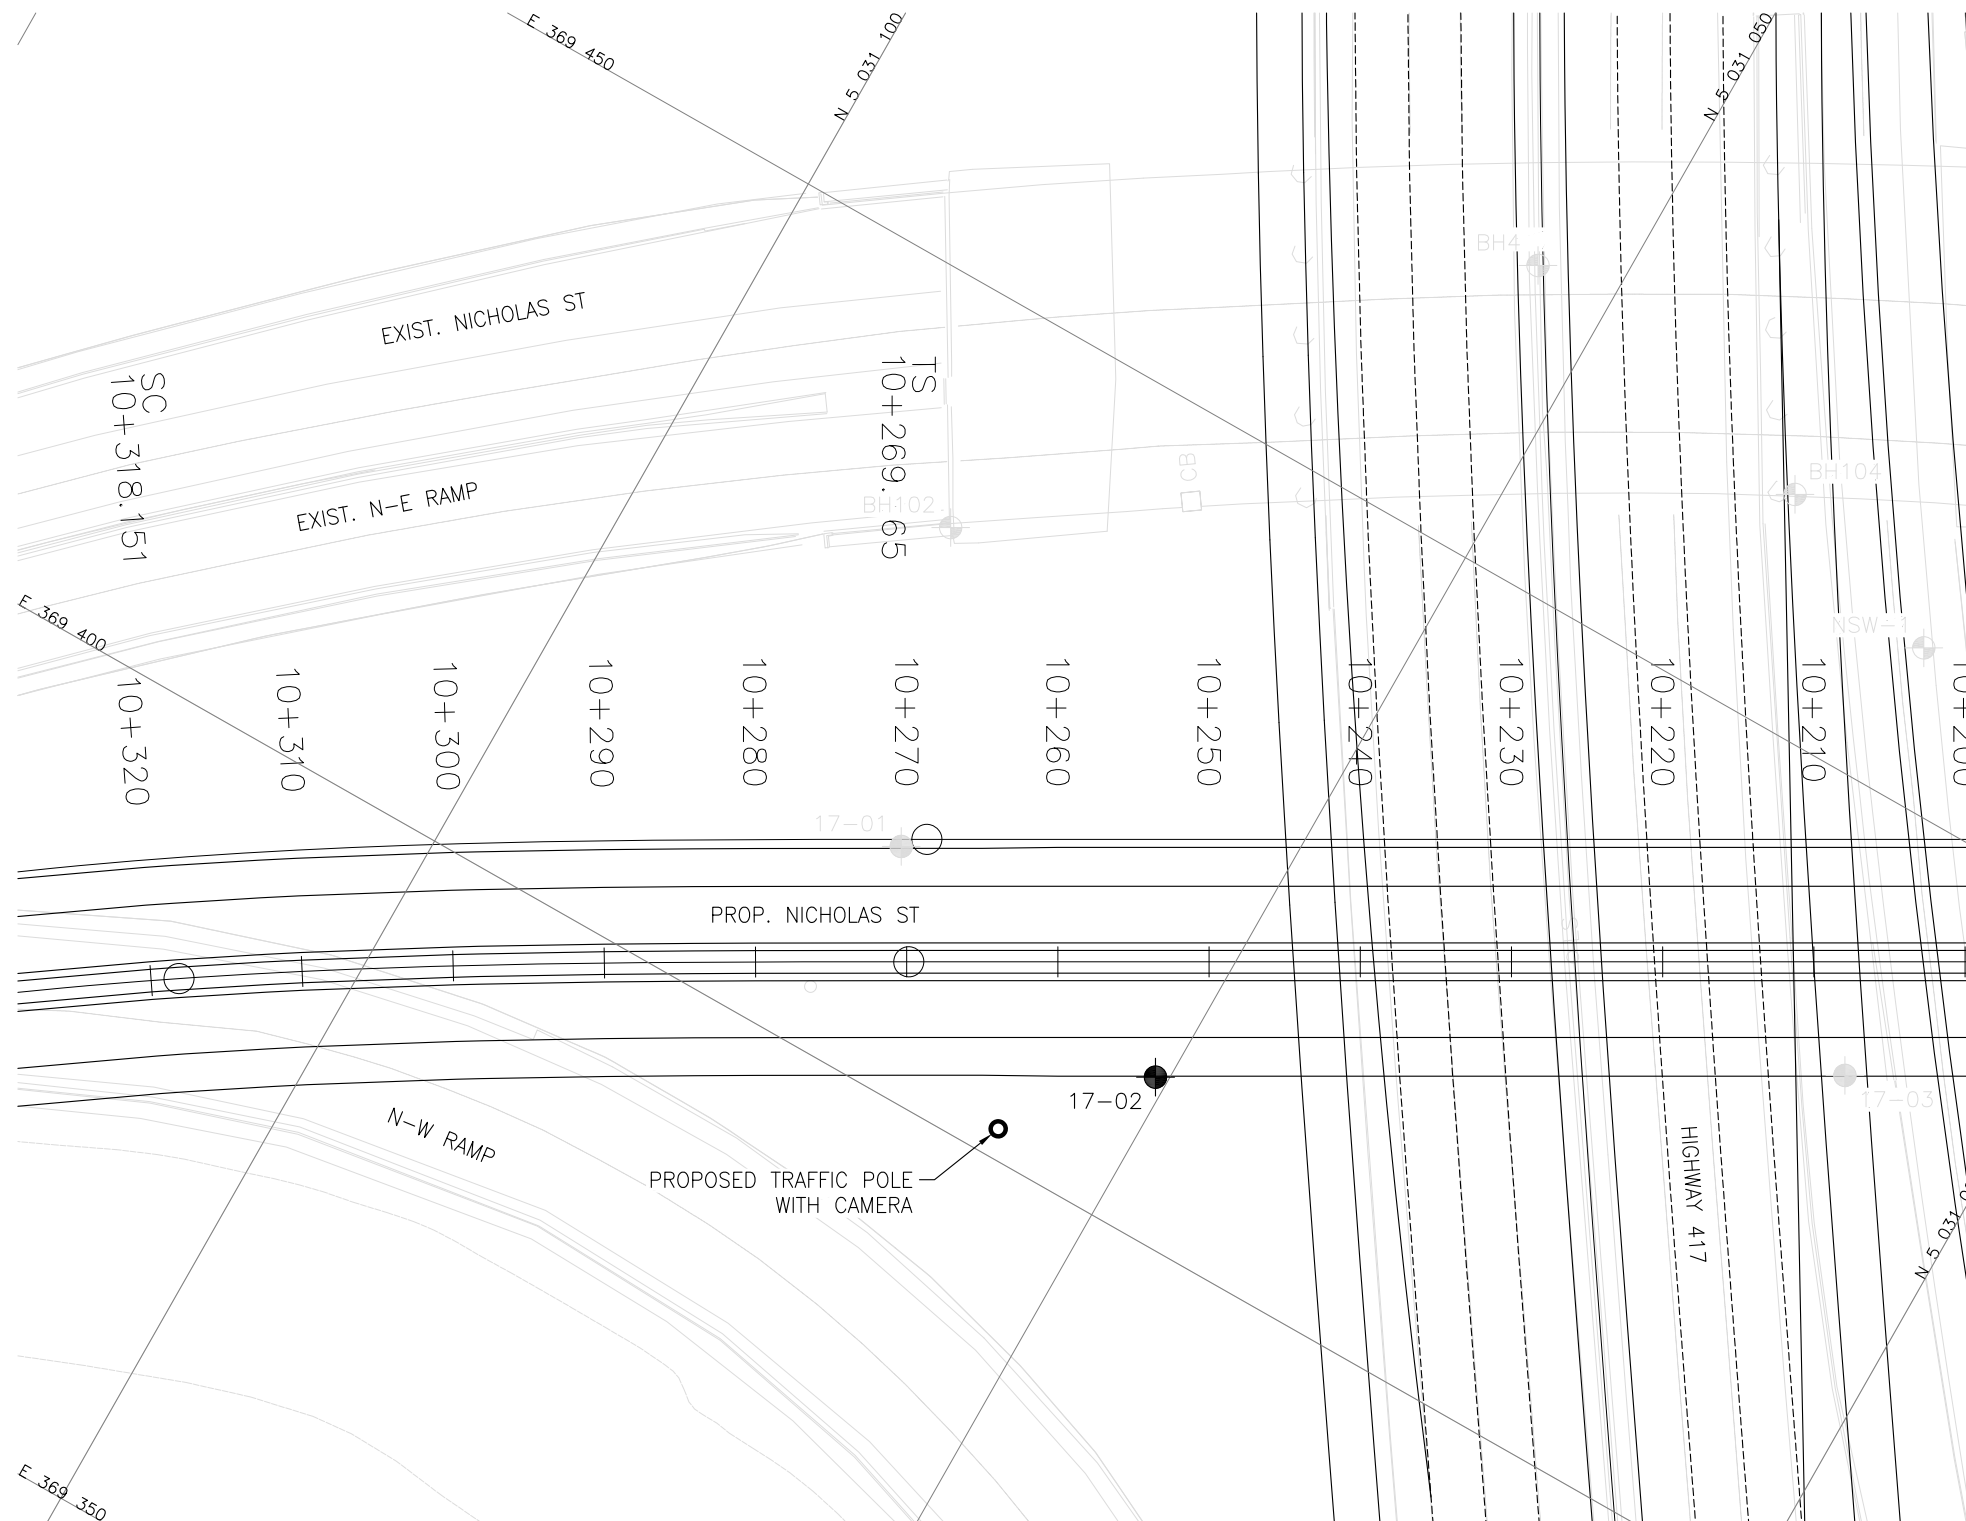
PLAN

Borehole 17-02 from the previous investigation is located in the vicinity of the proposed camera pole. Please refer to Geocres Report 31G5-284 for a full description of investigation methodology. The location of Borehole 17-02 is shown on the Borehole Location Drawing included in Appendix A. Details of the soil stratigraphy encountered in Borehole 17-02 are presented on the Record of Borehole sheets included in Appendix B. Laboratory test results from the samples collected in Borehole 17-02 are included in Appendix C.

Information on the general location of the proposed camera pole was provided to Thurber by WSP. It is understood that the camera pole will be designed as a direct buried concrete pole with a total length of 24.348 m. The pole will be tapered with a base diameter of 620 mm and a tip diameter of 305 mm. The recommendations provided herein are based on the subsurface conditions encountered in a borehole that was drilled for a previous investigation, which is located in the vicinity of the proposed camera pole. The Record of Borehole is presented in Appendix B.

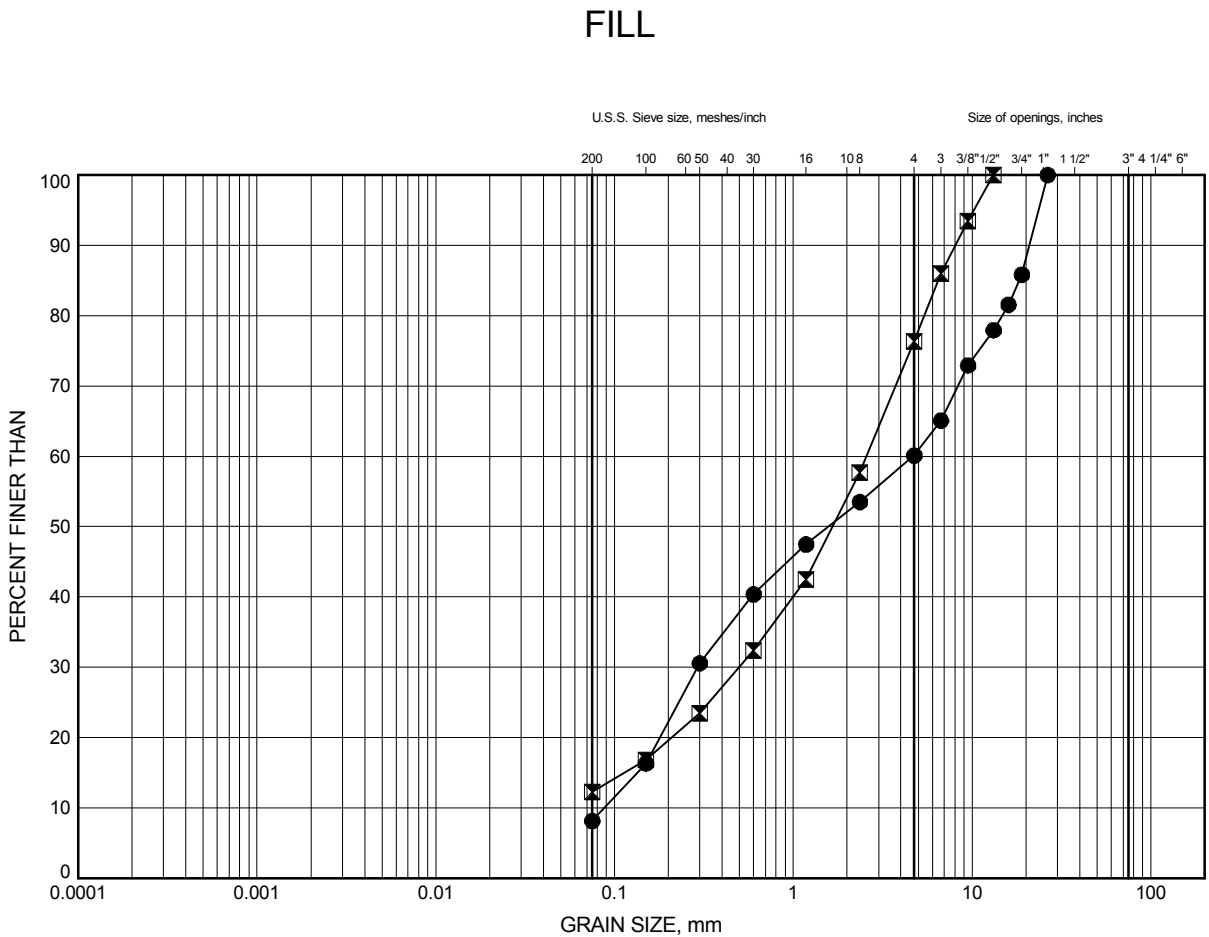
The results of grain size distribution testing conducted on two samples of the fill are summarized below and are illustrated on Figure C1 in Appendix C.

| Soil Particle | Percentage (%) |
| Gravel | 24 – 40 |
| Sand | 52 – 64 |
| Silt | 8 – 12 |

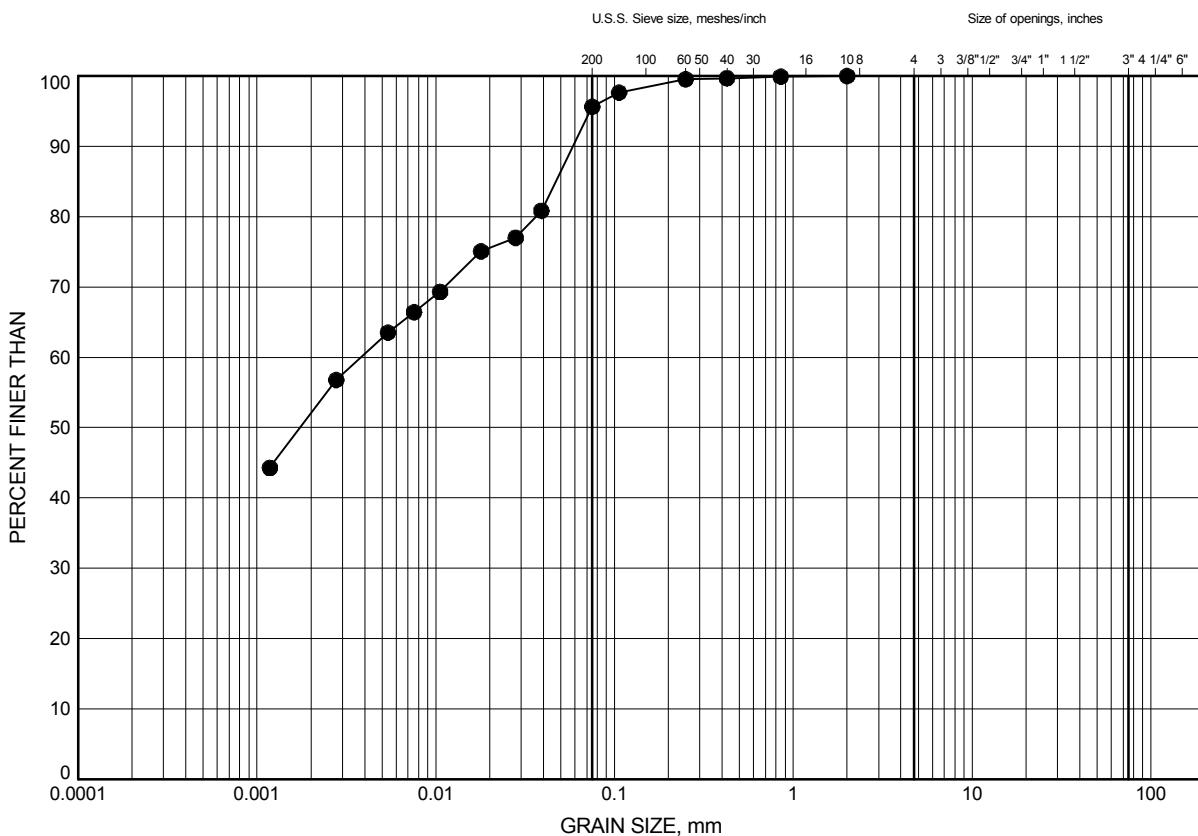
CLAY

The results of grain size distribution testing conducted on one sample of the clay are summarized below and are illustrated on Figure C2 in Appendix C.

| Soil Particle | Percentage (%) |
| Gravel | 0 |
| Sand | 4 |
| Silt | 44 |
| Clay | 52 |

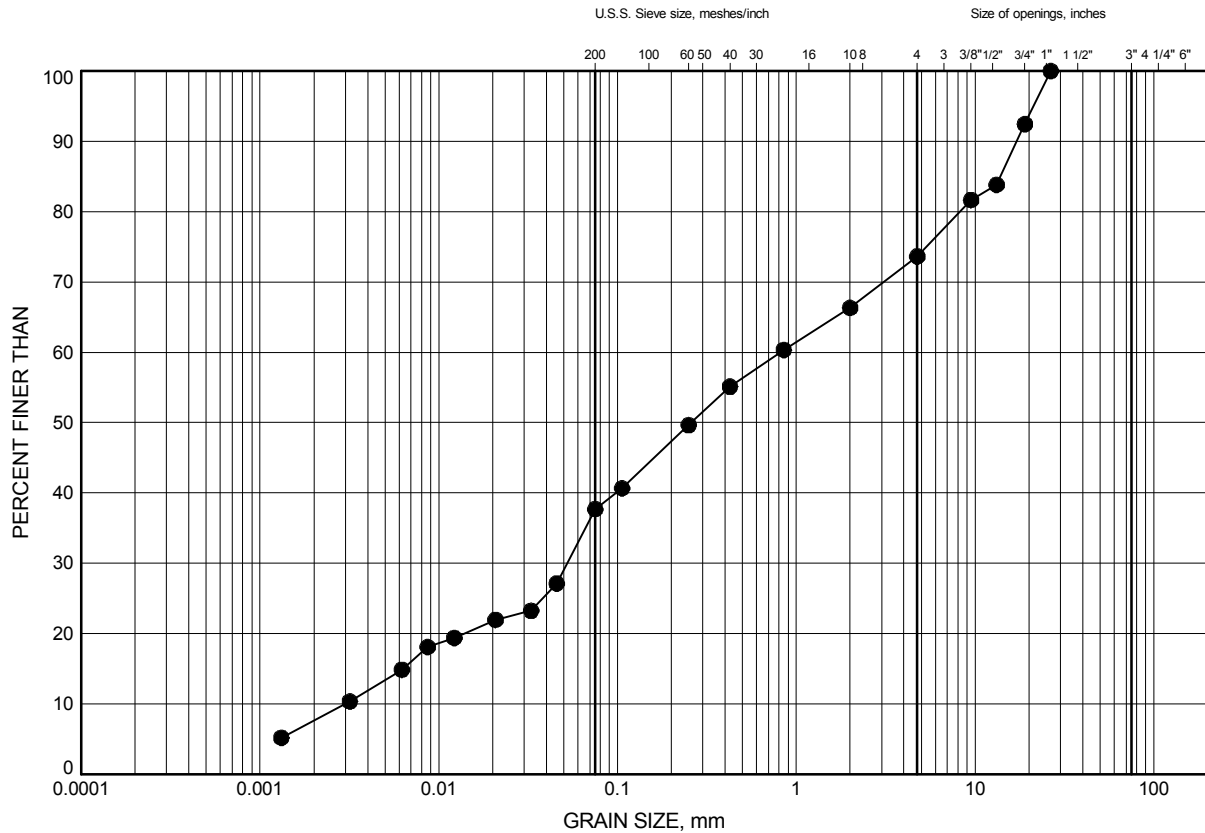
SANDY SILT WITH GRAVEL

The results of grain size distribution testing conducted on one sample of the sandy silt with gravel are summarized below and are illustrated on Figure C3 in Appendix C.

| Soil Particle | Percentage (%) |
| Gravel | 26 |
| Sand | 36 |
| Silt | 30 |
| Clay | 8 |

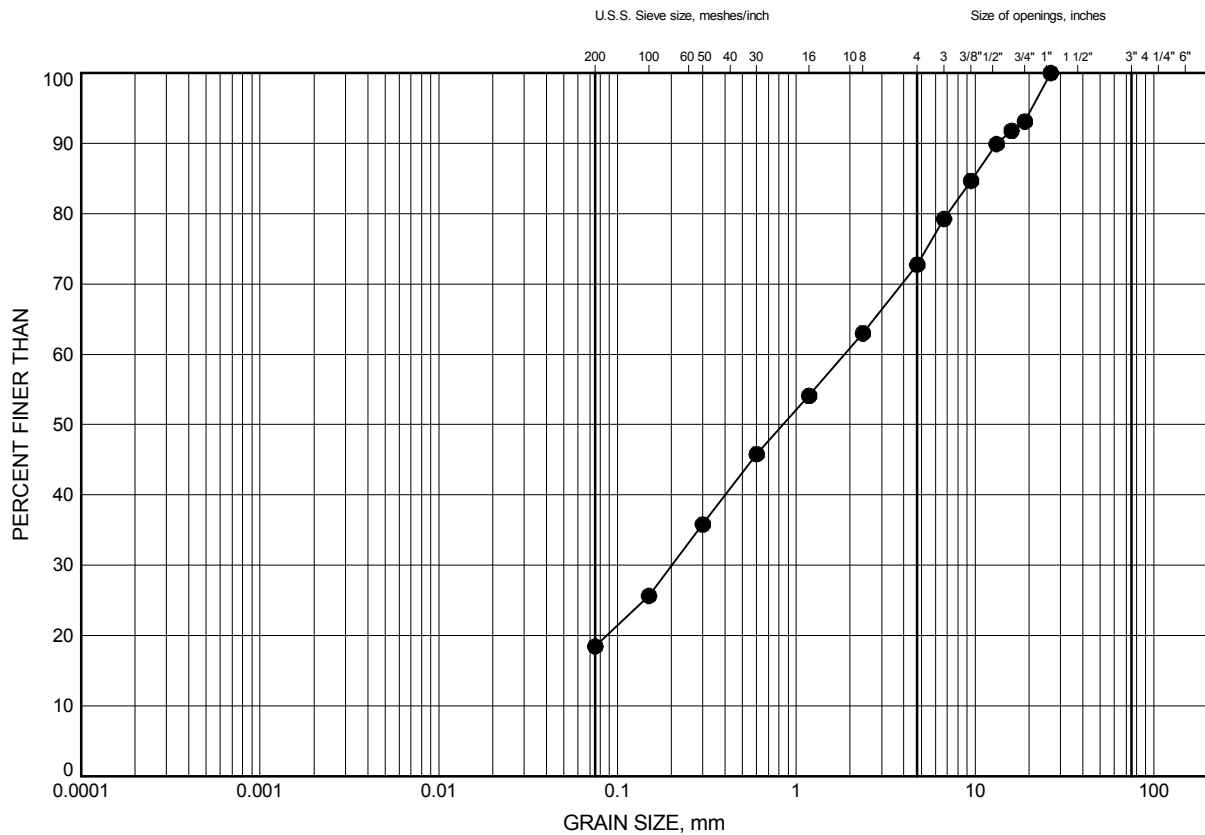
GLACIAL TILL

The results of grain size distribution testing conducted on one sample of the glacial till are summarized below and are illustrated on Figure C4 in Appendix C.

| Soil Particle | Percentage (%) |
| Gravel | 27 |
| Sand | 54 |
| Silt | 19 |

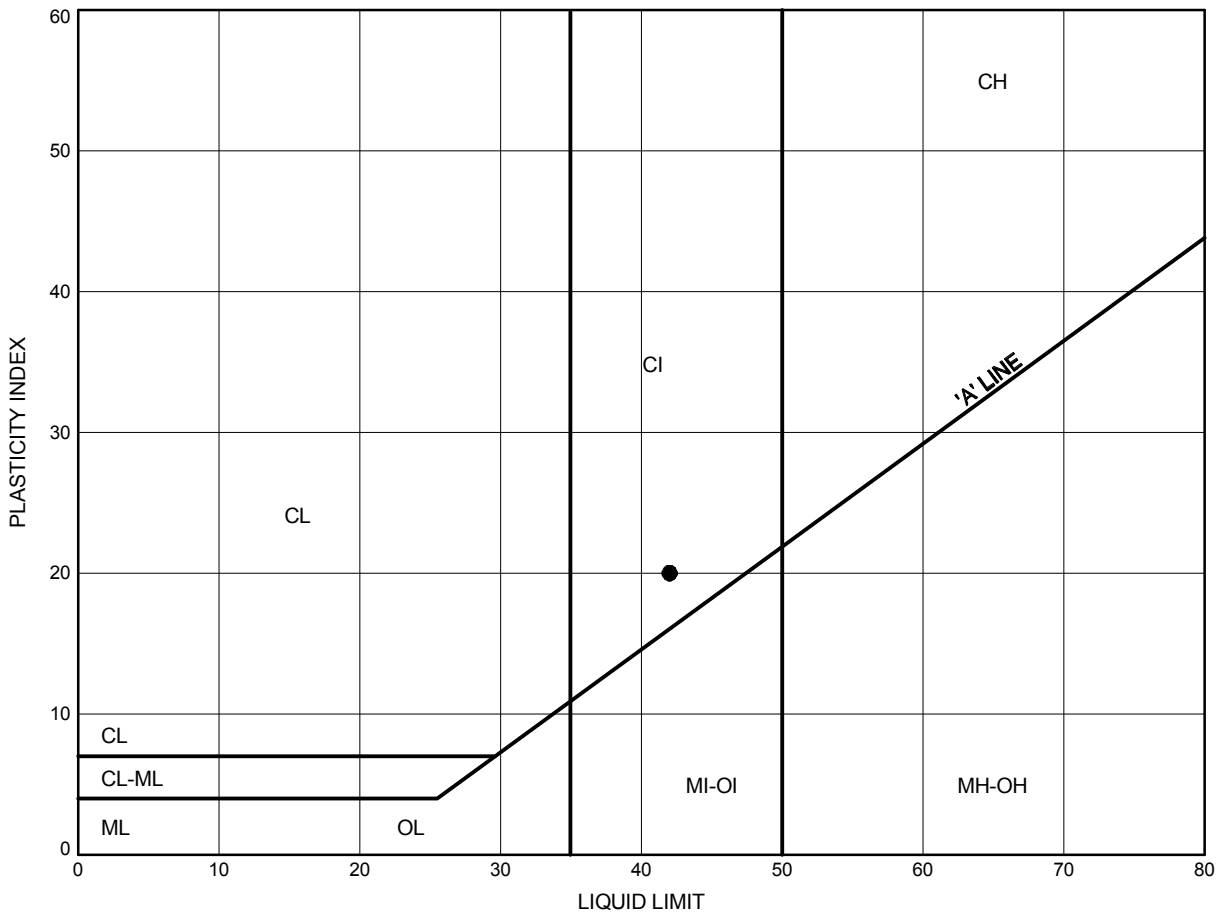
FIGURE C5

Atterberg Limit testing was completed on one sample of the clay. The results are summarized on the Record of Borehole sheets in Appendix B and on Figure C5 in Appendix C. The laboratory results are summarized below and indicate that the clay is of intermediate plasticity (CI).

| Parameter | Value |
| Liquid Limit | 42 |
| Plastic Limit | 22 |
| Plasticity Index | 20 |

Nicholas Street Interchange Camera Replacement
ATTERBERG LIMITS TEST RESULTS

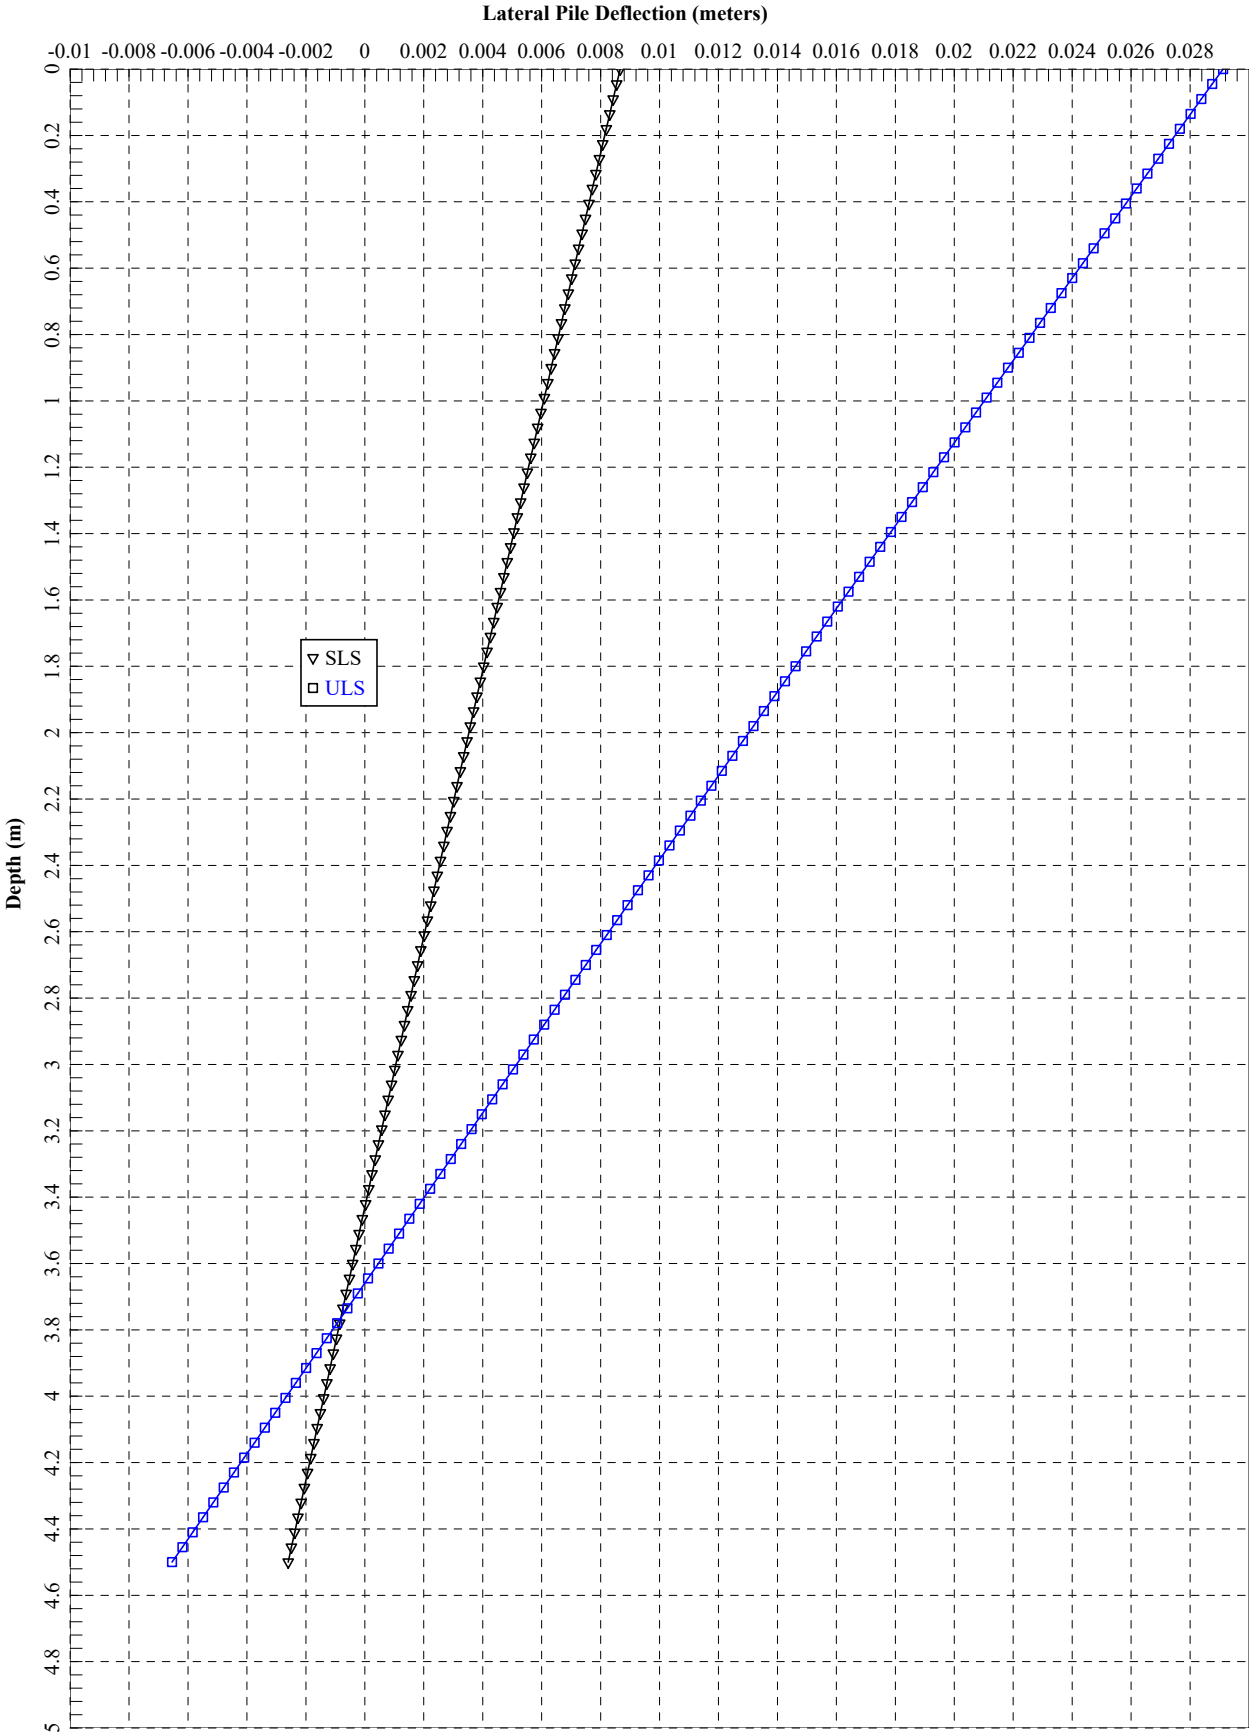
Figure D-1

The LPILE output graphs for shear, moment, deflection, and soil reaction are provided in Appendix D.
