**FOUNDATION INVESTIGATION REPORT
CAMERA POLE RELOCATION
HIGHWAY 417 NICHOLAS STREET INTERCHANGE
OTTAWA, ONTARIO**

GWP 4048-11-00

Geocres No.: 31G5-298

January 2019
Thurber File: 17532

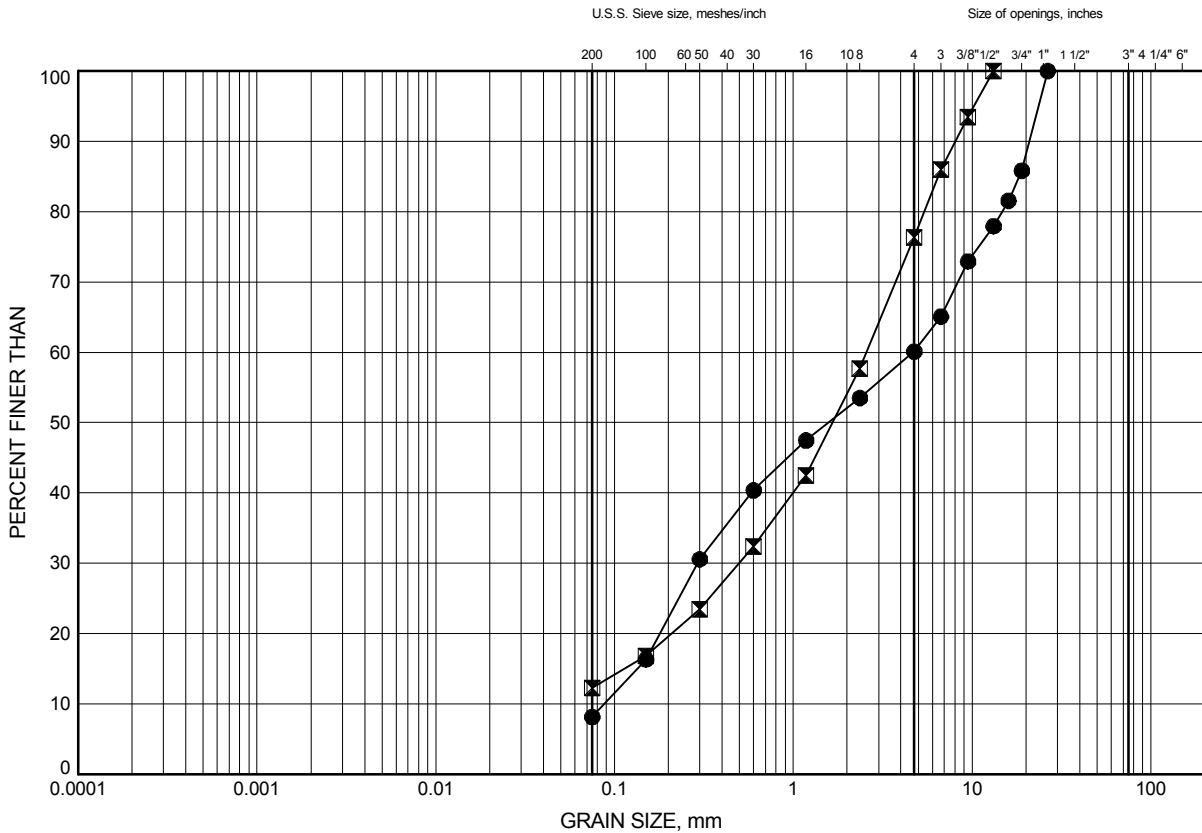
FILL

The results of grain size distribution testing conducted on two samples of the fill are summarized below and are illustrated on Figure C1 in Appendix C.

Soil Particle	Percentage (%)
Gravel	24 – 40
Sand	52 – 64
Silt	8 – 12
Clay

Fill was present below the topsoil. The fill was composed of sand with silt and gravel and contained waste debris (e.g., brick, coal, organics, wood, ash, and glass). The fill was 4.0 m thick with a base elevation of 55.8 m. The fill was generally brown in colour from 0.2 to 3.0 m depth and was brown-black from 3.0 to 4.2 m depth.

The SPT tests conducted in the fill gave N-values ranging from 1 to 23 blows, indicating a very loose to compact state of packing.

The recorded moisture contents of the fill ranged from 14 to 105%, increasing with depth.

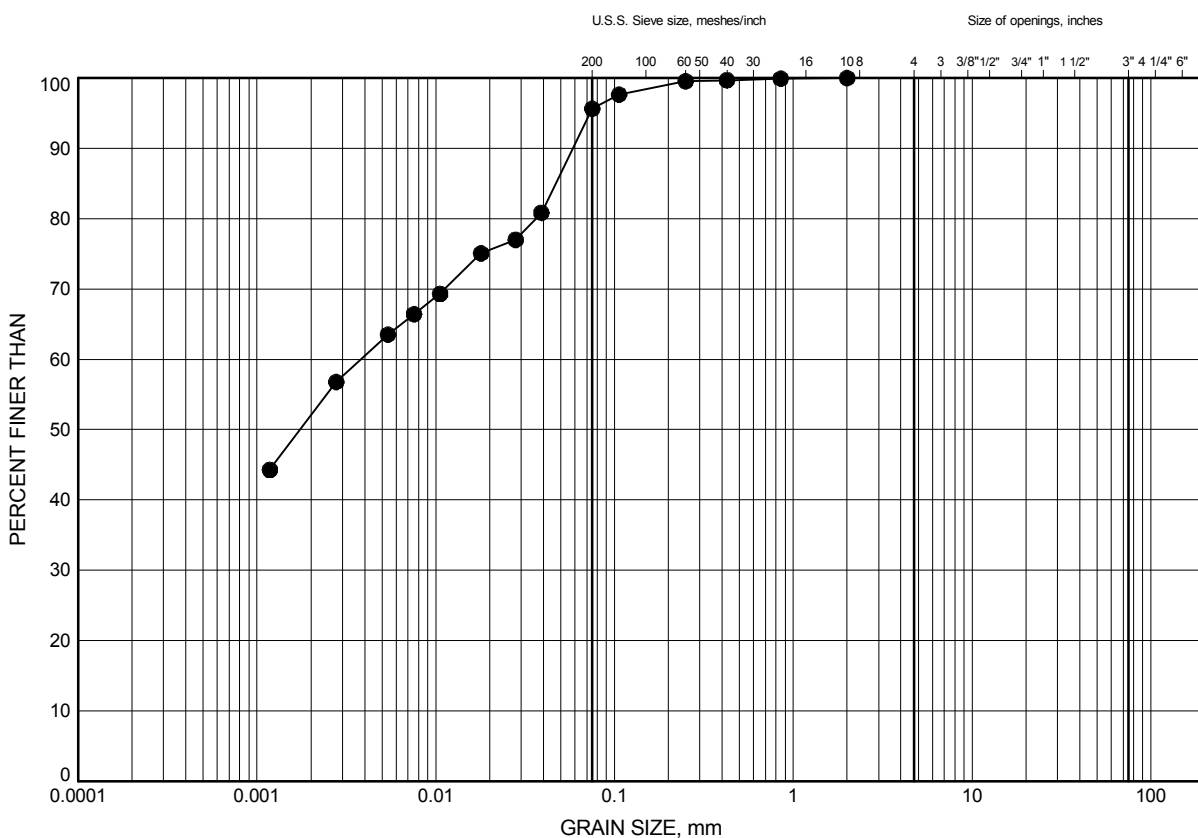
CLAY

The results of grain size distribution testing conducted on one sample of the clay are summarized below and are illustrated on Figure C2 in Appendix C.

Soil Particle	Percentage (%)
Gravel	0
Sand	4
Silt	44
Clay	52

A native deposit of sensitive marine clay was present below the silty sand. The clay was grey in colour and was 3.3 m thick with a base elevation of 52.1 m.

One SPT test conducted in the clay gave an N-value of 2 blows. Field vane tests were performed within the deposit and recorded undrained shear strengths ranging from 47 to 87 kPa, indicating a firm to stiff consistency. Remoulded field vane testing in the clay indicates a sensitive to extra-sensitive soil based on criteria provided in the Canadian Foundation Engineering Manual.

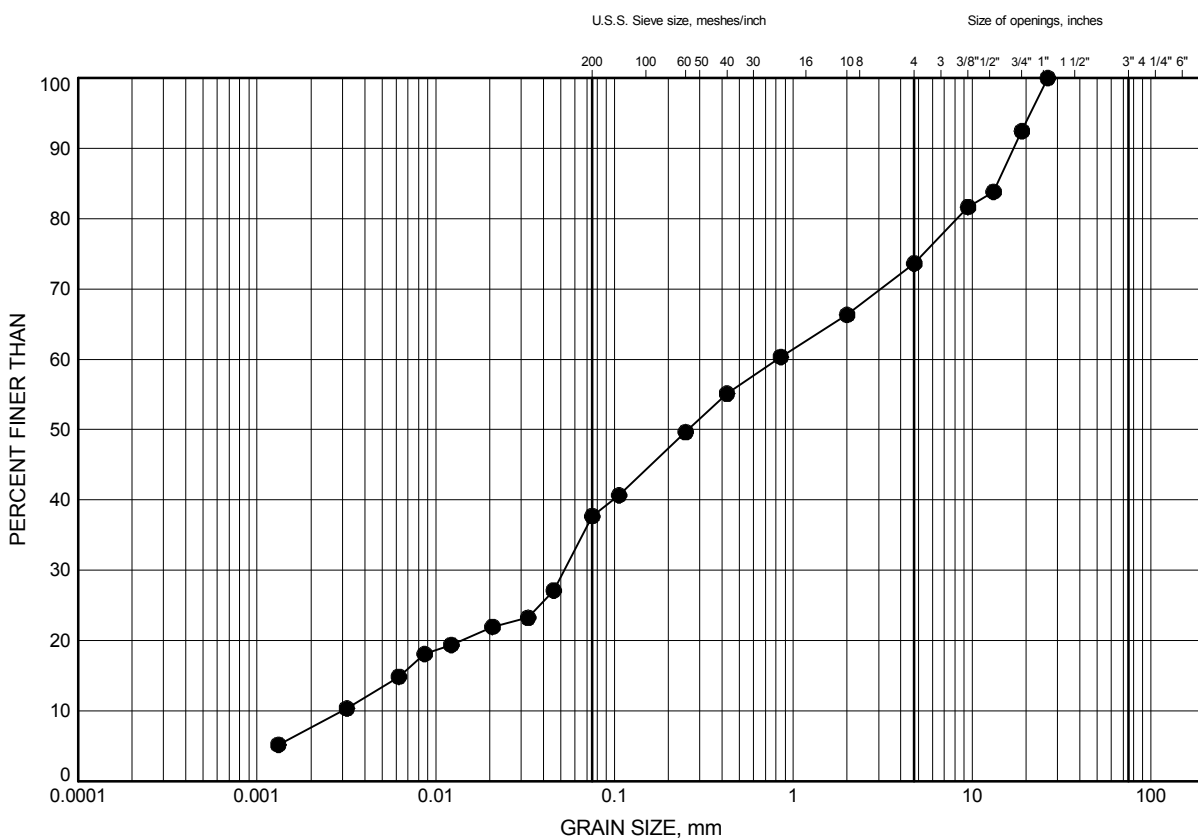
SANDY SILT WITH GRAVEL

The results of grain size distribution testing conducted on one sample of the sandy silt with gravel are summarized below and are illustrated on Figure C3 in Appendix C.

Soil Particle	Percentage (%)
Gravel	26
Sand	36
Silt	30
Clay	8

A native deposit of sandy silt with gravel (a transitional layer between the silt and underlying glacial till) was present below the silt. The sandy silt with gravel was 1.1 m thick with a base elevation of 50.2 m.
