FOUNDATION INVESTIGATION REPORT

Harris Creek Culvert - Site 44X-0289/C0 Highway 124, 11.2 km East of Highway 400 MTO GWP 5119-13-00, WP 5124-13-01

1776446-R02-REV1

January 21, 2020

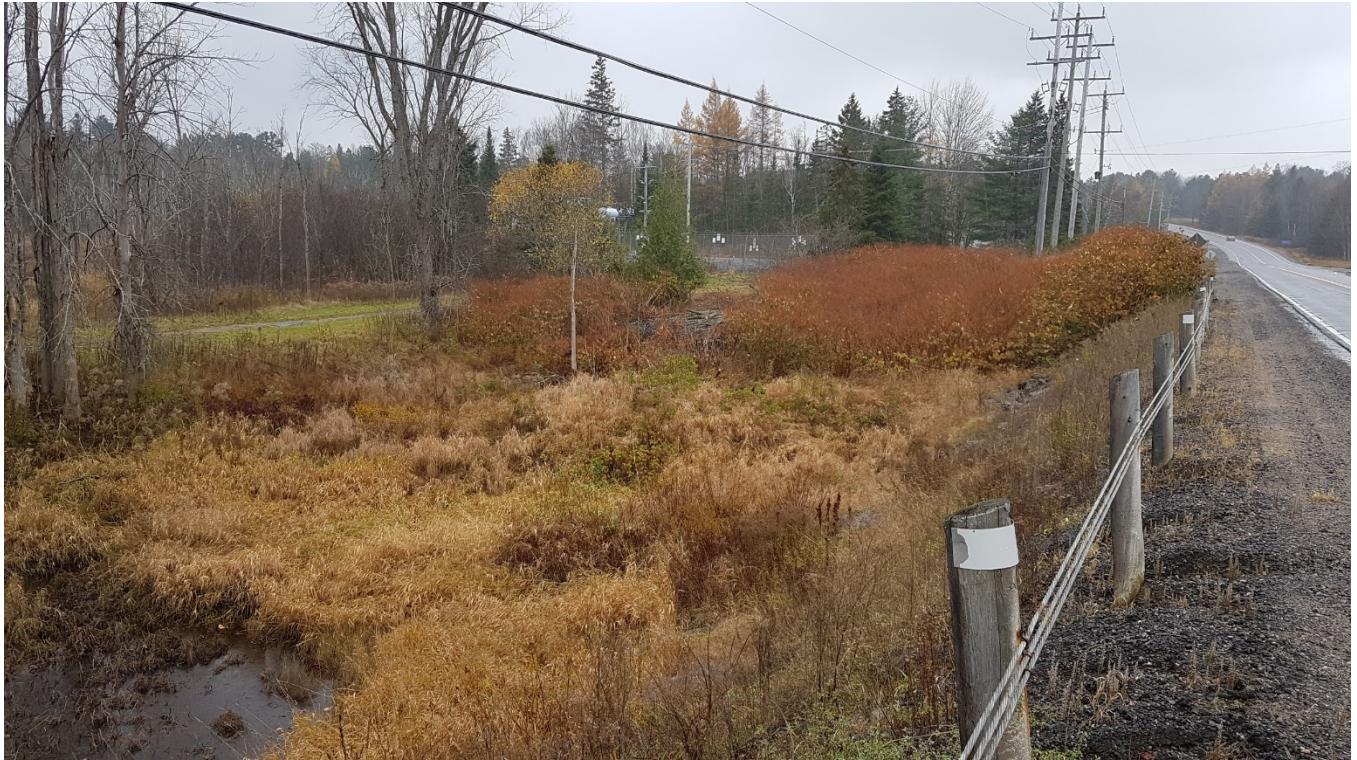
Photograph 1: Harris Creek Culvert – Hwy 124 – Looking West from South (Outlet) End of Culvert (November 2017)

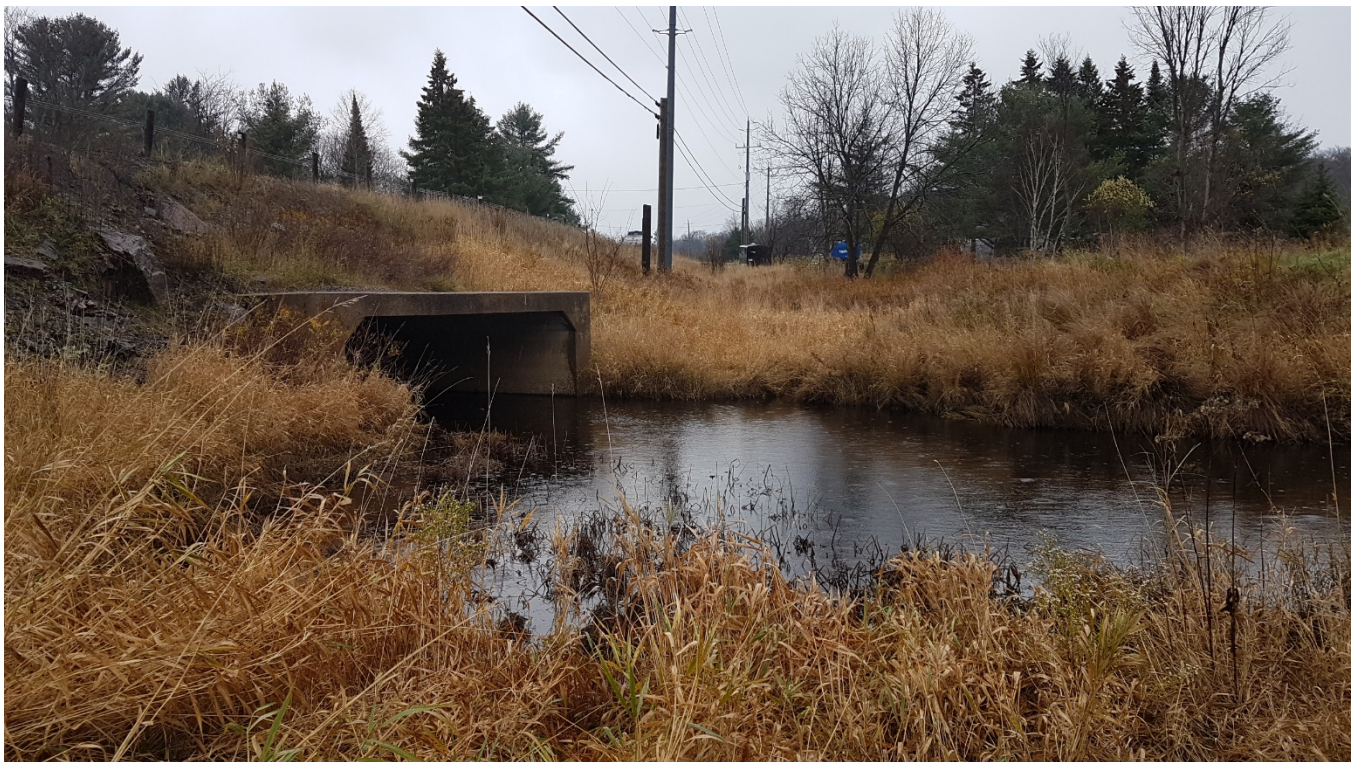
Photograph 2: Harris Creek Culvert – Hwy 124 – Looking at South (Outlet) End of Culvert (November 2017)

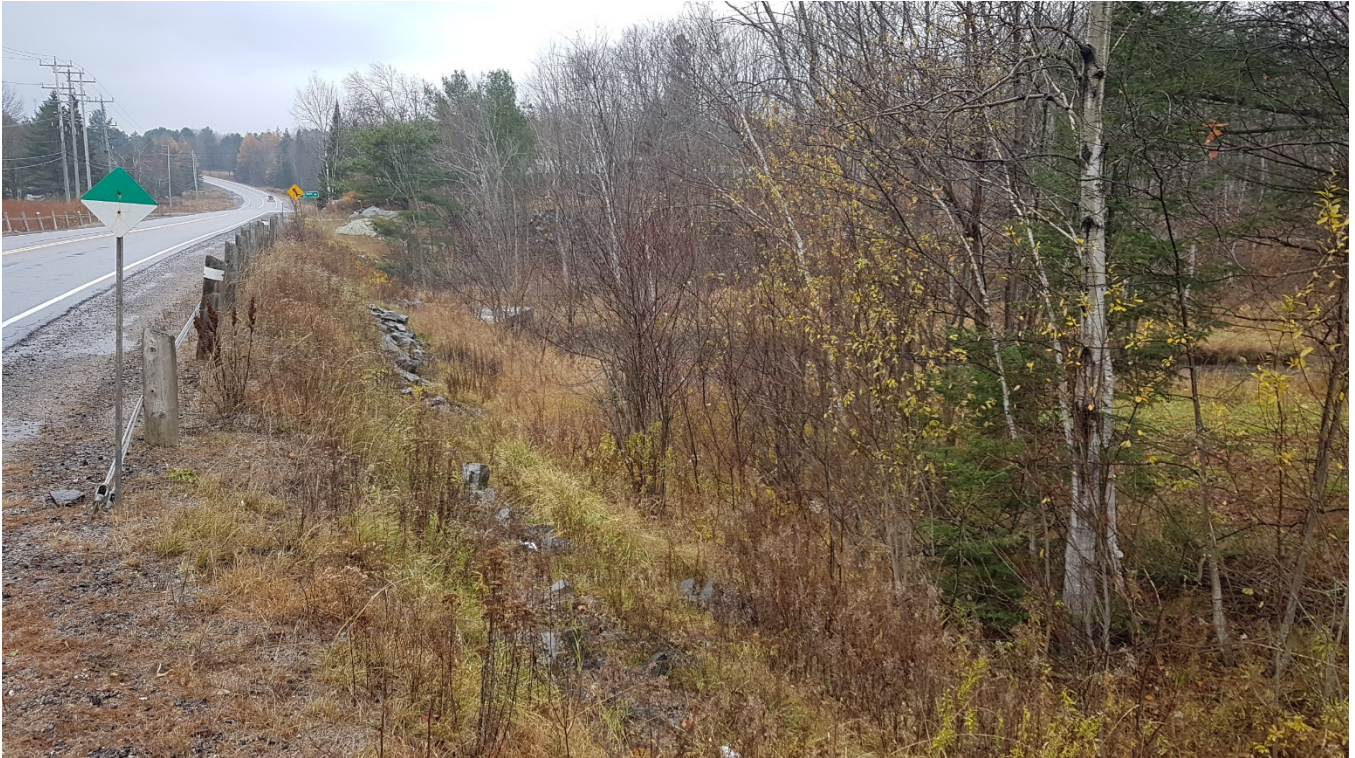
Photograph 3: Harris Creek Culvert – Highway 124, Looking West at North (Inlet) End of Culvert (November 2017)

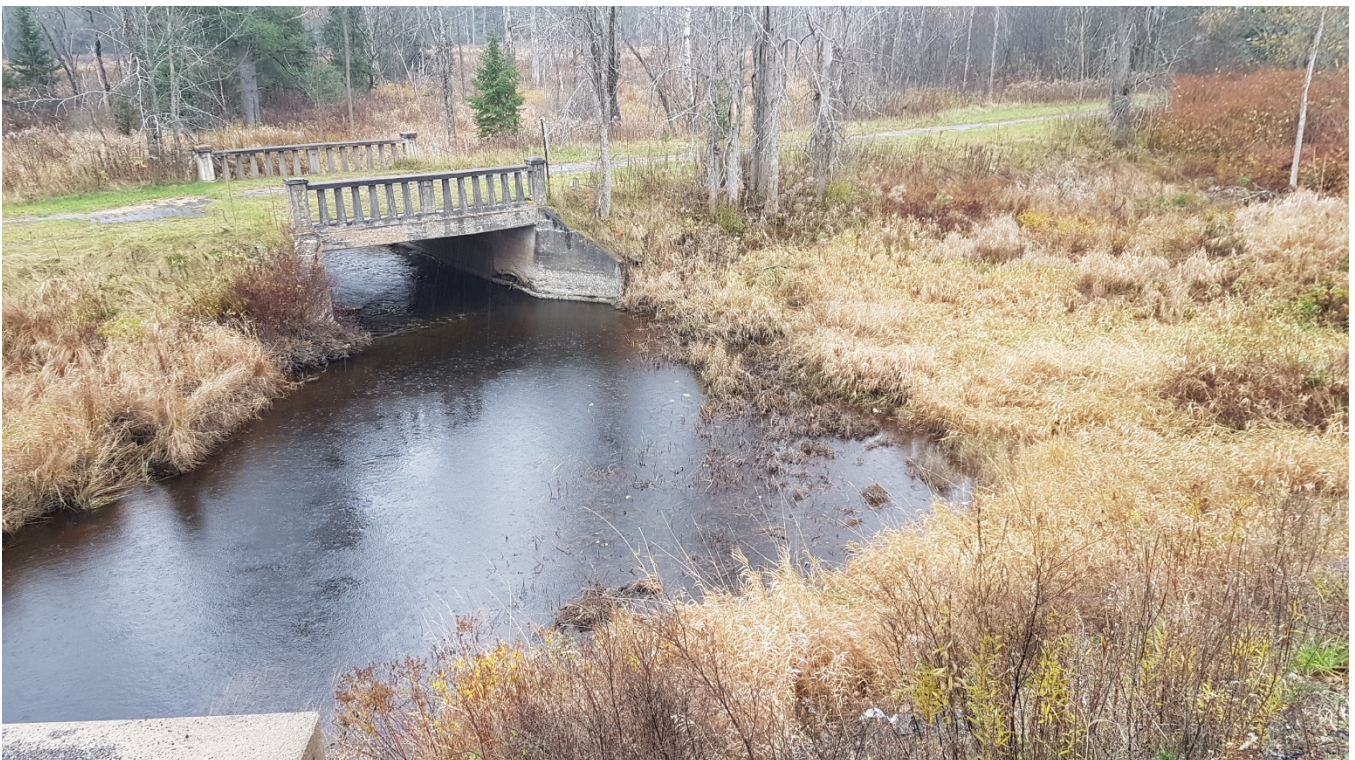
Photograph 4: Harris Creek Culvert – Highway 124, Looking South from Outlet End of Culvert (November 2017)
