**FINAL**  
**FOUNDATION INVESTIGATION REPORT**  
**HIGHWAY 118 CULVERT STA. 18+245, OAKLEY TOWNSHIP**  
**ASSIGNMENT NO. 5017-E-0003**  
**G.W.P. 5287-14-00**

Geocres No.: 31E-398

August 2019  
Thurber File No.: 20244

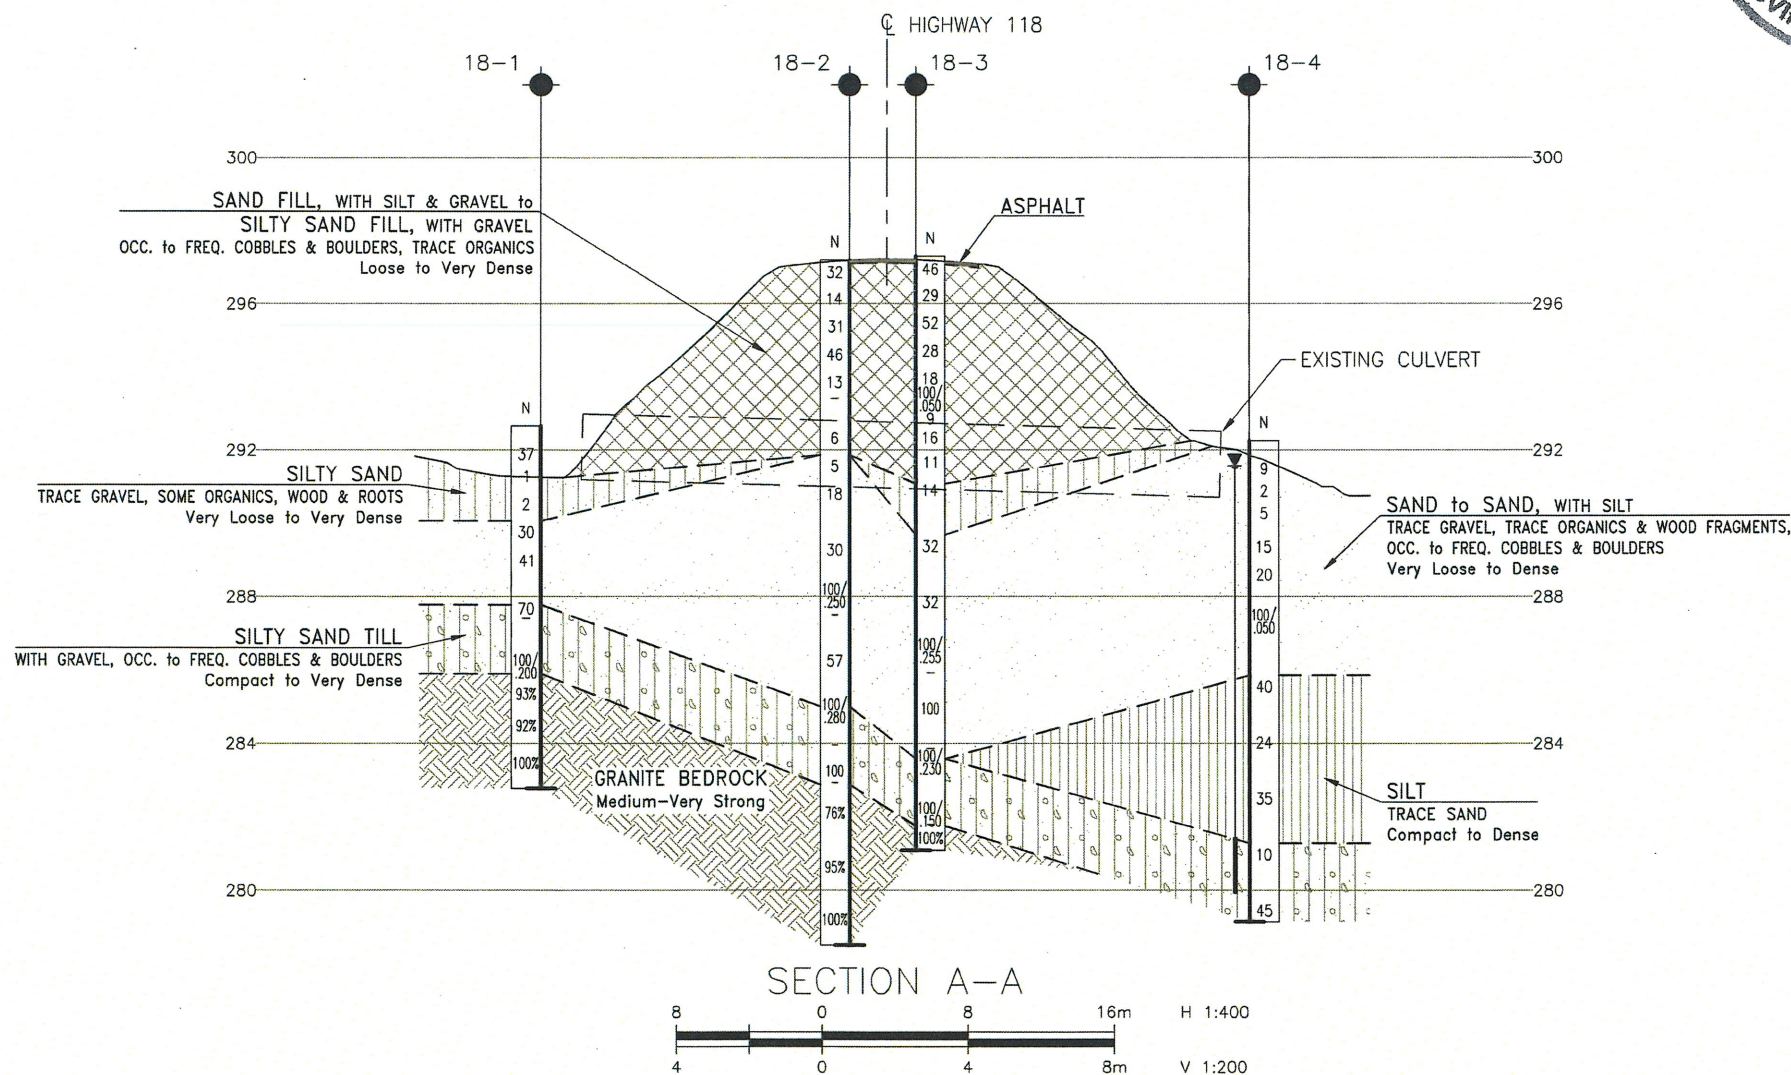
HIGHWAY 118  
STATION 18+245  
CULVERT REPLACEMENT  
BOREHOLE LOCATIONS AND SOIL STRATA

The northing, easting and elevation of the boreholes are shown on the Borehole Location and Soil Strata Drawing No. 1 in Appendix A, the individual Record of Borehole sheets in Appendix B and in Table 3-1. The termination depth of each of the boreholes are also provided, below. The site is within MTM Zone 10. The borehole elevations were surveyed with a Nikon-AP-8 with an accuracy of +/- 1.5 mm. The survey referenced the top of the south end of the culvert, which has an elev. 292.544 m, as provided by MPCE. Horizontal locations were measured relative to existing site features.

Details of the encountered soil stratigraphy are presented on the Record of Borehole sheets included in Appendix B and the Borehole Location and Soil Strata drawing included in Appendix A. A general description of the stratigraphy, based on the conditions encountered in the boreholes, is given in the following paragraphs. However, the factual data presented on the Record of Borehole sheets takes precedence over this general description for interpretation of the site conditions. It must be recognized that the soil and groundwater conditions may vary between and beyond borehole locations.

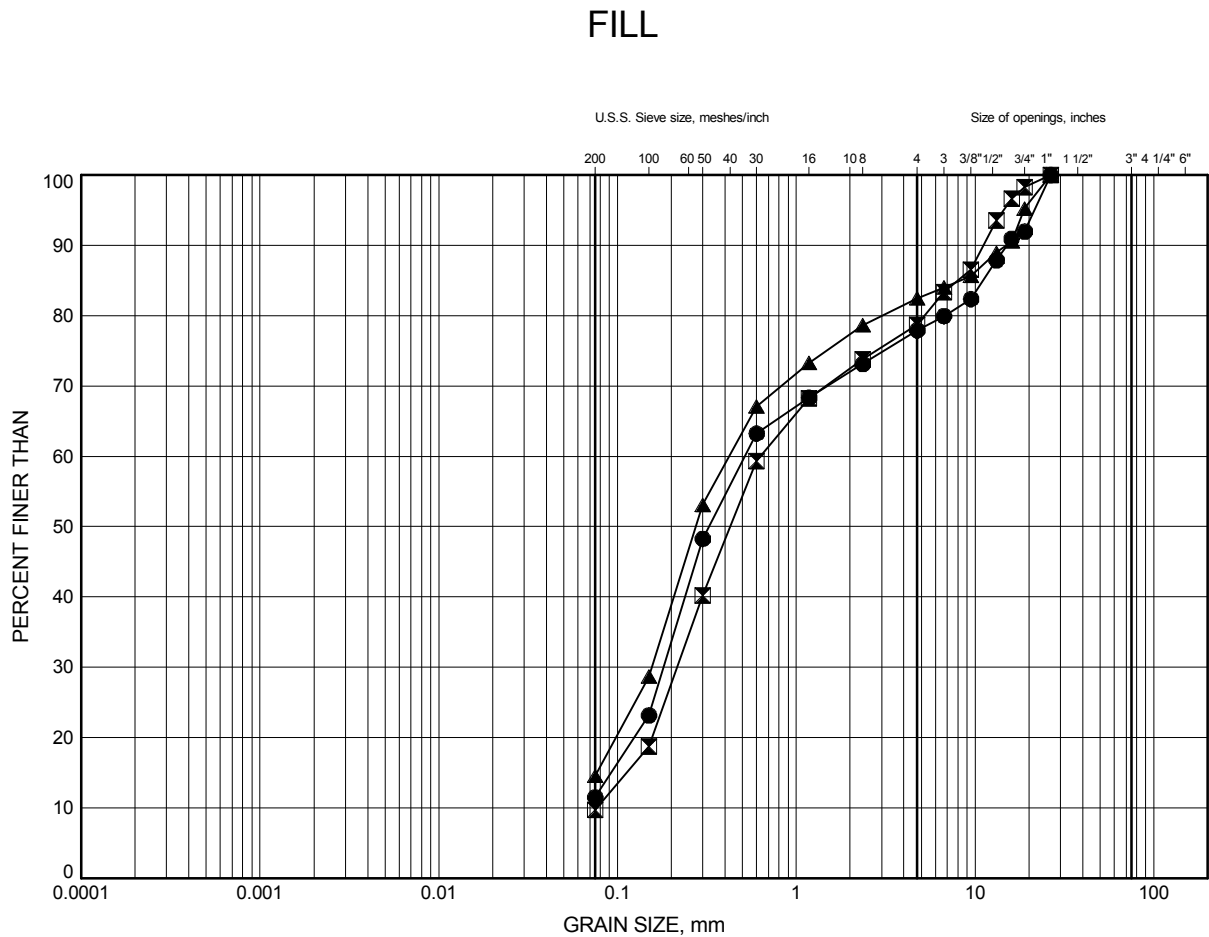
FIGURE C1

# HWY 118 Culverts Station 18+245 GRAIN SIZE DISTRIBUTION

Recorded moisture contents ranged from 5 to 15%. The results of grain size analyses conducted on two samples of the sand fill are summarized below and are provided on the Record of Borehole sheets in Appendix B and illustrated on Figure C1 in Appendix C.

Recorded moisture contents ranged from 13 to 22%. The results of a grain size analysis conducted on one sample of the silty sand fill indicated this material to consist of 18% gravel, 68% sand and 14% fines. These results are provided on the Record of Borehole sheet in Appendix B and are also illustrated on Figure C1 in Appendix C.

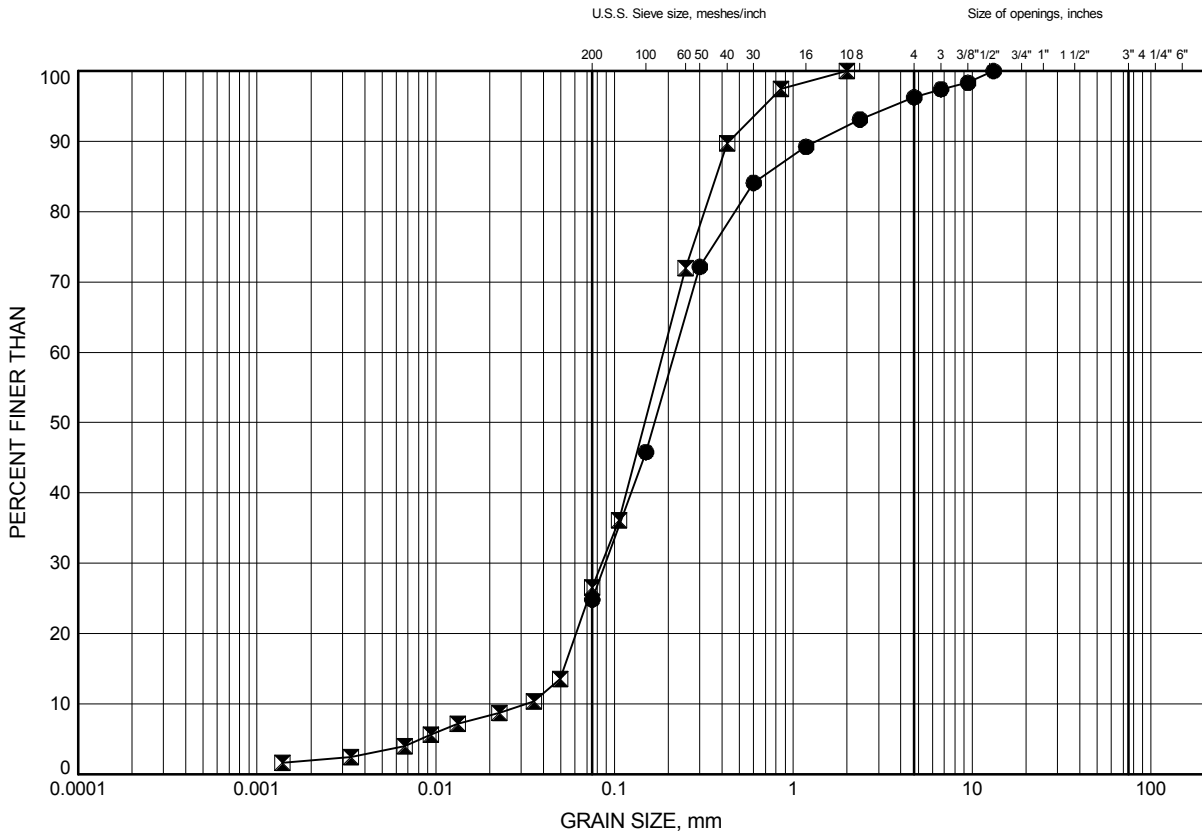
FIGURE C2

## SILTY SAND (SM)

Recorded moisture contents of the silty sand typically ranged from 23 to 35%. The results of grain size analyses conducted on two samples of the silty sand are summarized below and are illustrated on Figure C2 in Appendix C.

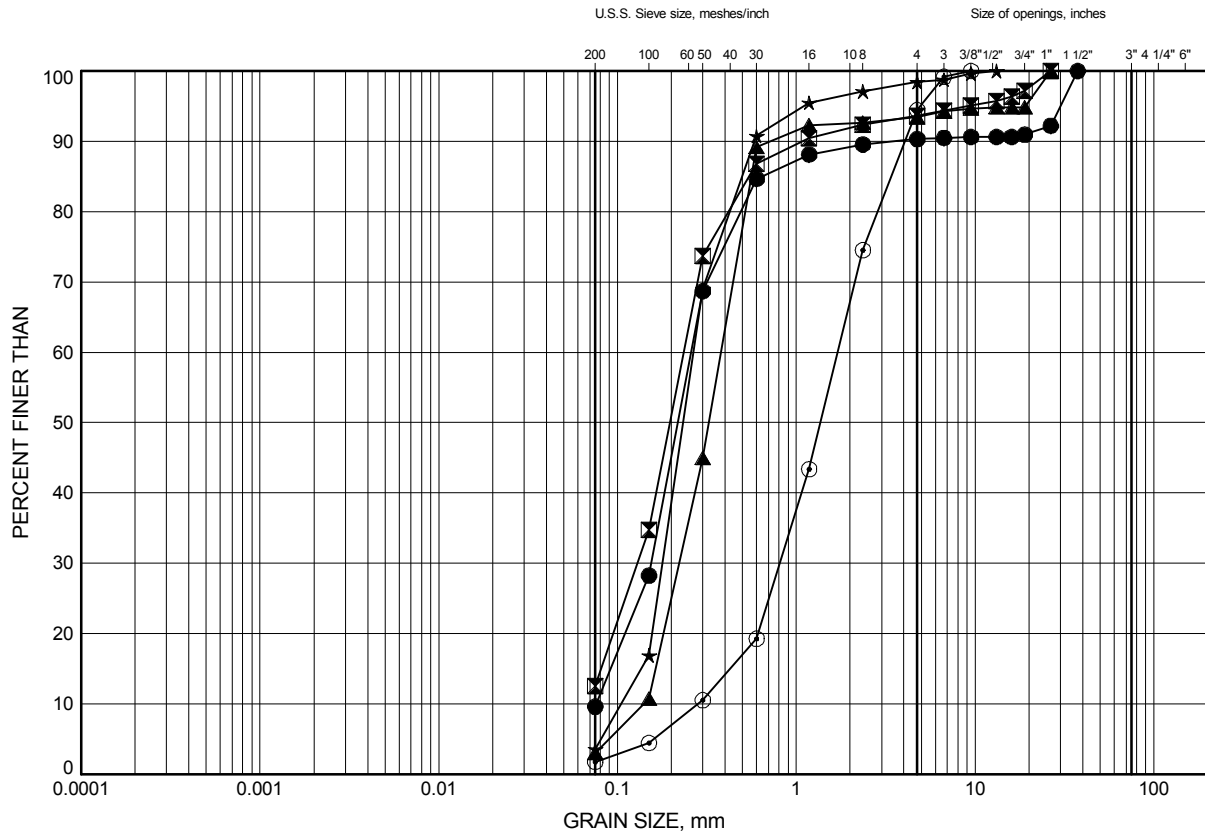
FIGURE C3

### SAND (SP to SP-SM)

The moisture content of the samples tested typically ranged from 10 to 40% with a single moisture content of 71% recorded in Borehole 18-4. The results of grain size analyses conducted on five samples of the sand are summarized below and are illustrated on Figure C3 in Appendix C.

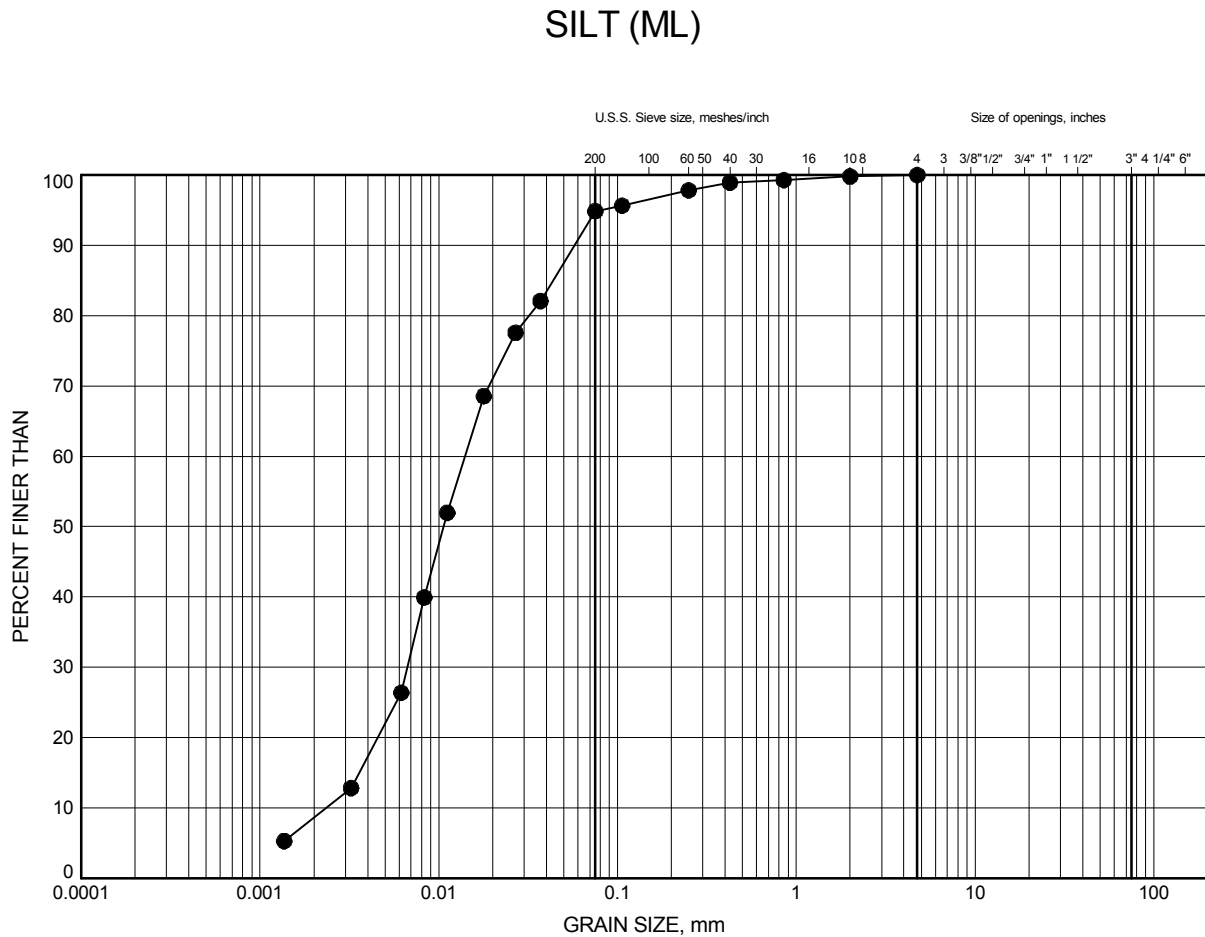
FIGURE C4

# HWY 118 Culverts Station 18+245 GRAIN SIZE DISTRIBUTION

Recorded moisture contents ranged from 22 to 27%. The results of a grain size analysis conducted on one sample of the silt indicated this material to consist of 0% gravel, 5% sand, 86% silt and 9% clay. These results are provided on the Record of Borehole sheet in Appendix B and are illustrated on Figure C4 in Appendix C.

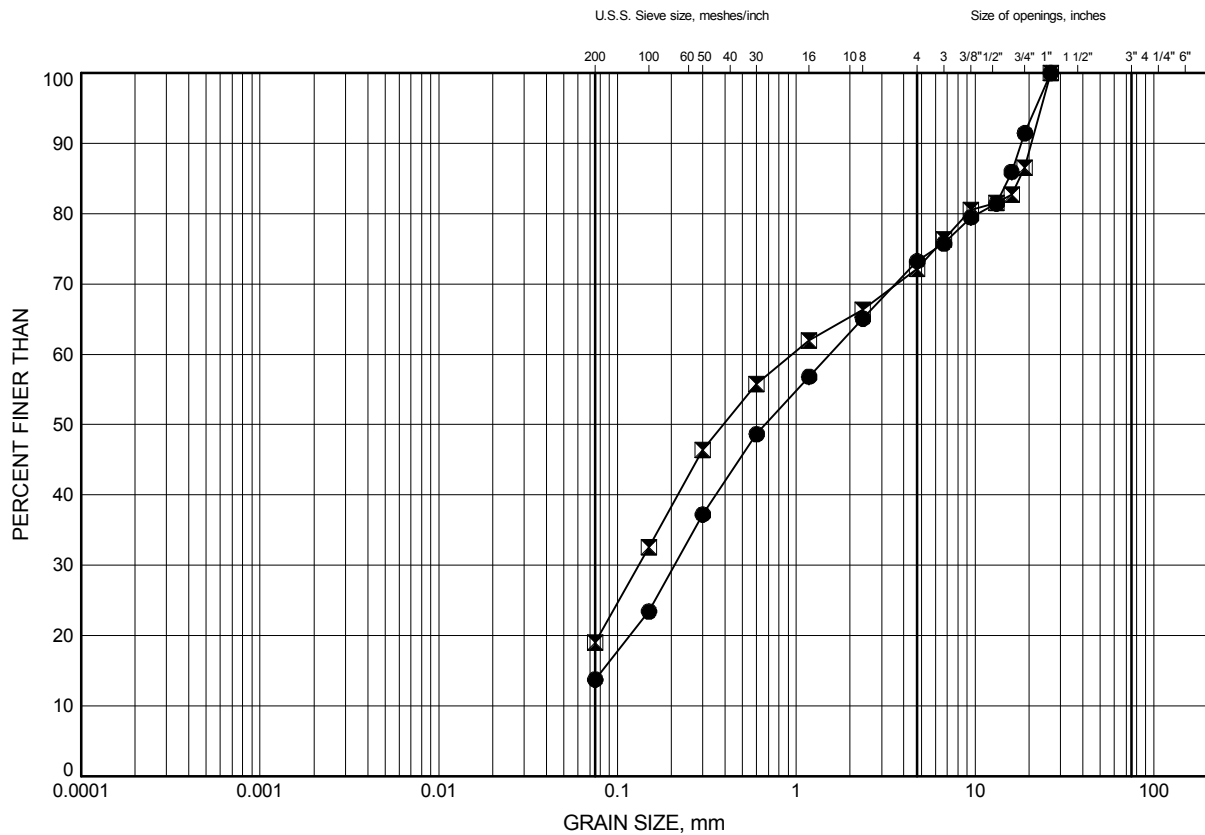
FIGURE C5

## SILTY SAND (SM) with gravel (GLACIAL TILL)

Recorded moisture contents of the till typically ranged from 6 to 13%. The result of grain size analyses conducted on two samples of the till are summarized below and are provided on the Record of Borehole sheets in Appendix B and are illustrated on Figure C5 in Appendix C.

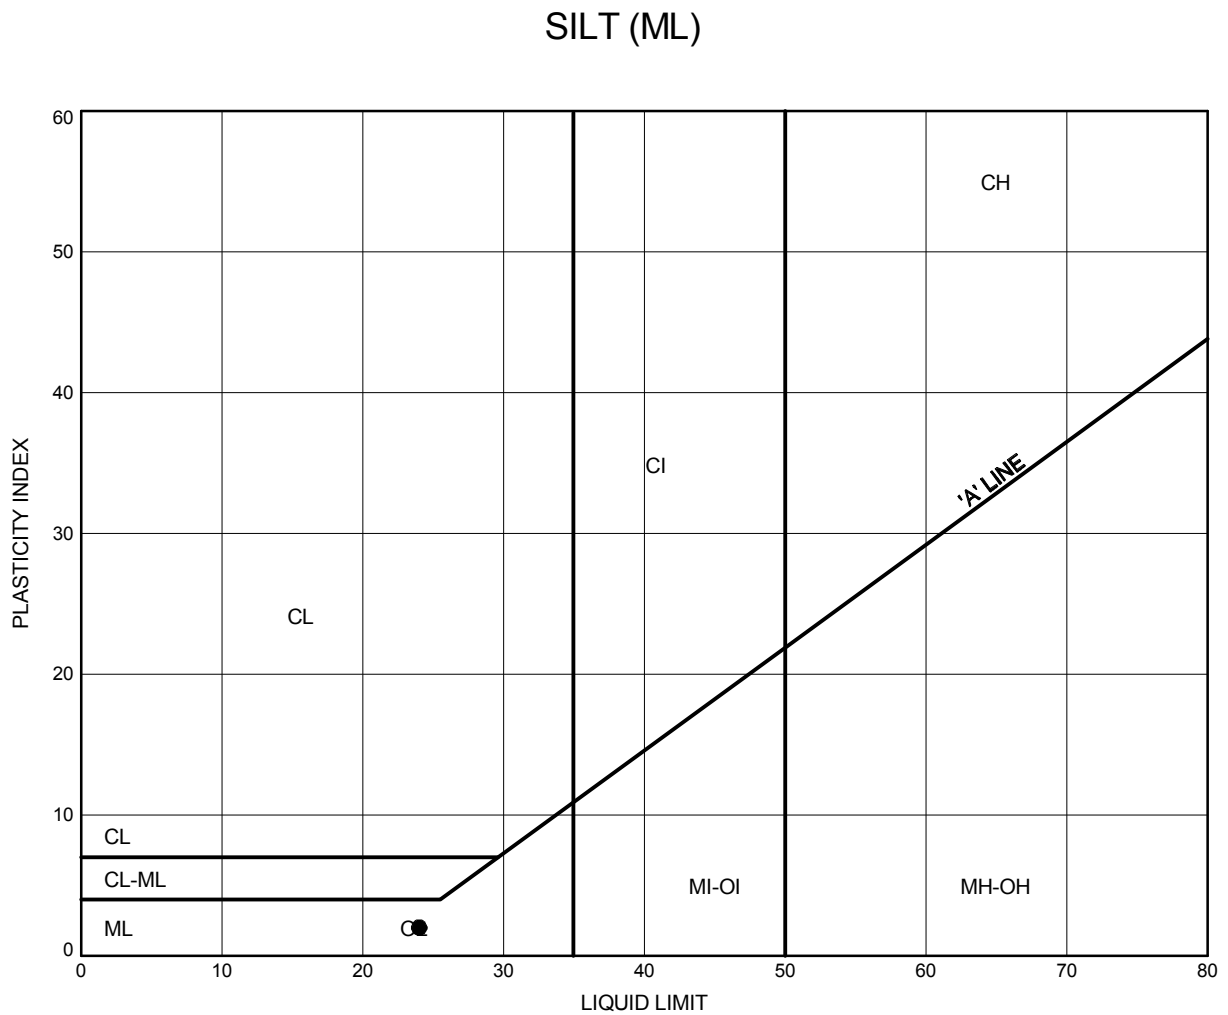
FIGURE C6

# ATTERBERG LIMITS TEST RESULTS

SYMBOL	BOREHOLE	DEPTH (m)	ELEV. (m)
●	18-4	9.3	282.5

An Atterberg Limit test was completed on one sample and the results indicated the silt to exhibit low plasticity (ML) with a liquid limit of 24, a plasticity limit of 22 and a plasticity index of 2. The results are illustrated on Figure C6 in Appendix C.

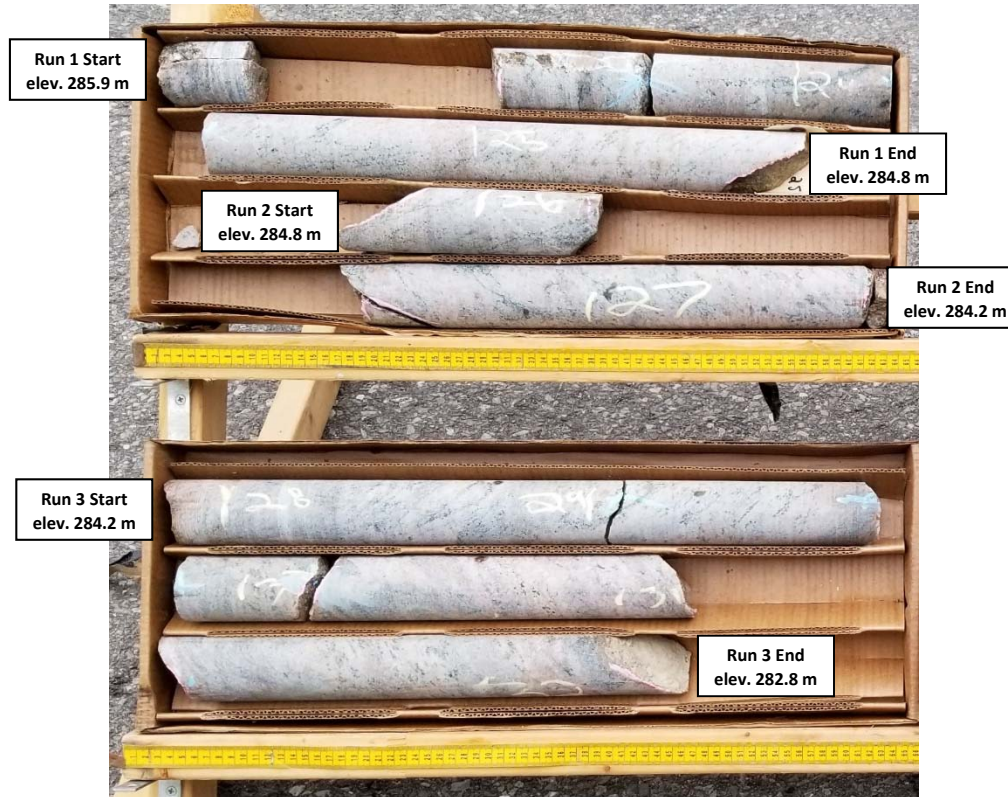
**Borehole 18-1**  
**Run 1 to 3 (of 3)**  
**Elevation 285.9 m to 282.8 m**

The bedrock core samples consisted of slightly weathered to fresh granite. The Total Core Recovery (TCR) from all core samples was 100%, the Solid Core Recovery (SCR) ranged from 56 to 100% and the Rock Quality Designation (RQD) ranged from 76 to 100%. Based on the measured RQD values, the bedrock is classified as good to excellent in quality (Table 3.10, Canadian Foundation and Engineering Manual 2006).

Photographs of the bedrock core are provided in Appendix C. The intact granite bedrock is predominantly medium to very strong. Photographs of the bedrock core are provided in Appendix C.

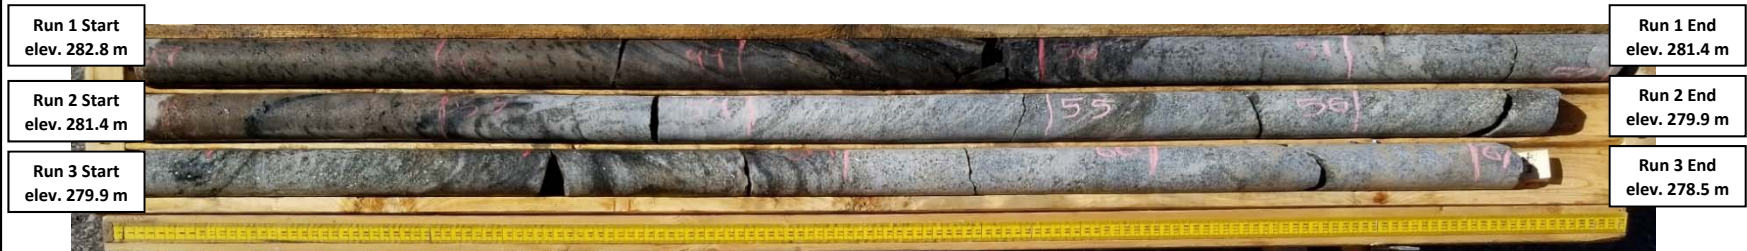
**Borehole 18-2**  
**Run 1 to 3 (of 3)**  
**Elevation 282.8 m to 278.5 m**

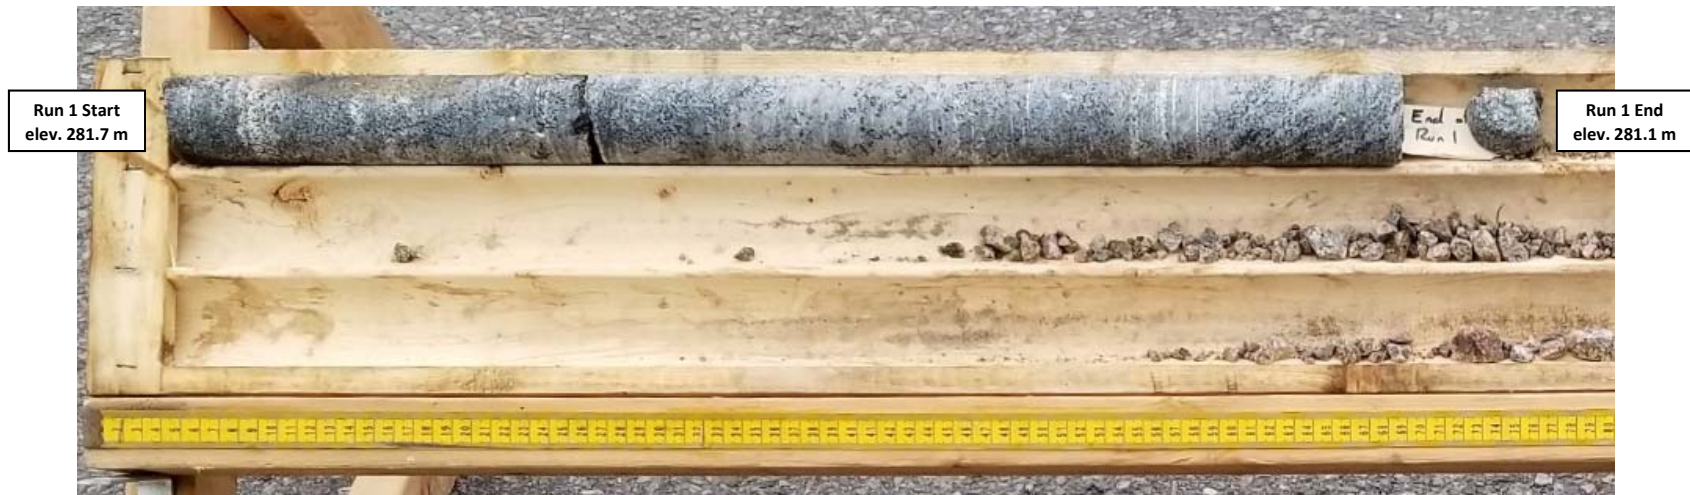
**Borehole 18-3**  
**Run 1 to 1 (of 1)**  
**Elevation 281.7 m to 281.1 m**

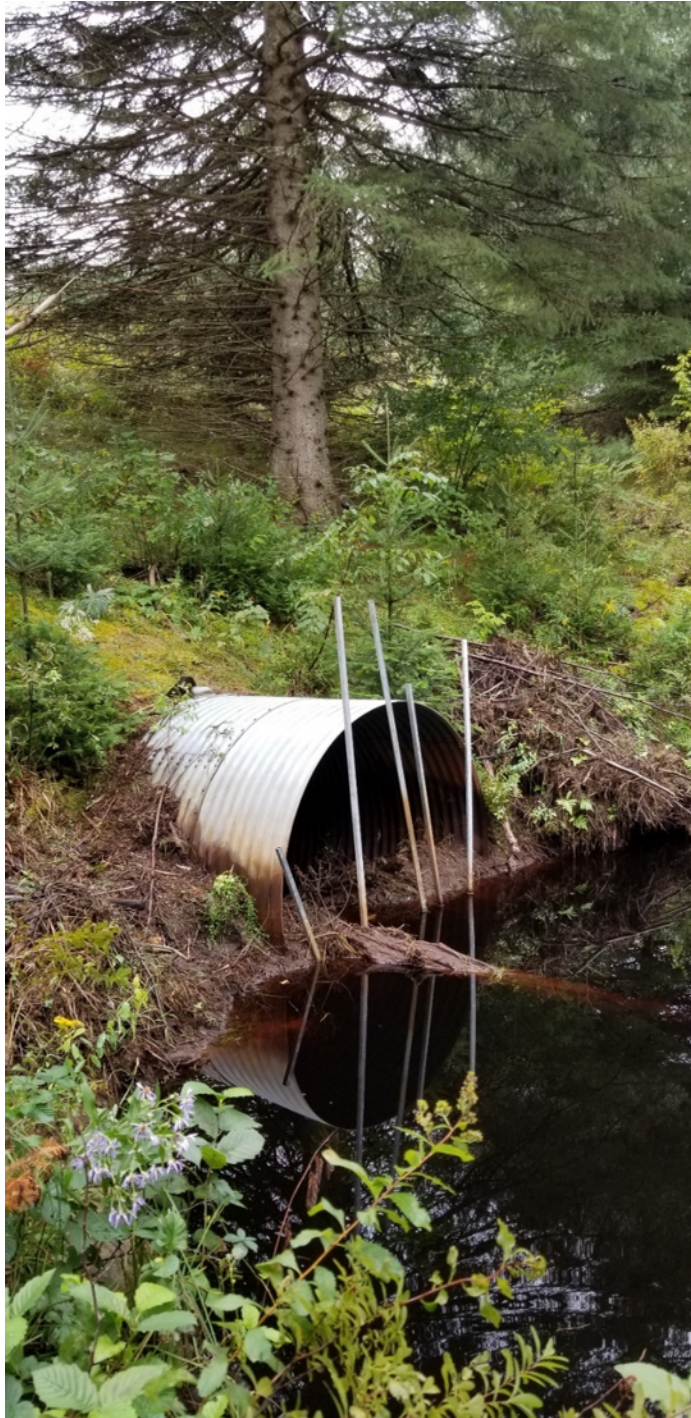
Photo 2. Looking Southwest at Culvert 18+245 Inlet (2018/09/11)

The existing culvert conveys (unnamed) creek flow from the north to the south under a high fill embankment supporting Highway 118. As shown on the base plan drawings provided by MPCE, the existing culvert is a non-structural corrugated steel plate (SPCSP) culvert with a diameter of 1.8 m. The length of the culvert is 36.6 m and the inverts of the culvert are shown at elevation 291.1 and 290.7 m at the inlet (north) and outlet (south), respectively. No signs of erosion or slope instability were noted on the existing highway embankments during the field investigation. The roadway surface over the culvert was generally in good condition with no dips or bumps noted during the field investigation. The existing culvert, as assessed by MPCE, showed minor signs of corrosion and had significant sediment deposits inside.

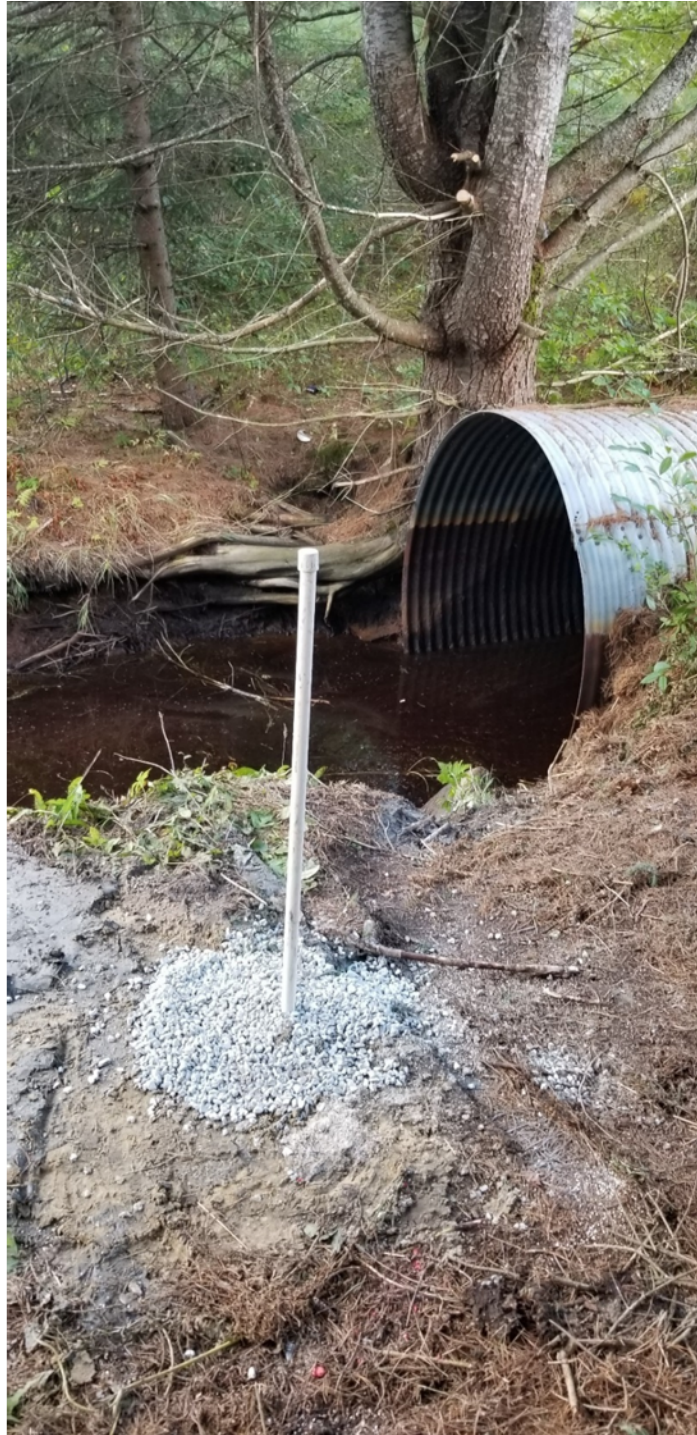
**Photo 5. Looking west at Culvert 18+245 Outlet with Piezometer 18-4 (2018/09/15)**

A 19 mm diameter standpipe piezometer was installed in Borehole 18-4 to allow for measurements of the groundwater level after completion of drilling. The piezometer installation details are illustrated on the respective Record of Borehole sheet provided in Appendix B. The boreholes were backfilled in accordance with MOE requirements (O.Reg. 903 as amended). Boreholes 18-2 and 18-3 were backfilled with granulars within the depth of pavement structure and capped with 150 mm of cold patch asphalt to reinstate the travelling surface.
