**FINAL**  
**FOUNDATION INVESTIGATION REPORT**  
**HIGHWAY 118 CULVERT STA. 18+550, DRAPER TOWNSHIP**  
**ASSIGNMENT NO. 5017-E-0003**  
**G.W.P. 5287-14-00**

Geocres No.: 31E-400

August 2019  
Thurber File No.: 20244

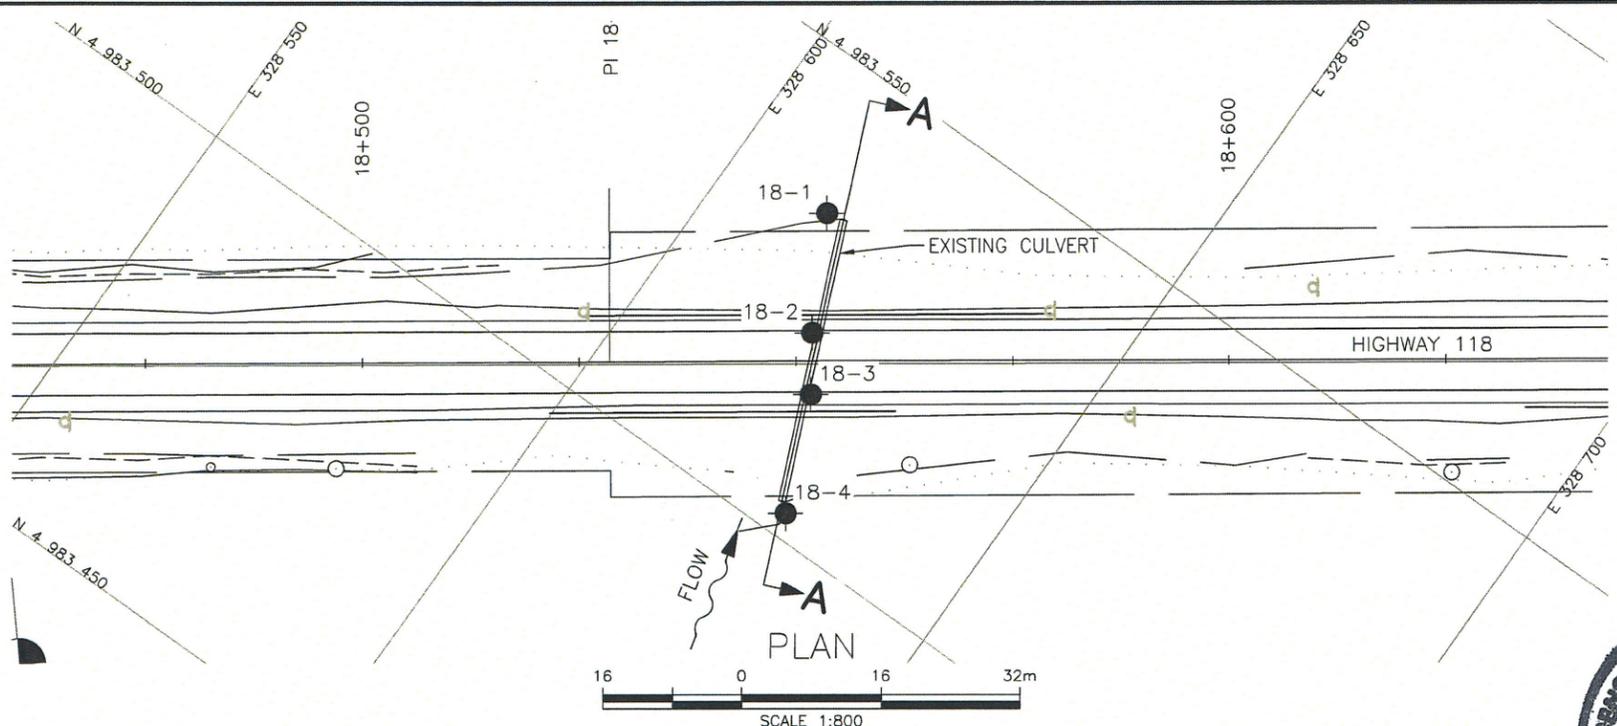
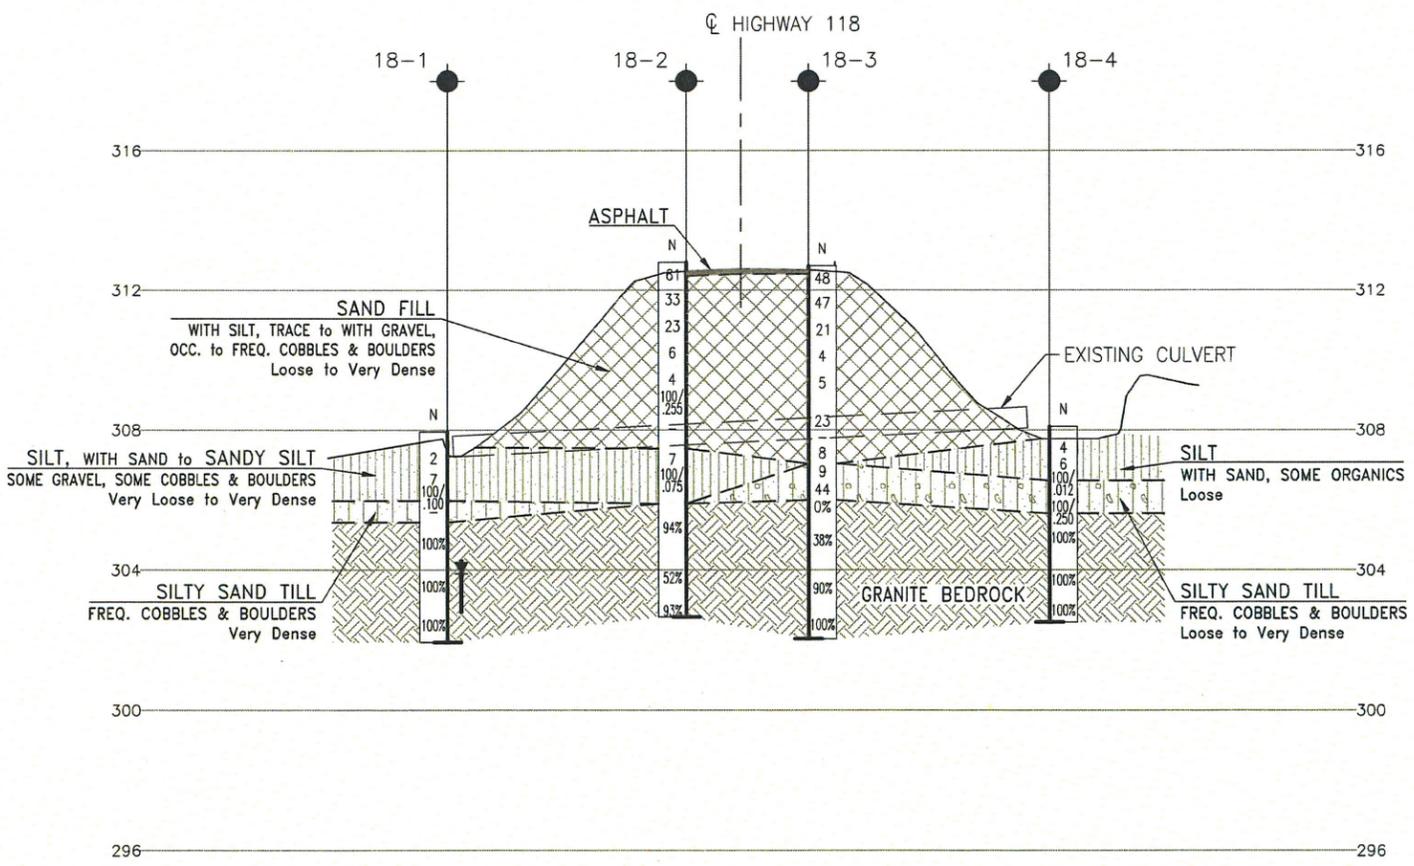
HIGHWAY 118  
STATION 18+550  
CULVERT REPLACEMENT  
BOREHOLE LOCATIONS AND SOIL STRATA

SECTION A-A

The northing, easting and elevation of the boreholes are shown on the Borehole Location and Soil Strata Drawing No. 1 in Appendix A, the individual Record of Borehole sheets in Appendix B and in Table 3-1. The termination depth of each of the boreholes are also provided, below. The site is within MTM Zone 10. The borehole elevations were surveyed with a Nikon-AP-8 with an accuracy of +/- 1.5 mm. The survey referenced Benchmark MTCBM 828005 (elev. 314.169 m) shown on the historical baseplan drawing provided by MPCE. Horizontal locations were measured relative to existing site features.

Details of the encountered soil stratigraphy are presented on the Record of Borehole sheets included in Appendix B and the Borehole Location and Soil Strata drawing included in Appendix A. A general description of the stratigraphy, based on the conditions encountered in the boreholes, is given in the following paragraphs. However, the factual data presented on the Record of Borehole sheets governs any interpretation of the site conditions. It must be recognized that the soil and groundwater conditions may vary between and beyond borehole locations.

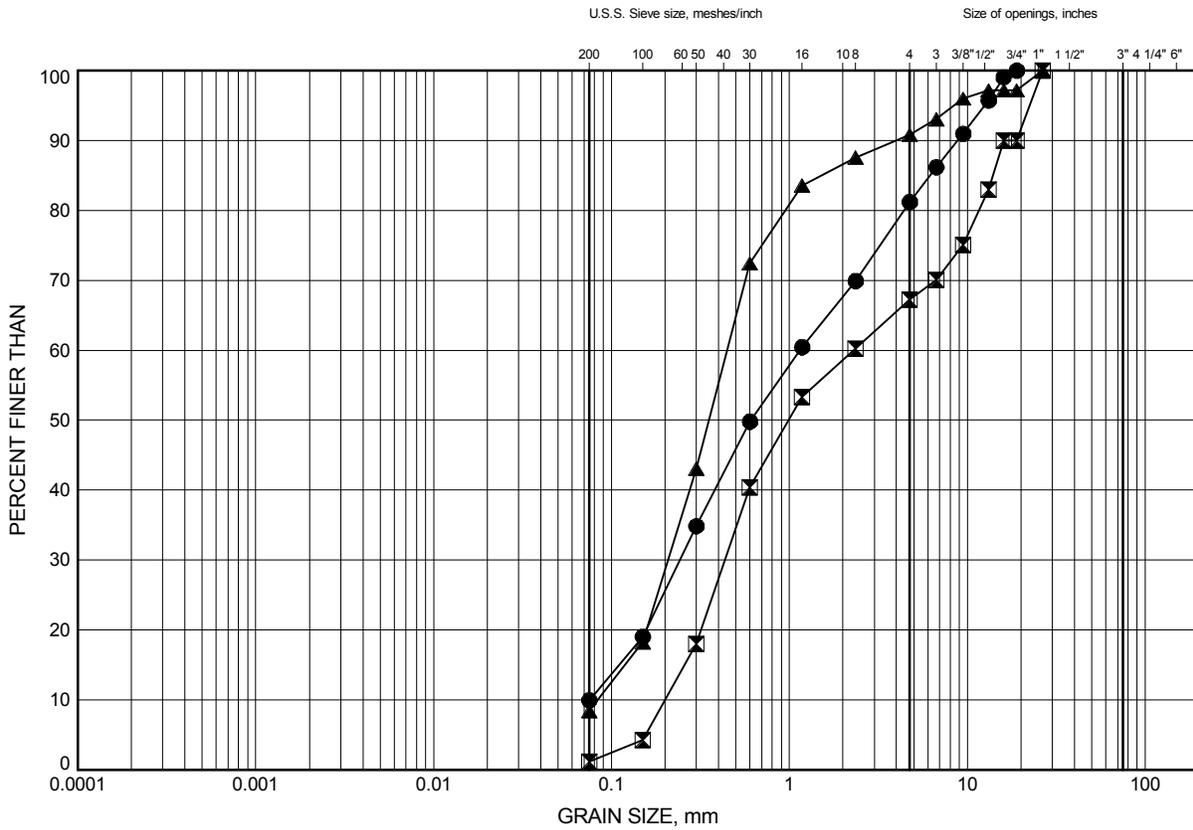
FIGURE C1

**FILL**

Recorded moisture contents ranged from 7 to 18%. The results of grain size analyses conducted on three samples of the sand fill are summarized in the table below and are illustrated on Figure C1 in Appendix C.

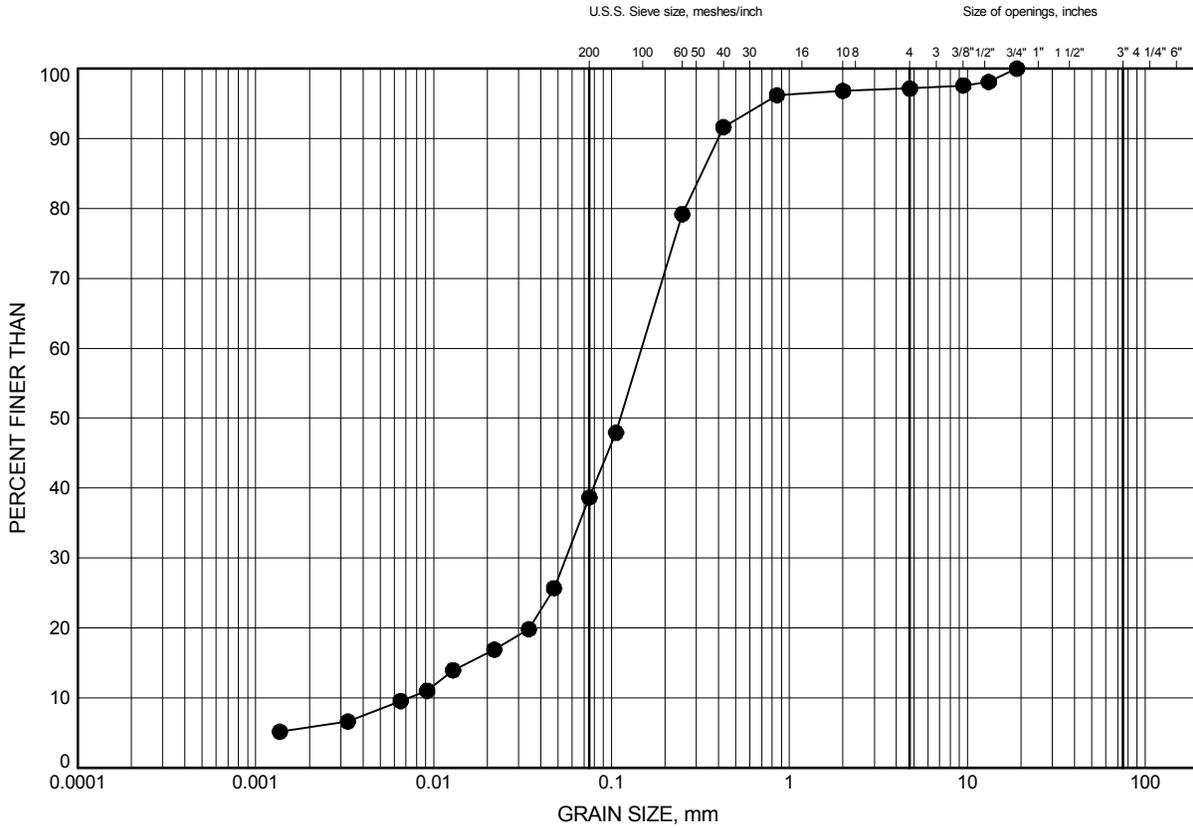
FIGURE C3

**SILTY SAND (SM) (TILL)**

Recorded moisture contents ranged from 12 to 29%. The results of a grain size analysis conducted on one sample of the till indicated this material to consist of 3% gravel, 59% sand, 33% silt and 5% clay. These results are illustrated on Figure C3 in Appendix C. An Atterberg Limit test was completed on one sample of the till and indicated that the material is non-plastic.

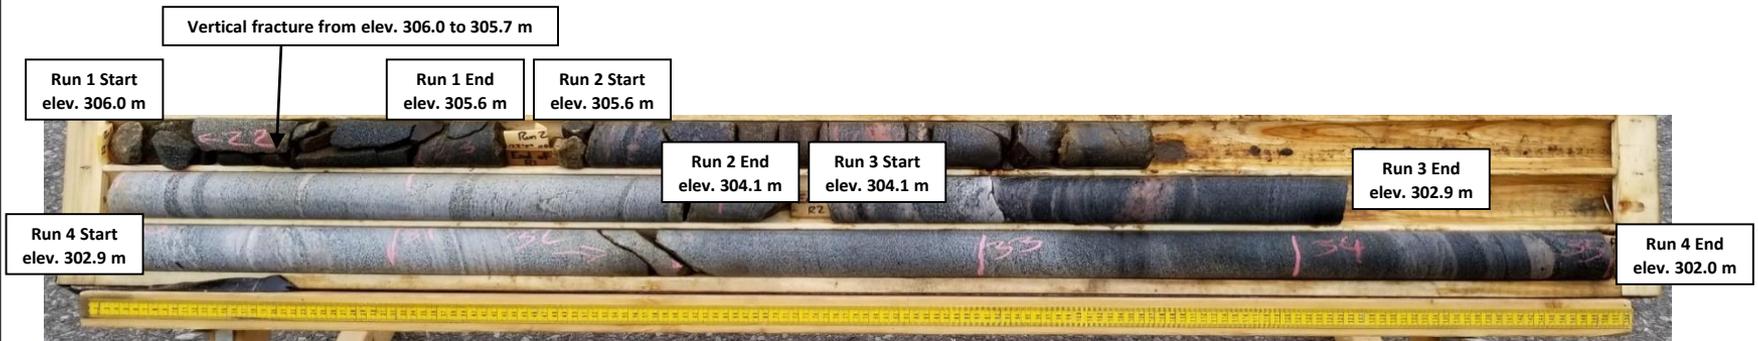
# Borehole 18-3

Run 1 to 4 (of 4)  
Elevation 306.0 m to 302.0 m

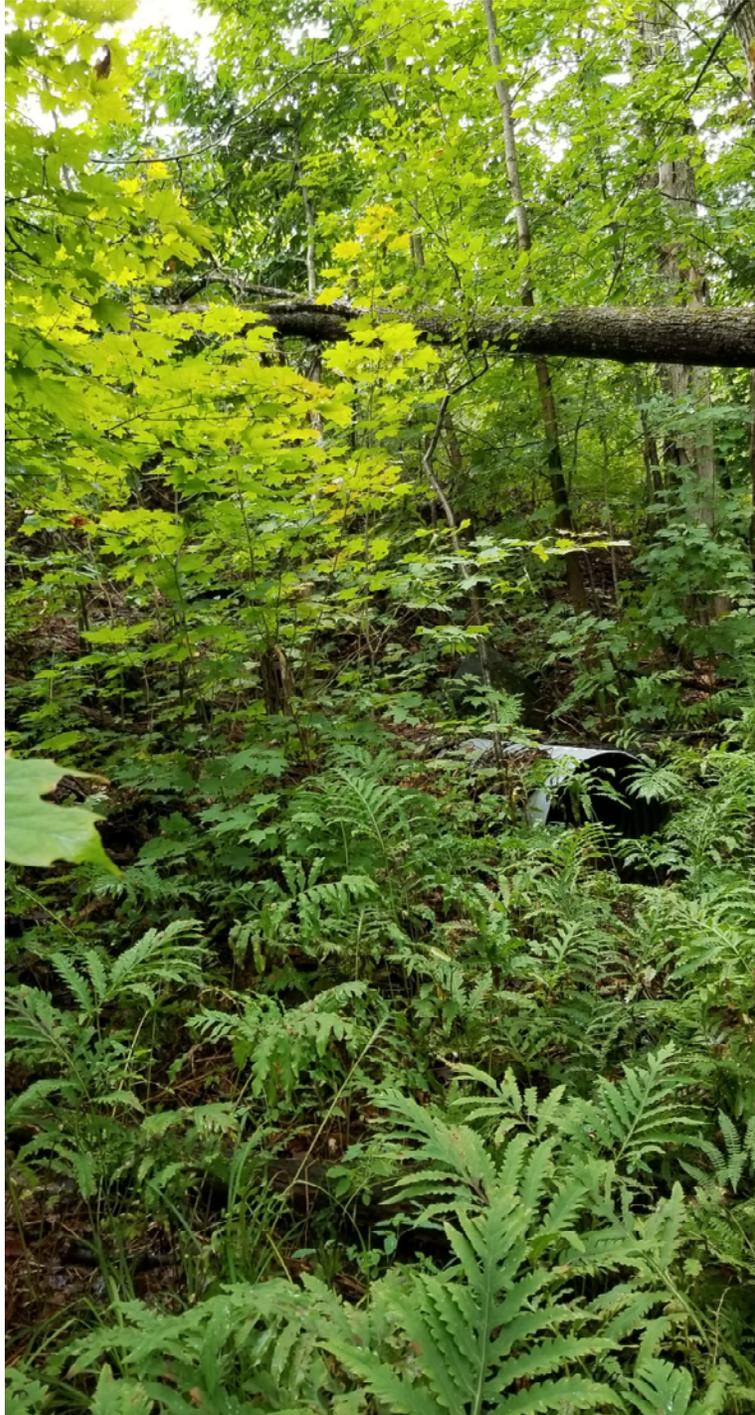
**Photo 1. Looking Southwest at Culvert Outlet at Sta. 18+550 (2018/09/11)**

Photographs showing the existing conditions in the area of the culvert at the time of the field investigation are included in Appendix D for reference.

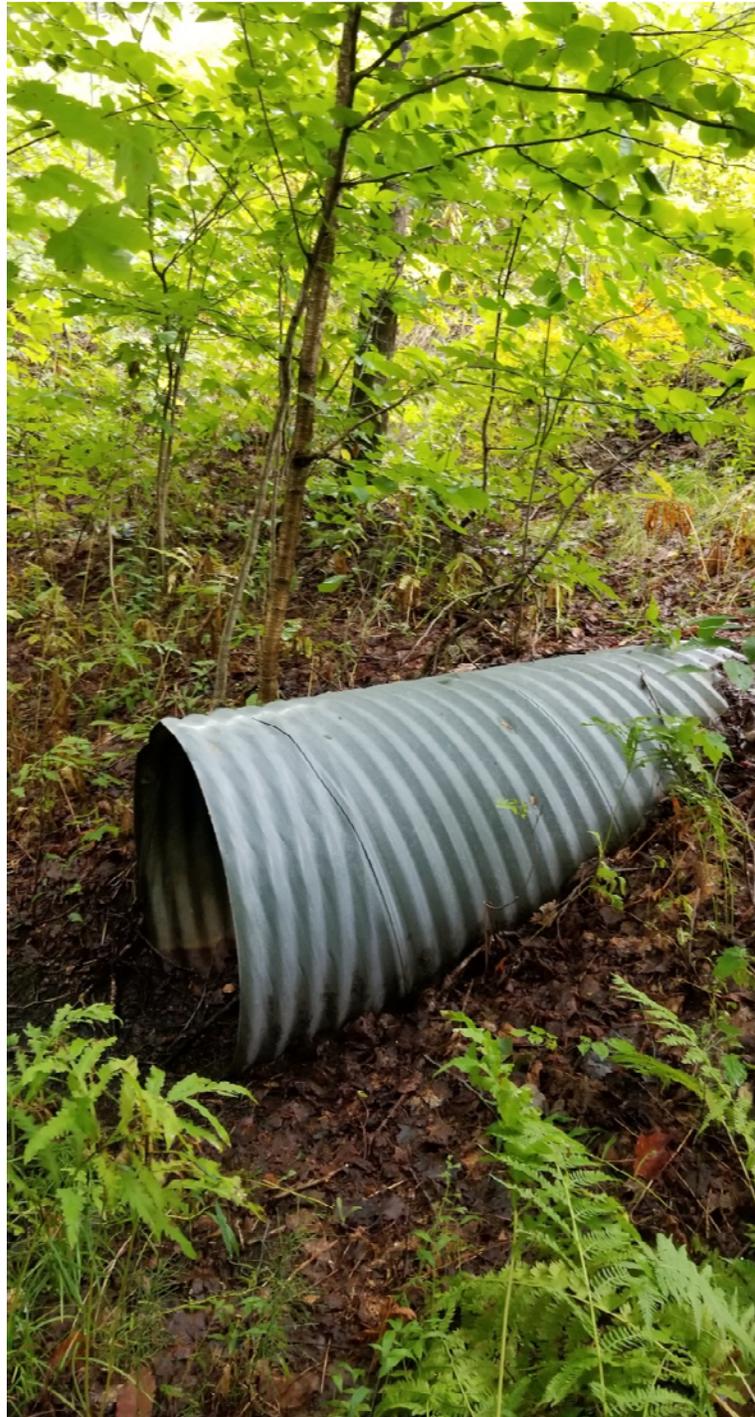
**Photo 2. Looking Northeast at Culvert Inlet at Sta.18+550 (2018/09/11)**
