**FOUNDATION INVESTIGATION REPORT
OVERHEAD SIGN REPLACEMENT
NICHOLAS STREET ON-RAMP TO HIGHWAY 417
OTTAWA, ONTARIO**

**GWP 4048-11-00
WP 4253-15-01**

March 2018
Thurber File: 18006

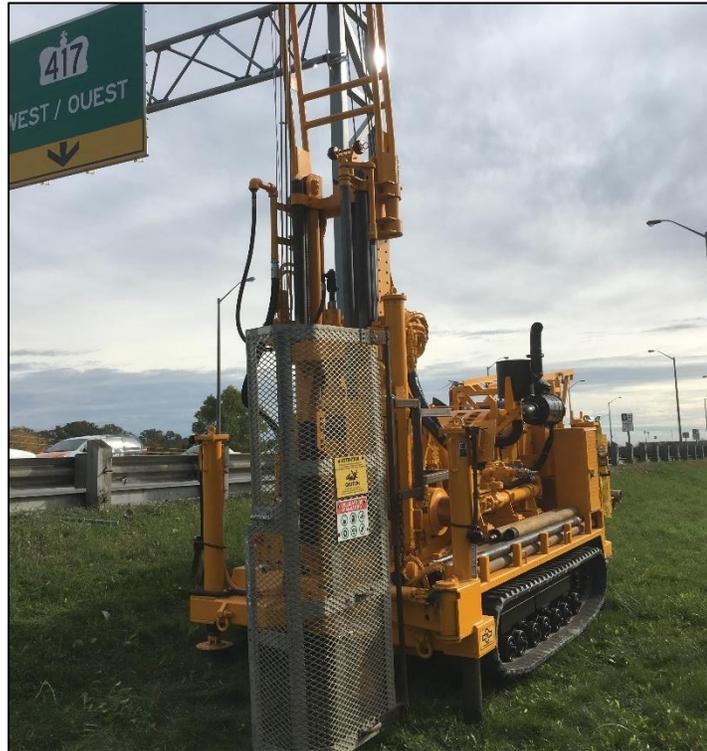
Photo 1. Drill rig set up on Borehole 17-01, looking south (2017-10-26).

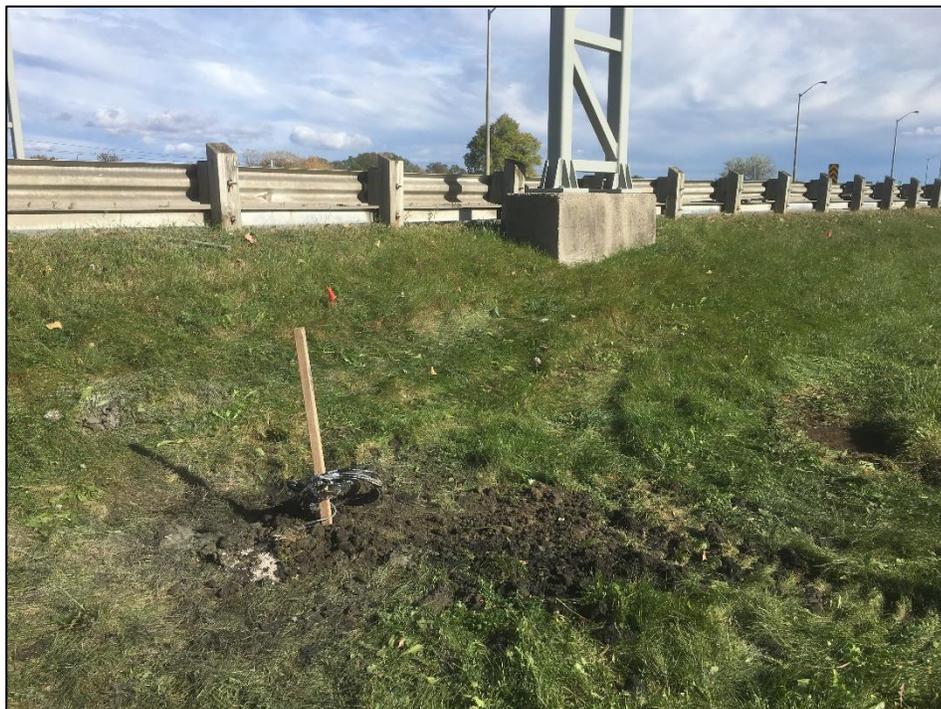
Photo 2. Borehole 17-01 upon completion of vibrating wire installation (2017-10-26).

A vibrating wire piezometer was installed in Borehole 17-01 with its sensor tip at a depth below ground surface of 8.4 m (elev. 57.7 m) to allow for measurements of the groundwater level after completion of drilling. The vibrating wire piezometer was installed within sand and sealed with bentonite. Following completion of the field investigation, the vibrating wire piezometer will be decommissioned. The boreholes were backfilled in general accordance with MOEE requirements (O.Reg. 903).

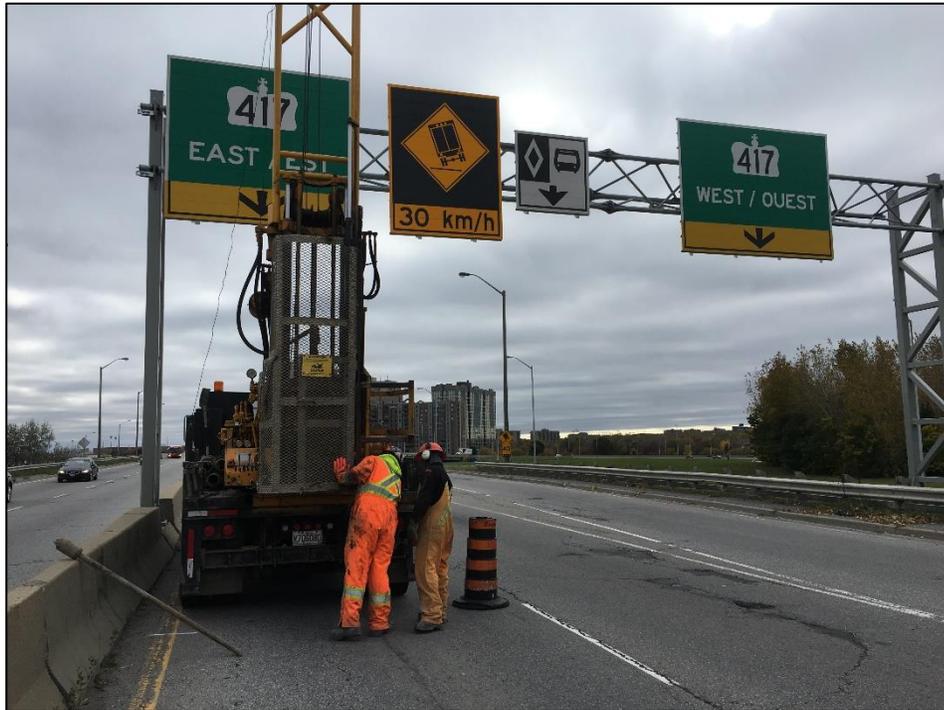
Photo 3. Drill rig set up on Borehole 17-02, looking south (2017-10-27).

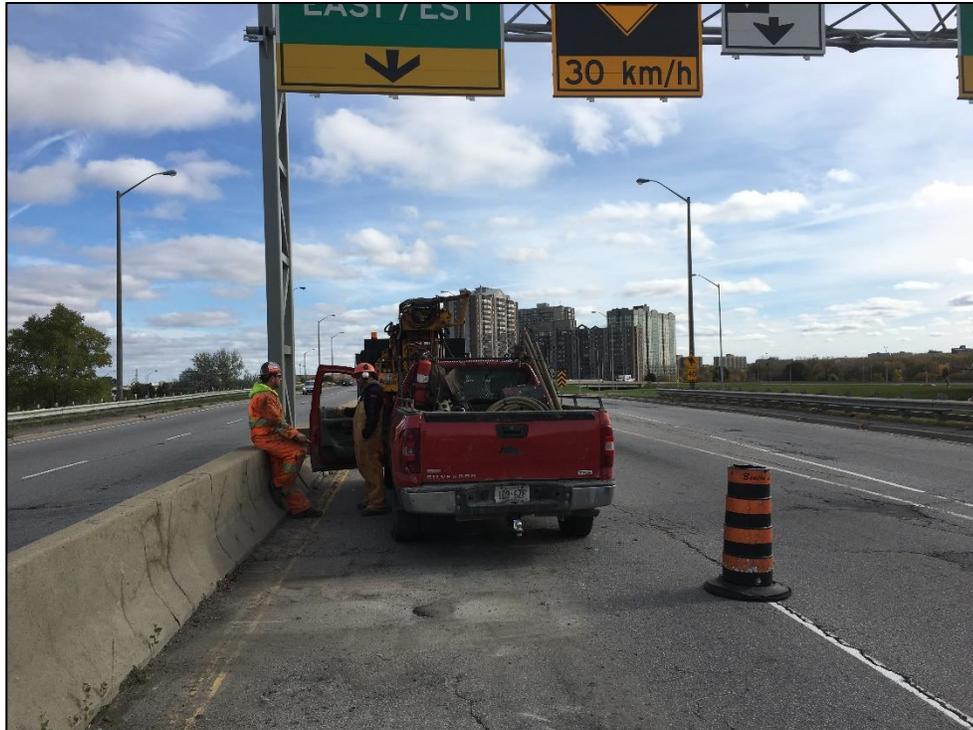
Photo 4. Borehole 17-02 upon completion of backfilling (2017-10-27).
