FINAL REPORT

Foundation Investigation and Design Site 16-318 Highway 416 and County Road 43 Ramp Terminal Intersection Improvements United Counties of Leeds and Grenville, Ontario *GWP 4129-18-00*

Golder Associates Ltd.

May 2021

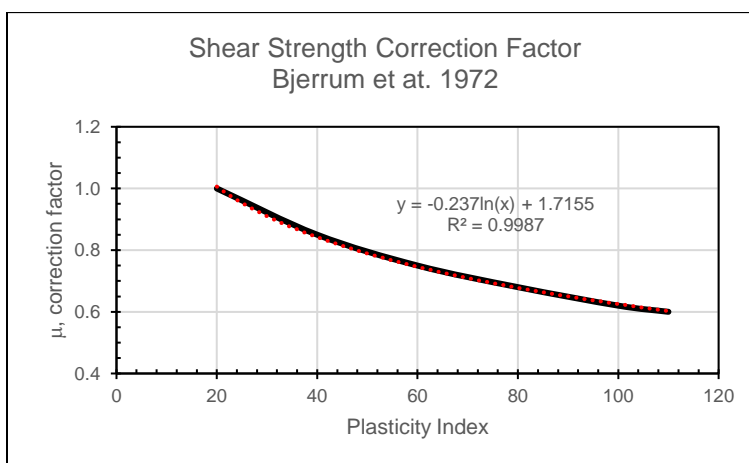
Graph 1: Shear Strength Correction Factor, after Bjerrum et al 1972

The correction factor μ varies with measured plasticity index in accordance with the relationship provided in Bjerrum et. al. 1972 and reproduced in following graph.

As shown on the Plot 1 on Figure B in Appendix E, there is a variation in the plasticity index values throughout the clay stratigraphy. Design μ values were therefore selected based on the results of the index testing carried out for the current investigation as indicated on Plots 2 and 3 on Figure B and summarized in Table 7 for the embankment and toe of slope shear strengths, respectively.

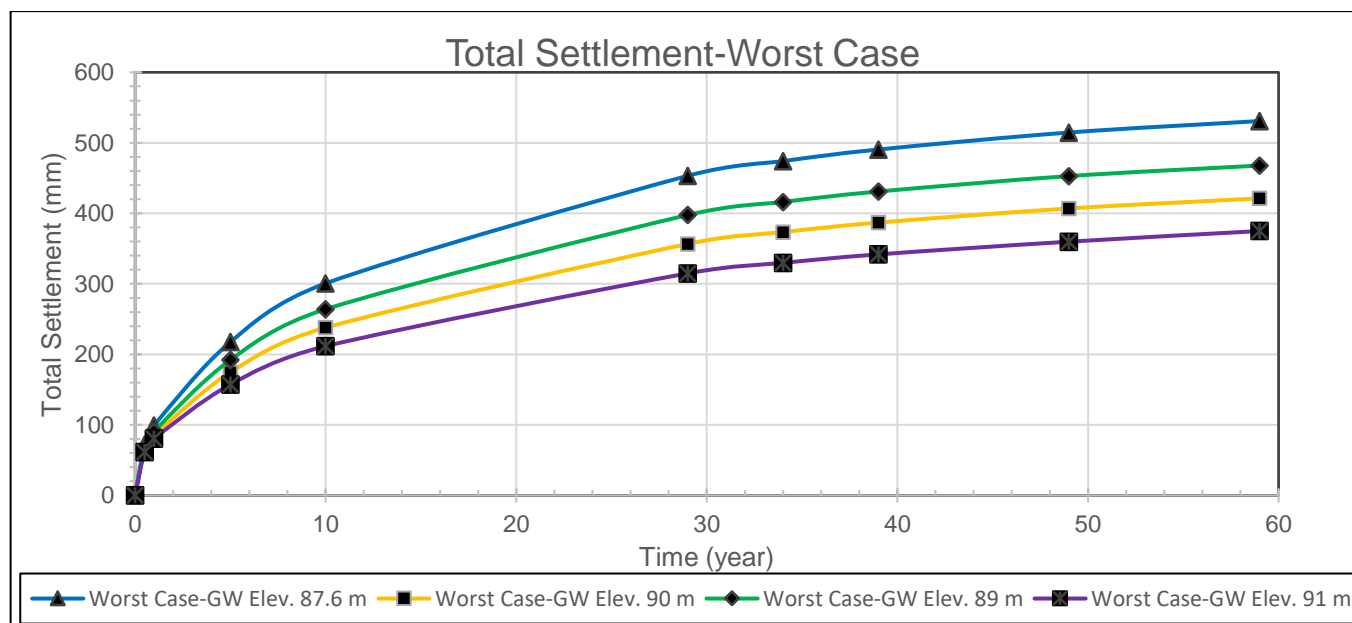
Graph 2: The results of the settlement versus time worst case analysis parameters

The results of the settlement versus time results are reproduced in Graphs 2 and 3, for the *worst case* analysis parameters and the *most likely* analysis parameters, respectively:

From the above graphs it can be seen that during the 30 years the embankment has been in place, about 125 to 315 mm of total (primary consolidation plus secondary) settlement has likely occurred. In addition, there has likely been periods of increased settlement during periods with lower groundwater levels. The magnitude of the additional settlement due to temporarily lowered groundwater levels is difficult to estimate, since the above graphs assume a lowered groundwater level over the entire time period. However, lowering the groundwater level would re-initiate primary consolidation response to the increased loading and it is reasonable to assume that the increased settlement would correspond to the initial settlement at the start of loading as shown in the above graphs (i.e., may be in the order of 50 mm over a few months).

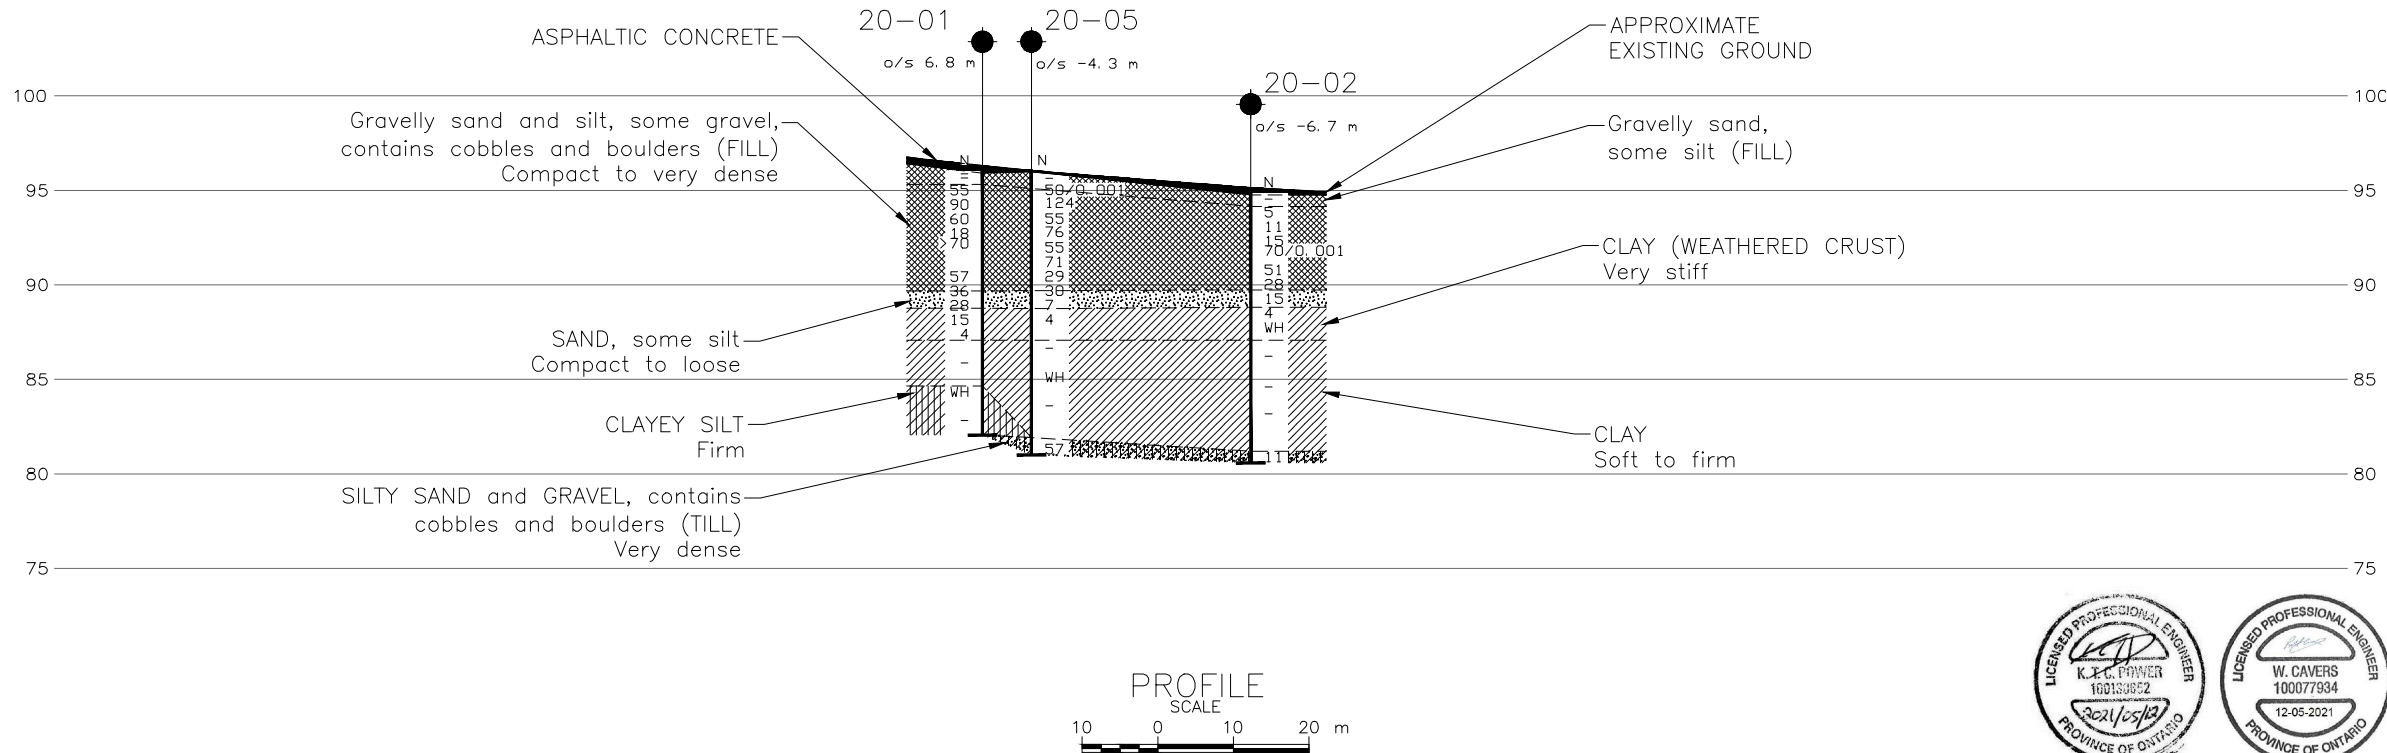
HWY. 416		PROJECT NO. 1899802		DIST. EASTERN	
SUBM'D. KCP	CHKD. KCP	DATE: 5/13/2021	SITE: 19-318		
DRAWN: ZS	CHKD. KCP	APPD. WC	DWG. 1

HIGHWAY 416 UNDERPASS
AT COUNTY ROAD 43
BOREHOLE LOCATIONS AND SOIL STRATA
LAT. 45.028392 LONG. -75.622089

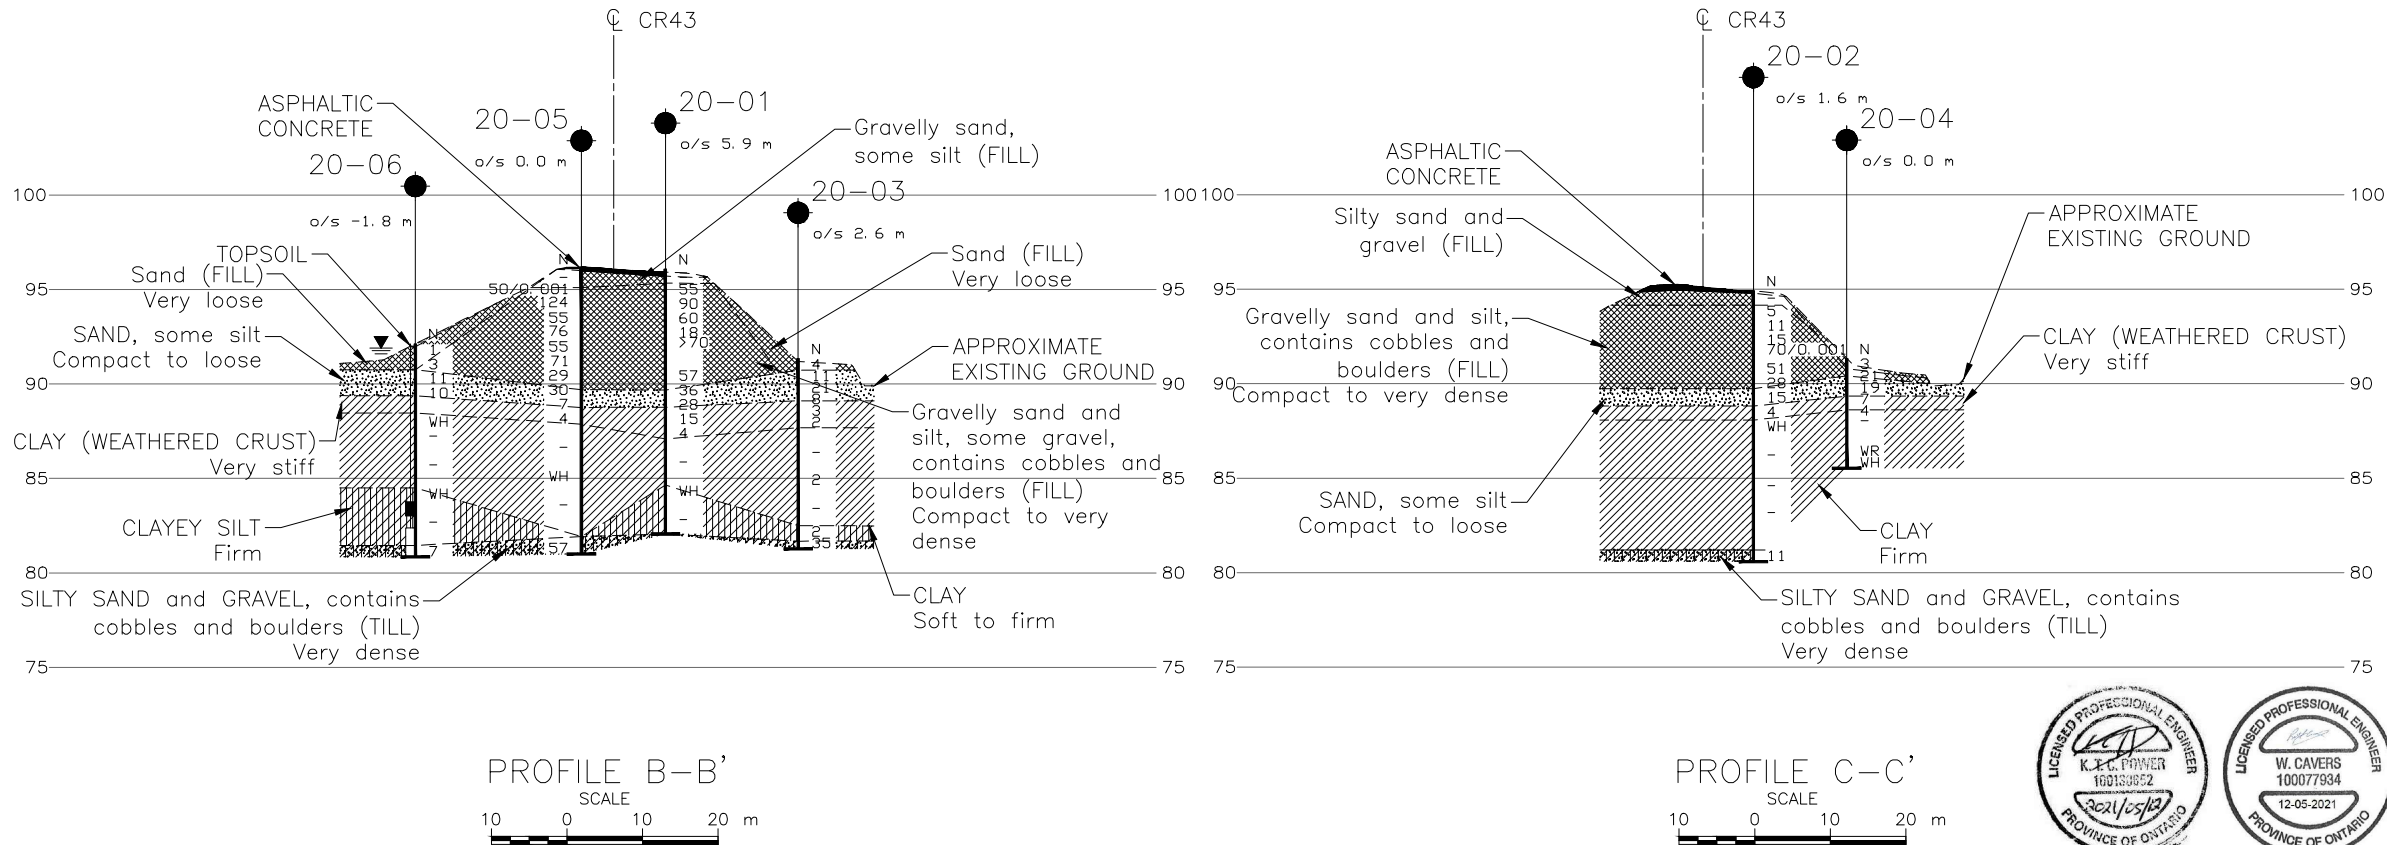
NO.	DATE	BY	REVISION
Geocres No. 31G-286			
HWY. 416	PROJECT NO. 1899802		DIST. EASTERN
SUBM'D. KCP	CHKD. KCP	DATE: 5/13/2021	SITE: 19-318
DRAWN: ZS	CHKD. WC	APPD. WC	DWG. 2

HIGHWAY 416 OVERPASS
AT COUNTY ROAD 43
BOREHOLE LOCATIONS AND SOIL STRATA
LAT. 45.028392 LONG. -75.622089

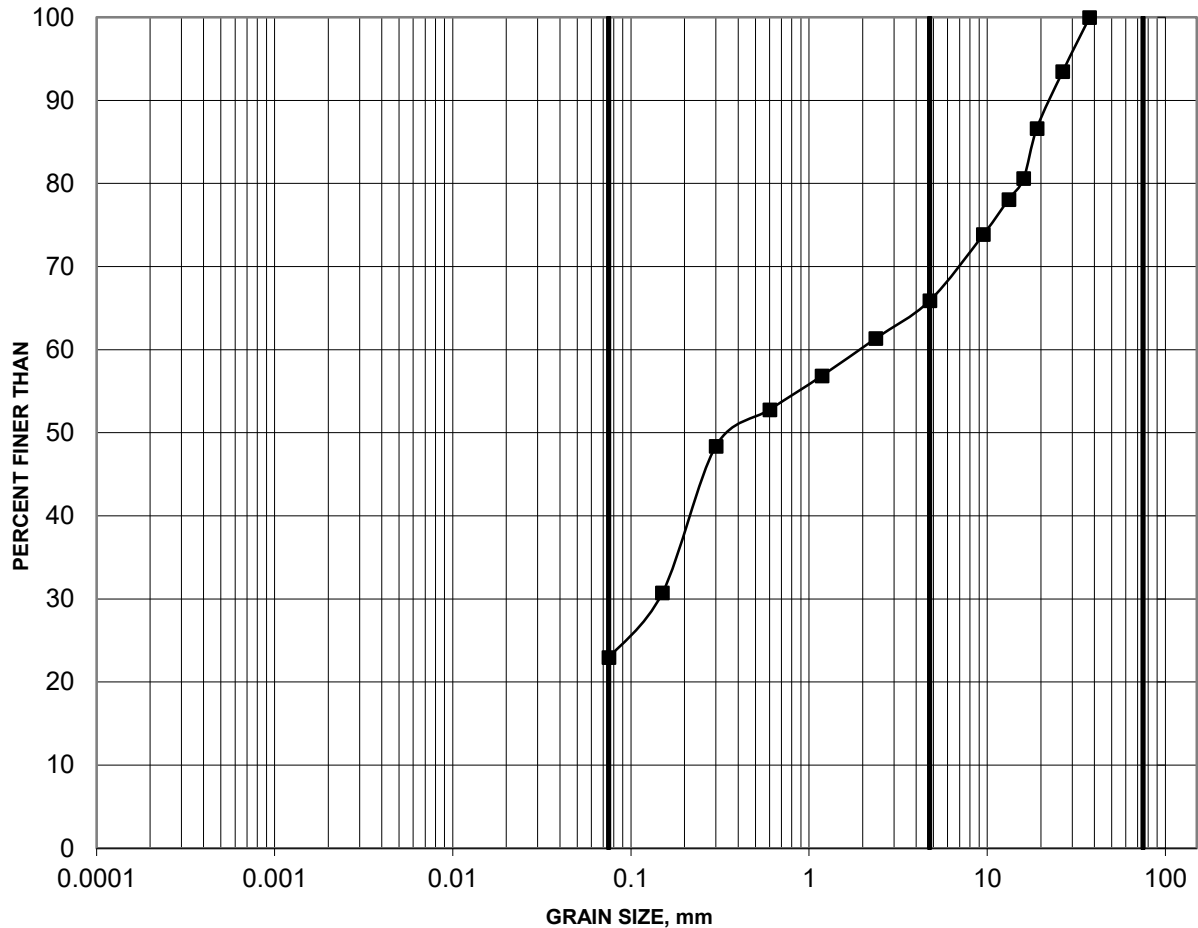
FIGURE B1

SILTY SAND AND GRAVEL (FILL)

Borehole	Sample	Depth (m)	Constituents (%)			
				Gravel	Sand	Silt	Clay
■	20-01	1B	0.23-0.61	34	43	23

Pavement structure fill consisting predominantly of sand and gravel with varying amounts of silt was encountered below the asphaltic concrete pavement at the highway borehole locations. The top of this layer was encountered at elevations ranging from 96.0 to 94.8 m and ranges in thickness from 0.7 to 0.9 m. The measured moisture content of one sample tested was 3%. The results of grain size analysis testing carried out on a single sample of pavement structure fill are provided on Figure B1 in Appendix B.

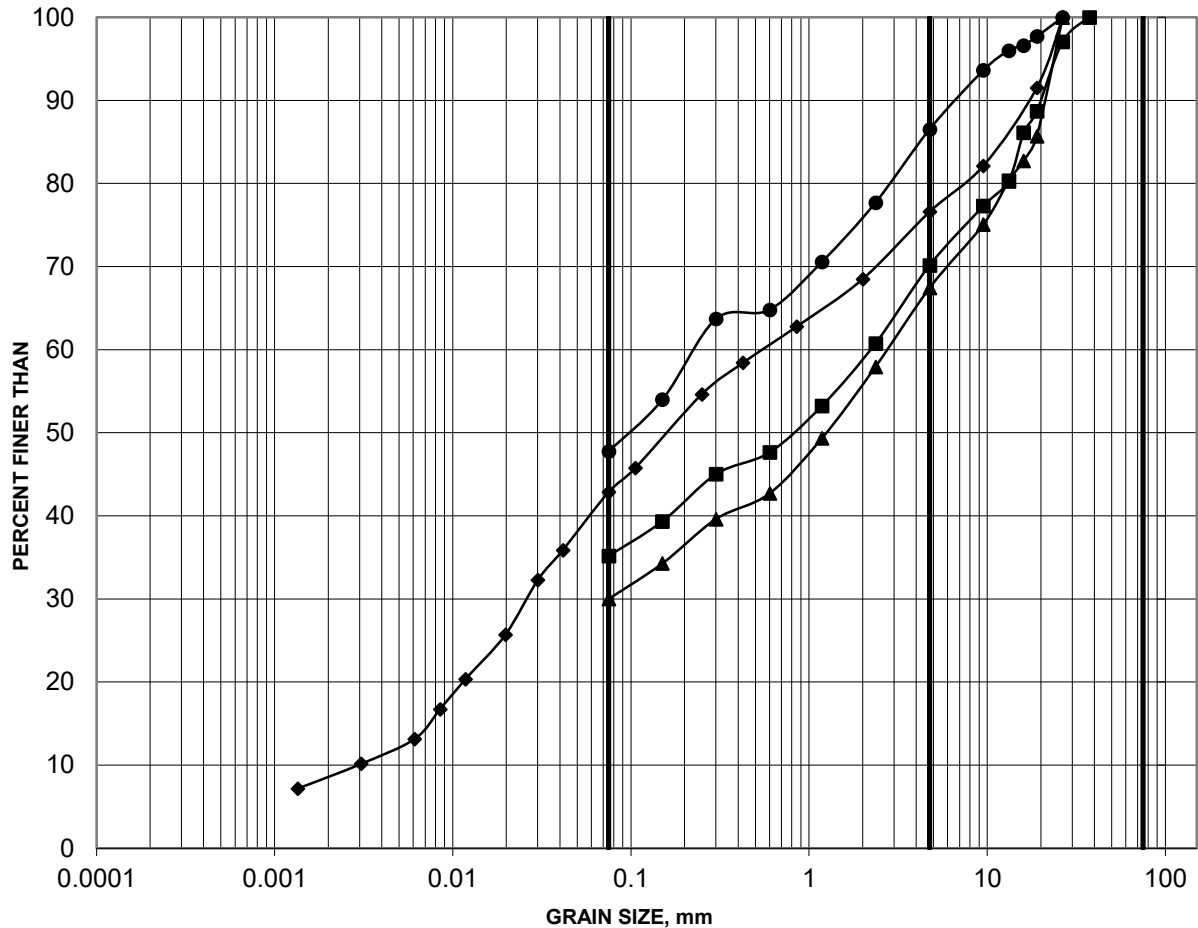
FIGURE B2

SAND AND SILT (FILL)

Borehole	Sample	Depth (m)	Constituents (%)			
				Gravel	Sand	Silt	Clay
■	20-01	3	1.52-2.13	30	35		35
◆	20-02	3	1.52-2.13	23	34	34	9
▲	20-02	6	3.81-4.42	33	37		30
●	20-05	3	1.52-1.98	13	39		48

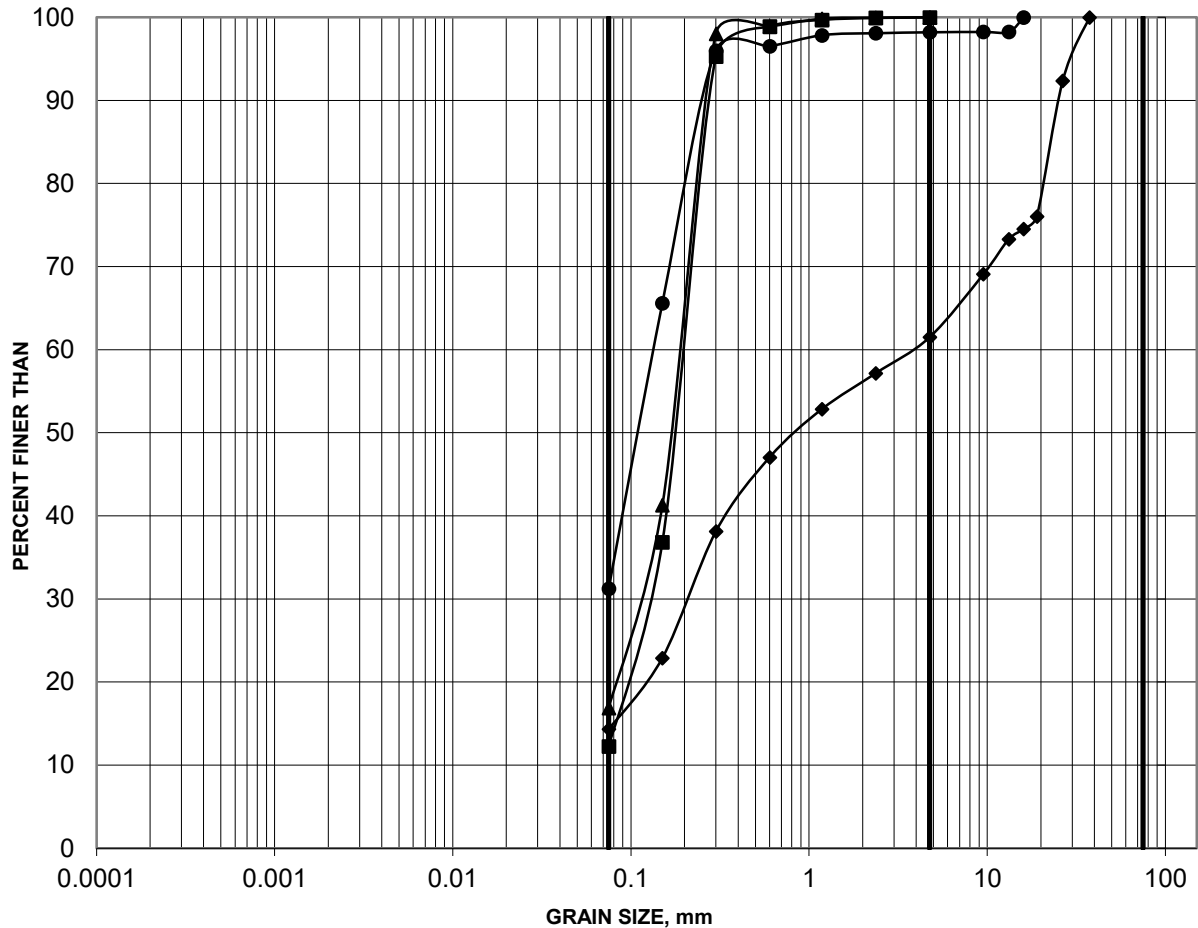
FIGURE B3

SAND TO SAND AND GRAVEL

Borehole	Sample	Depth (m)	Constituents (%)			
				Gravel	Sand	Silt	Clay
■	20-01	9B	6.40-6.71	0	88	12	
◆	20-02	8	5.33-5.94	38	48	14	
▲	20-03	2	1.22-1.83	0	83	17	
●	20-04	3	1.22-1.83	2	67	31

The moisture content of the samples of the sand tested ranged from 22 to 24%. The results of grain size analysis testing carried out on four samples of this material are illustrated on Figure B3 in Appendix B.

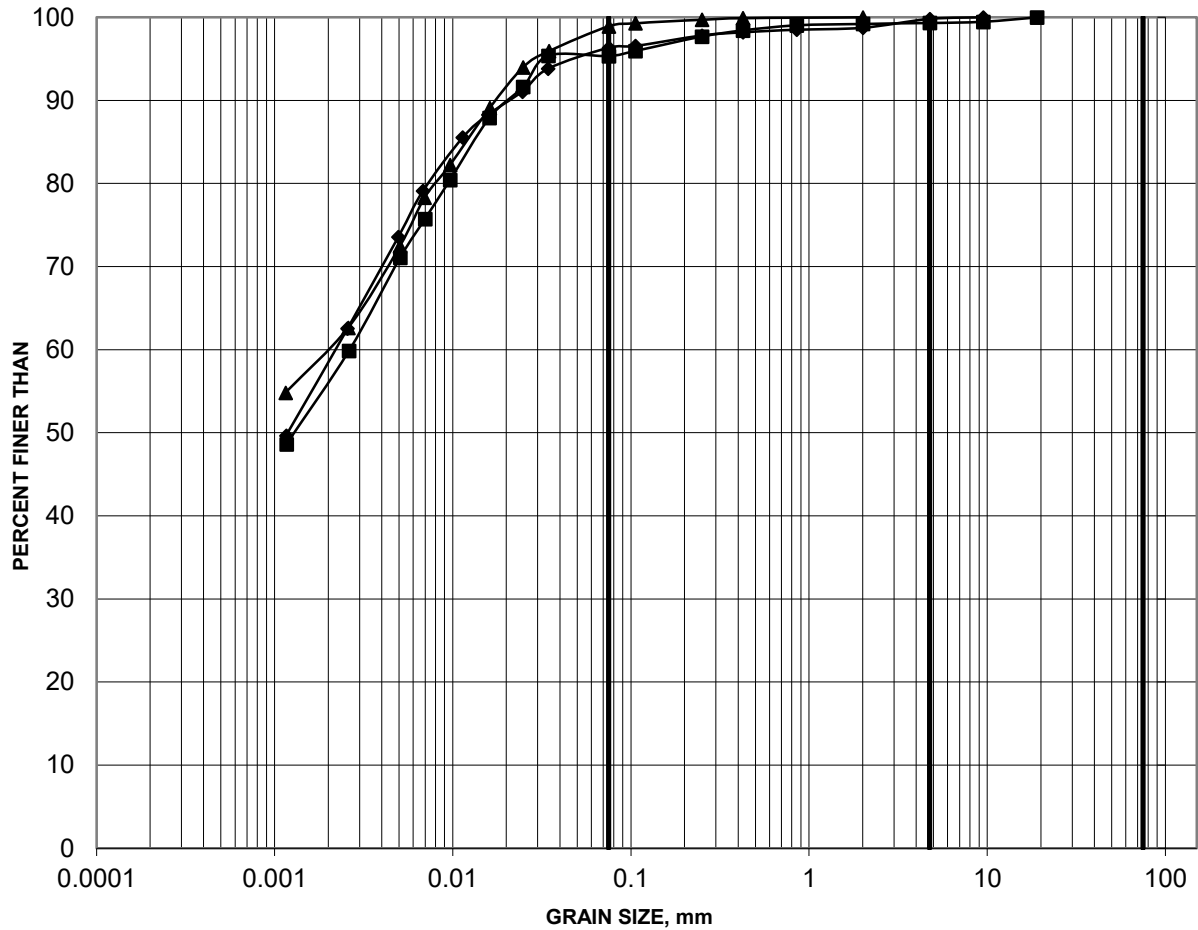
FIGURE B4

WEATHERED CLAY CRUST

Borehole	Sample	Depth (m)	Constituents (%)			
				Gravel	Sand	Silt	Clay
■	20-01	11	7.62-8.23	1	4	39	56
◆	20-03	6	3.05-3.66	0	4	37	59
▲	20-05	10B	7.35-7.65	0	1	39	60

The moisture content of the samples of the clay crust tested ranged from 36 to 52%. The results of grain size analysis testing carried out on three samples of this material are illustrated on Figure B4 in Appendix B. The results of Atterberg Limits testing completed on four samples of the weathered crust indicate liquid limits ranging from 50 to 53, plastic limits ranging from 22 to 24 and plasticity indices ranging from 27 to 31. The Atterberg Limits analysis results are illustrated on Figure B5 in Appendix B and indicate a clay intermediate to high plasticity but more typically high plasticity (CH).

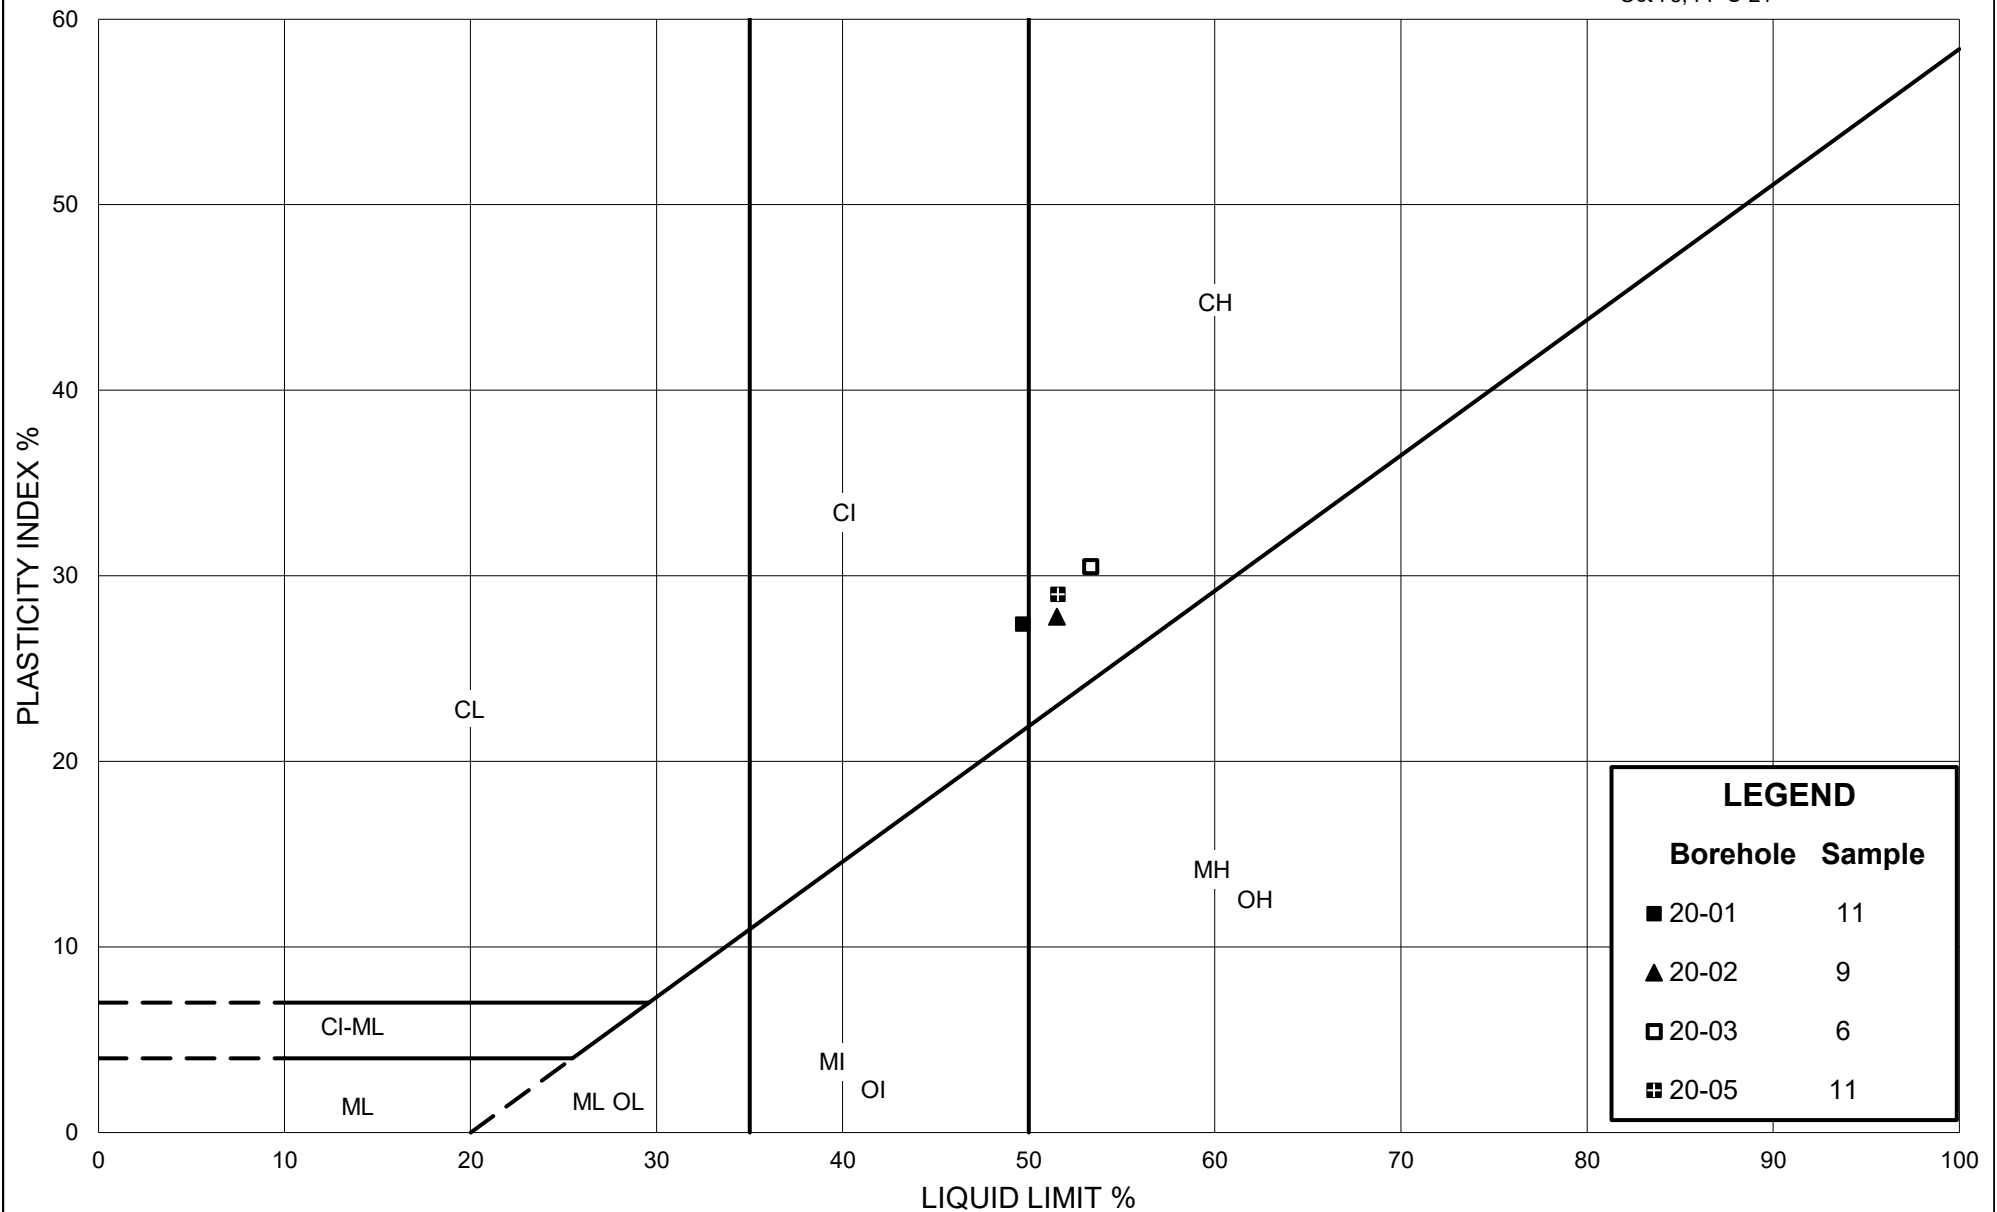
PLASTICITY CHART WEATHERED CLAY CRUST

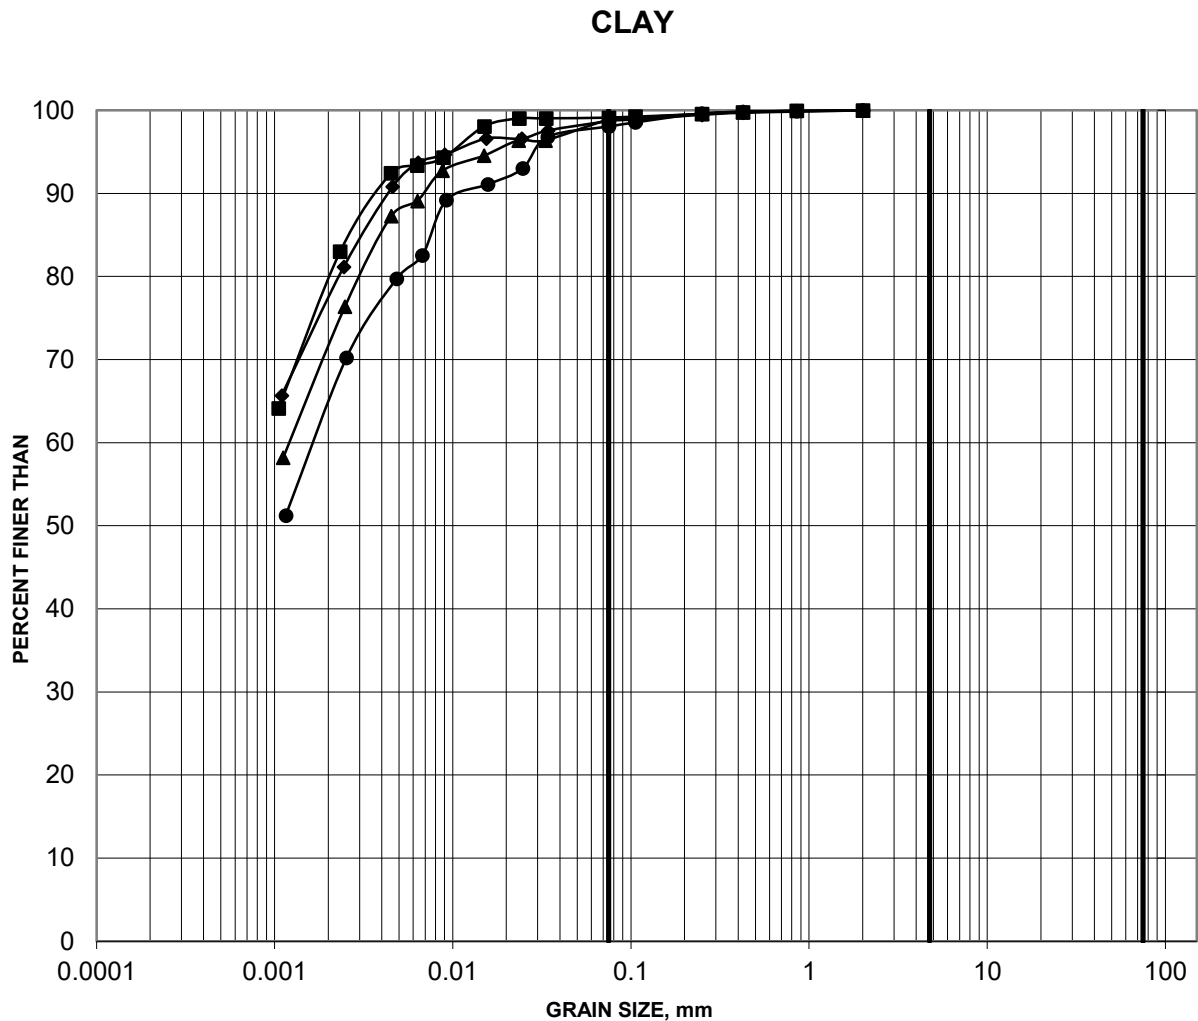
FIGURE B6

SILT AND CLAY	FINE	MEDIUM	COARSE	FINE	COARSE	COBBLE SIZE
	SAND SIZE			GRAVEL SIZE

Borehole	Sample	Depth (m)	Constituents (%)			
				Gravel	Sand	Silt	Clay
■	20-02	11	8.38-8.99	0	1	20	79
◆	20-04	7	4.57-5.18	0	1	22	77
▲	20-05	13	10.67-11.28	0	1	27	72
●	20-06	5	3.81-4.42	0	2	33	65

The moisture content of the samples of the grey clay tested ranged from 53 to 79%. The results of grain size analysis testing conducted on four samples of the grey clay are illustrated on Figure B6 in Appendix B. The results of Atterberg Limits testing completed on seven samples of the grey clay indicate liquid limits ranging from 56 to 77, plastic limits ranging from 21 to 25 and plasticity indices ranging from 33 to 52. The Atterberg Limits analysis results are illustrated on Figure B7 in Appendix B and indicate a clay with high plasticity (CH).

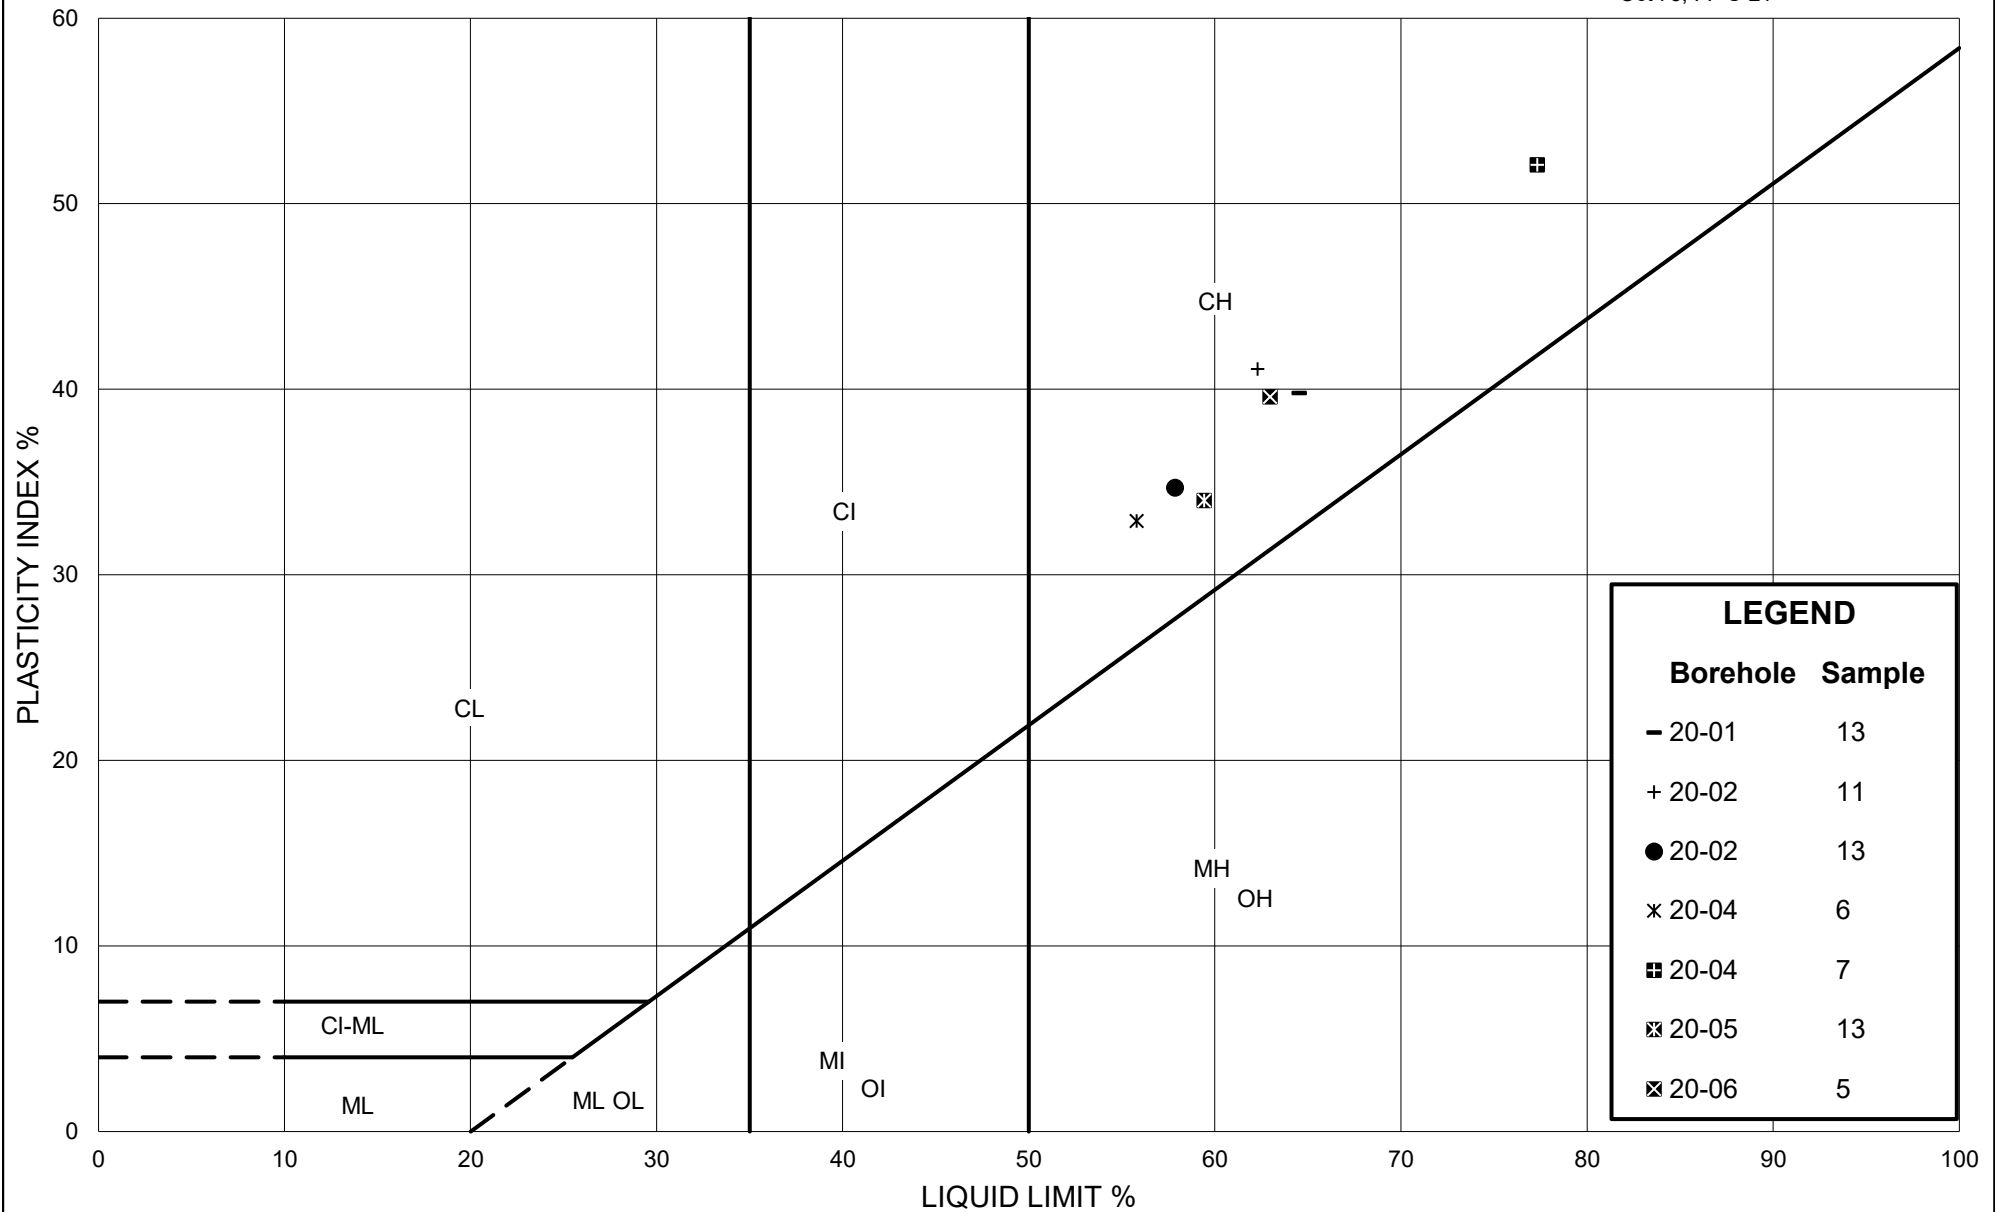
PLASTICITY CHART CLAY

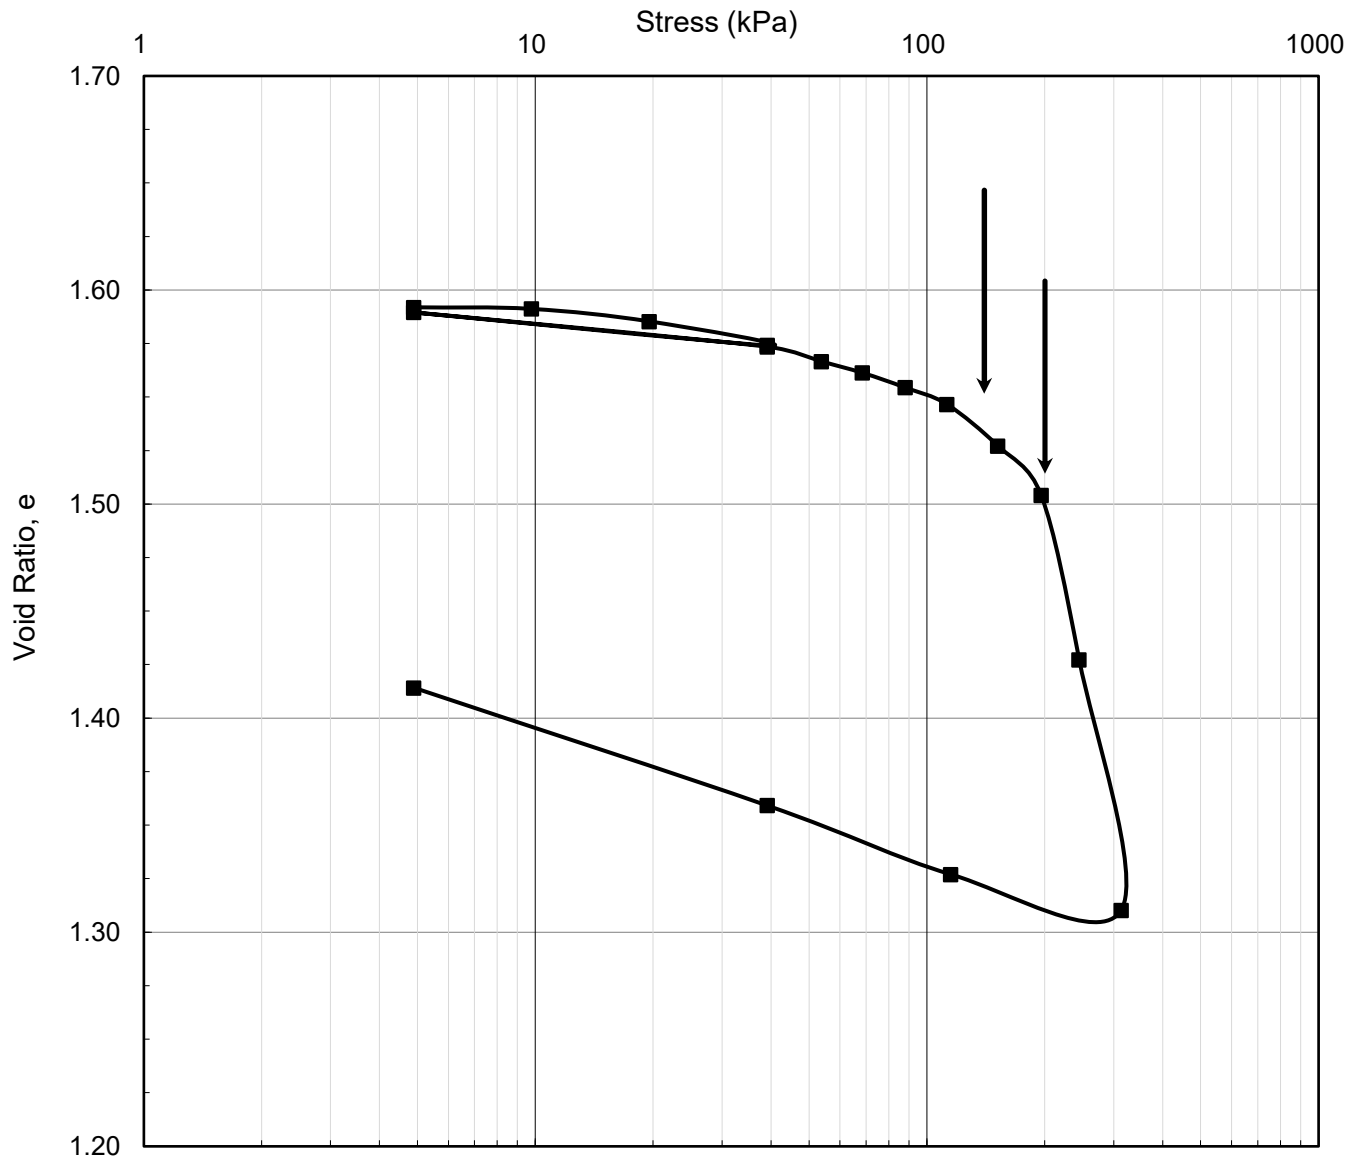
$\sigma'_{vo} = 140 \text{ kPa}$
CALCULATED EXISTING EFFECTIVE
OVERBURDEN PRESSURE

$\sigma'_p = 200 \text{ kPa}$
MOST PROBABLE APPARENT
PRECONSOLIDATION PRESSURE

Borehole:	20-01	$w_i =$	57%	$S_o =$	100%	$\gamma =$	16.6 kN/m ³
Sample:	13	$w_f =$	52%	$e_o =$	1.59	$G_s =$	2.80
Depth (m):	10.36	$w_l =$	65%	$C_c =$	0.790		
Elevation (m):	96.1	$w_p =$	25%	$C_r =$	0.180

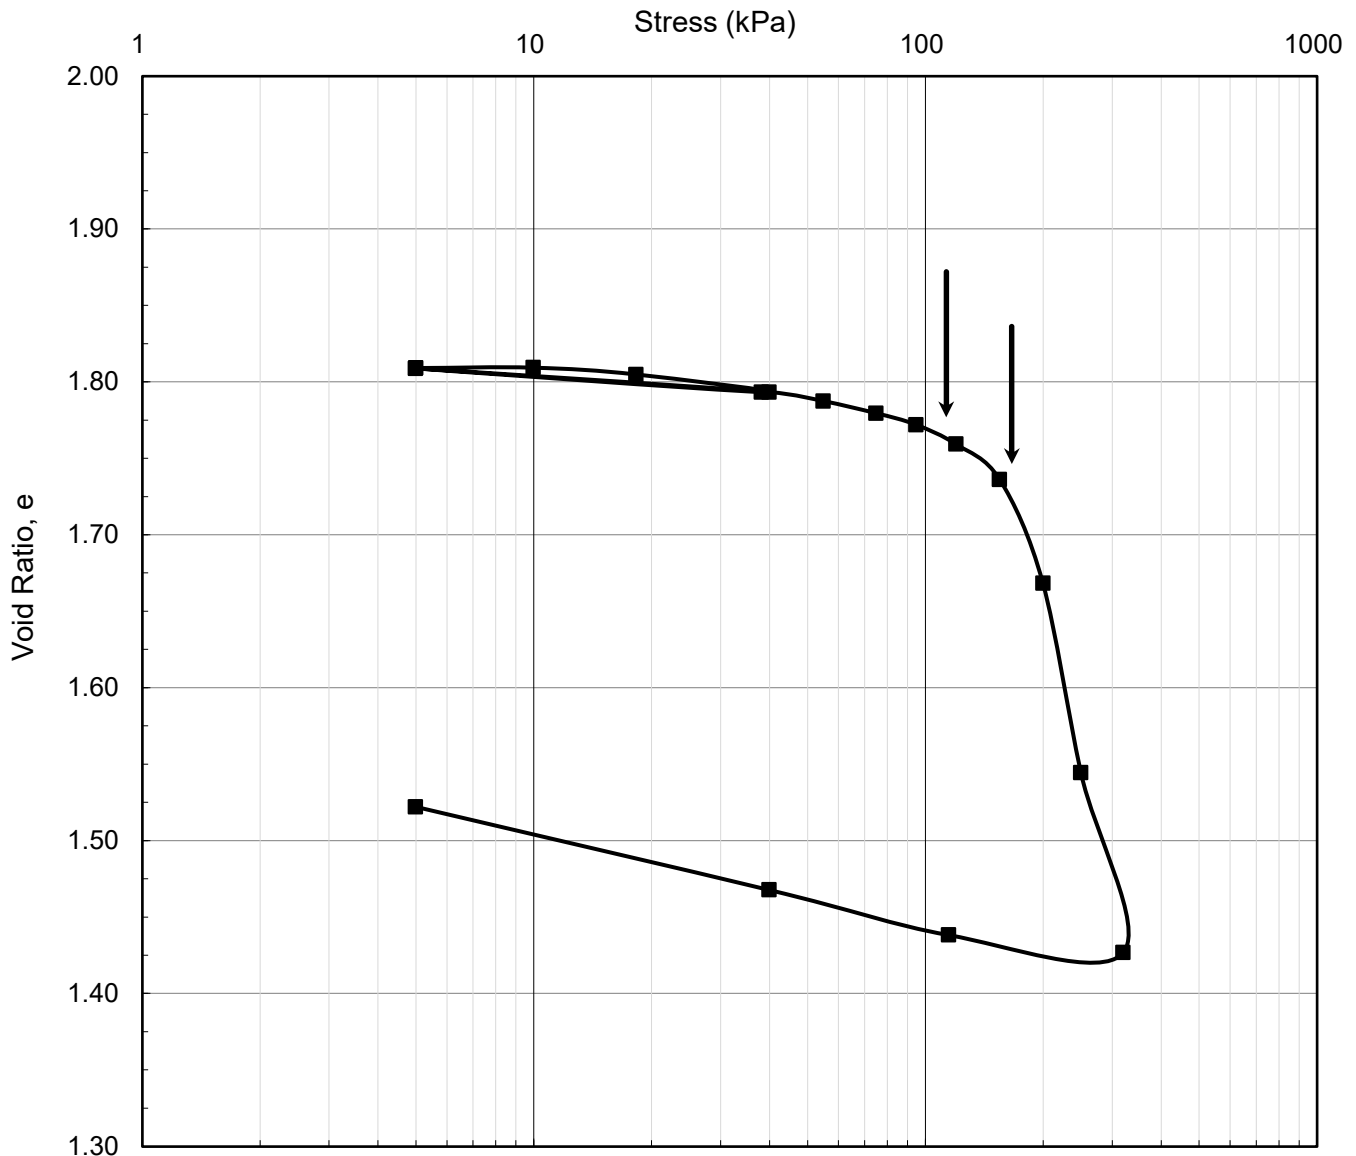
$\sigma'_{vo} = 113 \text{ kPa}$
CALCULATED EXISTING EFFECTIVE
OVERBURDEN PRESSURE

$\sigma'_p = 166 \text{ kPa}$
MOST PROBABLE APPARENT
PRECONSOLIDATION PRESSURE

Borehole:	20-02	$w_i =$	64%	$S_o =$	100%	$\gamma =$	16.1 kN/m ³
Sample:	11	$w_f =$	55%	$e_o =$	1.81	$G_s =$	2.81
Depth (m):	8.86	$w_l =$	62%	$C_c =$	1.270		
Elevation (m):	94.9	$w_p =$	21%	$C_r =$	0.013

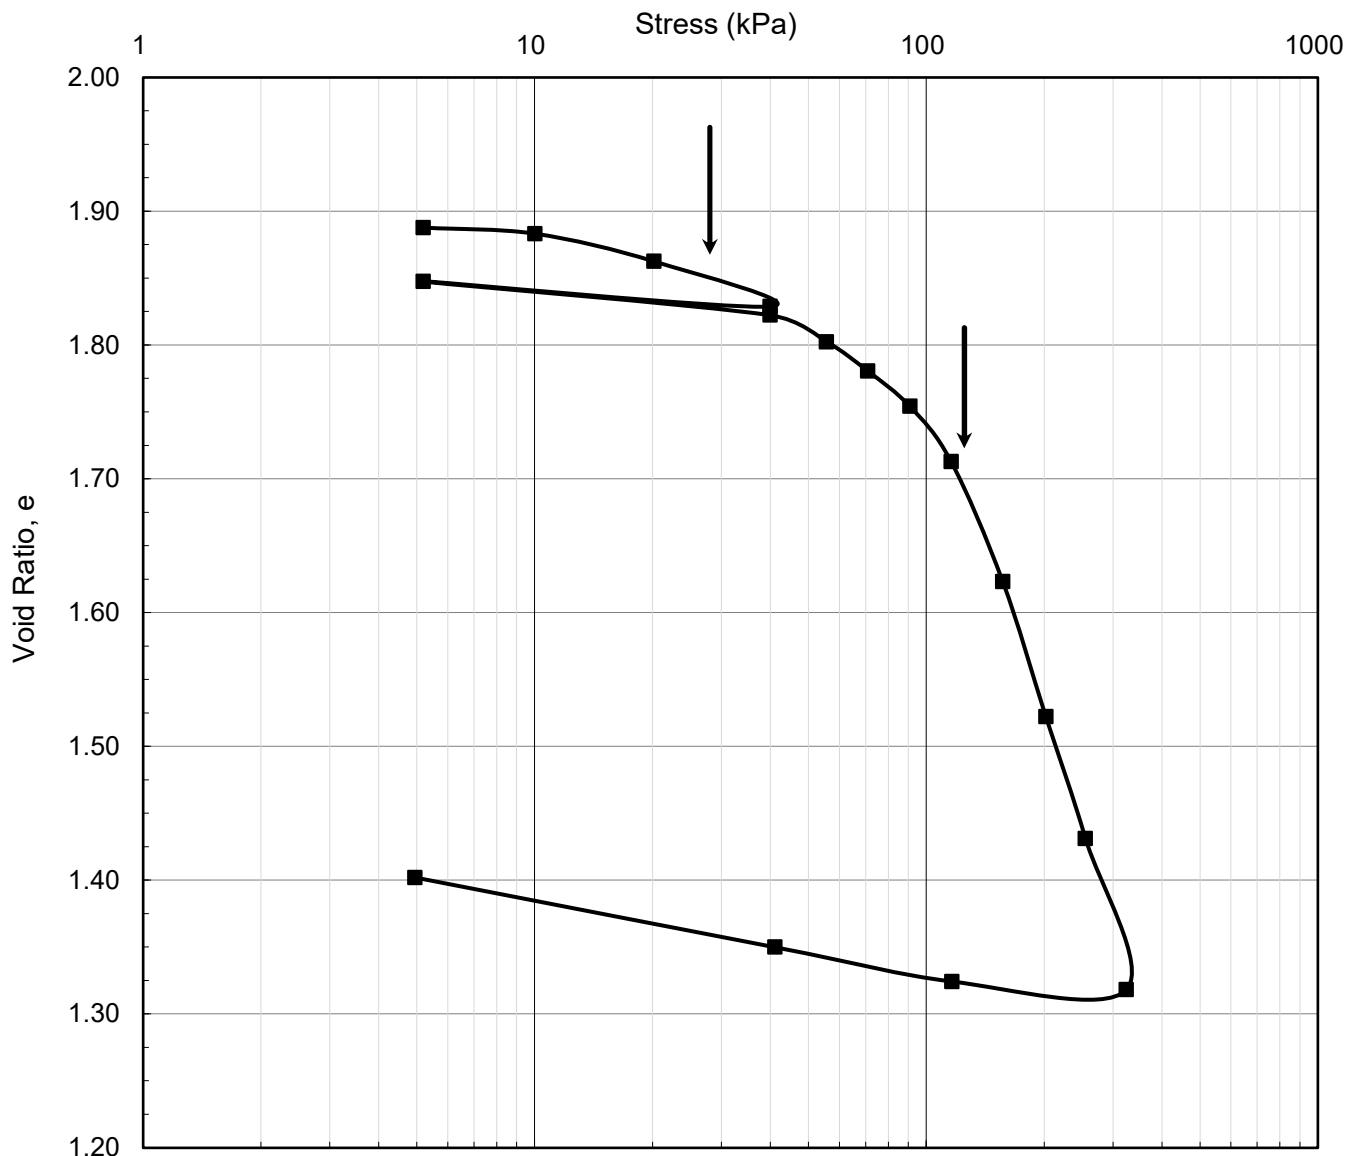
$\sigma'_{vo} = 28 \text{ kPa}$
CALCULATED EXISTING EFFECTIVE
OVERBURDEN PRESSURE

$\sigma'_p = 125 \text{ kPa}$
MOST PROBABLE APPARENT
PRECONSOLIDATION PRESSURE

Consolidation Test Results
