FINAL REPORT

Foundation Investigation and Design Site 16-318 Highway 416 and County Road 43 Ramp Terminal Intersection Improvements United Counties of Leeds and Grenville, Ontario *GWP 4129-18-00*

Golder Associates Ltd.

May 2021

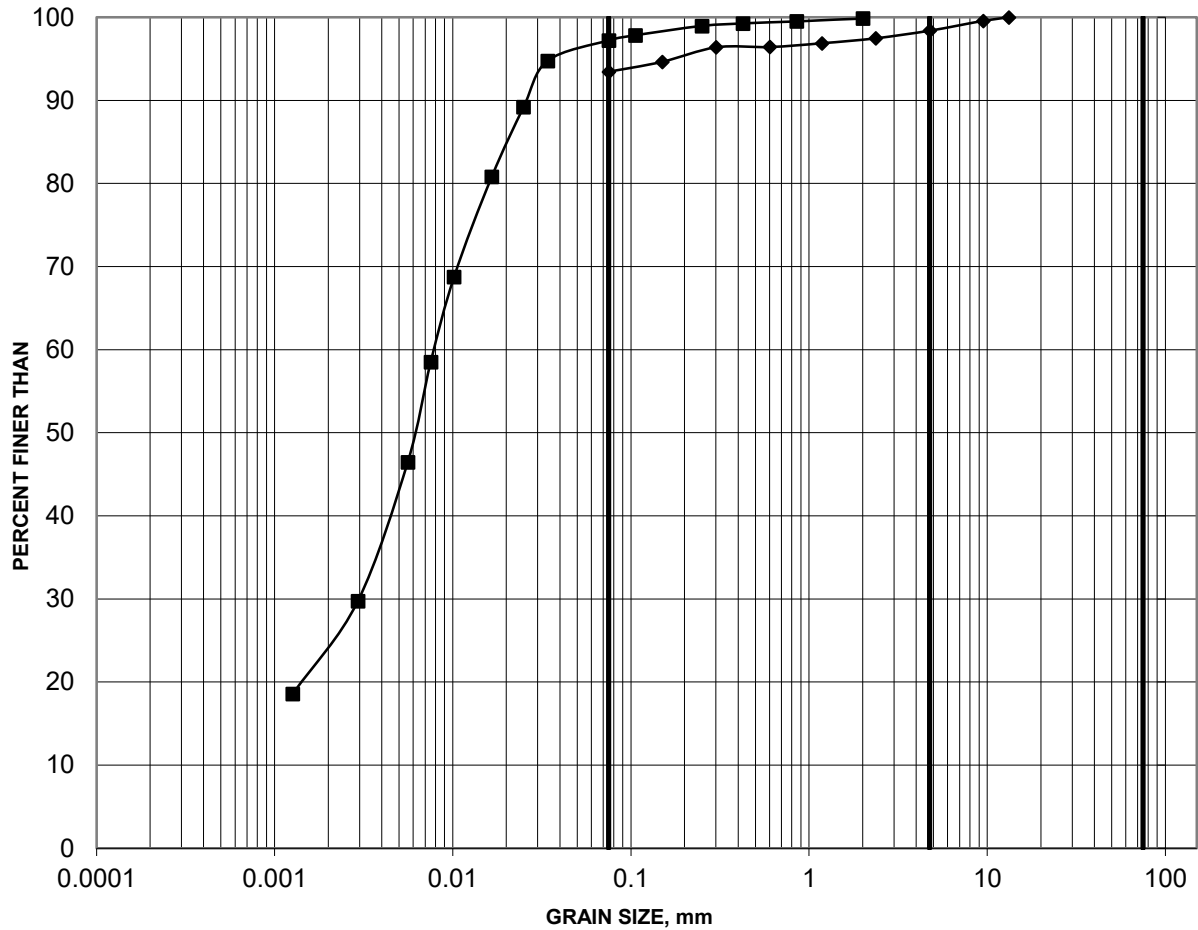
FIGURE B11

CLAYEY SILT

Borehole	Sample	Depth (m)	Constituents (%)			
				Gravel	Sand	Silt	Clay
■	20-03	10	8.84-9.45	0	3	72	25
◆	20-03	11	9.45-10.06	2	5	93

The measured moisture content of samples tested ranged from 30 to 48%. The results of grain size analysis testing carried out on two samples of this material are provided on Figure B11 in Appendix B. The results of Atterberg Limits tests completed on three samples of the clayey silt indicated liquid limit values ranging from 27 to 33, plastic limit value values ranging from 17 to 18, and plasticity indices values ranging from 10 to 15. The Atterberg Limits analysis results are provided on Figure B12 in Appendix B and indicate a clayey silt of low plasticity (CL).

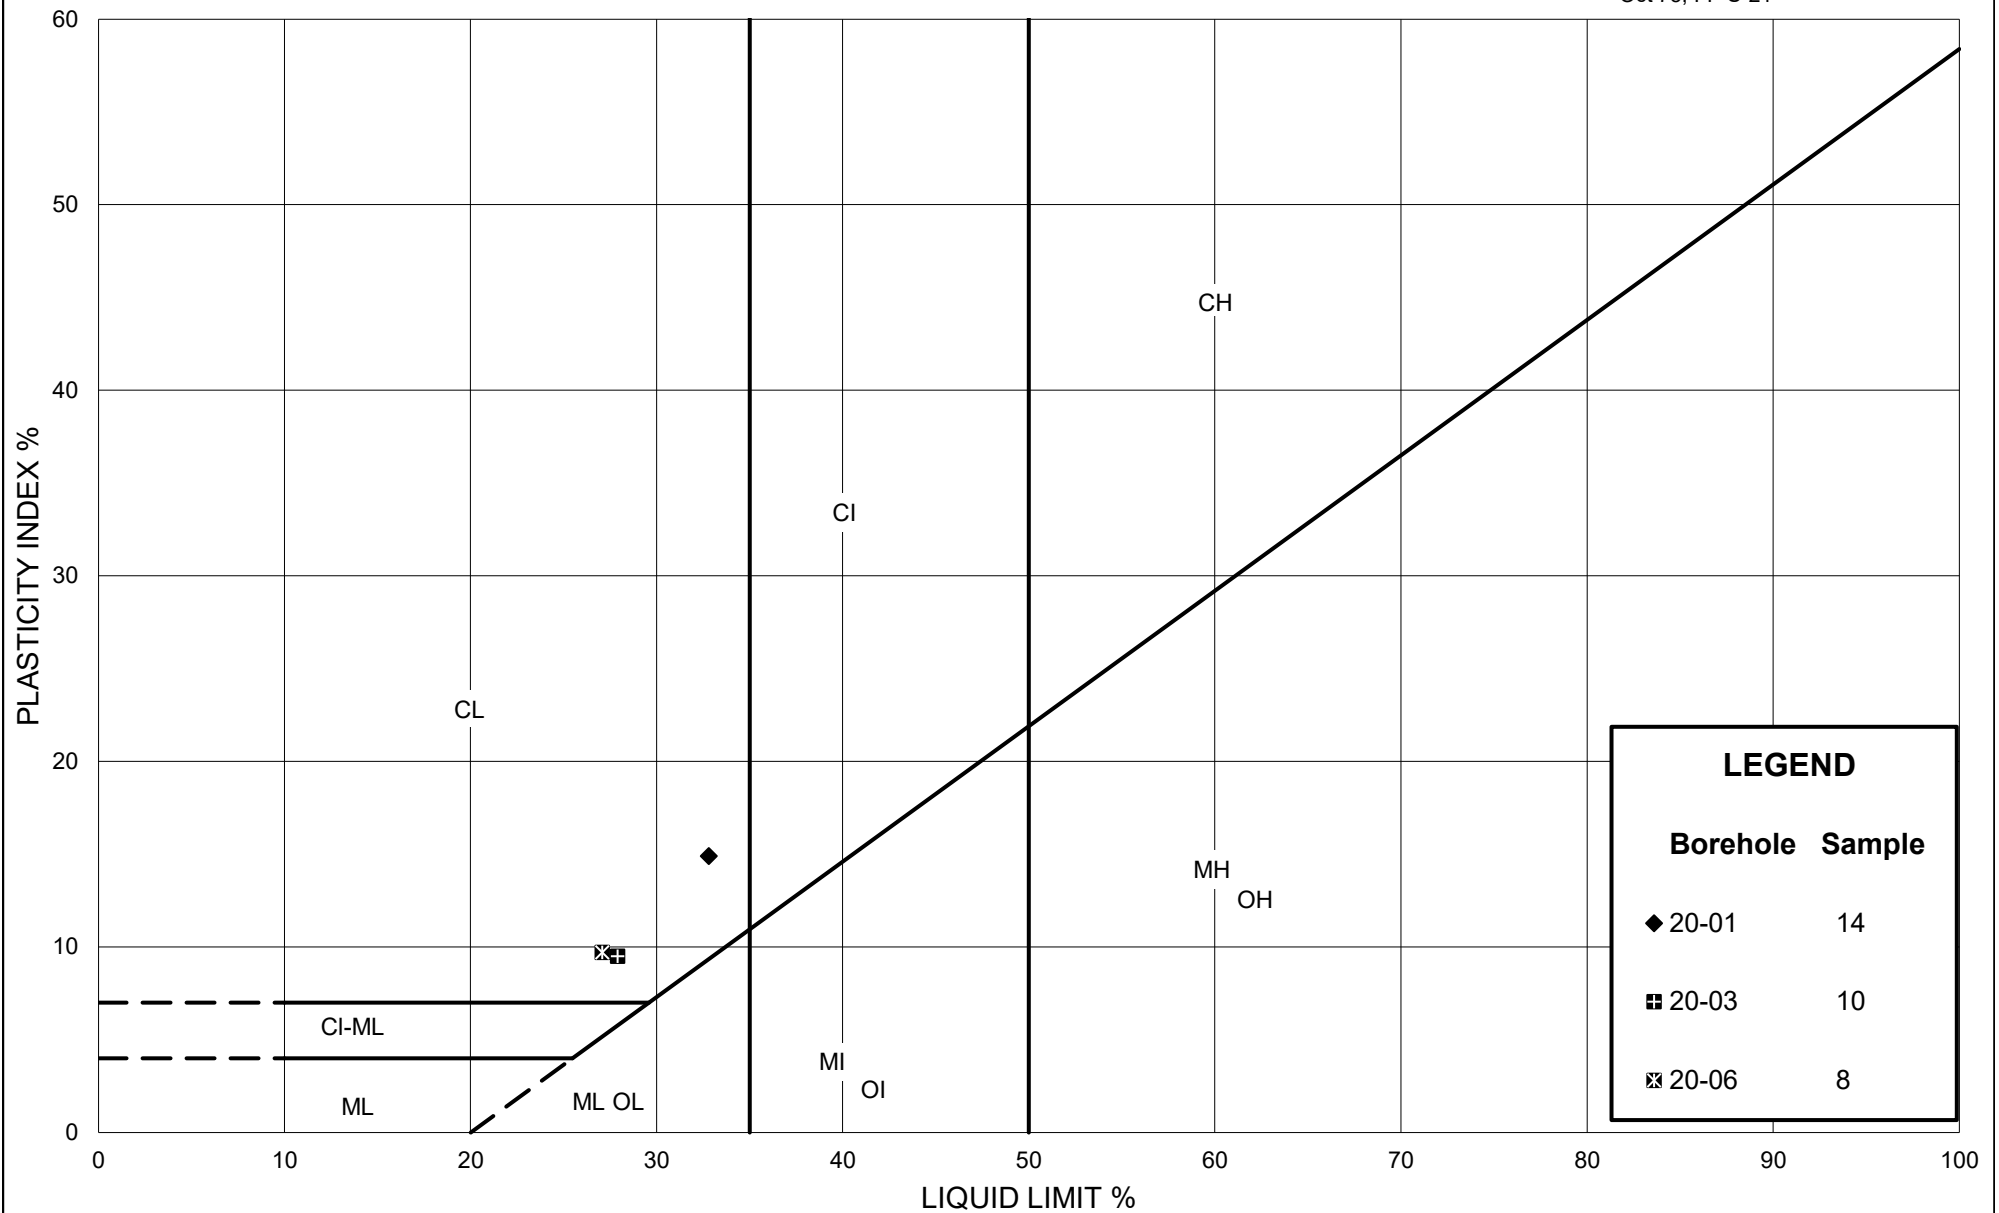
PLASTICITY CHART

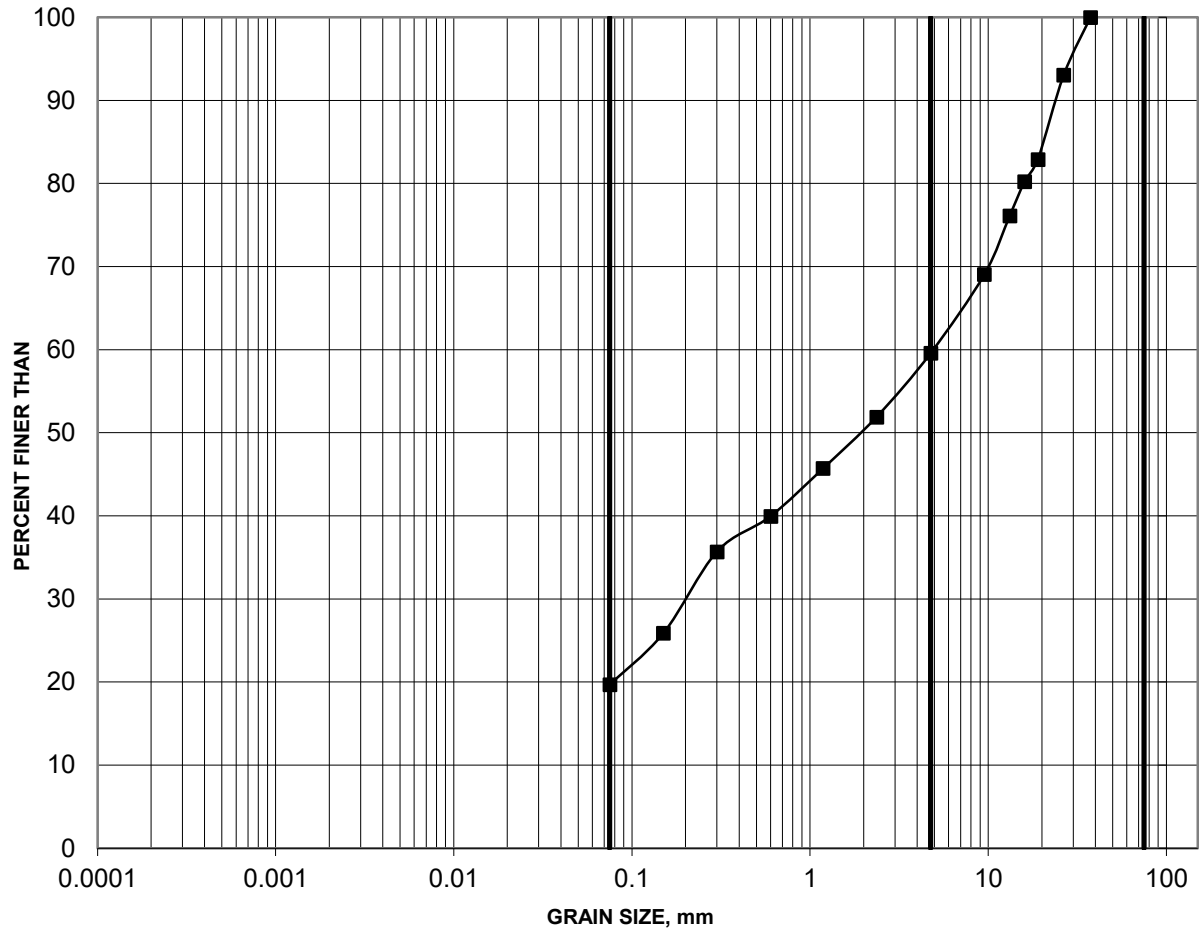
FIGURE B13

SILTY SAND AND GRAVEL (GLACIAL TILL)

Borehole	Sample	Depth (m)	Constituents (%)			
				Gravel	Sand	Silt	Clay
■	20-05	15	14.48-15.09	40	40	20

The SPT N values ranged from 7 to 57 blows per 0.3 m of penetration indicating a loose to very dense state of compactness. The measured moisture content of the sample tested was 8%. The results of grain size analysis testing carried out on a single sample of this material are provided on Figure B13 in Appendix B.

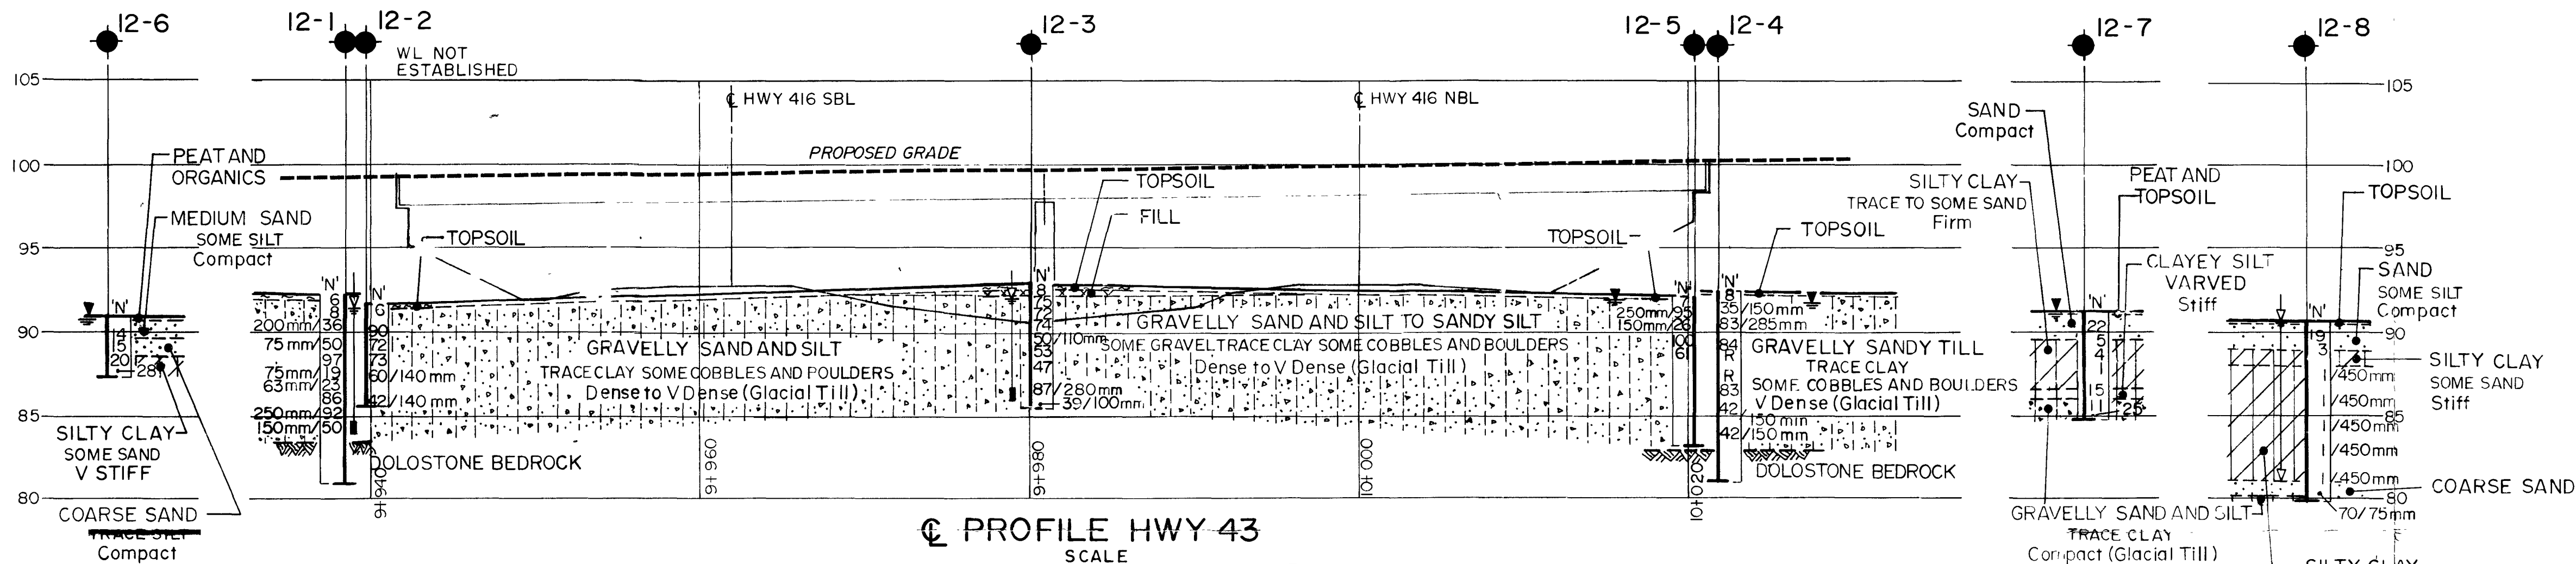
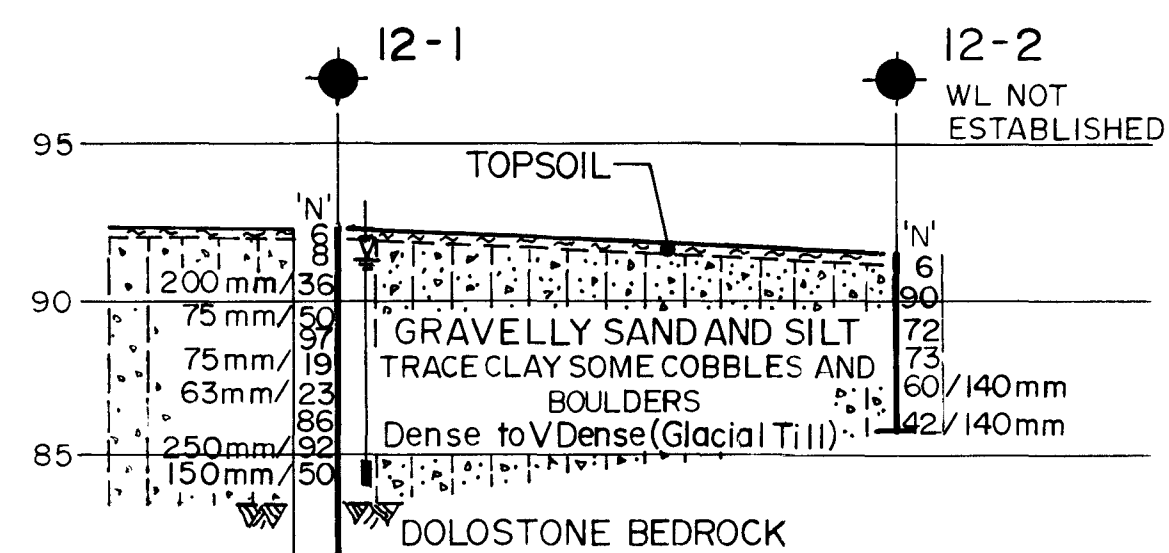
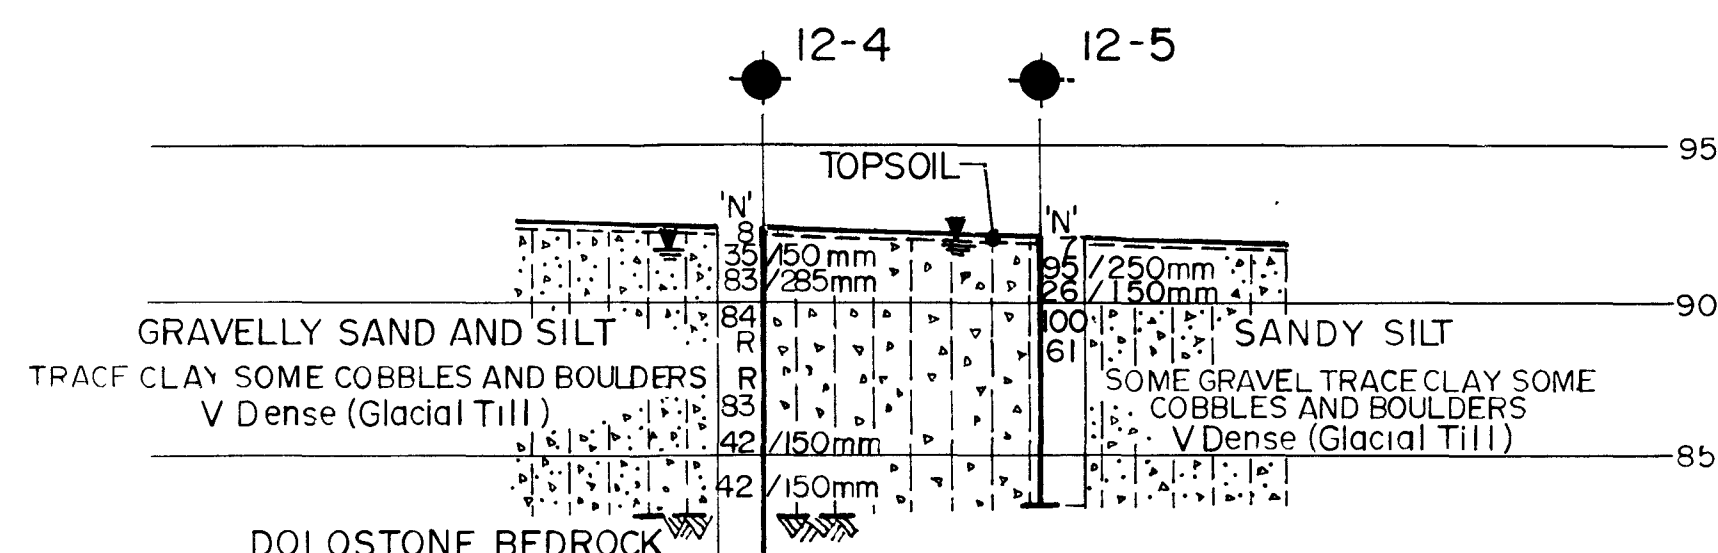
Previous Investigation GEOCREs No. 31G-205
Bore Hole Locations & Soil Strata Drawing
Record of Boreholes 12-1 to 12-8
Sheet 346 Highway 43 Underpass Bridge 12
Highway 416 General Arrangement Drawing

PLAN

PROFILE HWY 43

A total of eight boreholes were advanced at the site as part of the original investigation along the then proposed CR43 bridge alignment over Highway 416. The subsurface soil, bedrock and groundwater conditions encountered in the boreholes and the results of in-situ testing from the previous investigation are given on the Record of Borehole presented in Appendix C. The borehole locations and the interpreted stratigraphic profiles projected along the proposed alignment provided on Drawing 372-89-06-A also presented in Appendix C.

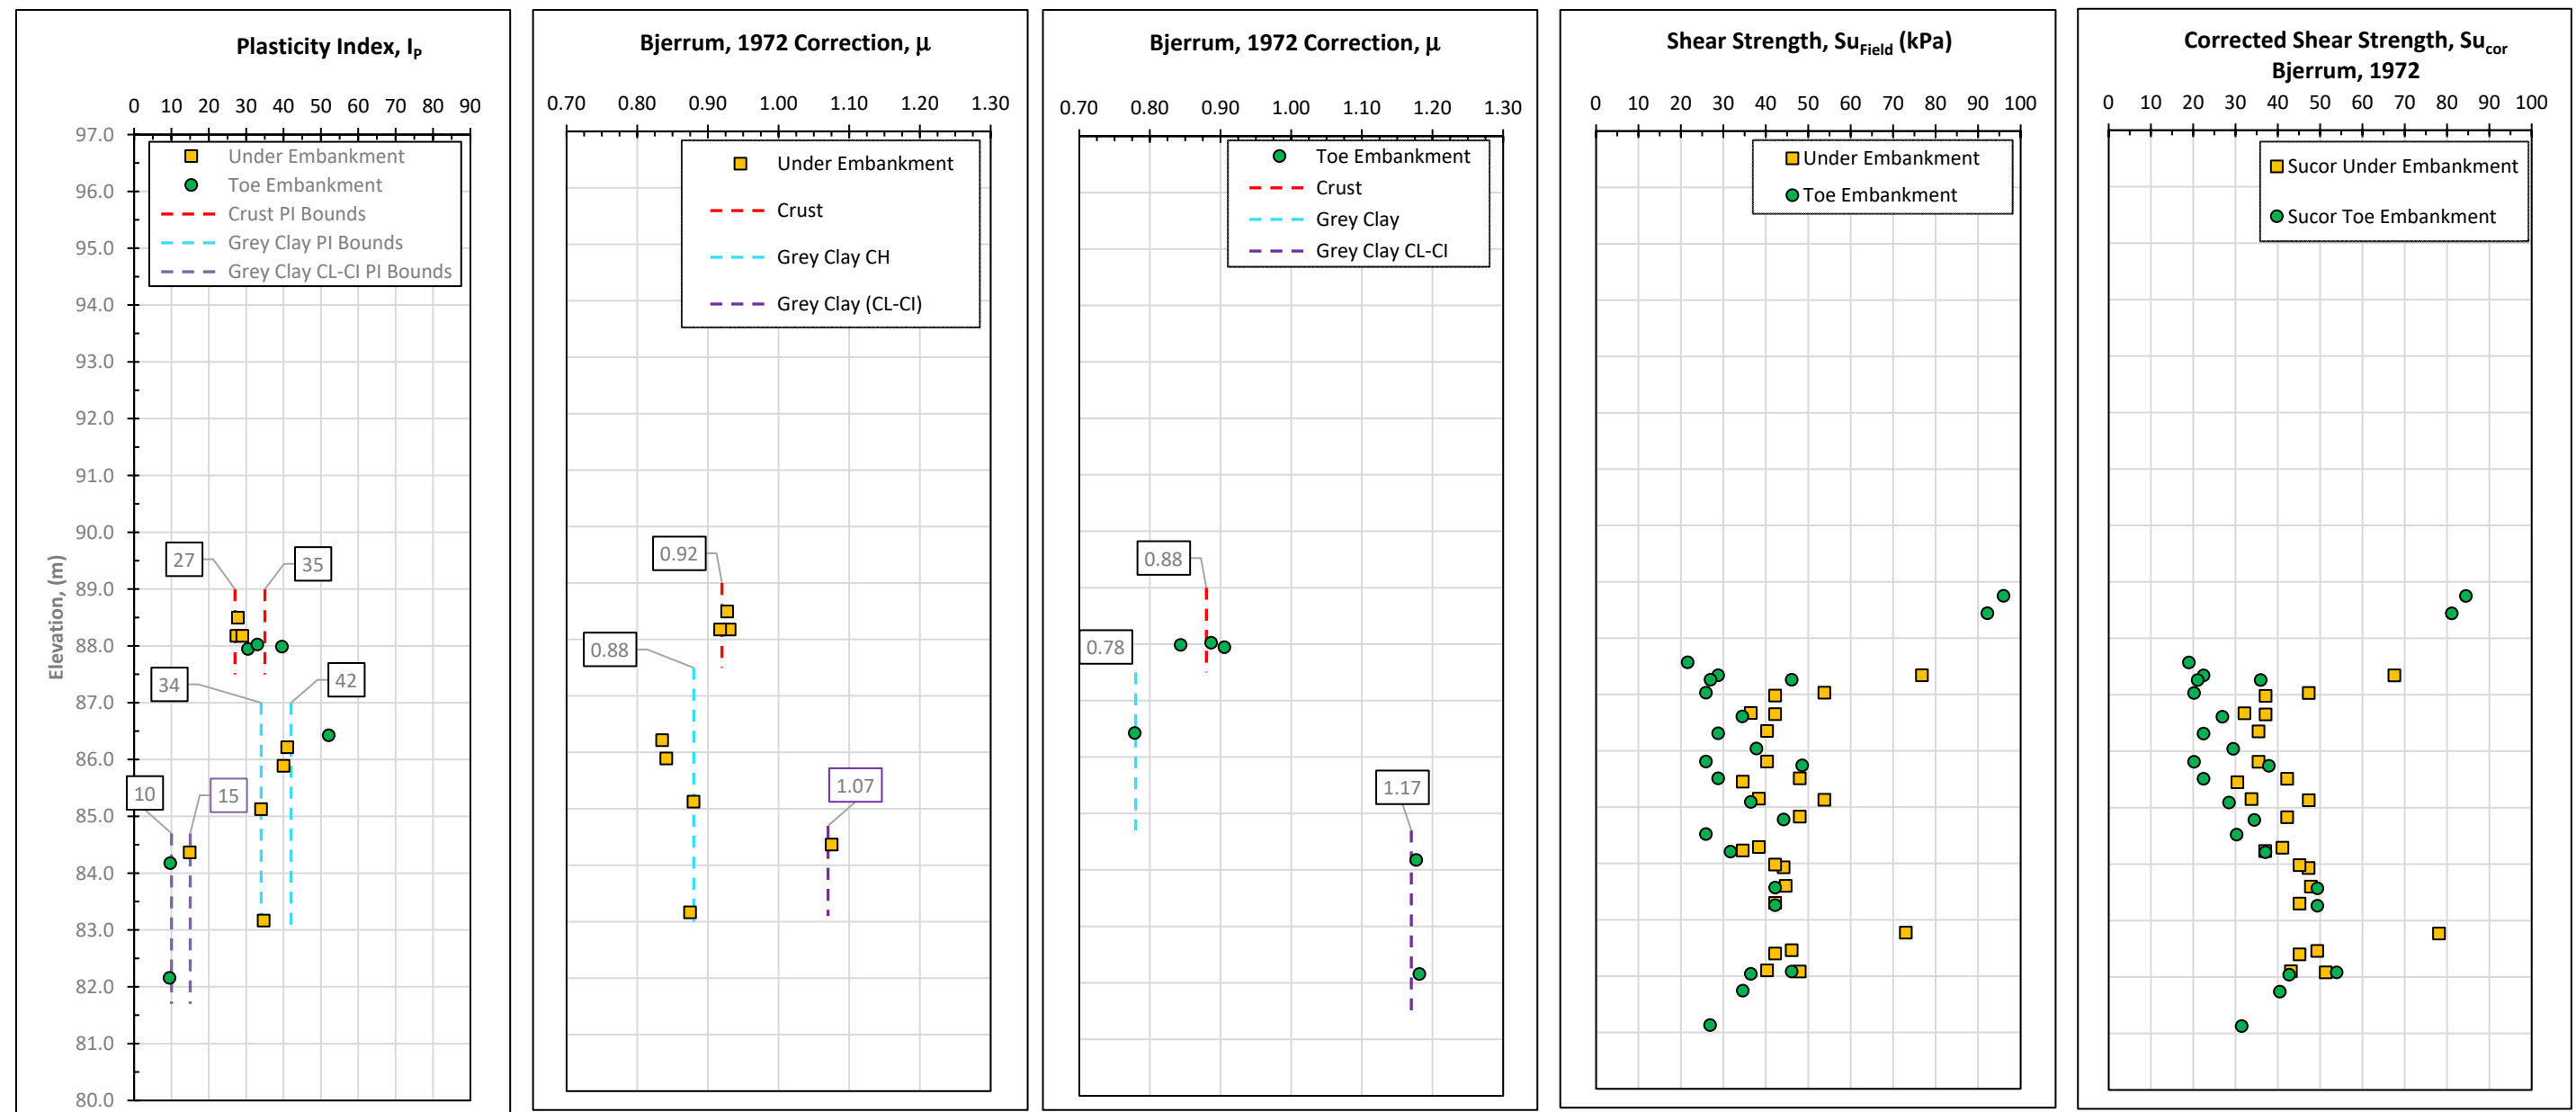
FIGURE B

Foundation Investigation and Design
Highway 416 Underpass at County Road 43
Corrected Shear Strength Bjerrum, 1972

As shown on the Plot 1 on Figure B in Appendix E, there is a variation in the plasticity index values throughout the clay stratigraphy. Design μ values were therefore selected based on the results of the index testing carried out for the current investigation as indicated on Plots 2 and 3 on Figure B and summarized in Table 7 for the embankment and toe of slope shear strengths, respectively.

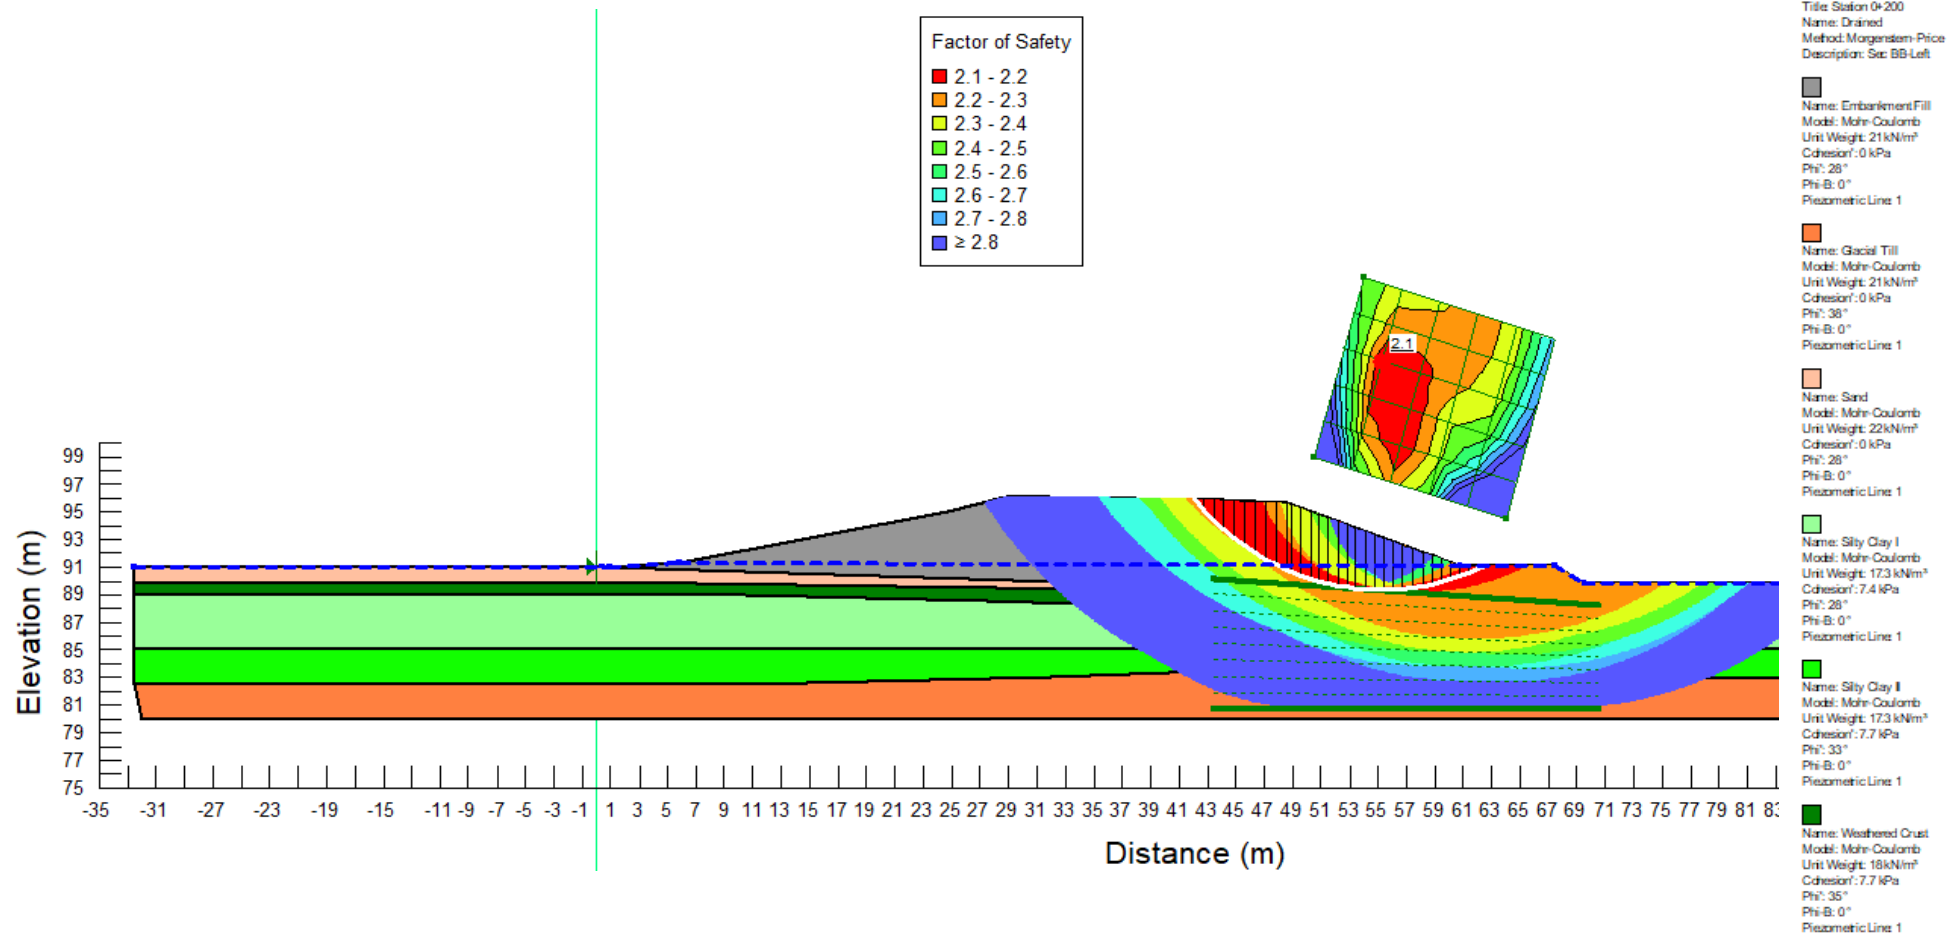
Section BB

Scenario 1 – Static Drained Analysis

Foundation Investigation and Design
 Highway 416 Underpass at County Road 43
 Slope Stability Assessment

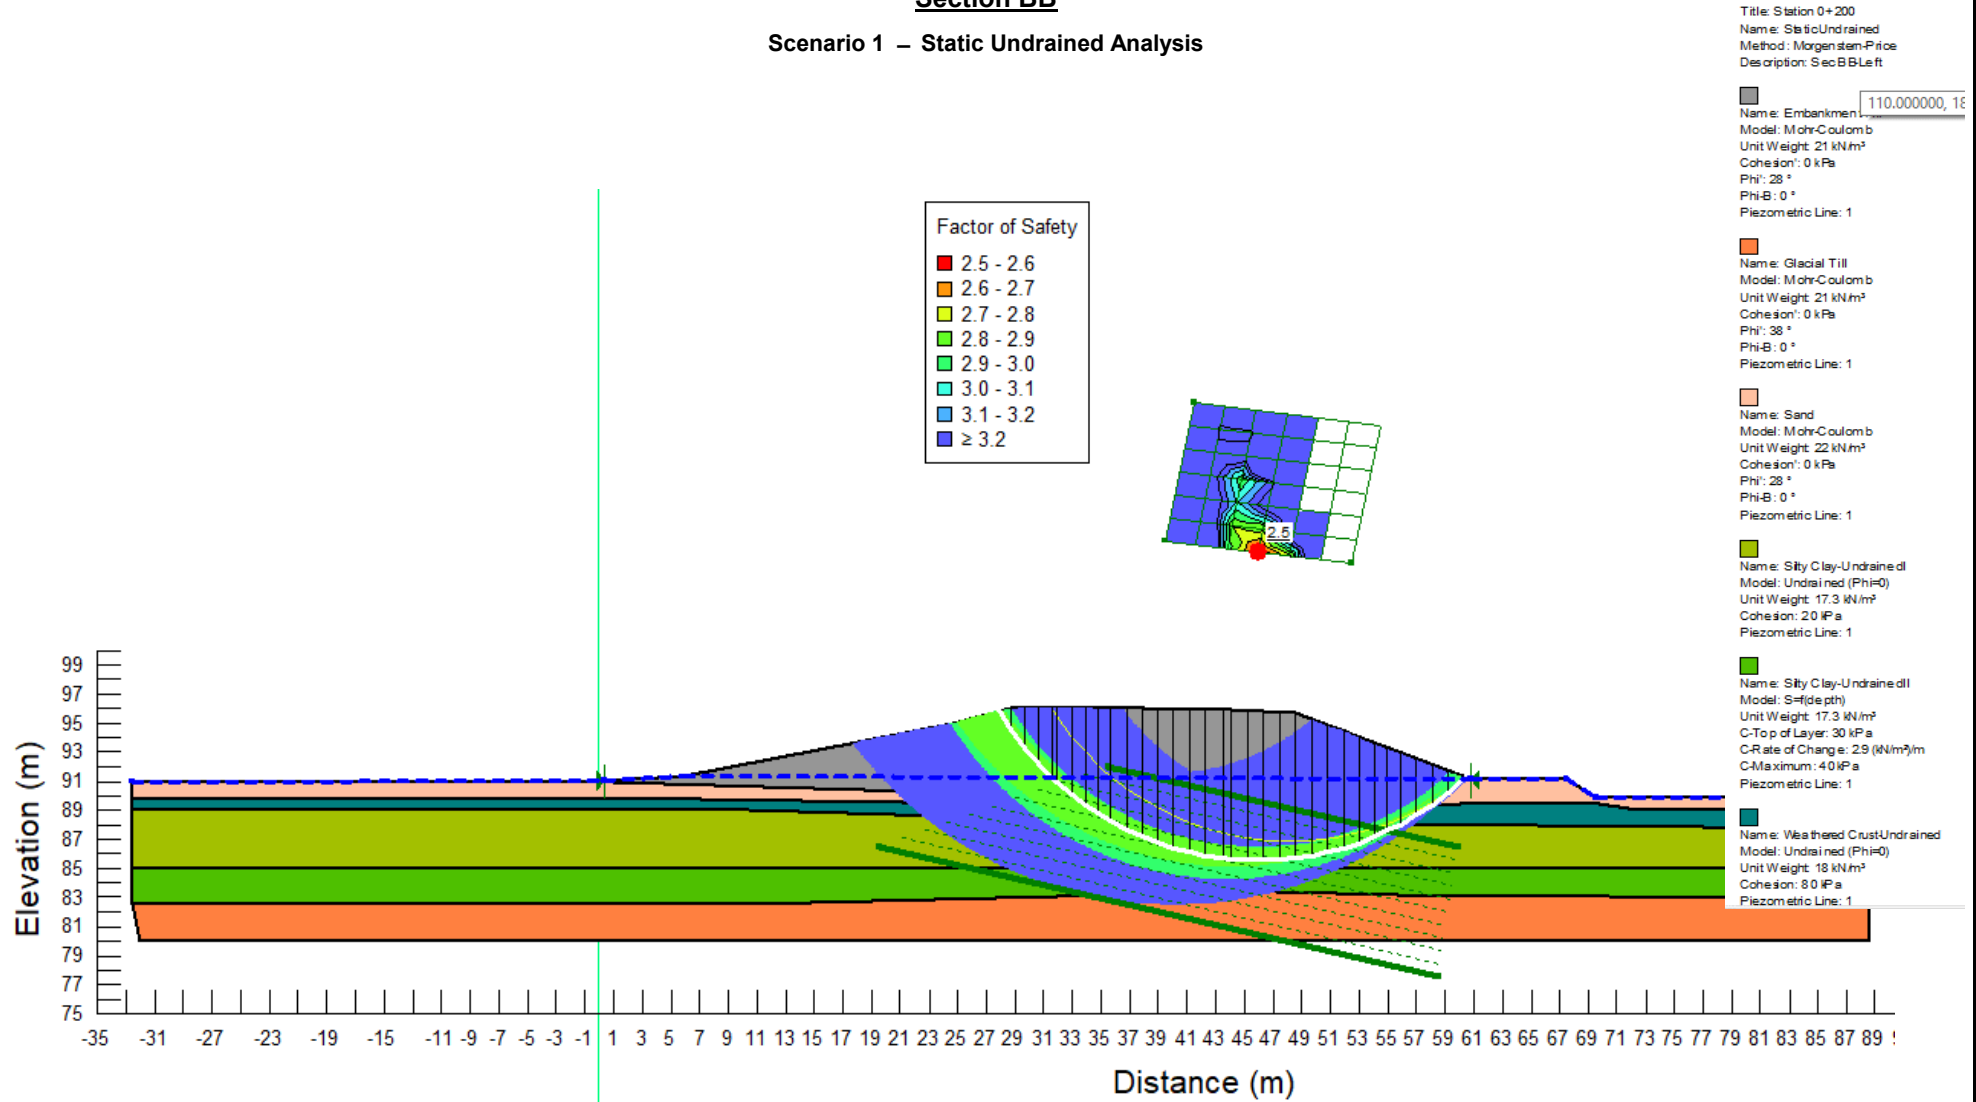
Scenario 1 – Static Undrained Analysis

Foundation Investigation and Design
Highway 416 Underpass at County Road 43
Slope Stability Assessment

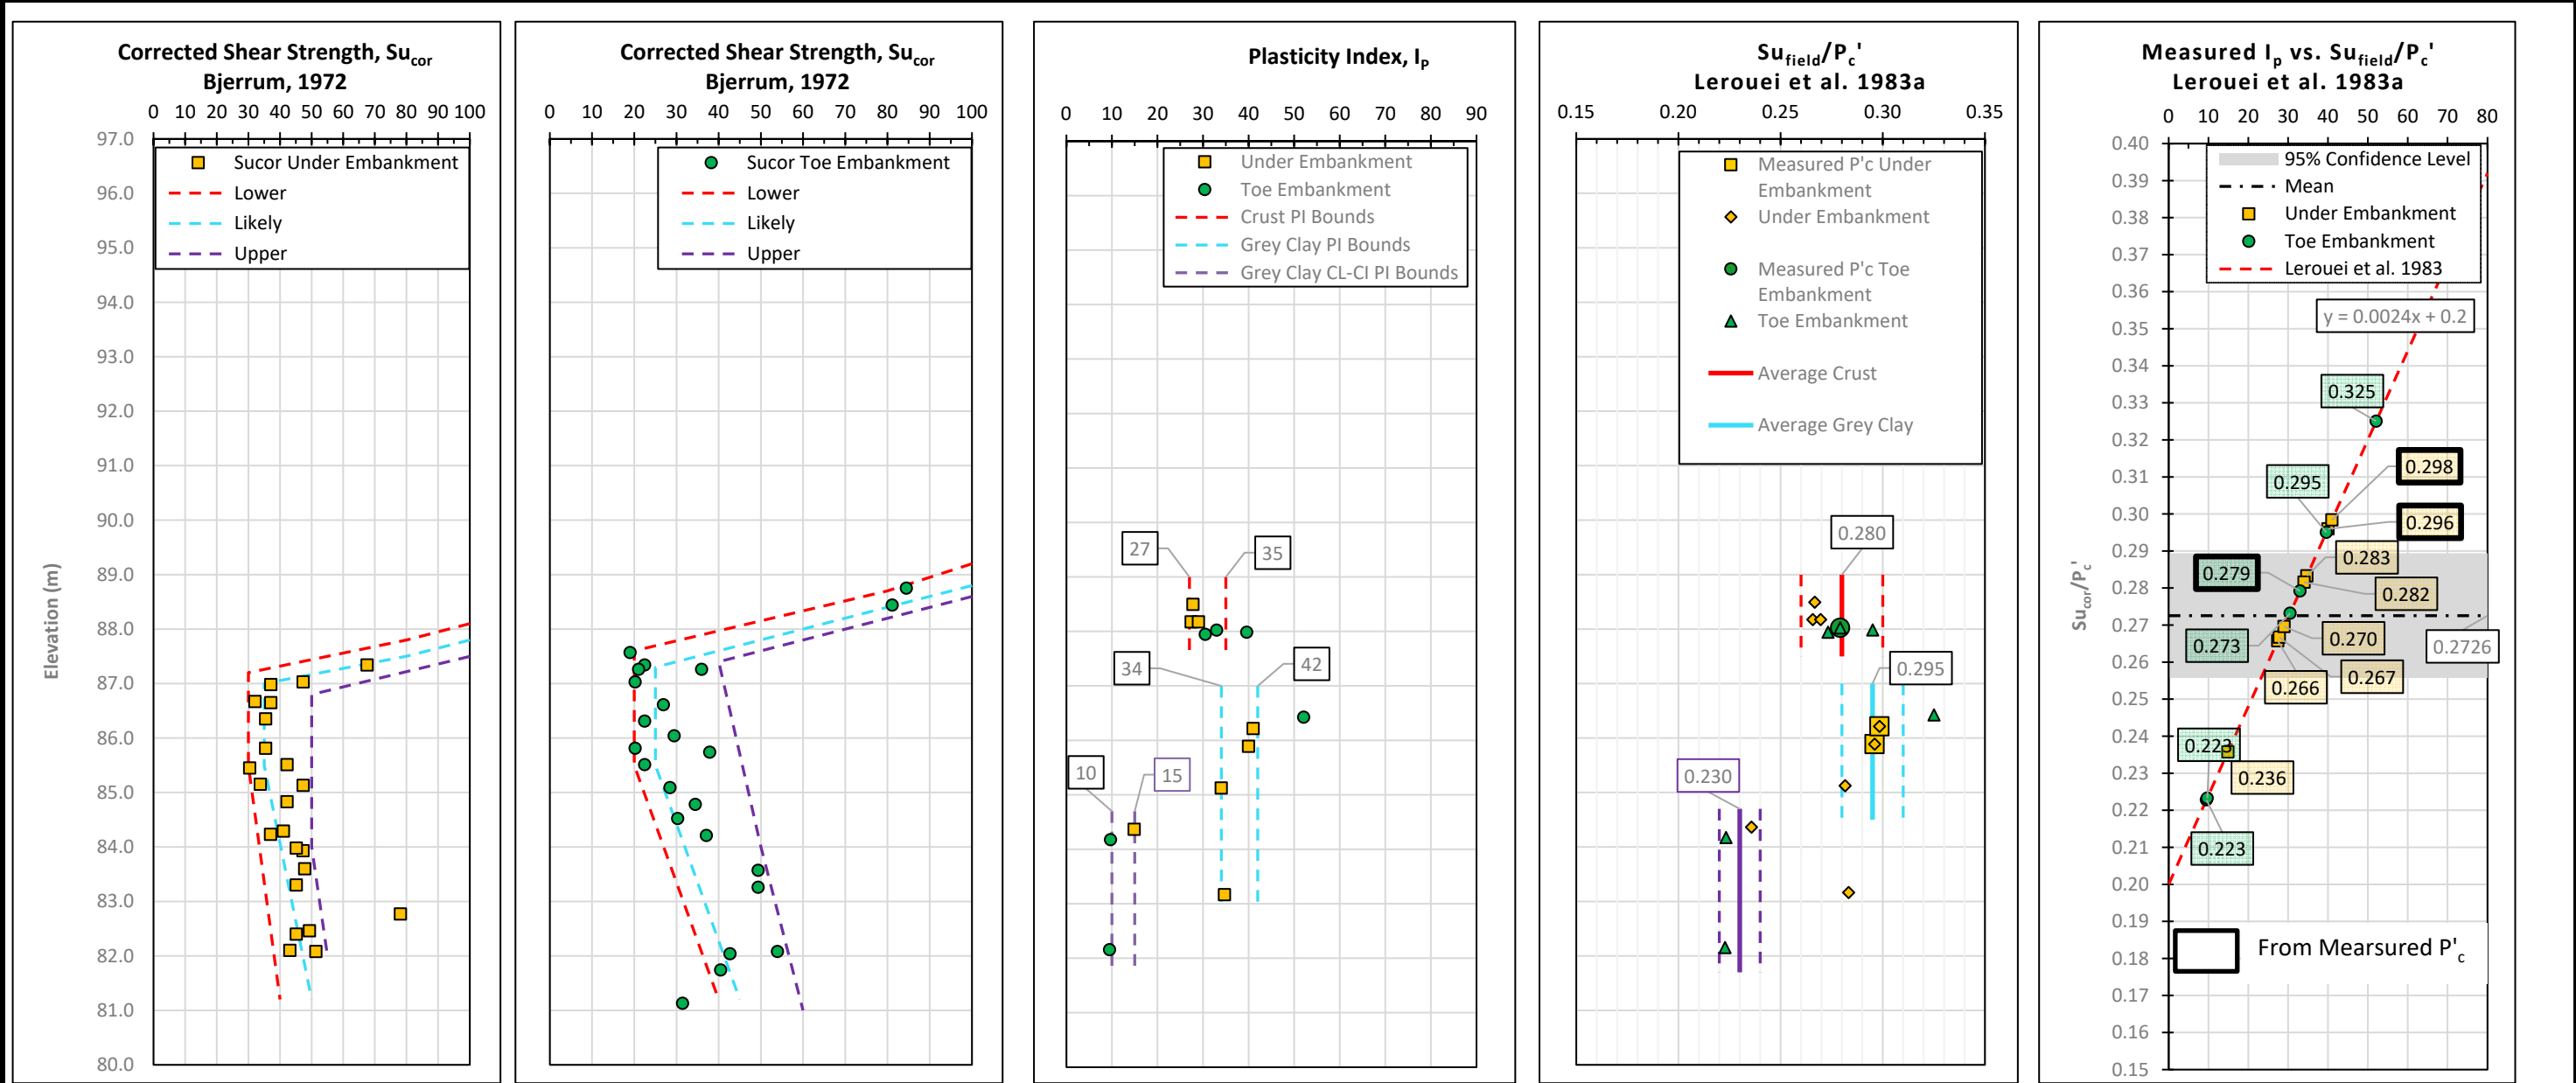
FIGURE D

Foundation Investigation and Design
Highway 416 Underpass at County Road 43
Preconsolidation Pressure & Lerouei et al. 1983a
