**FOUNDATION INVESTIGATION REPORT
BUG RIVER BRIDGE REPLACEMENT
HIGHWAY 105, RED LAKE DISTRICT, ONTARIO
G.W.P. 6942-10-00, SITE 41N-2**

Geocres Number: 52K-8

October 16, 2012
File: 19-5308-40

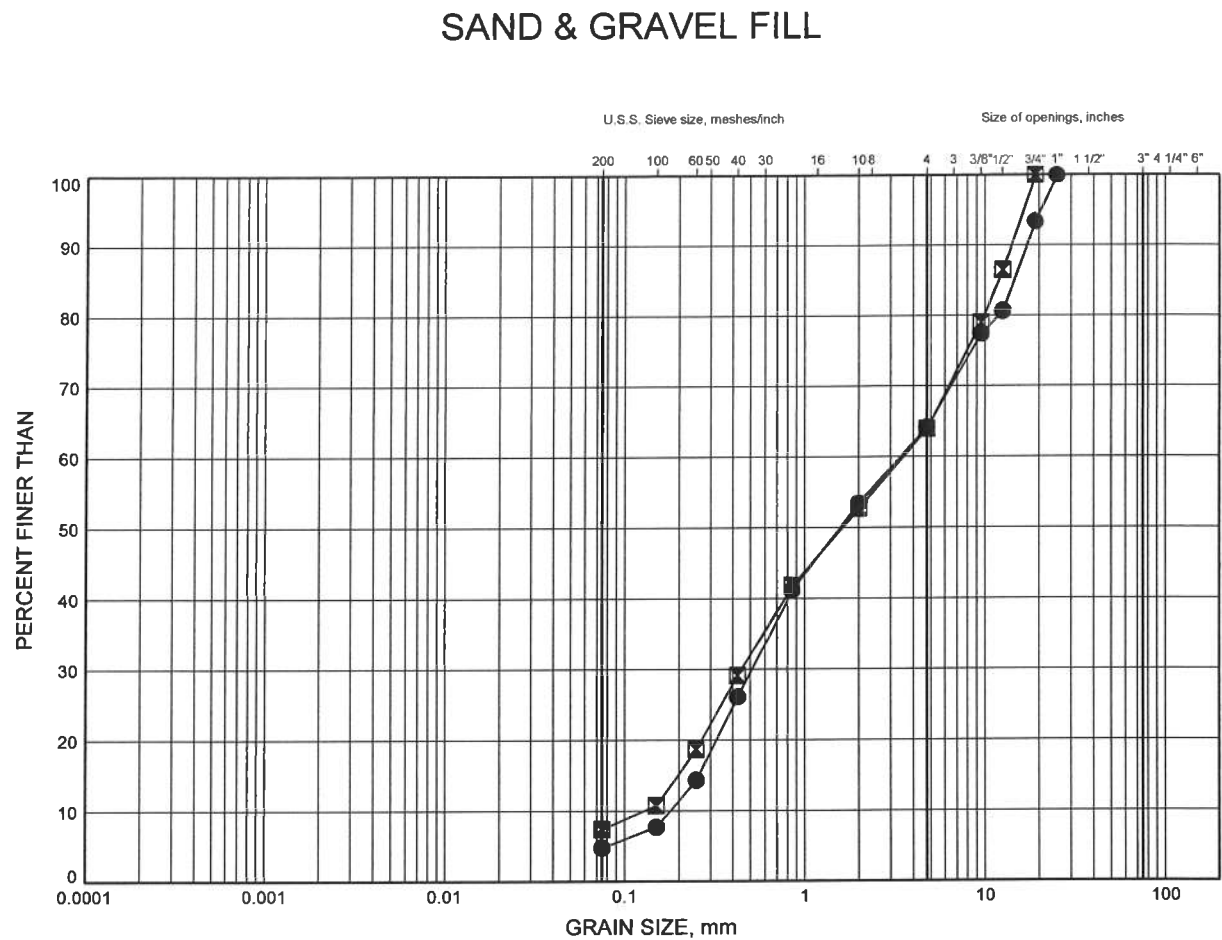
FIGURE B1

GRAIN SIZE DISTRIBUTION

The recovered soil samples were subjected to Visual Identification (VI) and to natural moisture content determination. Selected samples were also subjected to gradation analysis (hydrometer and sieve) and Atterberg Limits tests, where appropriate. The results of these tests are summarized on the Record of Borehole sheets included in Appendix A and are presented on the figures included in Appendix B.

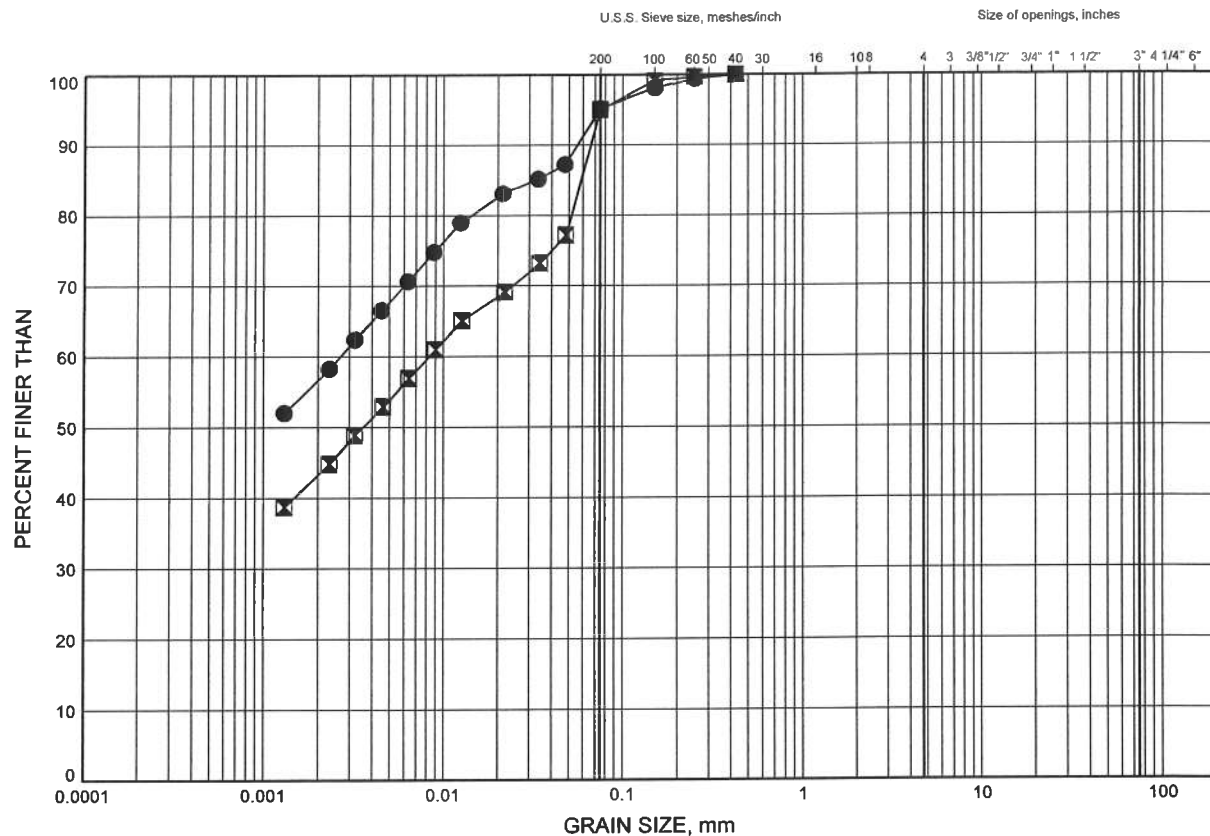
FIGURE B2

SILTY CLAY

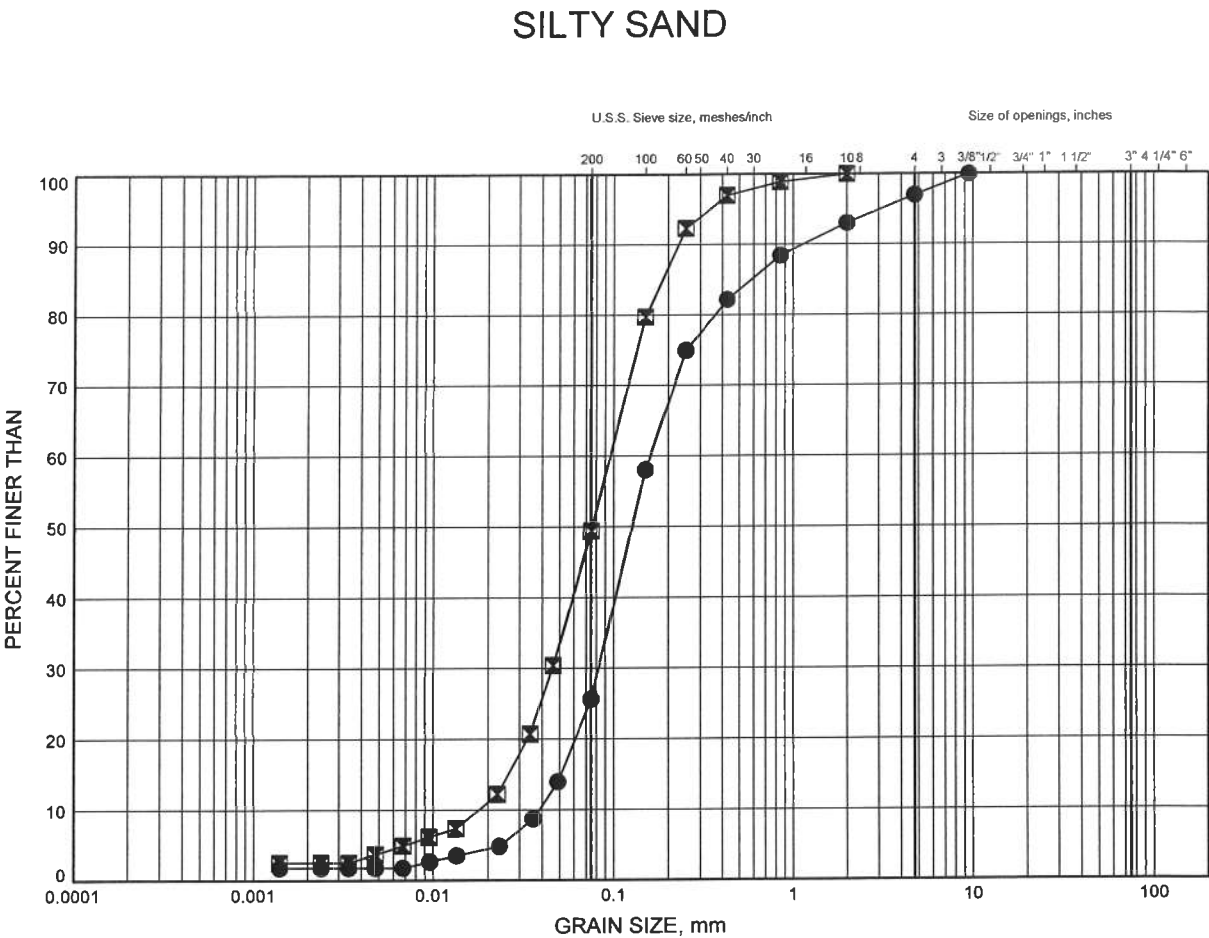
FIGURE B3

GRAIN SIZE DISTRIBUTION

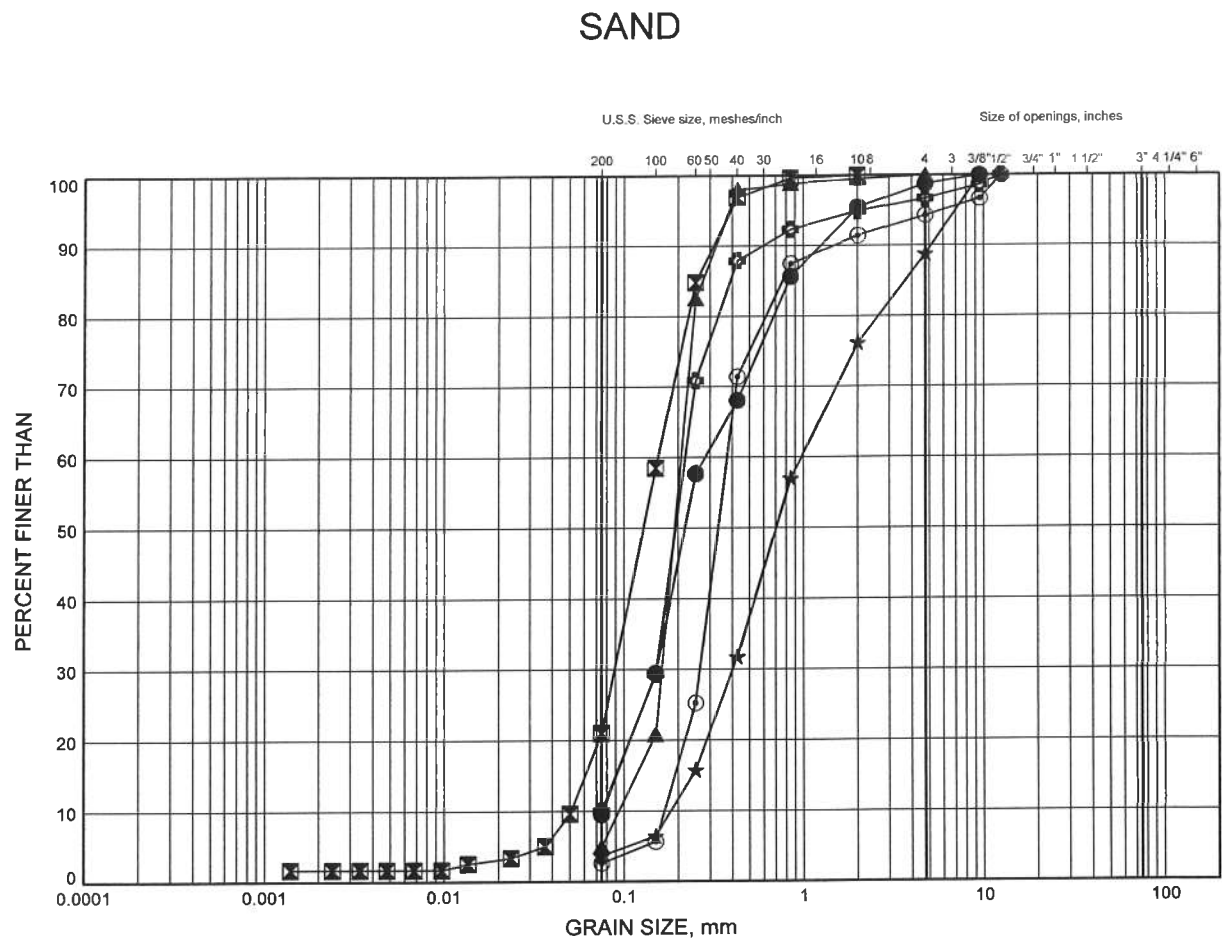
FIGURE B4

GRAIN SIZE DISTRIBUTION

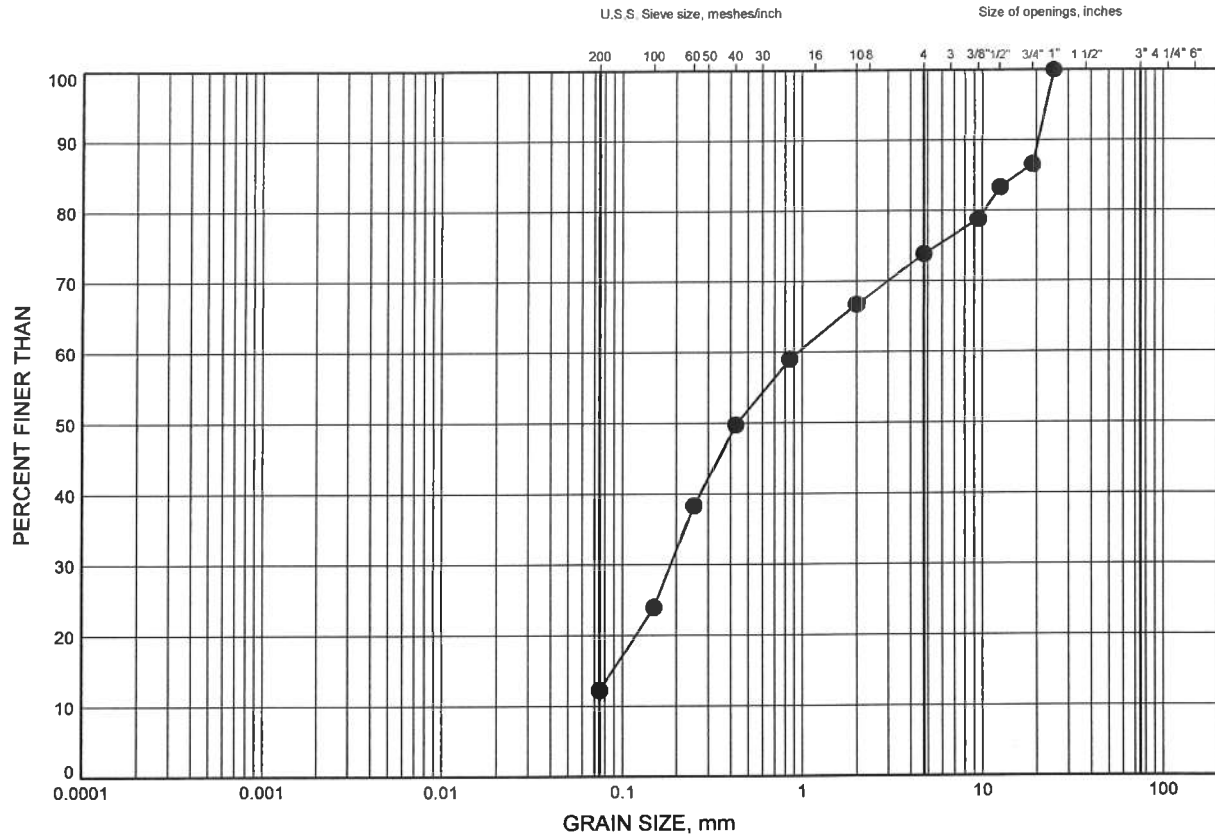
FIGURE B6

Some GRAVEL to GRAVELLY SAND

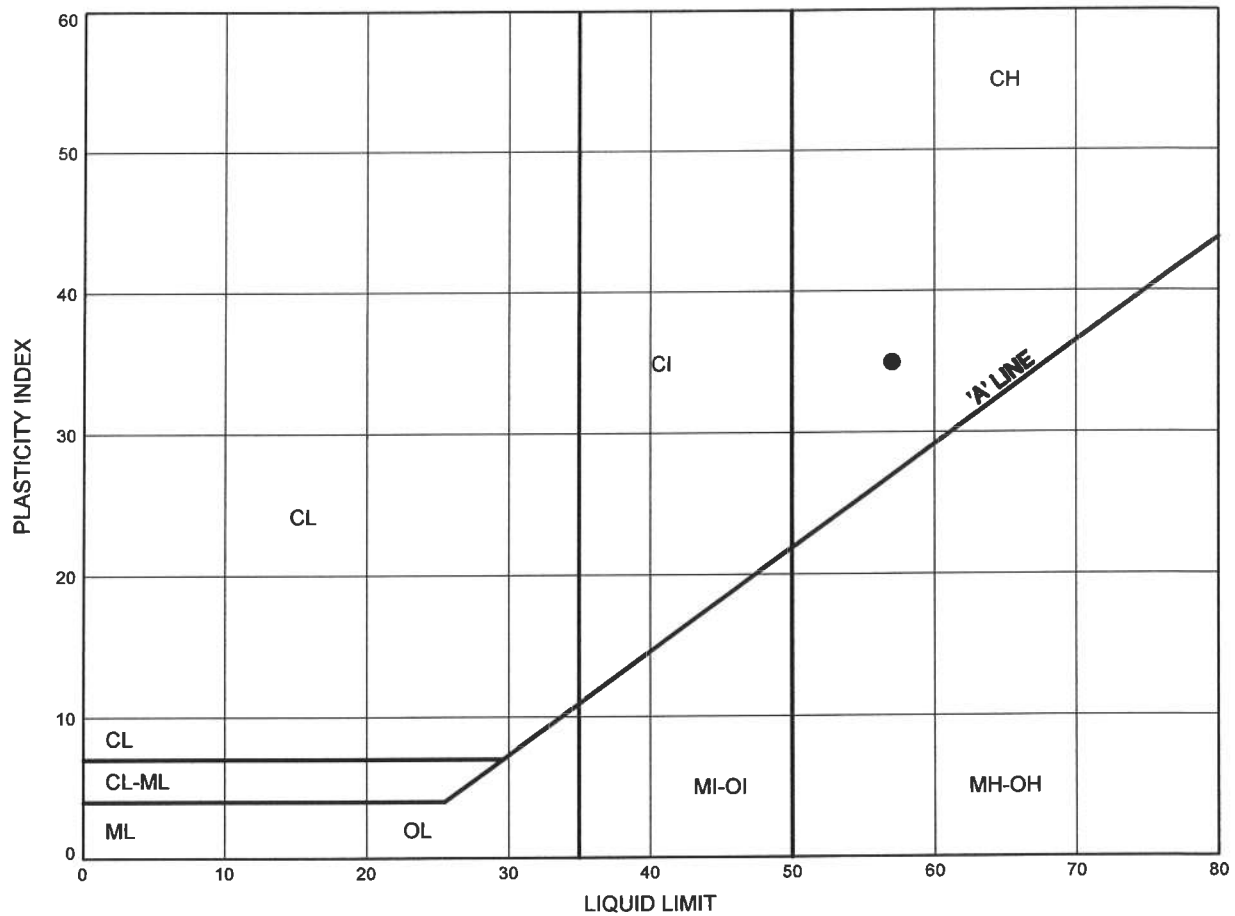
FIGURE B7

SILTY CLAY

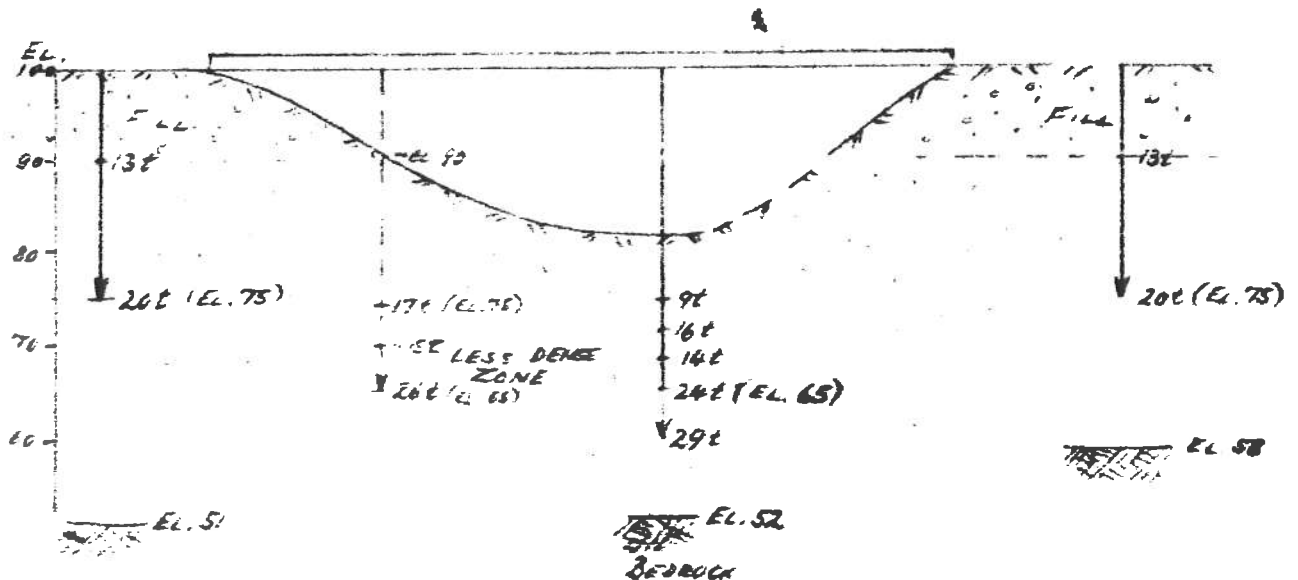
Sectional Profile with safe bearing values (F.S.=3) at Various Point Elevations for some selected pile locations

The new Big River Bridge is proposed to be founded on one foot diameter piles which will carry safely between 20 and 26 tons, each at 25' to 35' depth below the bridge deck, depending on the pile locations as shown on enclosure 4, 1-10. The allowable load per pile for a spacing of three diameters, at which the foundation acts like a deep long footing, would be of the order of 15 tons for $\frac{1}{4}$ inch of differential settlement tolerated. Utilising the safe bearing values of 20 to 26 tons or more would only increase the settlement proportionately.

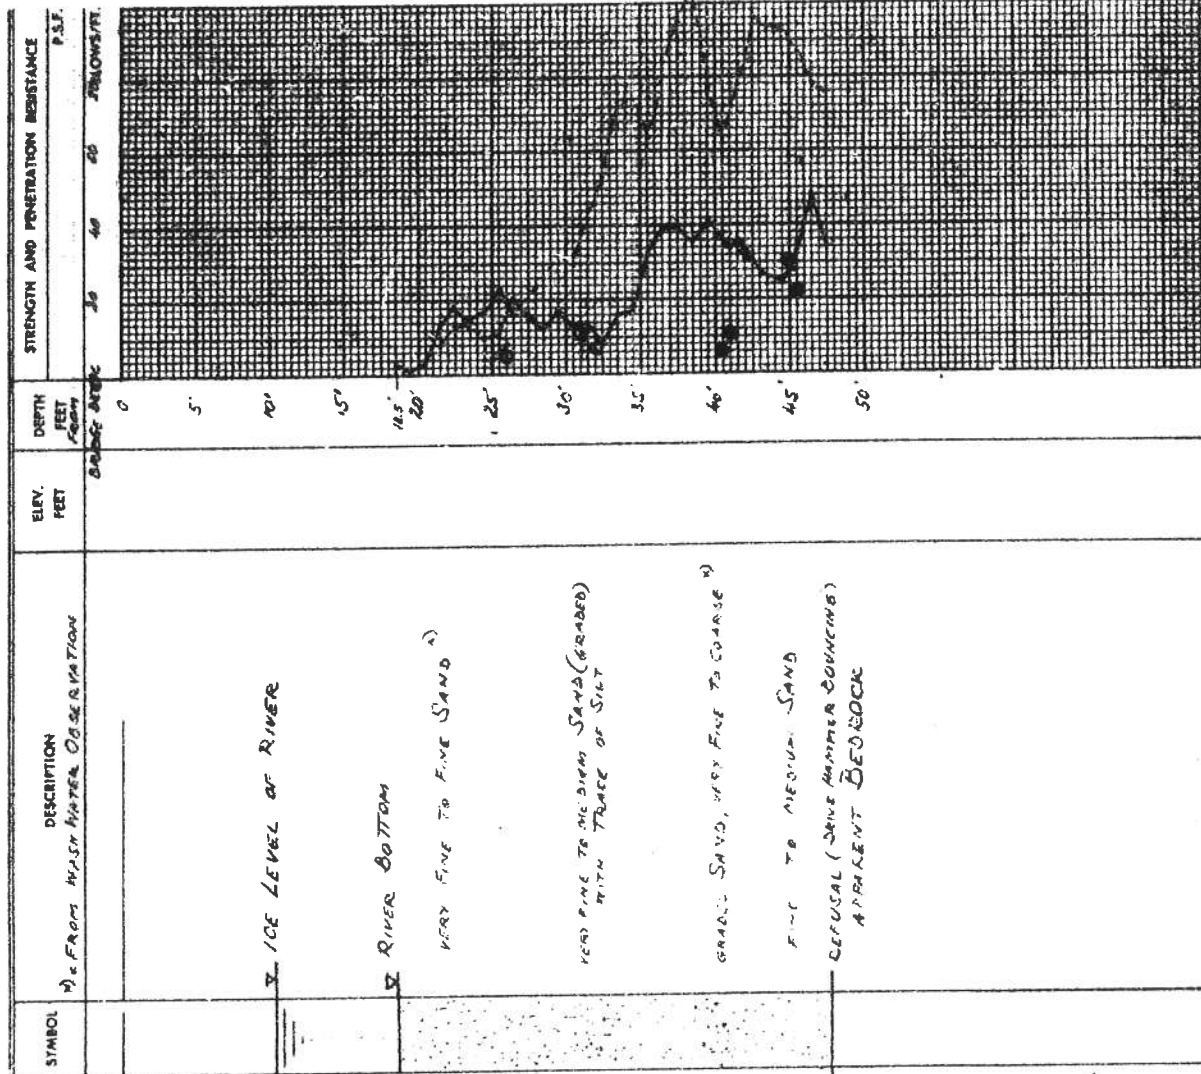
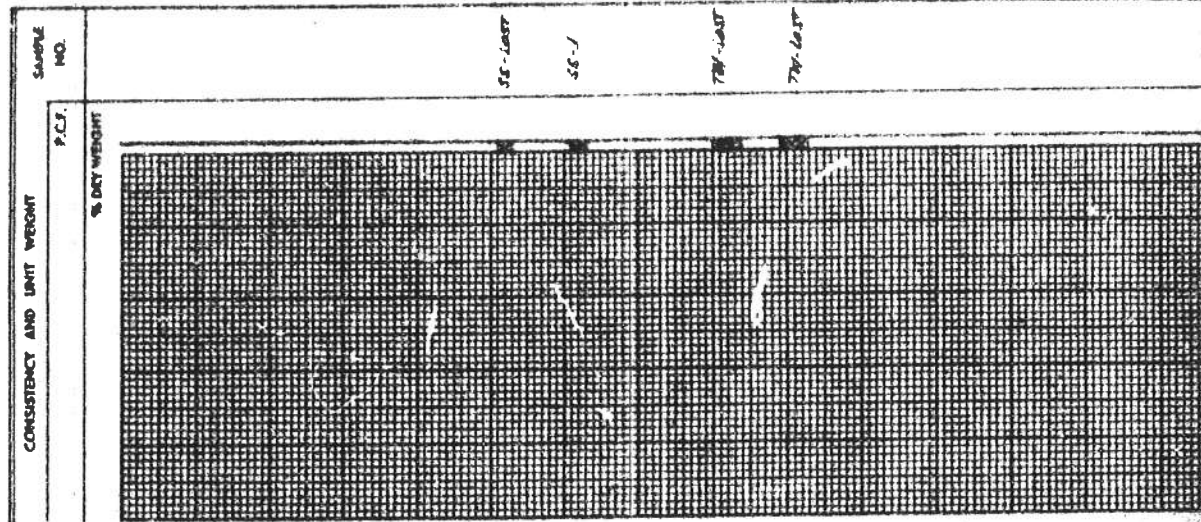
Engineering Data Sheet for Borehole: 3

Project: PROPOSED NEW BUG RIVER BRIDGE
 Location: HWY. 105, RED LAKE DISTRICT, ONT.
 Hole Location
 Hole Elevation and Datum
 Field Work Begun APRIL 14th, 1958 Ended APRIL 16th, 1958 Date
 Field Supervisor R. CASE
 Driller M. LINTON
 Prep: K. T.
 Checked: K. TURBESING

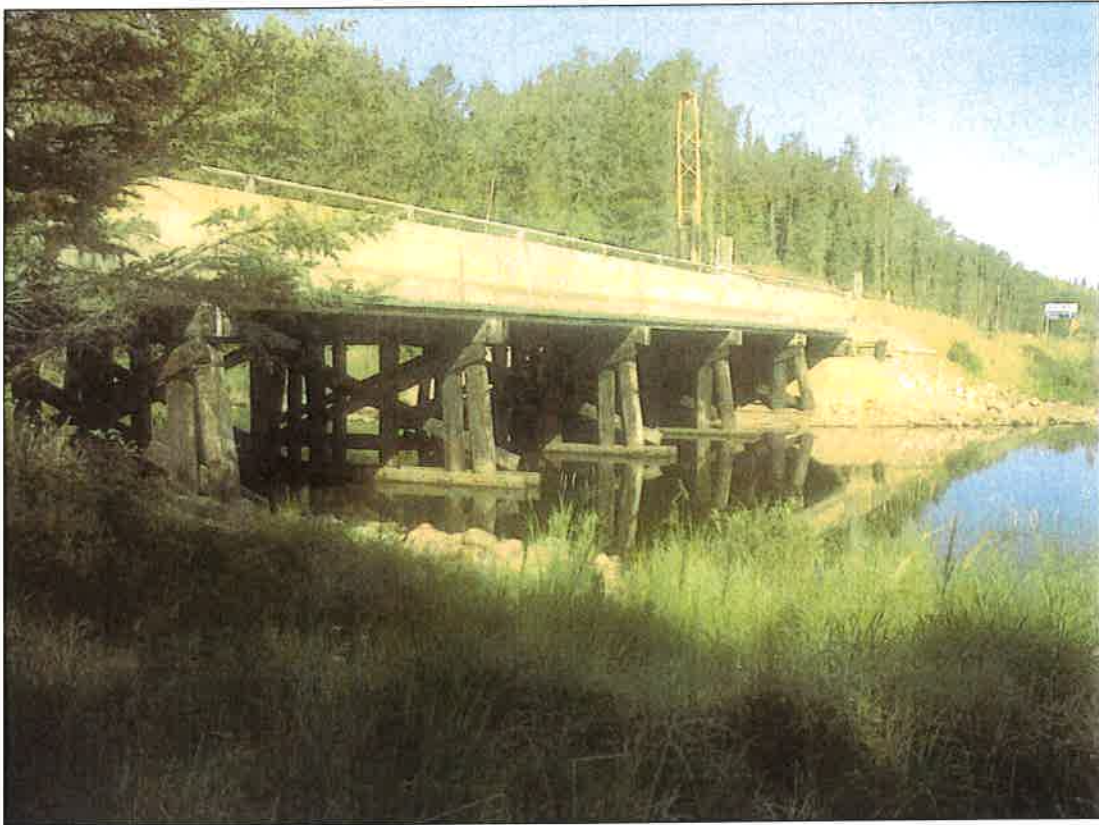
Photograph 3 –Bug River Bridge

Selected photographs in Appendix D show the general nature of the surrounding land and the existing bridge structure. Photos of the site indicate presence of rock fill on the forward and side slopes below the existing abutments. It is not confirmed if this rockfill is for erosion control purposes or whether the embankments contain rockfill.

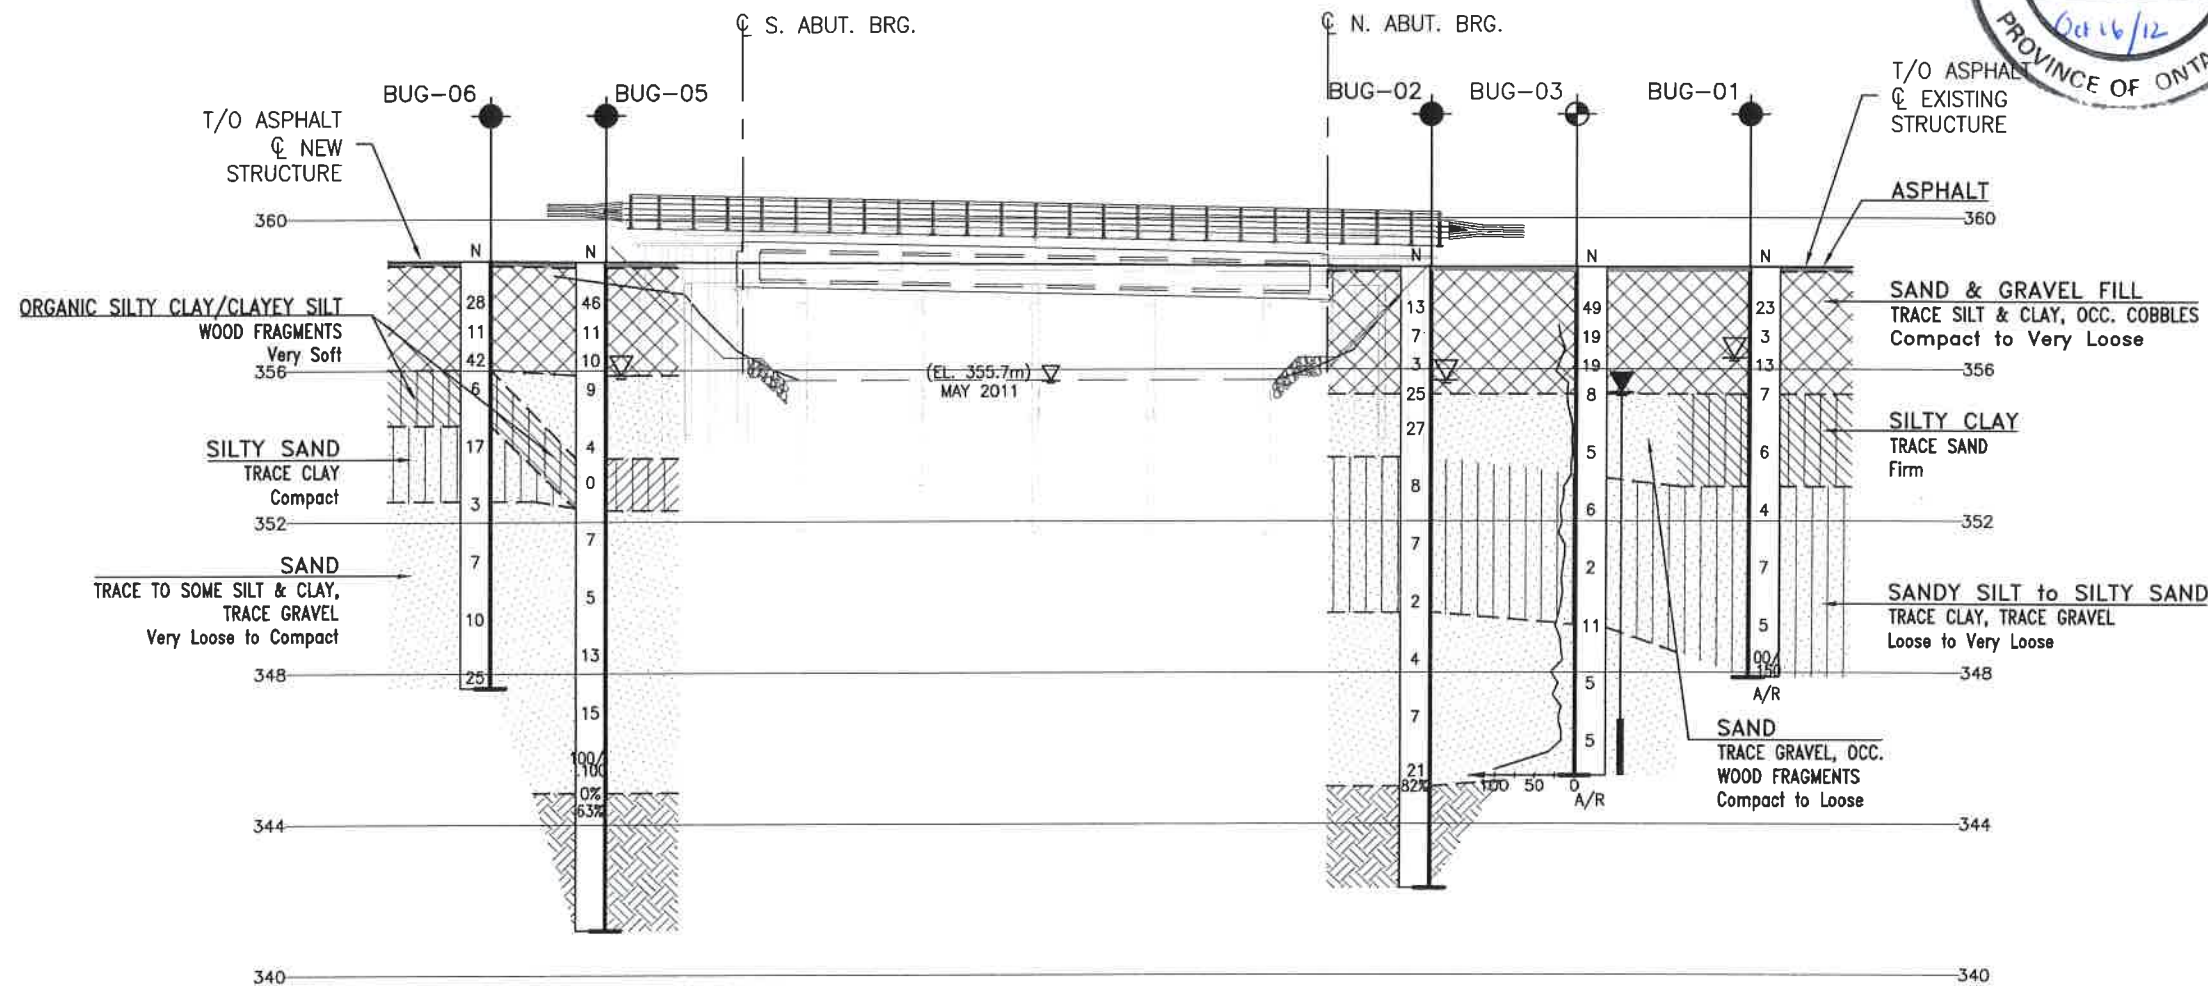
BUG RIVER BRIDGE
REPLACEMENT
HIGHWAY 105
BOREHOLE LOCATIONS AND SOIL STRATA

PROFILE ALONG ϕ HWY. 105

The approximate locations of the boreholes drilled for the current investigation are shown on the attached Borehole Locations and Soil Strata Drawing included in Appendix E. The boreholes were drilled behind the existing abutment locations. The latest General Arrangement (GA) drawing shows that the proposed abutments are located about 3.0 m to 4.0 m in front of the existing abutments. The borehole locations were marked in the field and utility clearances were obtained prior to drilling.
