**FOUNDATION INVESTIGATION REPORT
HIGHWAY 527 MAX CREEK CULVERT
89 KM NORTH OF HIGHWAY 11/17, THUNDER BAY UNORGANIZED
SITE NO.: 48C-222/C
ASSIGNMENT NO. 6017-E-0013**

G.W.P. 6827-14-00

Geocres No.: 52H-45

December 2018
Thurber File: 19773

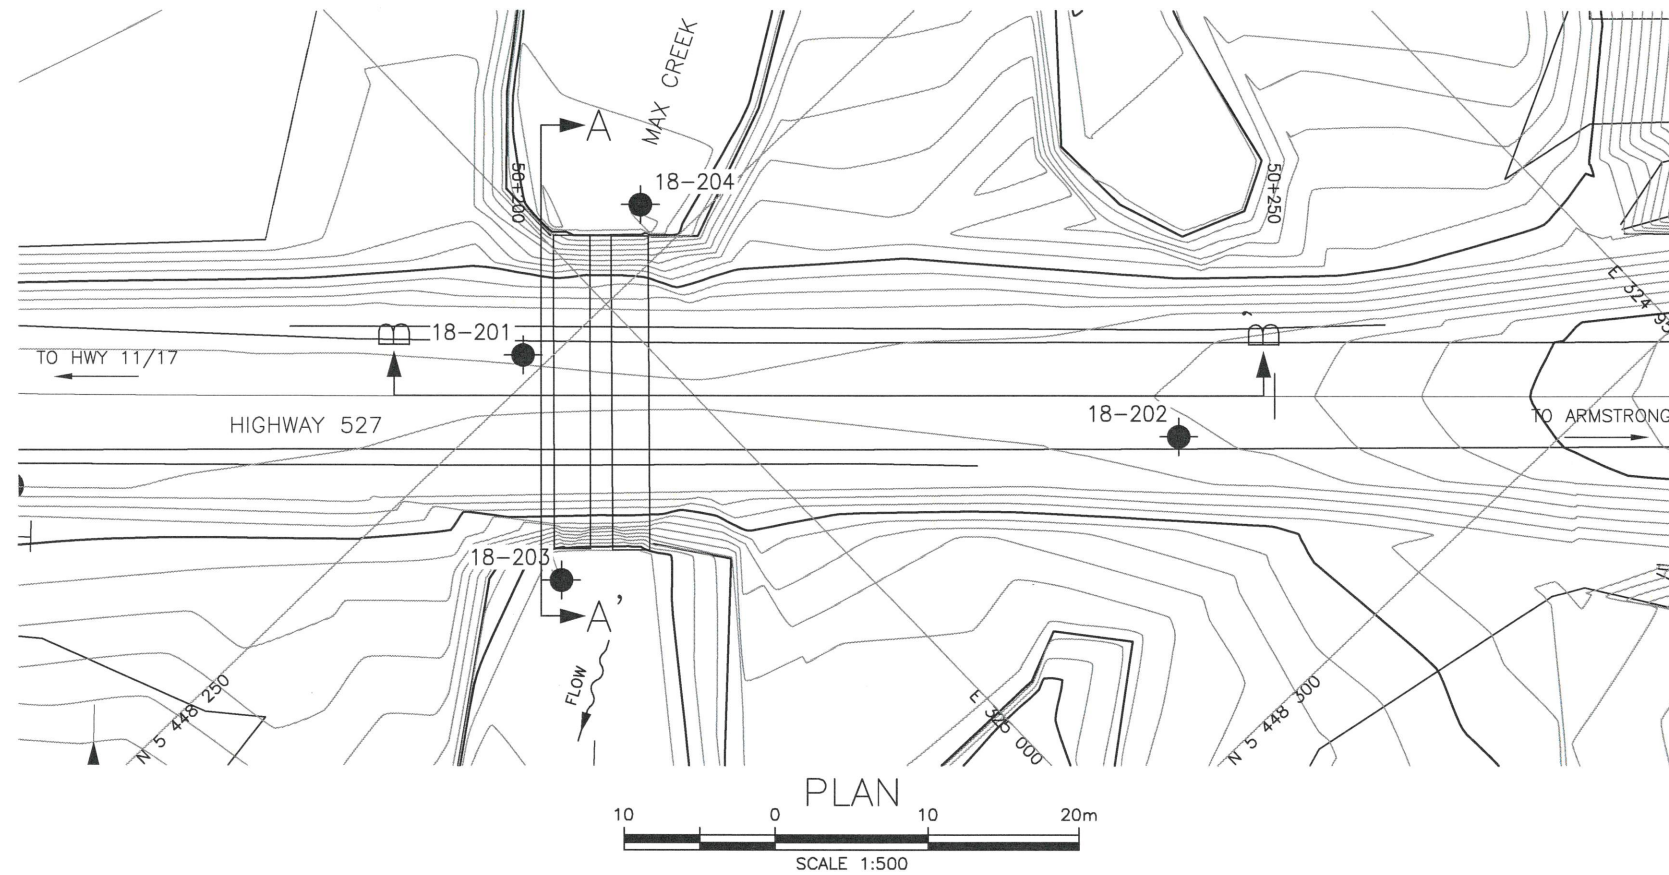
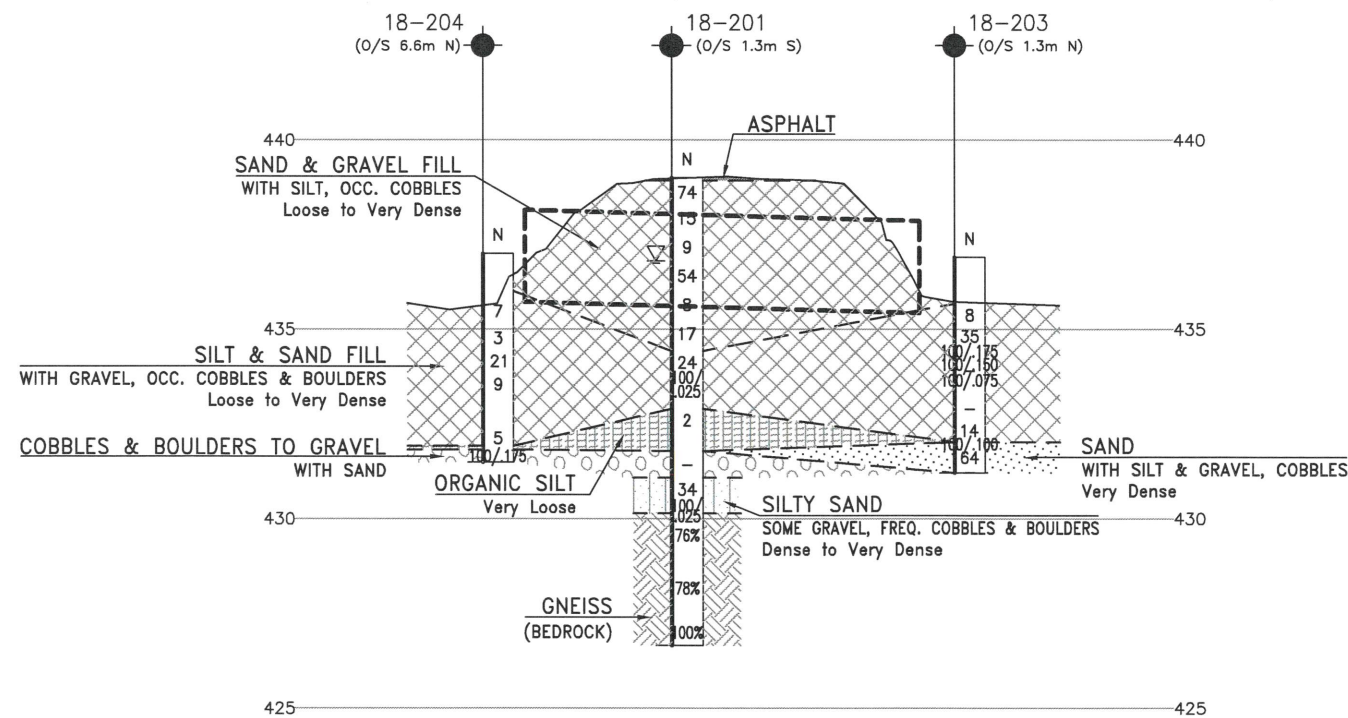
DATE	BY	DESCRIPTION
DESIGN DP	CHK SP	CODE
DRAWN AN	CHK DP	SITE
		LOAD
		STRUCT
		DATE DEC 2018
		DWG 1

HIGHWAY 527
MAX CREEK CULVERT
REPLACEMENT
BOREHOLE LOCATIONS AND SOIL STRATA

Details of the encountered soil stratigraphy are presented on the Record of Borehole sheets included in Appendix B and the Borehole Locations and Soil Strata drawing included in Appendix A. A general description of the stratigraphy, based on the conditions encountered in the boreholes, is given in the following paragraphs. However, the factual data presented on the Record of Borehole sheets takes precedence over this general description for interpretation of the site conditions. It must be recognized that the soil and groundwater conditions may vary between and beyond borehole locations.

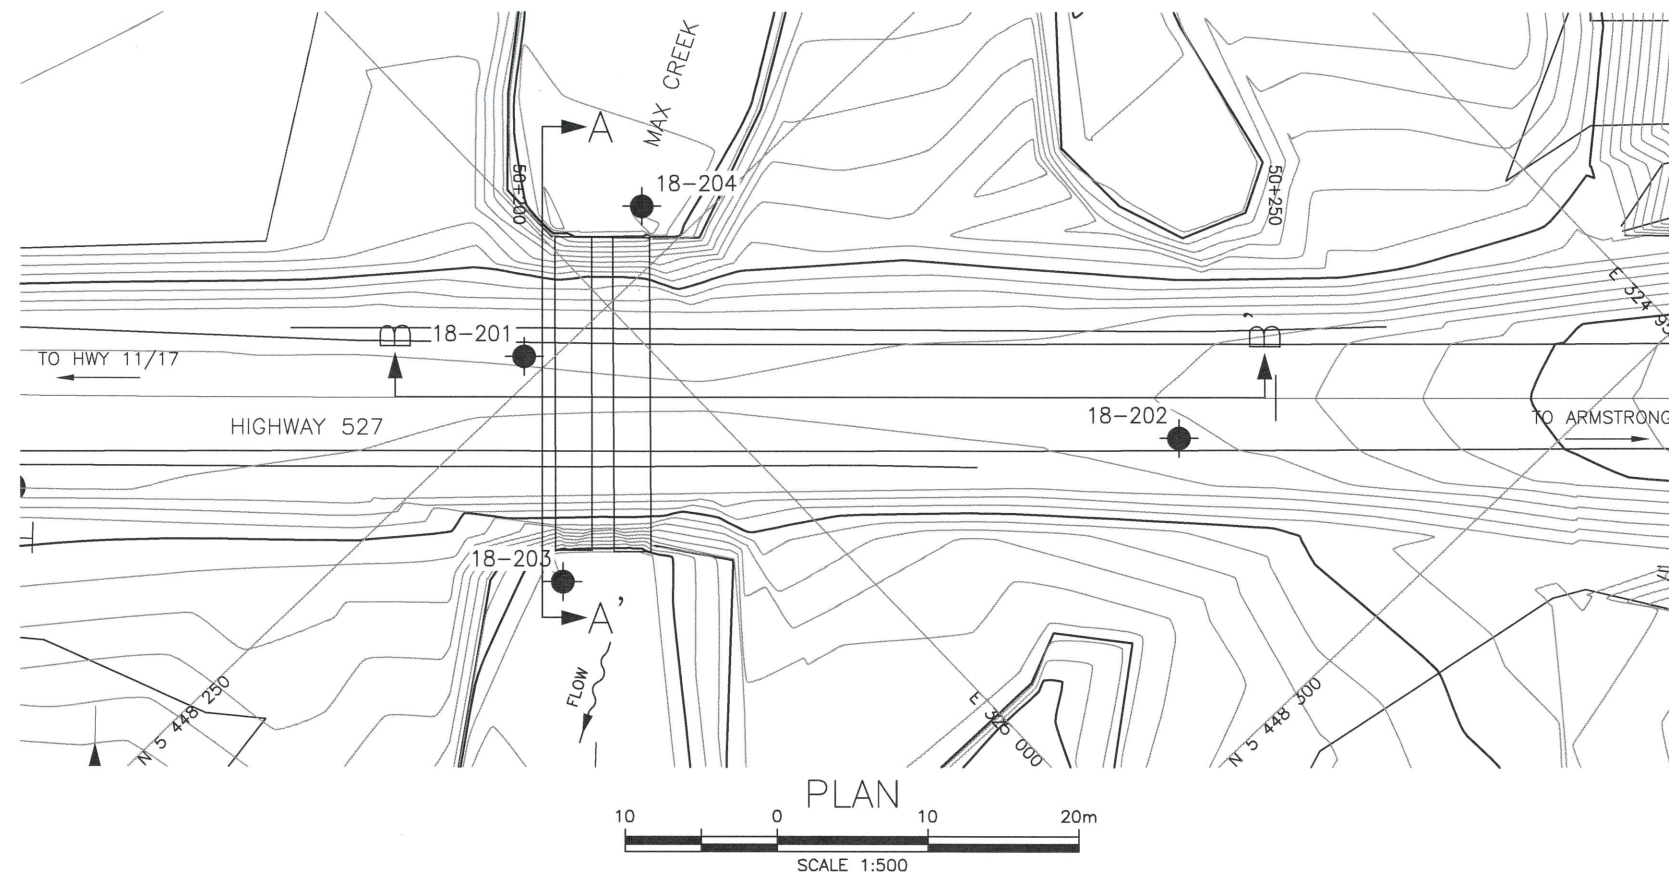
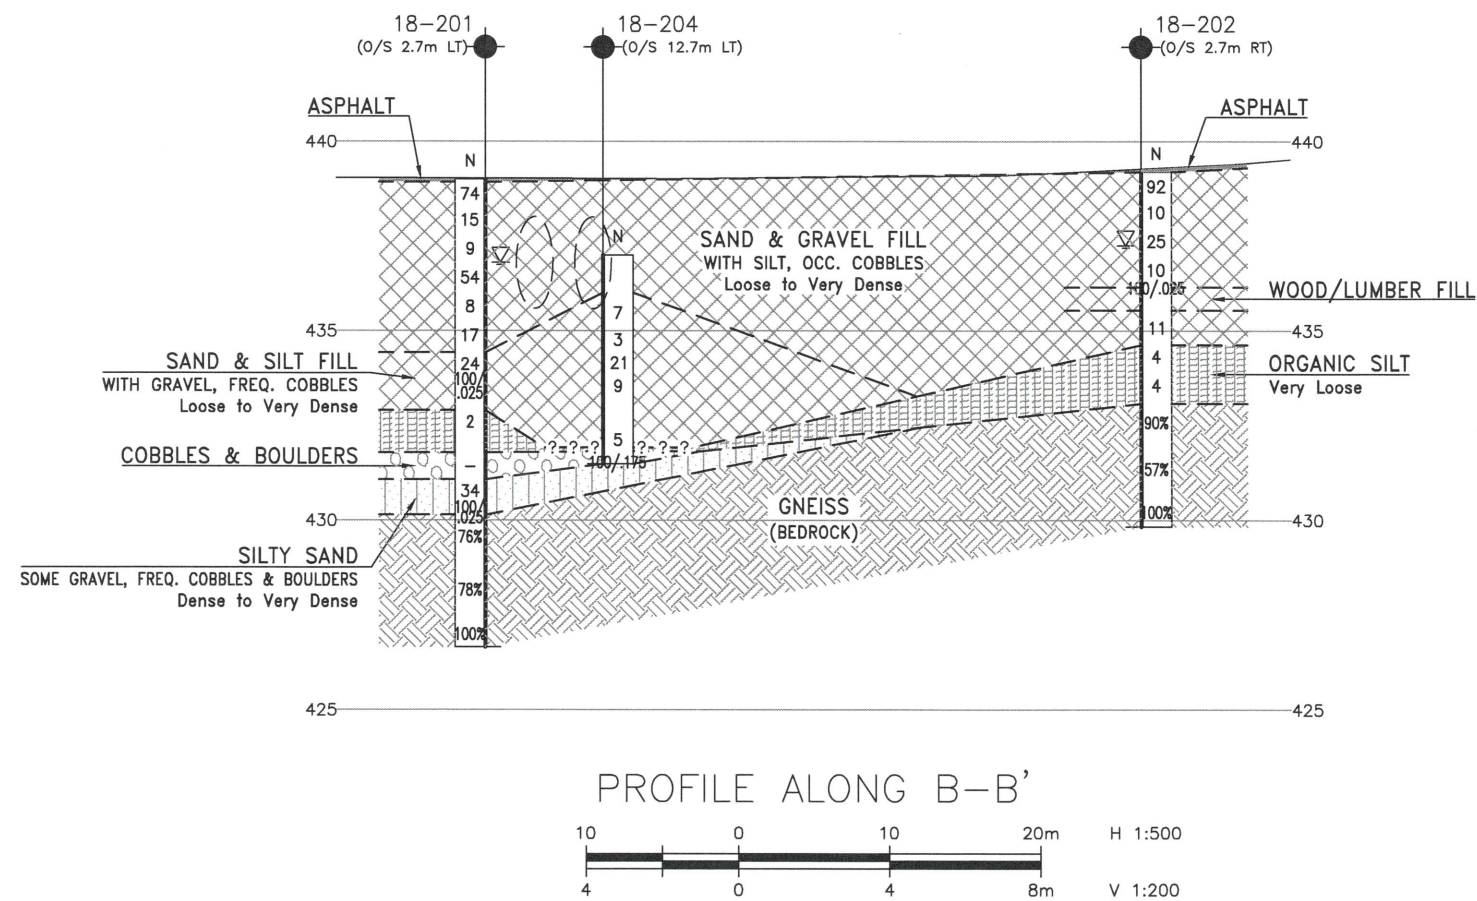
REVISIONS	DATE	BY	DESCRIPTION
DESIGN	DP	CHK SP	CODE
DRAWN	AN	CHK DP	SITE
			LOAD
			STRUCT
			DWG 2
			DATE DEC 2018

HIGHWAY 527
MAX CREEK CULVERT
REPLACEMENT
BOREHOLE LOCATIONS AND SOIL STRATA

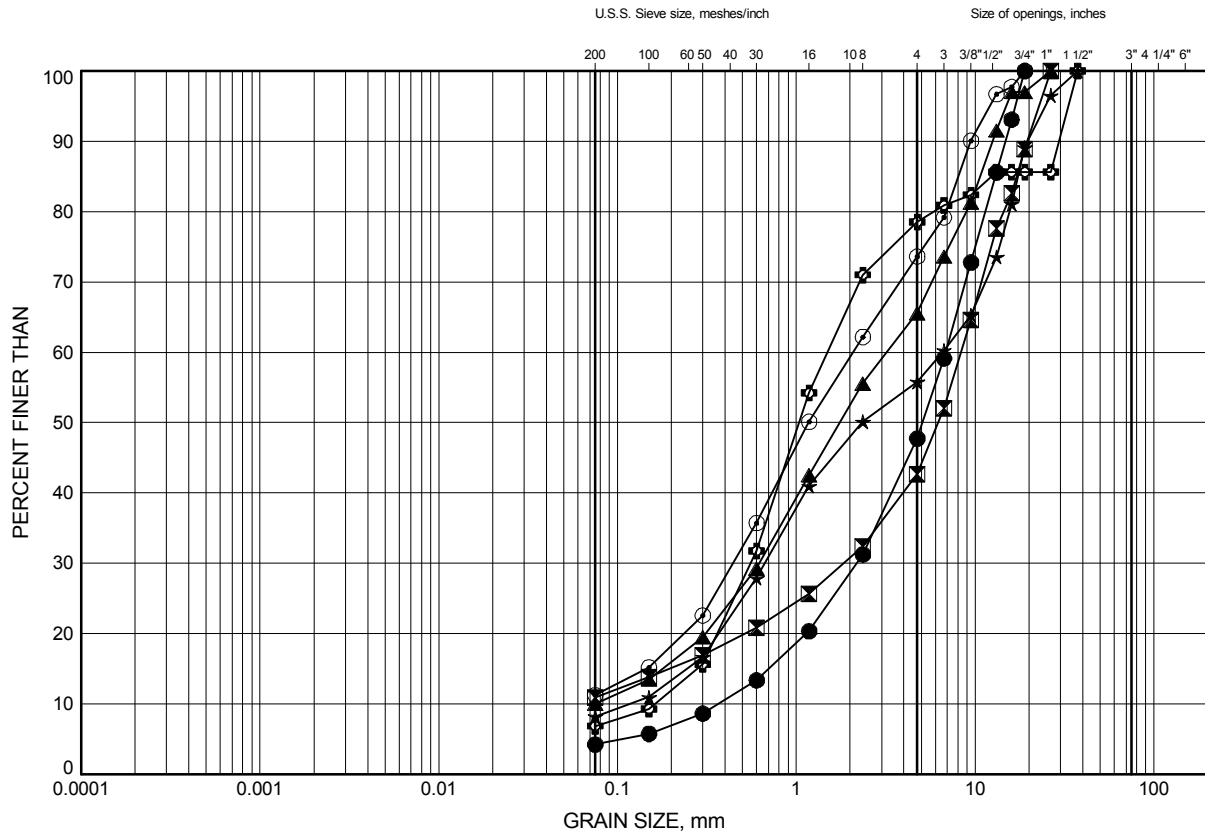
FIGURE C1

Sand and Gravel Fill

Gradation analyses were completed on six samples of the granular fill. The grain size distribution curves for these samples are included in Figure C1 of Appendix C. The results of the tests are summarized in Table 5-1 below and are presented on the corresponding Record of Borehole sheets in Appendix B.

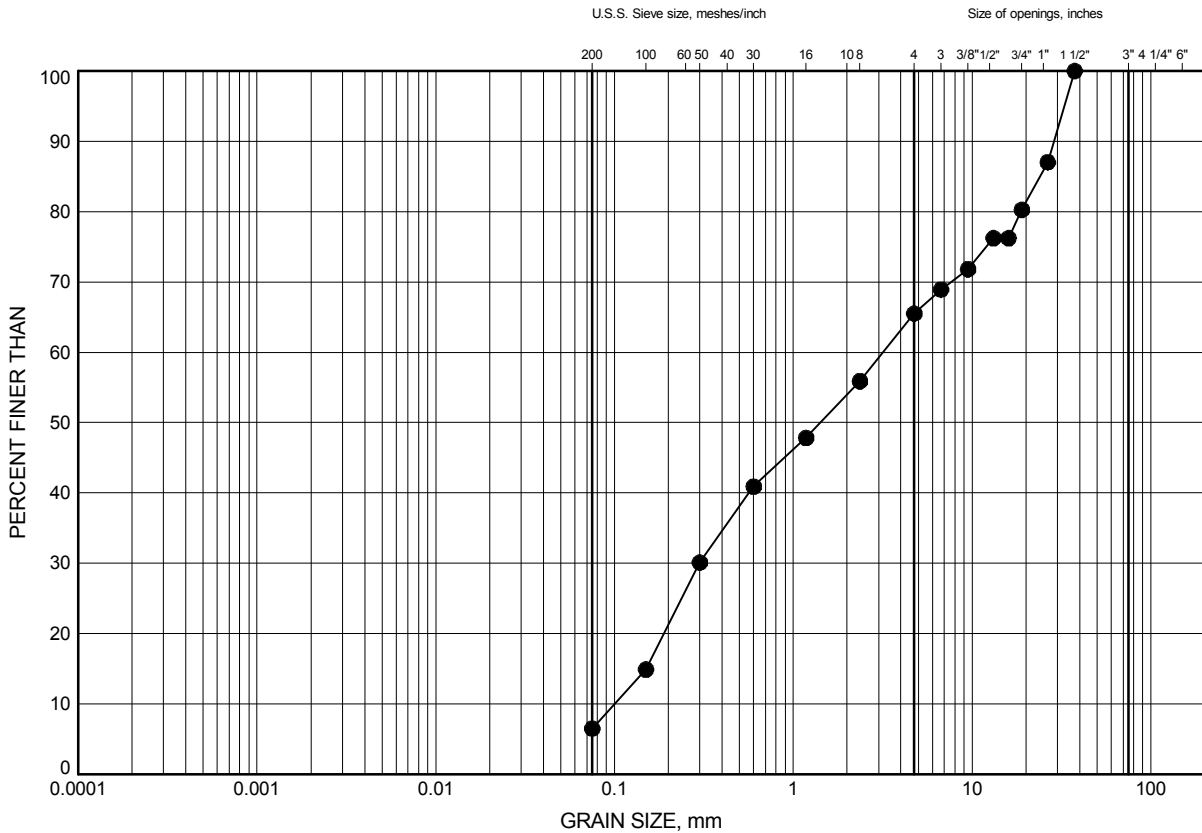
FIGURE C2

Sand with Silt and Gravel

A gradation analysis was completed on one sample of the sand layer. The grain size distribution curve is included in Figure C2 of Appendix C. The results of the test are summarized in Table 5-2 below and are presented on the corresponding Record of Borehole sheet in Appendix B.

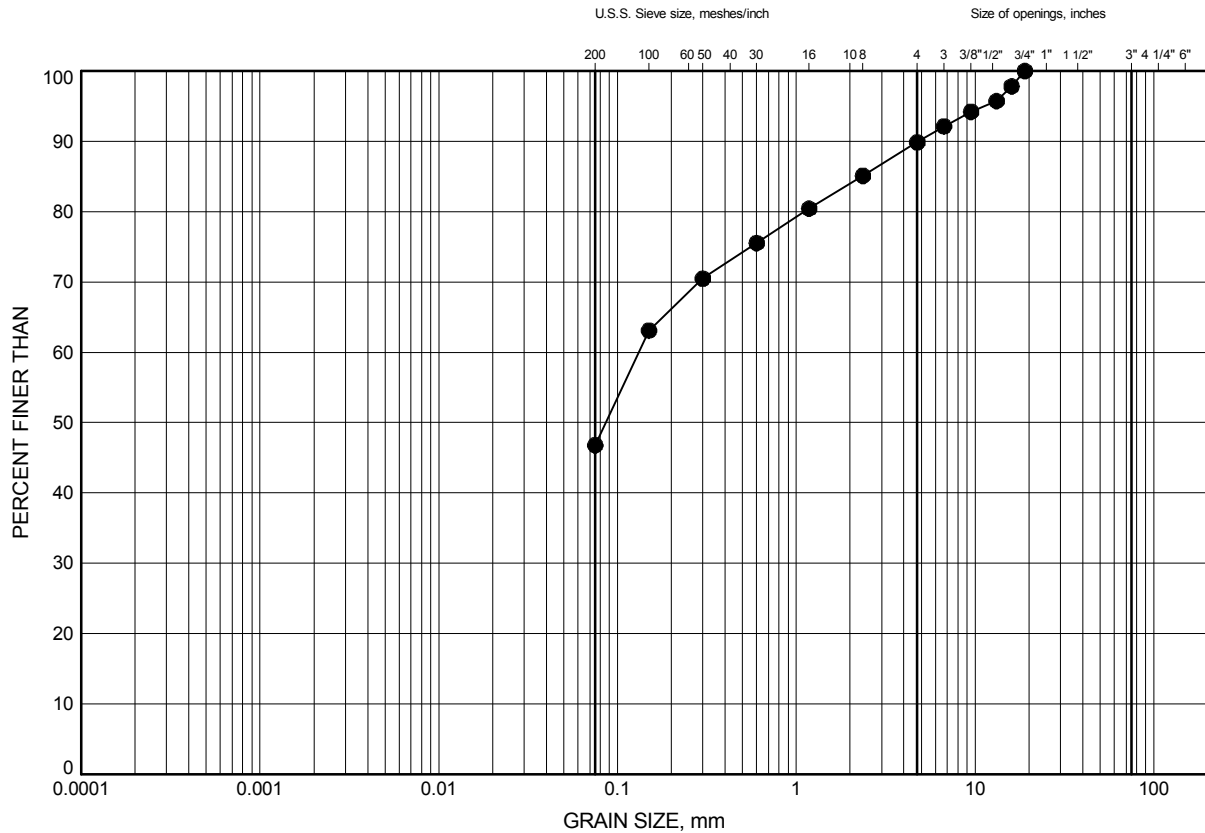
FIGURE C3

Silty Sand Till

A gradation analysis was completed on one sample of the till. The grain size distribution curve is included in Figure C3 of Appendix C. The results of the test are summarized in Table 5-3 below and are presented on the corresponding Record of Borehole sheet in Appendix B.

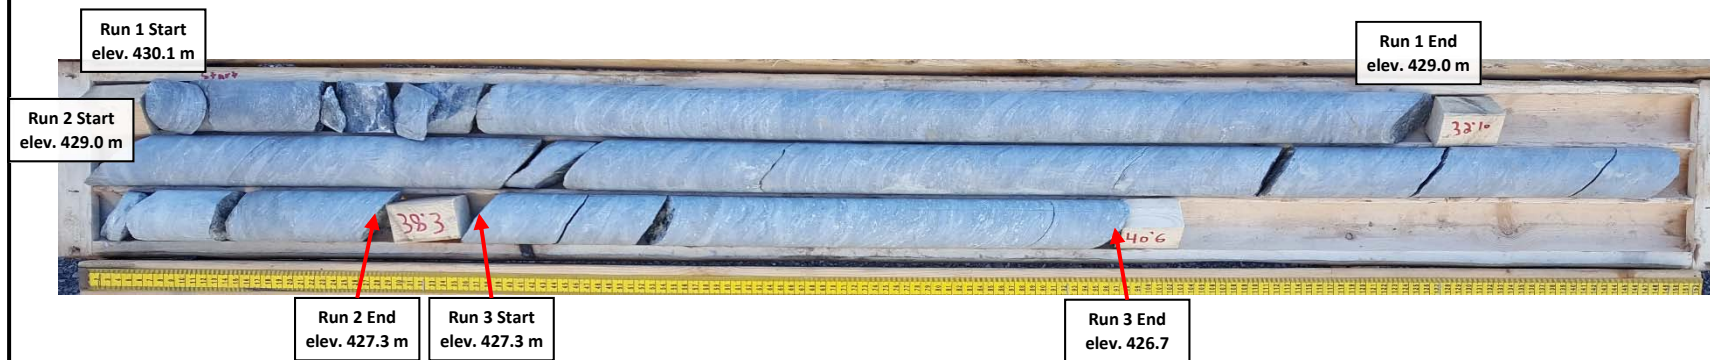
Borehole 18-201
Run 1 to 3 (of 3)
Elevation 430.1 to 426.7 m

The bedrock encountered within Boreholes 18-201 and 18-202 consisted of fresh, banded, light to dark grey, fine to medium grained gneiss. The Total Core Recovery (TCR) measured on the recovered bedrock core was 100%, the Solid Core Recovery (SCR) ranged from 92 to 100% and the Rock Quality Designation (RQD) ranged from 57 to 100%. Based on the measured RQD values, the bedrock is classified as fair to excellent quality. The gneiss bedrock is estimated to be very strong. Photographs of the bedrock core are provided in Appendix C.

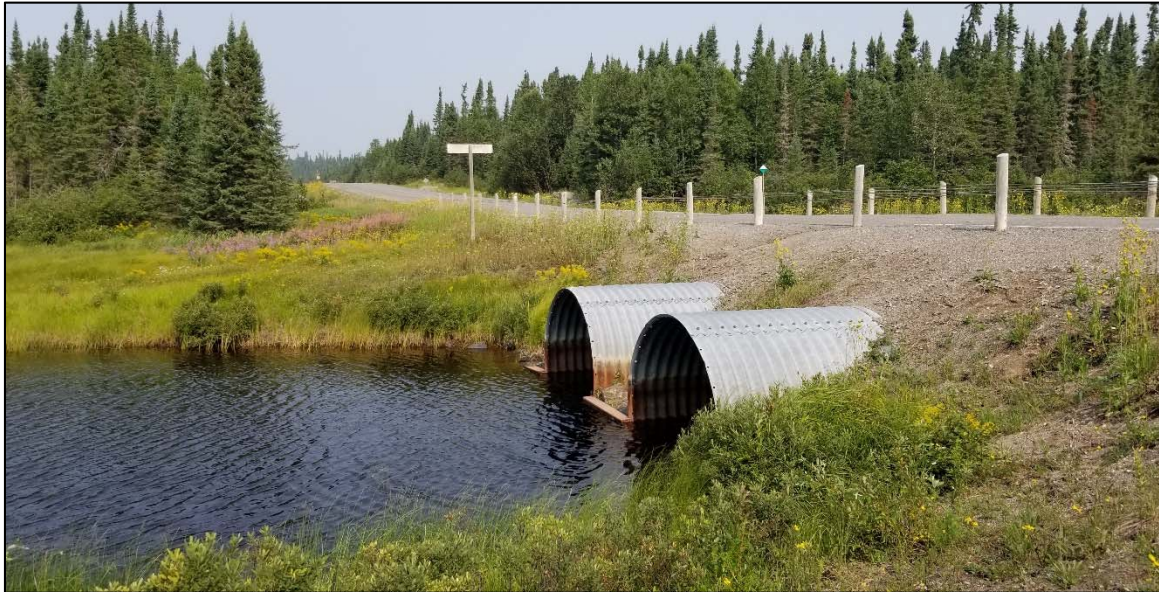
Photo 1. Looking northward at culvert inlets (2018/08/12)

The existing culvert, conveying Max Creek under Highway 527, is a twin corrugated steel pipe (CSP) culvert constructed in 1984. A site survey plan from Hatch indicates that each CSP has a diameter of 2.4 m and is approximately 20.7 m long. The culvert alignment is generally southwest to northeast with the flow through the culvert toward the northeast.

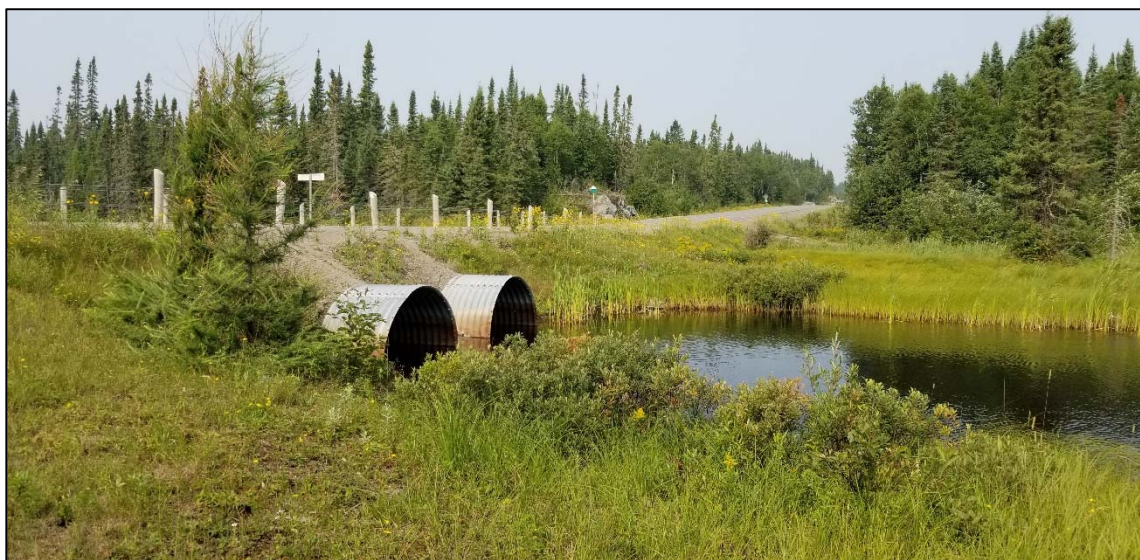
Photo 2. Looking northward at culvert outlets (2018/08/12)

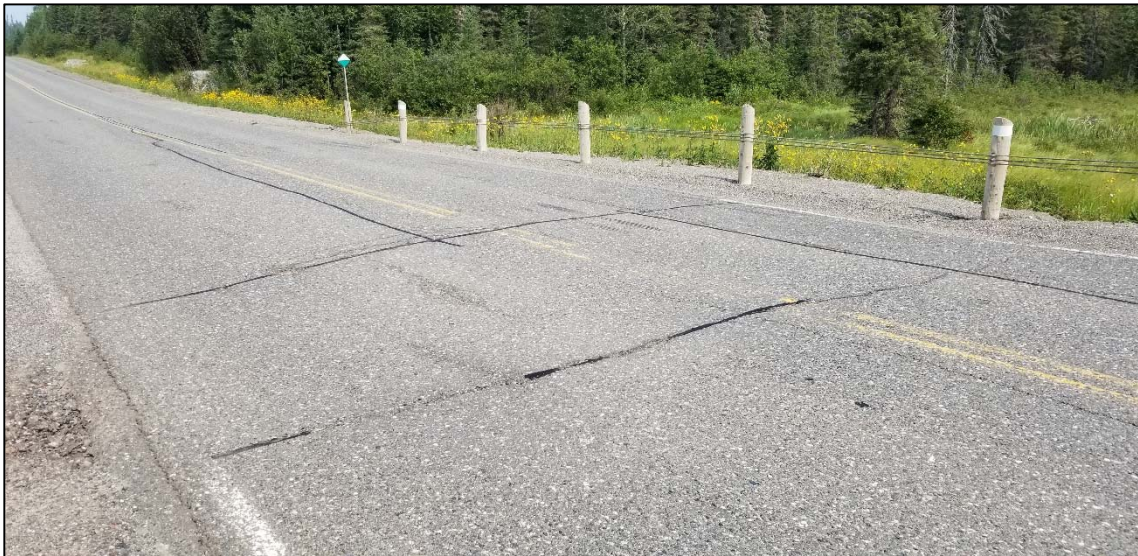
Photo 7. Transverse cracking near north culvert (2018/08/12)

An OSIM report for the culverts dated Friday October 30th, 2015 indicated some transverse and longitudinal cracking of the pavement north of the culverts and some longitudinal cracking south of the culverts. Further, the report commented on signs of settlement of the foundation below both culverts. Minor settlement of the north culvert barrel was also indicated. A visual inspection of the pavement in the vicinity of the culvert completed in June 2018 does not suggest poor pavement performance (i.e. no bumps or sagging of the pavement). Photographs showing the existing conditions in the area of the culvert are included in Appendix D for reference.
