**Highway 144 Grading and Resurfacing
Culvert Replacement
Station 22+343 - TWP of Dowling
GWP 5081-06-00**

**Highway 144
GWP 5081-06-00
From 1.5 km South of Sudbury Municipal Road 8, Northerly 18.1 km to Cartier
West Entrance (Center Street)**

FINAL FOUNDATION INVESTIGATION REPORT

Date: October 7, 2013
Ref. N^o: 11/11/11209-F2

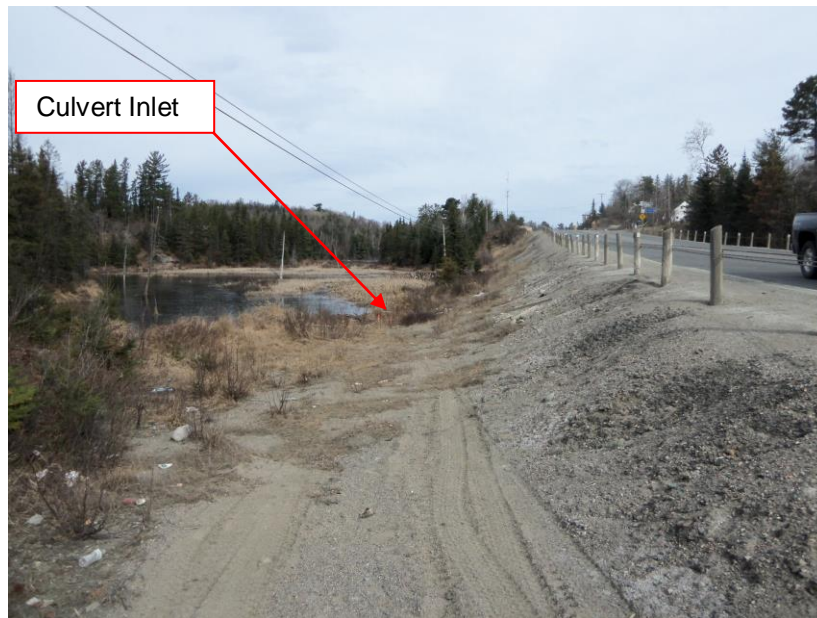
Photo: 1

Existing Embankment, Left (West) Side - Looking North

The foundation investigation for this CSP culvert is located at Station 22+343, Township of Dowling. The topography at the site is a low wet land area with flooded organic terrain to the west (left) and east (right) of the embankment. The existing highway embankment currently supports three undivided lanes of highway, two in the northbound direction and one in the southbound direction. The existing highway, at the culvert locations, is constructed on a fill embankment some 3.7 m in height, with centerline elevation of 372.3 m at the culvert location. The culvert at this location is a 910 mm diameter CSP culvert, some 27.6 m in length. Flow through the culvert is from left (west) to right (east) (see Photo Essay, Appendix 4).

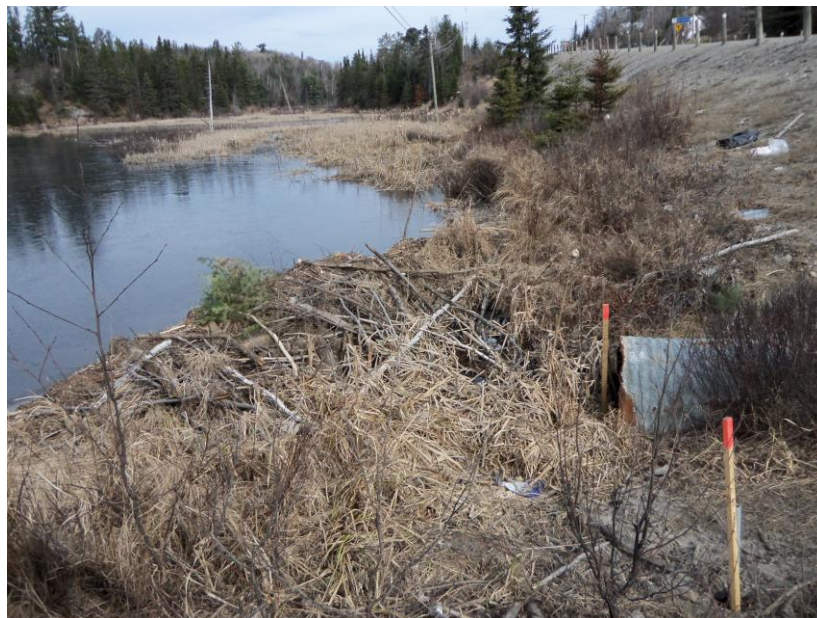
Photo: 2

Culvert Inlet – Looking North

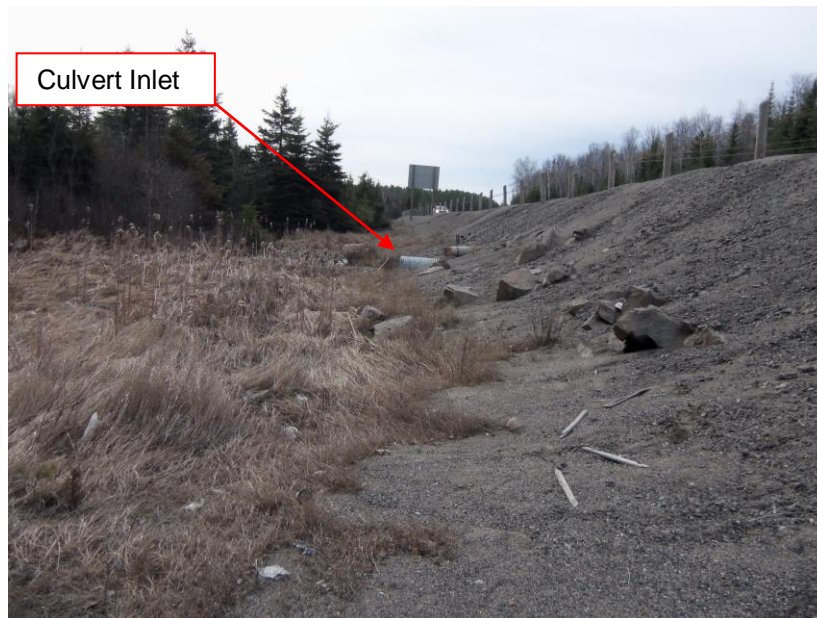
Photo: 3

Existing Embankment, Right (East) Side - Looking South

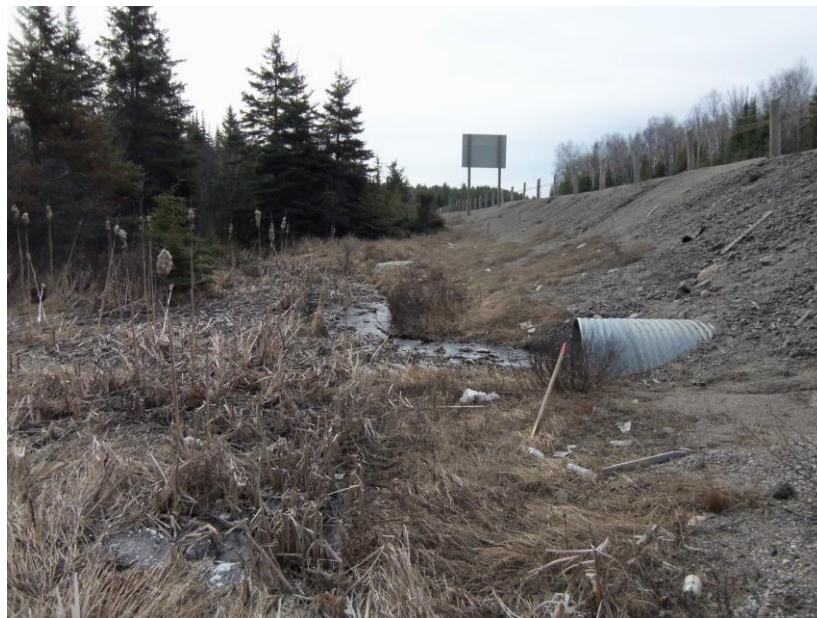
Photo: 4

Culvert Outlet – Looking South

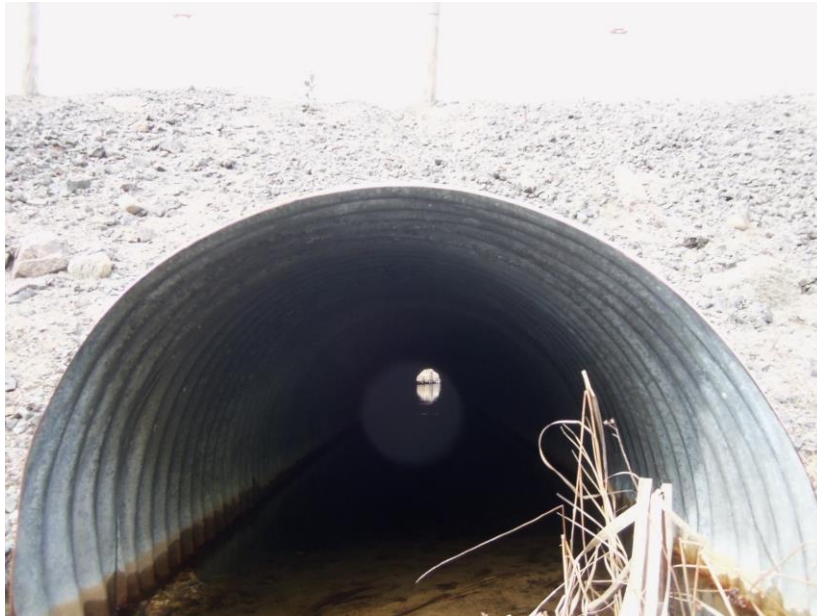
Photo: 5

View Through Culvert – Looking East
