**Highway 654 Rehabilitation
Culvert Replacement
Station 15+282 - Twp. of North Himsworth
GWP 5090-05-00**

FINAL FOUNDATION INVESTIGATION REPORT

Date: January 10, 2013
Ref. N°: 12/03/12027-F1

Geocres No. 31L-166

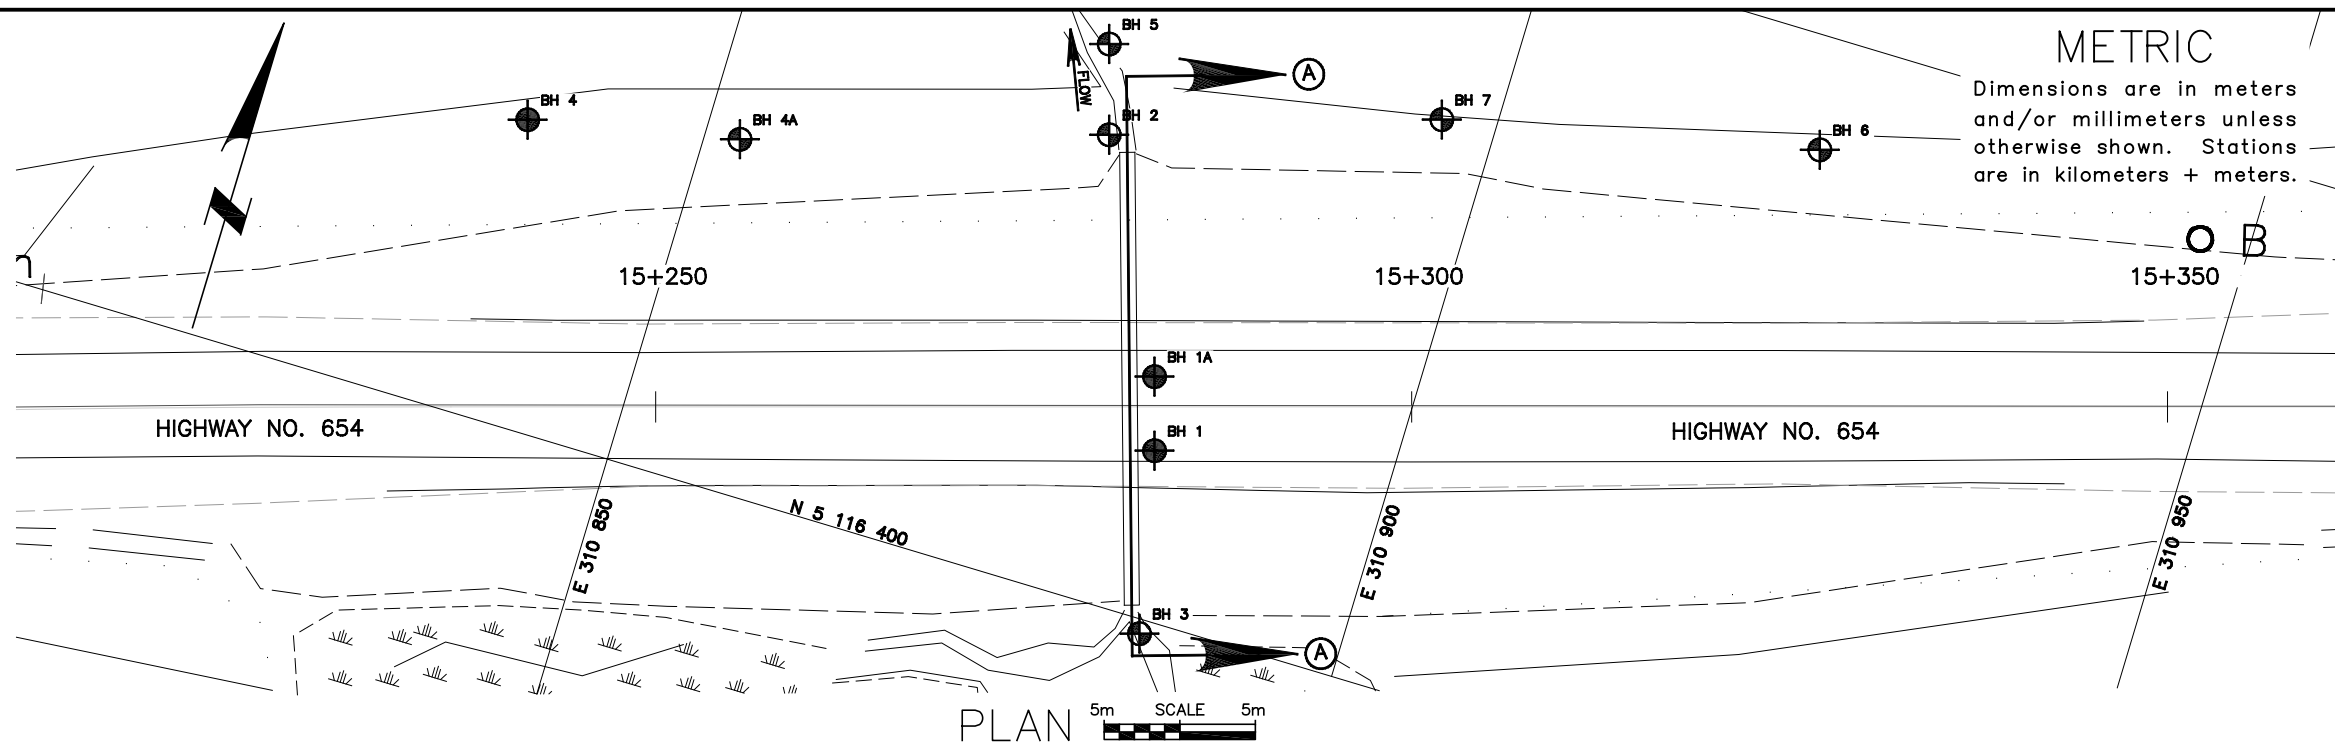
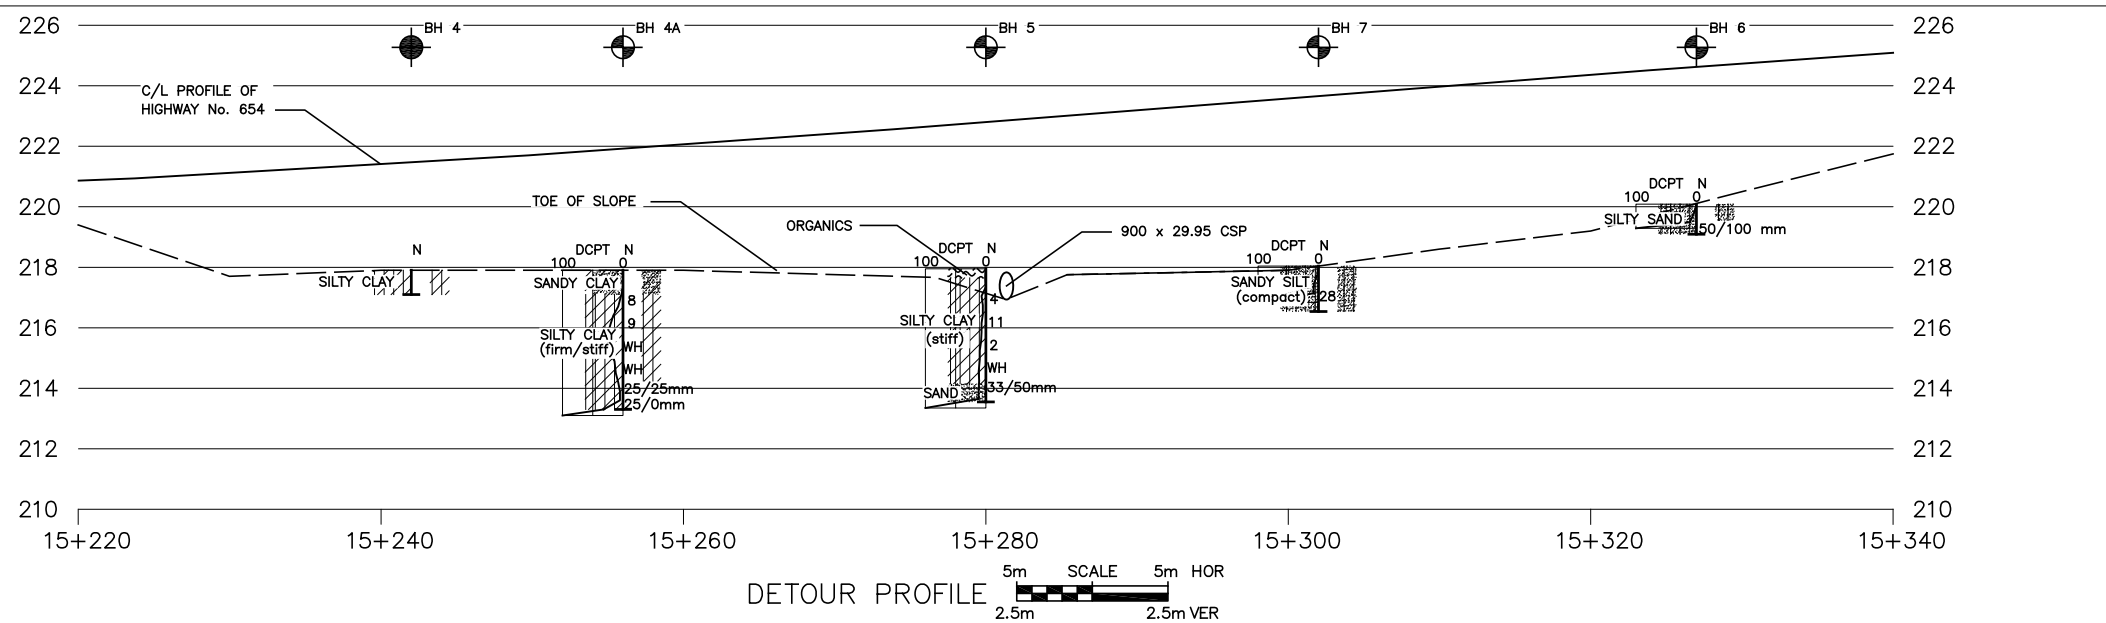
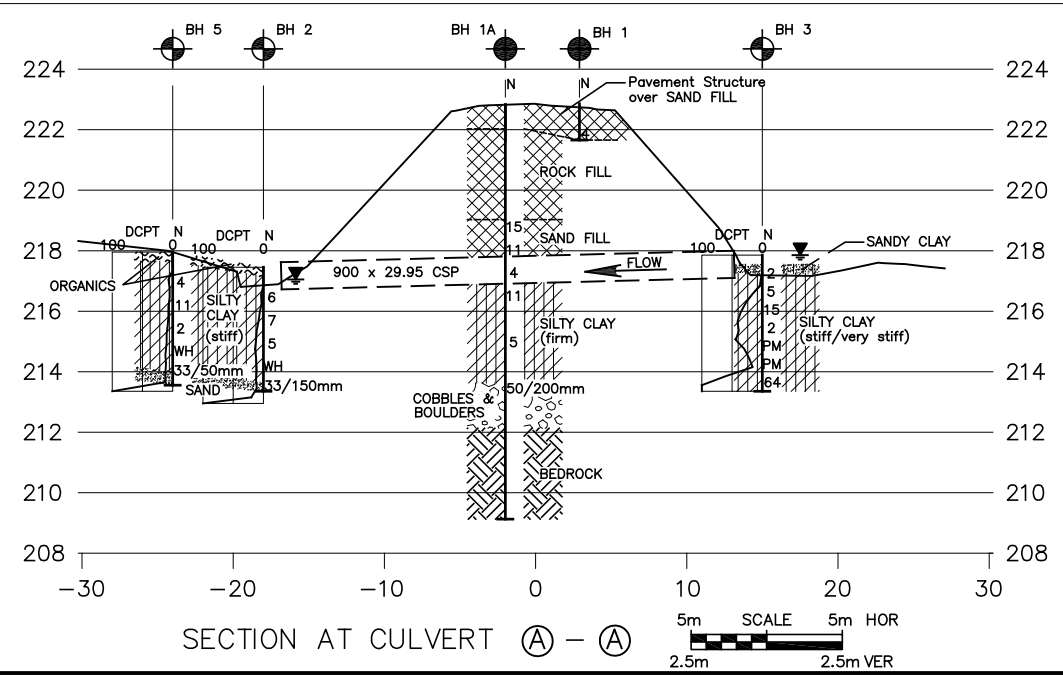
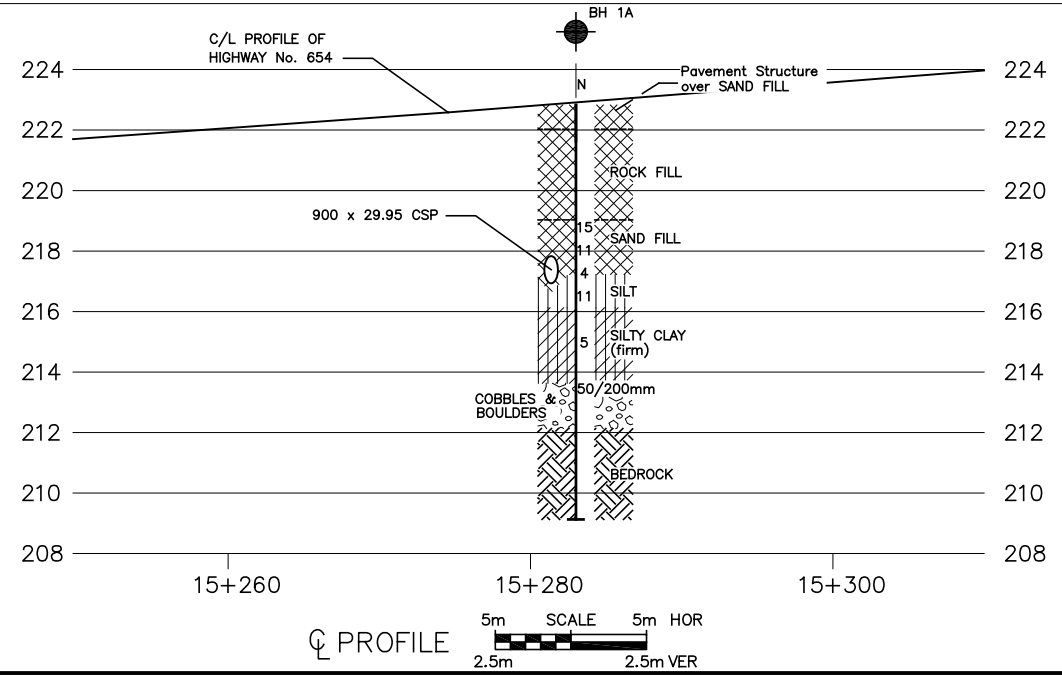
REVISIONS	DATE	BY	DESCRIPTION	
	Aug 2012	RG	DRAFT	
	Dec 2012	RG	FINAL	
HWY No. 654 – North Himsworth Twp – Culvert at Station 15+282				
SUBM'D			REF 12027	SITE
DRAWN RG		CHK MAM	DATE August 2012	FIG 2

A plan and profile illustrating the borehole locations and stratigraphic sequences is shown on Figure No. 2, Appendix 3. During the course of the exploration program, seven (7) sampled boreholes were put down at this site, with Borehole No. 1 and Borehole No. 1A advanced through the embankment, and Borehole Nos. 2 and 3 advanced at the culvert ends. Boreholes No. 4 to 7 inclusive were advanced at the toe of the embankment to the left (north) of the existing embankment. At the time of the subsurface investigation, the ground surface elevations at Boreholes Nos. 1, 1A, 2, 3, 4, 4A, 5, 6, and 7 were recorded at 222.7, 222.8, 217.5, 217.9, 217.9, 217.9, 218.0, 220.1, and 218.0 m, respectively.

Details of the subsurface conditions revealed by the investigation program are presented on the enclosed Record of Borehole Logs (Appendix 2) and on Figure No. 2 (Appendix 3). Please note that stratigraphic delineation presented on the borehole logs and soil strata plot are the results of non-continuous sampling, response to drilling progress, the results of SPT and Dynamic Cone Penetration Test (DCPT), plus field observations. Typically such boundaries represent transitions from one zone to another and are not an exact demarcation of specific geological unit. Additional consideration should be given to the fact that subsurface conditions may vary markedly between adjacent boreholes and beyond any specific boring location, and are shown on the drawings for illustration purposes only.

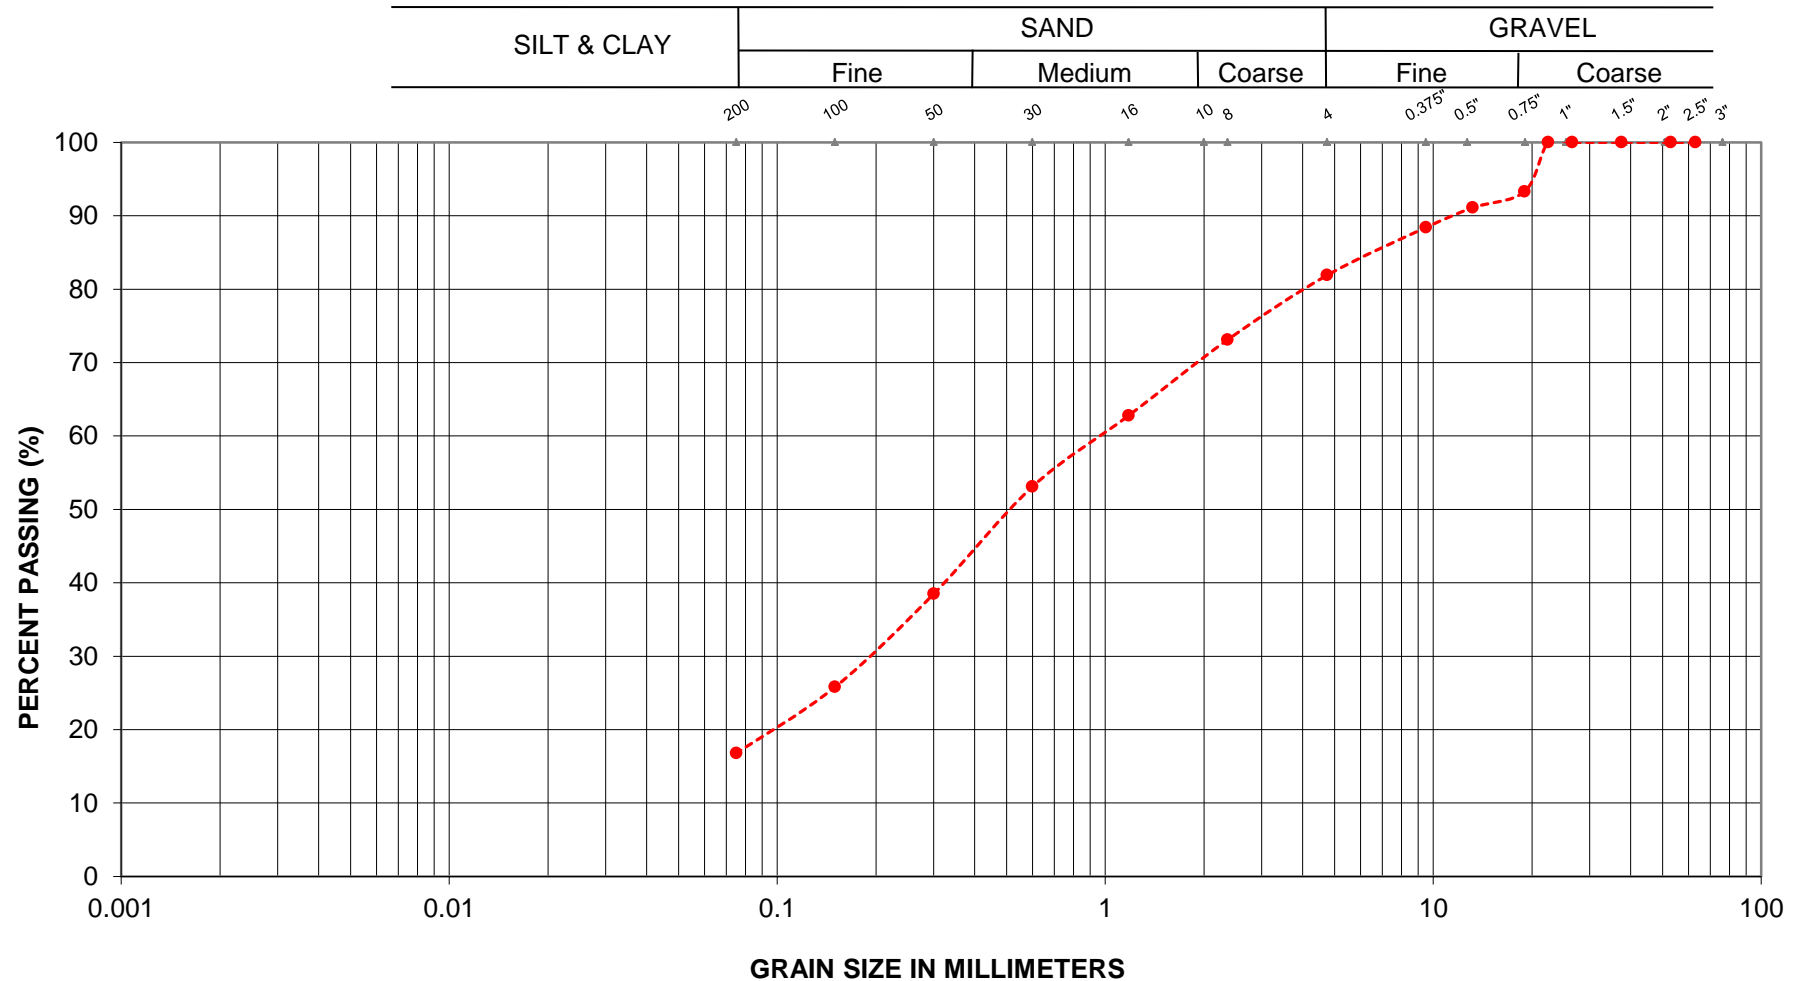
FIGURE L-1

GRAIN SIZE ANALYSIS

---●--- BH No.: 1A Sa No.: 1 Depth: 3.8 - 4.3 m

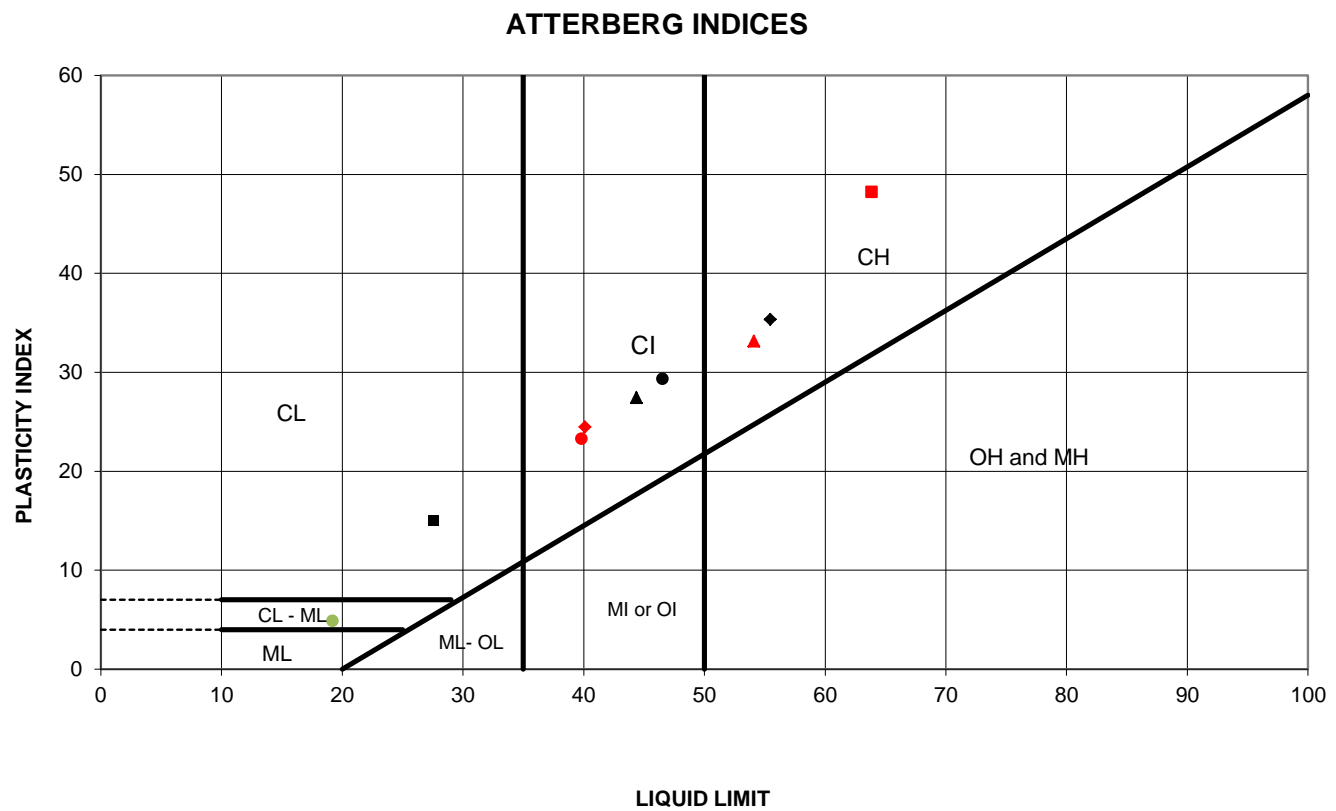
FIGURE L-4

ATTERBERG LIMITS TEST RESULTS

SYMBOL	BH	Sa. No.	Depth(m)	Elev.(m)	Liquid Limit	Plastic Limit	Plasticity Index	NMC %
●	1A	5	7.6	215.2	46.6	17.2	29.3	31.1
◆	2	3	1.5	216.0	55.5	20.1	35.3	30.0
■	2	5	3.0	214.5	27.6	12.6	15.0	28.7
▲	3	3	1.2	216.7	44.4	16.9	27.4	27.8
●	3	6	3.0	214.9	39.8	16.6	23.3	40.7
◆	4A	4	2.3	215.6	40.1	15.6	24.5	40.9
■	5	2	0.8	217.2	63.9	15.6	48.2	76.8
▲	5	5	3.0	215.0	54.1	21.0	33.2	38.5
●	7	2	0.8	217.2	19.2	14.3	4.9	9.6

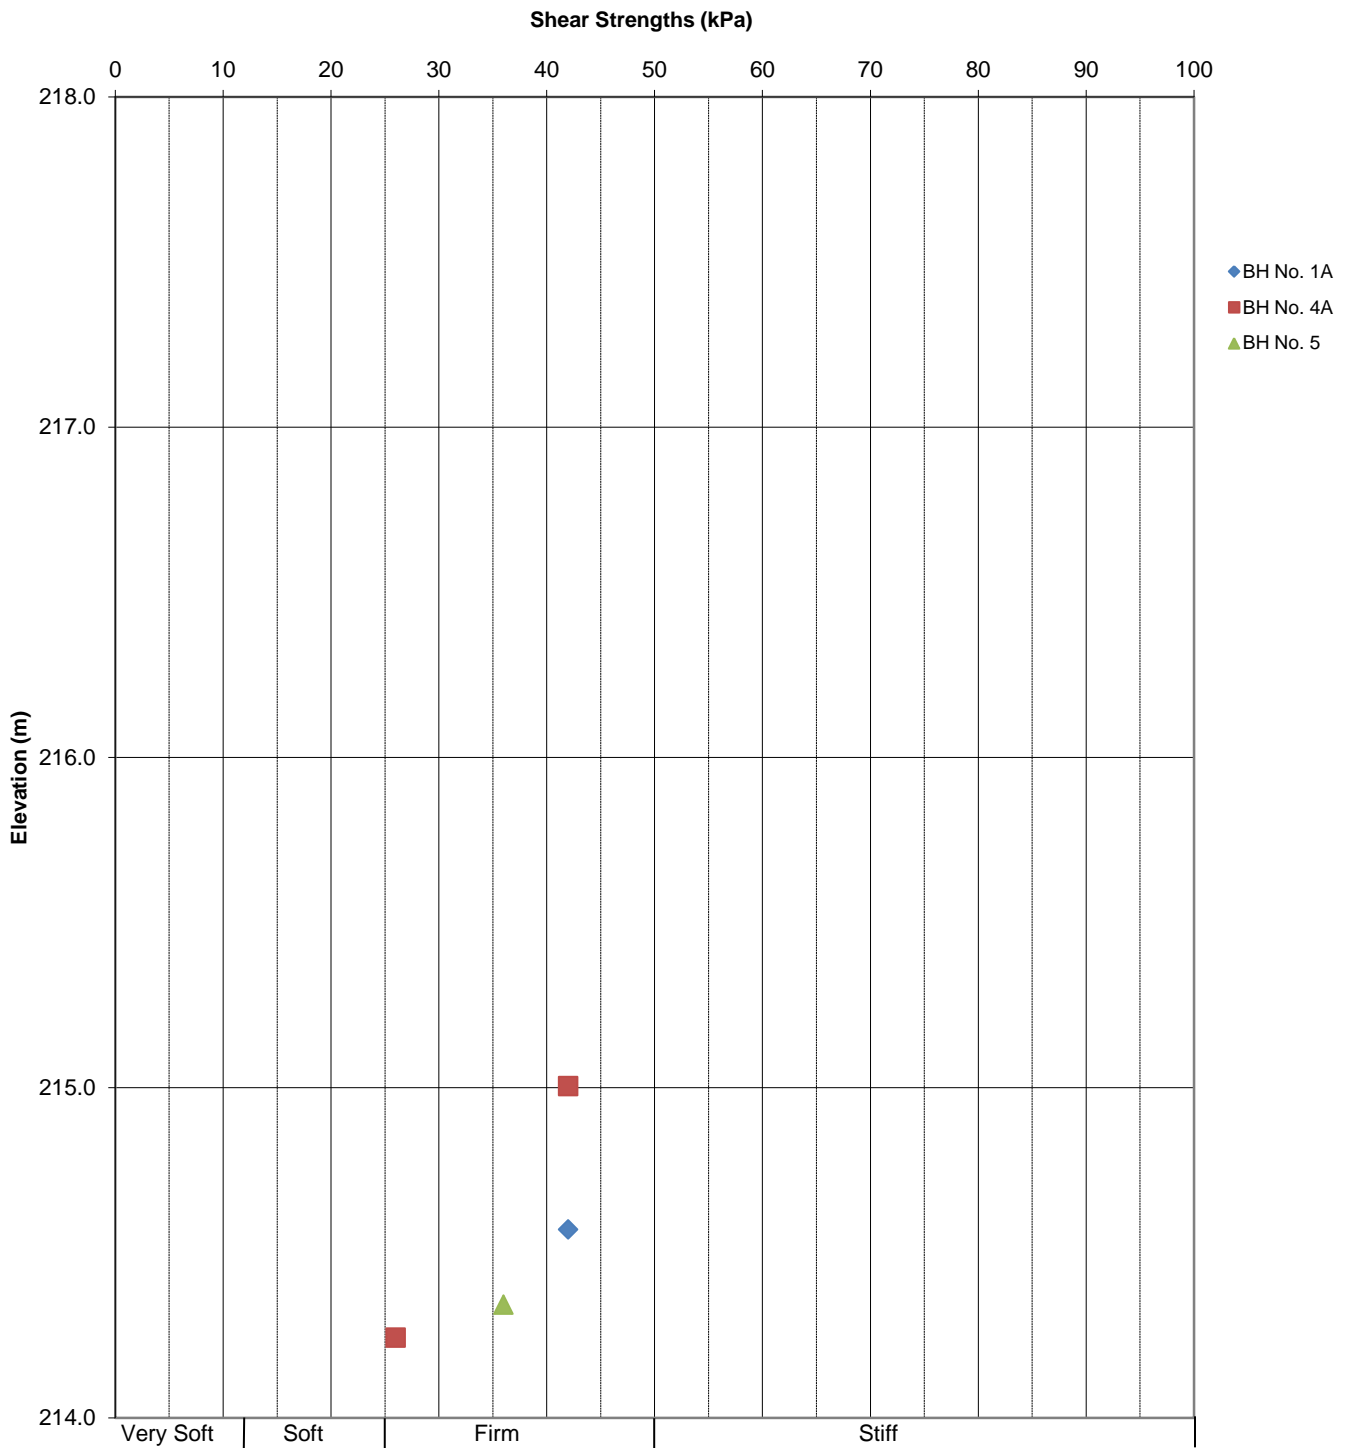
In-Situ Shear Strengths vs. Depth

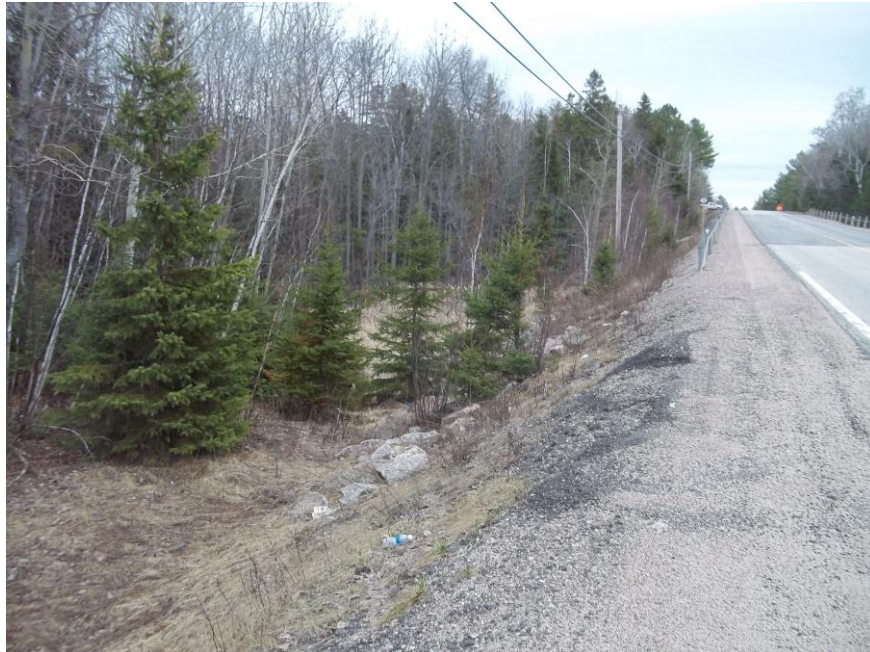
Photo: 1

Existing Embankment – Left Side, Looking East

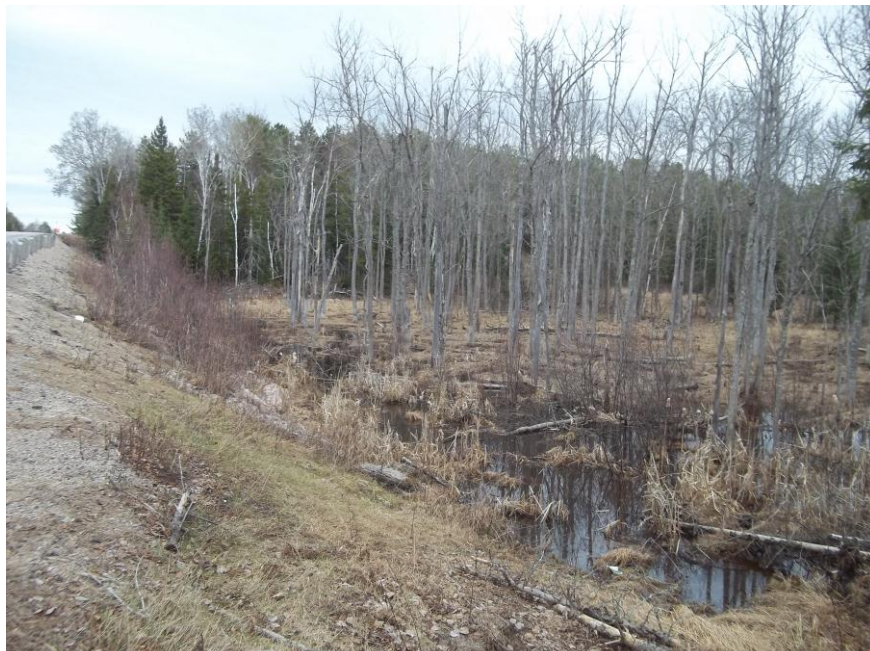
Photo: 2

Existing Embankment – Right Side, Looking East

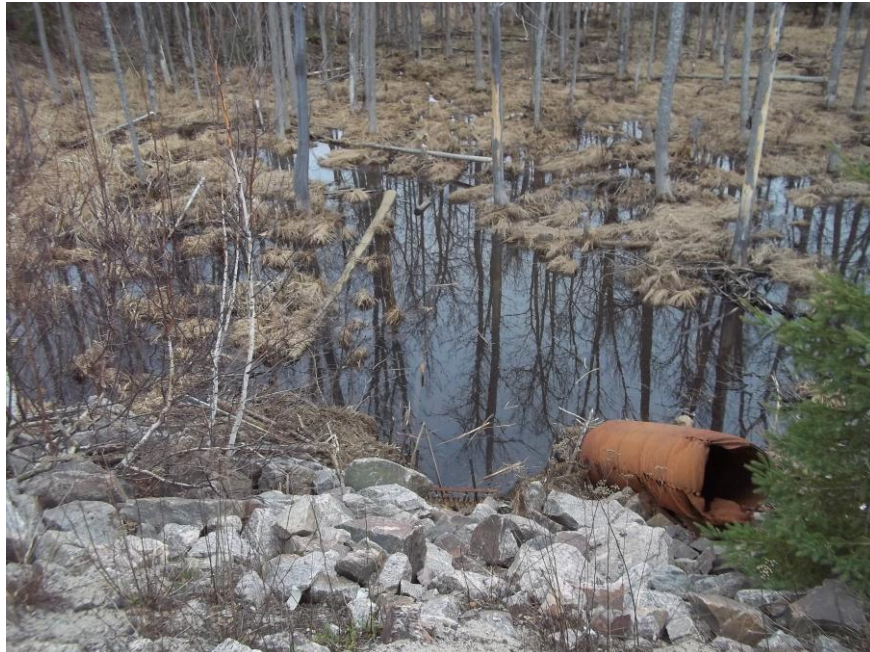
Photo: 3

Culvert Inlet – Looking South

The water level in the culvert was measured between elevations of 217.4 to 218.9 m (outlet and inlet, respectively), at the time of this investigation.

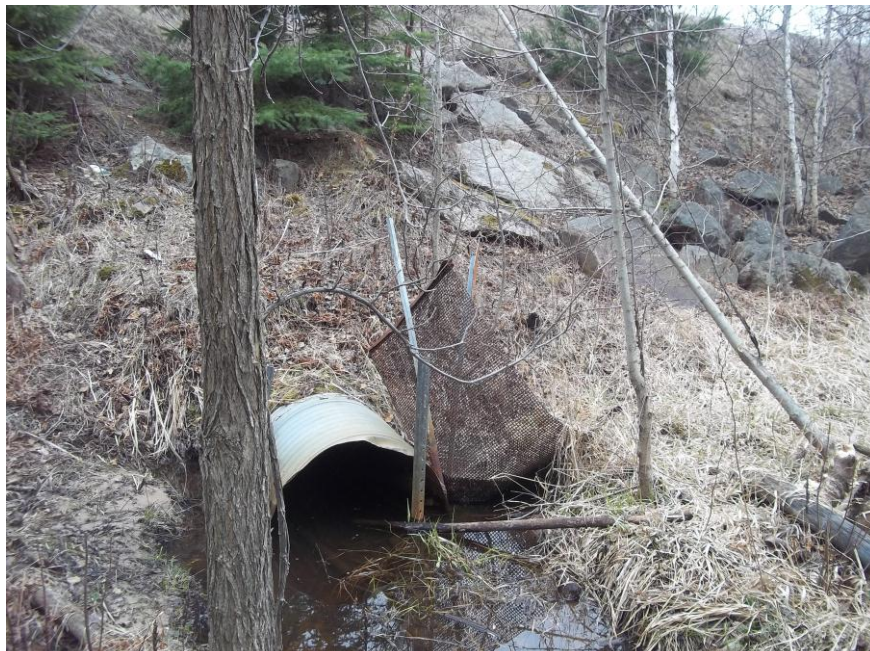
Photo: 4

Culvert Outlet – Looking South
