**Highway 124 Rehabilitation
Culvert Replacement
Station 25+160 - Twp. of Croft
GWP 5467-09-00**

FINAL FOUNDATION INVESTIGATION REPORT

Date: May 30, 2013
Ref. N^o: 12/08/12141-F2

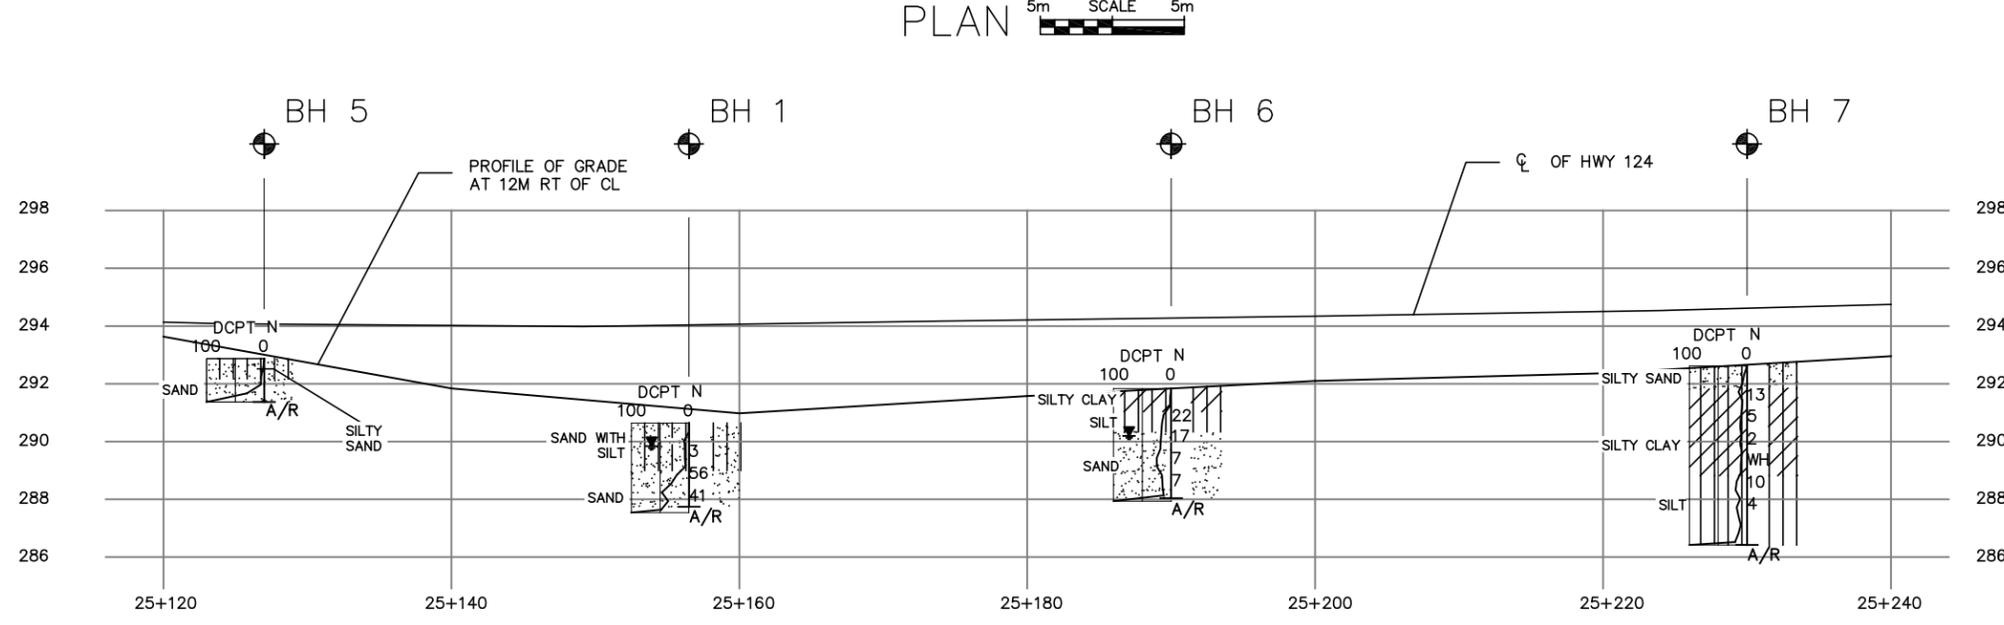
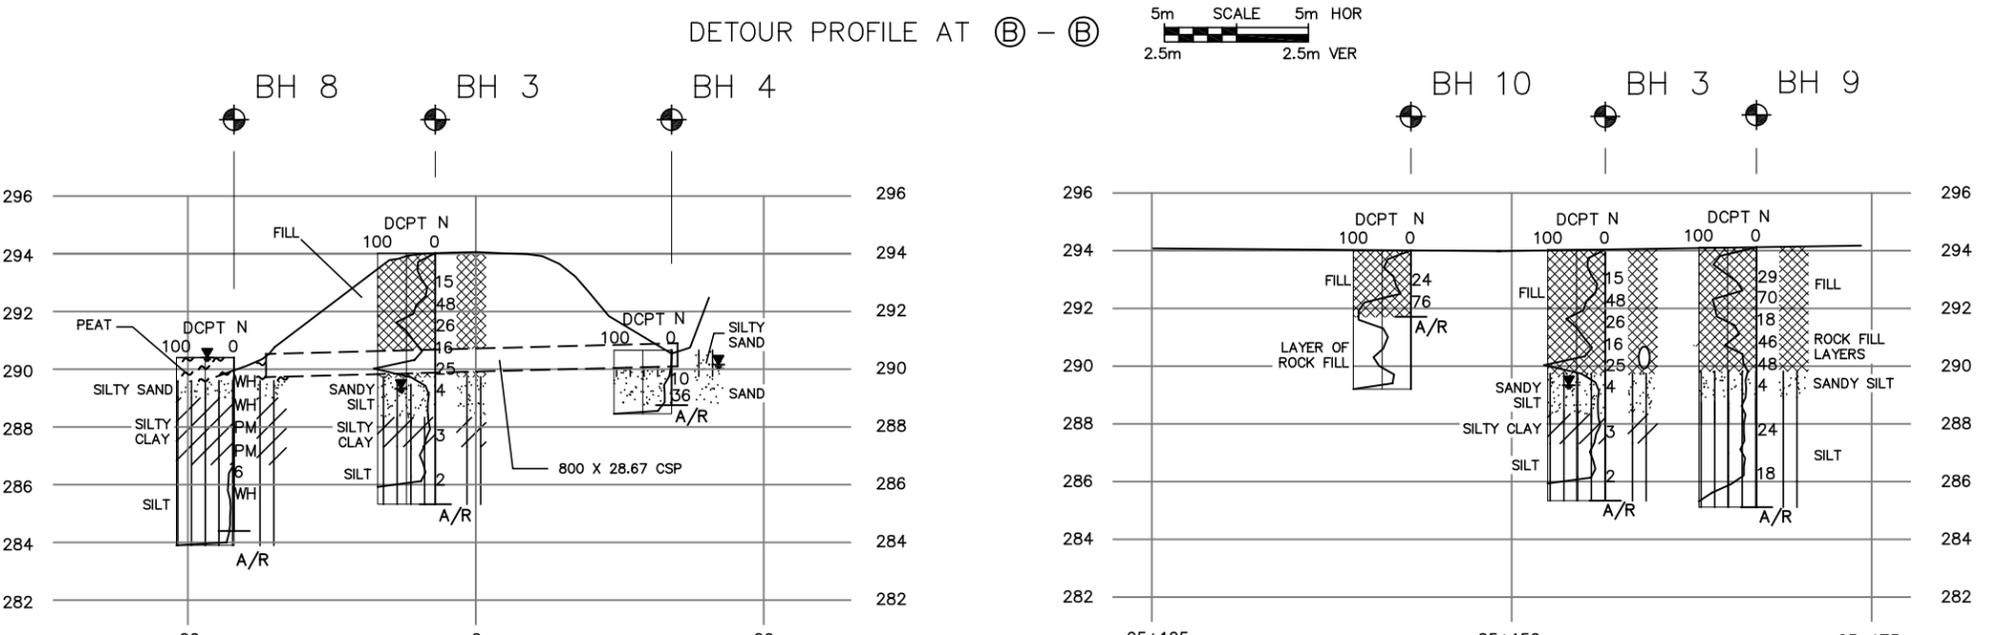
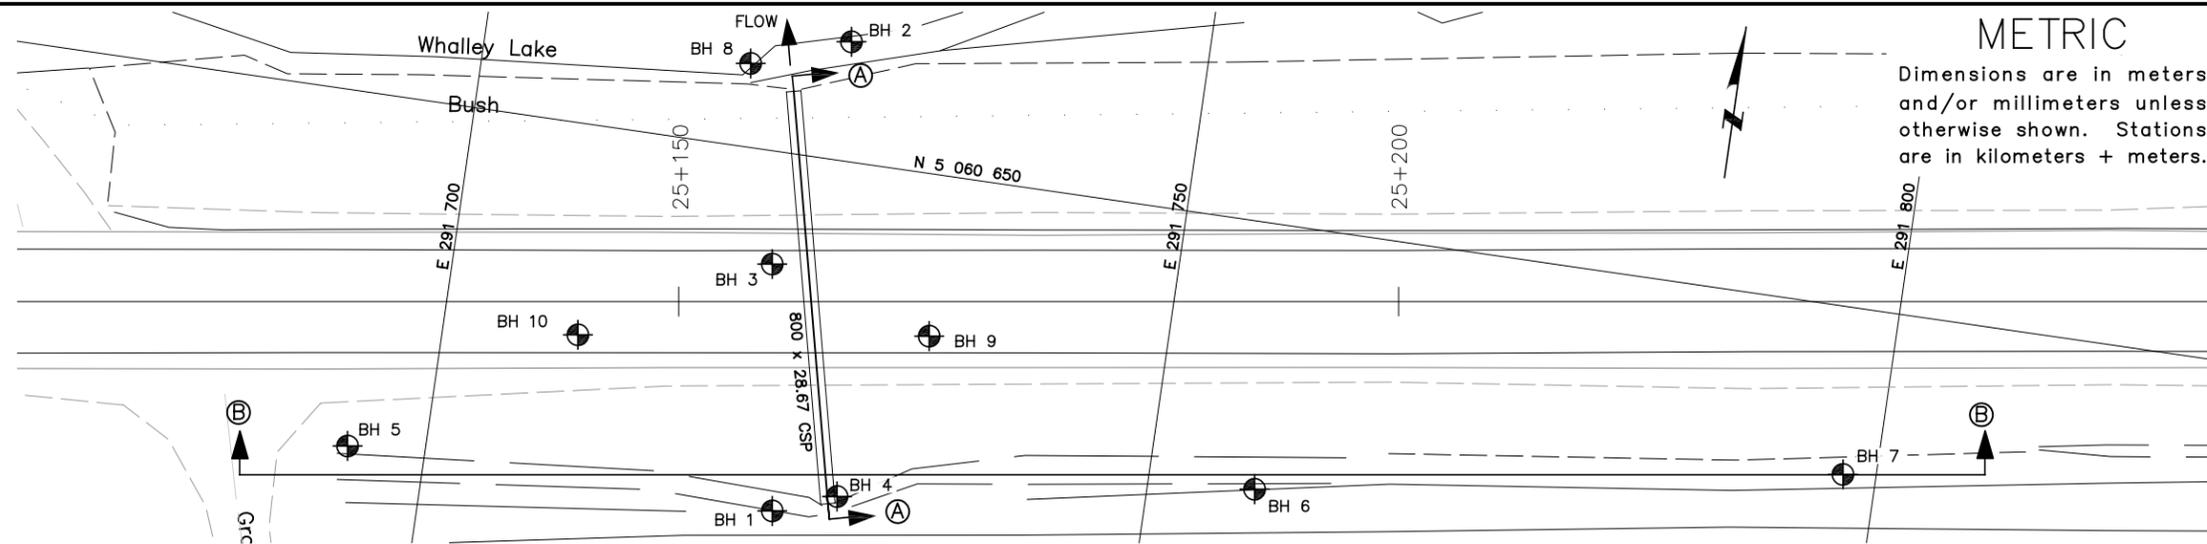
Drawing
 2

HWY No. 124 - Croft Twp - Culvert at Station 25+159.20	REF 12141-F2
SUBM'D	GEOCRE 31E-322B SITE
DRAWN IK	CHK MAM DATE January 2013 FIG 2

Details of the subsurface conditions revealed by the investigation program are presented on the enclosed Record of Borehole Logs (Appendix 2) and on Figure No. 2 (Appendix 3). Please note that stratigraphic delineation presented on the borehole logs and soil strata plot are the results of non-continuous sampling, response to drilling progress, the results of SPT and Dynamic Cone Penetration Tests (DCPT), plus field observations. Typically such boundaries represent transitions from one zone to another and are not an exact demarcation of a specific geological unit. Additional consideration should be given to the fact that subsurface conditions may vary markedly between adjacent boreholes and beyond any specific boring location, and are shown on the drawings for illustration purposes only.

A plan and profile illustrating the borehole locations and stratigraphic sequences is shown on Figure No. 2, Appendix 3. During the course of the exploration program, ten (10) sampled boreholes were put down at this site, with Borehole Nos. 3, 9, and 10 advanced through the embankment, and Borehole Nos. 1 and 4, and 2 and 8, advanced at the culvert inlet and outlet, respectively. Boreholes No. 5 to 7 inclusive were advanced at the toe of the embankment to the south (right) of the existing embankment. At the time of the subsurface investigation, the ground surface elevations at Boreholes Nos. 1 to 10 were recorded at 290.6, 290.2, 294.0, 290.7, 293.1, 291.9, 292.6, 290.5, 294.0, and 294.0 m, respectively.

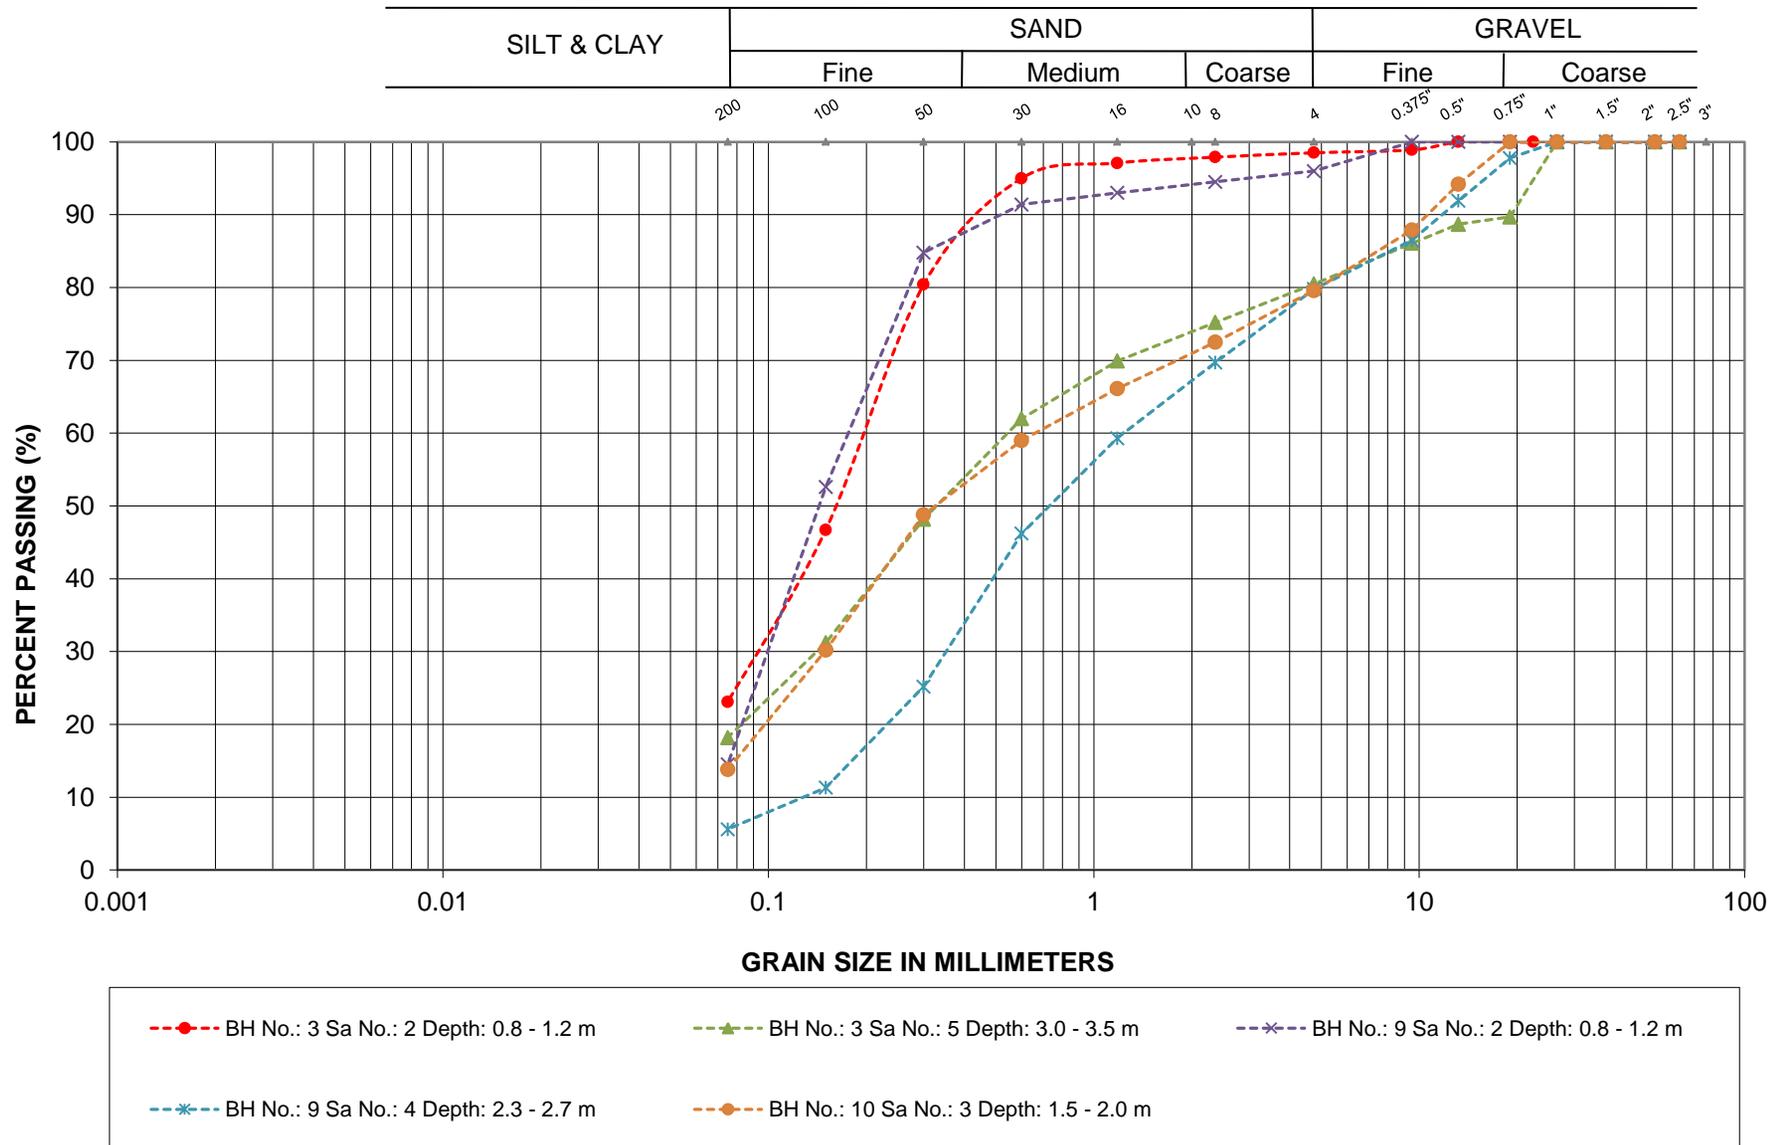
GRAIN SIZE ANALYSIS

EMBANKMENT FILL

Underlying the crushed gravel at Borehole Nos. 3, 9, and 10, a deposit of fill consisting of brown sand trace to with silt trace to some gravel was penetrated. A distinction between the subbase and embankment fill was not observed. The natural moisture content measured on samples of this deposit was in the order of 2 to 22%. Gradation analyses were carried out on five (5) samples of this deposit, the results of which indicated 1 to 20% gravel size particles, 63 to 81% sand size particles, and 6 to 23% silt and clay size particles (Figure No. L-1, Appendix 3). Based on SPT 'N' values of 15 to 76 blows per 300 mm penetration, the compactness of this deposit was described as compact to very dense, generally compact. This deposit was encountered to a depth of 4.3 m below grade at Borehole Nos. 3 and 9 (elevation 289.7 m). Auger refusal, probably on a boulder/rock fill, was encountered in this deposit at a depth of 2.3 m at Borehole No. 10 (elevation 291.7 m).

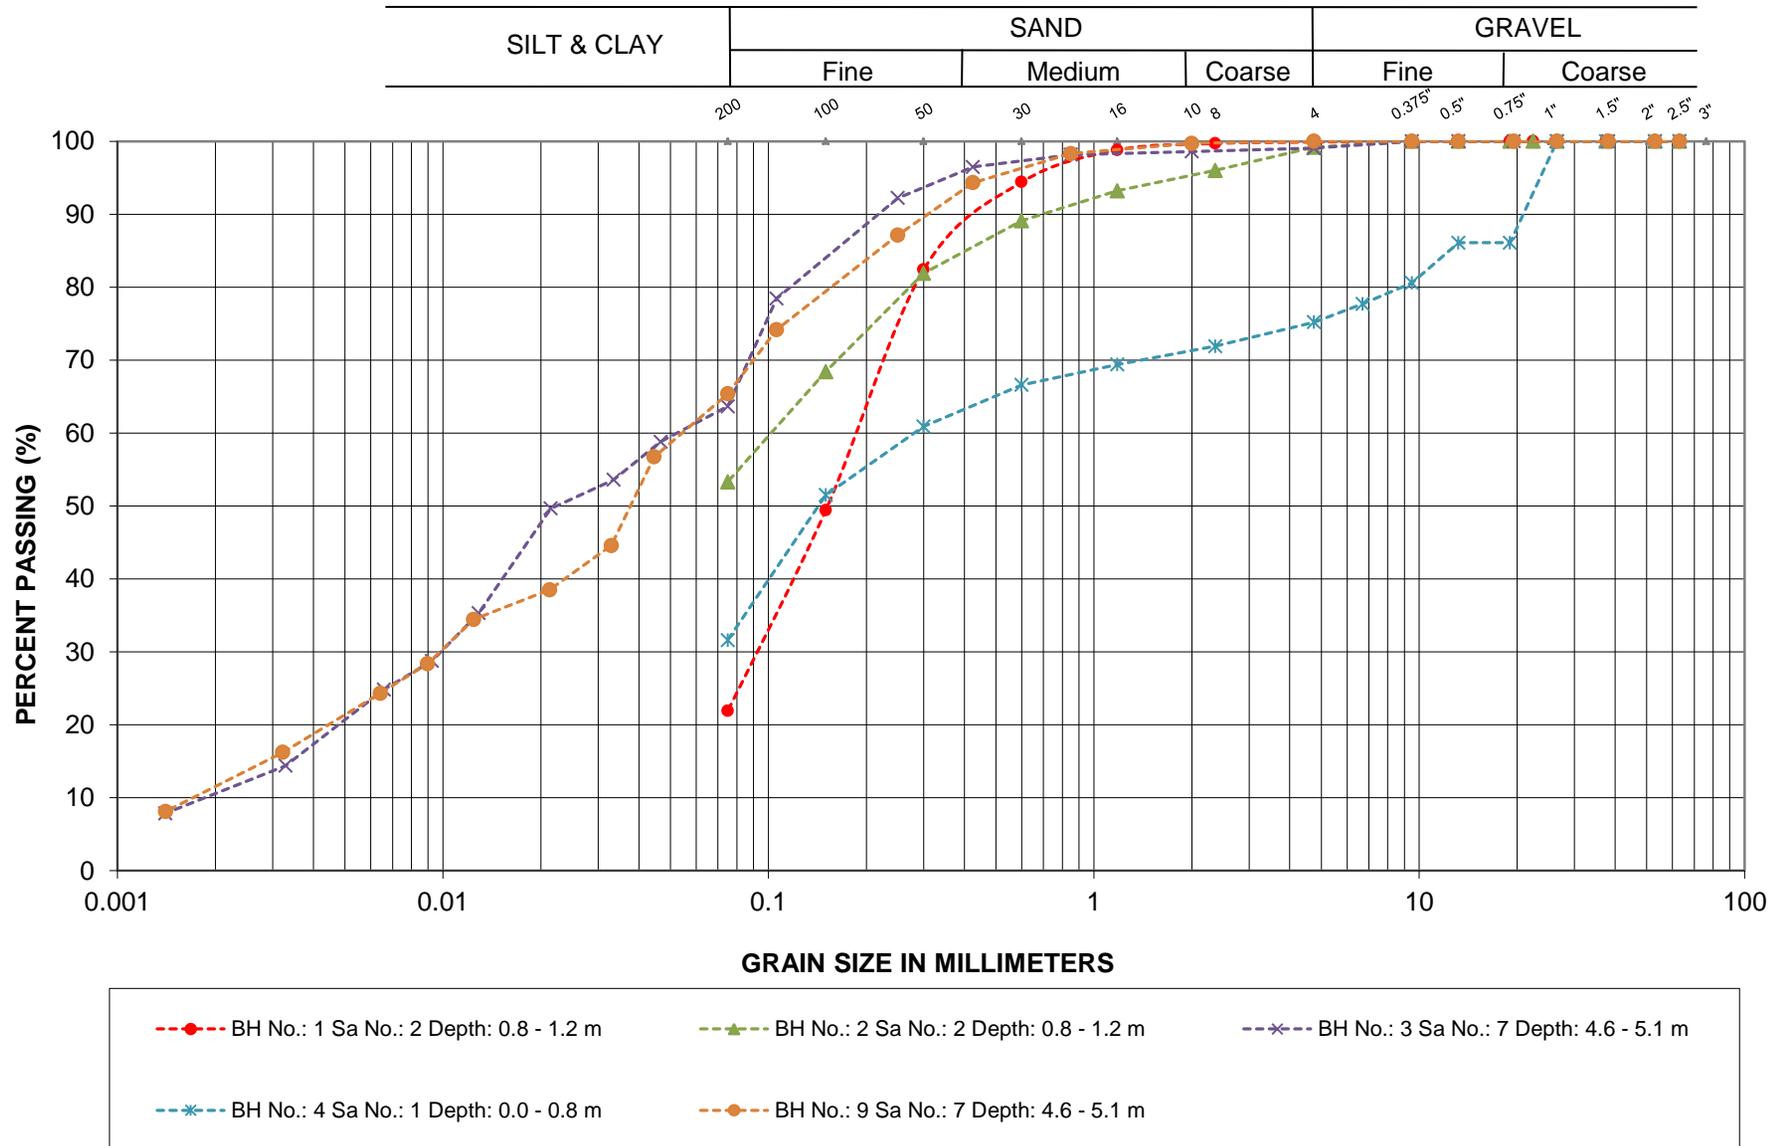
GRAIN SIZE ANALYSIS

SILTY SAND/SANDY SILT

At surface at Borehole Nos. 1, 4, and 5, underlying the surficial organics at Borehole Nos. 2, 6, and 7, underlying the peat at Borehole No. 8, and underlying the fill at Borehole Nos. 3 and 9, a deposit of grey silty sand described as a sand with silt to a silt and sand, trace to with gravel was penetrated. Trace organics were encountered in this deposit. The natural moisture content measured on samples of this deposit was in the order of 15 to 39%. Gradation analyses were carried out on five (5) samples of this deposit, the results of which indicated 0 to 25% gravel size particles, 35 to 78% sand size particles, and 22 to 65% silt and clay size particles (Figure No. L-2, Appendix 3). Based on SPT 'N' values of 0 (static weight of hammer) to 4 blows per 300 mm penetration, the compactness of this deposit was described as very loose. This deposit was encountered to depths of 1.5, 1.5, 5.7, 0.9, 0.7, 0.8, 1.4, and 5.2 m below grade at Borehole Nos. 1, 2, 3, 4, 5, 7, 8, and 9, respectively (elevations 289.1, 288.7, 288.3, 289.8, 292.4, 291.8, 289.1, and 288.8 m, respectively).

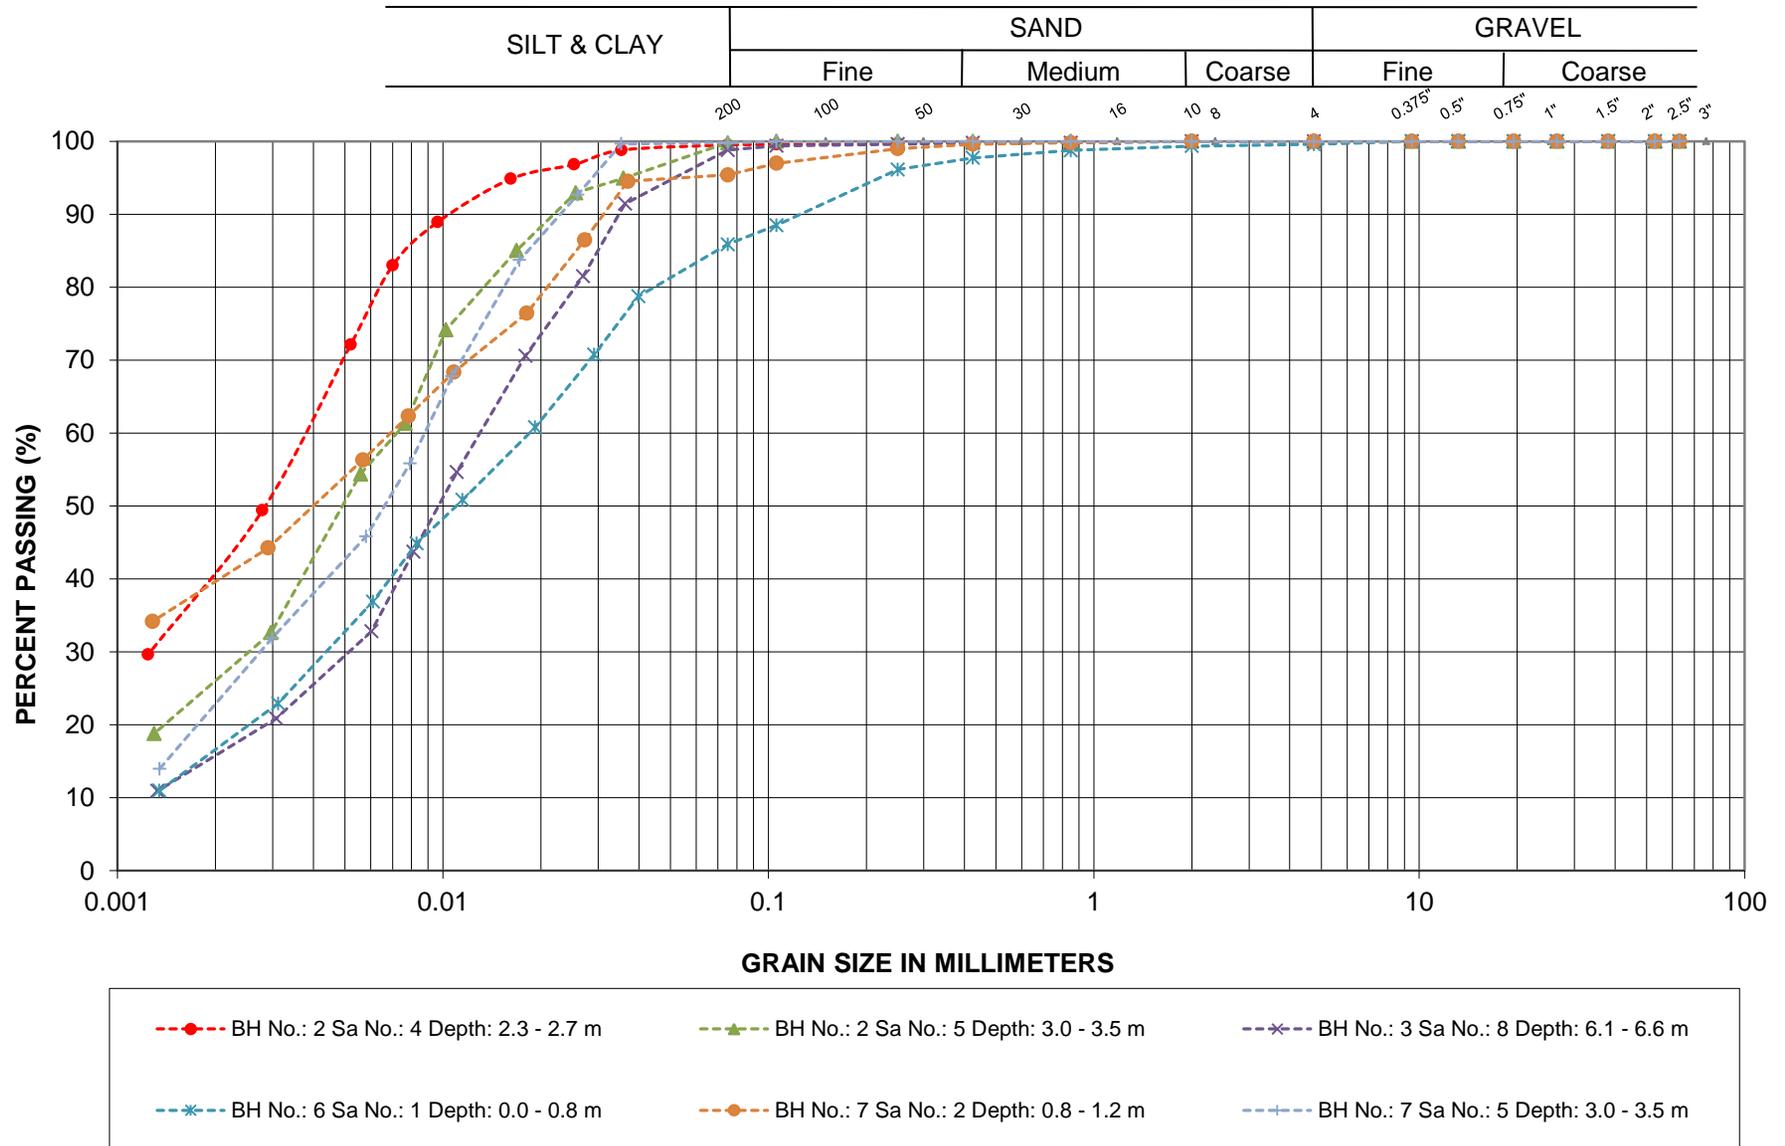
GRAIN SIZE ANALYSIS

SILTY CLAY

Underlying the silty sand at Boreholes Nos. 2, 3, 7, and 8, and at surface at Borehole No. 6, a deposit of grey silty clay was penetrated. The natural moisture content measured on samples of this deposit was in the order of 25 to 54%. Hydrometer analyses were carried out on six (6) samples of this deposit, the results of which indicated 0% gravel size particles, 1 to 14% sand size particles, 56 to 83% silt size particles, and 16 to 40% clay size particles (Figure No. L-3, Appendix 3). Atterberg Limits testing was carried out on six (6) samples of this deposit, the results of which indicated a Plastic Limit in the order of 19 to 23% and a Liquid Limit in the order of 32 to 46% (Figure No. L-6, Appendix 4). Based on results of Atterberg Limits testing, this deposit was described as a silty clay of low to medium plasticity (CL to CI). Based on in-situ shear strengths of 16 to 94 kPa, this deposit was described as soft to stiff. This deposit was encountered to depths of 3.8, 6.7, 0.8, 3.8, and 3.7 m below grade at Borehole Nos. 2, 3, 6, 7, and 8, respectively (elevations 286.4, 287.3, 291.1, 288.8, and 286.8 m, respectively).

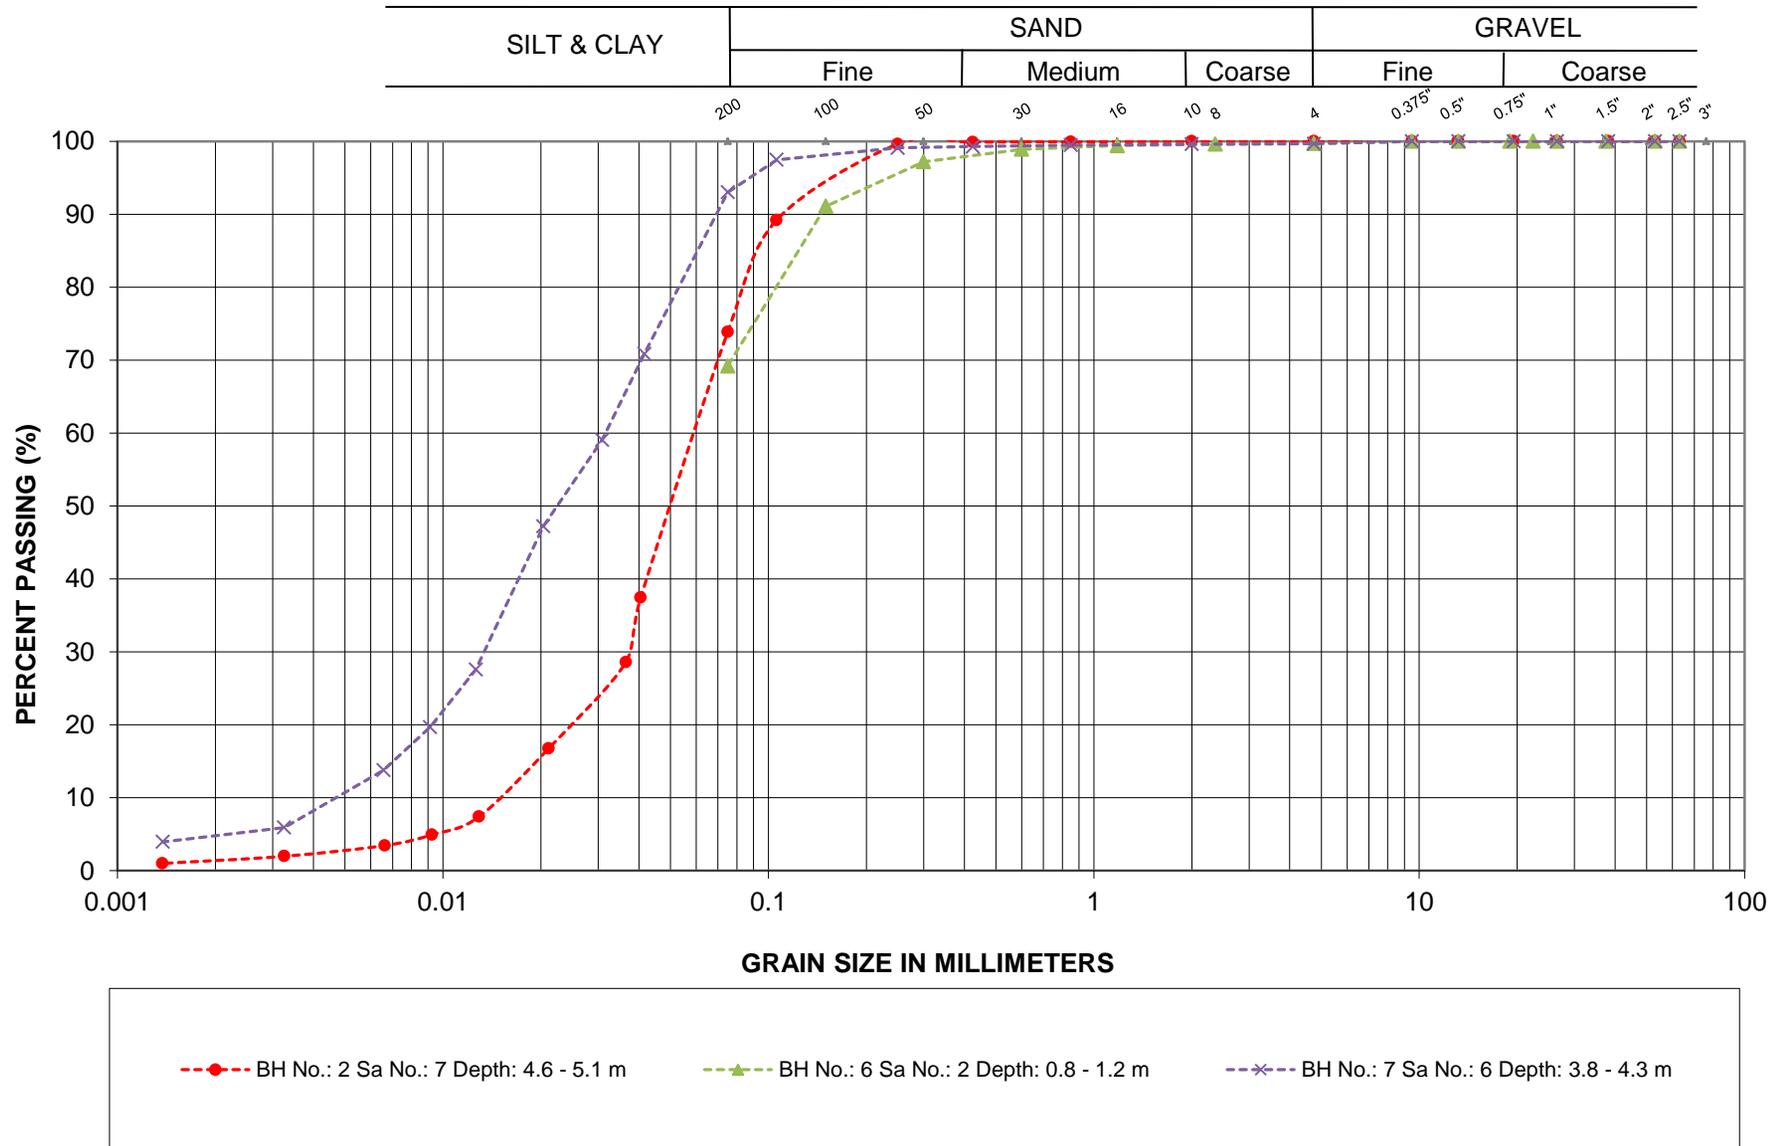
GRAIN SIZE ANALYSIS

SILT

Underlying the silty clay at Borehole Nos. 2, 3, 6, 7, and 8 and underlying the silty sand at Borehole No. 9, a deposit of grey silt, trace to with sand, trace clay gravel was penetrated. The natural moisture content measured on samples of this deposit was in the order of 18 to 26%. Hydrometer analyses were carried out on three (3) samples of this deposit, the results of which indicated 0% gravel size particles, 7 to 31% sand size particles, 69 to 88% silt size particles, and 2 to 5% clay size particles (Figure No. L-4, Appendix 3). This deposit was encountered to

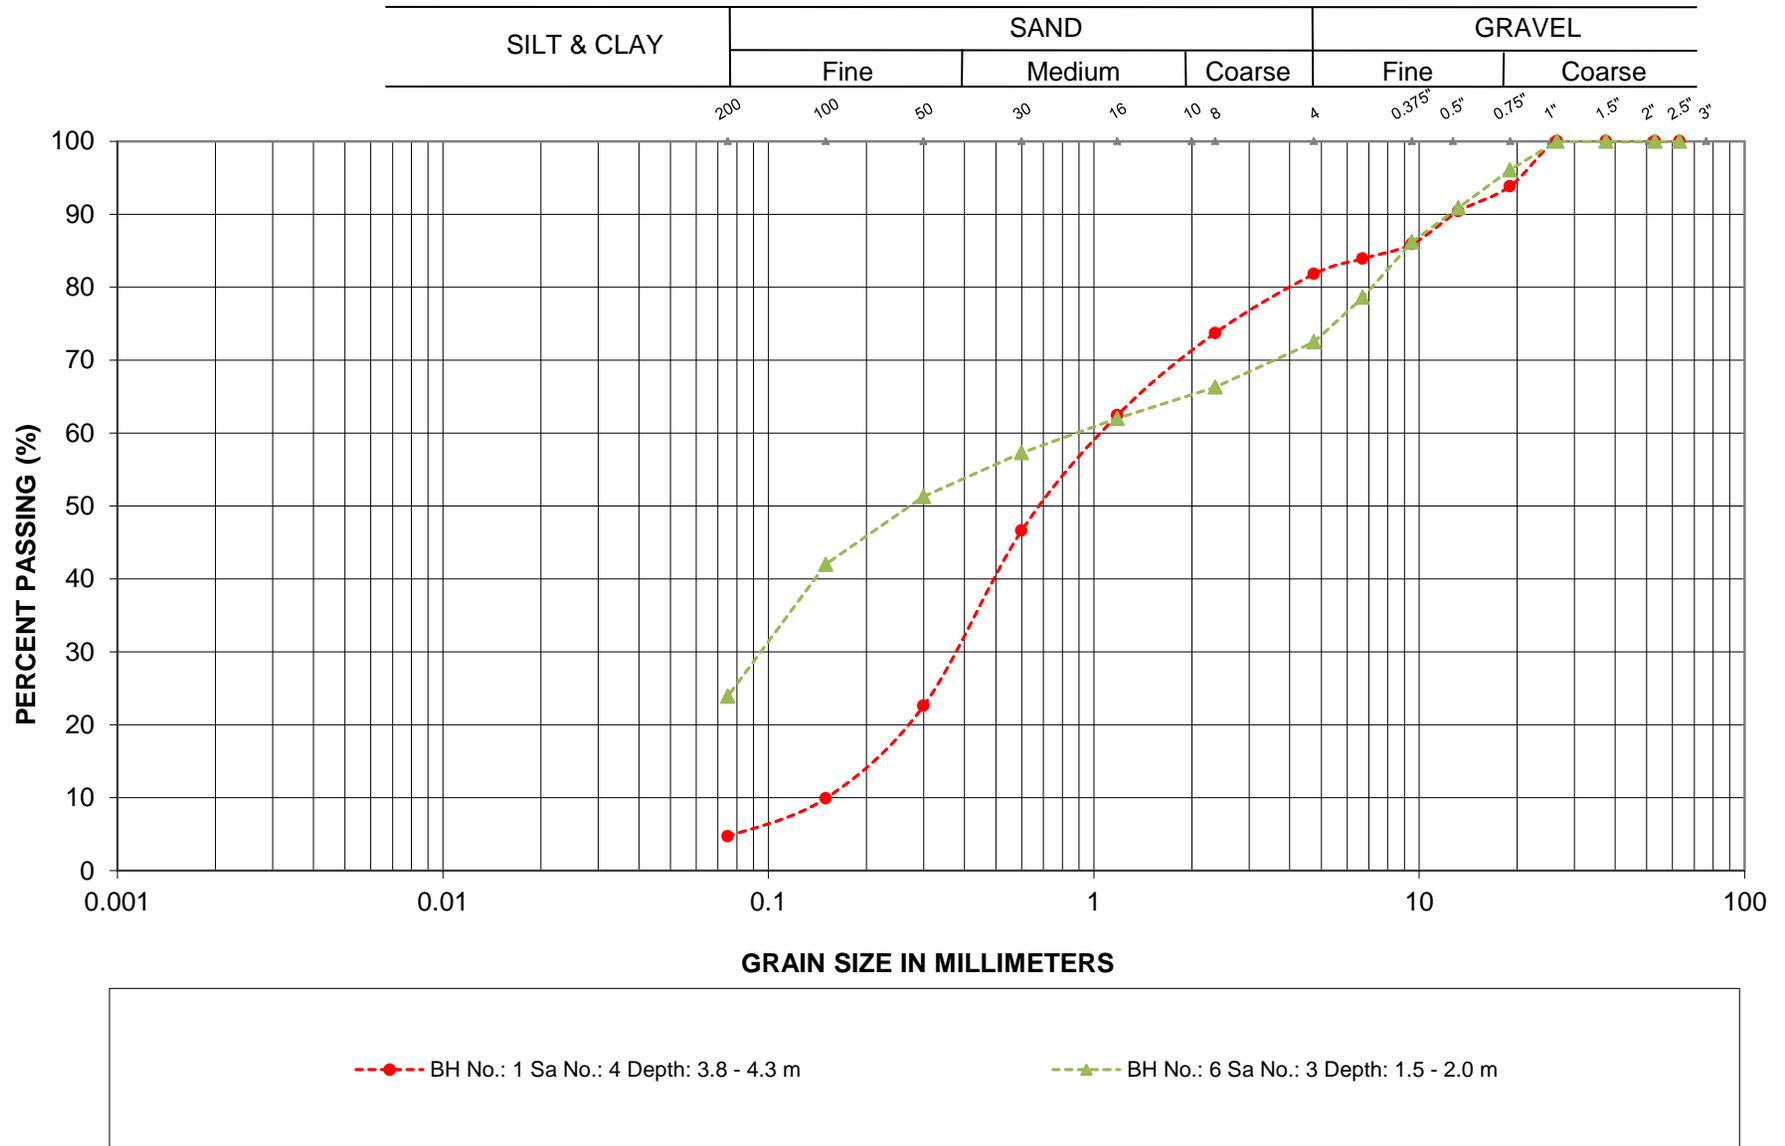
GRAIN SIZE ANALYSIS

SAND

Underlying the silty sand deposit at Borehole Nos. 1, 4, and 5, and underlying the silt deposit at Borehole Nos. 2 and 6, a deposit of grey sand trace to with silt, some to with gravel was penetrated. Occasional cobbles and boulders were encountered in this deposit. The natural moisture content measured on samples of this deposit was in the order of 10 to 23%. Gradation analyses were carried out on two (2) samples of this deposit, the results of which indicated 18 to 27% gravel size particles, 49 to 77% sand size particles, and 5 to 24% silt and clay size particles (Figure No. L-5, Appendix 3). Auger refusal was encountered in this deposit at depths of 2.9, 6.9, 1.9, 1.5, and 3.8 m at Borehole Nos. 1, 2, 4, 5, and 6, respectively (elevations 287.7, 283.3, 288.8, 291.6, and 288.1 m, respectively).

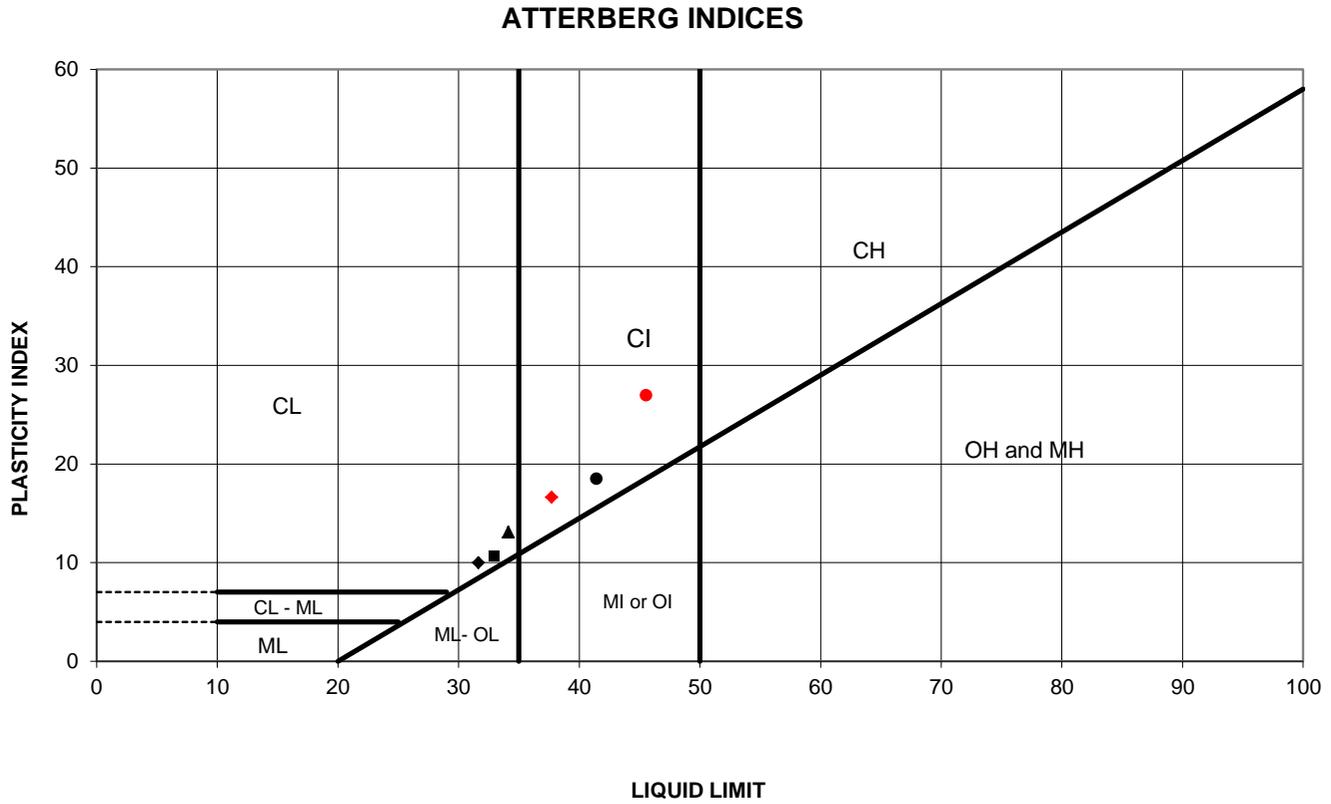
FIGURE L-6

ATTERBERG LIMITS TEST RESULTS

SYMBOL	BH	Sa. No.	Depth(m)	Elev.(m)	Liquid Limit	Plastic Limit	Plasticity Index	NMC %
●	2	4	2.3	287.9	41.4	23.0	18.5	53.6
◆	2	5	3.0	287.2	31.7	21.7	10.0	46.0
■	3	8	6.1	287.9	32.9	22.3	10.6	30.1
▲	6	1	0.0	291.9	34.1	21.1	13.1	33.5
●	7	2	0.8	291.8	45.6	18.6	27.0	24.8
◆	7	5	3.0	289.6	37.7	21.1	16.6	34.5

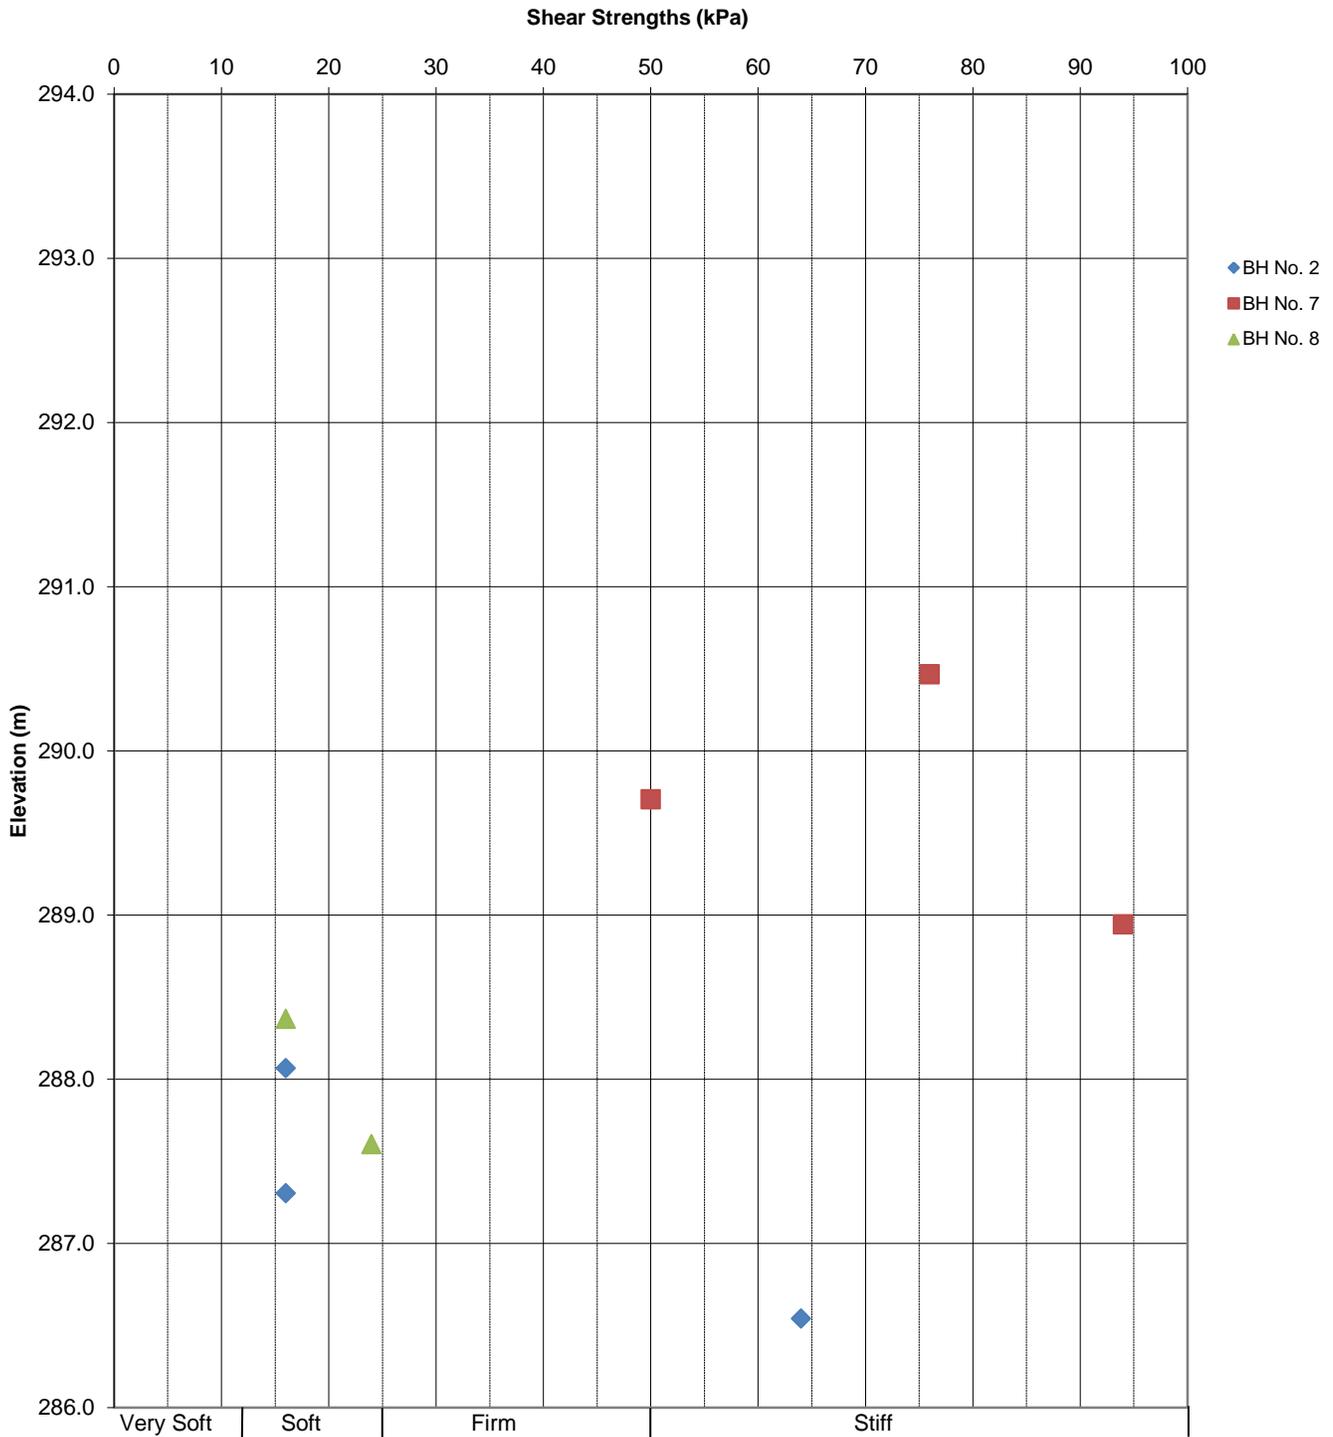
In-Situ Shear Strengths vs. Depth

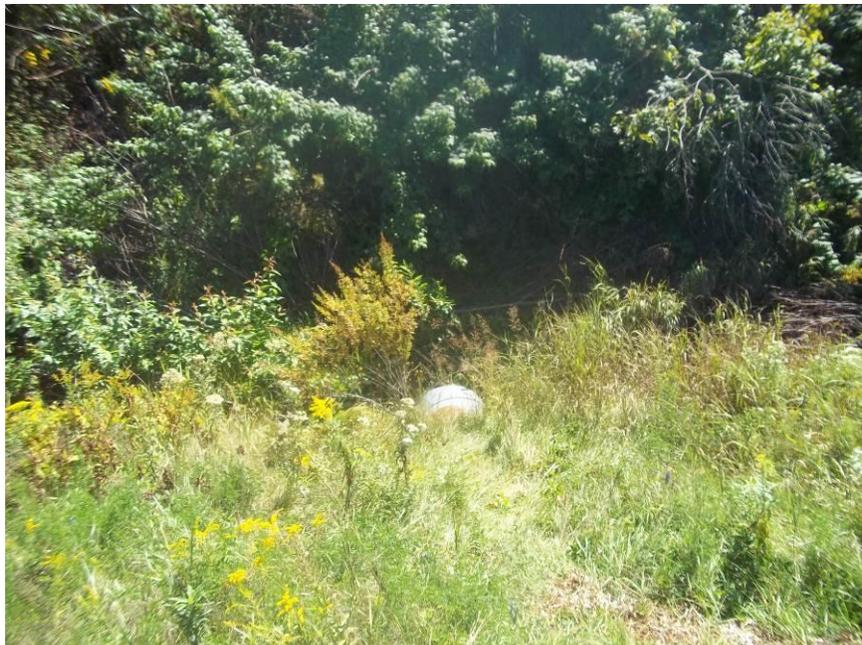
Photo: 4

Culvert Invert – Looking South

The existing 800 mm diameter Corrugated Steel Pipe (CSP) culvert, to be replaced, is located at Station 25+160, Township of Croft. The topography at the site is low, and the culvert allows flow from a ditch, on the south side of the embankment, to Whalley Lake to the north. The existing highway embankment currently supports two undivided lanes of highway, running in an east-west direction. The existing highway, at the culvert location, is constructed on a rock fill embankment some 4.3 m in height, with centerline elevation of 294.0 m at the culvert location. The culvert at this location is an 800 mm diameter CSP culvert, some 28.67 m in length. Flow was not observed in the culvert at the time of this investigation (see Photo Essay, Appendix 4). In general, the flow at this culvert location is from south to north based on culvert inverts and topography.

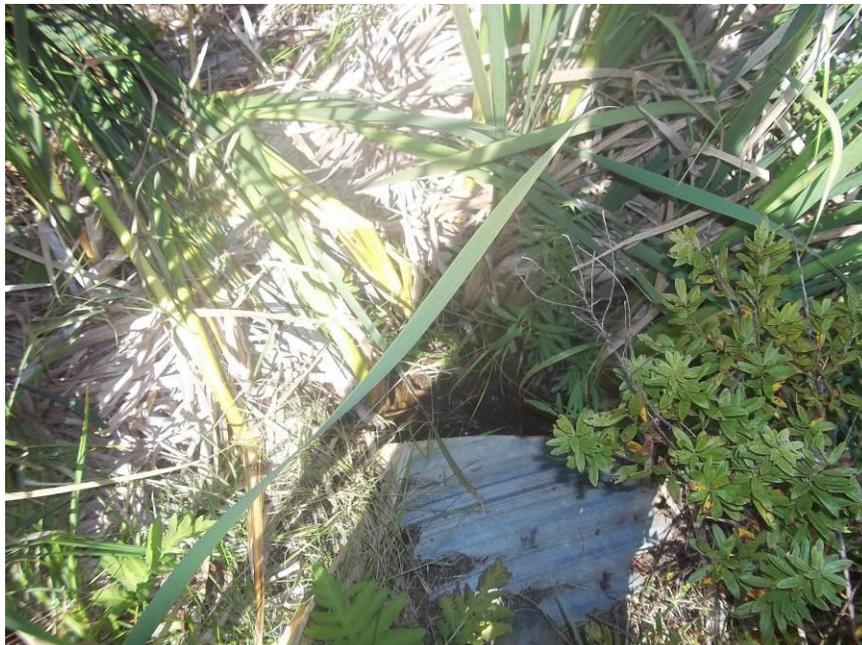
Photo: 6

Culvert Outlet
