**Highway 631 Rehabilitation – GWP 548-00-00
Culvert Replacement – Mink Lake Culvert
Station 16+584 - Twp. of Abraham
Site No. 38C-071**

FINAL FOUNDATION INVESTIGATION REPORT

Date: March 11, 2014
Ref. N^o: 13/03/13042-F2

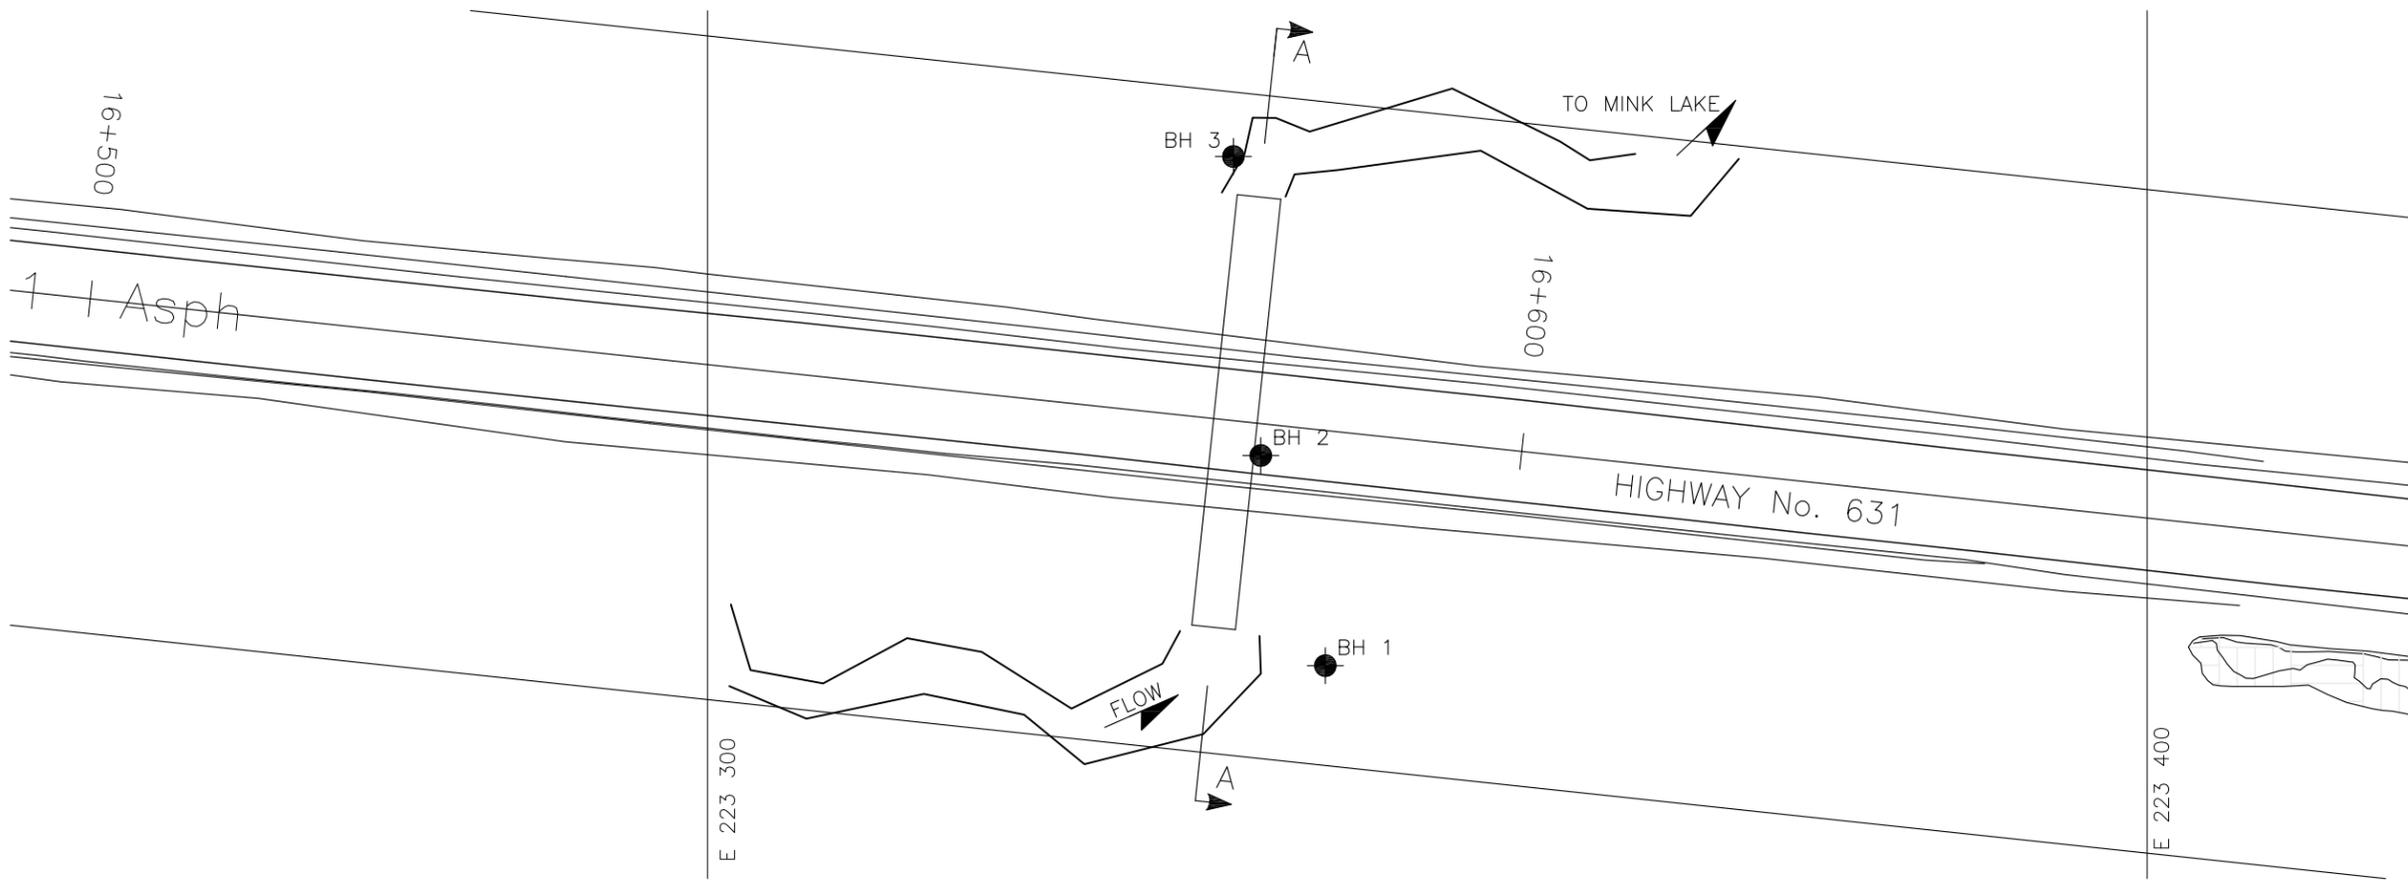
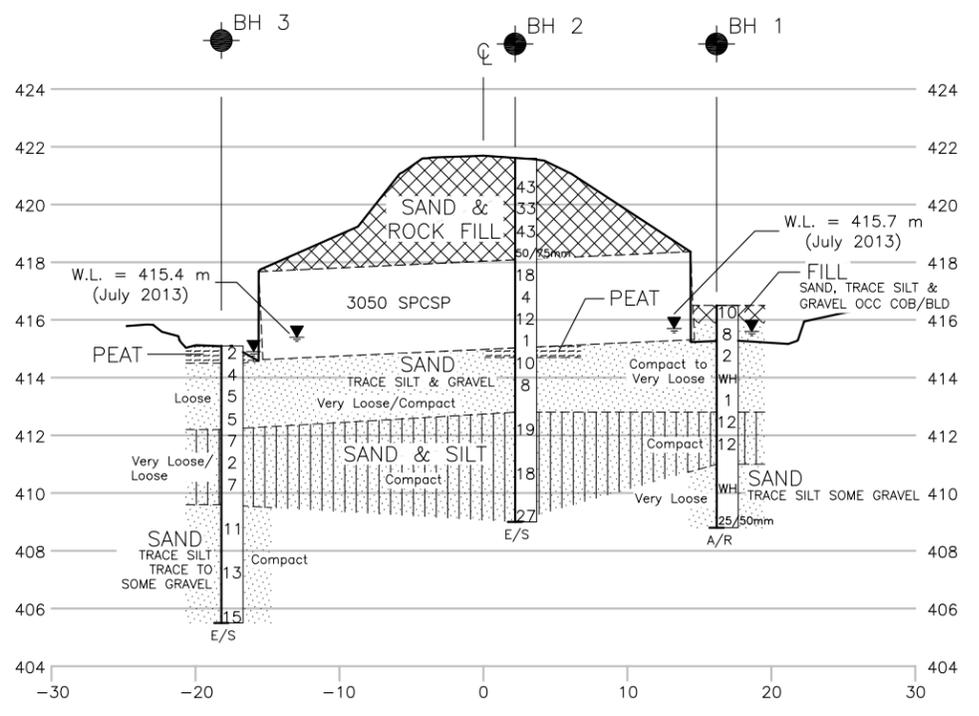
HWY 631
MINK LAKE CULVERT (SITE 38C-071)
ABRAHAM TOWNSHIP
BOREHOLE LOCATIONS & SOIL STRATA

CROSS SECTION A - A
5m SCALE 5m HOR
2.5m 2.5m VER

Borehole No.	Elev.	O/S	Co-ordinates	
			Northerly	Easterly
Borehole No. 1	416.5	16.2 m Rt	5386243.0	223342.9
Borehole No. 2	421.6	2.2 m Rt	5386258.3	223338.3
Borehole No. 3	415.1	18.2 m Lt	5386279.0	223336.5

Details of the subsurface conditions revealed by the investigation program are presented on the enclosed Record of Borehole Logs (Appendix 2) and on Drawing No. 2 (Appendix 3). It should be noted that the stratigraphic delineations presented on the borehole logs and soil strata plot are the result of non-continuous sampling, response to drilling progress, SPT and Dynamic Cone Penetration Test (DCPT) results, plus field observations at the time of drilling. Typically such boundaries represent transitions from one zone to another and are not an exact demarcation of a specific geological unit. Additional consideration should therefore be given to the fact that subsurface conditions may vary markedly between adjacent boreholes and beyond any specific boring location, and are shown on the drawings for illustration purposes only.

A plan and profile illustrating the borehole locations and stratigraphic sequences is provided on Drawing No. 2, Appendix 3. During the course of the exploration program, three (3) sampled boreholes were put down at this site, with Borehole No. 2 advanced through the embankment, and Borehole Nos. 1 and 3 advanced at the culvert ends. At the time of the subsurface investigation, the ground surface elevations at Boreholes Nos. 1 to 3 were recorded at 416.5, 421.6, and 415.1 m, respectively.

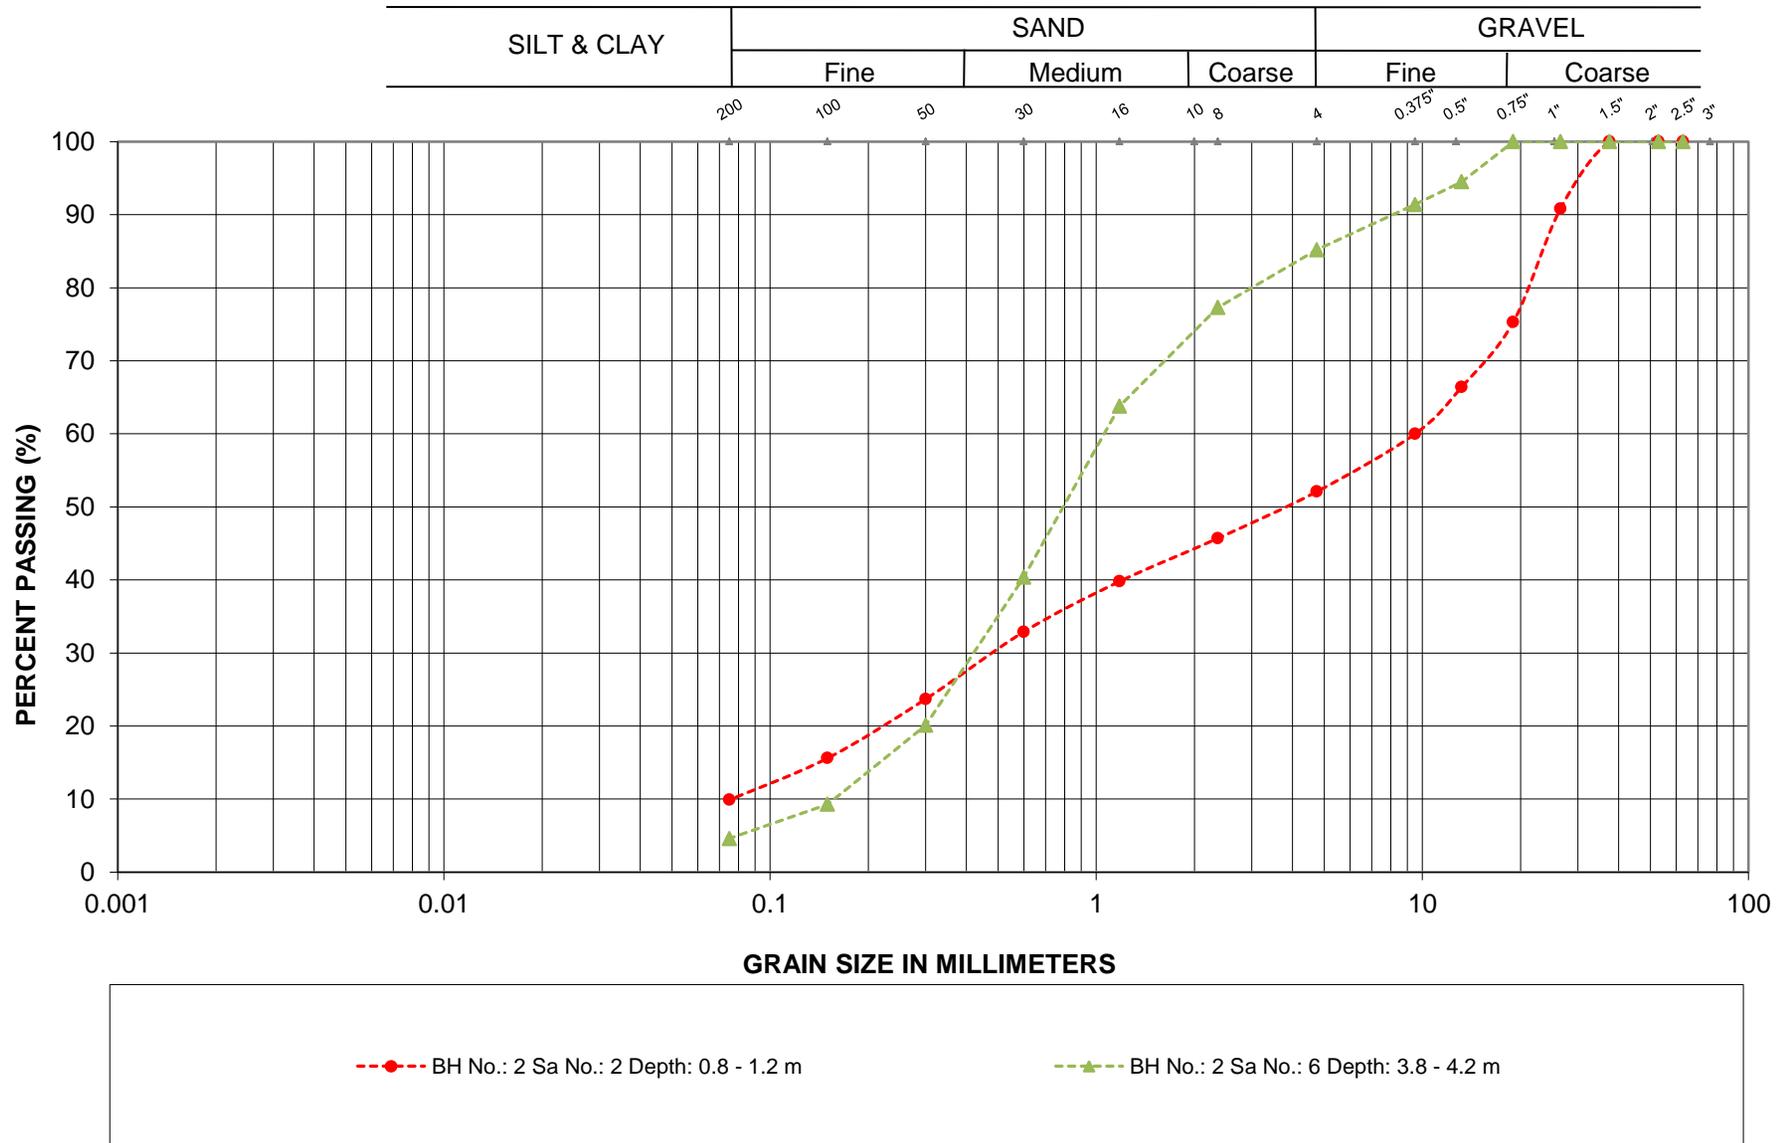
GRAIN SIZE ANALYSIS

EMBANKMENT FILL

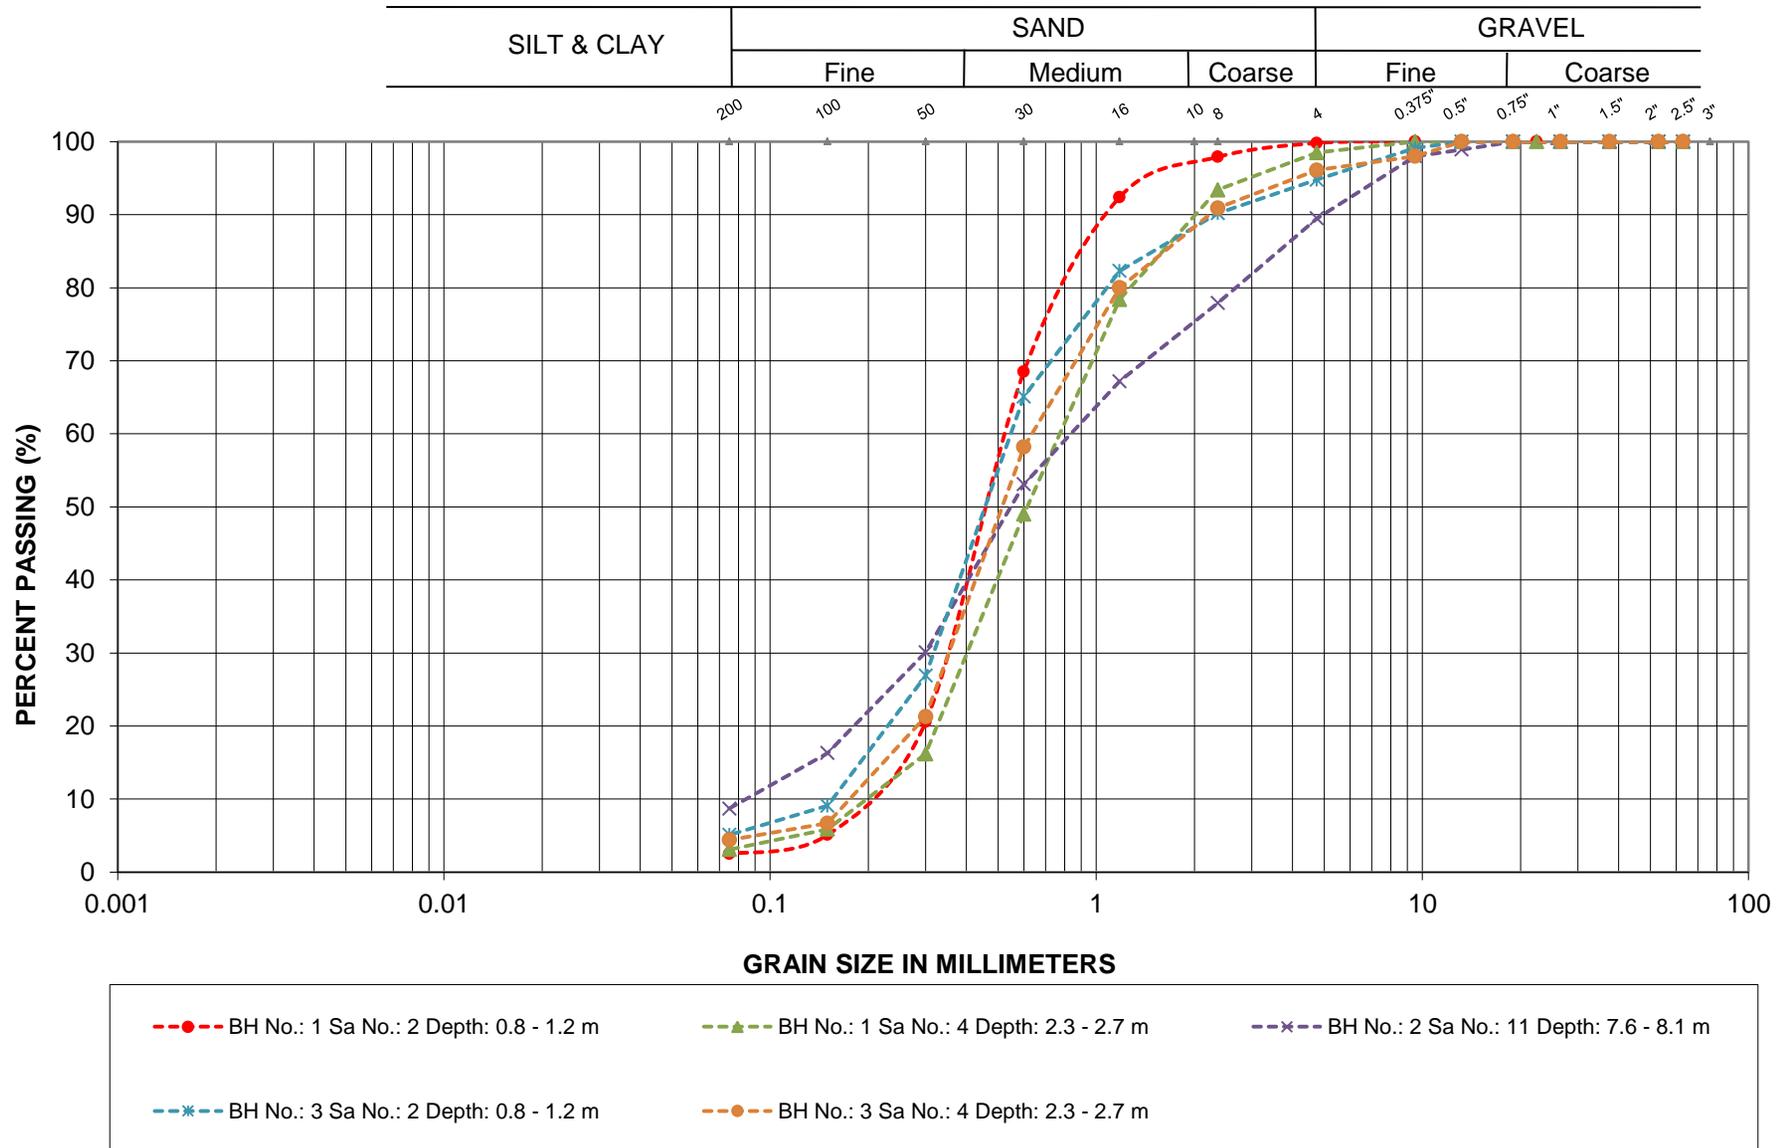
GRAIN SIZE ANALYSIS

SAND

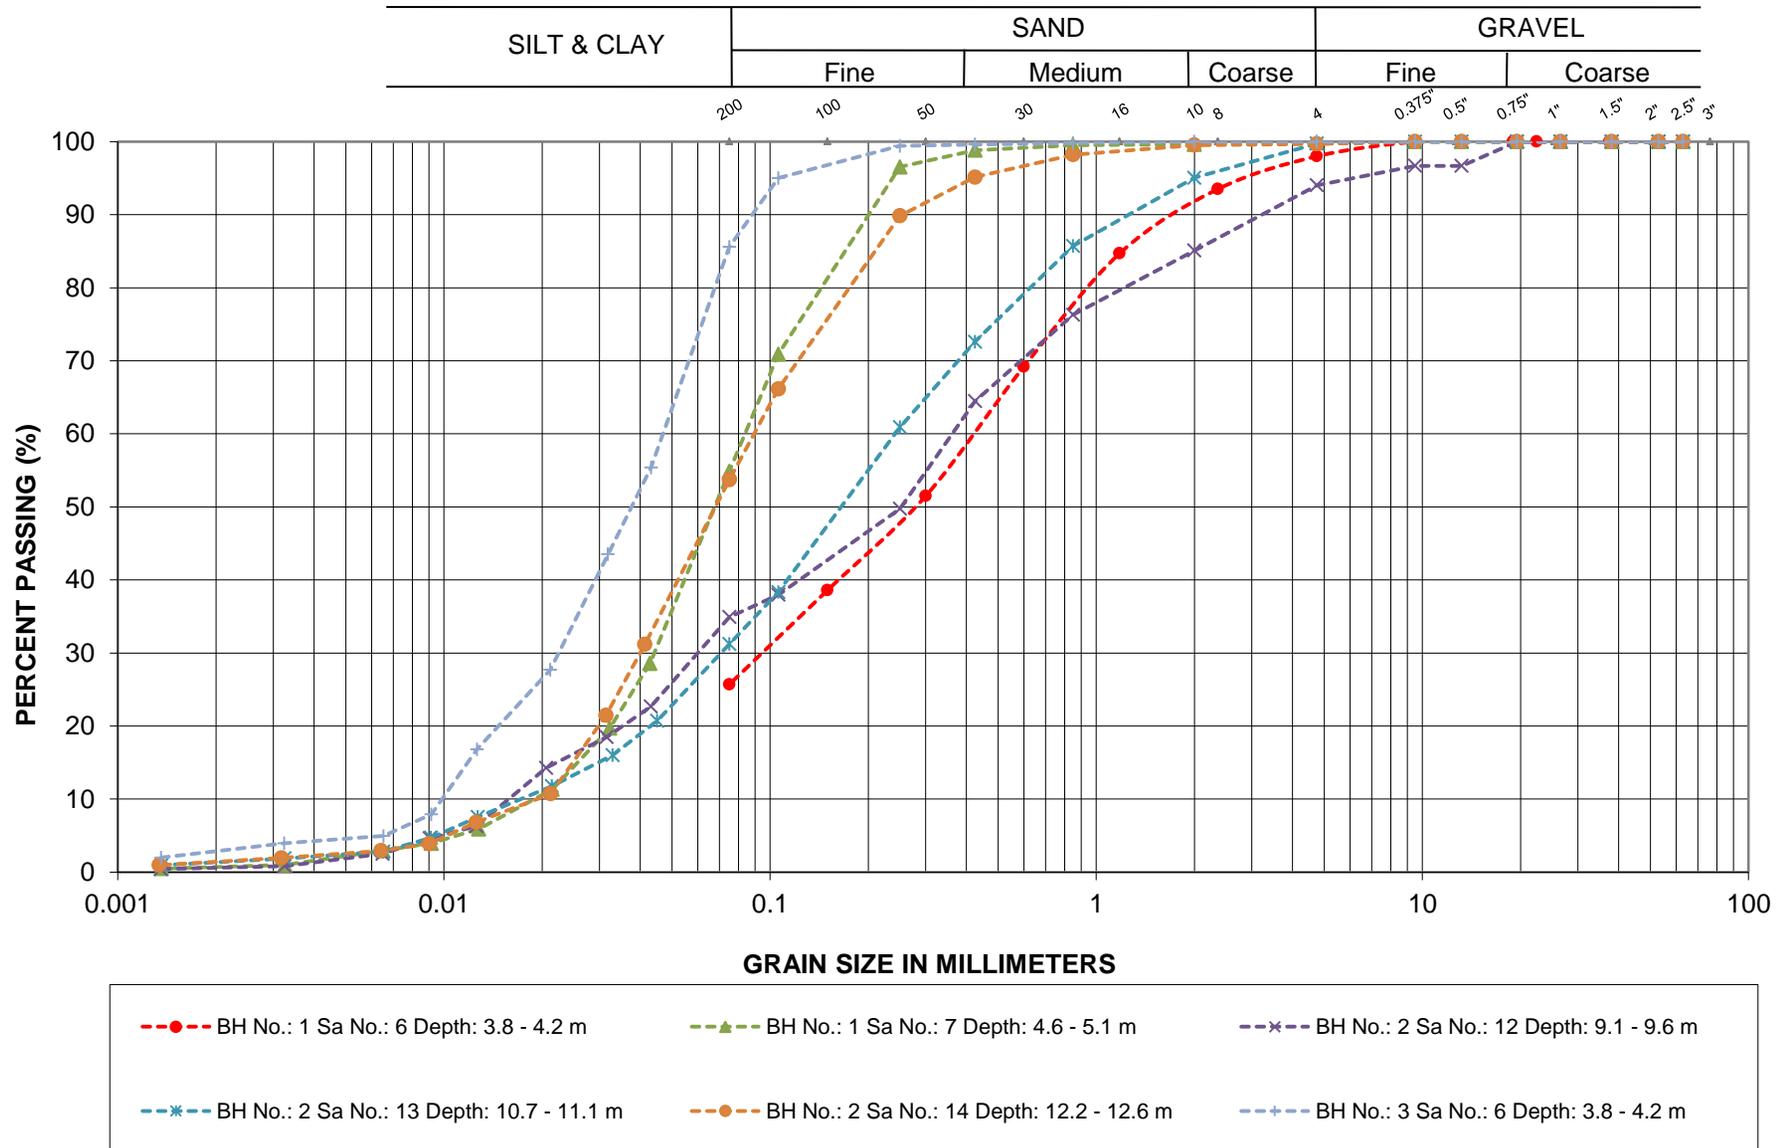
GRAIN SIZE ANALYSIS

SAND AND SILT

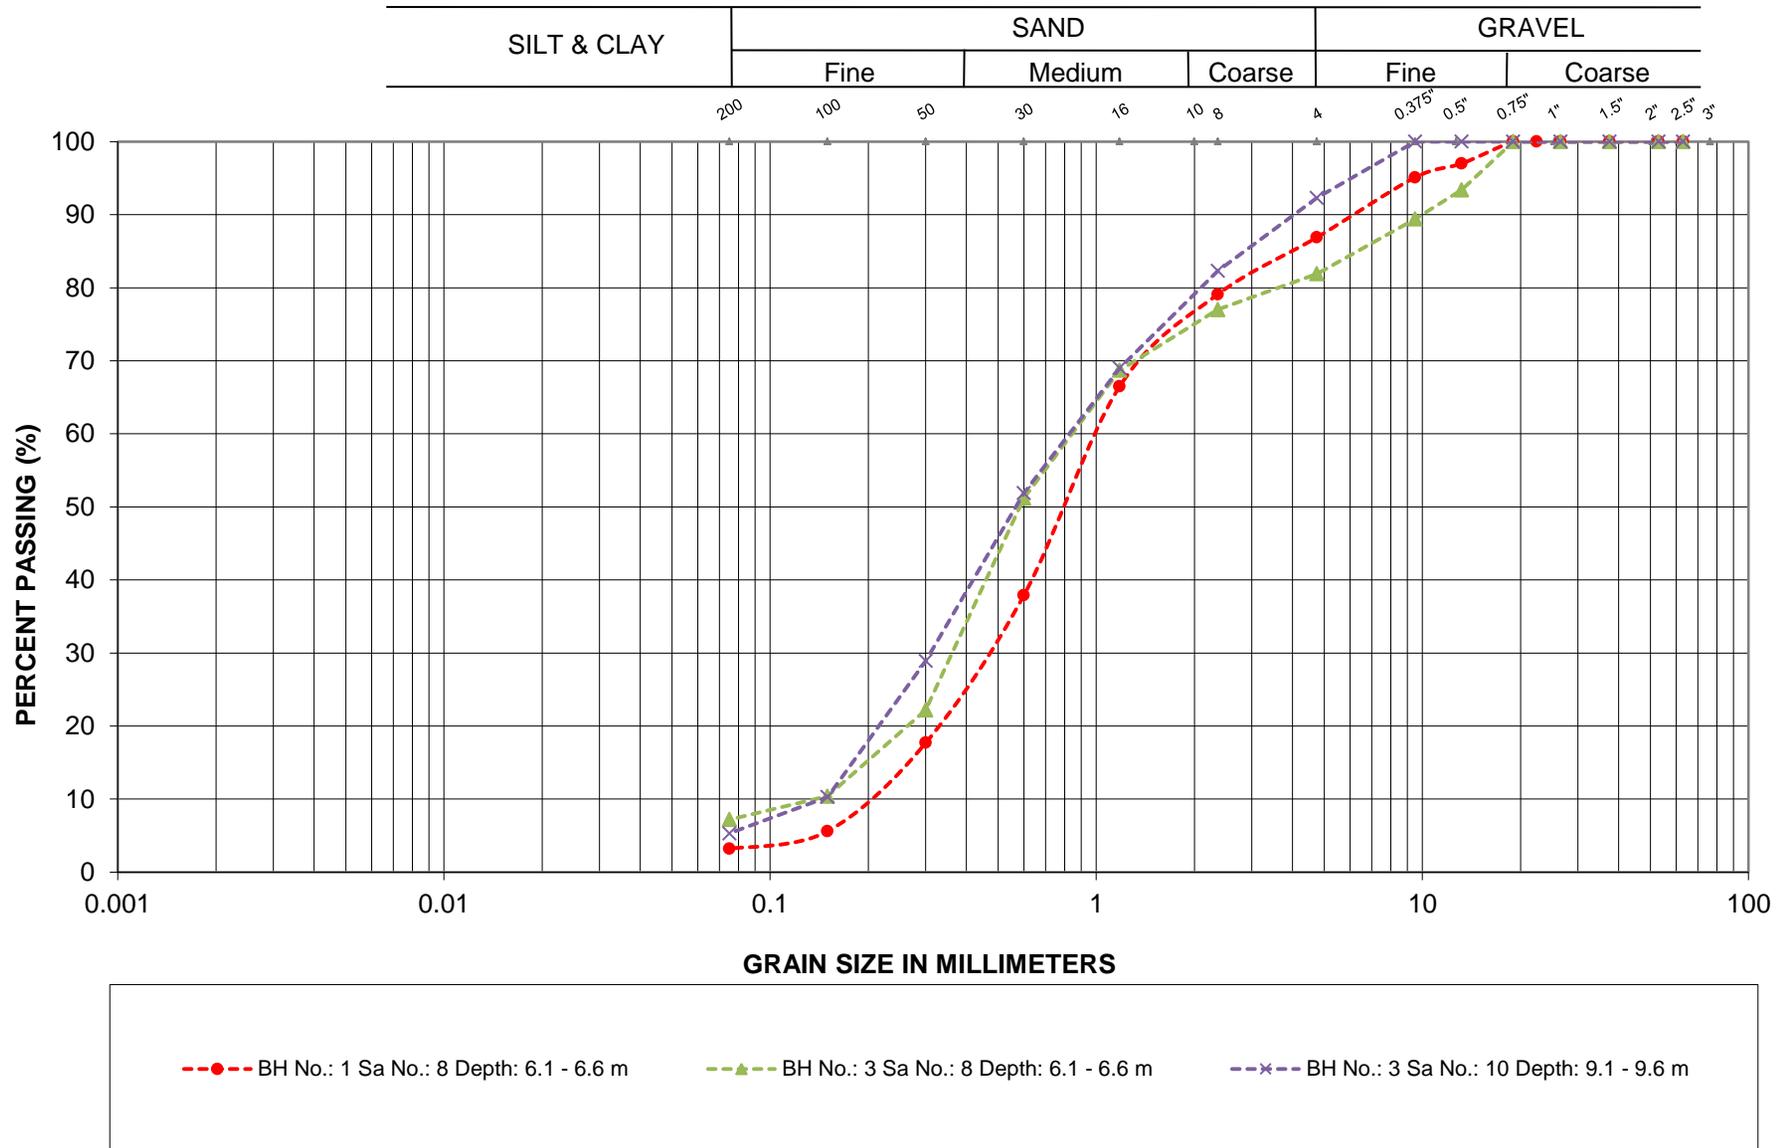
GRAIN SIZE ANALYSIS

SAND

particles, and 3 to 7% silt and clay size particles (Figure No. L-4, Appendix 3). Based on SPT 'N' values of 0 (static weight of hammer) to 15 blows per 300 mm penetration, the compactness of this deposit was described as very loose to compact, generally compact. Auger refusal was encountered in this deposit at a depth of 7.7 m at Borehole Nos. 1 (Elevation 408.8 m). Sampling was terminated in this deposit at a depth of 9.6 m below grade at Borehole No. 3 (Elevation 405.5 m).

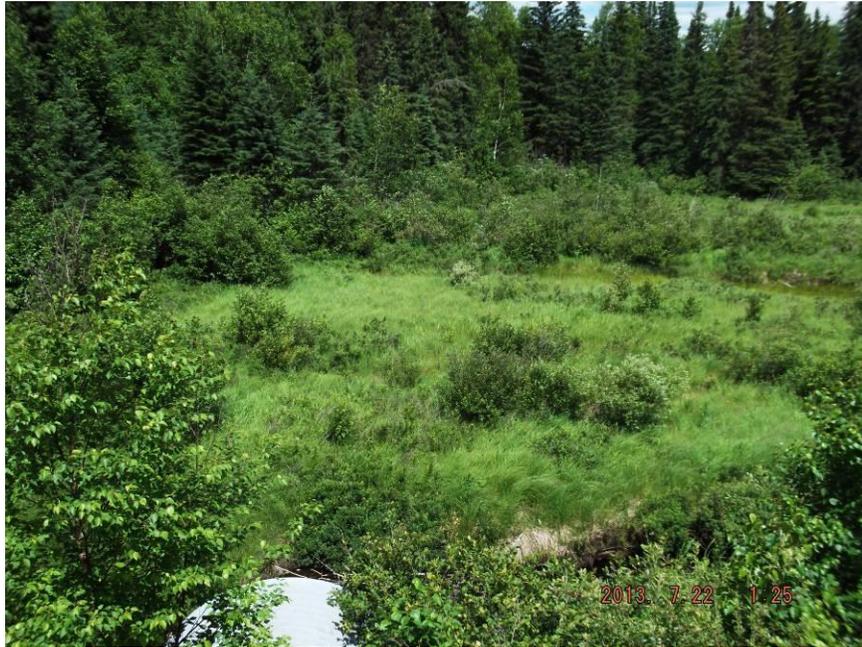
Photo: 1

Culvert Outlet – Looking North

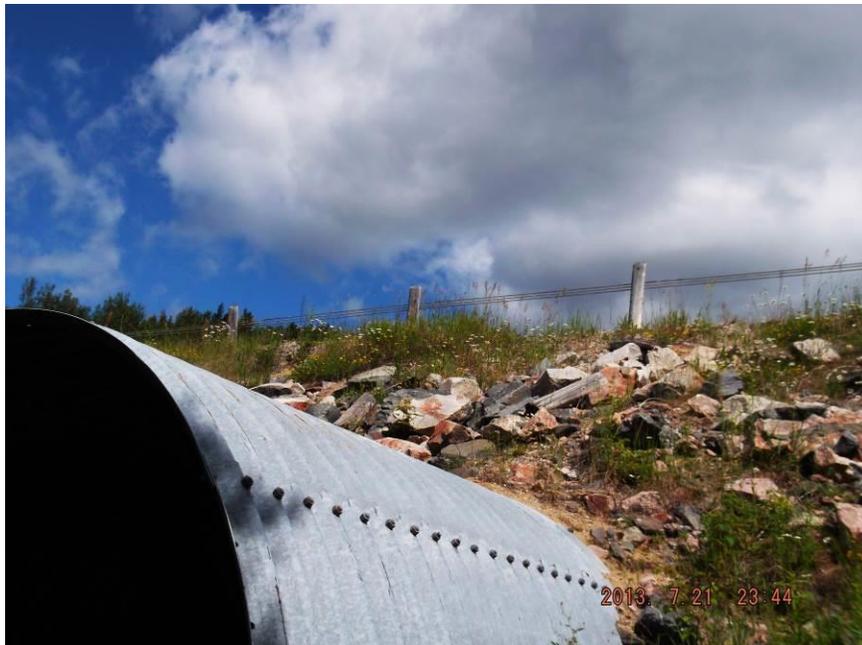
Photo: 2

Embankment at Outlet – Looking South

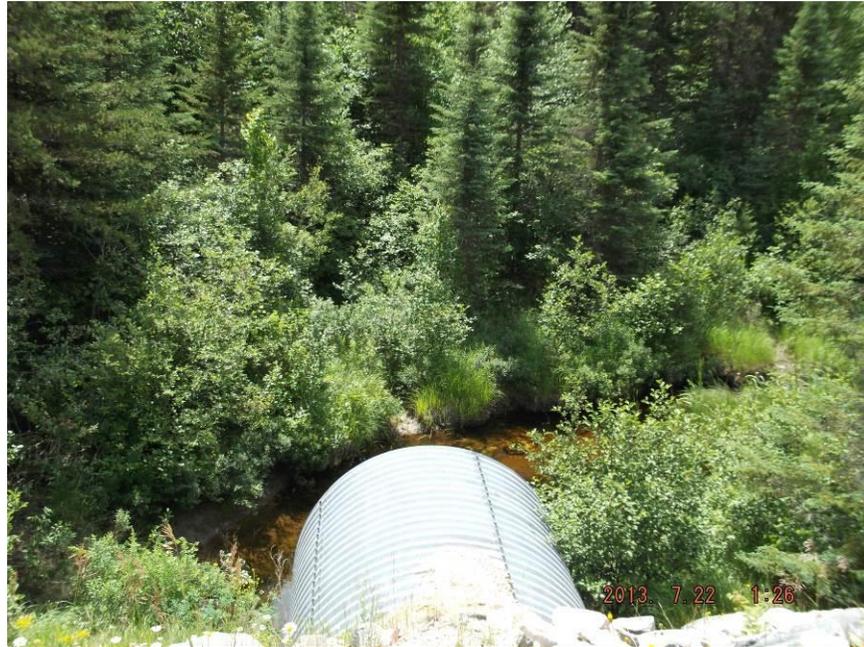
Photo: 3

Culvert Inlet – Looking South

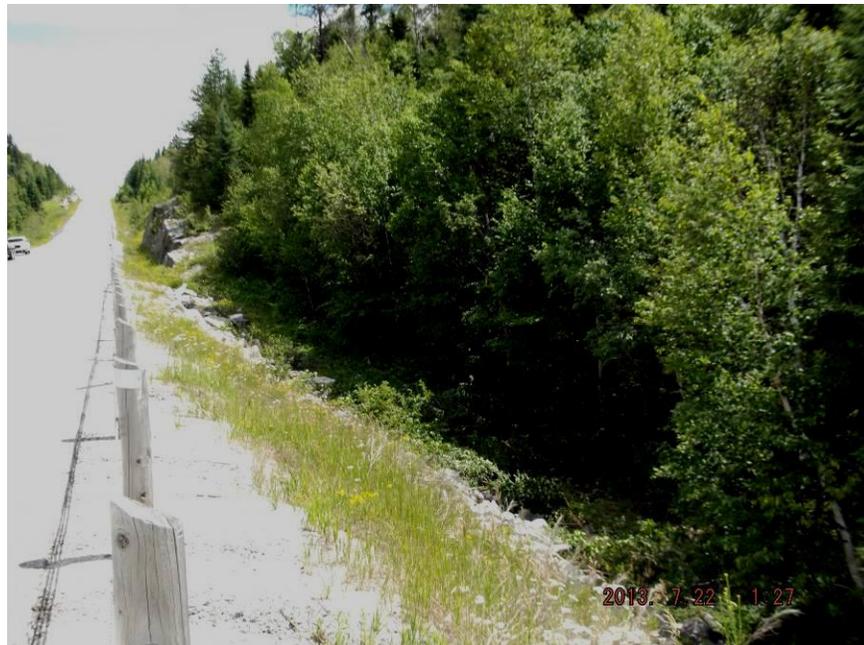
Photo: 4

South (Right) side of Embankment – Looking West

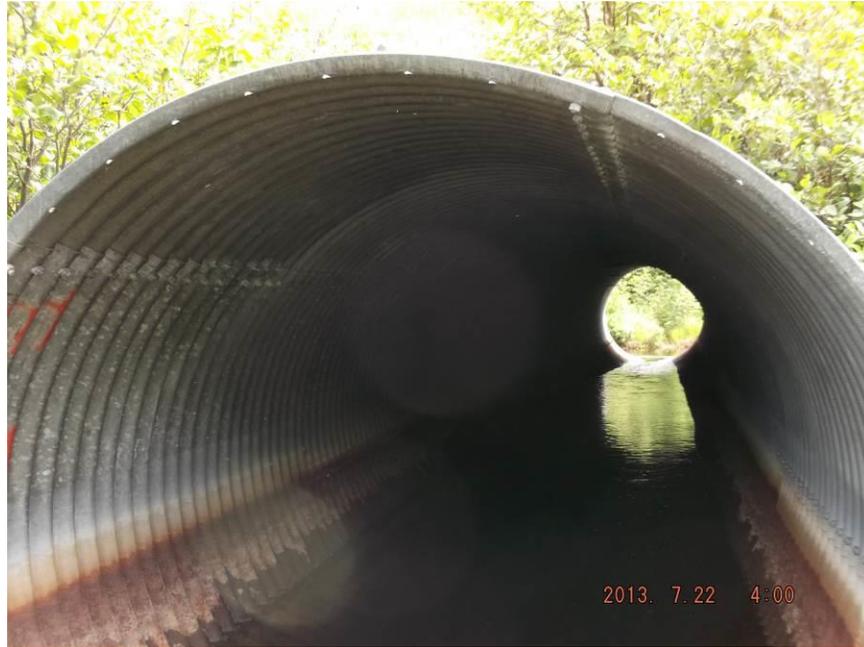
Photo: 5

View Through Culvert – Looking South
