**Little Mollie Creek Culvert
Twp. of Vrooman
Site No. 47-401/C**

**Highway 560, 6.5 km East of Junction with Highway 144
GWP 5263-10-00**

FINAL FOUNDATION INVESTIGATION REPORT

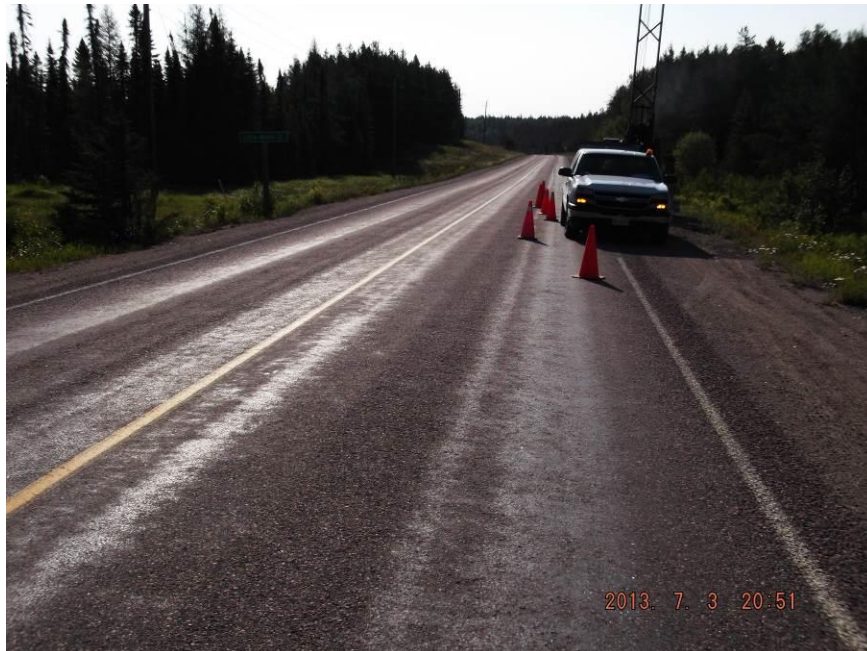
Photo: 1

Existing Embankment at Culvert Location – Looking East

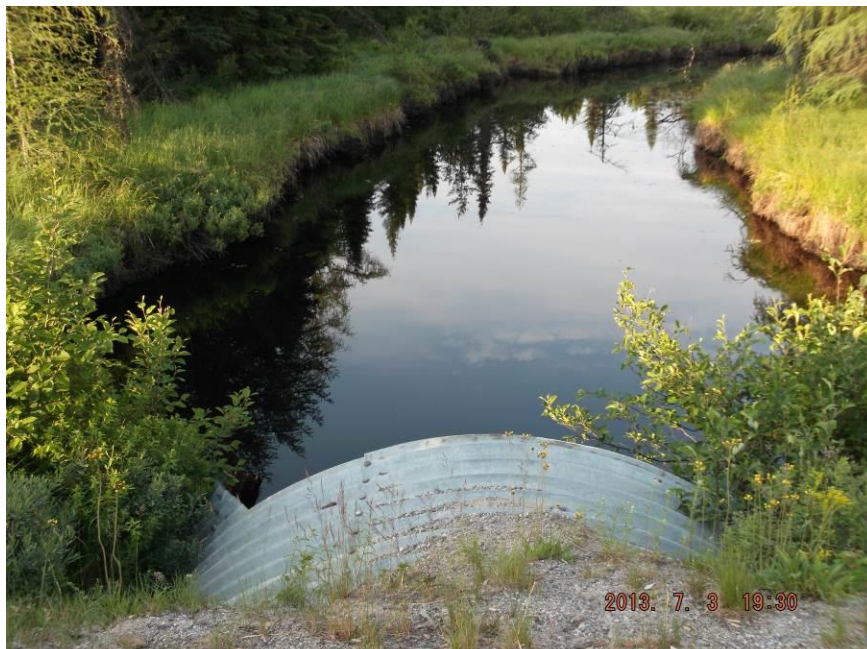
Photo: 2

Culvert Inlet – Looking South

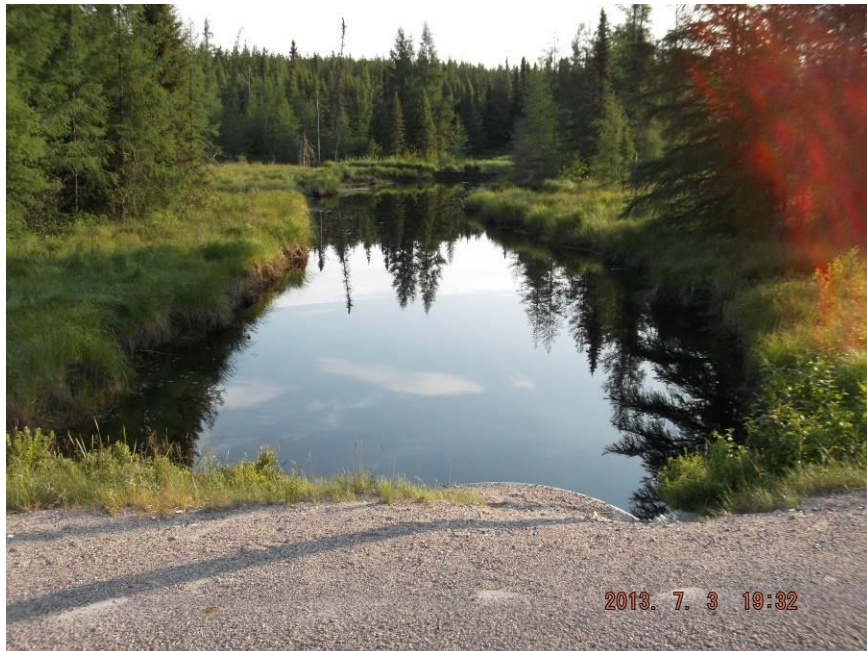
Photo: 3

Culvert Outlet – Looking North

At the time of this investigation, the water level at the culvert outlet was measured at elevation 383.8 m.

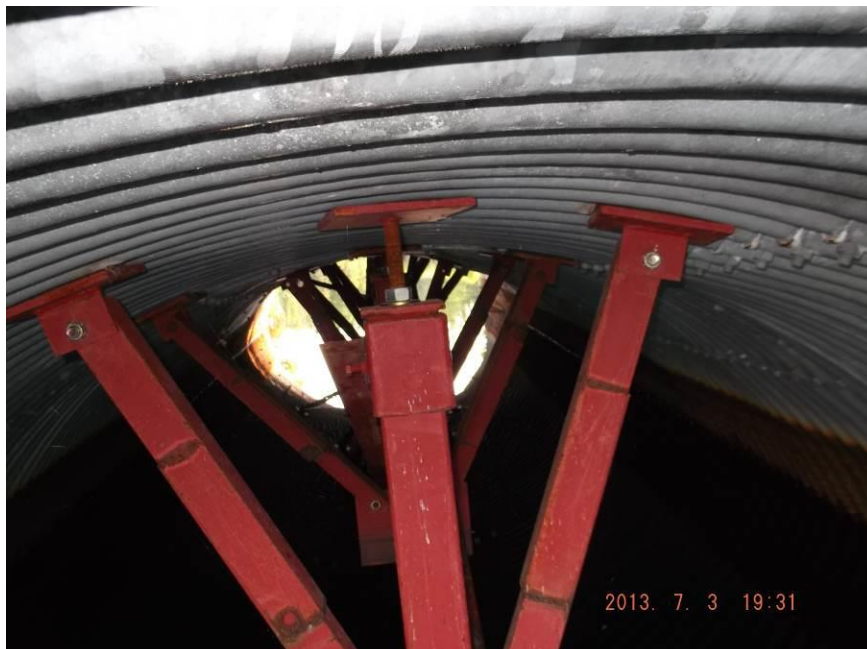
Photo: 4

View through culvert – Looking South
