**Culvert Replacement  
Highway 11  
Station 21+918 – Township of Idington  
GWP 163-98-00**

## **FINAL FOUNDATION INVESTIGATION REPORT**

Date: February 23, 2016  
Ref. N<sup>o</sup>: 15/05/15059-F6

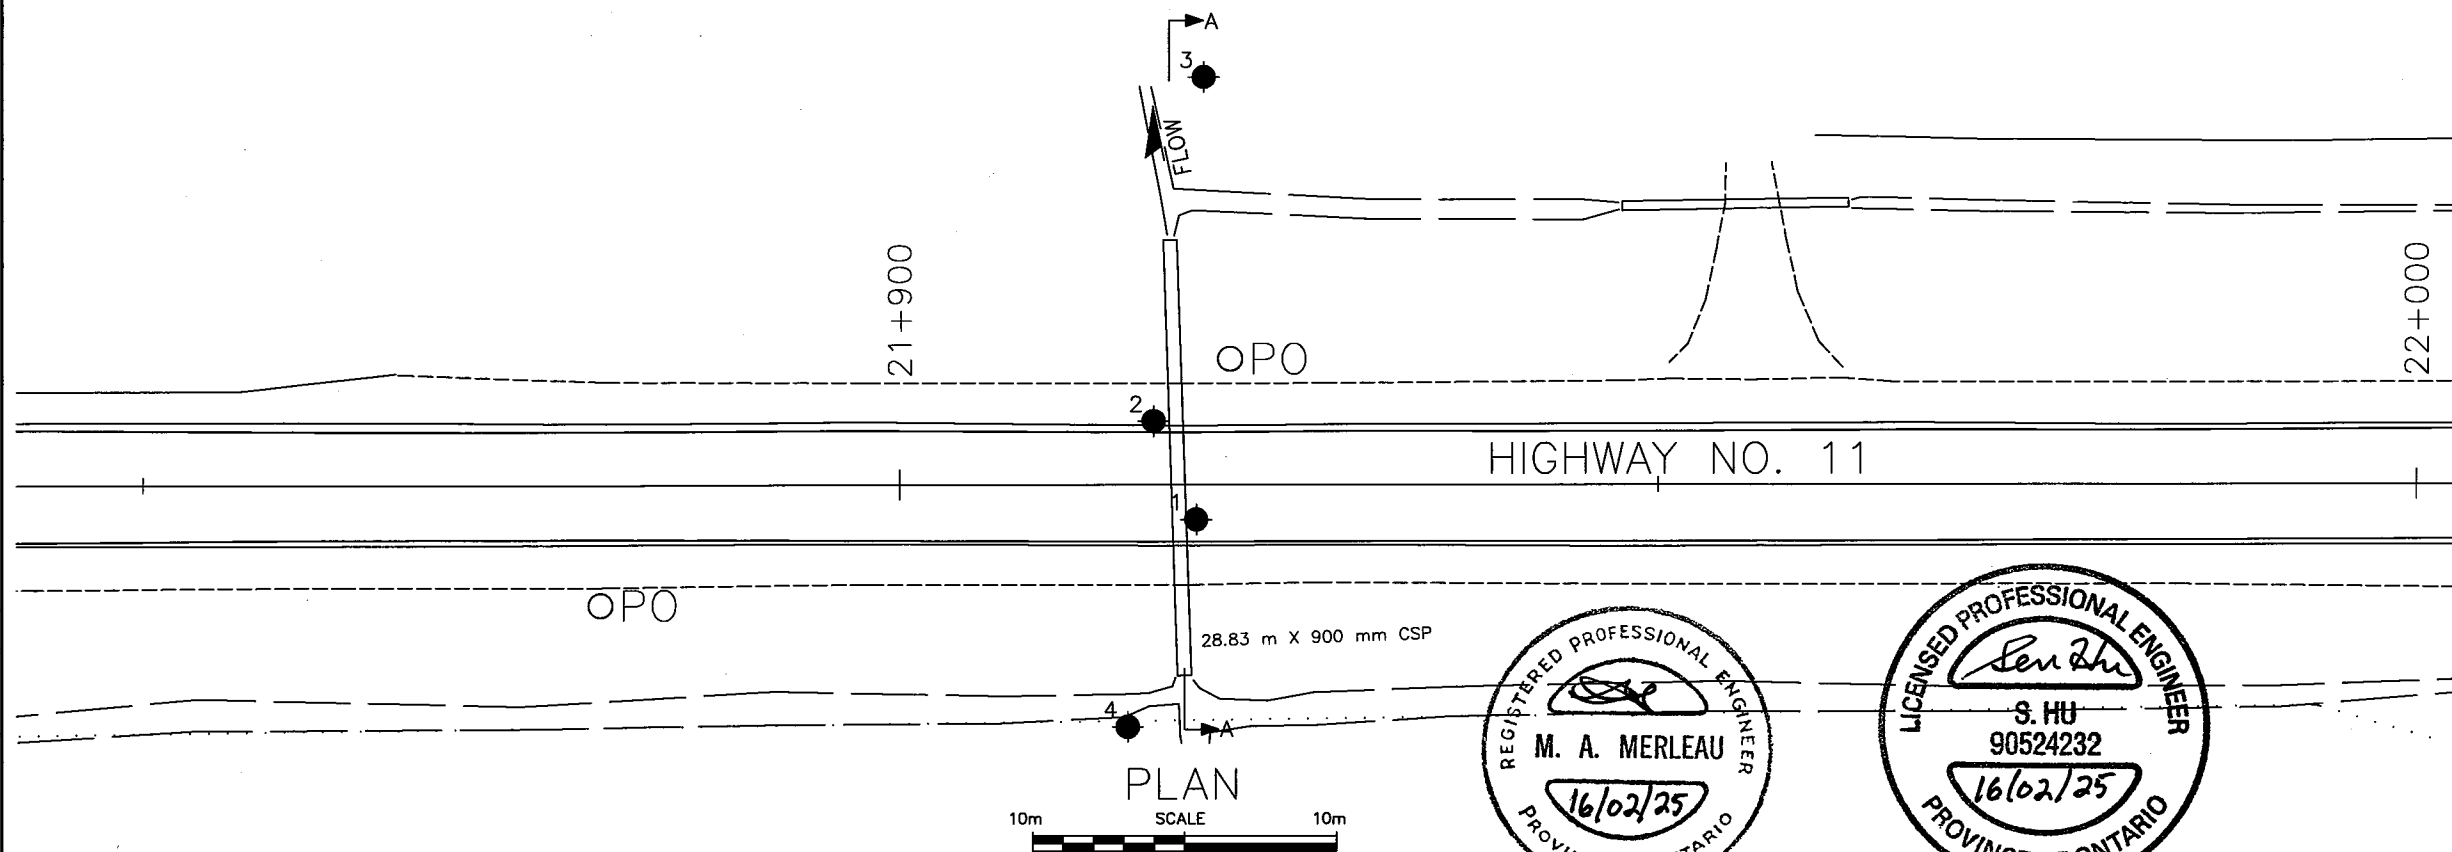
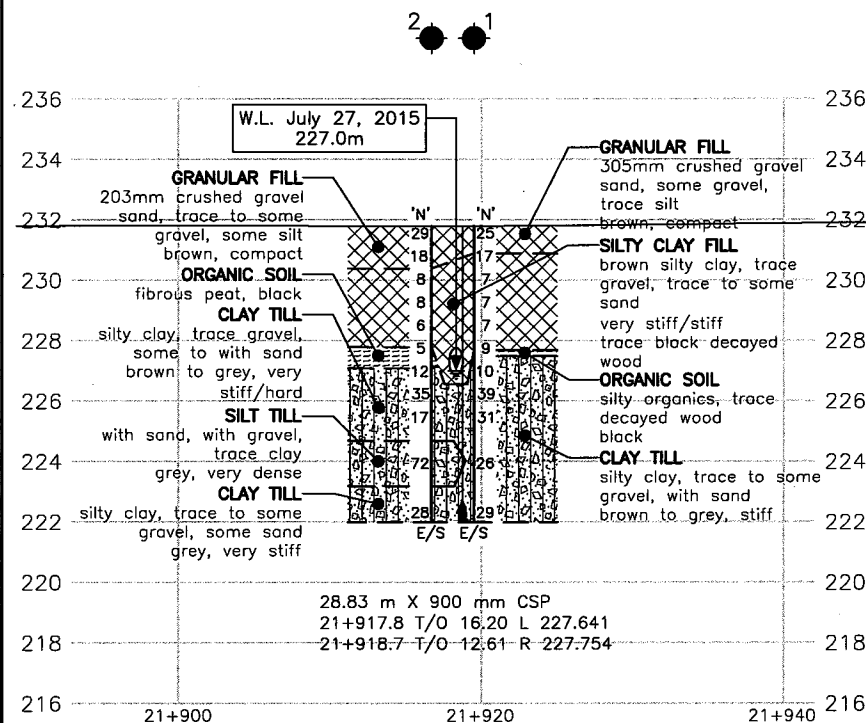
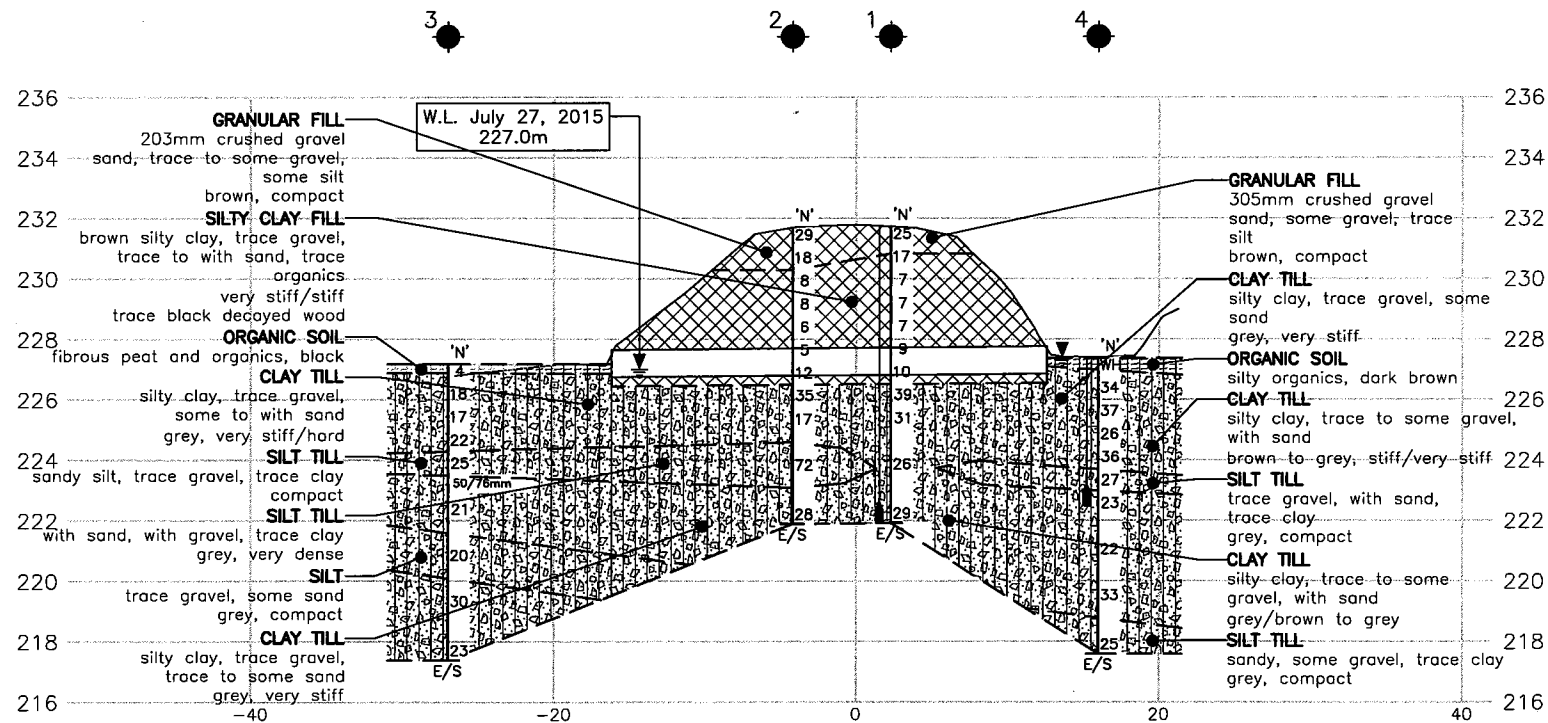
DRAWING  
2

BOREHOLE LOCATIONS  
AND SOIL STRATIGRAPHY

BOREHOLE No.	ELEVATION	O/S	NORTHING	EASTING
1	231.7	2.3m Rt	5484681.8	397125.7
2	231.7	4.2m Lt	5484688.7	397127.2
3	227.2	27.0m Lt	5484705.2	397143.3
4	227.4	16.0m Rt	5484673.4	397114.0

Details of the subsurface conditions revealed by the investigation program are presented on the enclosed Records of Borehole Logs (Appendix 2) and on Drawing No. 2 (Appendix 3). Please note that stratigraphic delineation presented on the borehole logs and soil strata plot are the results of non-continuous sampling, response to drilling progress, the results of SPT, plus field observations. Typically such boundaries represent transitions from one zone to another and are not an exact demarcation of specific geological unit. Additional consideration should be given to the fact that subsurface conditions may vary markedly between adjacent boreholes and beyond any specific boring location, and are shown on the drawings for illustration purposes only.

A plan and profile illustrating the borehole locations and stratigraphic sequences is shown on Drawing No. 2, Appendix 3. During the course of the exploration program, four (4) sampled boreholes were put down at this site, with Borehole Nos. 1 and 2 advanced through the embankment adjacent to the culvert, Borehole No. 3 advanced in the area adjacent to the culvert outlet, and Borehole No. 4 advanced adjacent the culvert inlet. At the time of the subsurface investigation, the ground surface elevations at Boreholes Nos. 1 to 4, inclusive, were recorded at elevations 231.7, 231.7, 227.2, and 227.4 m, respectively.

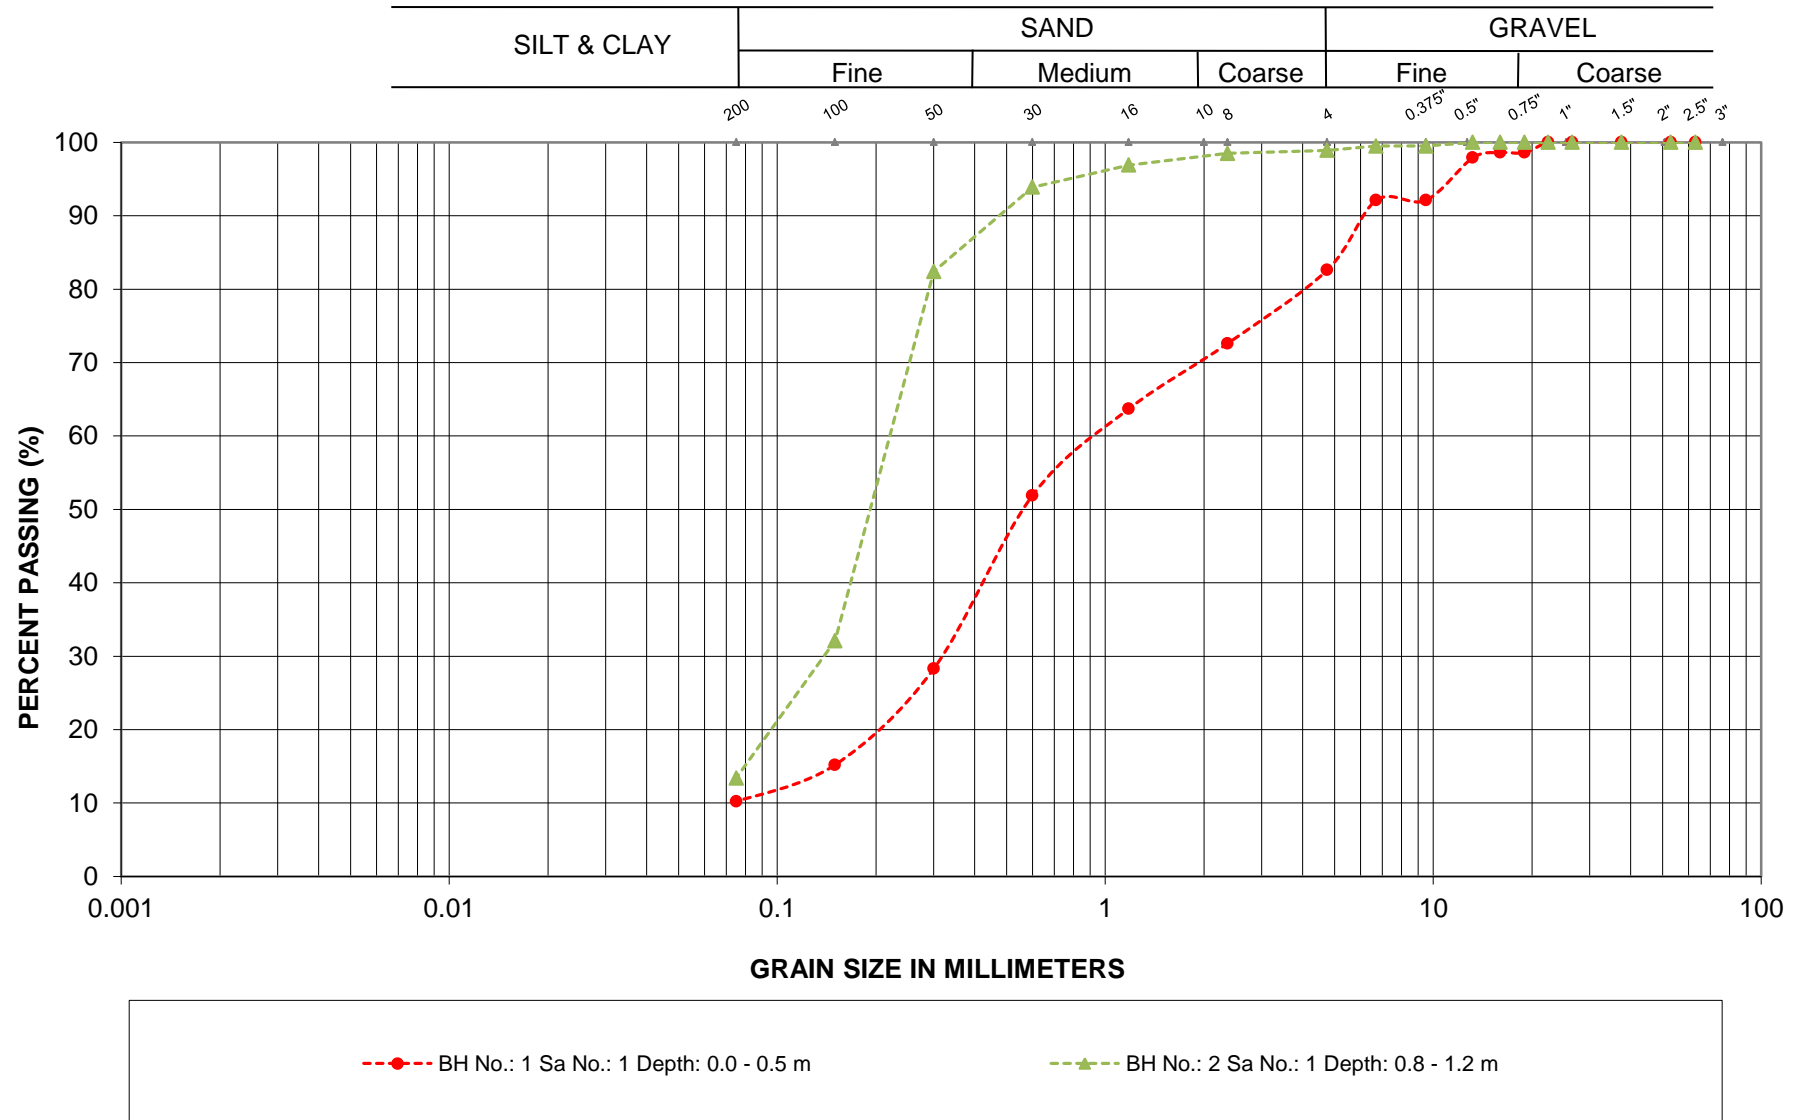
FIGURE L-1

GRANULAR FILL

Underlying the pavement structure at Borehole Nos. 1 and 2, a layer of fill consisting of brown sand trace to some gravel, trace to some silt was penetrated. The natural moisture content measured on samples of this deposit was in the order of 3 to 5%. Gradation analyses were carried out on two (2) samples of this deposit, the results of which indicated 1 to 17% gravel size particles, 73 to 86% sand size particles, and 10 to 13% silt and clay size particles (Figure No. L-1, Appendix 3). Based on SPT 'N' values of 18 to 29 blows per 300 mm penetration, the compactness of this deposit was described as compact. This fill layer was encountered to depths of 0.9 and 1.4 m below grade at Borehole Nos. 1 and 2, respectively (elevations 230.8 and 230.3 m, respectively).

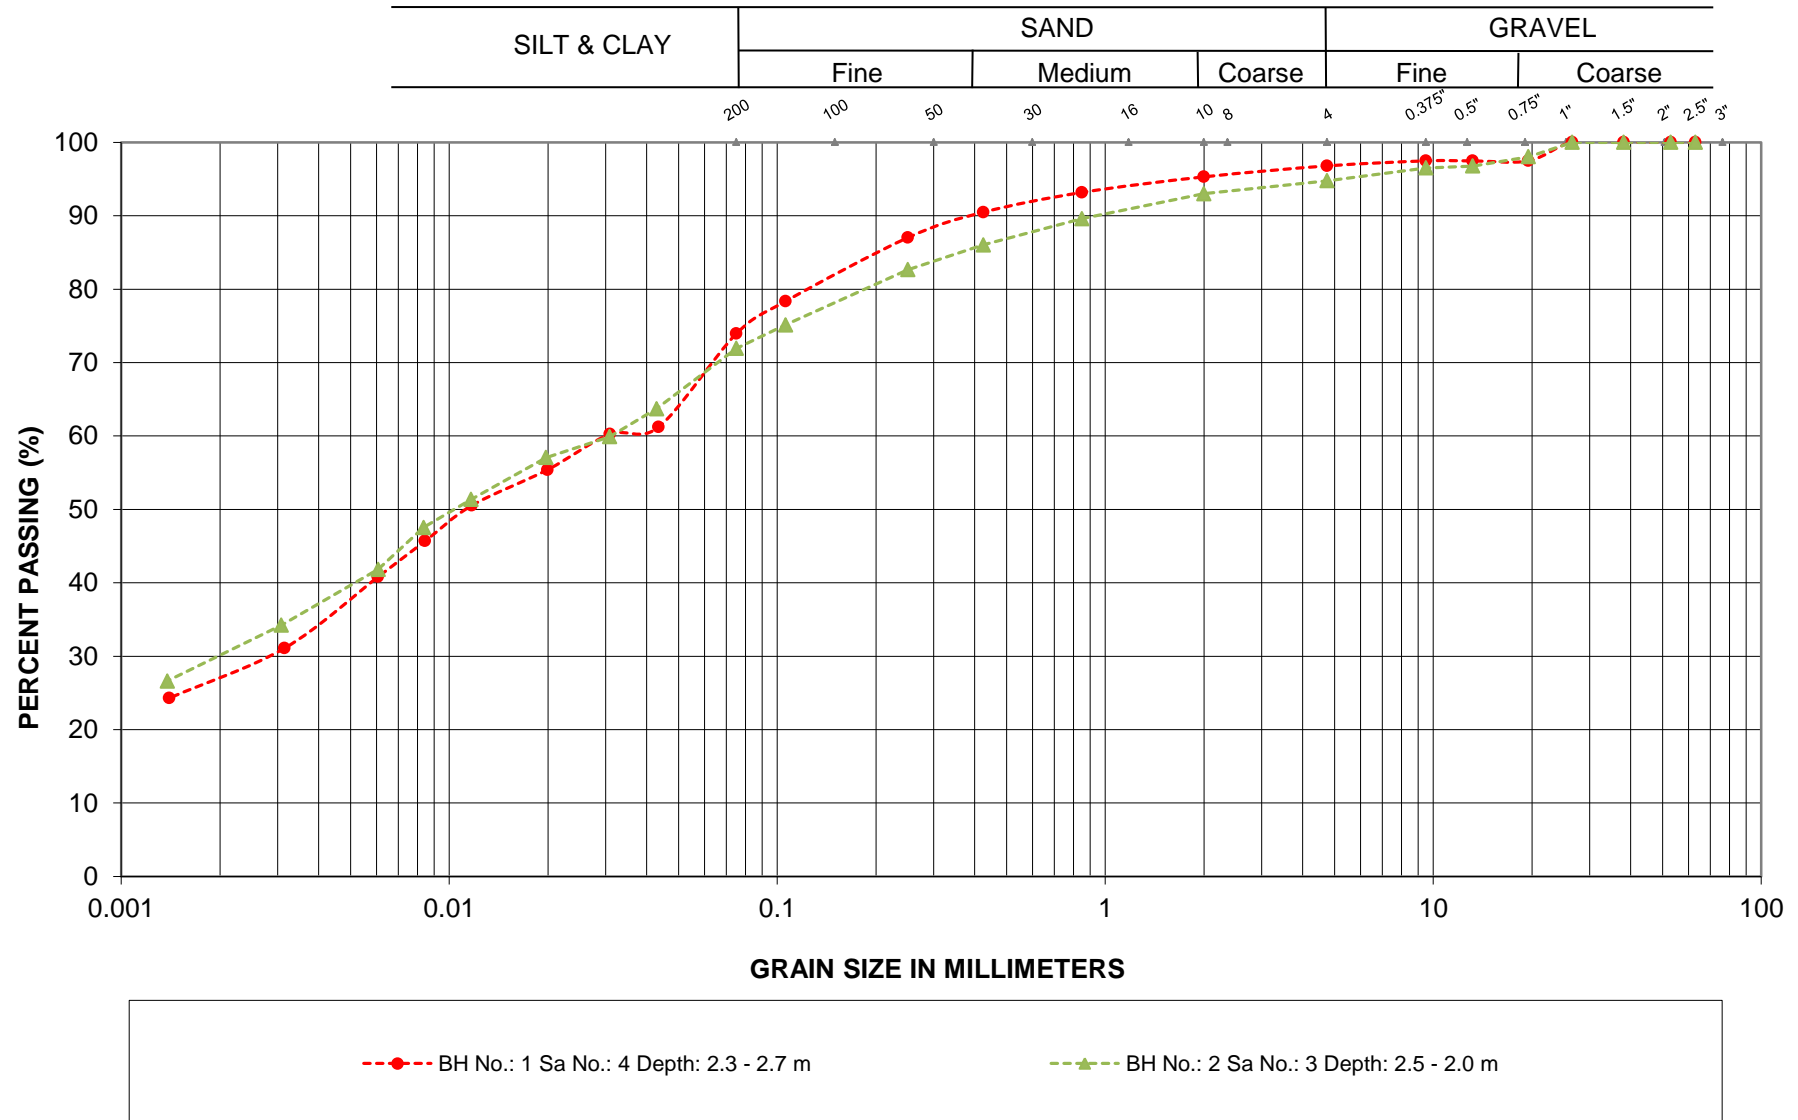
FIGURE L-2

SILTY CLAY FILL

samples of this deposit was in the order of 11 to 18%. Gradation (hydrometer) analyses were carried out on two (2) samples of this deposit, the results of which indicated 3 to 5% gravel size particles, 23% sand size particles, 42 to 47% silt size particles, and 27 to 30% clay size particles (Figure No. L-2, Appendix 3). Atterberg Limits testing was carried out on two (2) samples of this deposit, indicating a Plastic Limit in the order of 14 to 15% and a Liquid Limit in the order of 24 to 25%, indicating a clay of low plasticity (Figure No. L-5, Appendix 3). Based on SPT 'N' values ranging from 5 to 17 blows per 300 mm penetration of greater than 100 kPa, the consistency of this deposit was described as firm to very stiff. This fill layer was encountered to depths of 4.1 and 4.0 m below grade at Borehole Nos. 1 and 2, respectively (elevations 227.6 and 227.7 m, respectively).

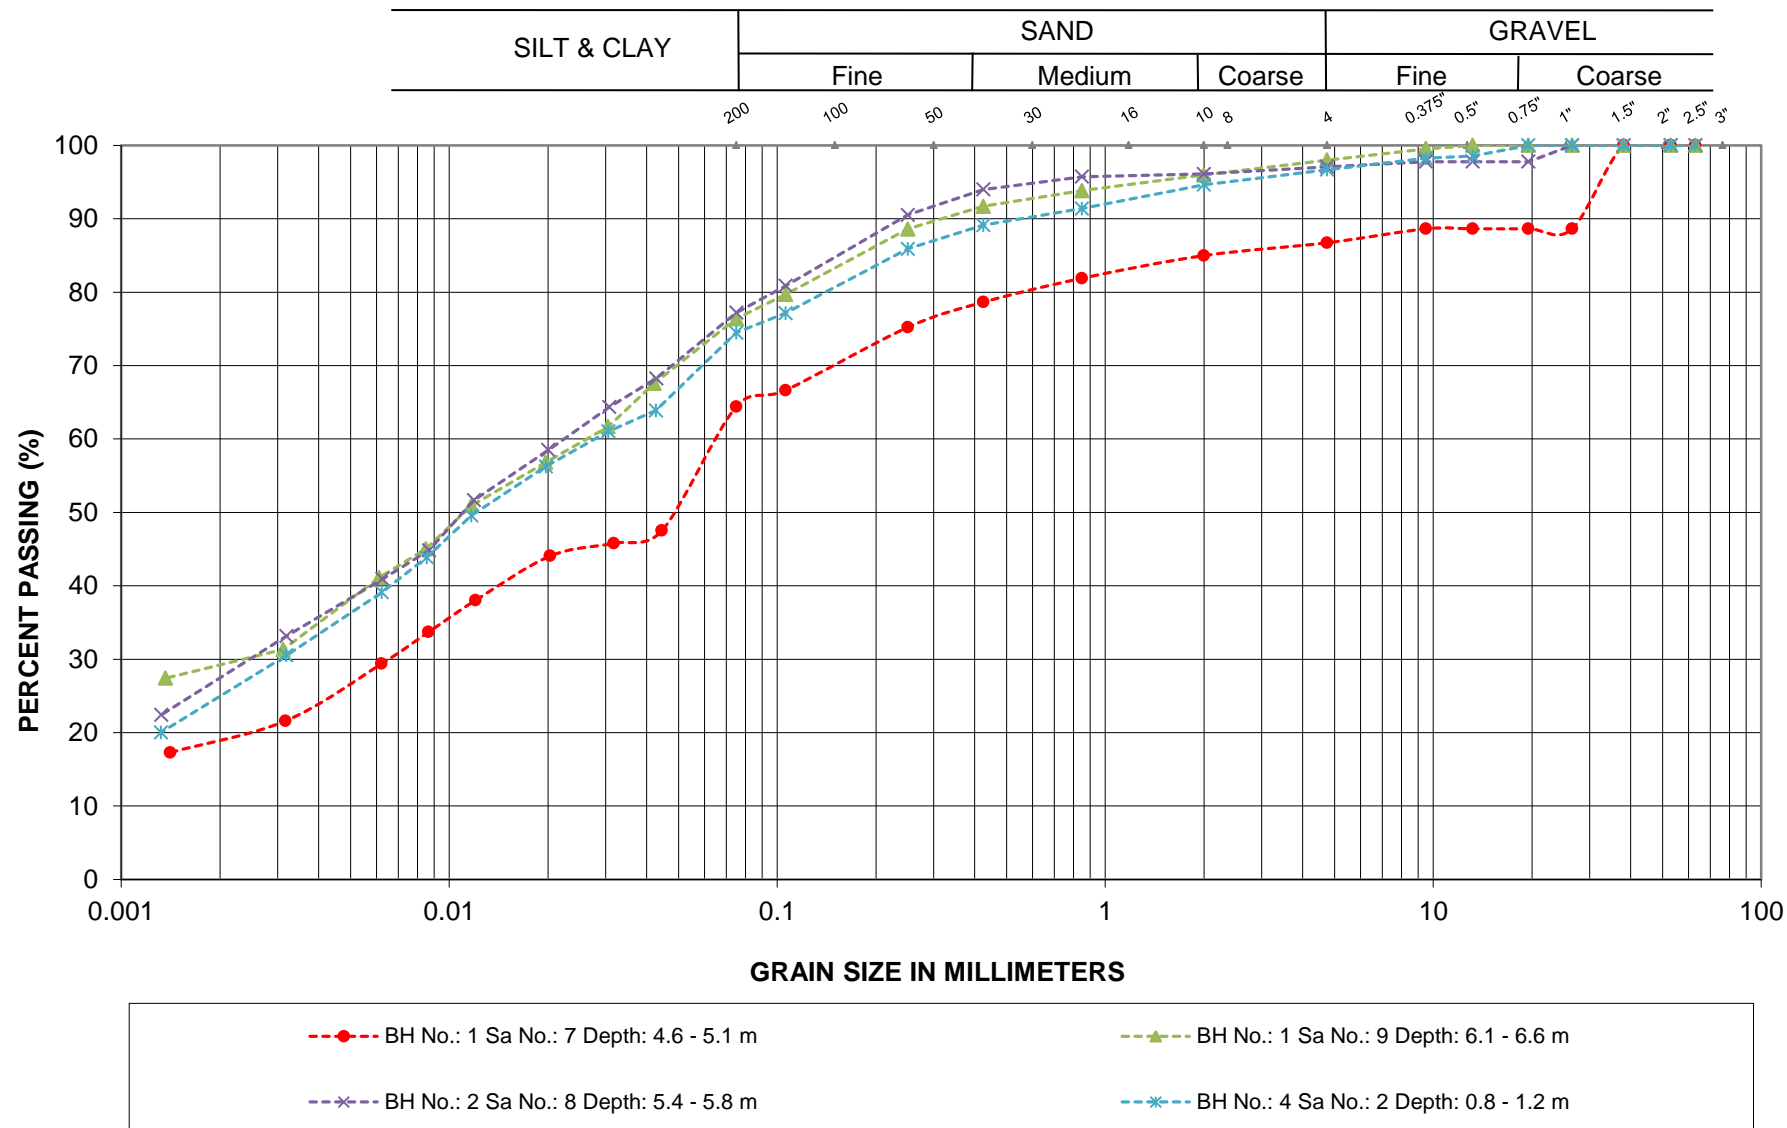
FIGURE L-3

SILTY CLAY TILL

The silty clay portion of the till deposit was described as silty clay, trace to some gravel, with sand. The natural moisture content measured on samples of the silty clay portions of the deposit was in the order of 10 to 30%. Gradation (hydrometer) analyses was carried out on five (5) single sample of this deposit, the results of which indicated 2 to 13% gravel size particles, 19 to 33% sand size particles, 46 to 50% silt size particles, and 18 to 32% clay size particles (Figure No. L-3, Appendix 3). Atterberg Limits testing was carried out on five (5) sample of this deposit, the results of which indicated a Plastic Limit in the order of 13 to 16% and a Liquid Limit in the order of 23 to 26% (Figure No. L-5, Appendix 3). The consistency of this deposit was described as very stiff.

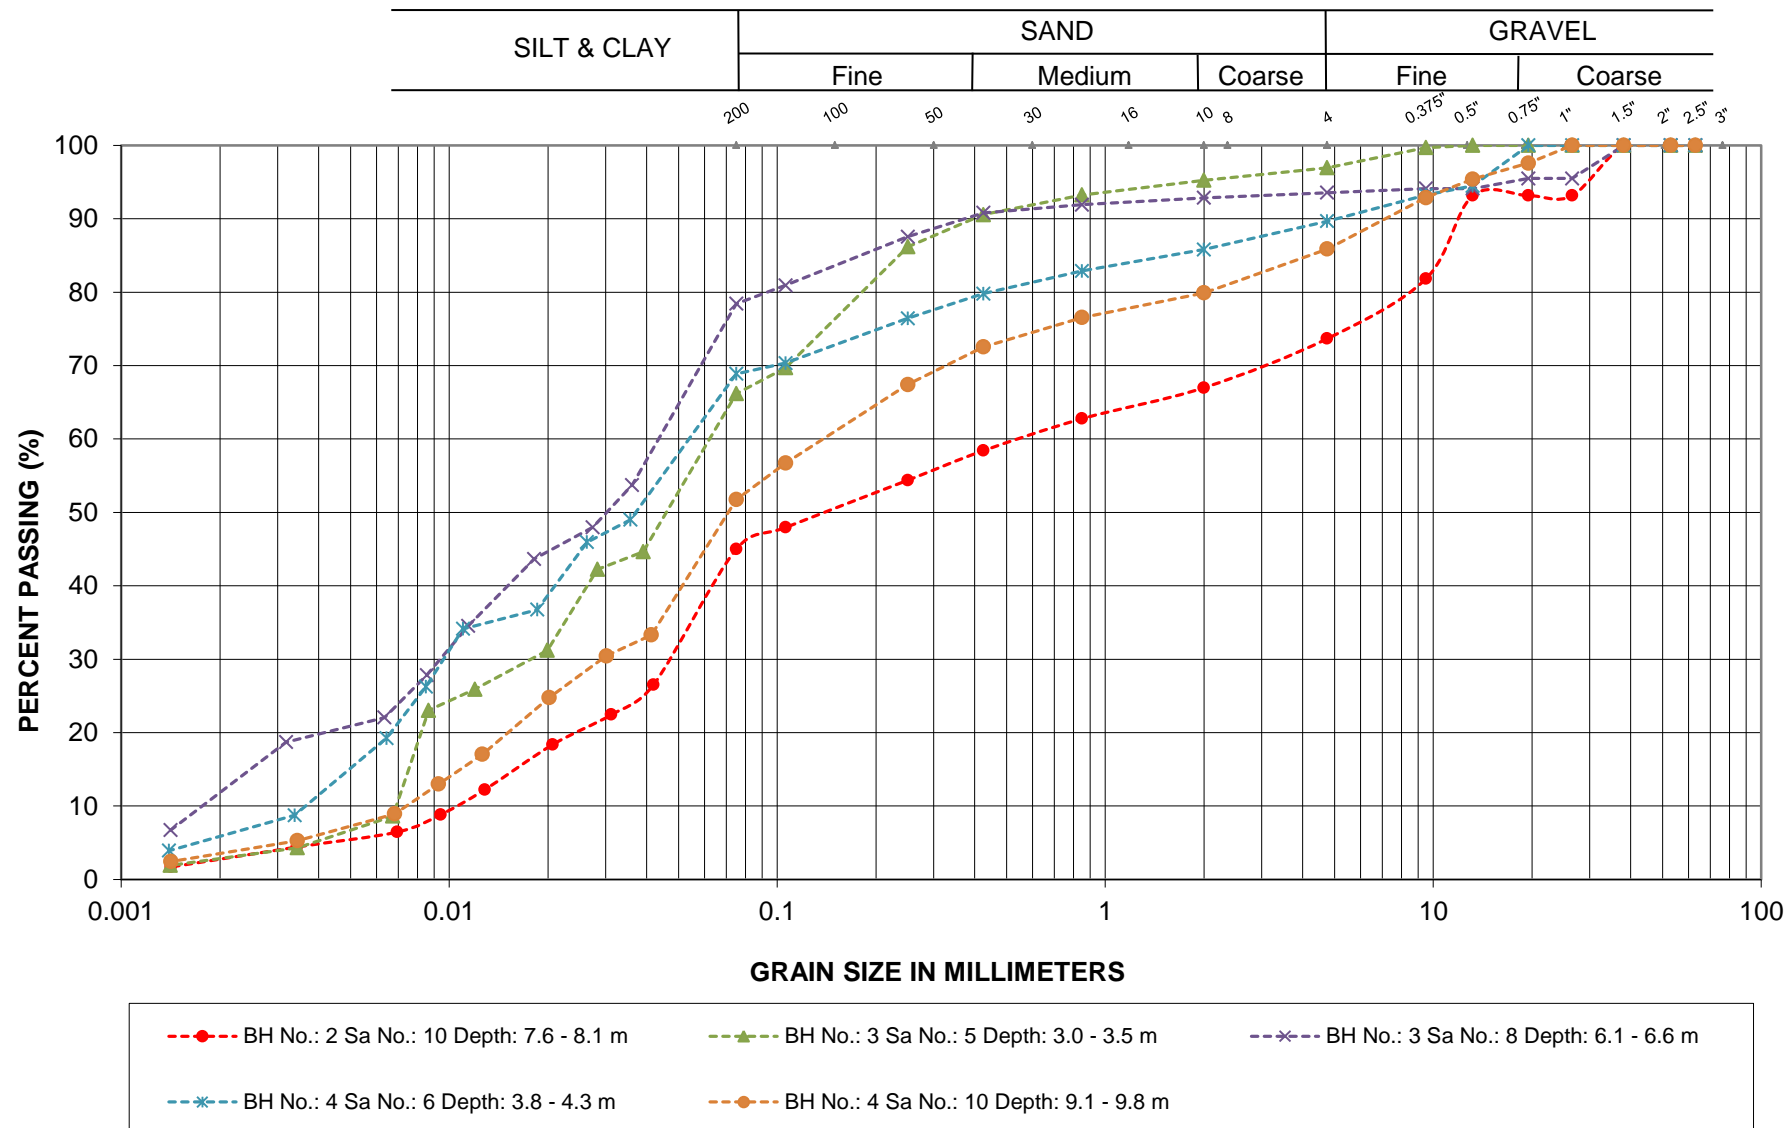
FIGURE L-4

SILT TILL

The silt portion of the till deposit was described as silt, trace to with gravel, with sand to sandy, trace to some. The natural moisture content measured on samples of this deposit was in the order of 12 to 18%. Gradation (hydrometer) analyses were carried out on five (5) sample of this deposit, the results of which indicated 3 to 26% gravel size particles, 16 to 41% sand size particles, 42 to 66% silt size particles, and 3 to 12% clay size particles (Figure No. L-4,

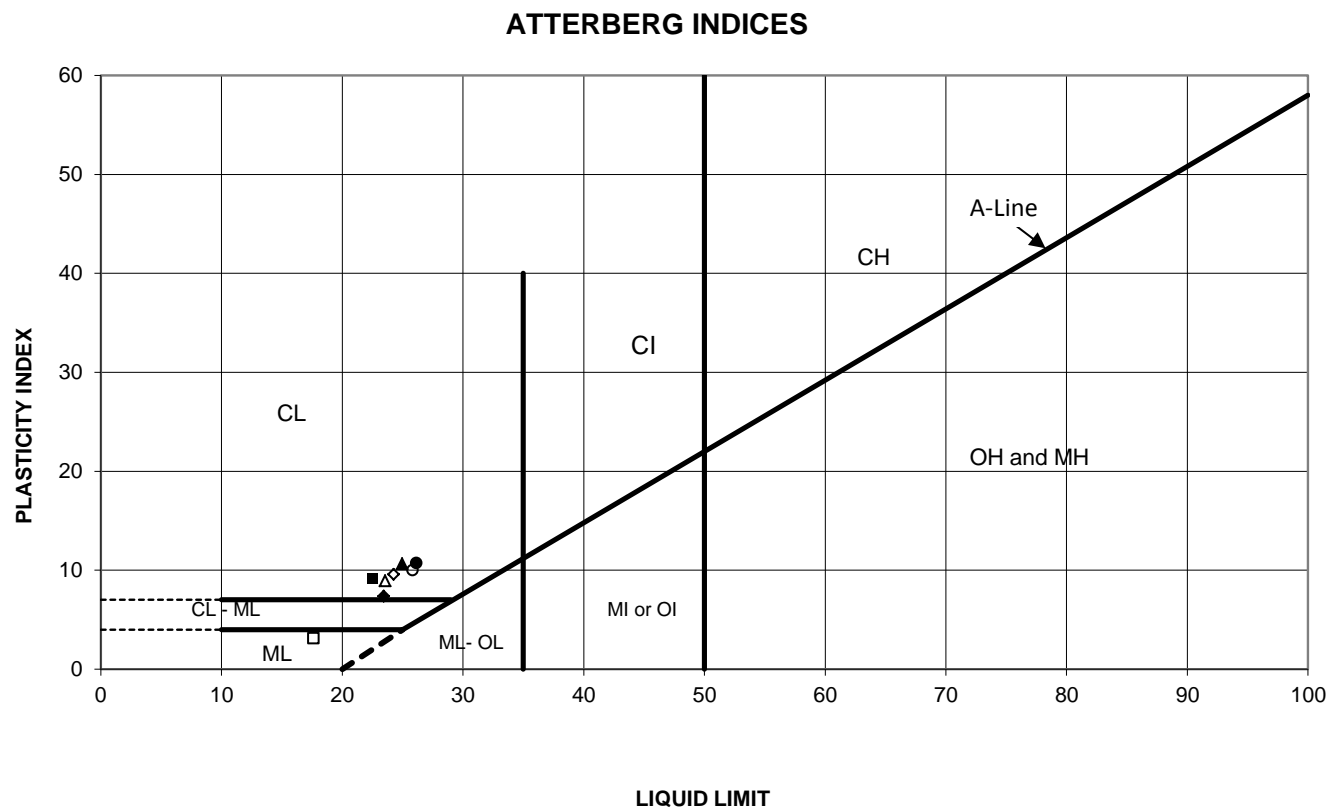
FIGURE L-5

# ATTERBERG LIMITS TEST RESULTS

SYMBOL	BH	Sa. No.	Depth(m)	Elev.(m)	Liquid Limit	Plastic Limit	Plasticity Index	NMC %
●	1	4*	2.5	229.2	26.1	15.4	10.7	13.0
◆	1	7	4.8	226.9	23.4	16.1	7.4	13.0
■	1	9	6.3	225.4	22.5	13.4	9.1	10.7
▲	2	3*	1.8	229.9	25.0	14.3	10.6	12.0
○	2	8	5.6	226.1	25.8	15.9	10.0	10.0
◇	3	2	1.0	226.2	24.3	14.7	9.6	10.2
□	3	8	6.3	220.9	17.6	14.5	3.1	13.4
△	4	2	1.0	226.4	23.6	14.6	8.9	10.1

Appendix 3). Atterberg Limits testing was attempted on five (5) samples of this deposit. The results generally indicated a non-plastic material, however, the result of one test indicated a Plastic Limit in the order of 15% and a Liquid Limit in the order of 18% (Figure No. L-5, Appendix 3). Based on STP 'N' values of 20 to 72 blows per 300 mm penetration, the compactness of this deposit was described as compact to very dense.

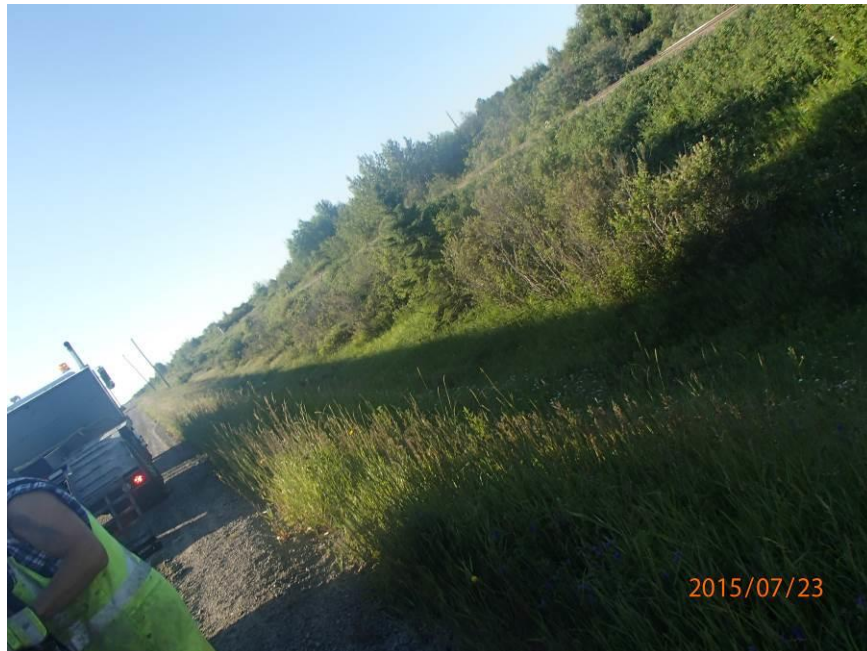
Photo: 1

Existing Embankment – Looking East along south ditch, Note ONR embankment

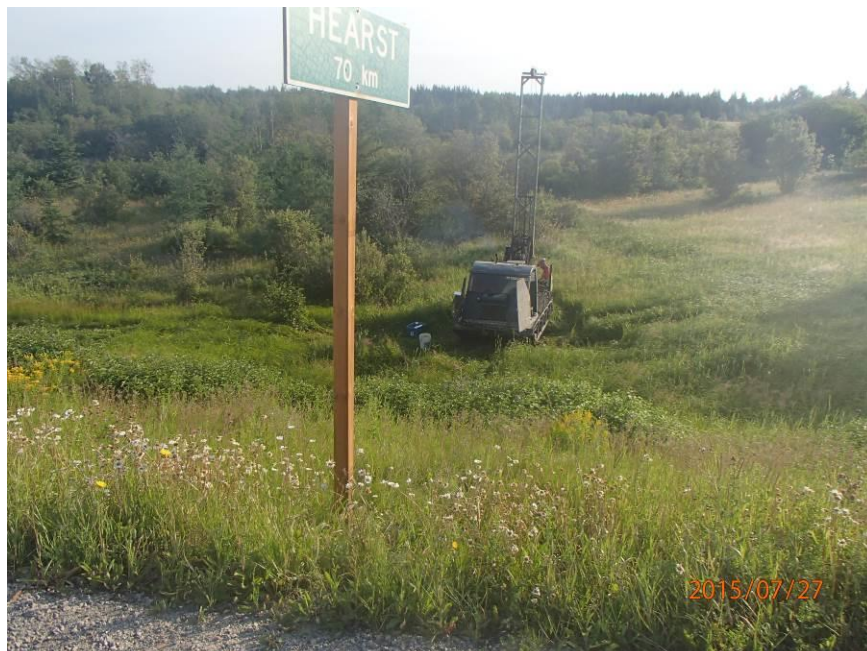
Photo: 2

Looking North, towards culvert outlet

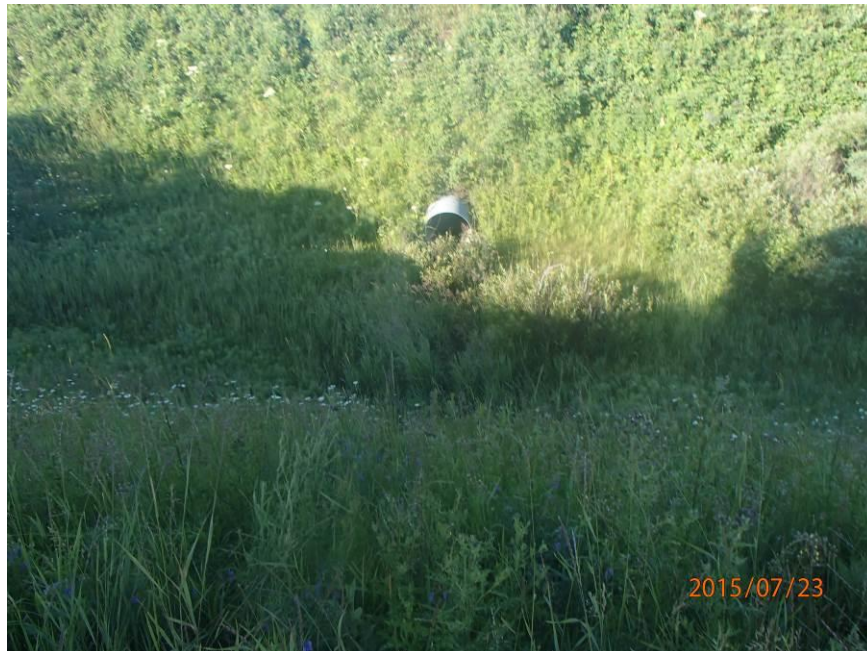
Photo: 3

Looking South, towards culvert inlet. Note culvert shown is in the ONR embankment.
