**Burford Creek Culvert Rehabilitation
Highway 94
Site No. 44-316
Station 11+652 - Township of North Himsworth
GWP 5090-06-00**

FINAL FOUNDATION INVESTIGATION REPORT

Date: December 23, 2016
Ref. N°: 16/02/16014-F3

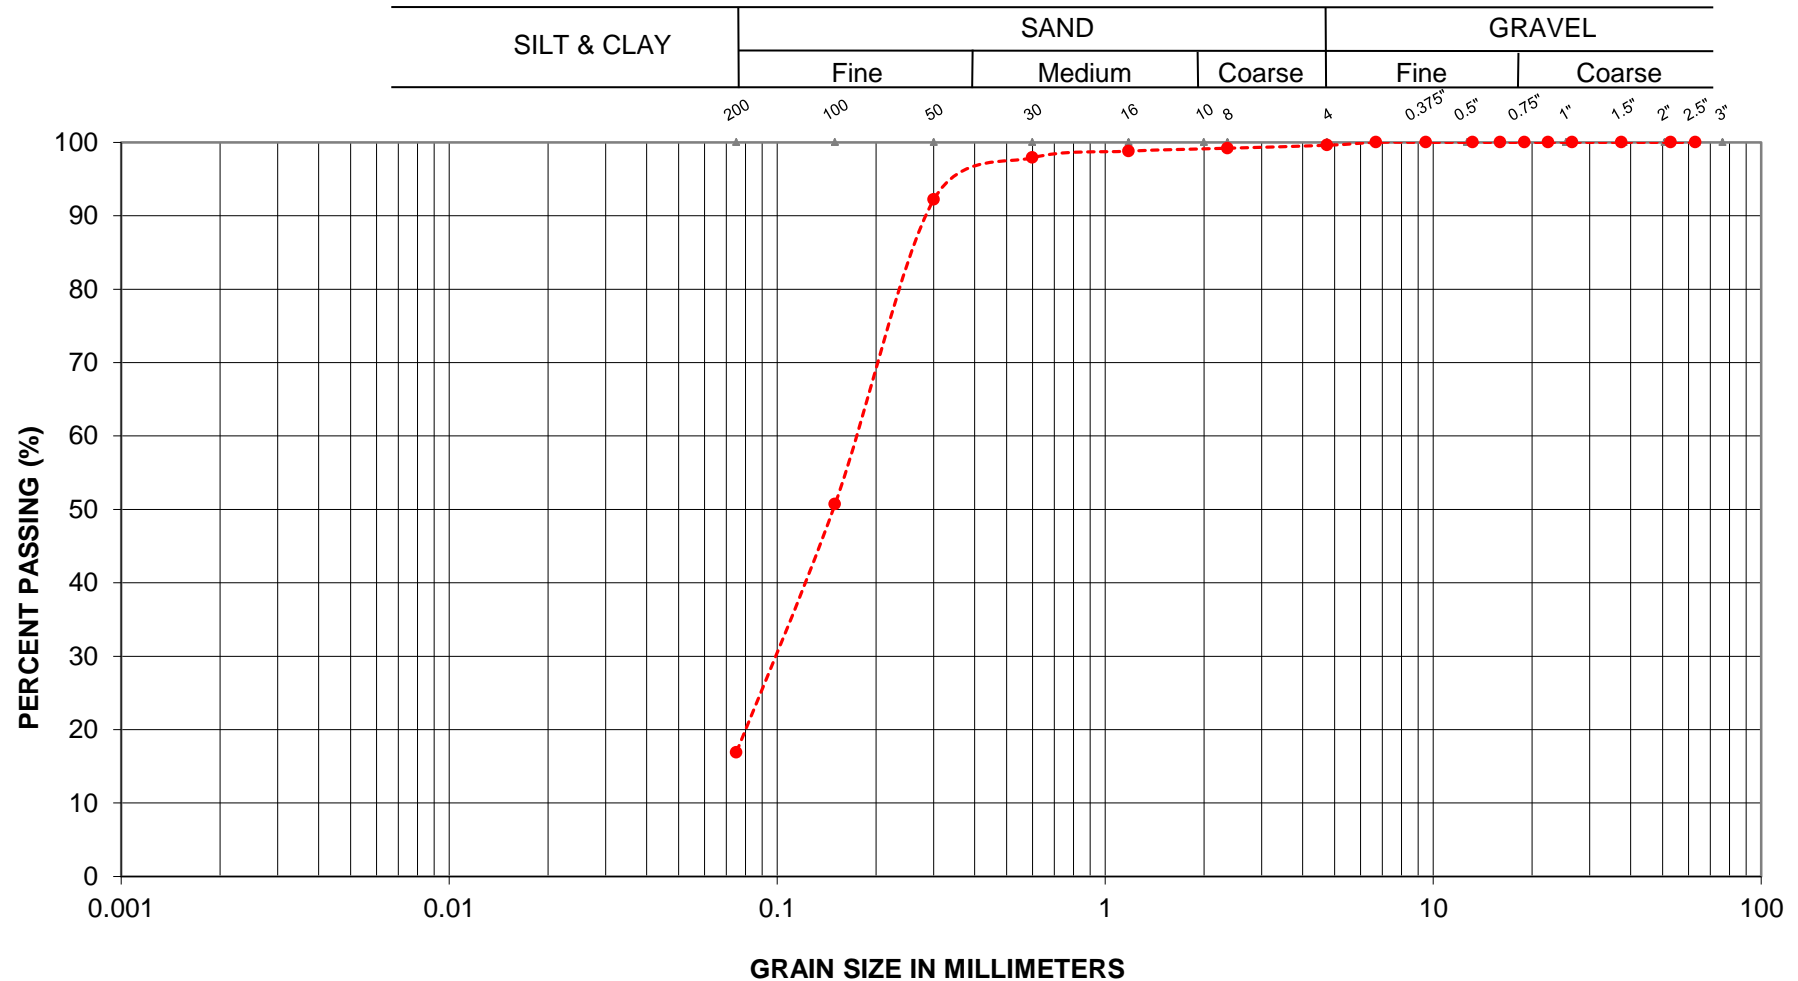
FIGURE L-1

GRAIN SIZE ANALYSIS

---●--- BH No.: 1 Sa No.: 1 Depth: 0.0 - 0.5 m

FILL

At surface at Borehole Nos. 1 and 2, a layer of fill described as of brown sand, trace gravel, some silt was penetrated. The natural moisture contents measured on samples recovered from this deposit were approximately 36%. A gradation (sieve) analysis was carried out on one (1) sample of this deposit, the results of which indicated 0% gravel size particles, 83% sand size particles, and 17% silt and clay size particles (Figure No. L-1, Appendix 3). Based on SPT 'N' values of 0 (static weight of hammer) to 2 blow per 300 mm penetration, the relative density/compactness of this deposit was described as very loose. This fill was encountered to

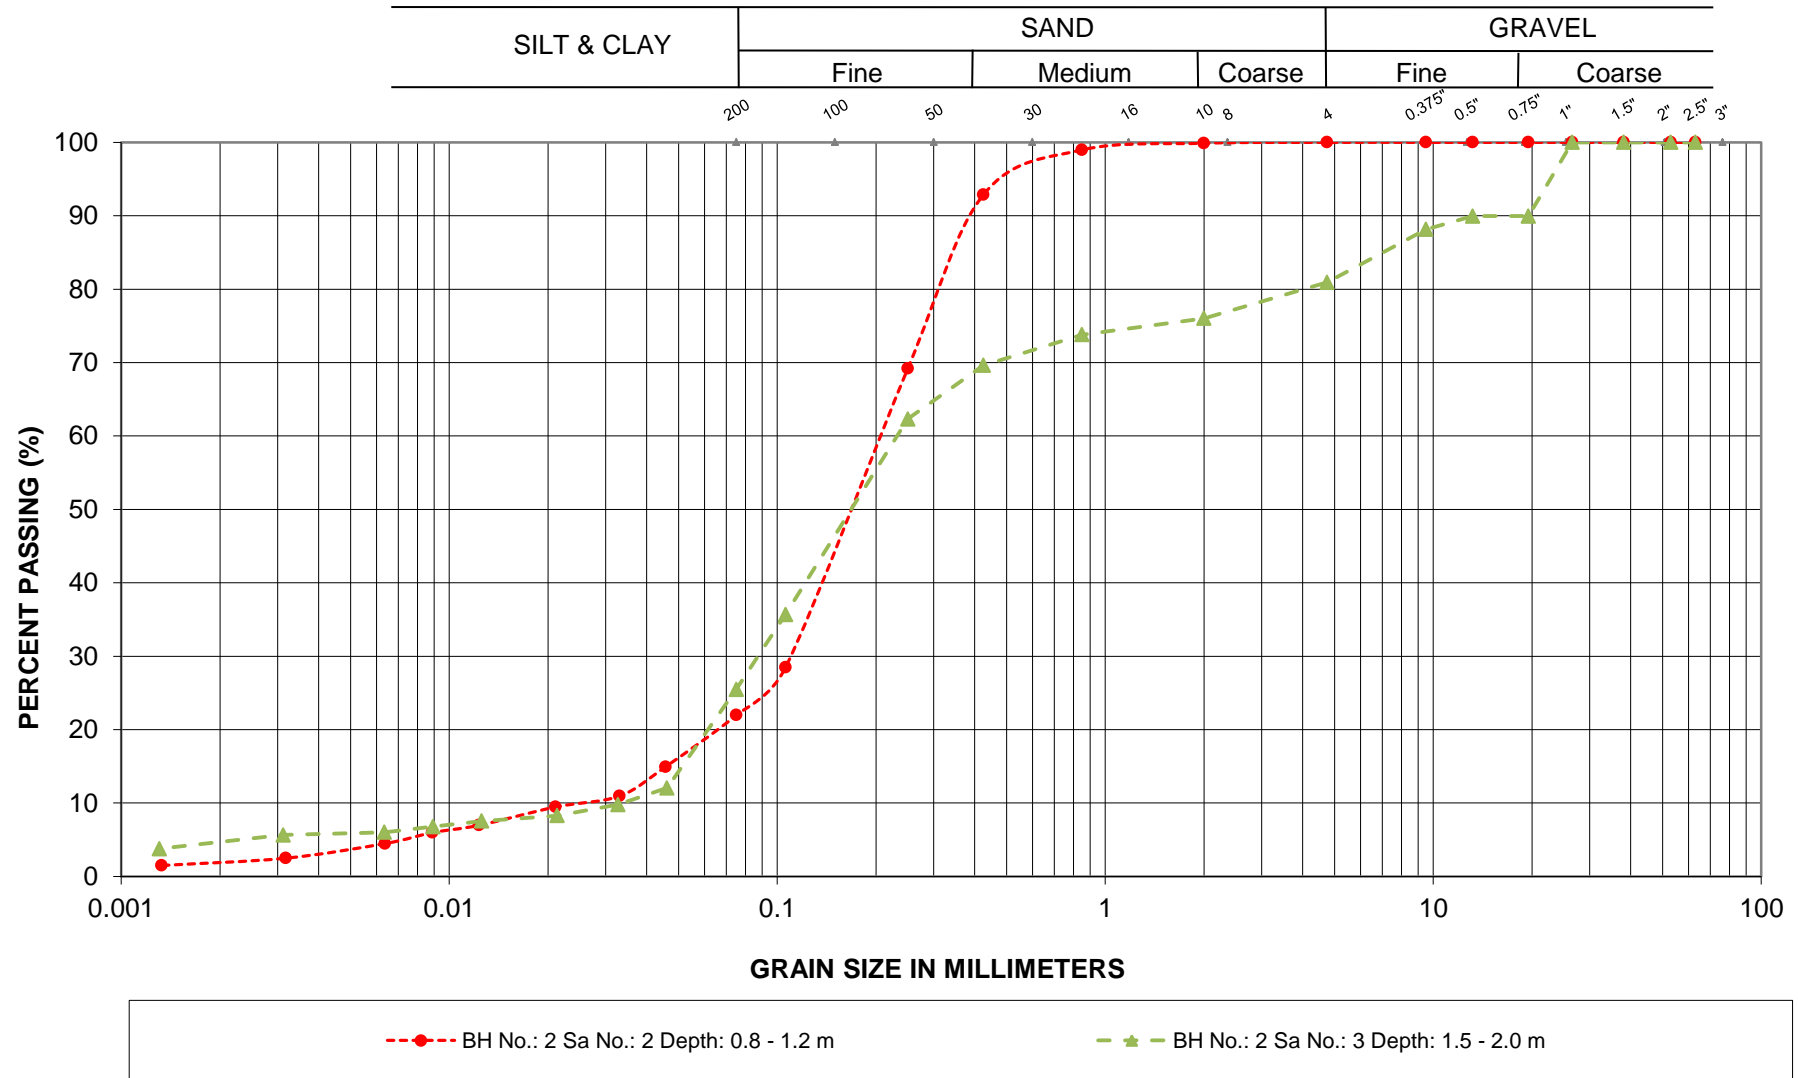
FIGURE L-2

GRAIN SIZE ANALYSIS

SAND (upper)

Underlying the fill at Borehole Nos. 1 and 2, an upper deposit of sand, some to trace gravel, with to some silt, trace clay was penetrated. Trace decayed wood and organics were encountered in this deposit. The natural moisture content measured on samples recovered from this deposit ranged from 20 to 35%. Gradation (hydrometer) analyses were carried out on two (2) samples of this deposit, and the results indicated 0 to 19% gravel size particles, 55 to 78% sand size particles, 20 to 21% silt size particles and 2 to 5% clay size particles (Figure No. L-2, Appendix 3). Based on SPT 'N' values of 3 to 64 blows per 300 mm penetration, the relative density/compactness of this deposit was described as very loose to very dense. This deposit was encountered to depths of 1.4 and 2.6 m below grade at Borehole Nos. 1 and 2, respectively (Elevations 195.8 and 194.9 m, respectively).

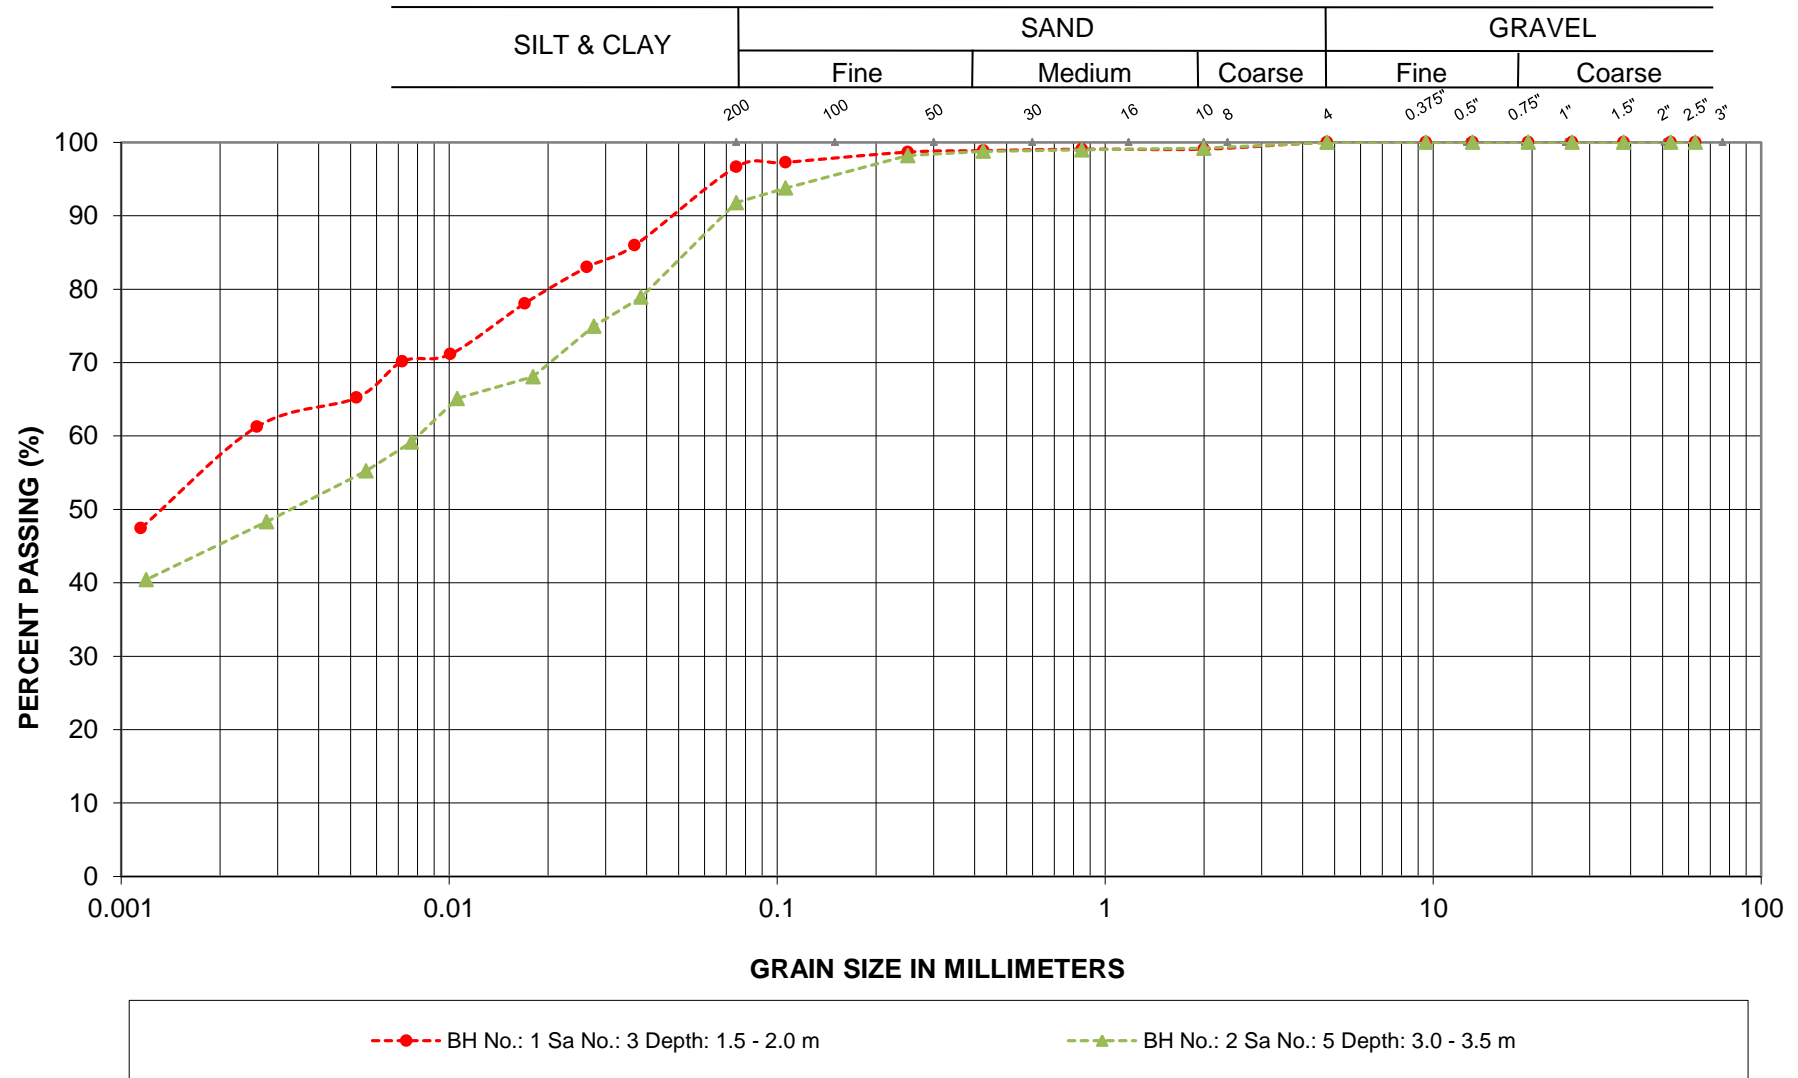
FIGURE L-3

GRAIN SIZE ANALYSIS

SILTY CLAY

Underlying the upper sand stratum at Borehole Nos. 1 and 2, a deposit of silty clay, trace sand was penetrated. The natural moisture content measured on samples recovered from this deposit ranged from 24 to 53%. Gradation (hydrometer) analyses were carried out on two (2) samples of this deposit, and the results indicated 0% gravel size particles, 3 to 8% sand size particles, 40 to 46% silt size particles and 46 to 57% clay size particles (Figure No. L-3, Appendix 3). Atterberg Limits testing was carried out on two (2) samples of this deposit. The Atterberg Limits testing indicated a Liquid Limit ranging from 35 to 46% and a Plastic Limit ranging from 11 to 16% to result in Plastic Index ranging from 24 to 30% (Figure No. L-5, Appendix 4). Based on in-situ shear strengths of 52 to 60 kPa, the consistency of this deposit was described as stiff. This deposit was encountered to depths of 2.3 and 3.7 m below grade at Borehole Nos. 1 and 2, respectively (Elevations 194.9 and 193.8 m, respectively).

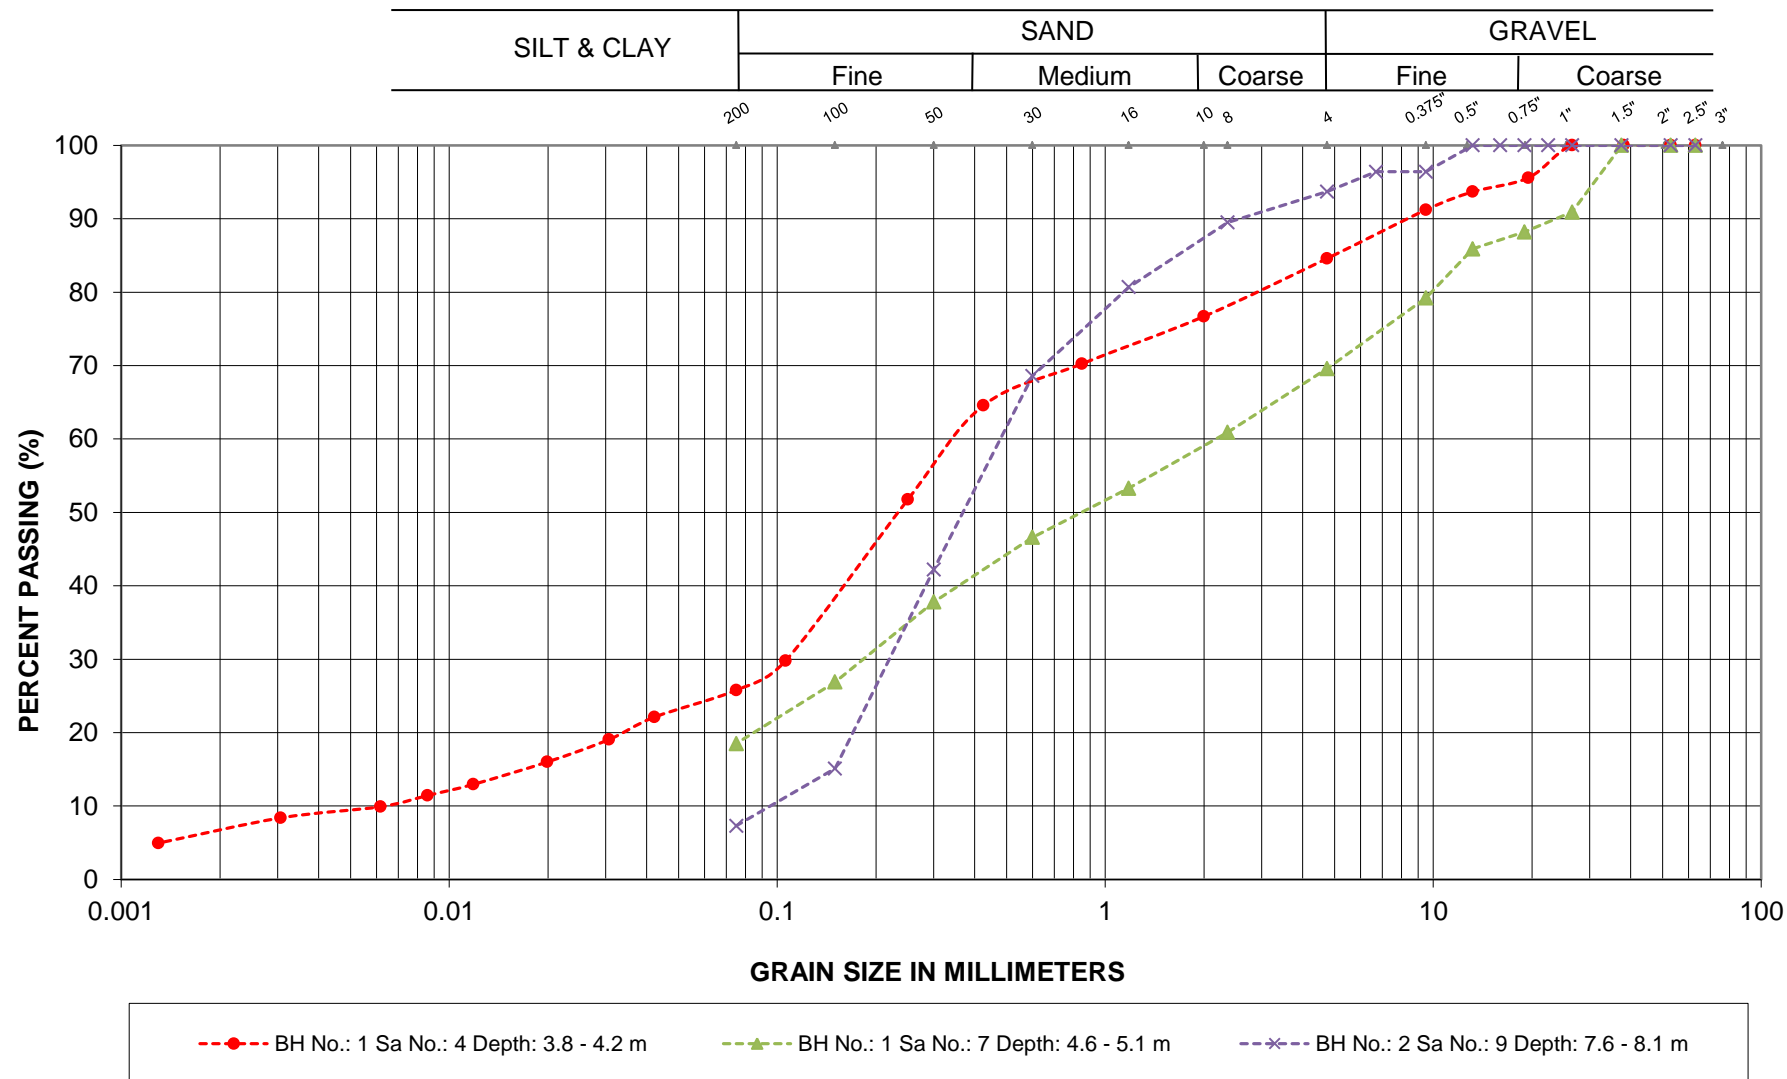
FIGURE L-4

GRAIN SIZE ANALYSIS

SAND (lower)

Underlying the silty clay at Borehole Nos. 1 and 2, a lower deposit of sand, with to trace gravel, some to trace silt, trace clay was penetrated. The natural moisture content measured on samples recovered from this deposit ranged from 9 to 36%. Gradation (sieve) analyses were carried out on two (2) samples of this deposit, and the results indicated 6 to 30 gravel size particles, 51 to 87% sand size particles, and 7 to 19% silt and clay size particles (Figure No. L-4, Appendix 3). A gradation (hydrometer) analysis was carried out on one (1) sample of this deposit, the results of which indicated 15% gravel size particles, 59% sand size particles, 19% silt size particles and 7% clay size particles (Figure No. L-4, Appendix 3). Based on SPT 'N' values of 0 (static weight of hammer) to 49 blows per 300 mm penetration, the relative density/compactness of this deposit was described as very loose to dense, generally compact on average. This deposit was encountered to depths of 6.9 and 9.1 m below grade at Borehole

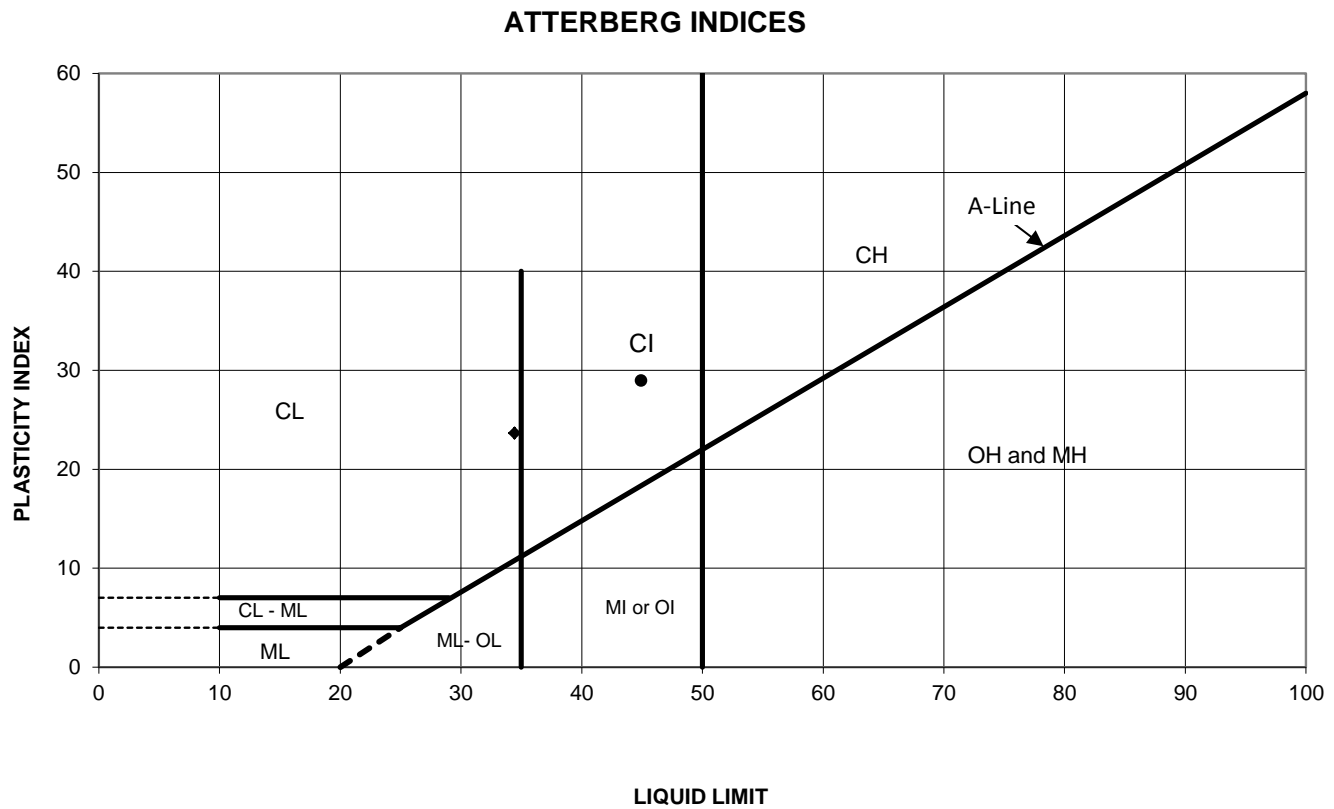
FIGURE L-5

ATTERBERG LIMITS TEST RESULTS

SYMBOL	BH	Sa. No.	Depth(m)	Elev.(m)	Liquid Limit	Plastic Limit	Plasticity Index	NMC %
●	1	3	1.8	195.4	45.0	16.0	28.9	53.1
◆	2	5	3.3	194.2	34.5	10.8	23.6	23.8

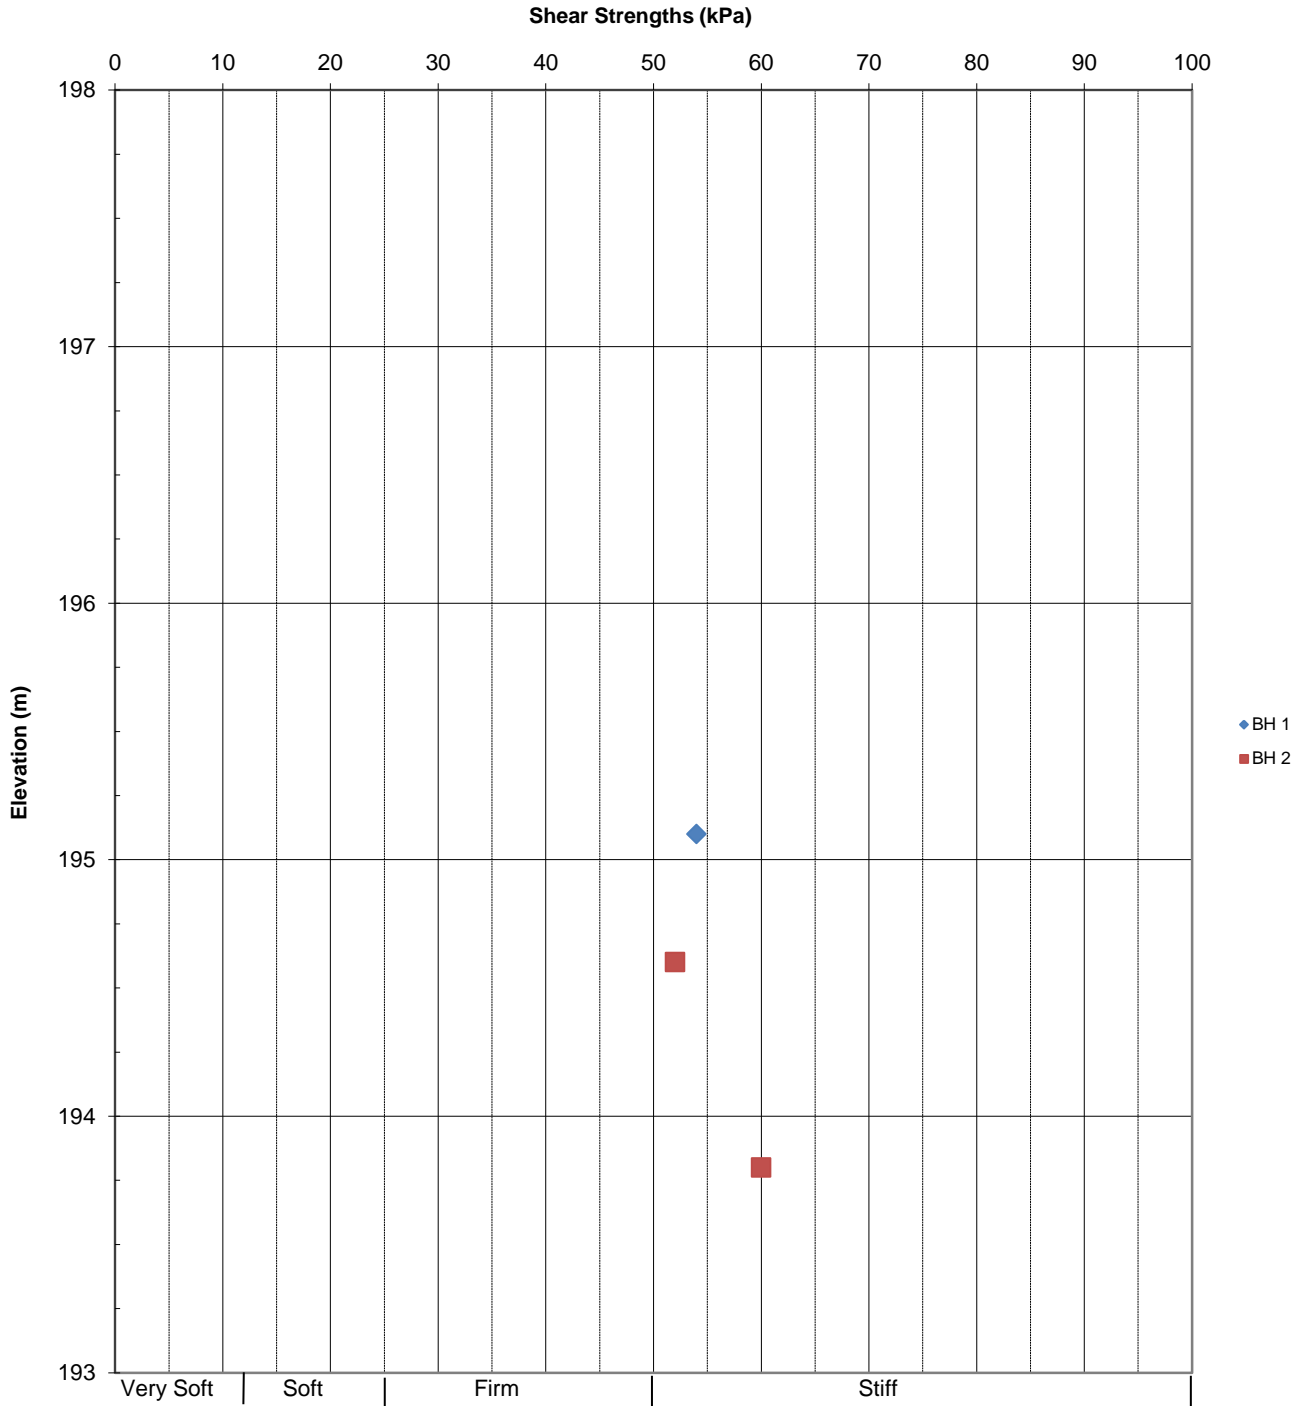
In-Situ Shear Strengths vs. Elevation

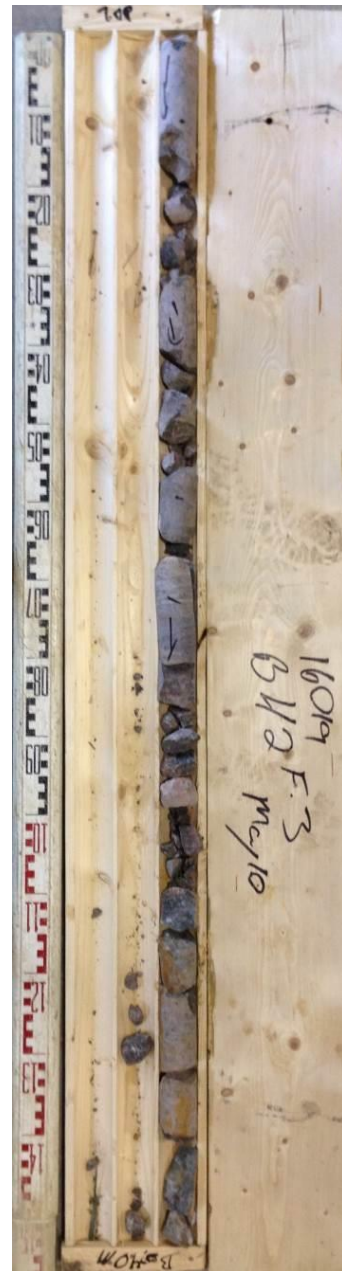
Photos: 2 and 3

Rock Cores – Borehole 1 (left) and Borehole 2 (right)

Underlying the lower sand deposit at Borehole Nos. 1 and 2, bedrock was proven by diamond core drilling. The bedrock was described as pink granite. Based on RQD values of 18 to 40%, the bedrock was described as very poor to poor quality. Based on visual review, the bedrock generally showed negligible weathering. Sampling in the bedrock was terminated at depths of 10.0 and 10.7 m below grade at Borehole Nos. 1 and 2, respectively (Elevations 187.2 and 186.8 m, respectively). Photos of rock cores recovered at Borehole Nos. 1 and 2 are shown in Enclosure No. 4, Appendix 4. It should be noted that, when encountered, the underlying bedrock surfaces in this area can be very erratic in nature, varying substantially in elevation over short horizontal distances.
