## Foundation Investigation Report

Highway 401 Eastbound Express and Collector Lanes between Victoria Park Avenue and Neilson Road - **Full Structure Replacement and Bridge Widening at CP Rail Overhead Eastbound Core and Collectors Structure (Site 37X-0213/B1 & B3)**

Assignment No. 2021-E-0018  
MTO Central Region  
Geocres Number: 30M14-550

**Type of Document:**  
Foundation Investigation Report

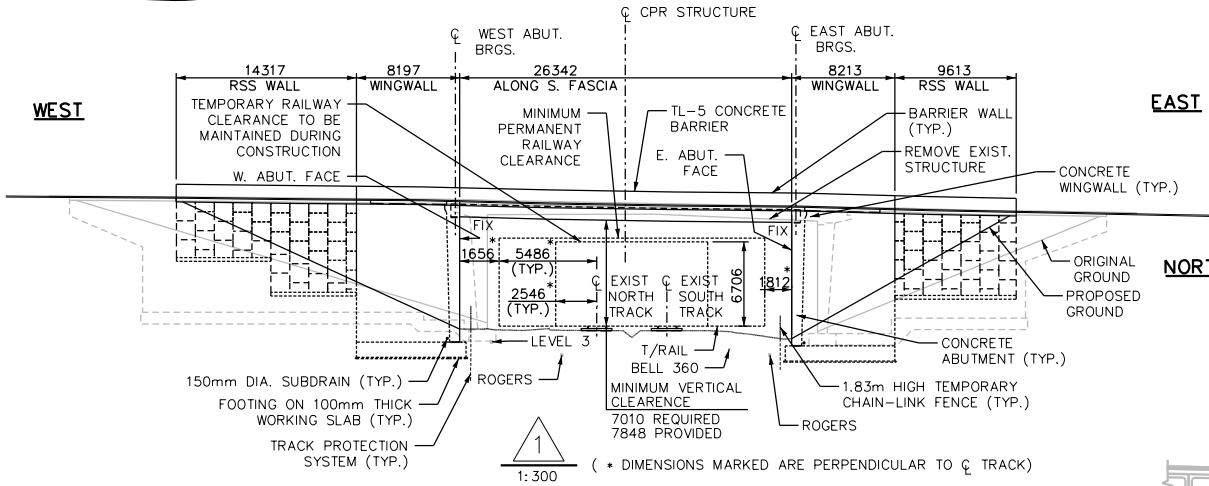
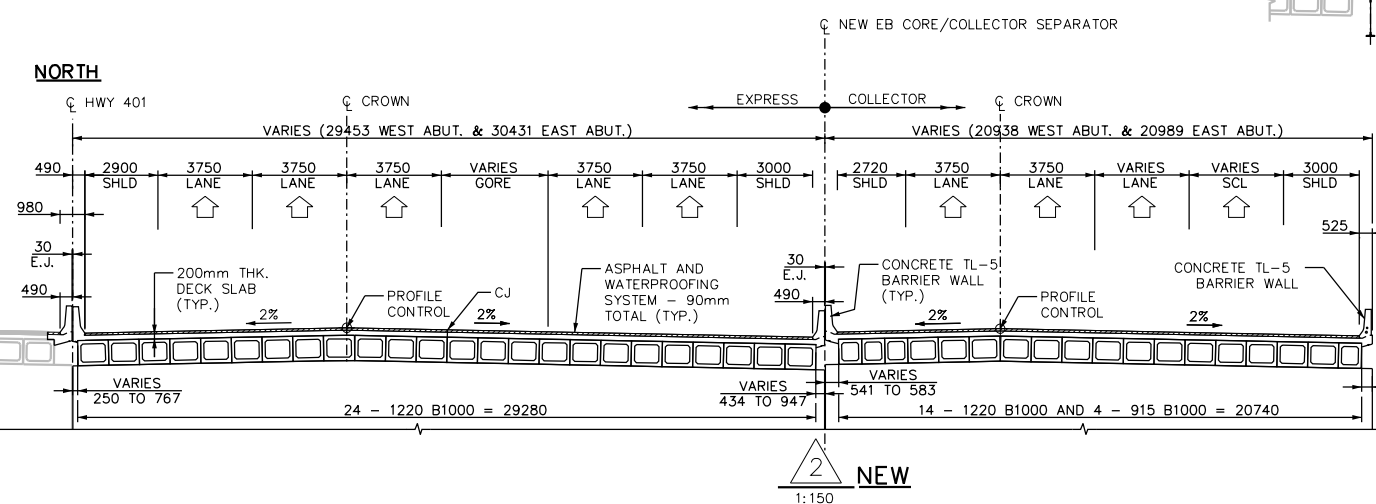
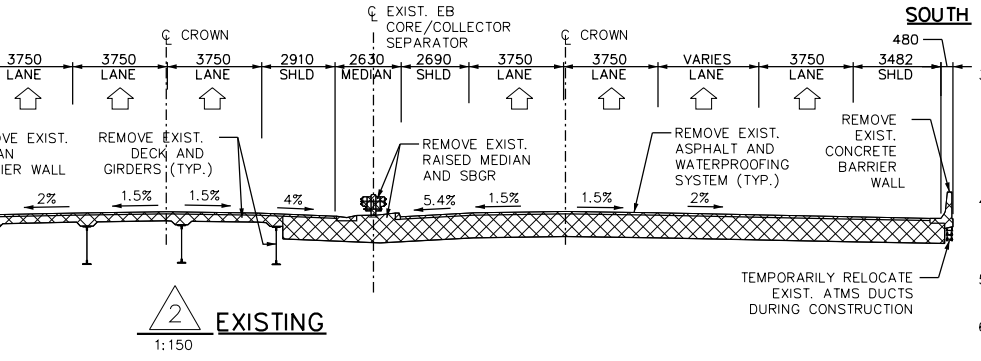
## Appendix B – General Arrangement Drawings

The GA drawing titled *Hwy 401 EB Core & Collector Lane CPR Overhead Bridge Rehab.*, prepared by AECOM, dated October 2024, shows the preliminarily proposed configuration of the CP Rail overhead structure. Foundation and Investigation Design Reports (FIDR) by Golder Associates Ltd., *"Bridge Widening and Replacement Highway 401 Rehabilitation from Warden Avenue to Brock Road, Toronto, Ontario, W.O.07-20012."*, dated March 2012 and *"CP Rail Overhead Replacement (Site No. 37-213), Highway 401 Westbound Core and Collector Lanes, Neilson Road to Warden Avenue, City of Toronto, Ontario, G.W.P No. 2162-11-00."*, dated January 17, 2019. A summary of the proposed structure is as follows:

- The existing overhead structure is about 27 m long (on skew) single-span concrete structure. It is understood that the existing abutments are supported on approximately 3.0 m wide spread footings founded at approximately Elev. 173.0 m at the east abutment and 173.3 m at the west abutment. Based on the available drawings and FIDRs, the existing Highway 401 pavement grade is at approximately Elev. 184.2 m to 184.8 m at the structure location, and the CP rail track grade is at approximately Elev. 174.8 m.

- The existing structure will undergo full structure replacement. This includes replacing the superstructure (existing bridge deck and girders) and foundations (semi-integral abutments). The structure will also be widened by approximately 10 m on the south side of the EB Collector. The existing retaining walls (37X-1768/W and 37X-1769/W) will be replaced with a new RSS wall along the south side of the widened collector structure. Additional widening along the south side of the EB Collector, east of the structure towards Kennedy Road, will be discussed in a separate report.

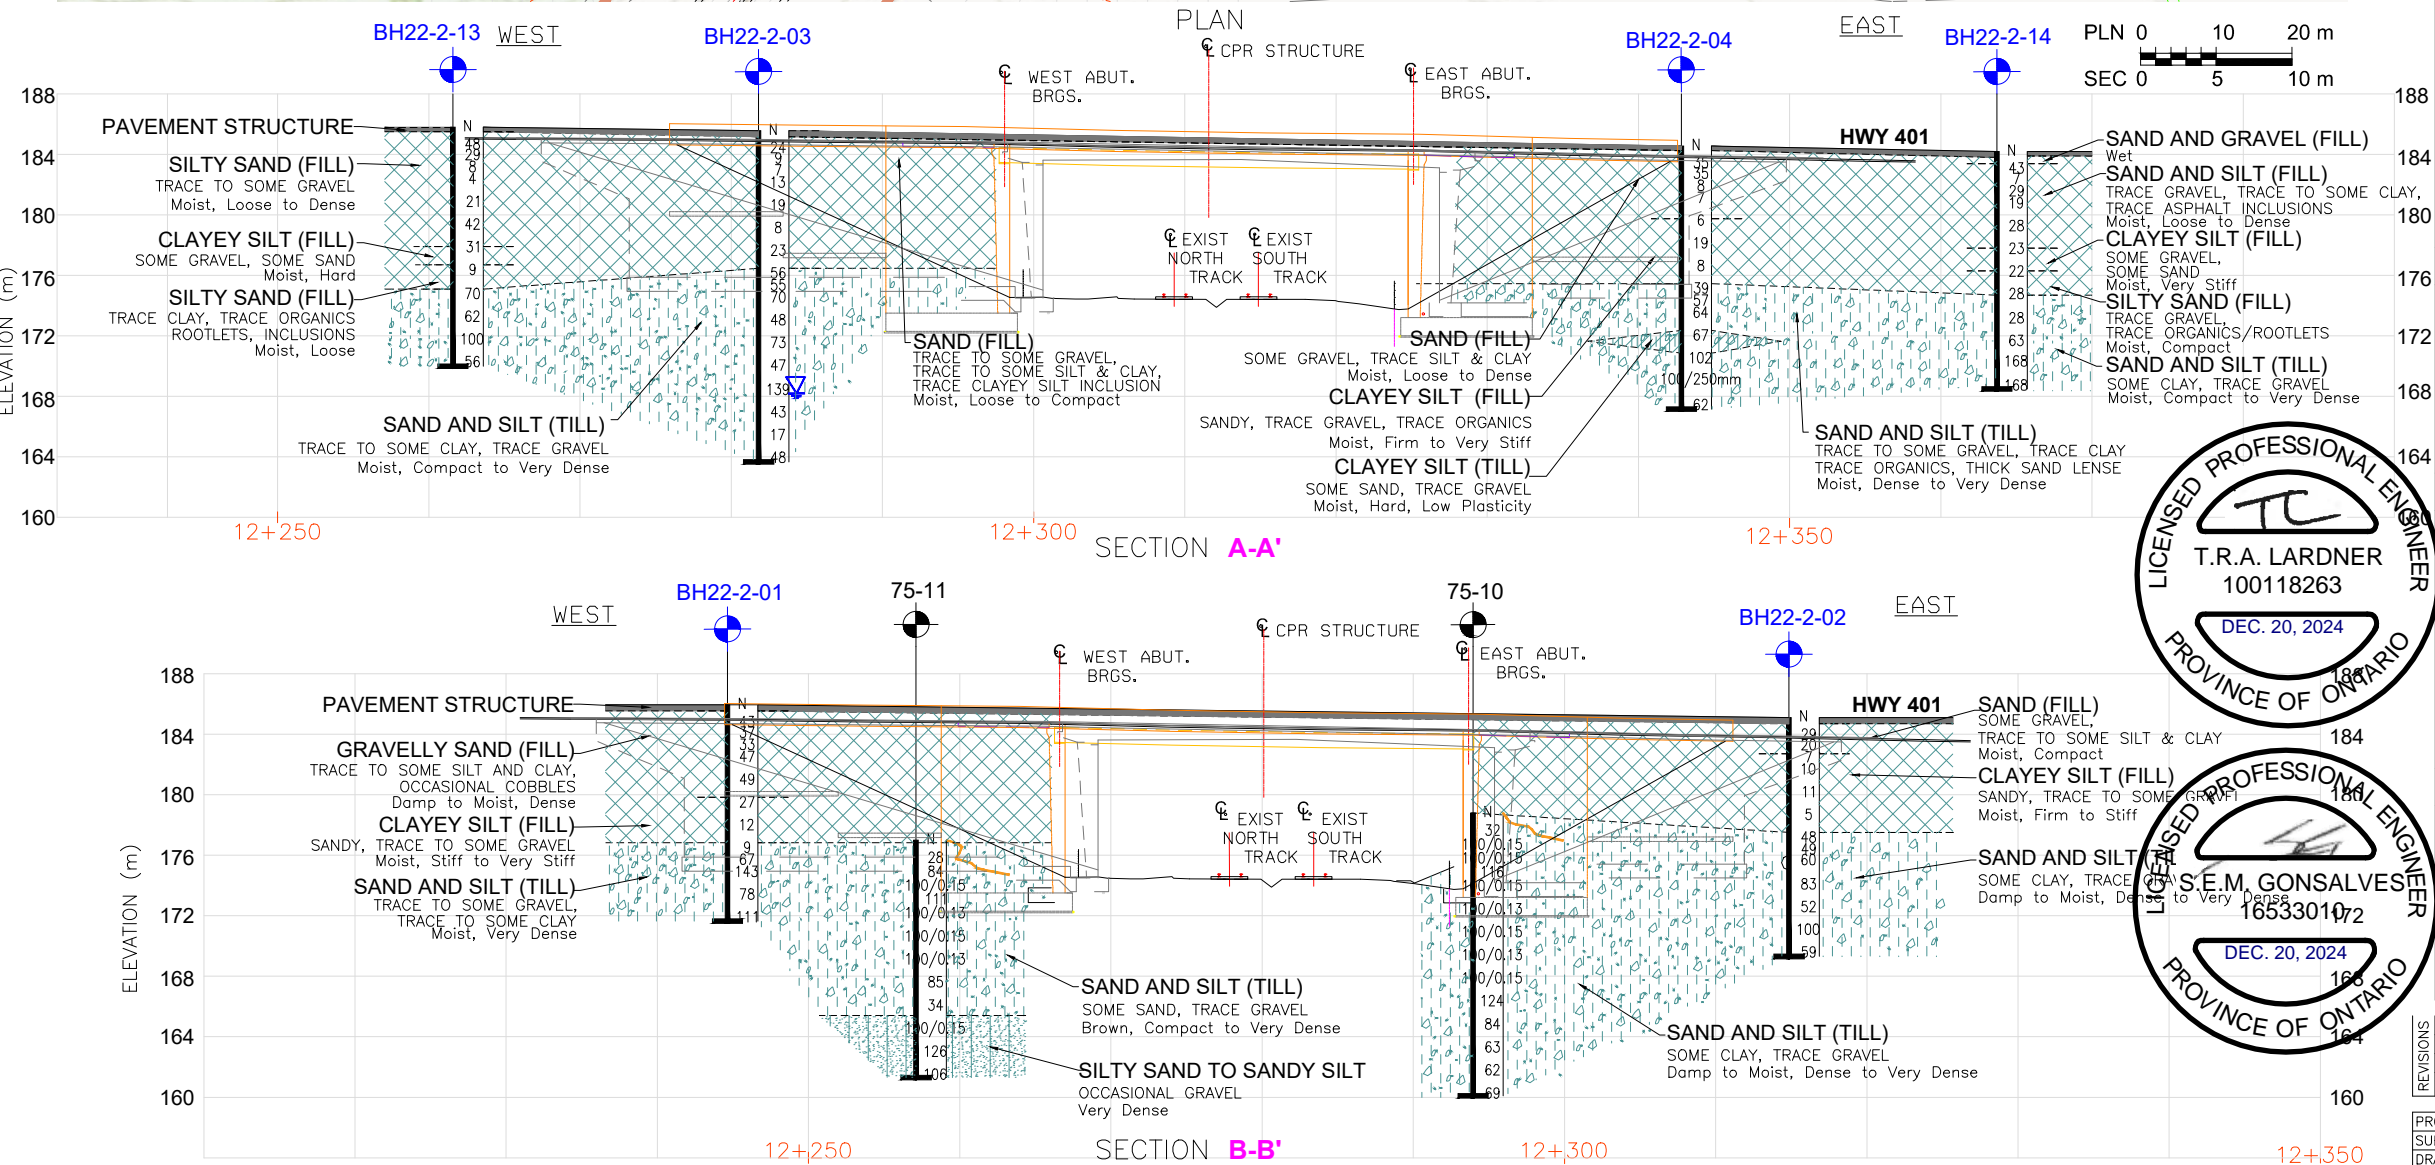
SHEET  
1

A borehole location plan and stratigraphic sections are provided in Appendix C. It should be noted that the stratigraphic boundaries indicated on the borehole log and stratigraphic sections are inferred from semi-continuous sampling, observations

of drilling progress, and results of Standard Penetration Tests. These boundaries typically represent transitions from one soil type to another and should not be interpreted as exact planes of geological change. Furthermore, subsurface conditions may vary between and beyond the borehole locations.

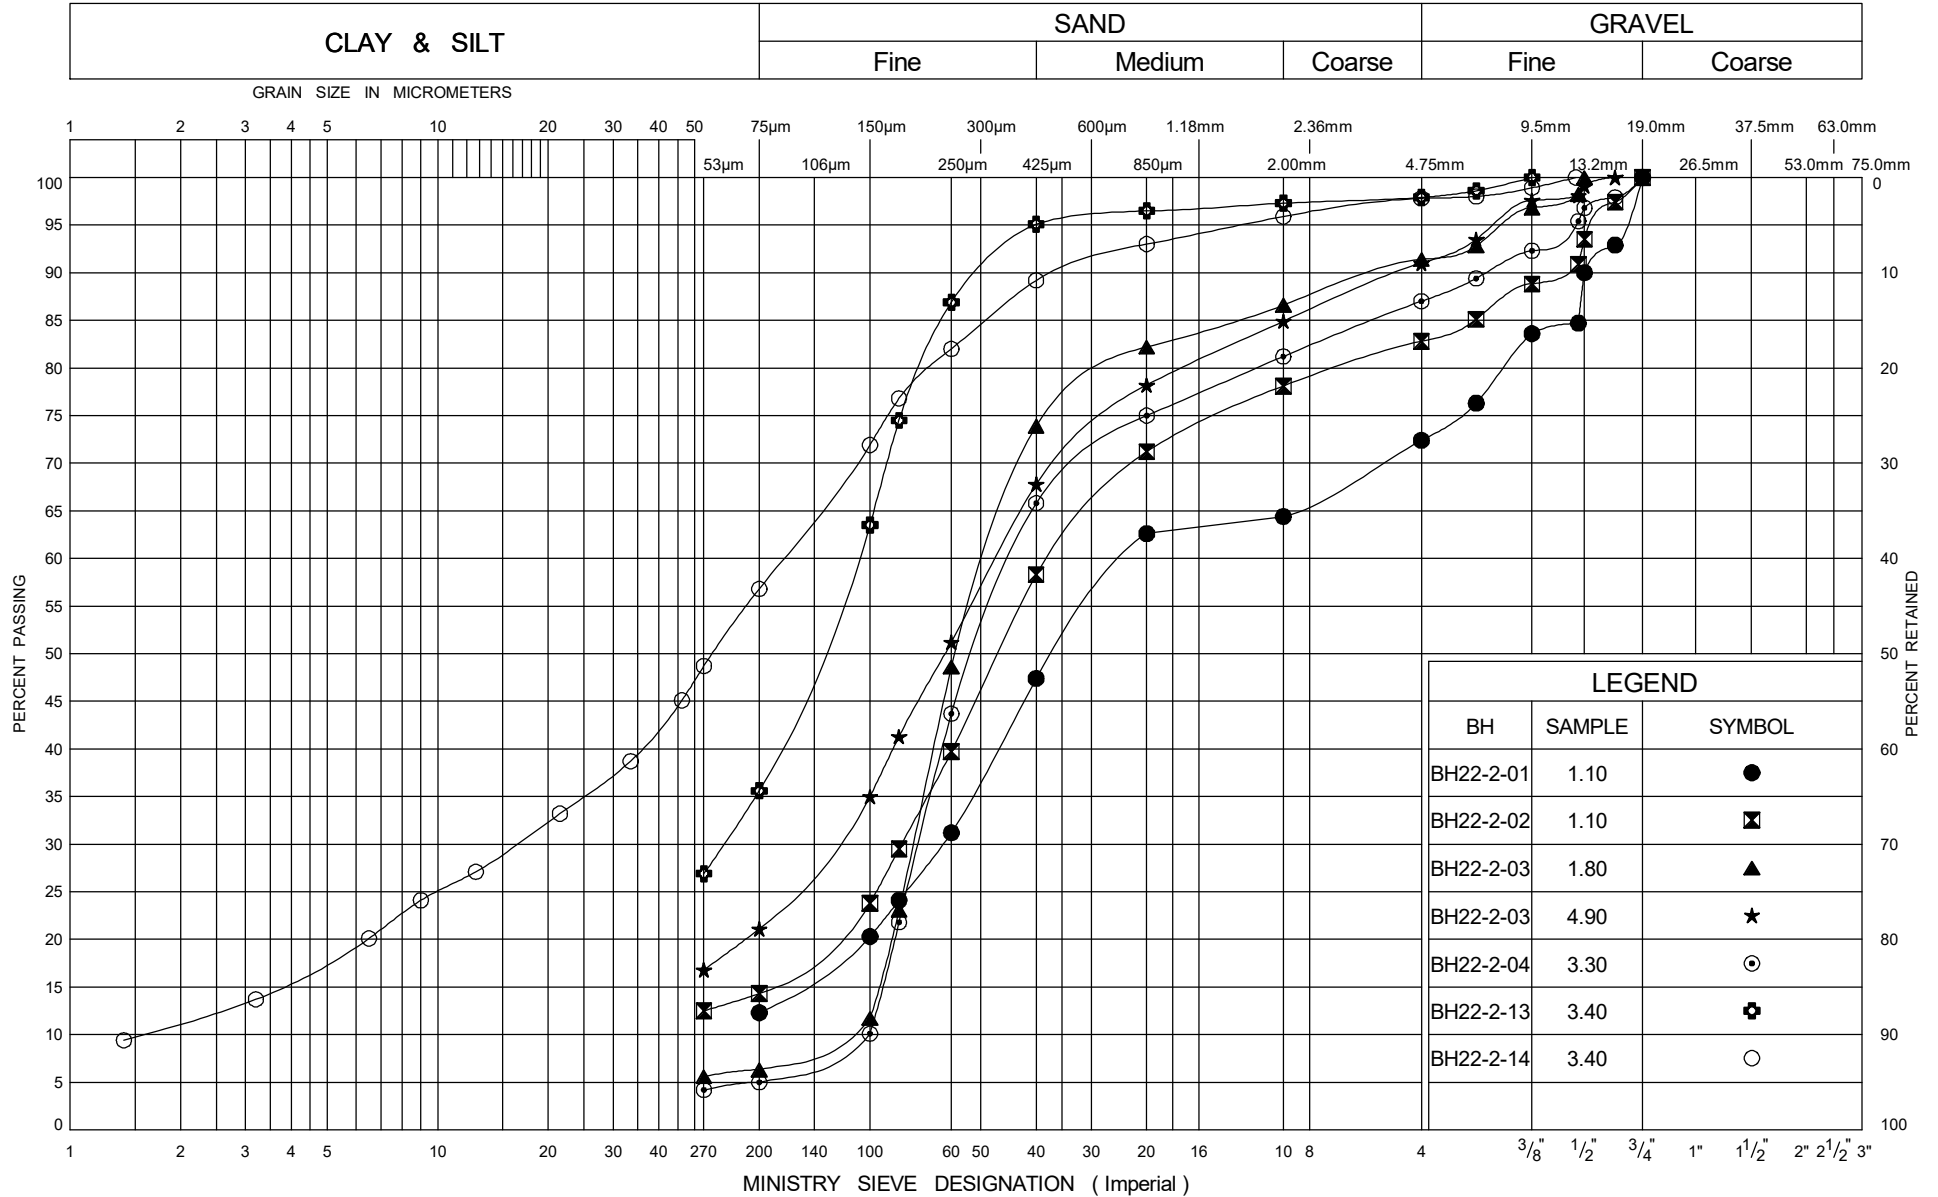
Cohesionless Fill

The results of the moisture content, unit weight, and grain size distribution tests performed by EXP are provided on the record of borehole sheets in Appendix D. The results of the grain size distribution tests performed by EXP are also provided in Figure 1 in Appendix E.

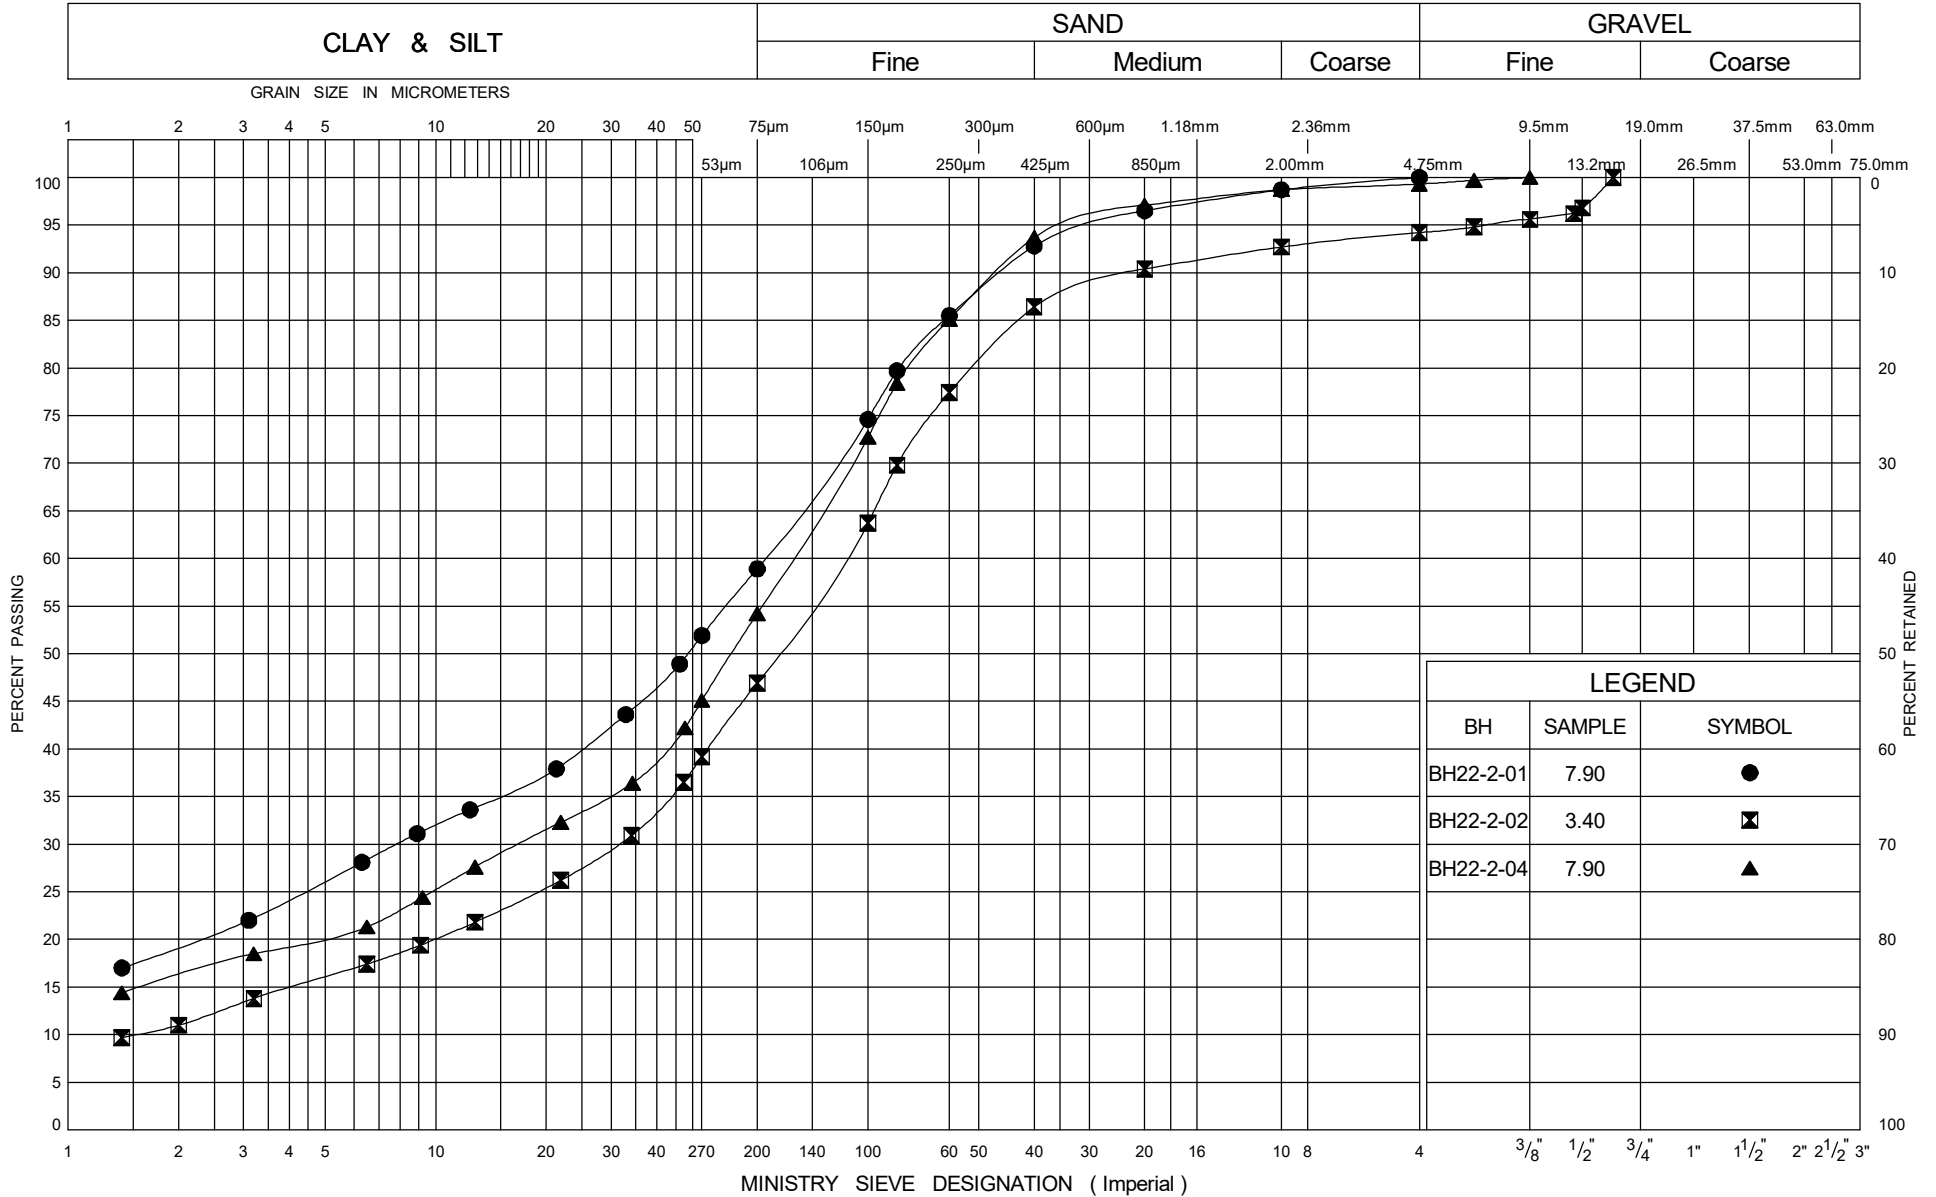
The results of the moisture content, grain size distribution, and Atterberg limit tests performed by EXP are provided on the record of borehole sheets in Appendix D. The results of the grain size distribution and Atterberg limit tests performed by EXP are also provided on Figure 2 and 6 in Appendix E.

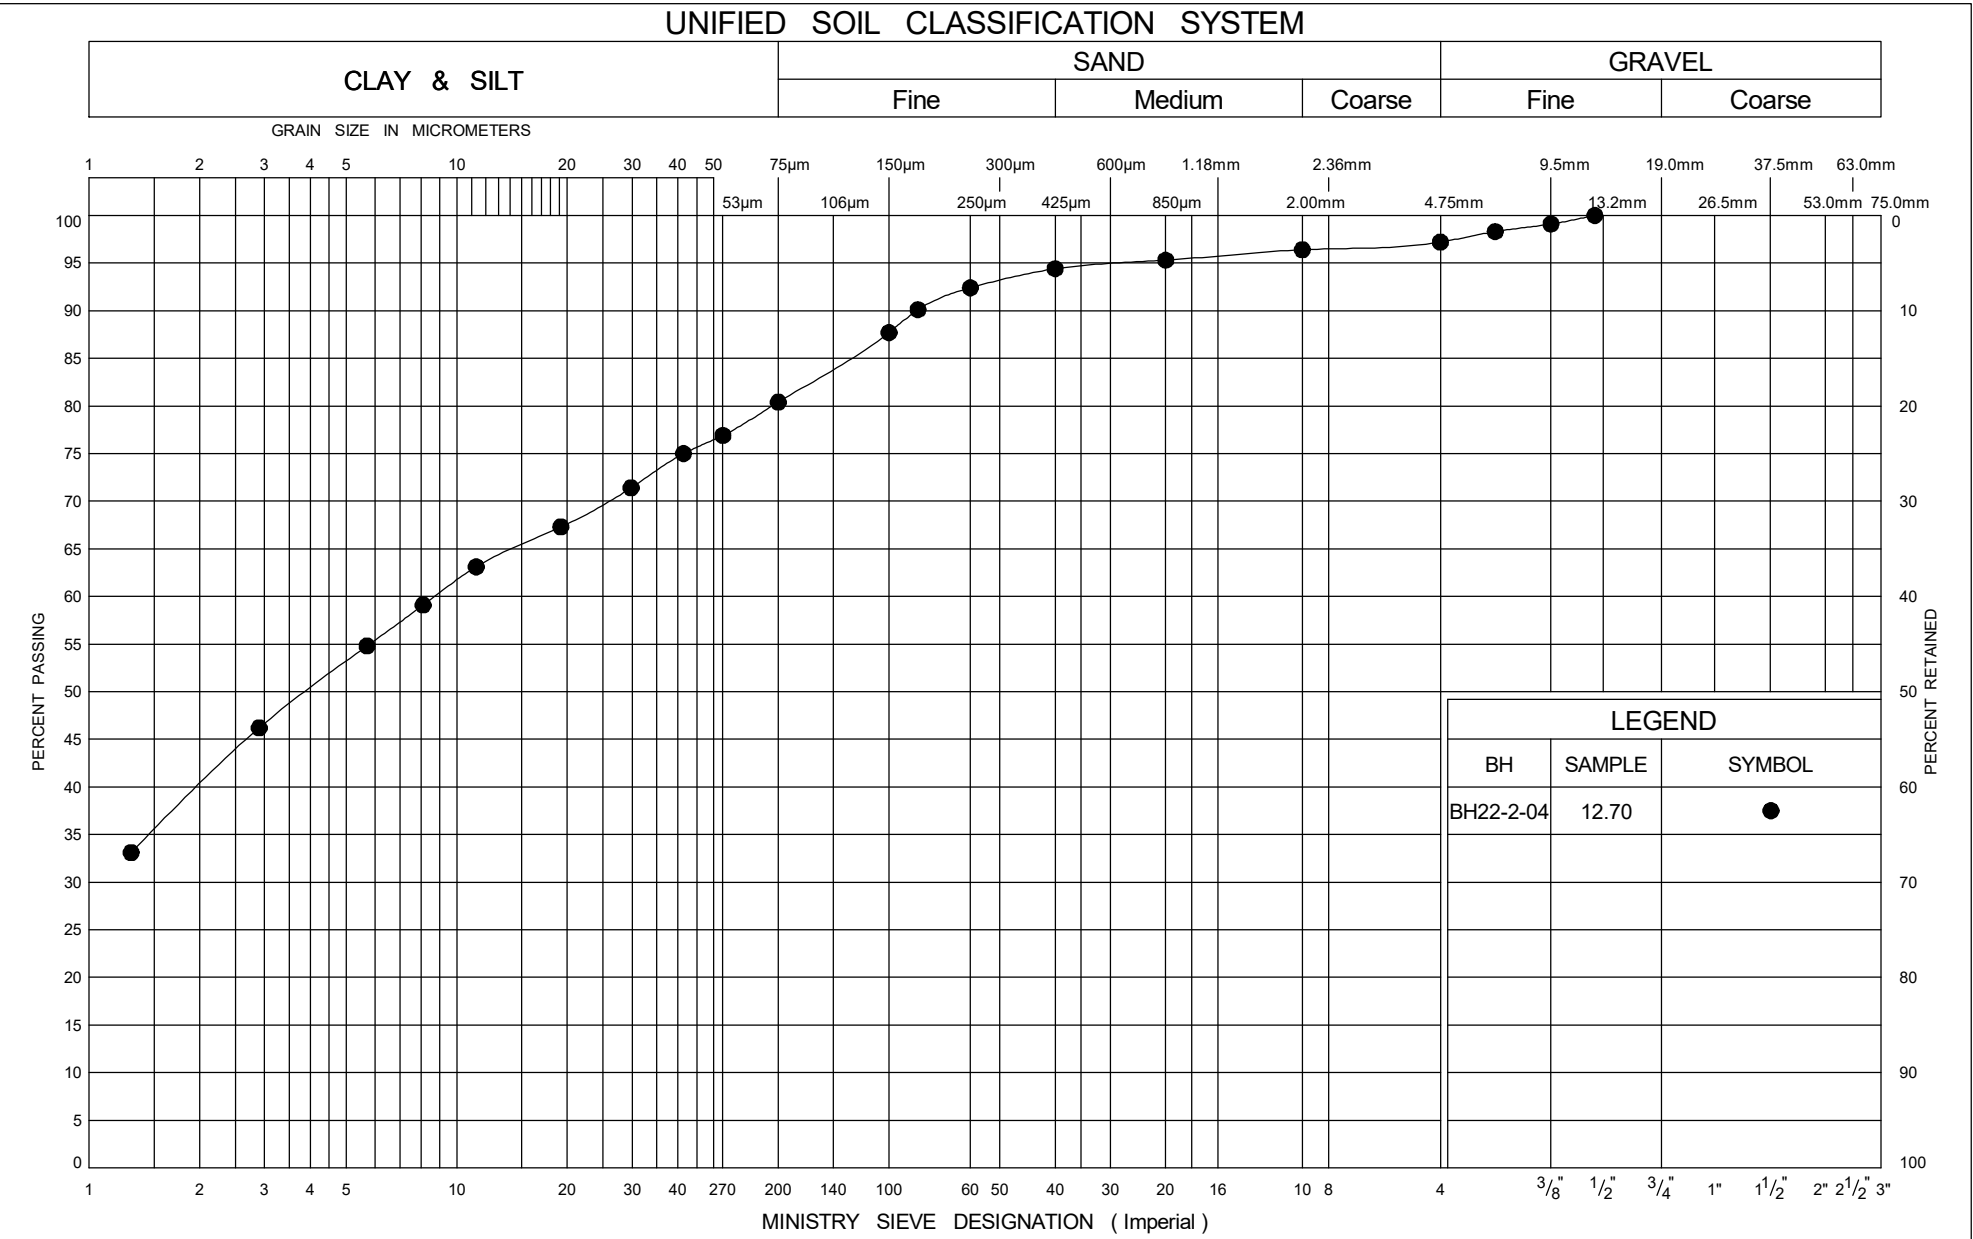
The results of the moisture content, grain size distribution and Atterberg limit tests performed by EXP are provided on the record of borehole sheets in Appendix D. The results of the grain size distribution and Atterberg limit tests performed by EXP are also provided on Figures 3 and 7 in Appendix E.
