## Foundation Investigation Report

Highway 401 Eastbound Express and Collector Lanes between Victoria Park Avenue and Neilson Road - **Superstructure Replacement at Kennedy Road Overpass Eastbound Core and Collectors Structure (Site 37X-0214/B1 & B3)**

Assignment No. 2021-E-0018  
MTO Central Region  
Geocres Number: 30M14-552  
(Latitude: 43.774739, Longitude: -79.284516)

**Type of Document:**  
Foundation Investigation and Design Report

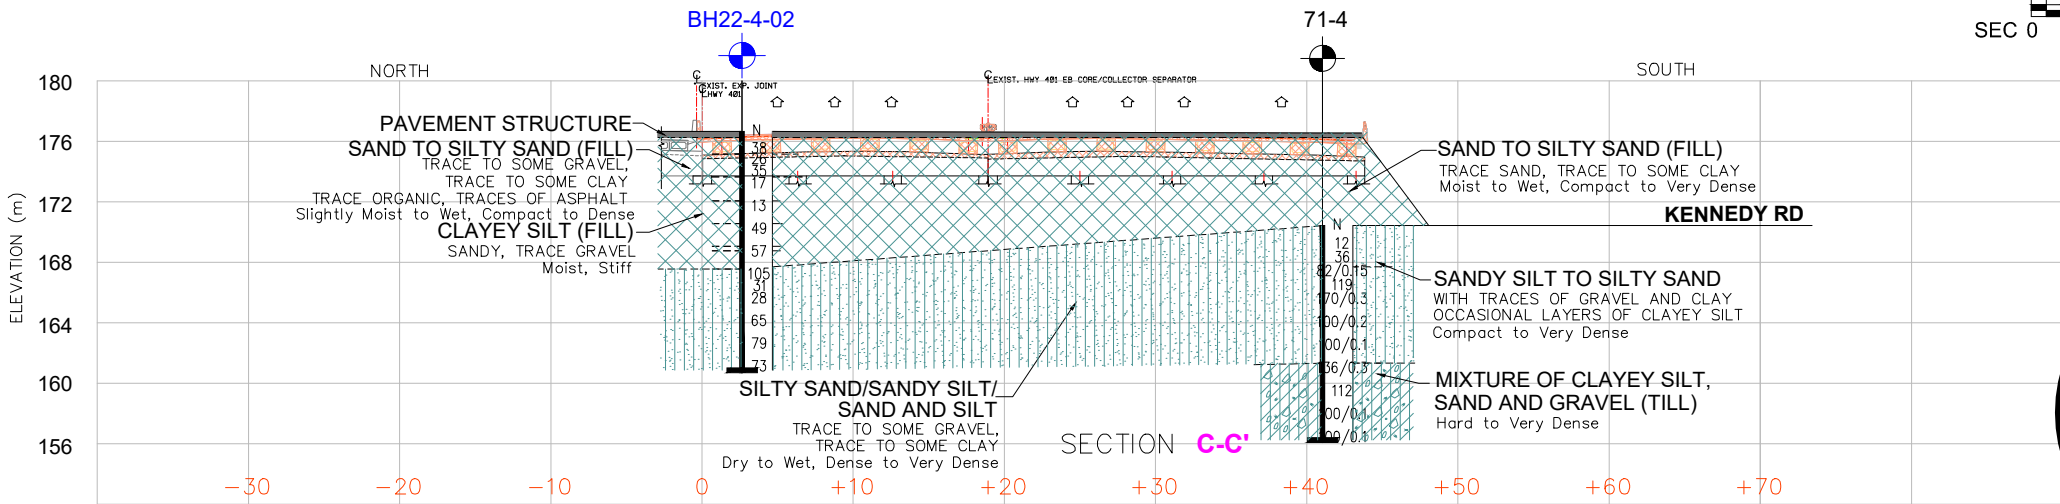
PROJECT No.	ADM-22000797-A0	GEOCRES No.	30M14-552
SUBM'D SH	CHKD. SM	DATE NOV. 14, 2024	SITE 37X-0214/B1 & B3
DRAWN SH	CHKD. TC	APPRD SG	DWG 01

CONT No.  
ASSIG No. 2021-E-0018  
GWP No.  
Superstructure Replacement at Kennedy Road Overpass  
Eastbound Core and Collectors Structure  
Latitude: 43.774789; Longitude: -79.284548  
BOREHOLE LOCATION PLAN & SOIL STRATA

A borehole location plan and stratigraphic sections are provided in Appendix C. It should be noted that the stratigraphic boundaries indicated on the borehole log and stratigraphic sections are inferred from semi-continuous sampling, observations of drilling progress and results of Standard Penetration Tests. These boundaries typically represent transitions from one soil type to another and should not be interpreted as exact planes of geological change. Furthermore, subsurface conditions may vary between and beyond the borehole locations.

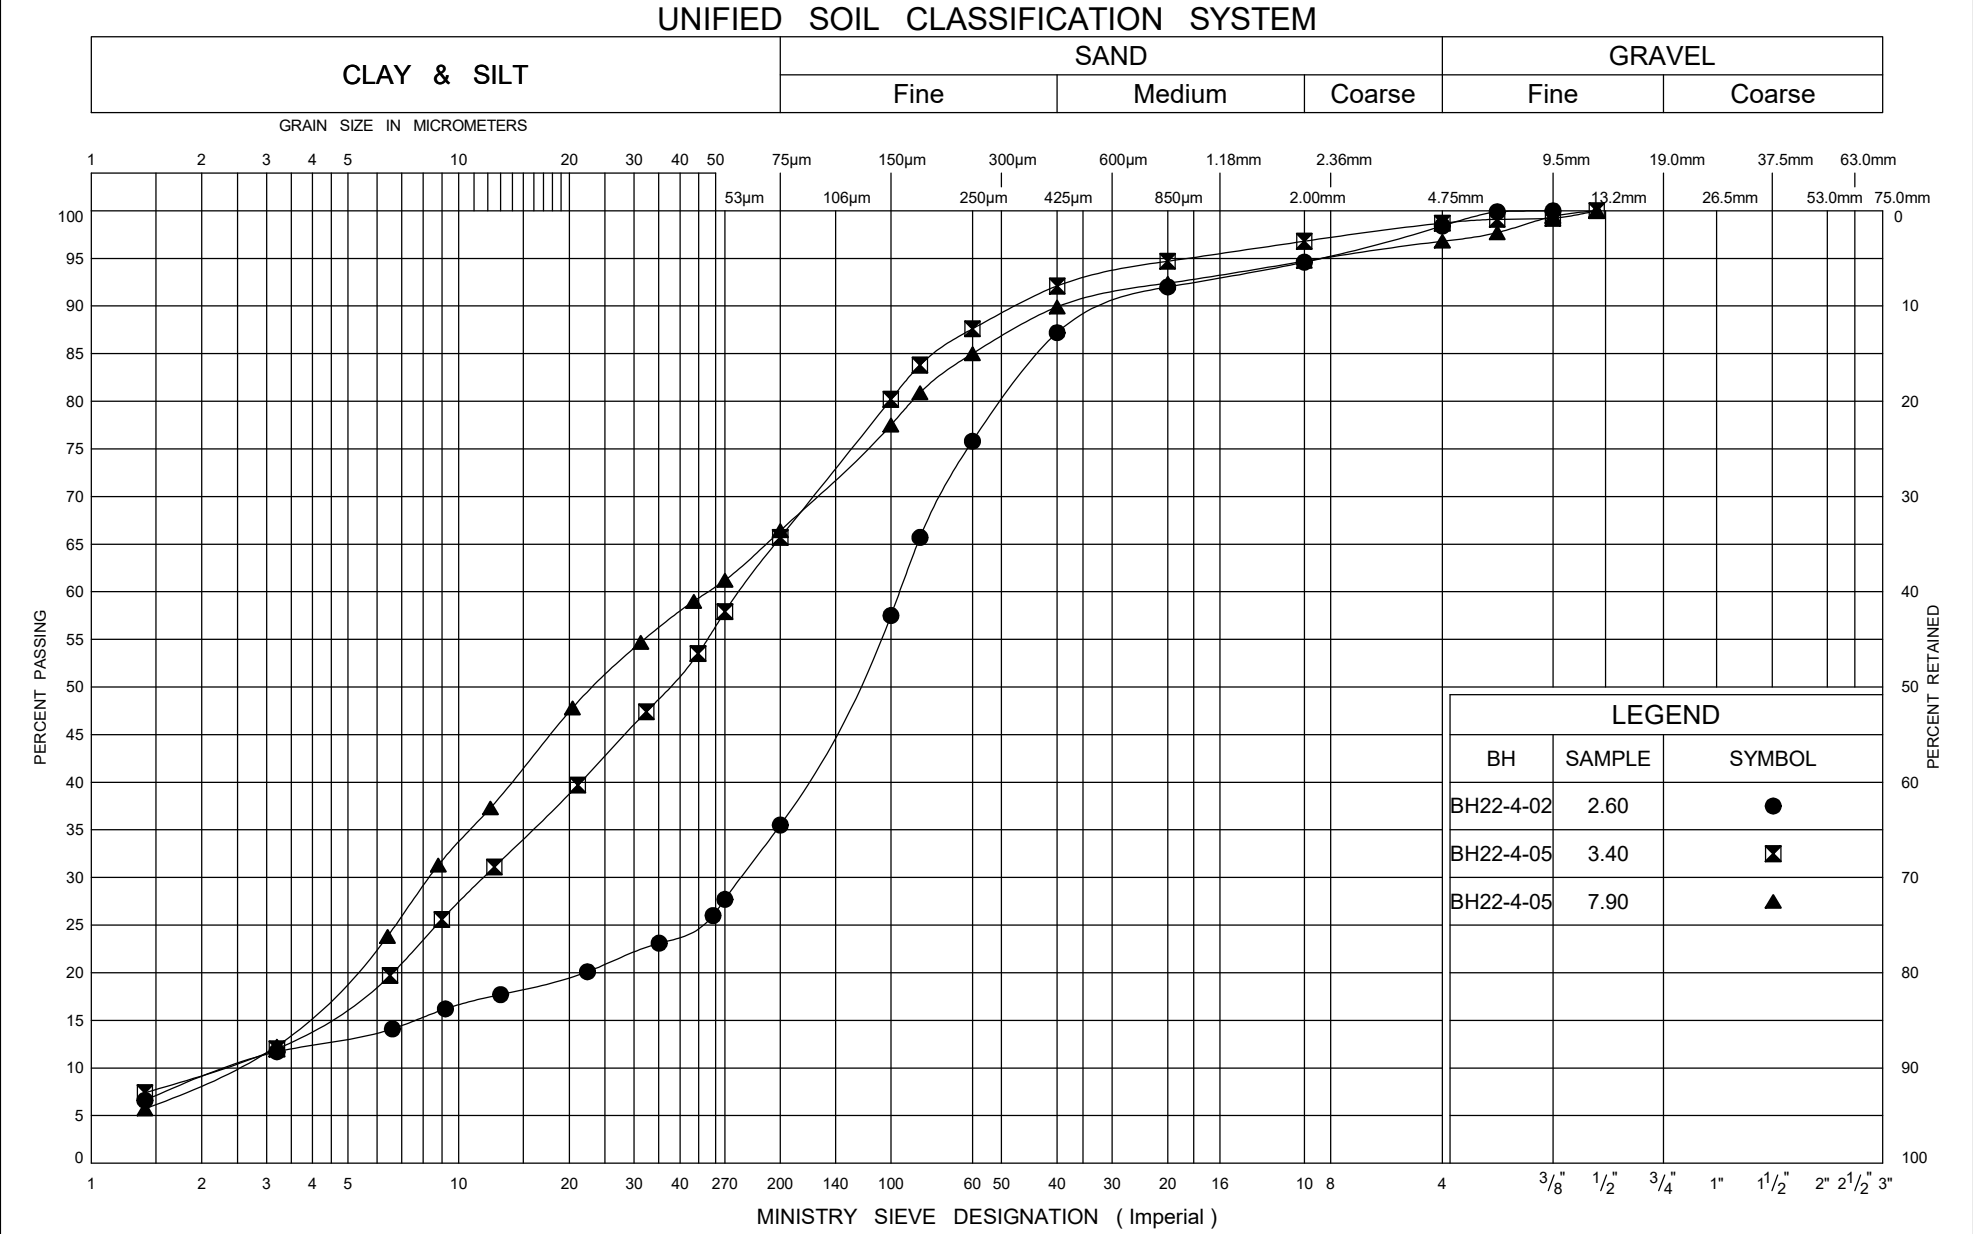
FIG No 1  
W P Site 37X-0214/B1&B3  
Hwy 401 - Kennedy Road O/P

**GRAIN SIZE DISTRIBUTION**  
Sand/Sandy Silt/Silty Sand Fill

The results of the moisture content, grain size distribution, Atterberg limits and unit weight tests performed by EXP are provided on the record of borehole sheets in Appendix D. The results of grain size distribution tests are also provided on Figure 1 in Appendix E.

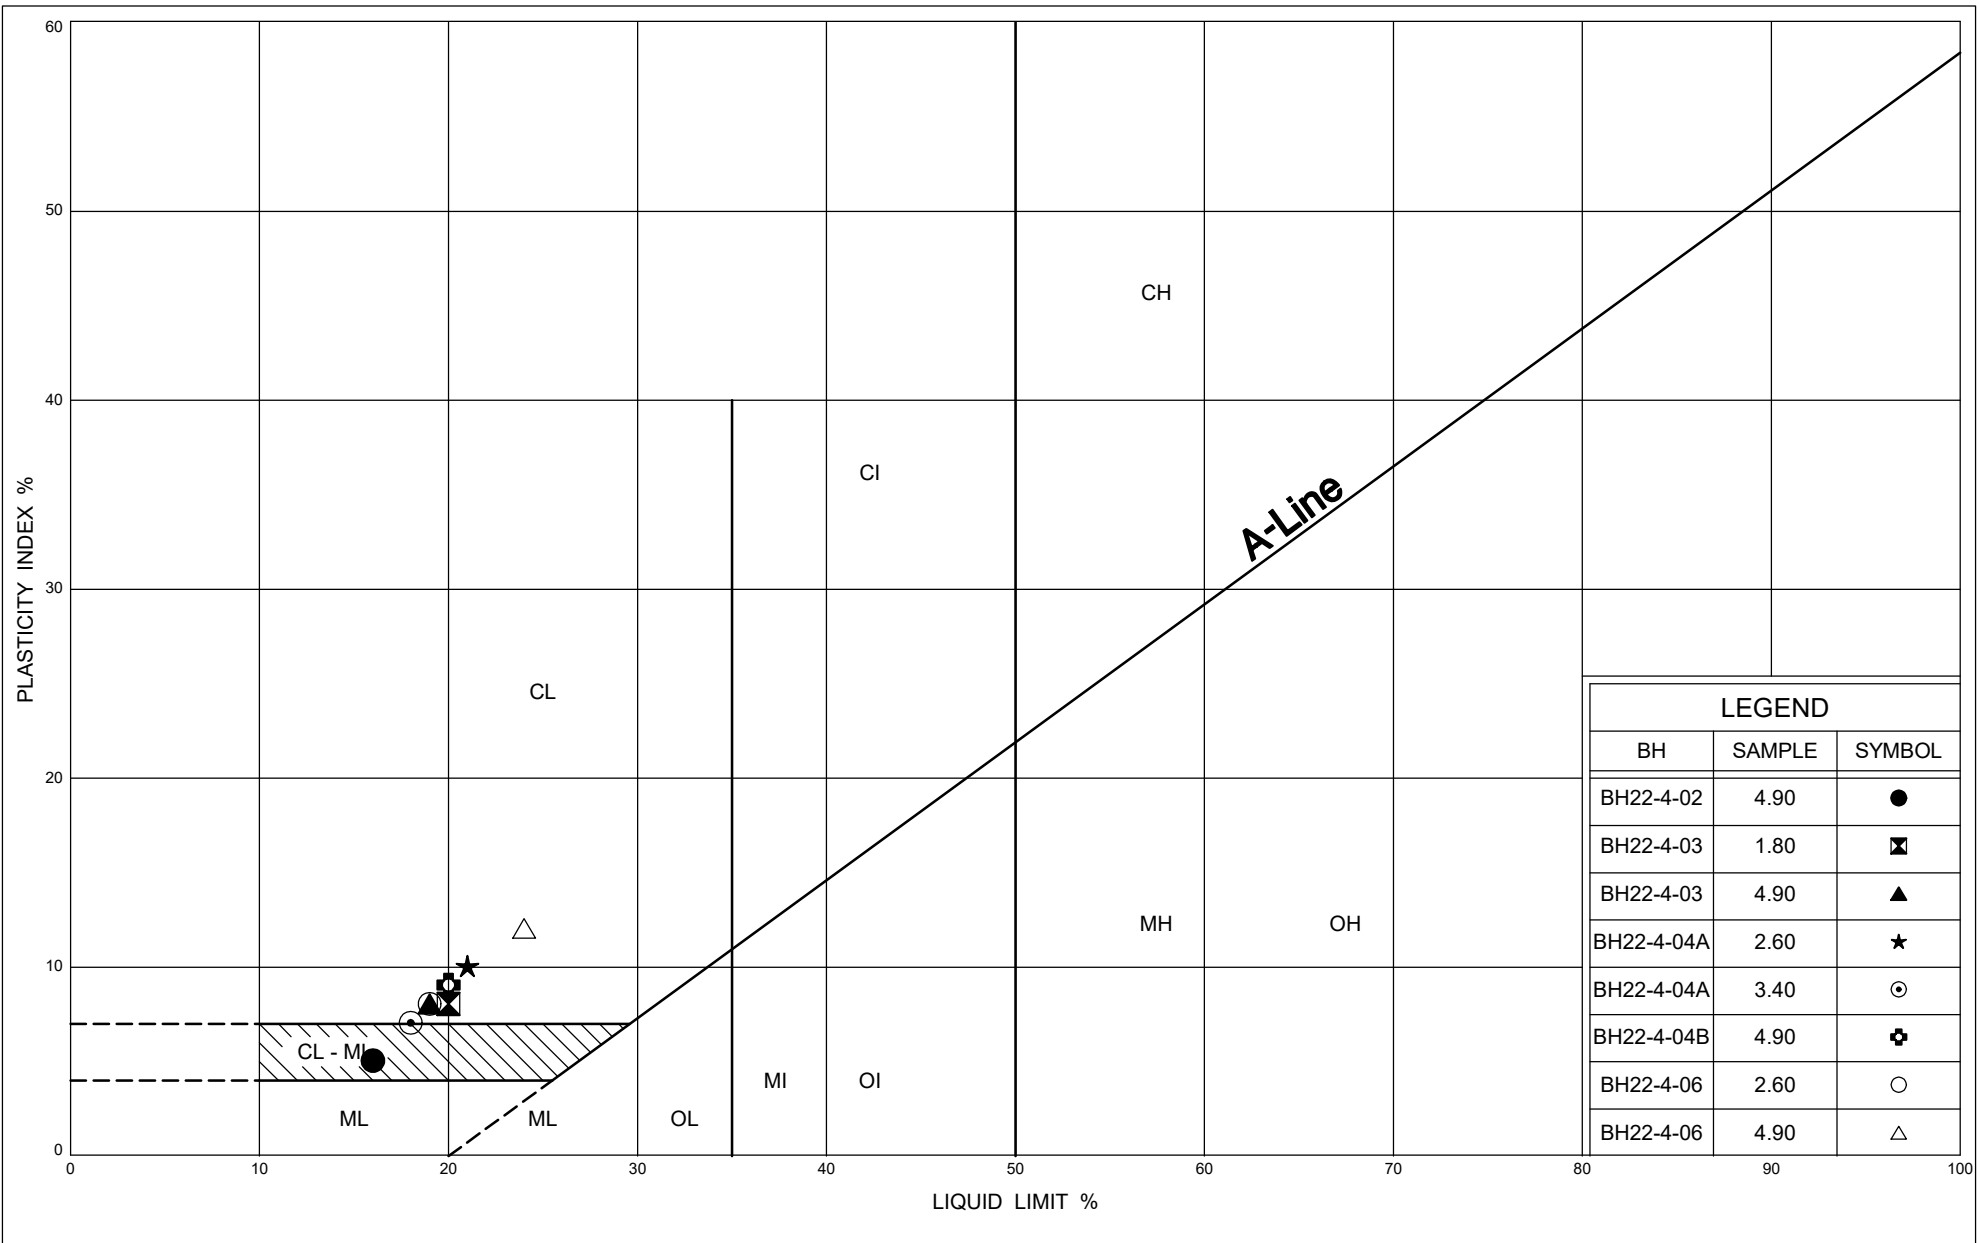
## PLASTICITY CHART
