Foundation Investigation Report

Highway 401 Eastbound Express and Collector Lanes between Victoria Park Avenue and Neilson Road - **Superstructure Replacement at Markham Road Overpass Eastbound Core and Collectors Structure (Site 37X-0218/B1 & B3)**

Assignment No. 2021-E-0018

December 20, 2024

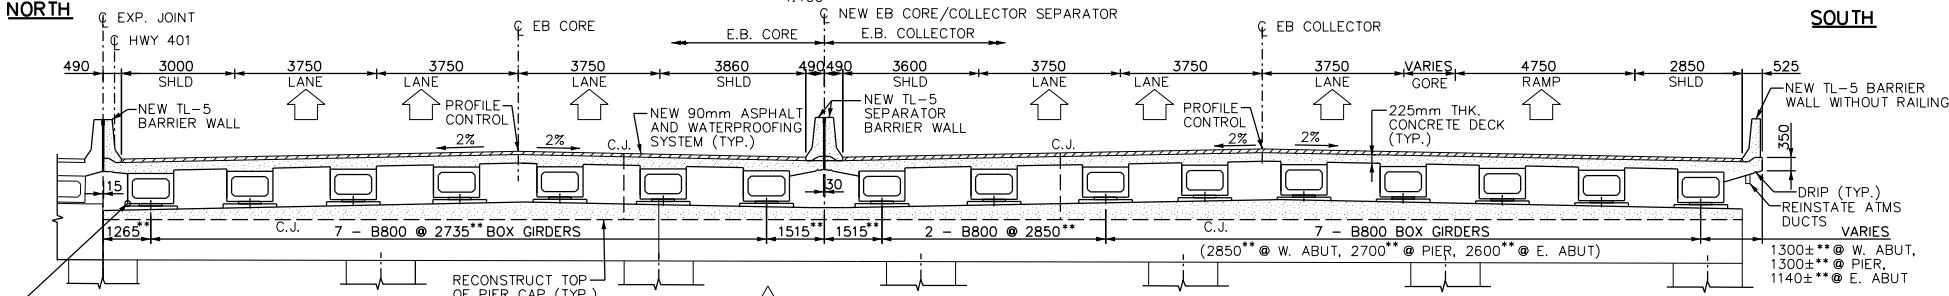
REHABILITATED
1:100

(** MEASUREMENTS PERPENDICULAR TO C/PIER & ABUTMENT BRGS)

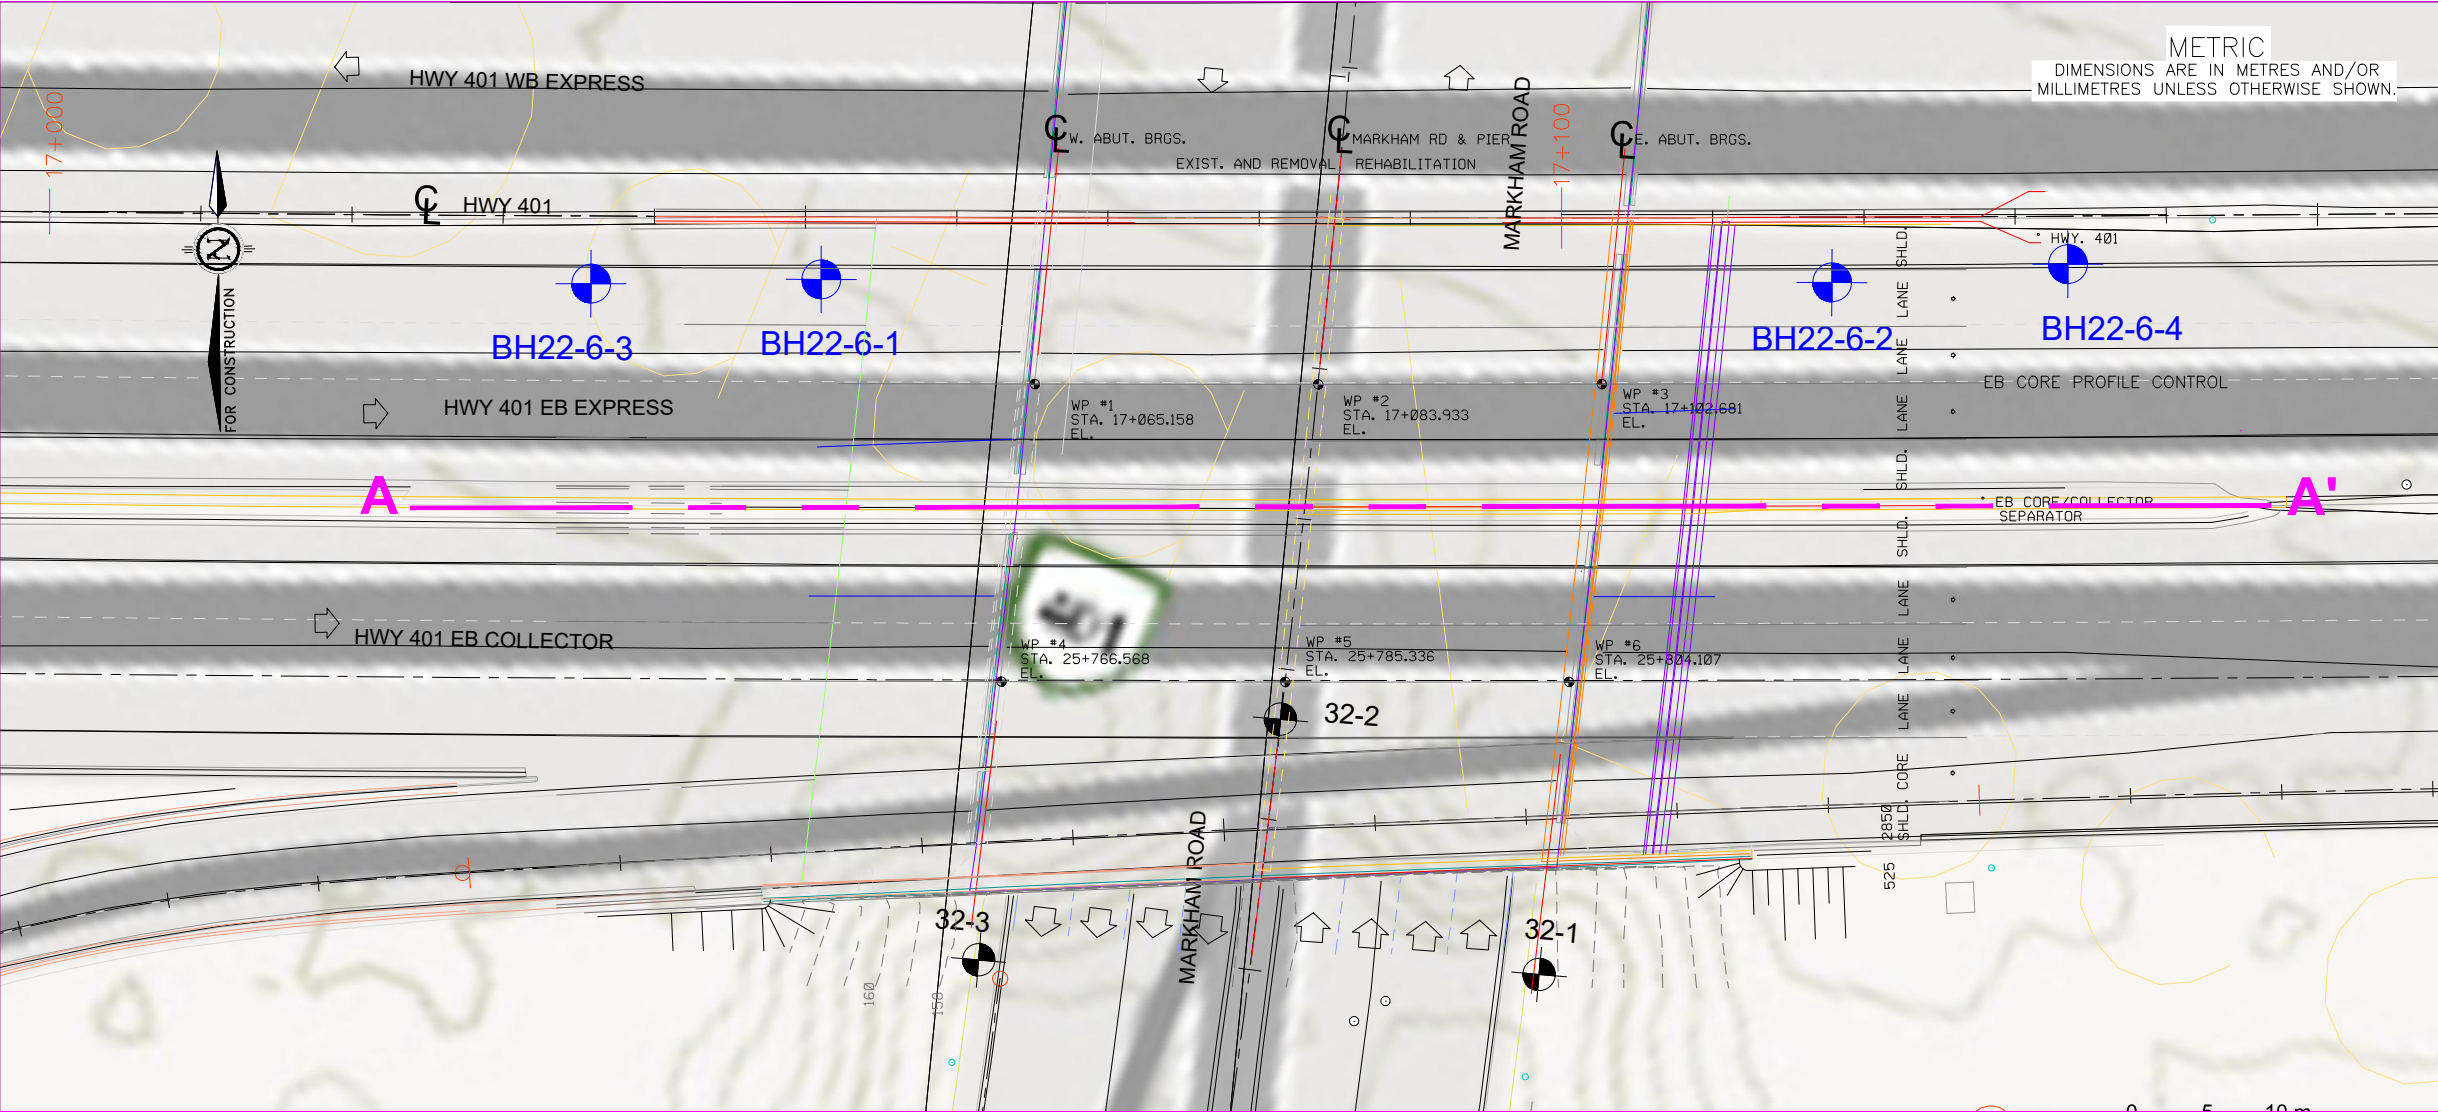
Superstructure Replacement at Markham Road Overpass
Eastbound Core and Collectors Structure
Latitude: 43.785377°; Longitude: -79.235209°
BOREHOLE LOCATION PLAN & SOIL STRATA

A borehole location plan and stratigraphic sections are provided in Appendix C. It should be noted that the stratigraphic boundaries indicated on the borehole log and stratigraphic sections are inferred from semi-continuous sampling, observations of drilling progress and results of Standard Penetration Tests. These boundaries typically represent transitions from one soil type to another and should not be interpreted as exact planes of geological change. Furthermore, subsurface conditions may vary between and beyond the borehole locations.

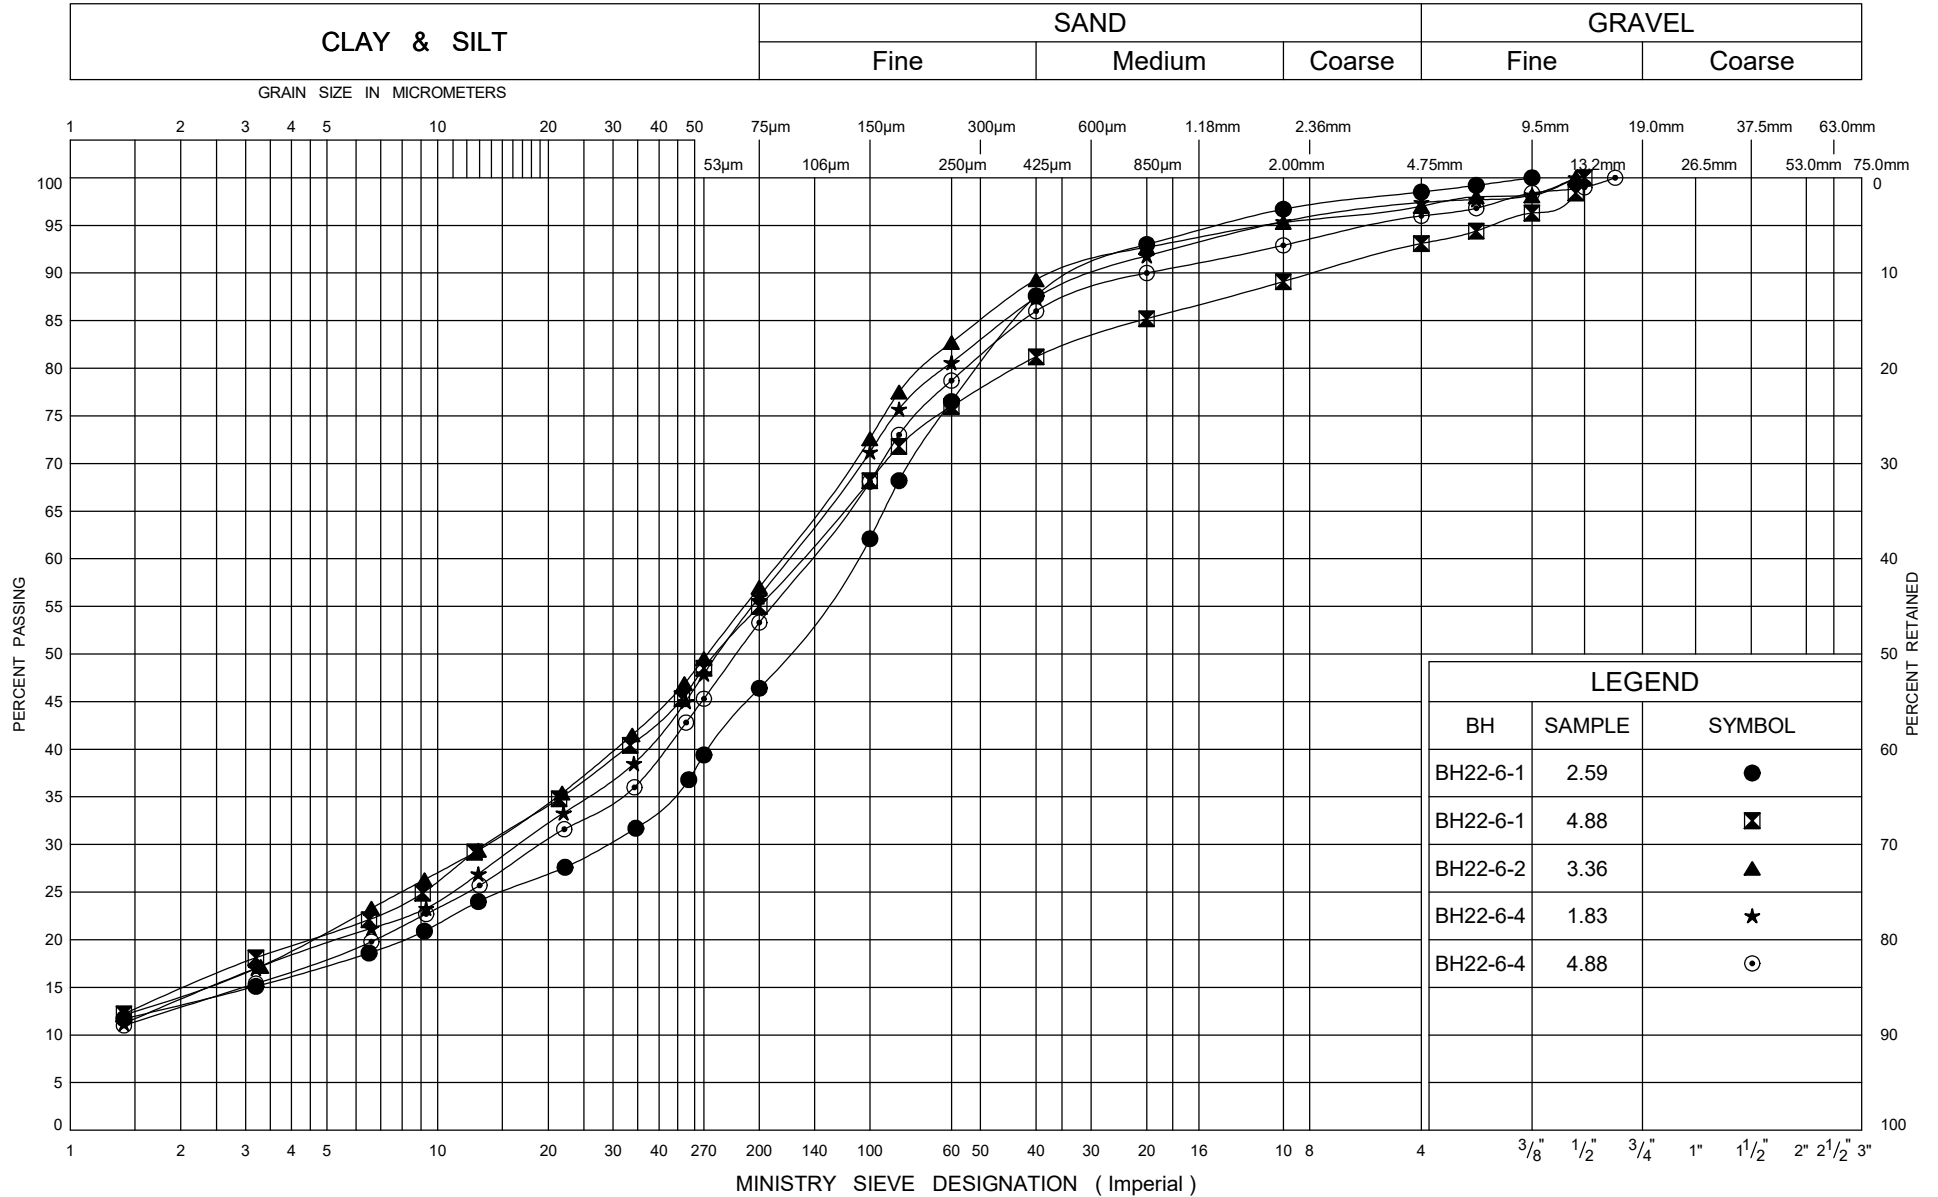
GRAIN SIZE DISTRIBUTION

Cohesive Fill: Clayey Silt

The results of the moisture content, grain size distribution, Atterberg limits and unit weight tests performed by EXP are provided on the record of borehole sheets in Appendix D. The results of grain size distribution and Atterberg limits tests are also provided on Figure 2 and 5 in Appendix E.

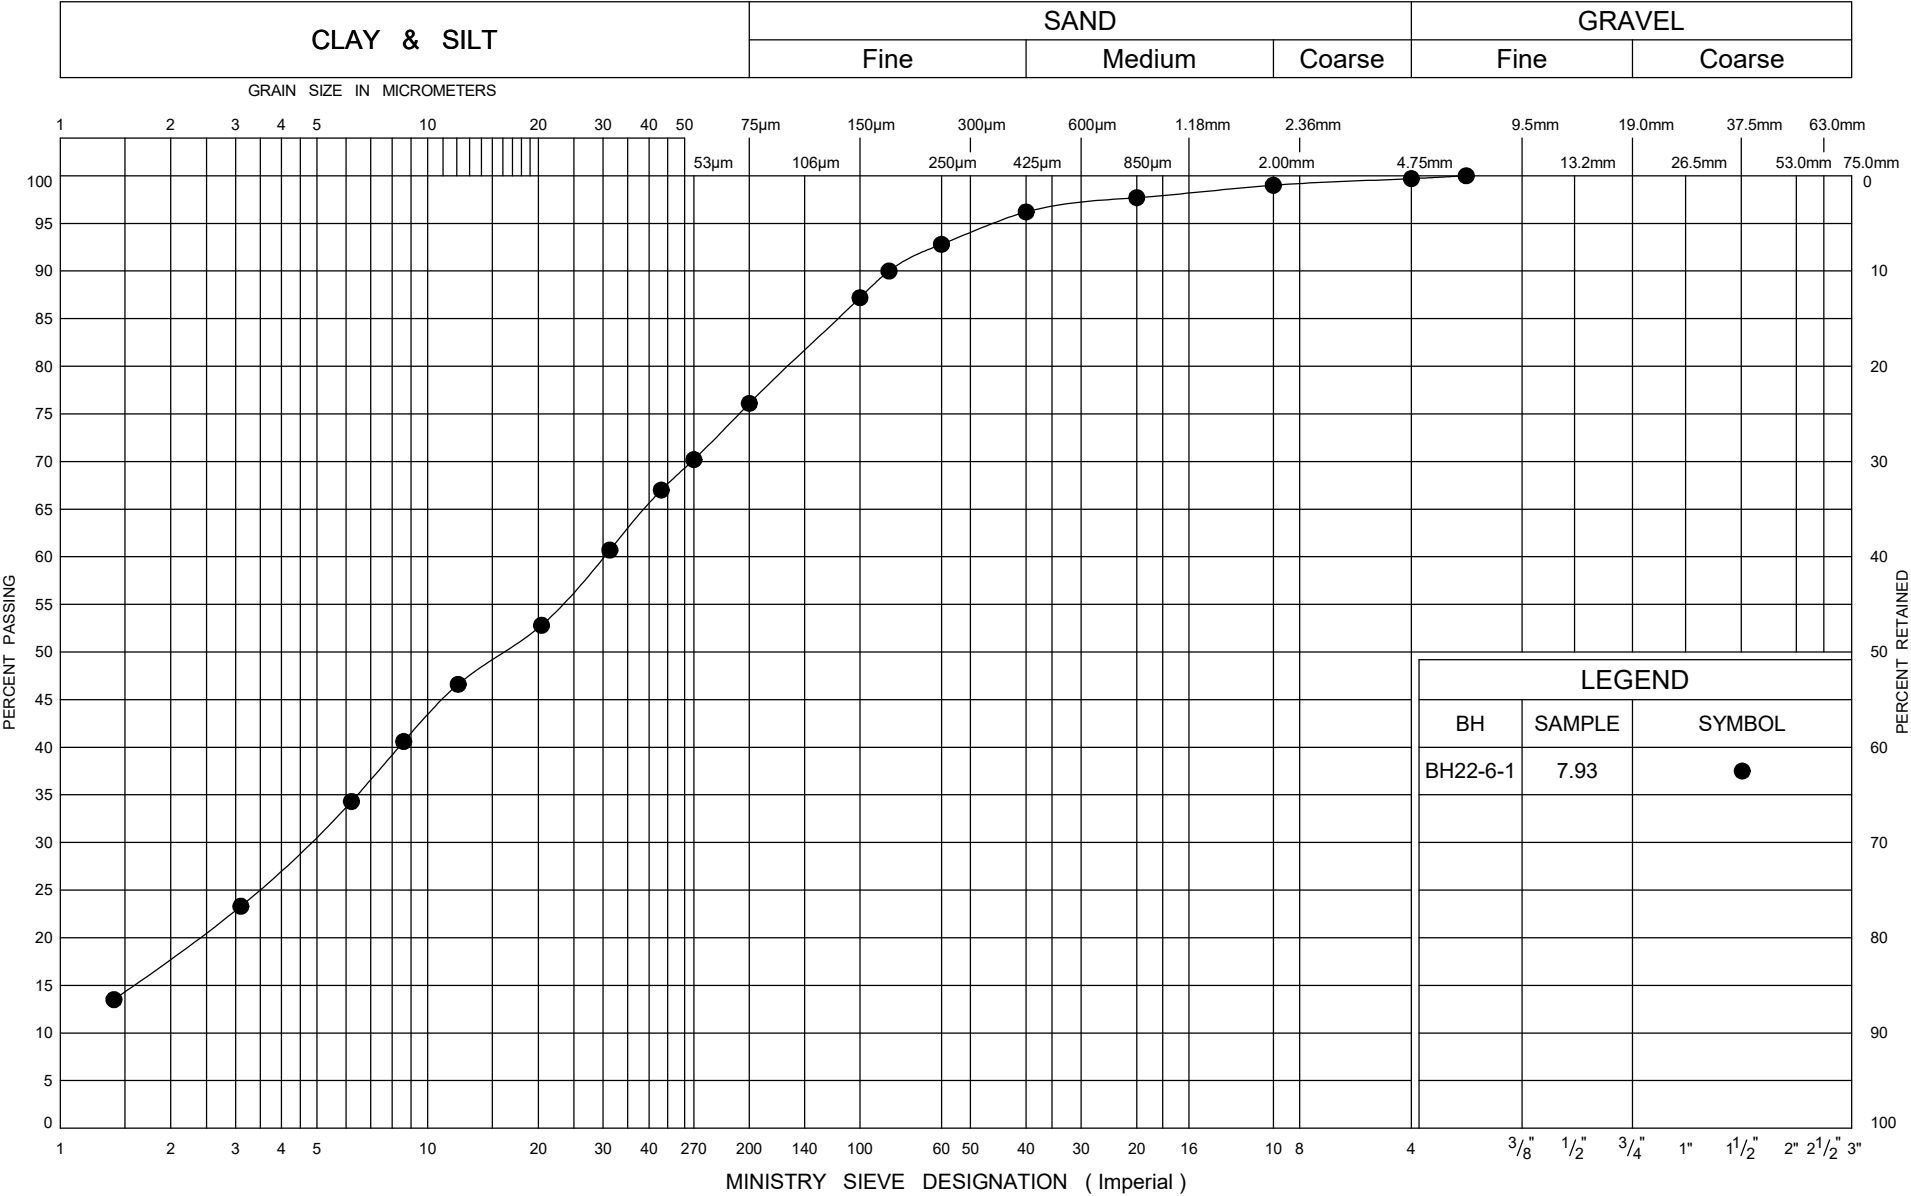
FIG No 3
W P Site 37X-0218/B1 & B3
Hwy 401 - Markham Rd. O/P

GRAIN SIZE DISTRIBUTION

Clayey Silt

The results of the moisture content, grain size distribution, Atterberg limits and unit weight tests performed by EXP are provided on the record of borehole sheets in Appendix D. The results of grain size distribution and Atterberg limits tests are also provided on Figure 3 and 6 in Appendix E. The results of tests performed by MTO are shown on the borehole logs attached in Appendix F.

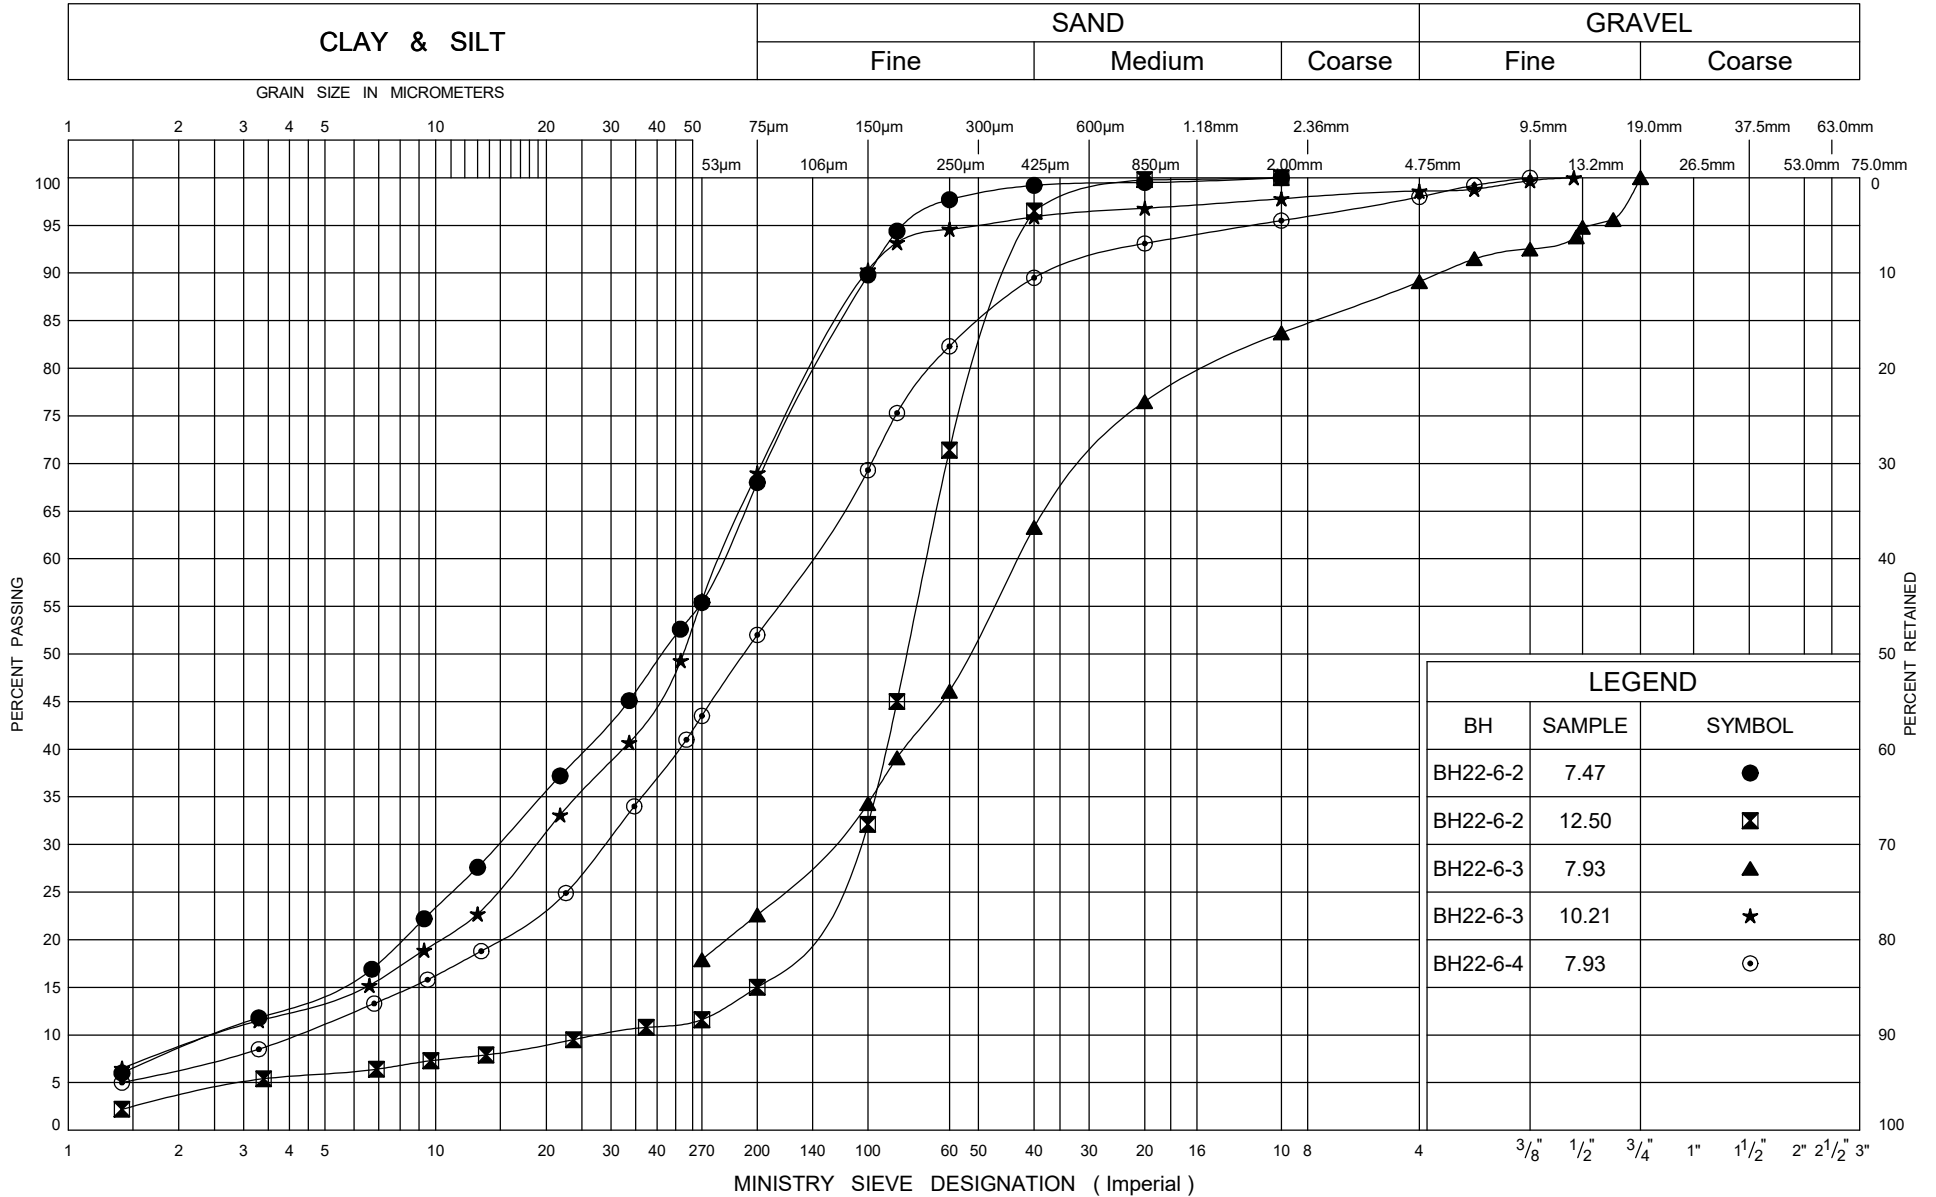
GRAIN SIZE DISTRIBUTION

Sand/Sand and Silt/Sandy Silt

The results of the moisture content, grain size distribution and unit weight tests performed by EXP are provided on the record of borehole sheets in Appendix D. The results of grain size distribution tests are also provided on Figure 4 in Appendix E. The results of tests performed by MTO are shown on the borehole logs attached in Appendix F.

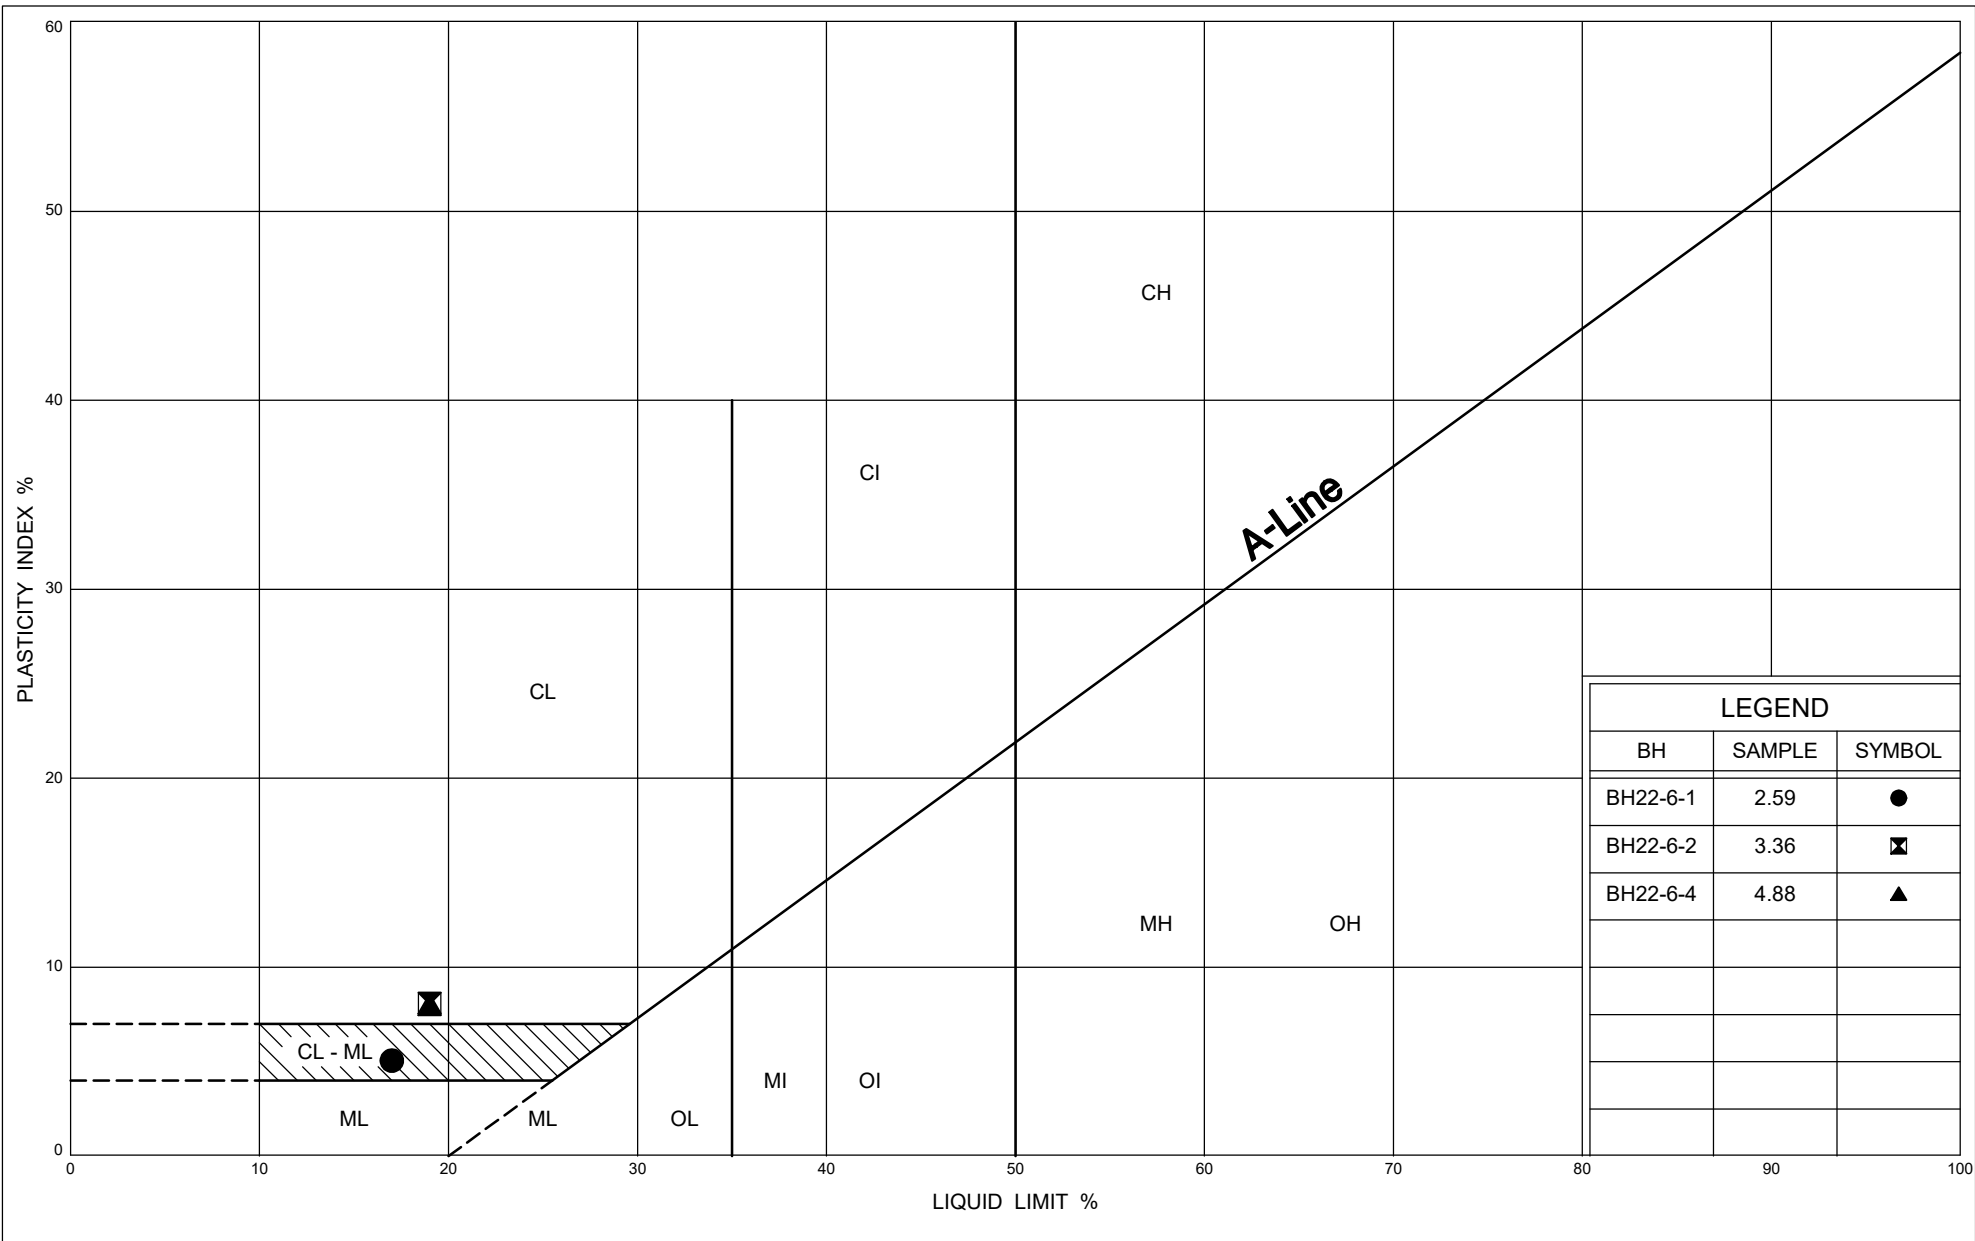
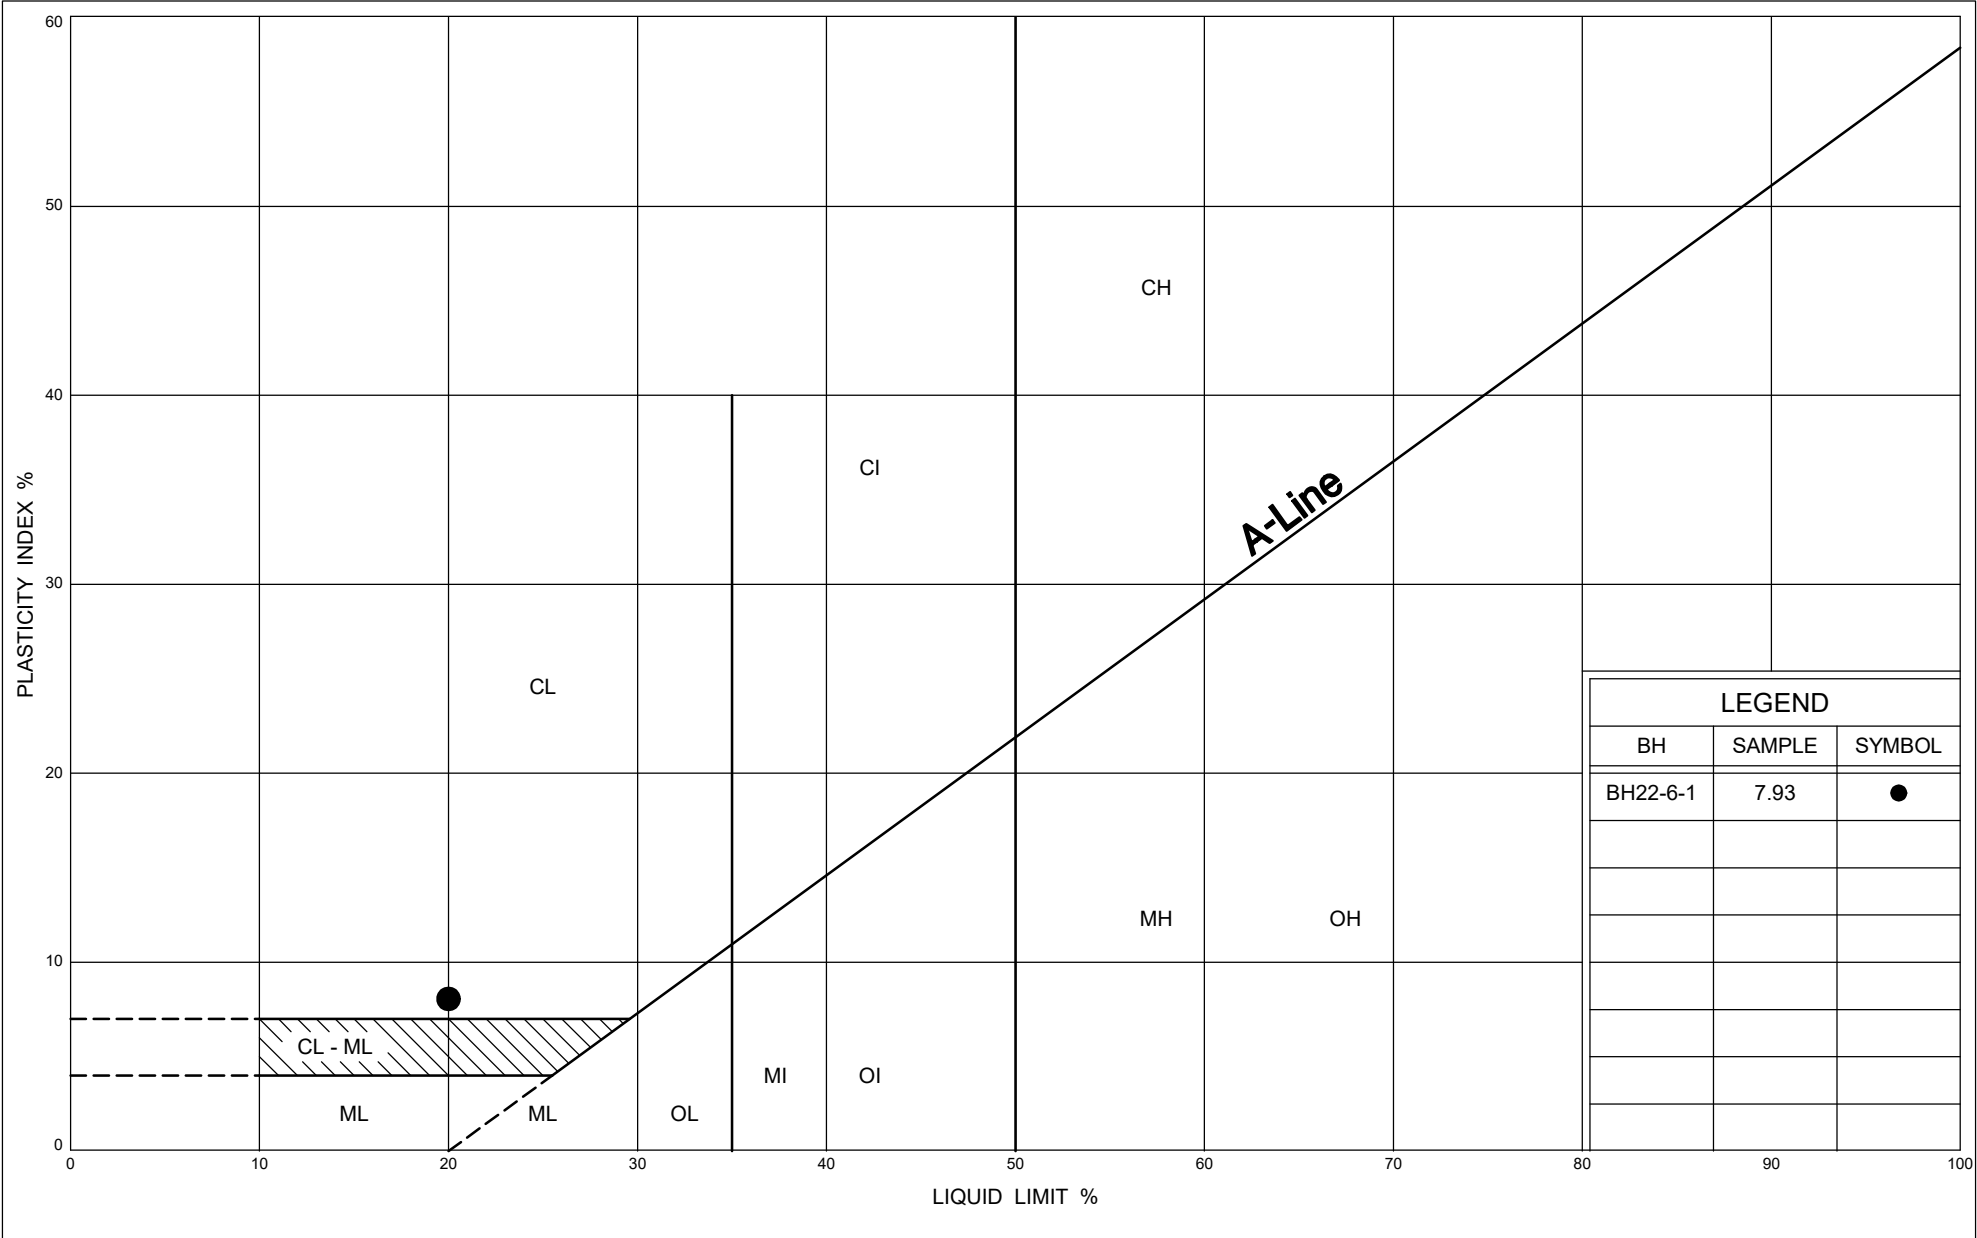
PLASTICITY CHART

LEGEND		
BH	SAMPLE	SYMBOL
BH22-6-1	7.93	●
