Foundation Investigation Report

Highway 401 Eastbound Express and Collector Lanes between Victoria Park Avenue and Neilson Road - **Superstructure Replacement at Midland Avenue Overpass Eastbound Core and Collectors Structure (Site 37X-0216/B1 & B3)**

Assignment No. 2021-E-0018
MTO Central Region
Geocres Number: 30M14-553

December 20, 2024

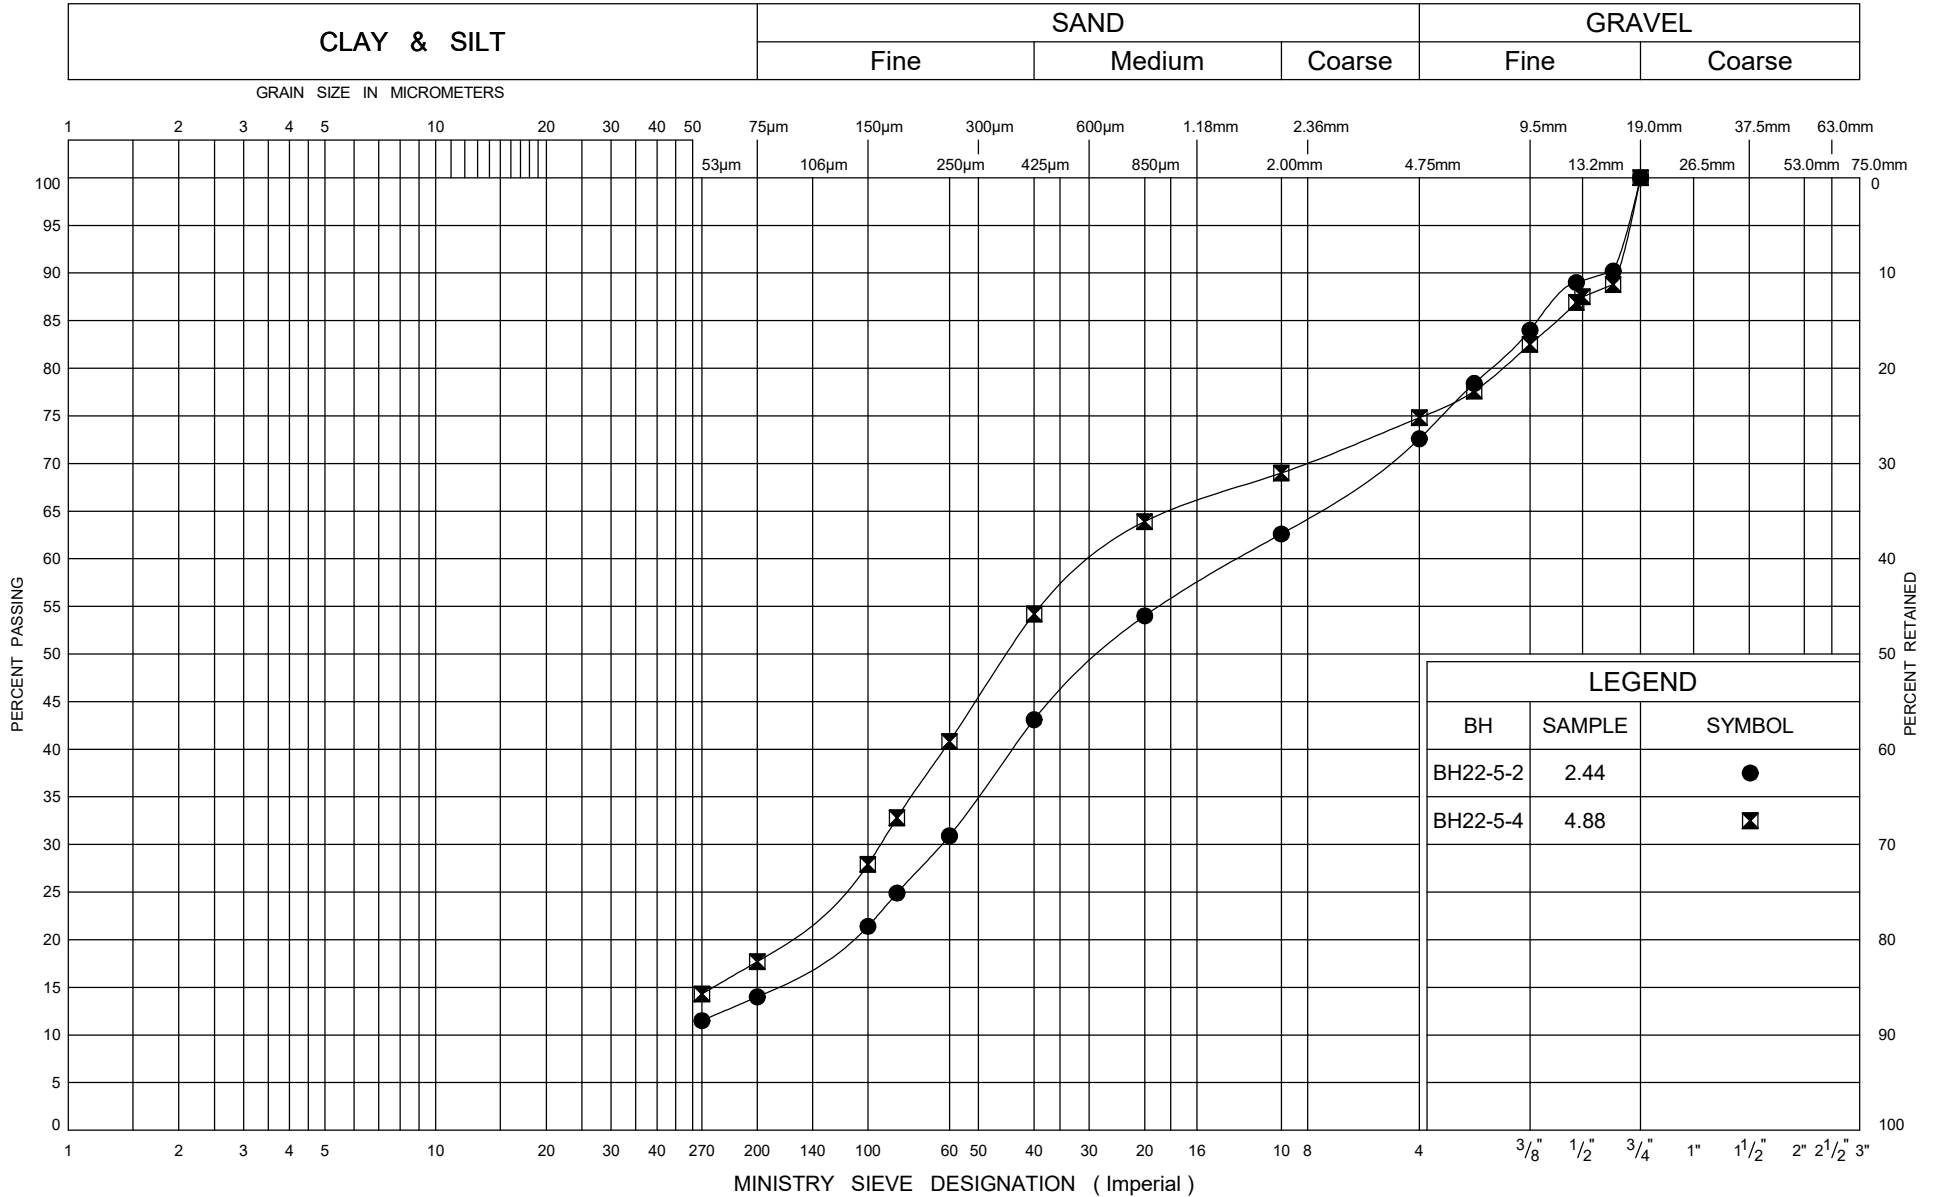
LEGEND		
BH	SAMPLE	SYMBOL
BH22-5-2	2.44	●
BH22-5-4	4.88	⊠

The results of the moisture content and grain size distribution tests performed by EXP are provided on the record of borehole sheets in Appendix D. The results of grain size distribution tests are also provided on Figure 1 in Appendix E.

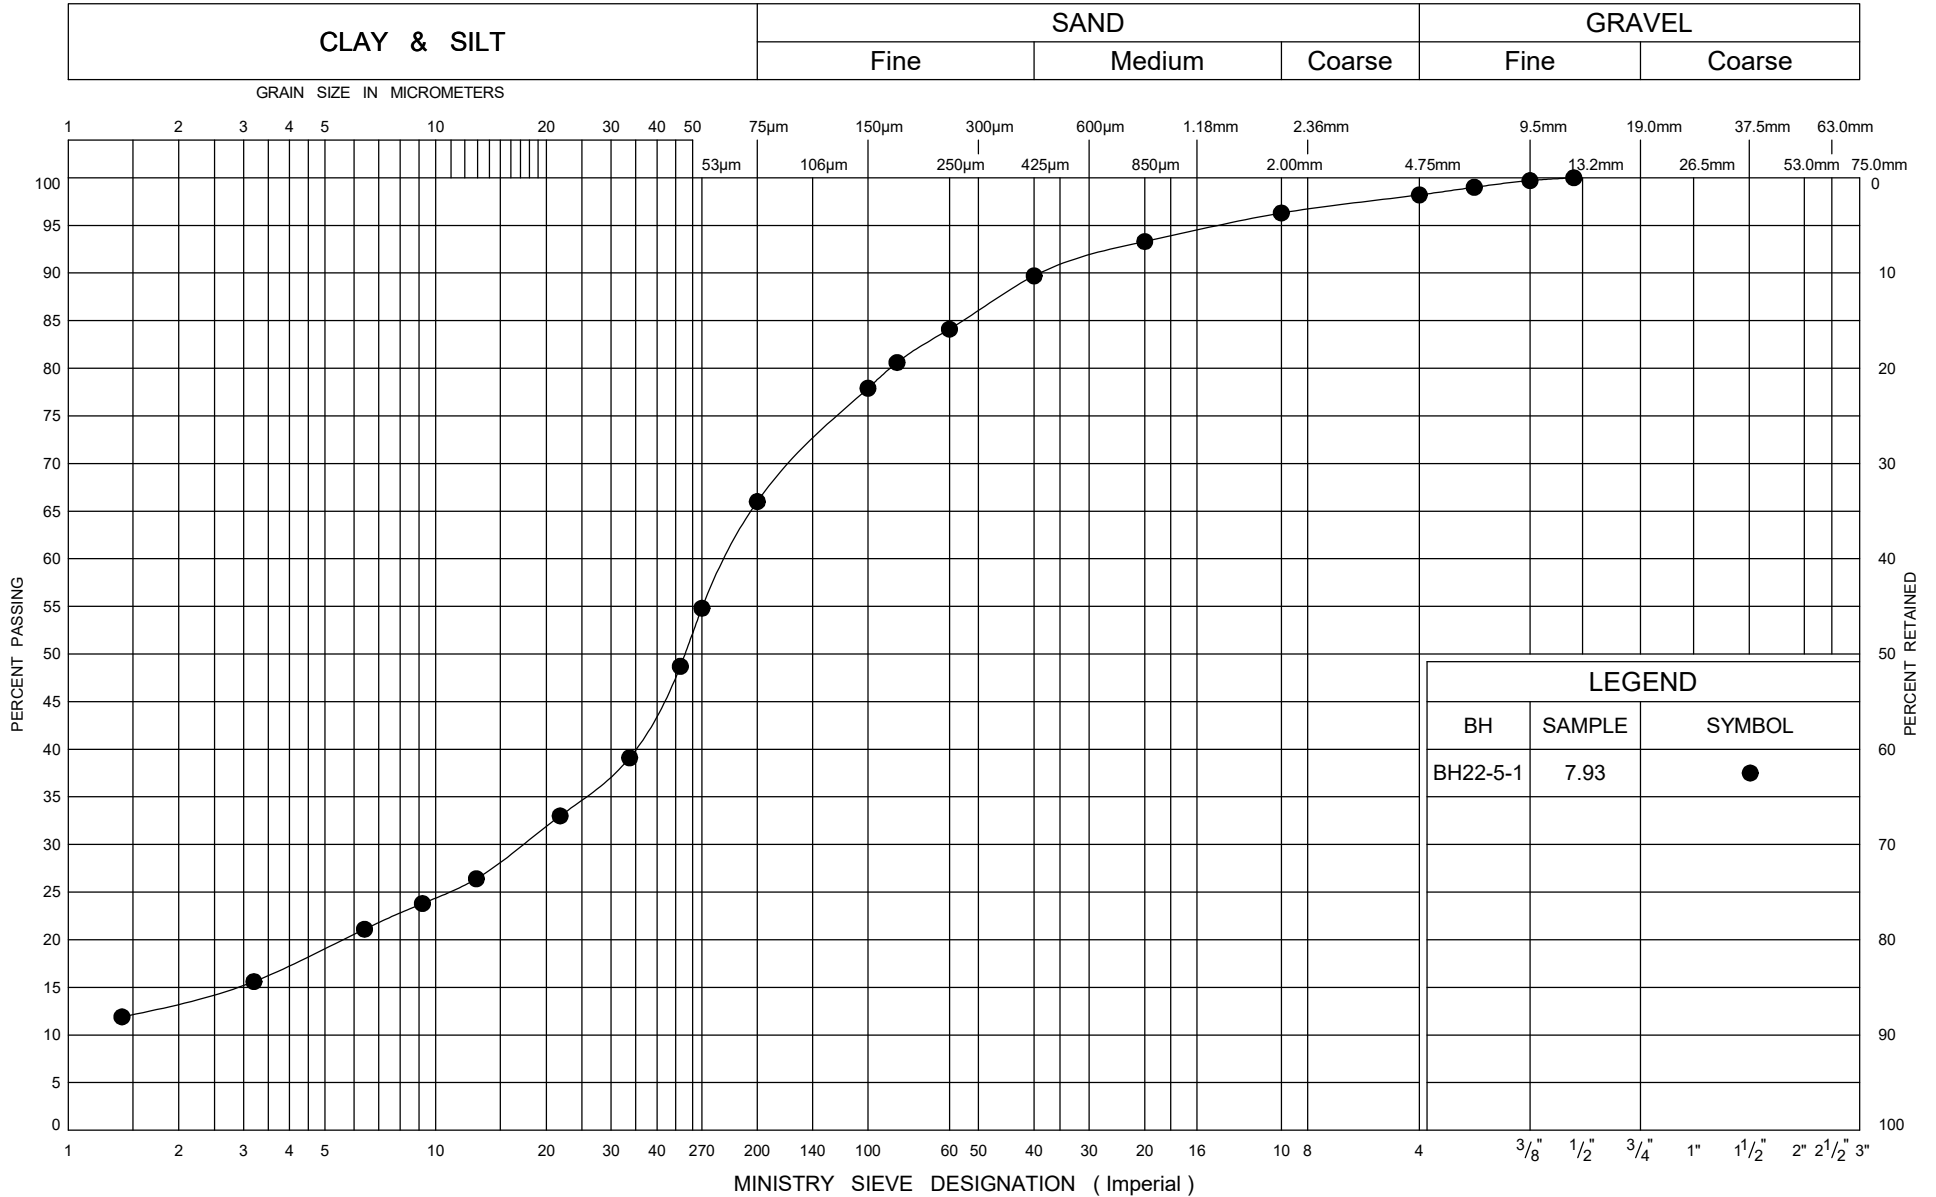
GRAIN SIZE DISTRIBUTION

Cohesive Fill: Clayey Silt

The results of the moisture content, grain size distribution, Atterberg limits and unit weight tests performed by EXP are provided on the record of borehole sheets in Appendix D. The results of grain size distribution and Atterberg limits tests are also provided on Figure 3 and 6 in Appendix E.

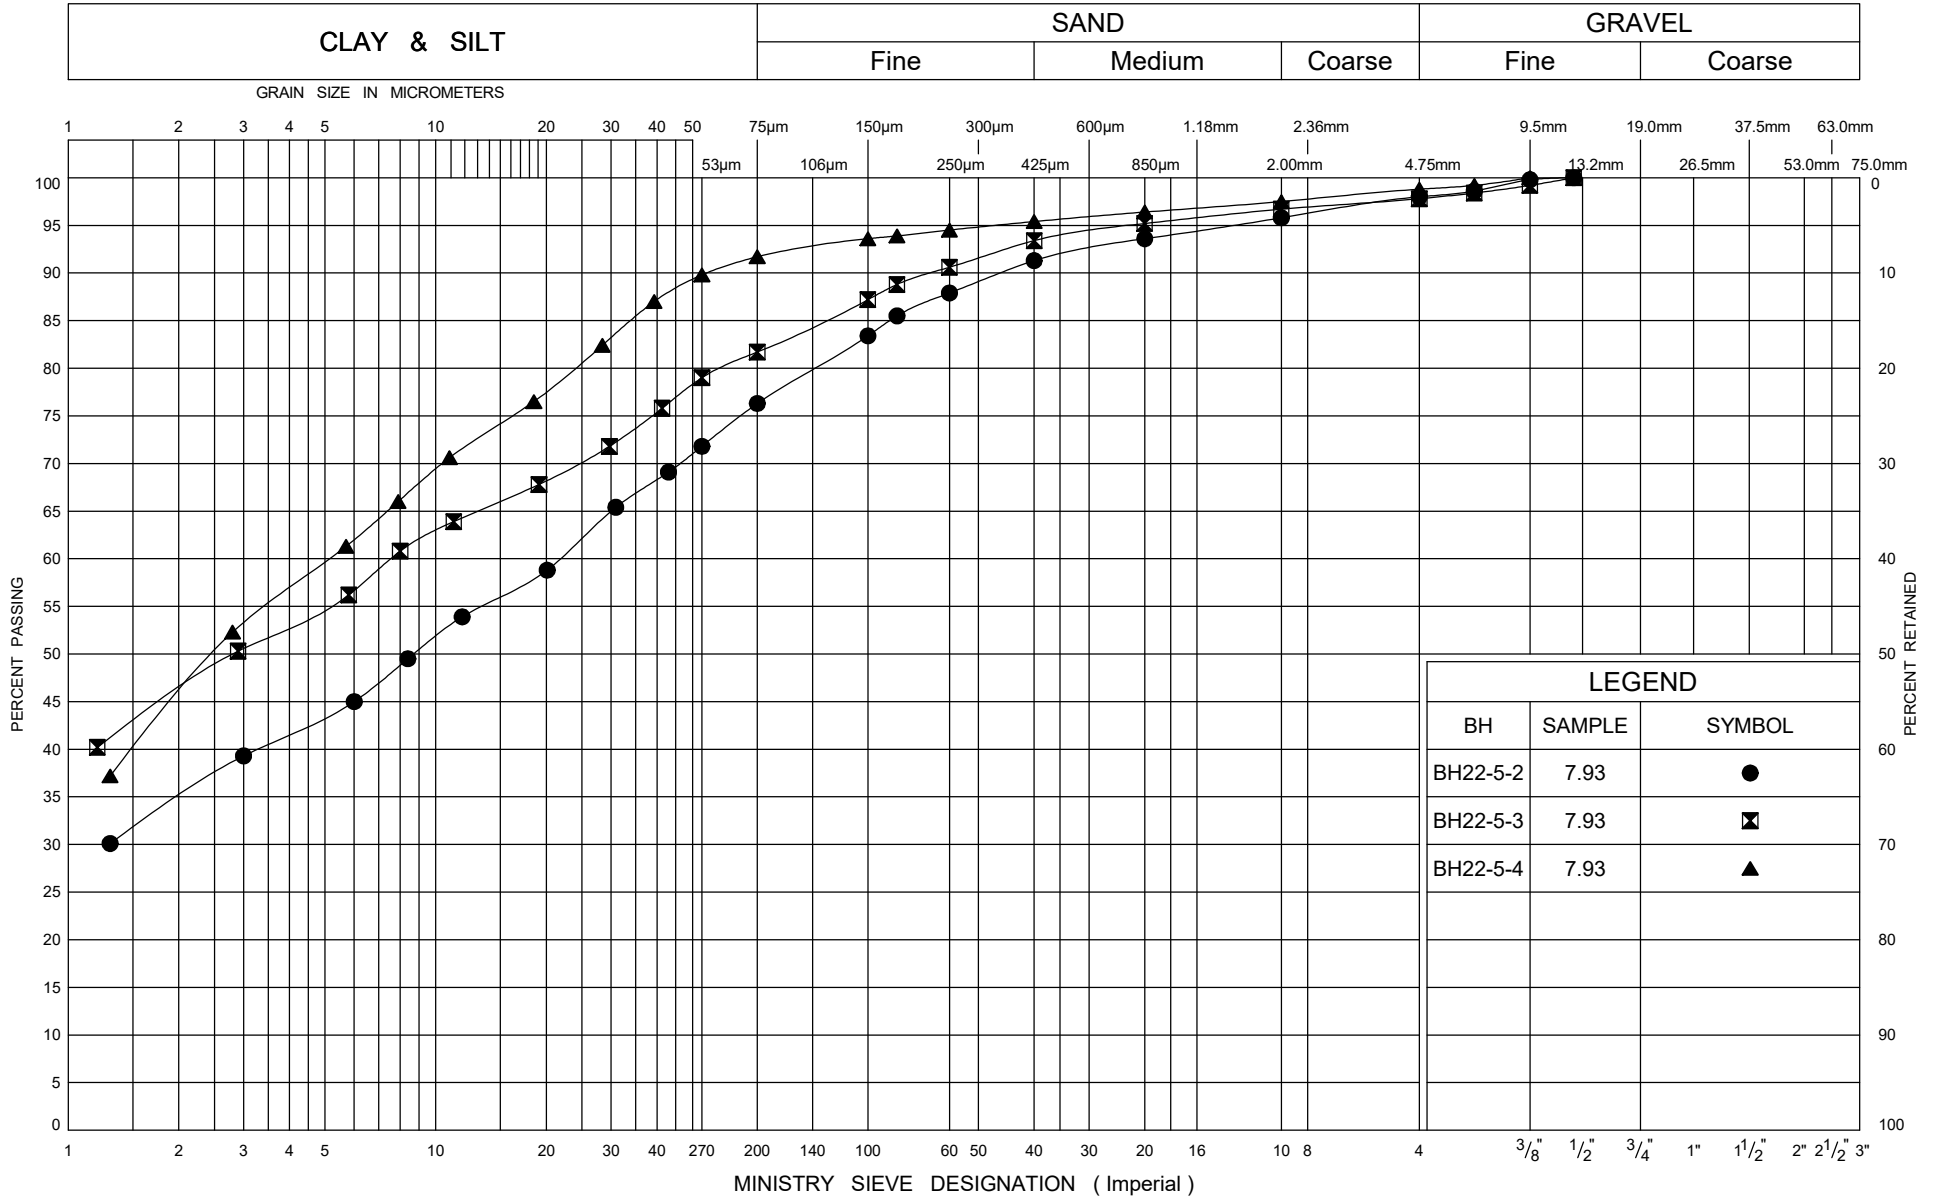
GRAIN SIZE DISTRIBUTION

Silty Clay

The results of the moisture content, grain size distribution, Atterberg limits and unit weight tests performed by EXP are provided on the record of borehole sheets in Appendix D. The results of grain size distribution and Atterberg limits tests are also provided on Figure 4 and 7 in Appendix E.

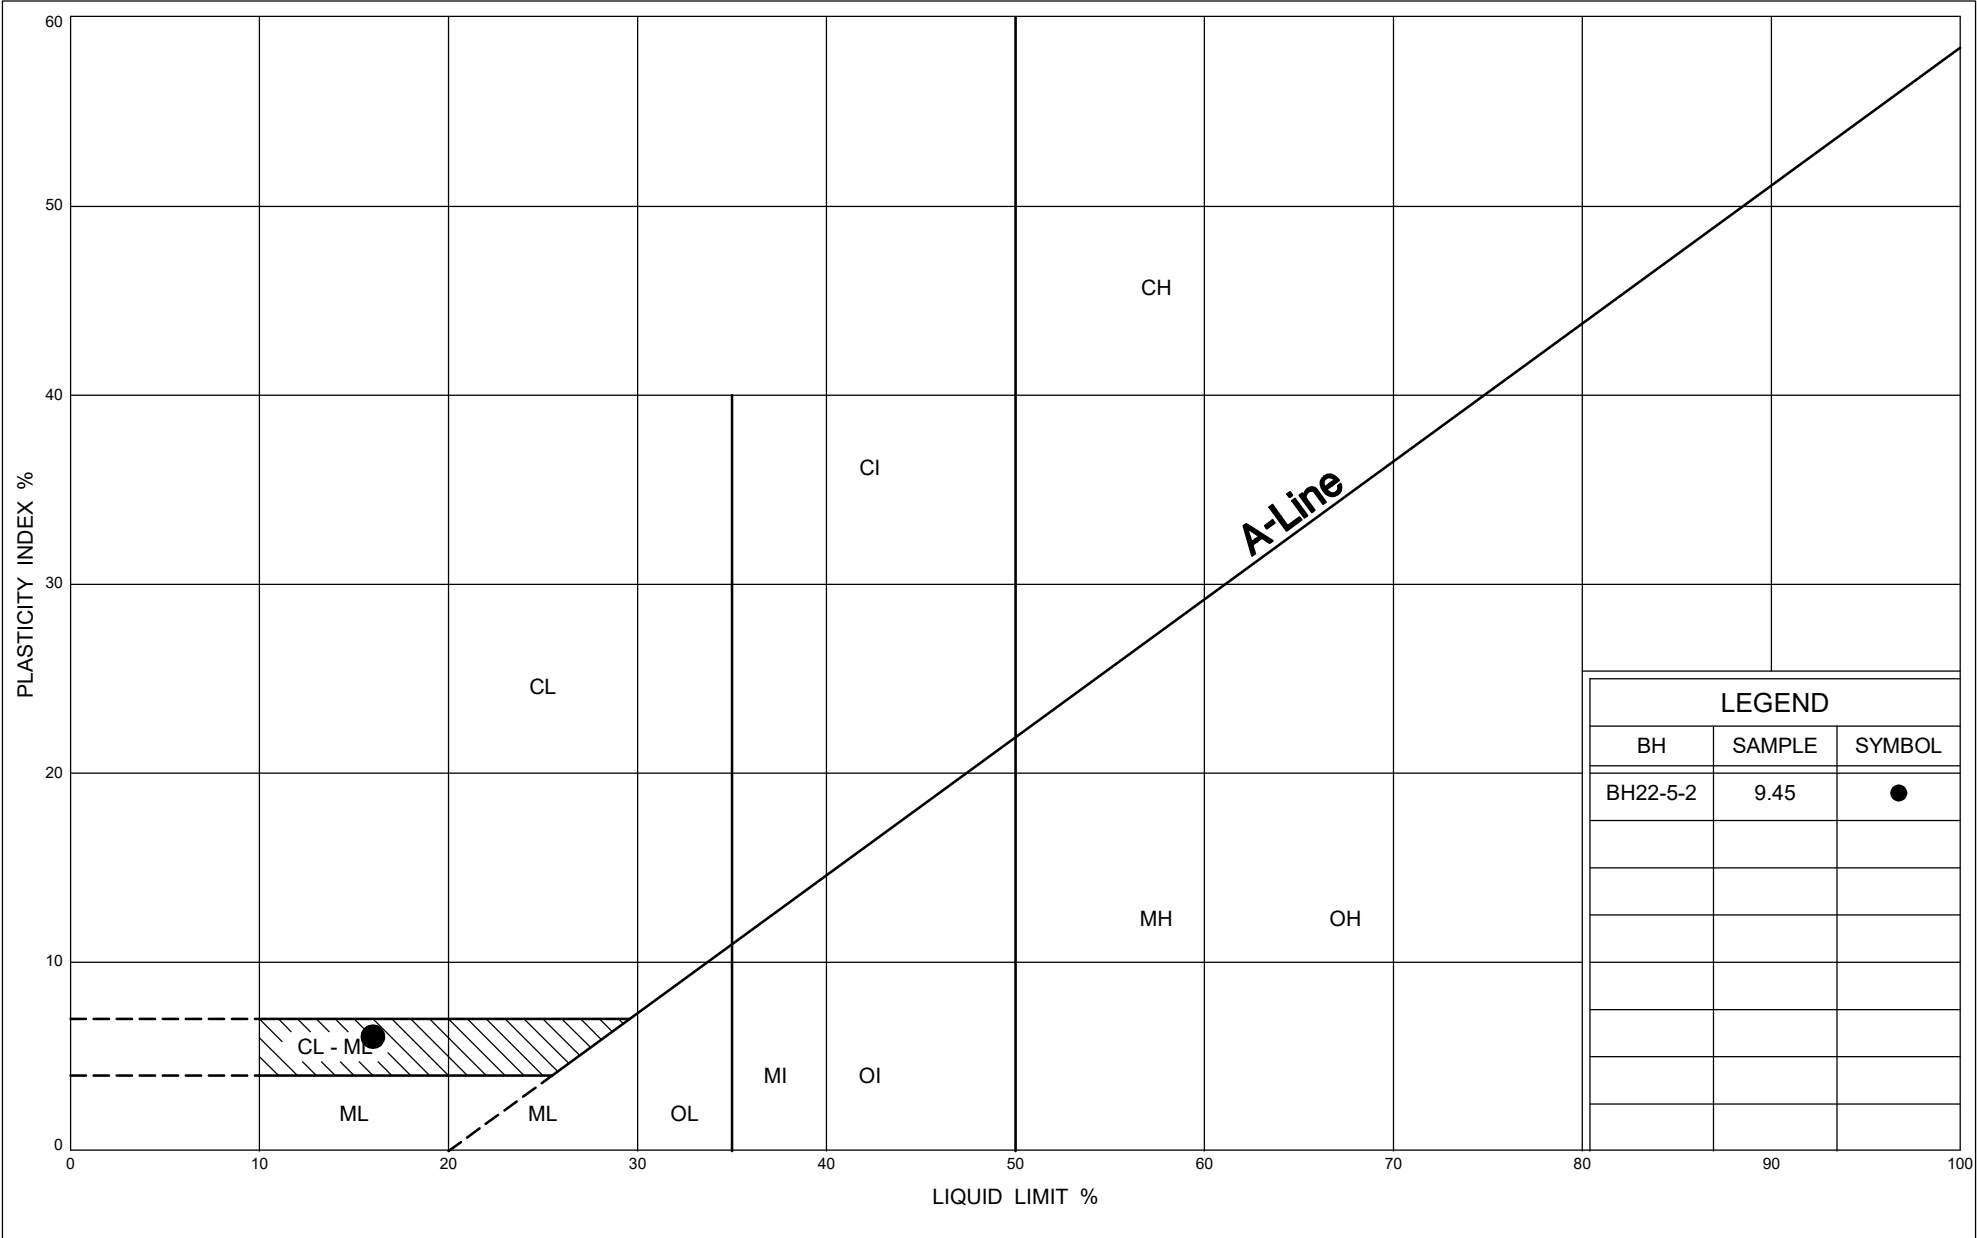
PLASTICITY CHART
