Foundation Investigation and Design Report

Slope Stability Assessment

Langstaff Road Underpass Southeast Embankment

Highway 400 Widening, Langstaff Road to Major Mackenzie Drive

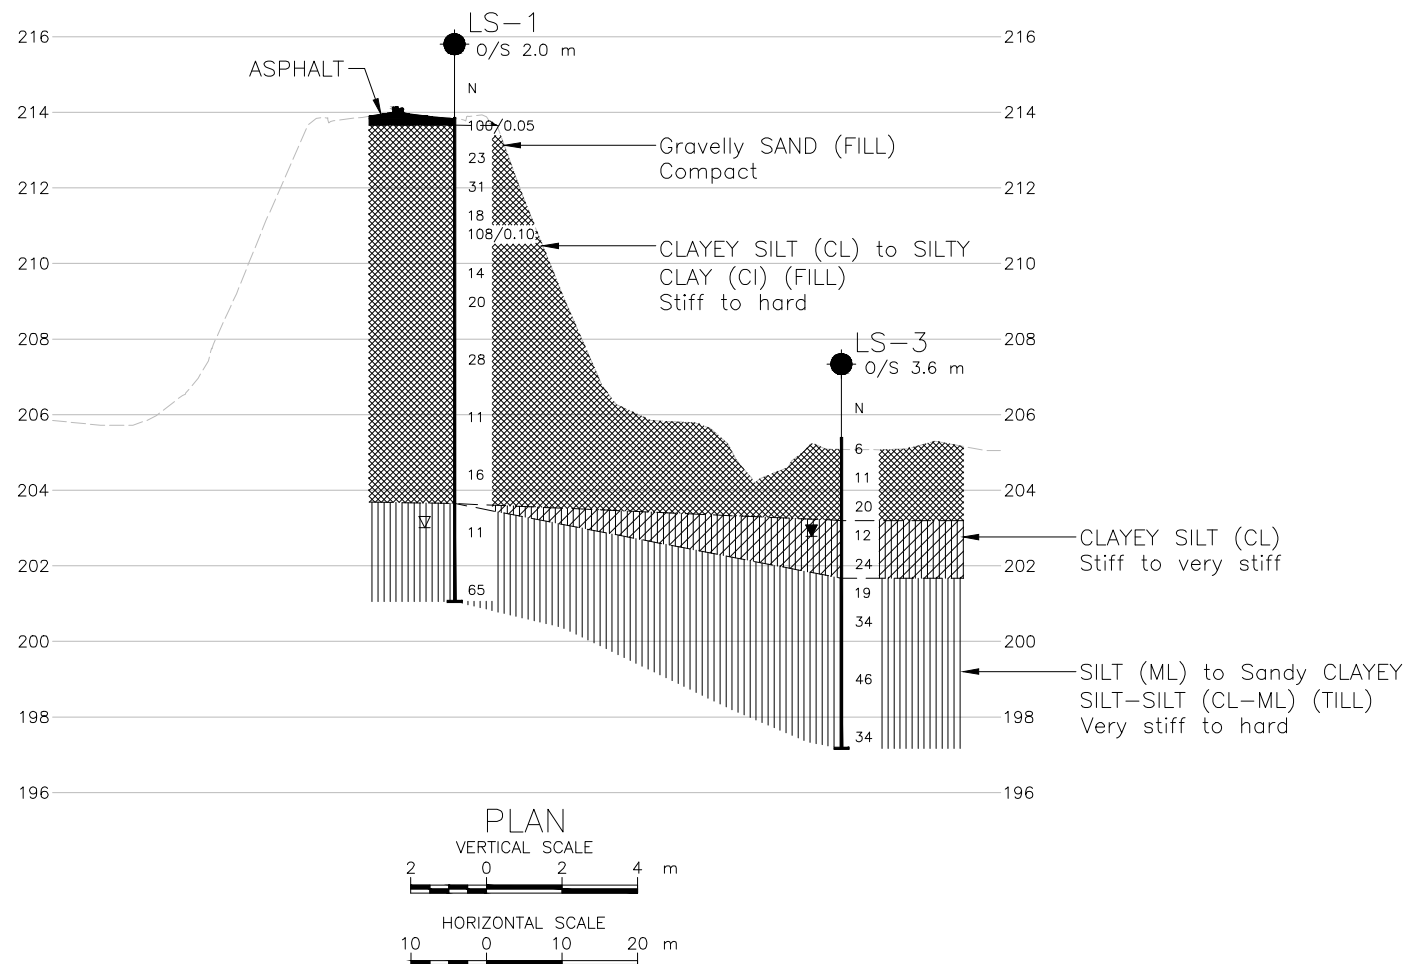
NO.		DATE		BY	
				REVISION	
Geocres No. 30M13-306					
HWY. 400			PROJECT NO. 21490972		DIST. .
SUBM'D. MH		CHKD. MH		DATE: 11/15/2023	SITE:
DRAWN: DD		CHKD. MH		APPD. LCC	DWG. 1

The field work for this subsurface exploration program consisted of three boreholes (designated LS-1, LS-2, and LS-3) advanced in the vicinity of the southeast embankment of the Langstaff Road Underpass. These boreholes were advanced between March 30, 2023, and July 17, 2023, at the approximate locations shown on Drawing 1.

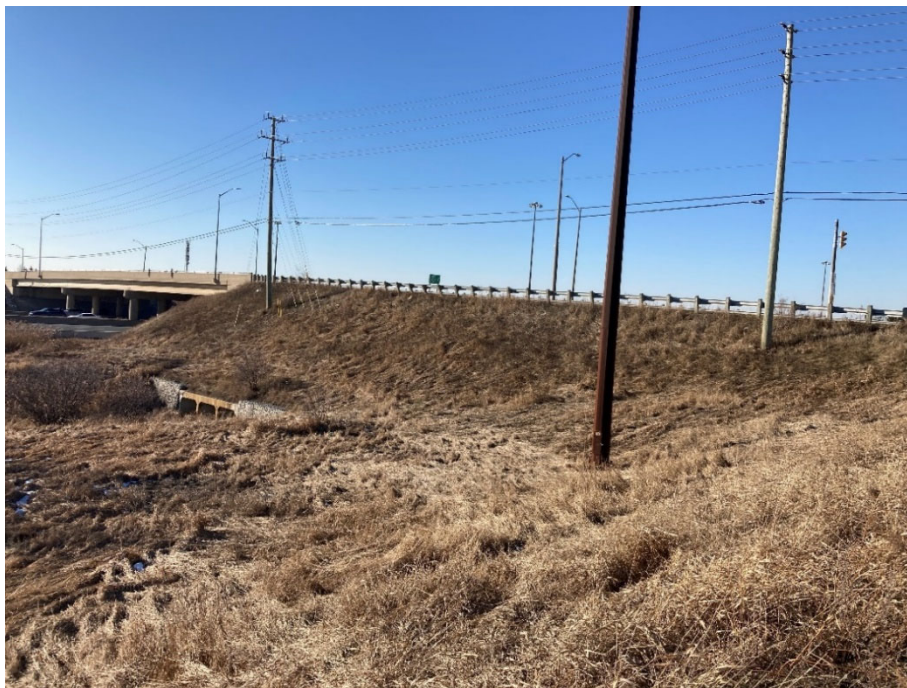
Photograph 1: Looking northwest at existing southeast embankment side slope; note the section of leaning guardrail in the background

Tilting of the existing guardrail posts and settlement along the concrete sidewalk has been identified at the Highway 400/Langstaff Road southeast embankment (see Photograph 2), triggering geotechnical investigation to assess the potential cause of this deformation/settlement and to provide foundation engineering recommendations for remedial works if and as applicable. Apart from the guardrail tilting and settlement of the sidewalk, the embankment side slopes are performing satisfactorily, with no visual signs of global instability (see Photograph 1).

It is recommended that the upper portion of the existing southeast side slope be regraded to an inclination of 2H:1V, new guardrail posts be installed, and the sidewalk be reconstructed. If it is possible to do so (given the proximity of the slope toe to the culvert and watercourse), consideration could also be given to more substantial regrading of the slope so that the guardrail posts are further away from the embankment crest. It is recommended that the fill material used for regrading consist of OPSS.PROV 1010 Granular A, Granular B Type II or SSM as such materials will have a higher effective friction angle than cohesive earth fill materials, and thus will promote surficial embankment stability. However, as the existing embankment fill is cohesive, fill for the regrading could also consist of cohesive earth fill excavated from elsewhere on the contract.

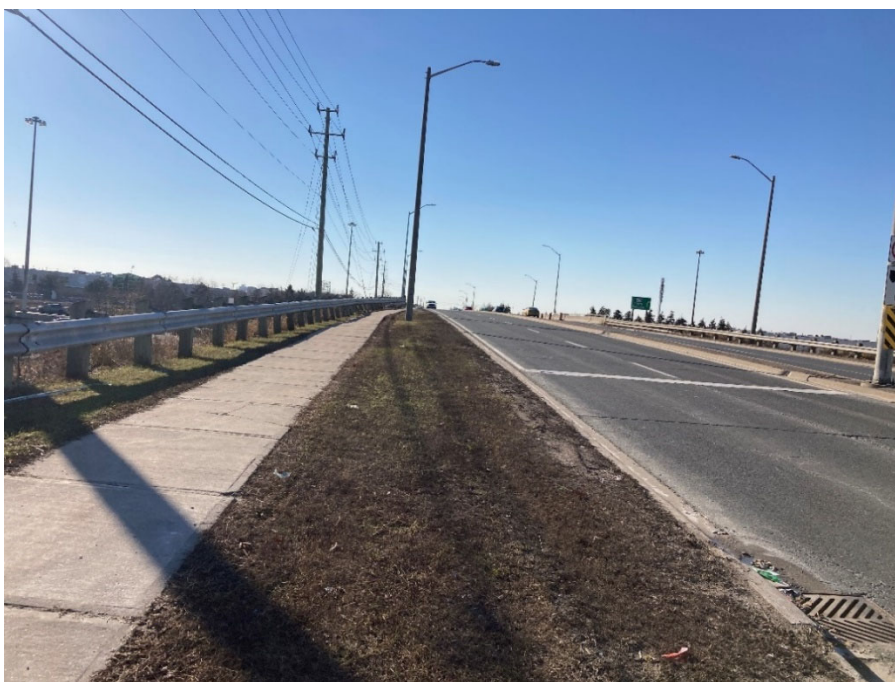
The guardrail along the south side of Langstaff Road in this quadrant is located immediately adjacent to the crest of the embankment slope, and some of the guardrail posts are leaning southward (i.e., downslope). Some limited settlement of the south edge of the sidewalk was also observed. There was no other visual evidence of slope instability, gabion wall instability or loss of ground behind the gabion wall in this quadrant at the time of field investigation. The ground surface conditions in the vicinity of the southeast embankment are shown on Photographs 1 to 3 following the text of this report.

Photograph 2: Looking west at sidewalk along the crest of the southeast embankment; note the section of leaning guardrail in the background

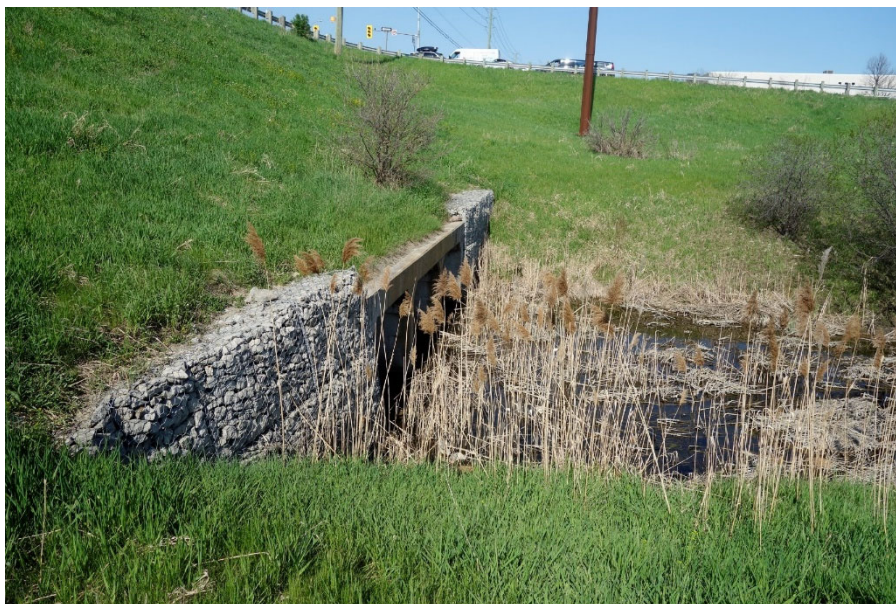
Photograph 3: Looking east towards gabion walls at Black Creek Triple Cell Culvert outlet (photograph taken at the toe of the southeast embankment)

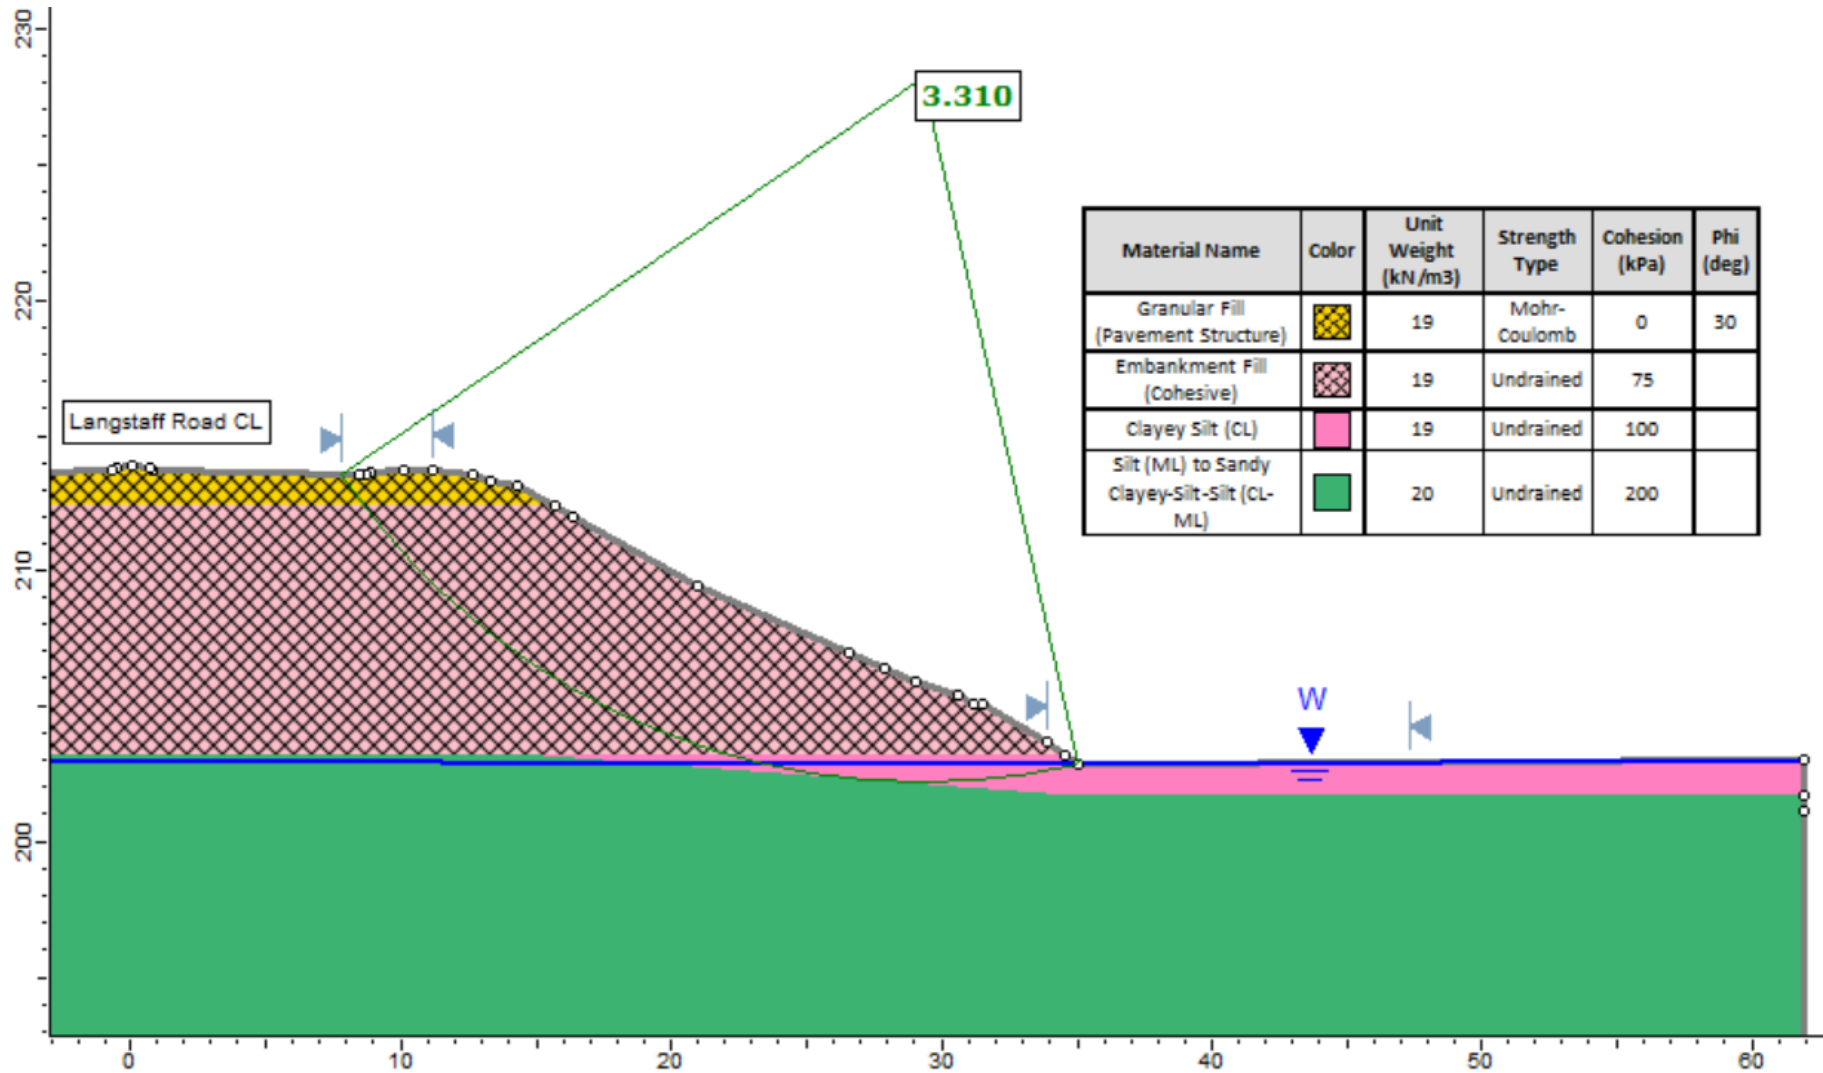
Figure 1 Global Stability Analysis Results – Existing Conditions (Short-Term, Undrained)

The analyses yielded a FoS of about 3.3 in the short-term (undrained) condition and a FoS of about 1.55 in the long-term (drained) condition for the existing southeast embankment side slope. Based on the existing embankment geometry and encountered subsurface conditions, with consideration of the observed embankment performance, these calculated FoS values demonstrate that global instability is not an issue for this site and has not contributed to settlement of the sidewalk or tilting of the guardrail.

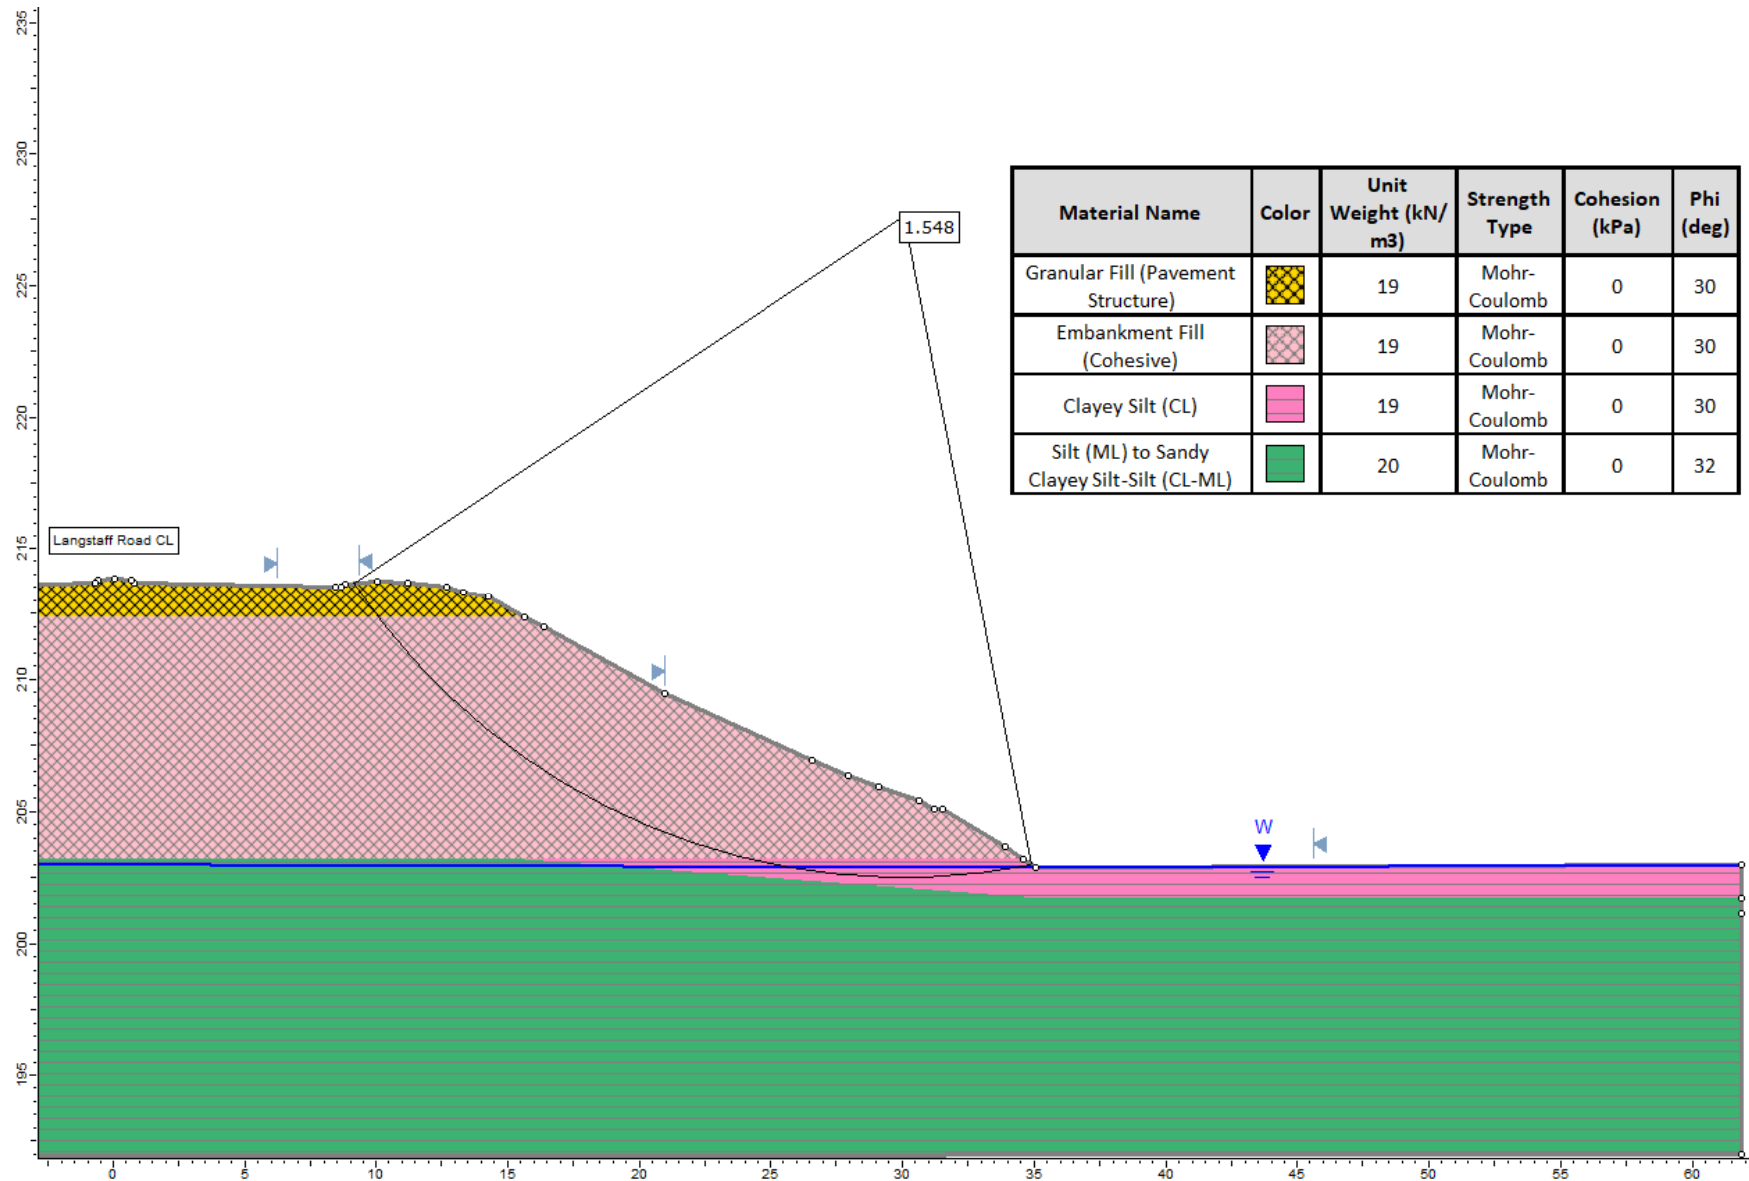
Figure 2 Global Stability Analysis Results – Existing Conditions (Long-Term, Drained)

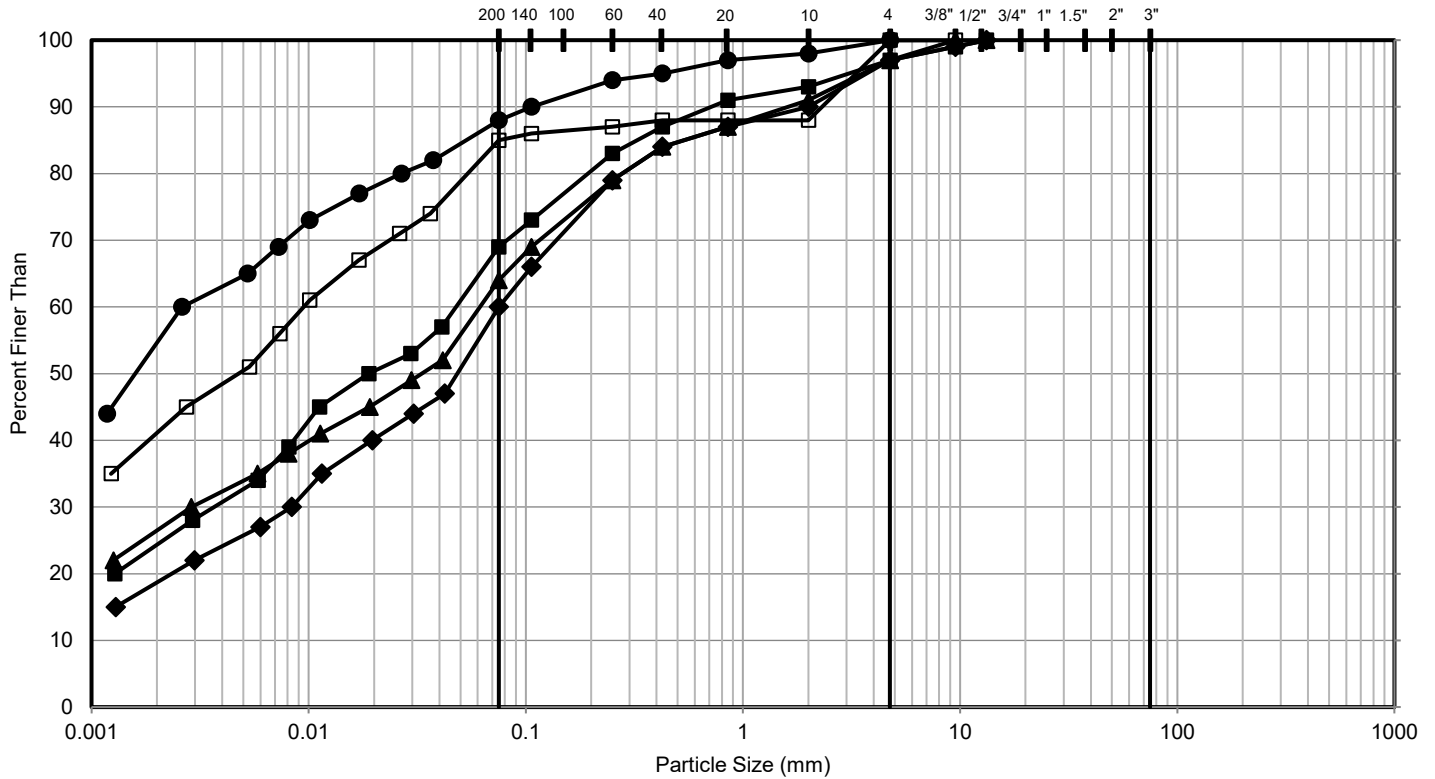
GRAIN SIZE DISTRIBUTION

Figure B1 Grain Size Distribution – CLAYEY SILT (CL) to SILTY CLAY (CI) (FILL)

Symbol	Sample Location	Sample Number	Depth (m)	Elevation (m)
■	LS-1	4	2.3 - 2.9	211.6 to 211.0
◆	LS-2	3	1.5 - 2.1	211.7 to 211.1
▲	LS-2	8	6.1 - 6.7	207.2 to 206.6
●	LS-2	10	9.1 - 9.8	204.1 to 203.5
□	LS-3	2	0.8 - 1.4	204.6 to 204.0

Grain size distribution testing was carried out on five samples of the cohesive fill and the results are presented on Figure B1 in Appendix B. Atterberg limit testing was carried out on five samples of the cohesive fill and the results are presented on a plasticity chart in Figure B2 in Appendix B. The Atterberg limits tests measured liquid limits ranging from about 24% to 46%, plastic limits ranging from about 13% to 19%, and plasticity indices ranging from about 11% to 27%. The Atterberg limits tests generally indicate a clayey silt to silty clay of low to medium plasticity. The water content measured on samples of the cohesive fill ranges from about 11% to 22%, generally near the plastic limit of the material.

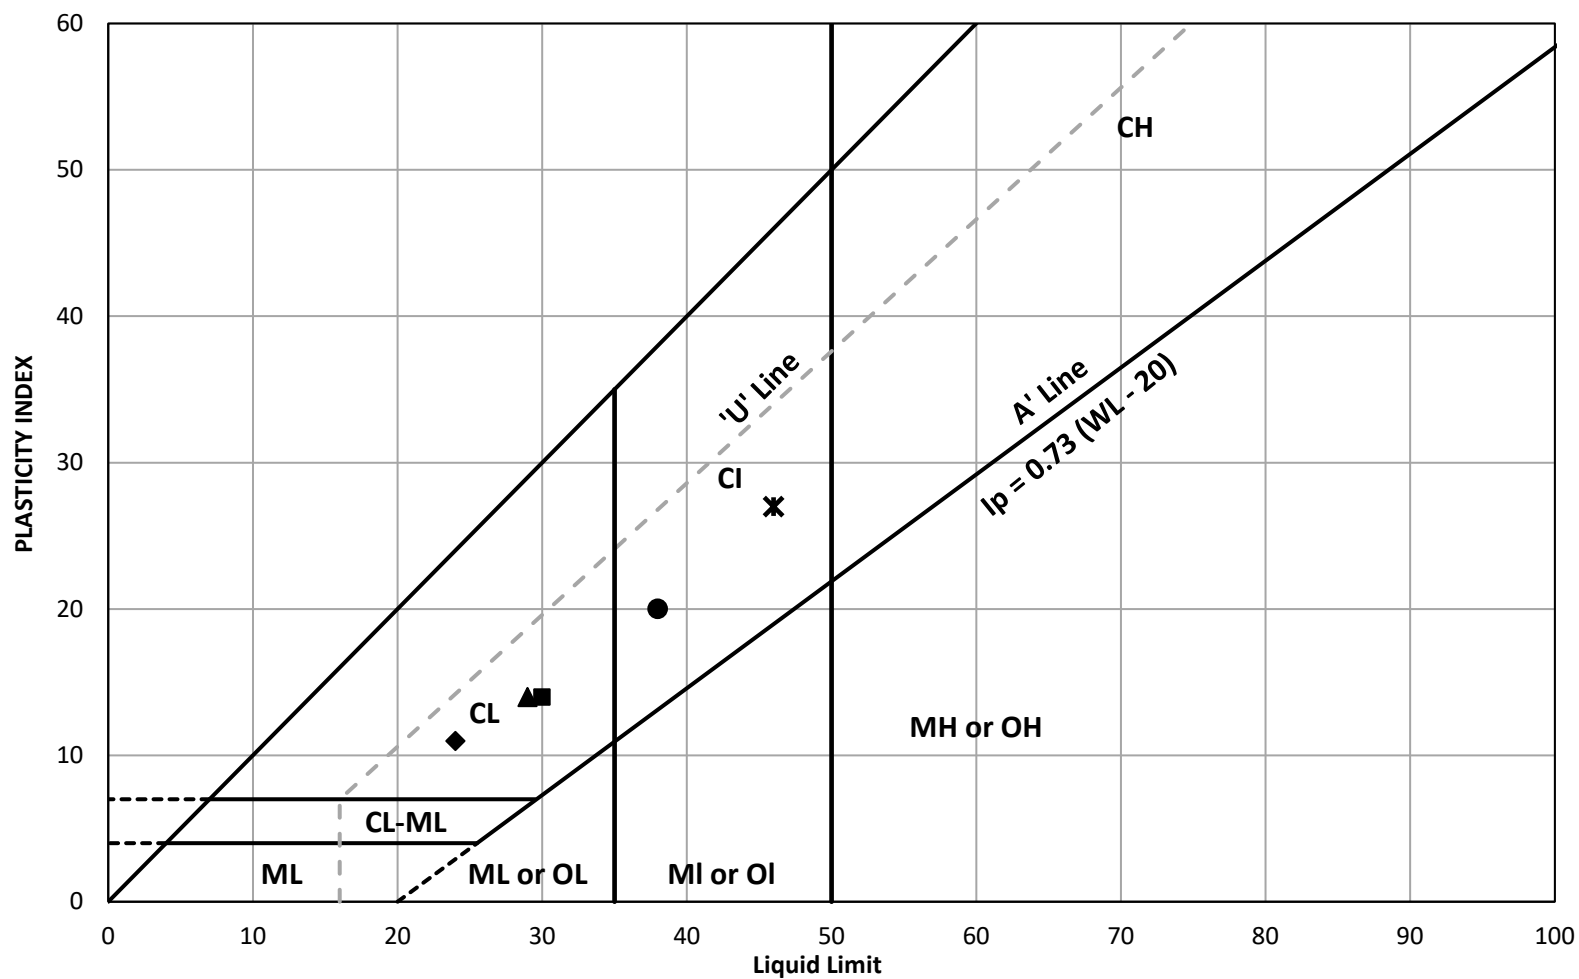
PROJECT			
LANGSTAFF ROAD SOUTHEAST EMBANKMENT HIGHWAY 400 WIDENING, GWP 2836-02-00			
TITLE			
PLASTICITY CHART CLAYEY SILT (CL) to SILT CLAY (CI) (FILL)			
PROJECT NO.	CONTROL	REV.	FIGURE
21490972	0	0	B2

Sample Location	Sample / Specimen Number	Depth (m)	Natural Water Content (%)	Liquid Limit	Plastic Limit	Plasticity Index	
■	LS-1	4	2.3 - 2.9	18.3	30	16	14	
◆	LS-2	3	1.5 - 2.1	11.3	24	13	11	
▲	LS-2	8	6.1 - 6.7	16.1	29	15	14	
●	LS-2	10	9.1 - 9.8	21.6	38	18	20	
*	LS-3	2	0.8 - 1.4	-	46	19	27

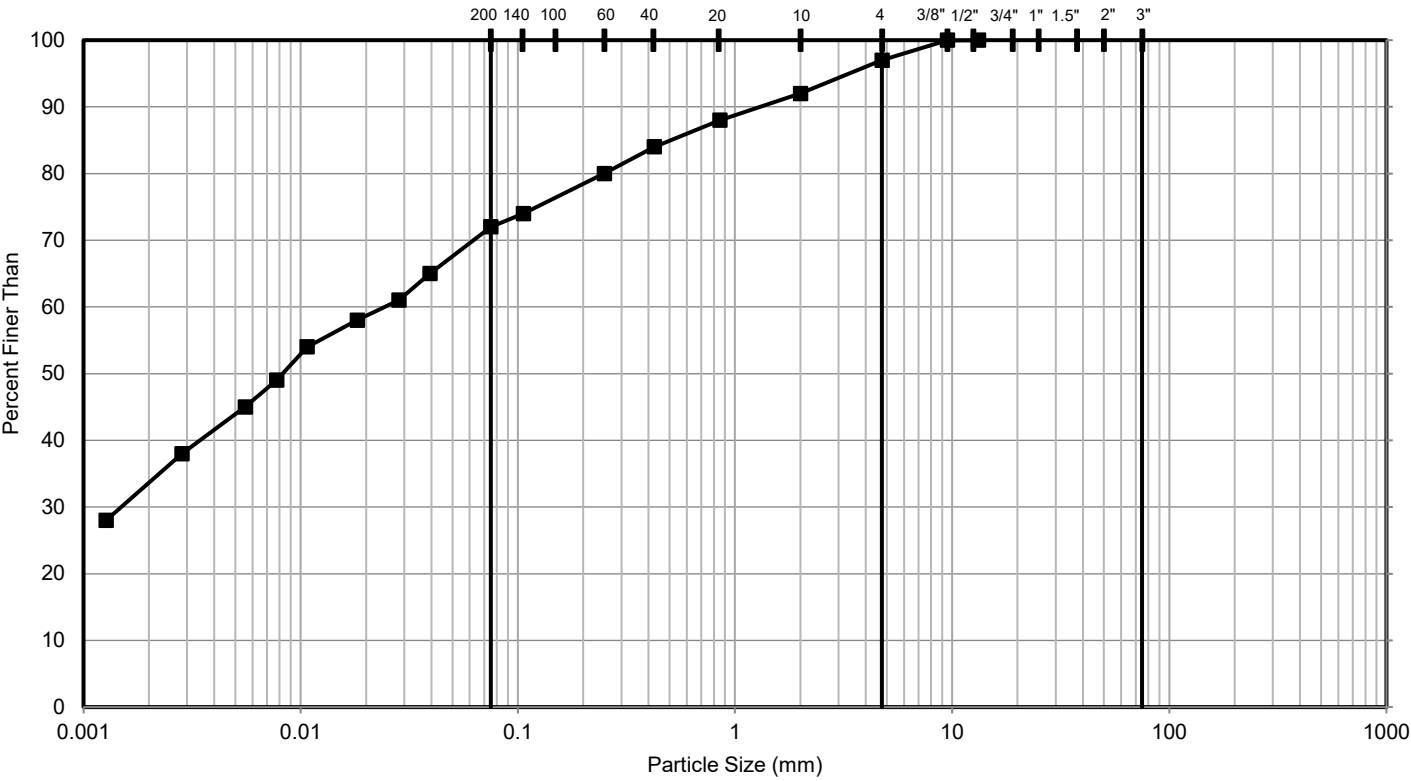
GRAIN SIZE DISTRIBUTION

Figure B3 Grain Size Distribution – CLAYEY SILT (CL)

Symbol	Sample Location	Sample Number	Depth (m)	Elevation (m)
■	LS-3	4	2.3 - 2.9	203.1 to 202.5

Grain size distribution testing was carried out on a sample of the cohesive deposit and the results are presented on Figure B3 in Appendix B. Atterberg limit testing was carried out on a sample of the cohesive deposit and the results

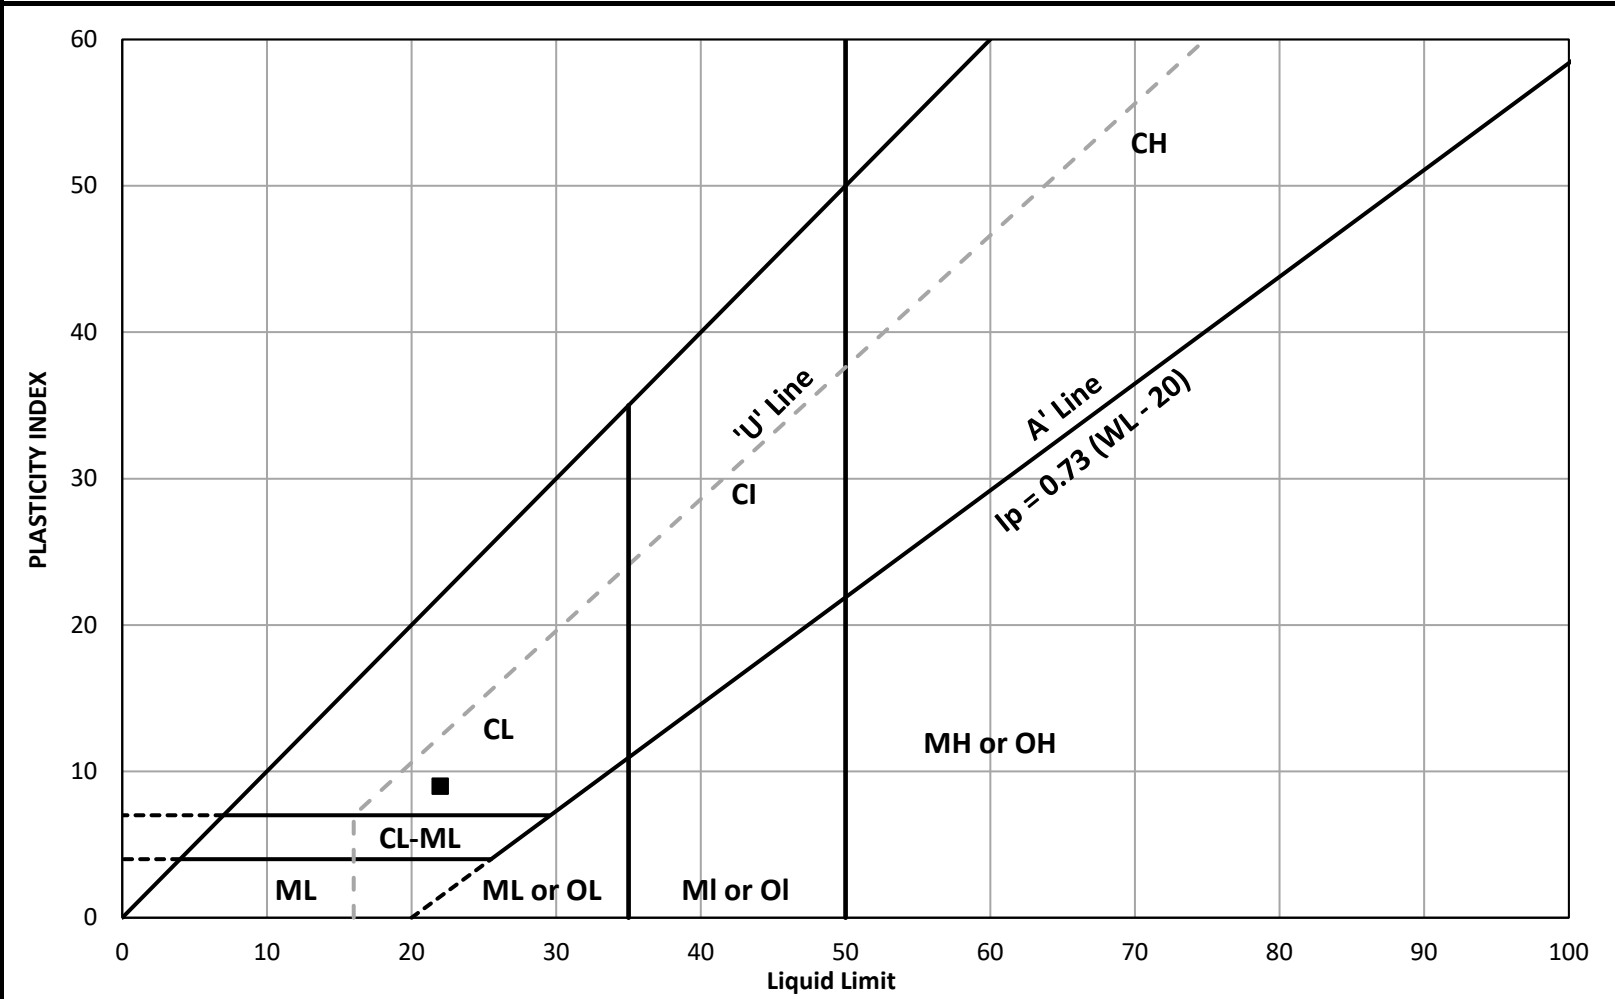
PROJECT			
LANGSTAFF ROAD SOUTHEAST EMBANKMENT HIGHWAY 400 WIDENING, GWP 2836-02-00			
TITLE			
PLASTICITY CHART CLAYEY SILT (CL)			
PROJECT NO.	CONTROL	REV.	FIGURE
21490972	0	0	B4

Sample Location	Sample / Specimen Number	Depth (m)	Natural Water Content (%)	Liquid Limit	Plastic Limit	Plasticity Index	
■	LS-3	4	2.3 - 2.9	-	22	13	9

are presented on Figure B4 in Appendix B. The Atterberg limits test measured a liquid limit of about 22%, a plastic limit of about 13% and a corresponding plasticity index of about 9%. The Atterberg limits test generally indicates a clayey silt of low plasticity.

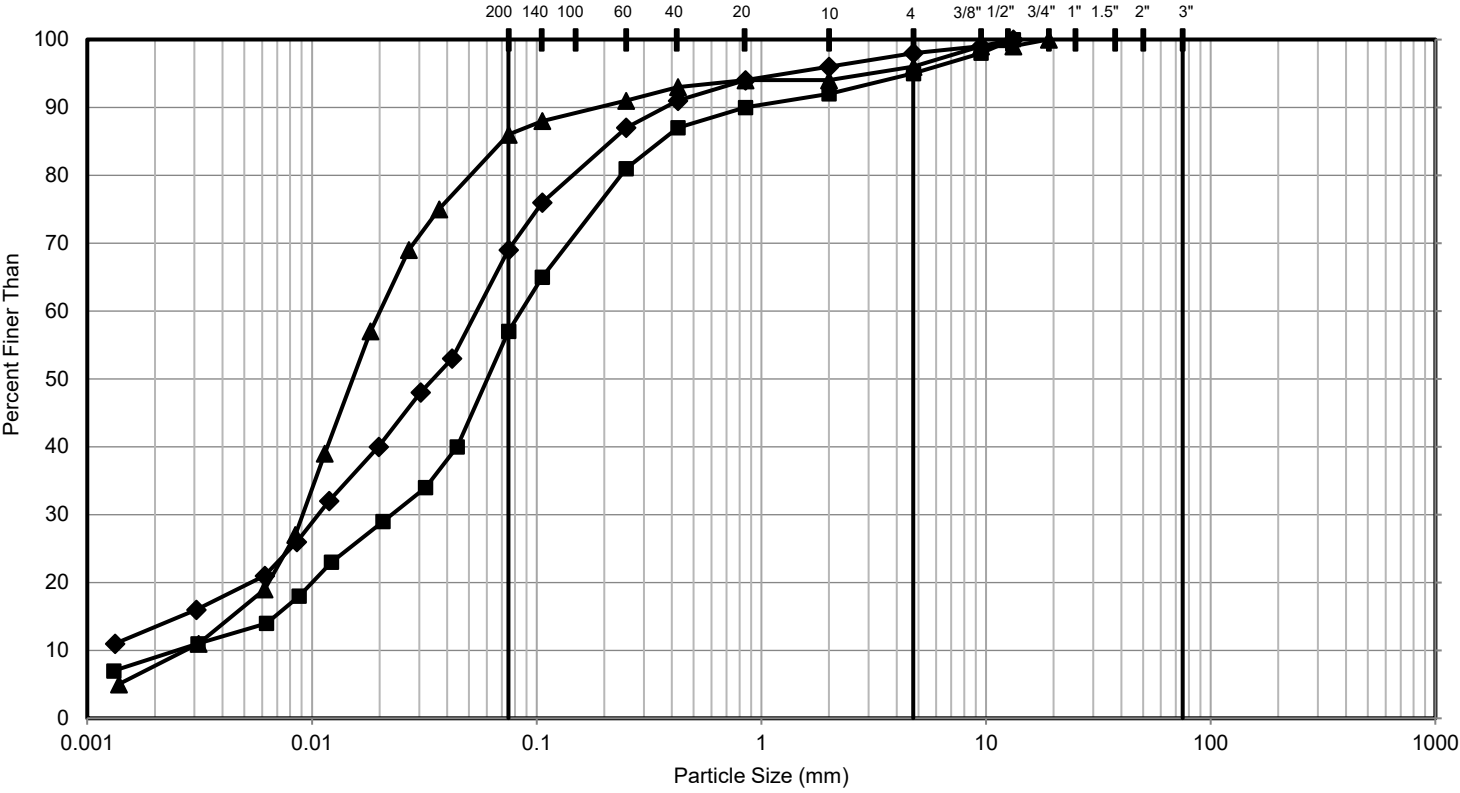
GRAIN SIZE DISTRIBUTION

Figure B5 Grain Size Distribution – SILT (ML) to CLAYEY SILT-SILT (CL-ML)

Symbol	Sample Location	Sample Number	Depth (m)	Elevation (m)
■	LS-1	11	10.7 - 11.3	203.2 to 202.6
◆	LS-1	12	12.2 - 12.8	201.7 to 201.1
▲	LS-3	8	6.1 - 6.7	199.3 to 198.7

Grain size distribution testing was carried out on three samples of the glacial till and the results are presented on Figure B5 in Appendix B. Atterberg limit testing was carried out on three samples of the glacial till and the results are presented on a plasticity chart in Figure B6 in Appendix B. The Atterberg limits tests measured liquid limits ranging from about 14% to 22%, plastic limits ranging from about 11% to 18%, and plasticity indices ranging from about 3% to 4%. The Atterberg limits tests generally indicate a silt to clayey silt-silt of slight to low plasticity. The water content measured on samples of the till ranges from about 7% to 13%, slightly below the plastic limit of the material.

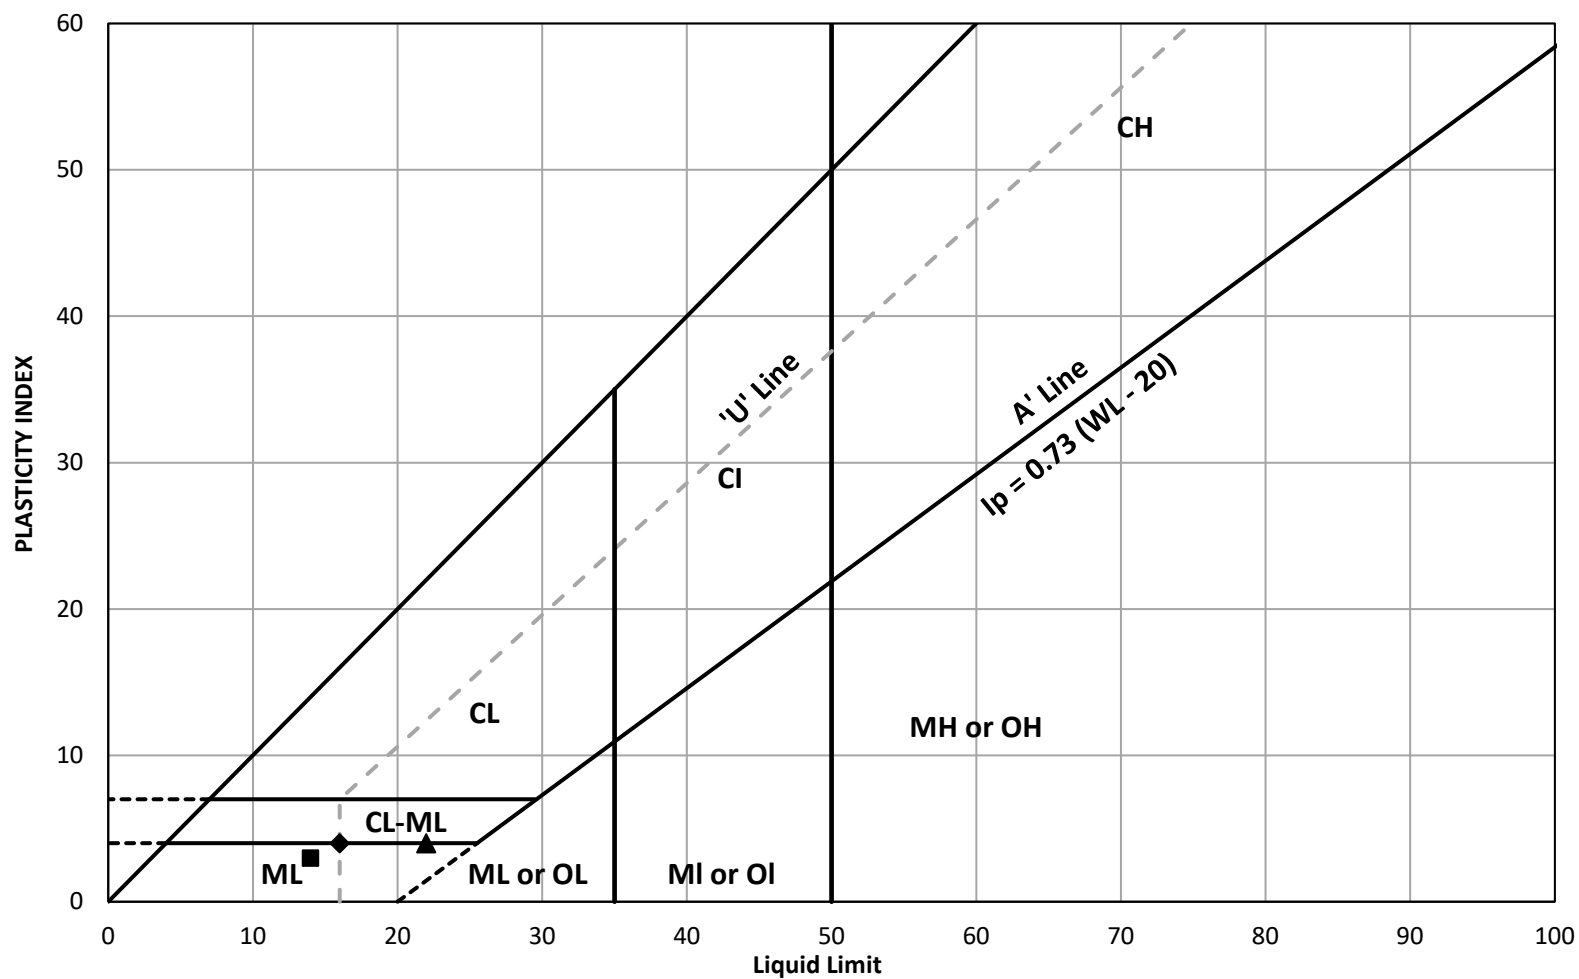
PLASTICITY CHART

Figure B6 Plasticity Chart – SILT (ML) to CLAYEY SILT-SILT (CL-ML)

Sample Location	Sample / Specimen Number	Depth (m)	Natural Water Content (%)	Liquid Limit	Plastic Limit	Plasticity Index	
■	LS-1	11	10.7 - 11.3	6.6	14	11	3	
◆	LS-1	12	12.2 - 12.8	9.7	16	12	4	
▲	LS-3	8	6.1 - 6.7	-	22	18	4
