THURBER ENGINEERING LTD.

MEMORANDUM

**HIGHWAY 404 S-E/W OFF RAMP
TO BLOOMINGTON ROAD
HIGHWAY 404 REHABILITATION
STOUFFVILLE ROAD TO MULOCK DRIVE
REGIONAL MUNICIPALITY OF YORK, ONTARIO
G.W.P. 2459-16-00 & 2461-16-00**

GEOCRES No. 30M14-519

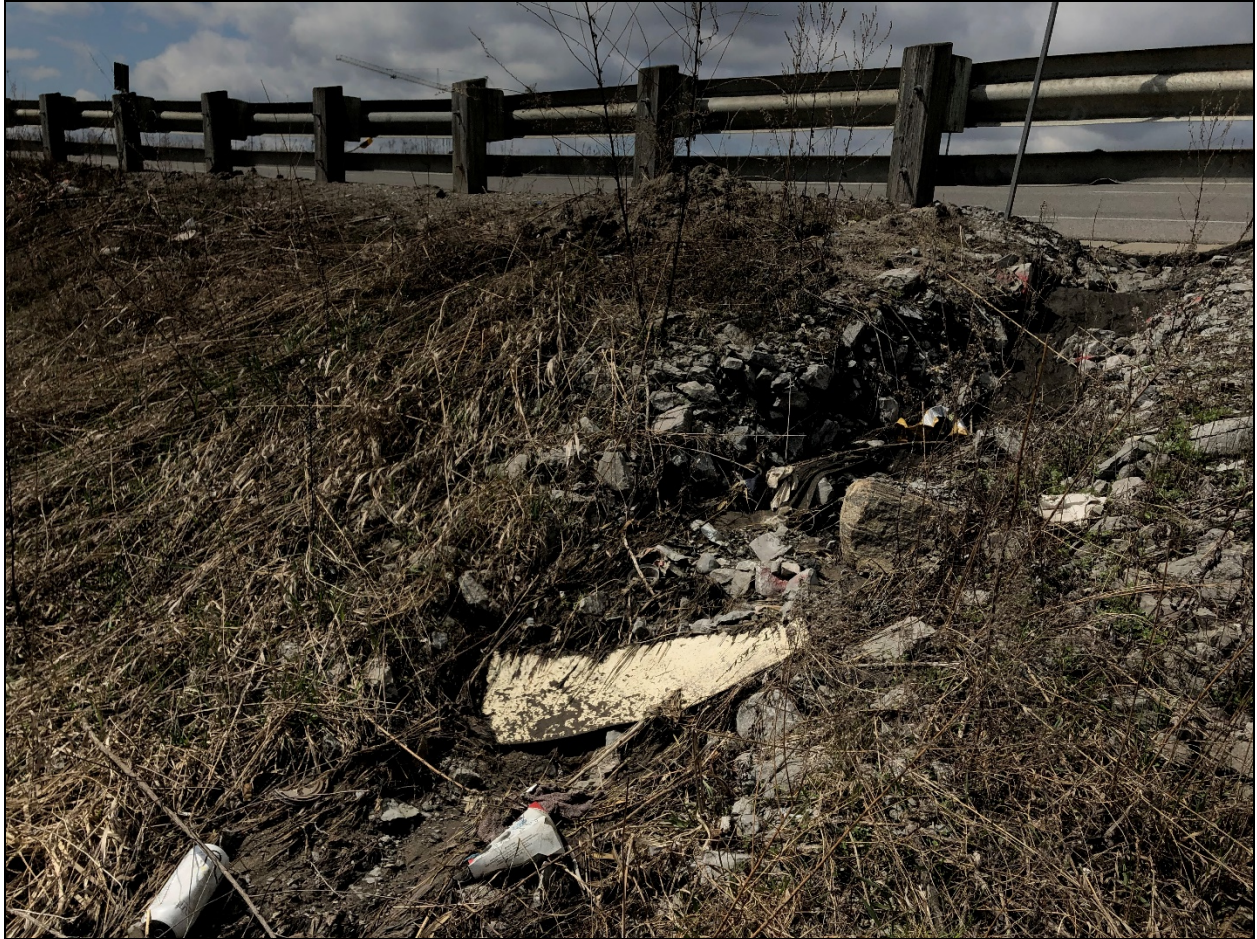
Photo 1- East side of the S-E/W Ramp
Modified swale at the of the curb. Fill observed at the top of the slope.

- The notch at the curb, which has apparently resulted in the gully immediately below it, should be filled. The gully and other surficial distress should be repaired and the original slope grade of 2.5H : 1V or flatter should be re-established to match adjacent slopes. Sloughed materials should be removed and the embankment slope be reinstated. New granular fill (Granular B Type II, as per OPSS.PROV 1010) should be placed on the slope from the toe upwards and keyed into the slope via a series of earth benches on the slope face. Permanent slope surfaces should be vegetated and seeded in accordance with current MTO practice with reference to OPSS.PROV 804. Remedial measures such as re-vegetation and/or placement of gravel sheeting may be required at some locations to minimize the potential of further erosion.

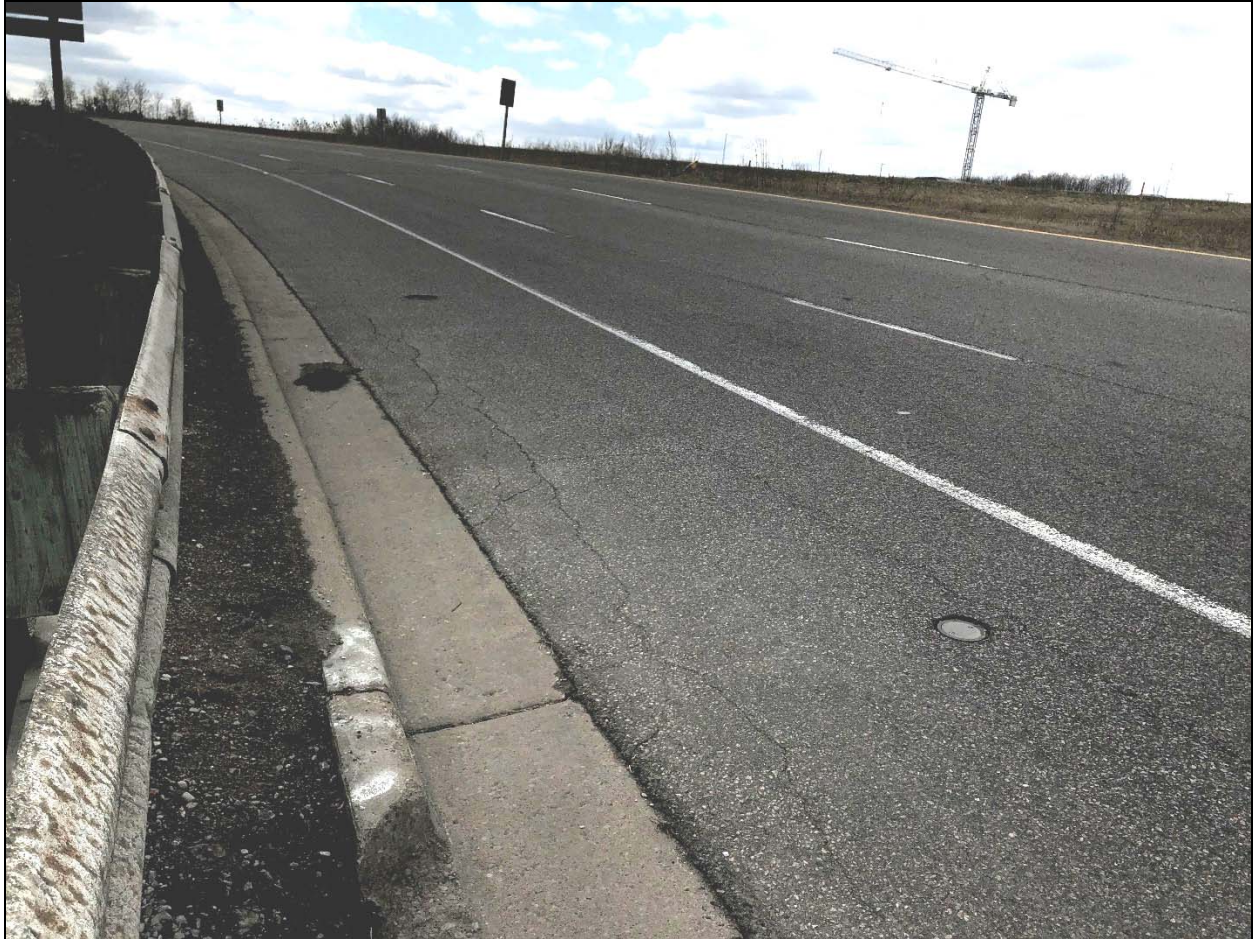
- About 8 m to the north of the mid-slope instability, a cut has been made at the curb presumably to allow water to flow down the slope; as a result, a gully has been formed on the slope immediately below this cut.
- There was no visible sign of asphalt patching and resurfacing in the vicinity of this location at the time of the site visits.

Photo 2- East side of the S-E/W Ramp
Looking southwest at the modified swale location

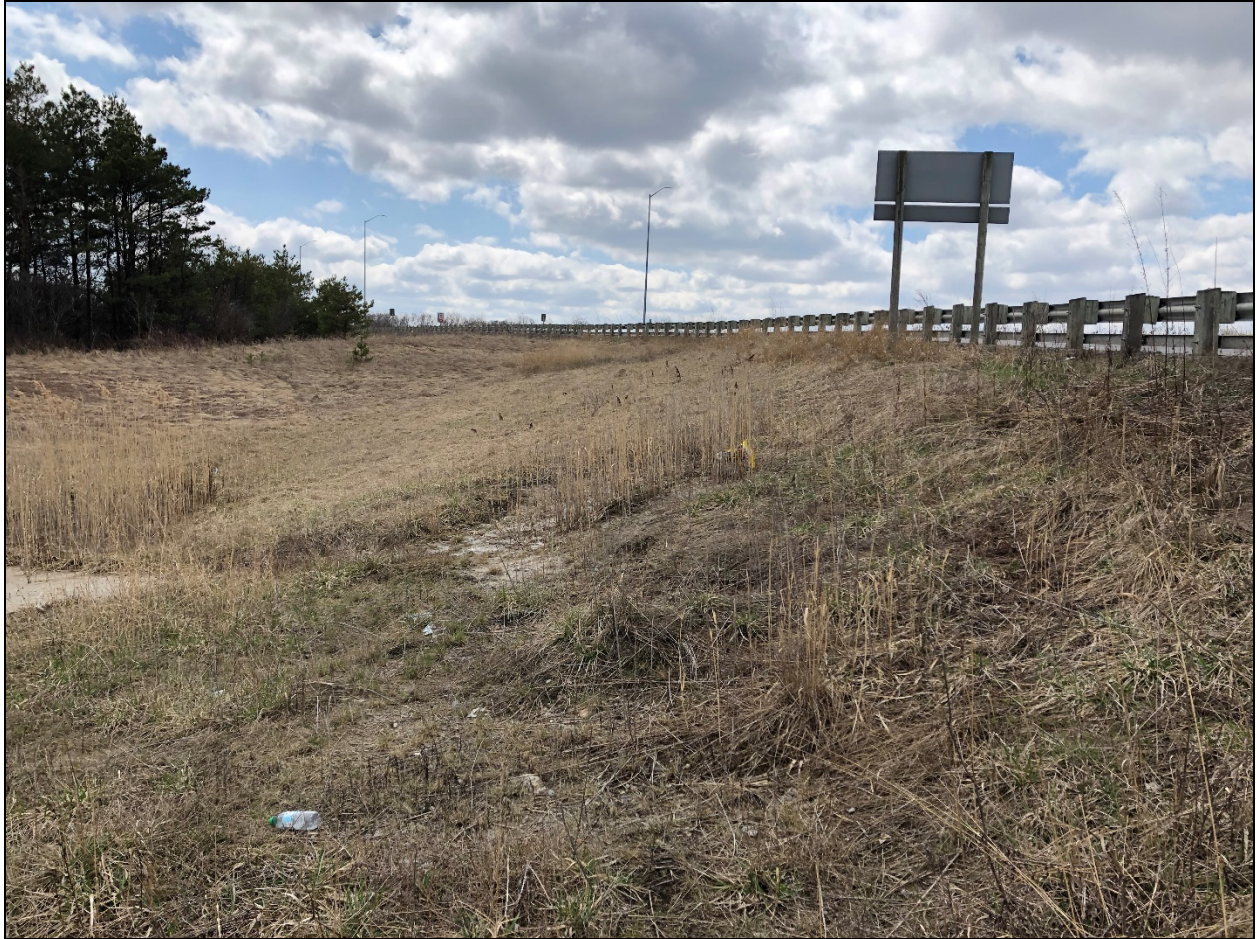
Photo 3- Existing slope at the S-E/W Ramp, looking south

Localized instability at mid-slope, with some fresh scarping and soil washing down towards the swampy area at the toe of the slope;

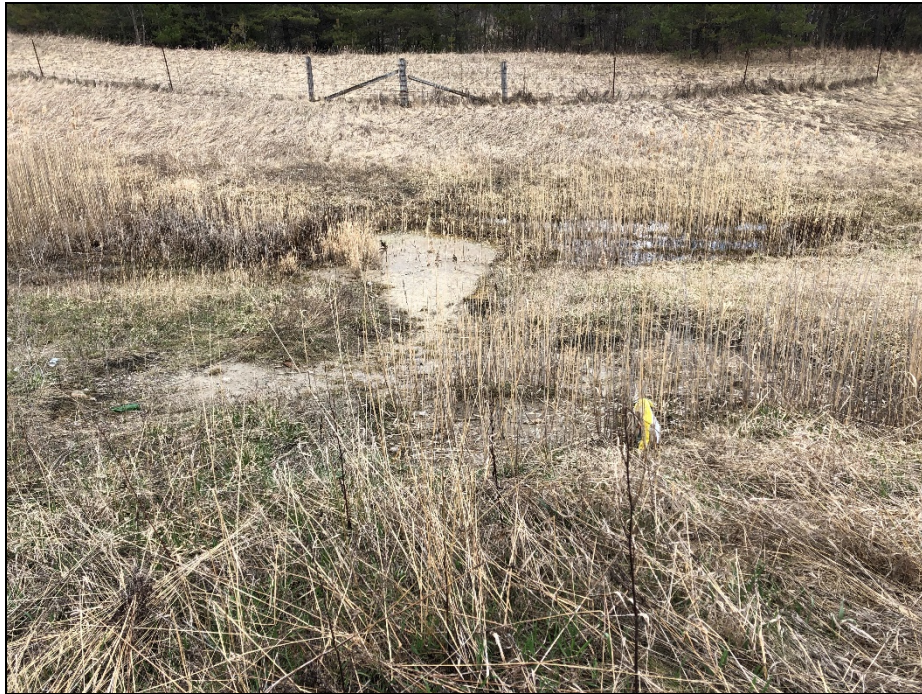
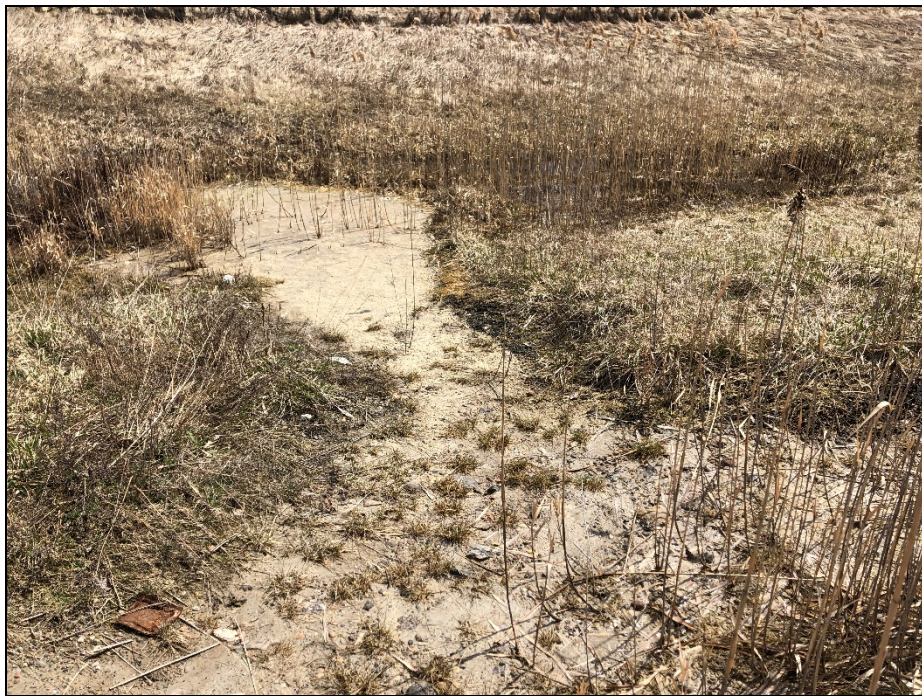
Photos 4 and 5- Existing slope at the S-E/W Ramp, looking towards the slope from top and mid-slope. Localized wet area at the toe of the slope.
