**FOUNDATION DESKTOP STUDY REPORT
PRELIMINARY DESIGN AND ENVIRONMENTAL ASSESSMENT
HIGHWAY 403 AT CPR SUBWAY
STRUCTURE REPLACEMENT ON NEW ALIGNMENT
HAMILTON, ONTARIO
W.O. #16-20004
SITE 36-32**

GEOCRES NO. 30M5-342

Date: November 9, 2022
File: 25963

**FOUNDATION DESKTOP STUDY REPORT
PRELIMINARY DESIGN AND ENVIRONMENTAL ASSESSMENT
HIGHWAY 403 AT CPR SUBWAY
STRUCTURE REPLACEMENT ON NEW ALIGNMENT
HIGHWAY 403 AND HIGHWAY 6 INTERCHANGE
HAMILTON, ONTARIO
W.O. #16-20004
SITE 36-32**

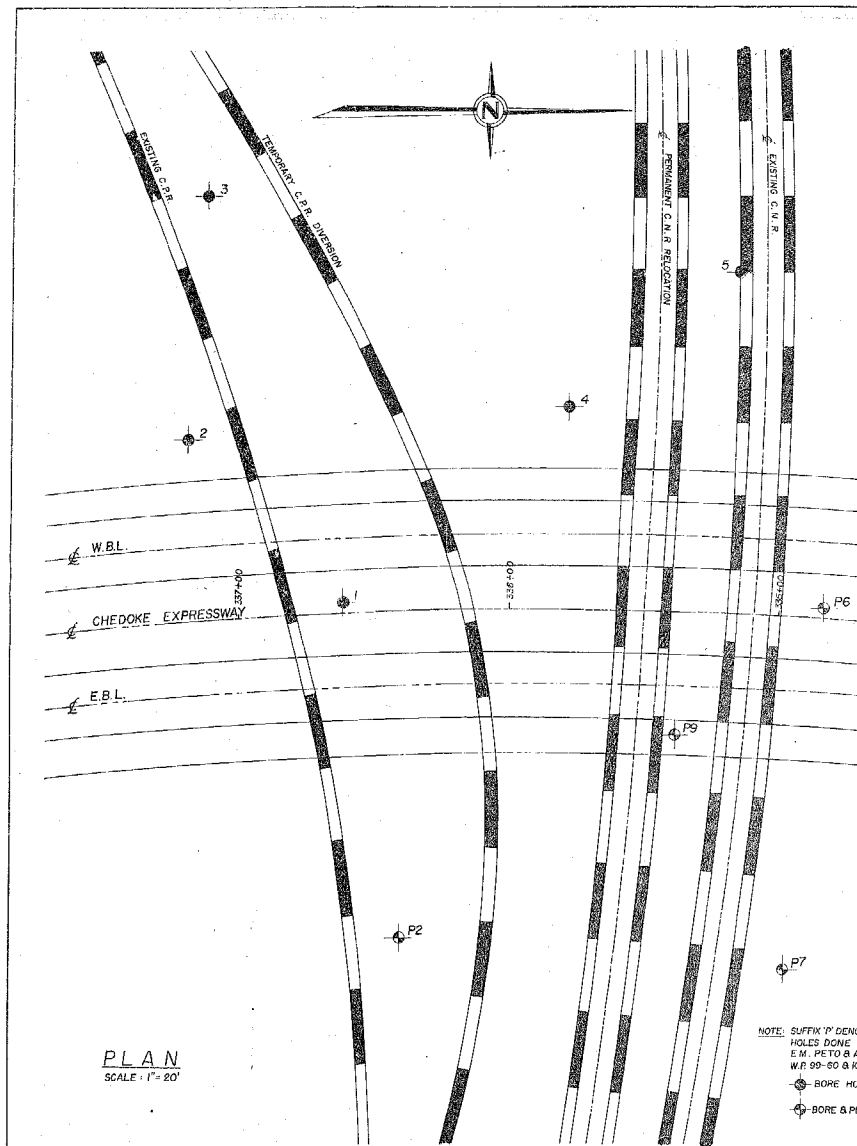
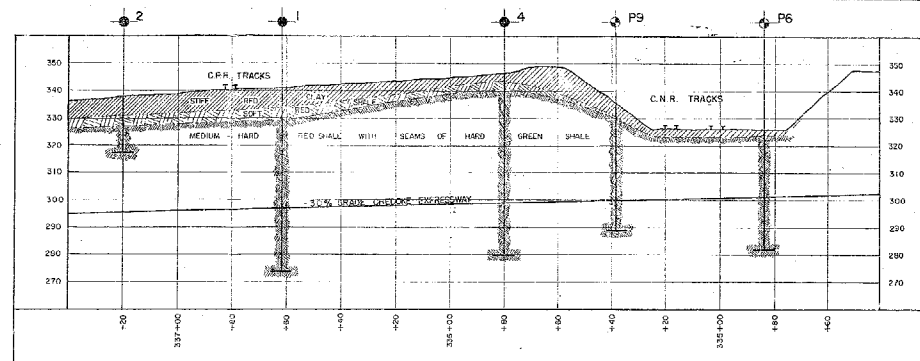
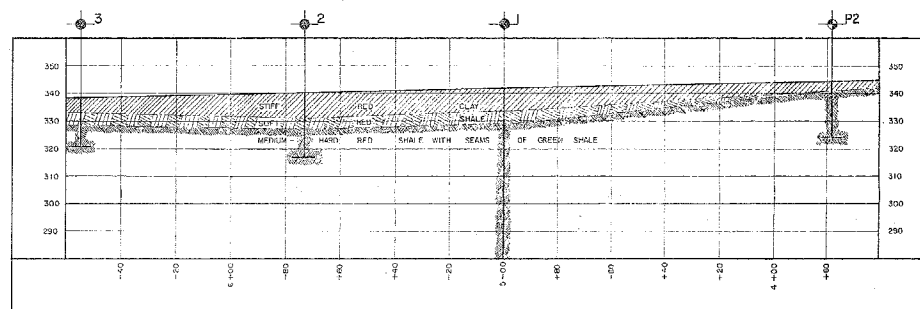
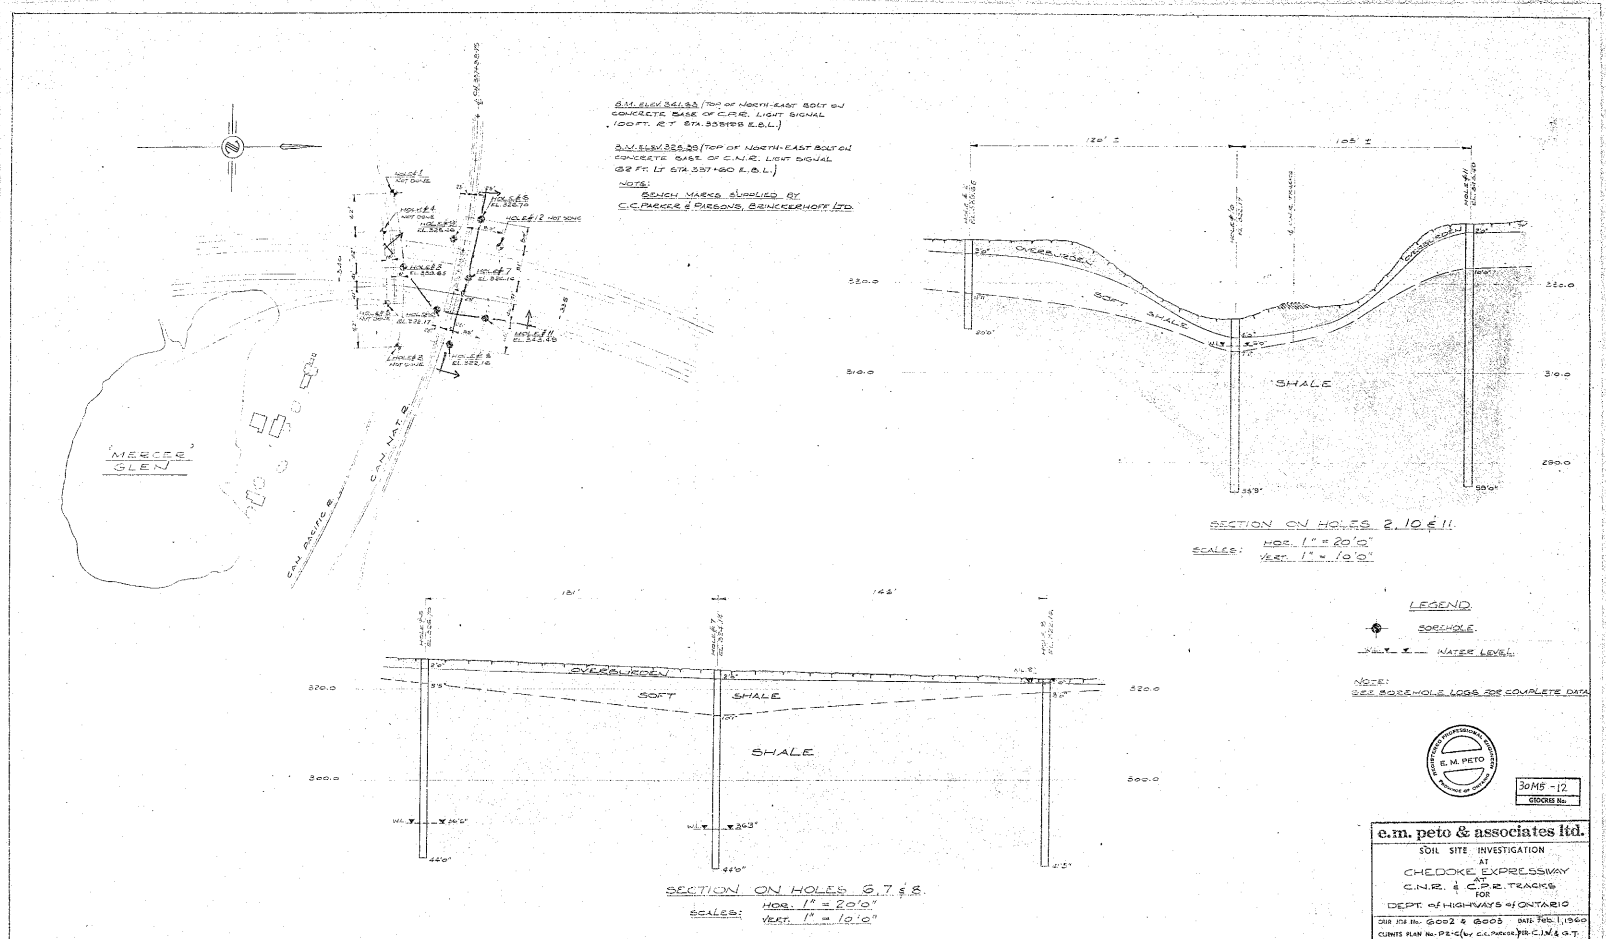
NOTE: SUFFIX "P" DENOTES
HOLES DONE BY
E.M. PETO & ASSOCIATES
W.P. 99-60 & 100-60
● BORE HOLE
● BORE & PENETRATION HOLE

DEPARTMENT OF HIGHWAYS — ONTARIO			
MATERIALS & RESEARCH SECTION			
C.N.R. & C.P.R. CROSSINGS			
SHOWING POSITIONS & ELEVATIONS OF HOLES			
Highway 403	District 4	County WENTWORTH	
LOCATION HAMILTON			
Drawn by J. J. [Signature]	Checked by [Signature]	W.P. 99-60 & 100-60	
DATE 8 June 1960	APPROVED BY [Signature]	SCALE 1 inch = 20 feet	
			60-F-35A

Two foundation investigations were conducted to cover the site in 1960 (References 1 and 2), prior to construction of the existing bridge. Borehole location plans from References 1 and 2 appear to indicate that four (4) boreholes (numbered 1, 2, 3 - from Reference 2, and numbered 2 - from Reference 1) were located in the vicinities of the CPR track crossing of Highway 403 (formerly Chedoke Expressway). A Standard Dutch Cone (Dynamic Cone Penetration Test - DCPT) was conducted in proximity of Borehole 2 from Reference 1. The Standard Dutch Cone was numbered P2. The actual locations of these boreholes in relation to the existing bridge cannot be confirmed since a co-ordinate system was not used at the time and there was no available record of the as-built locations of the bridge. In general, the boreholes were advanced through overburden soils using continuous flight augers to shale bedrock. According to the Record of Borehole Sheets, the boreholes were further advanced to obtain BX and AXT rock cores. Record of Borehole Sheets of Boreholes 1, 2, 3 (Reference 2) and 2, Standard Dutch Cone P2 (Reference 1), and a borehole location plan are included in Appendix A.

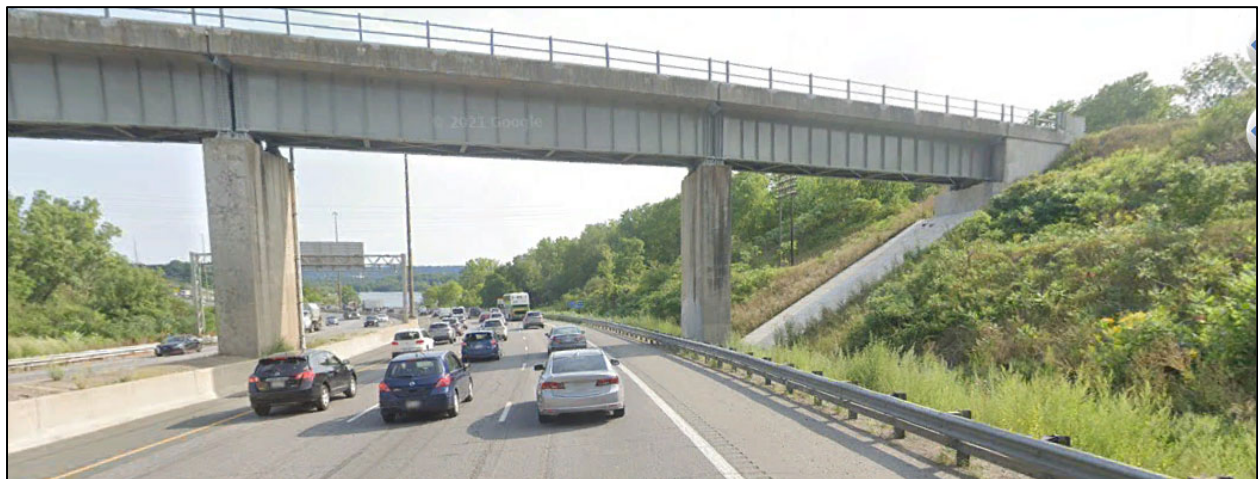
Photo 2- CPR Overpass
West Abutment, north side
Photo taken from Highway 403 WBL in June 2021

- Wet/seepage stains were noted on the abutment walls. Vertical and alligator cracks were noted at the concrete surfaces of the abutment and ballast walls.

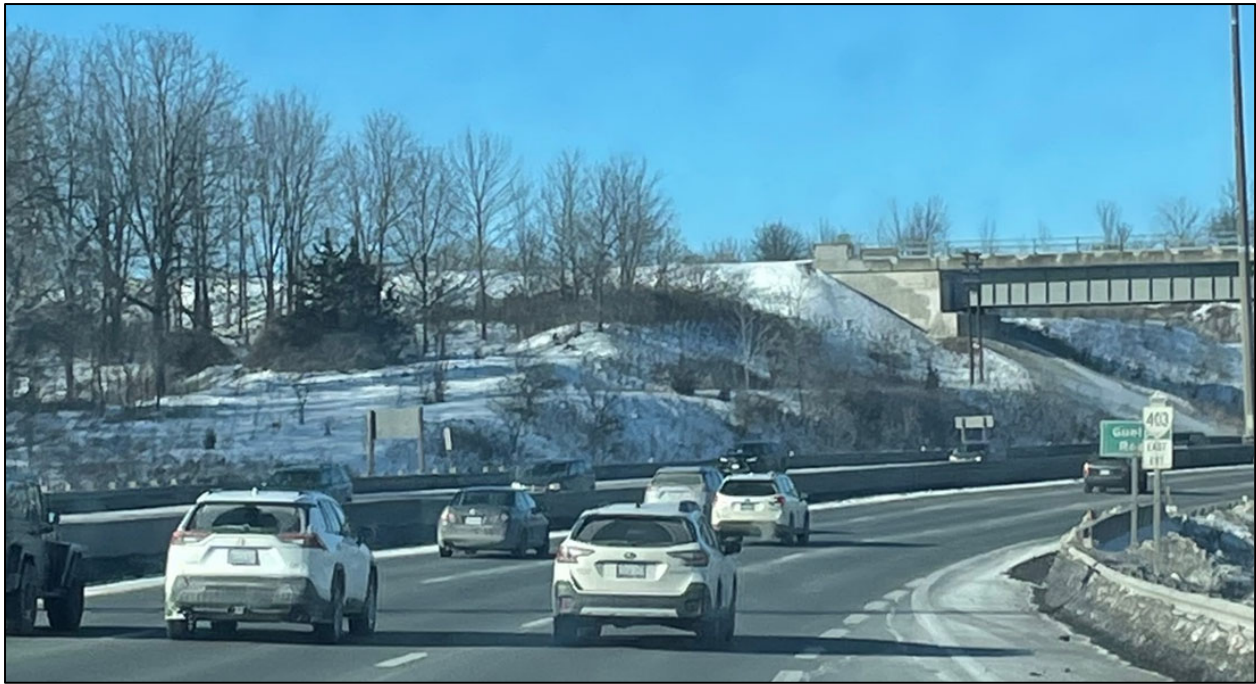
Photo 6- CPR Overpass
West Abutment, south side
Photo taken from Highway 403 EBL on January 29, 2022

- Concrete slope paving is present on the forward slope of the east and west abutments. Occasional seepage stains were noted on the concrete slope paving. Pipe drains were also observed at the top of the forward slope.

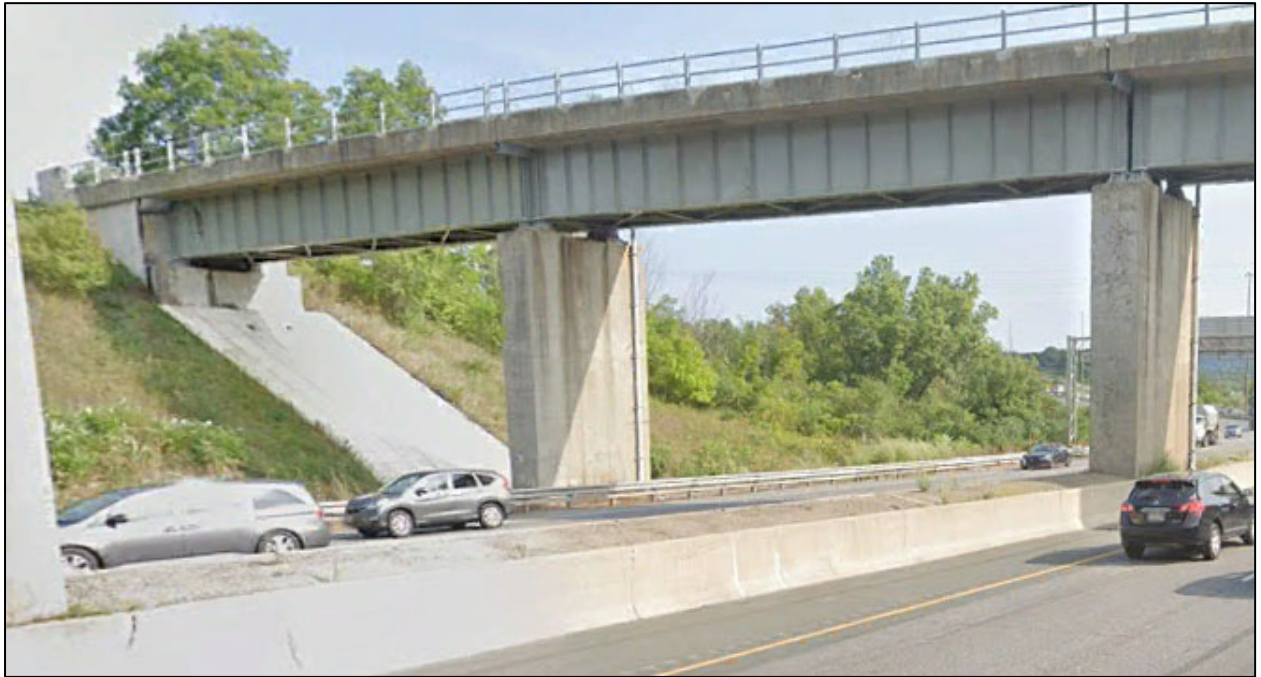
Photo 8- CPR Overpass
East Abutment, north side
Photo taken from Highway 403 WBL in June 2021

CN Rail Tracks

CP Rail Tracks

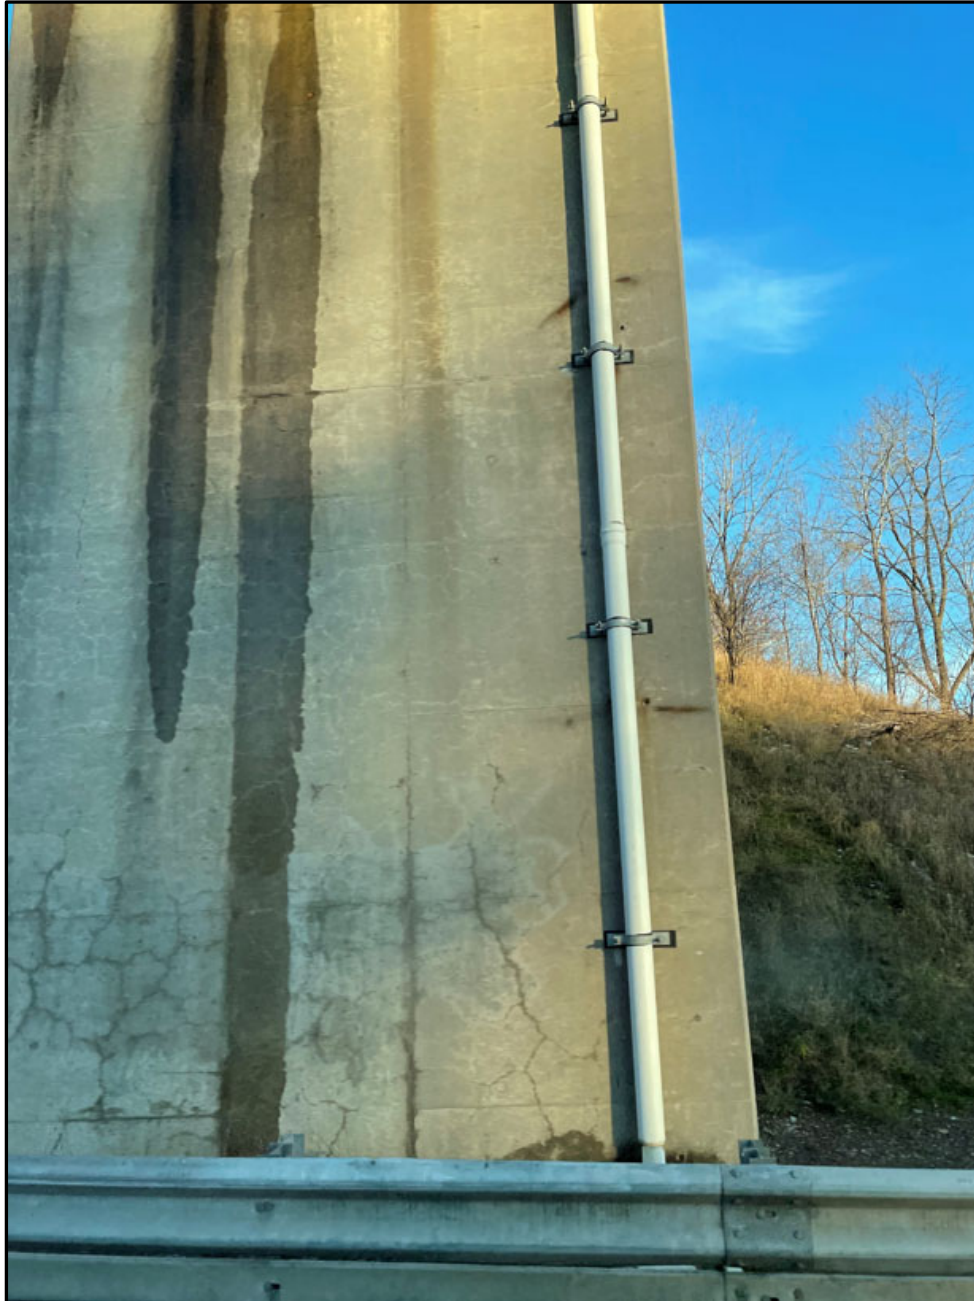
Photo 11- CPR Overpass
Pier 3
Photo taken from Highway 403 EBL on December 1, 2021

- Mid-height berms were observed along the south and north side slopes of the west approach embankment.
- Seepage was noticed at the three rectangular piers, which are wet stained along the concrete faces. Several narrow vertical and diagonal cracks were also noted on the piers.
