**DRAFT PRELIMINARY
FOUNDATION INVESTIGATION AND DESIGN REPORT
GRINDSTONE CREEK CULVERT REHABILITATION
HIGHWAY 403 AND HIGHWAY 6 INTERCHANGE
HAMILTON, ONTARIO
SITE 10-193/C
WO#16-20004
ASSIGNMENT NUMBER 2016-E-0027**

Date: May 15, 2023
File: 25963

Thurber was retained by AECOM to carry out this Phase 2 preliminary foundation investigation under the Ministry of Transportation Ontario (MTO) Assignment Number 2016-E-0027.

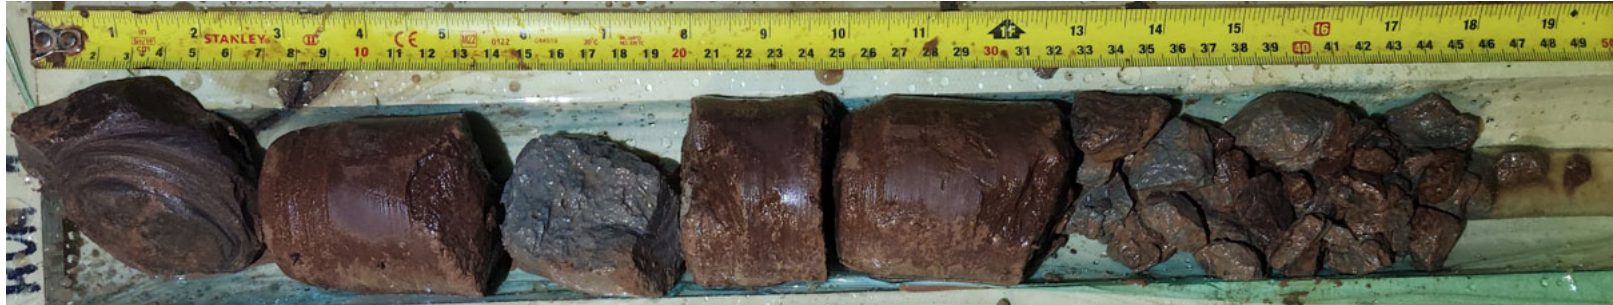
RUN 1

Date Drilled: September 27, 2022

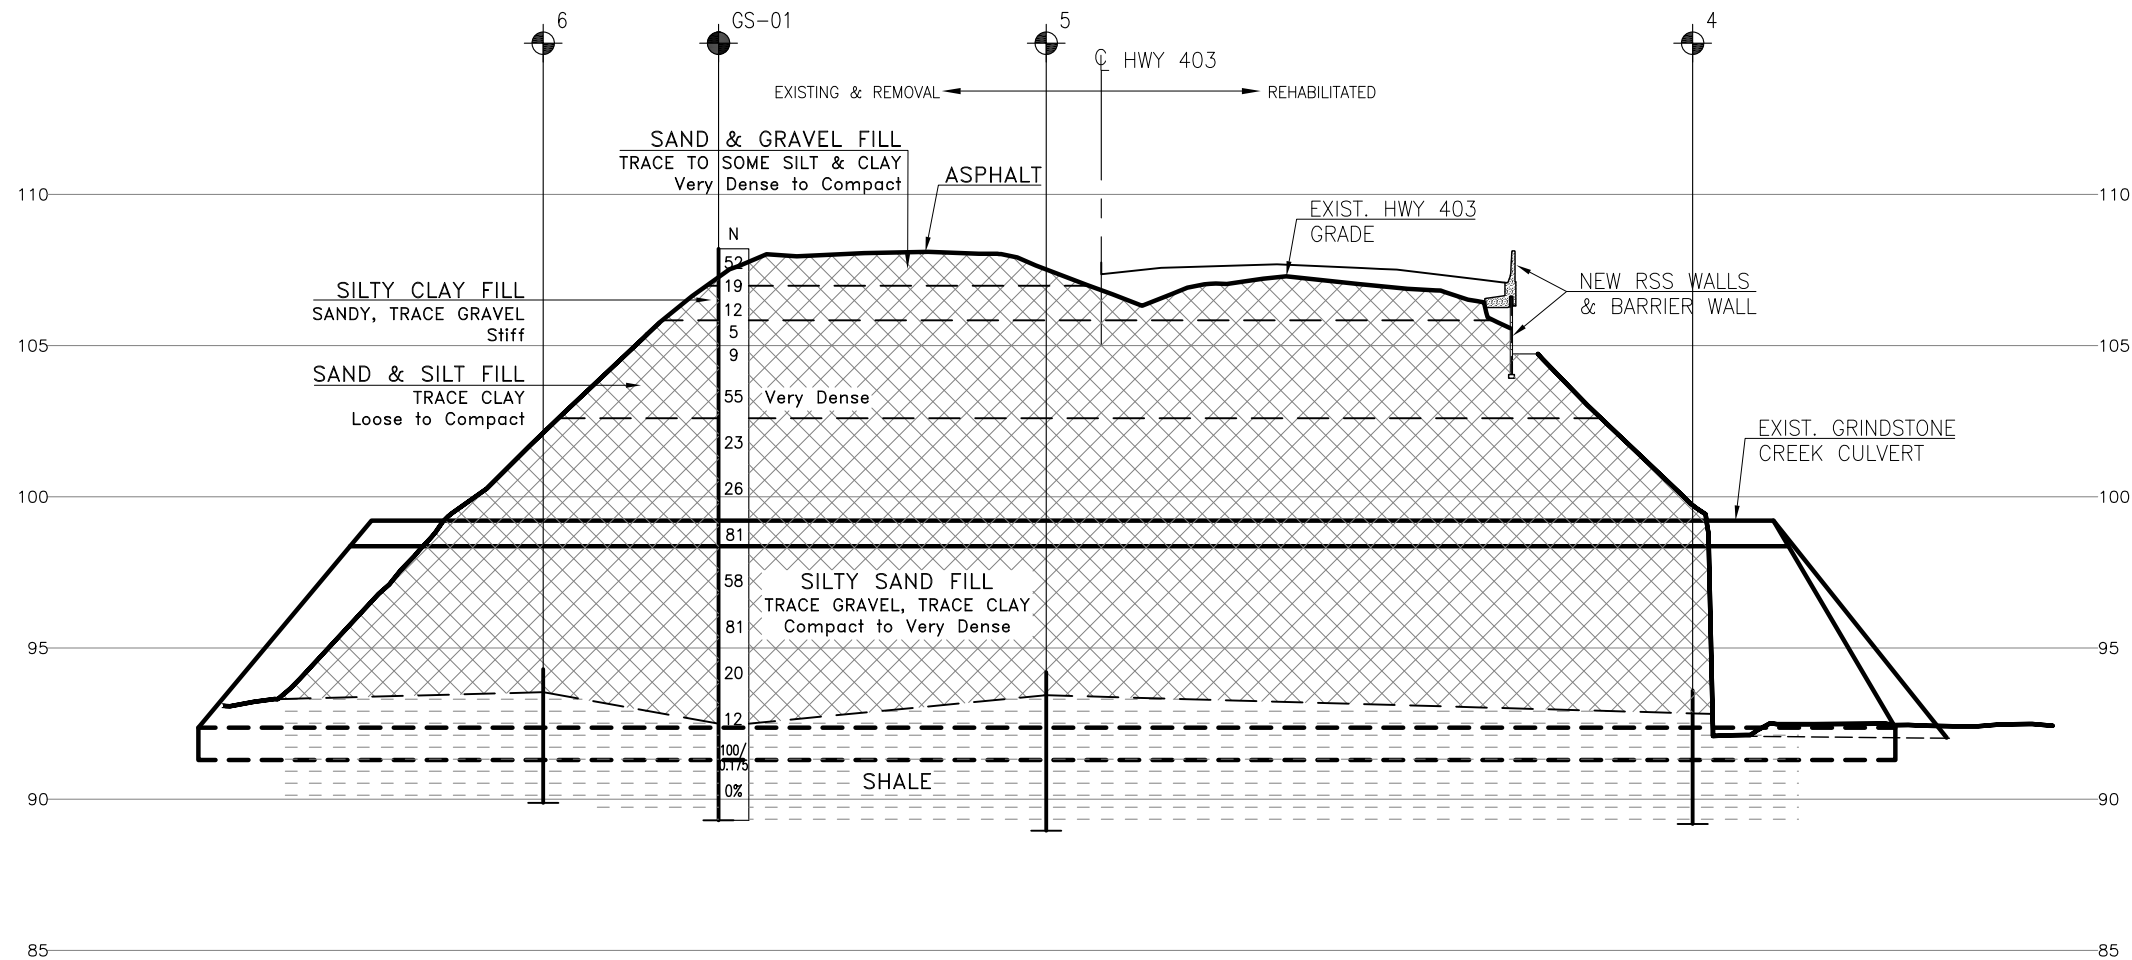
PROFILE ALONG GRINDSTONE CREEK CULVERT (A-A')

- 1) The boundaries between soil strata have been established only at Borehole locations. Between Boreholes the boundaries are assumed from geological evidence.
- 2) This drawing is for subsurface information only. Surface details and features are for conceptual illustration.
- 3) Coordinate system is MTM NAD 83 Zone 10.
