**PRELIMINARY  
FOUNDATION INVESTIGATION REPORT  
GRINDSTONE CREEK CULVERT REHABILITATION  
HIGHWAY 403 AND HIGHWAY 6 INTERCHANGE  
HAMILTON, ONTARIO  
SITE 10-193/C  
WO#16-20004  
ASSIGNMENT NUMBER 2016-E-0027**

**GEOCRES NO. 30M5-357**

Date: November 6, 2023  
File: 25963

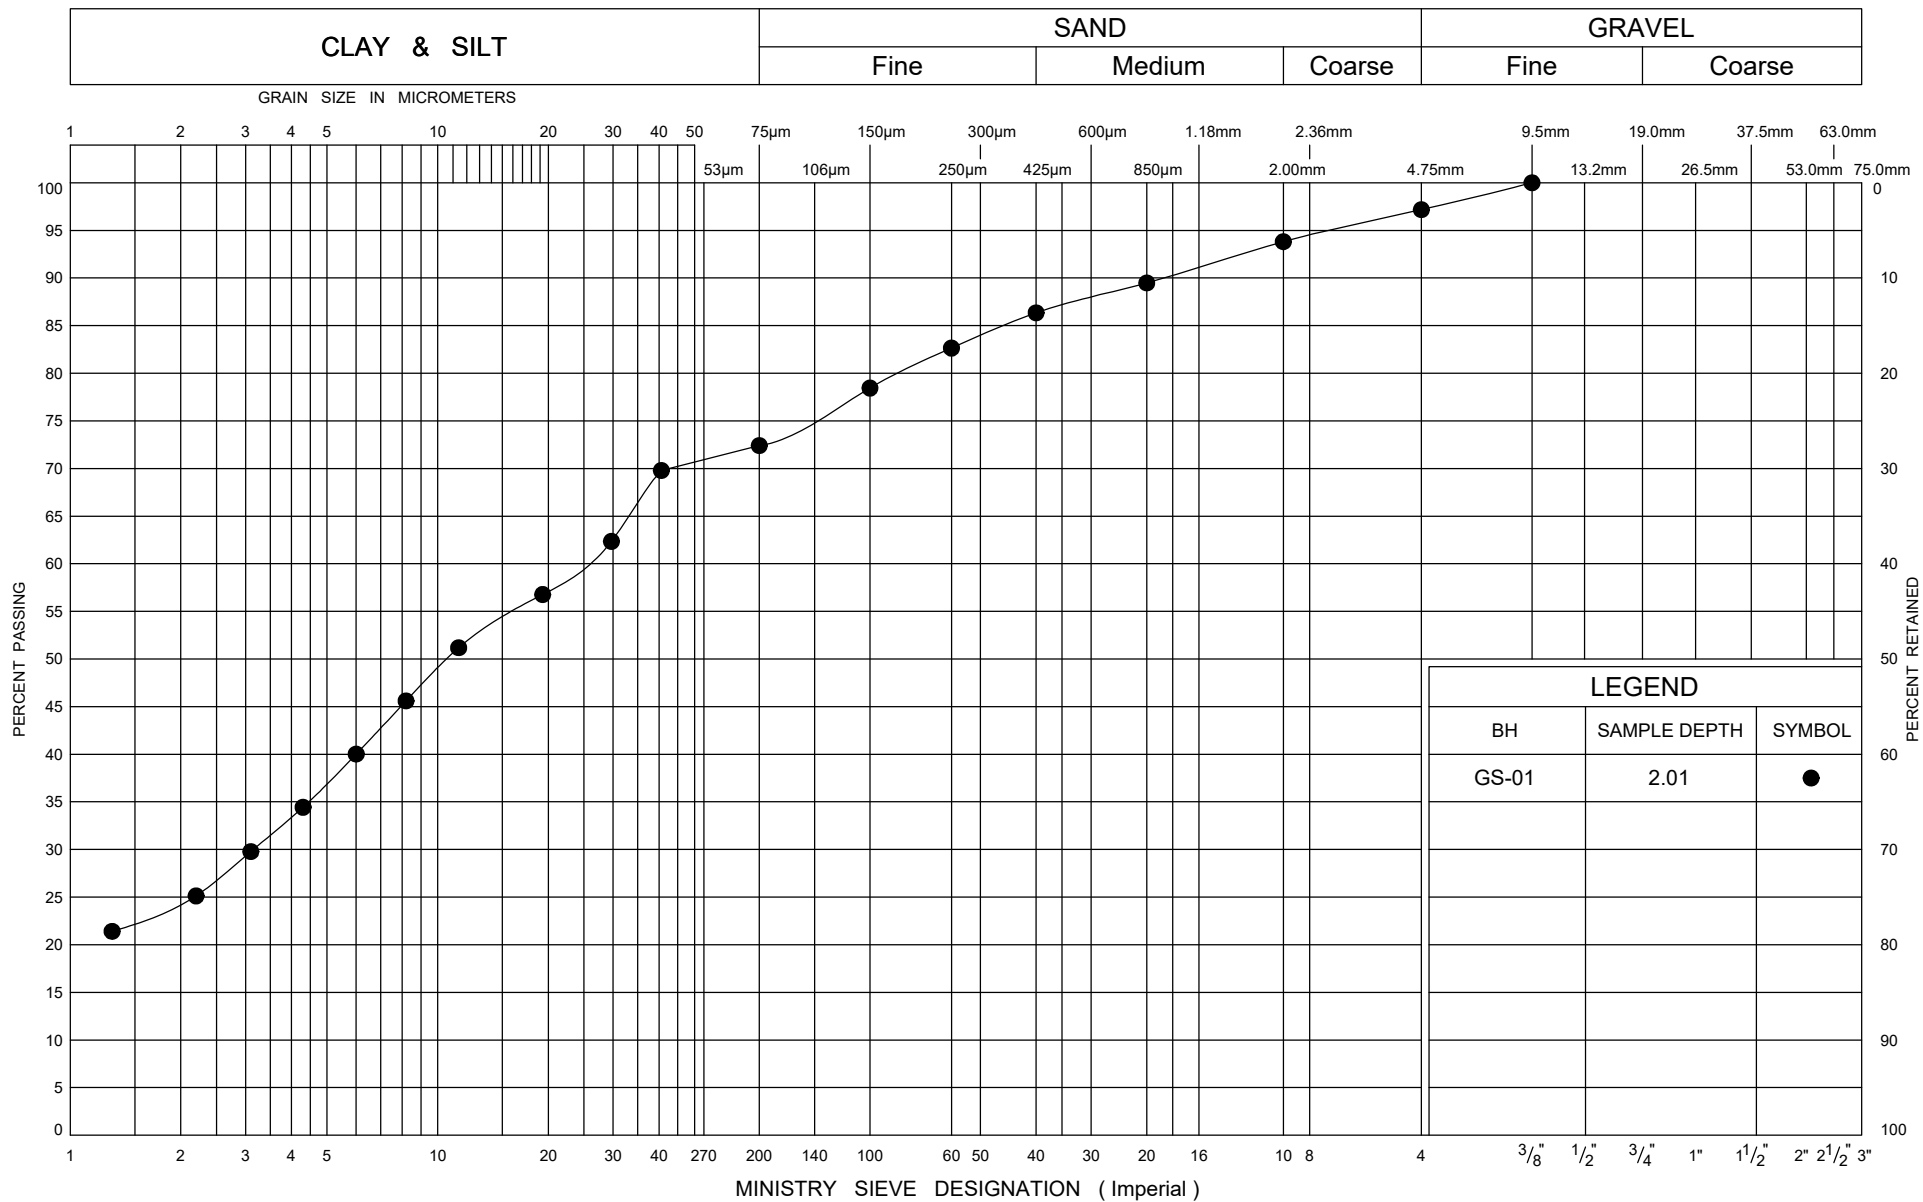
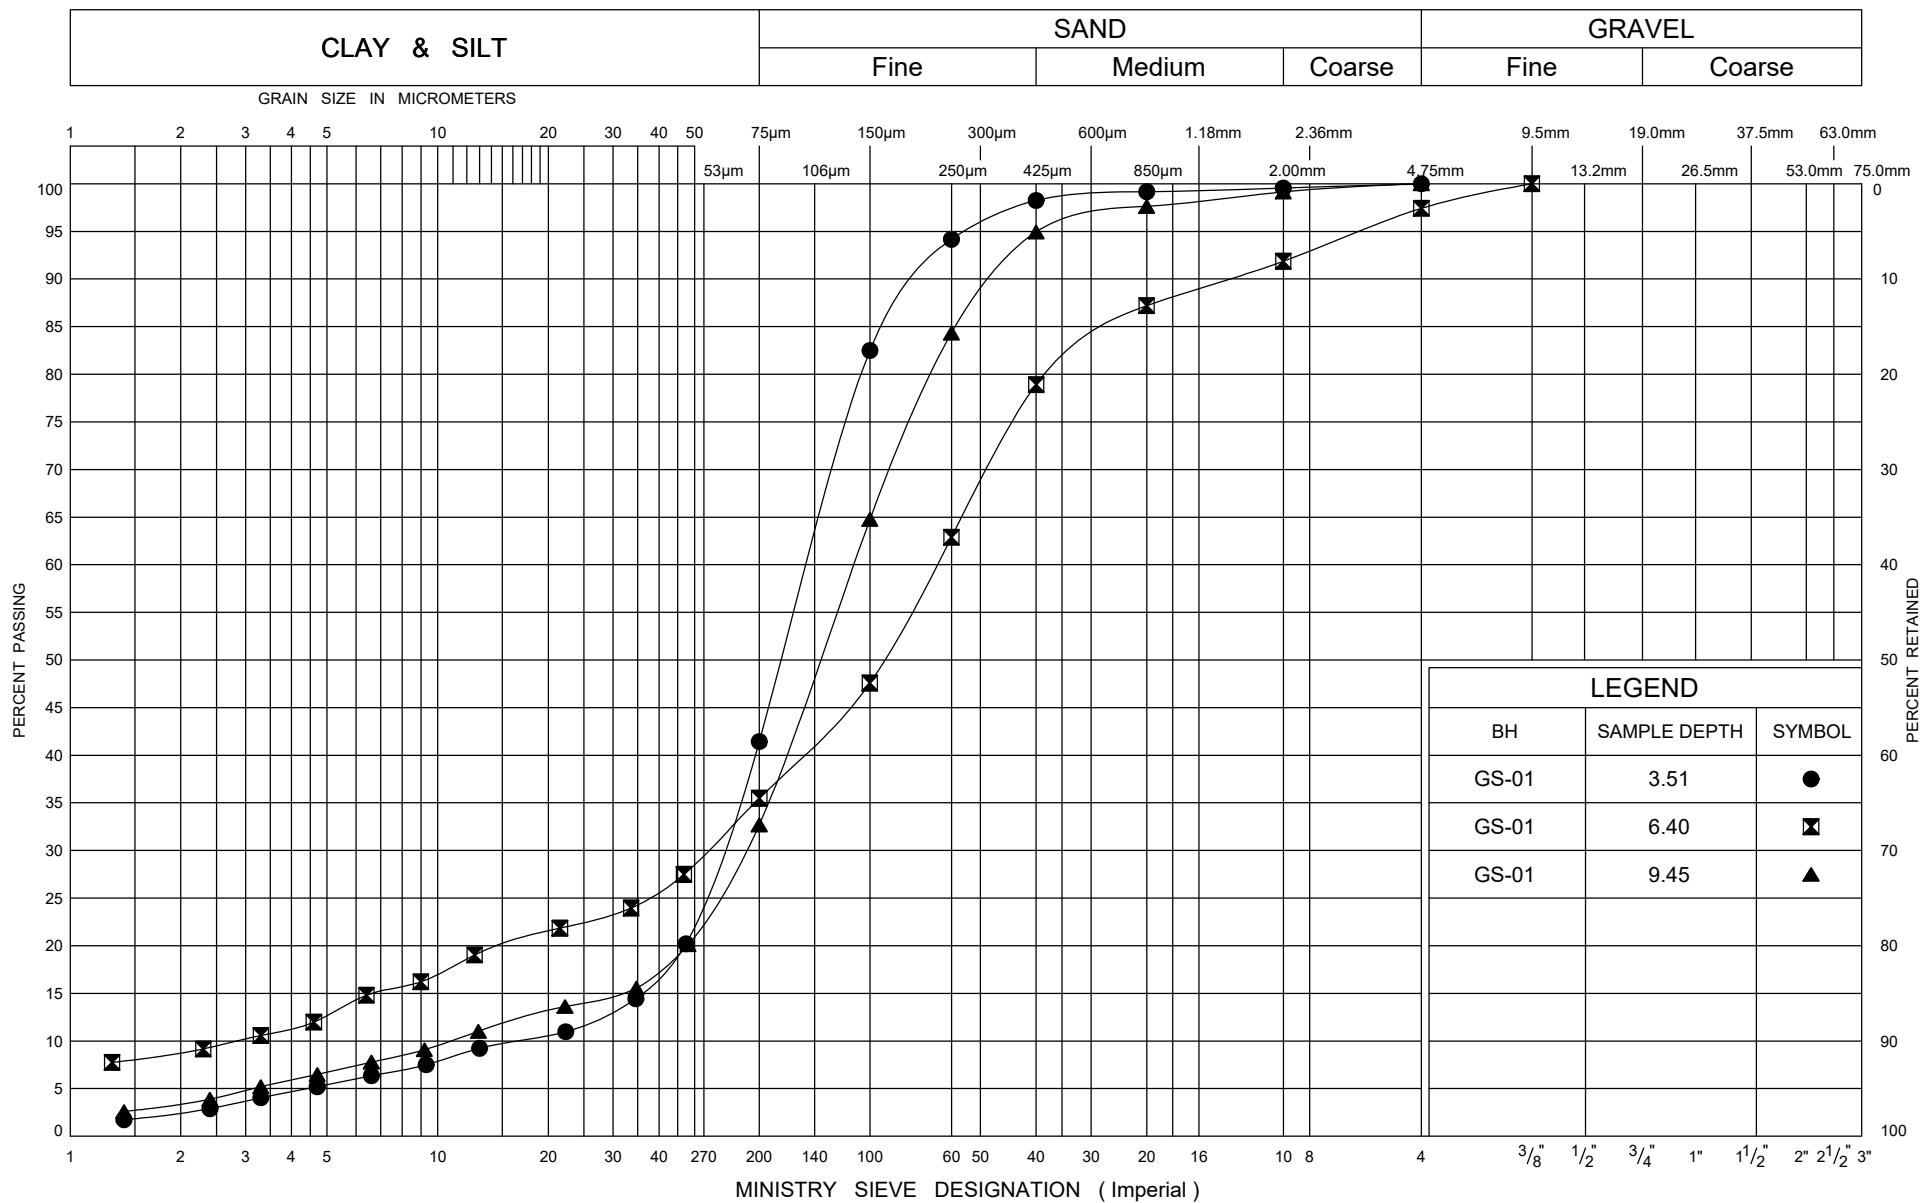
The results of grain size distribution analyses carried out on a sample of the cohesive fill and several samples of the cohesionless fill are presented on the Record of Borehole Sheets and Figures B1 and B2, respectively, in Appendix B and also summarized below:

Soil Particle	Cohesive Fill Percentage (%)	Cohesionless Fill Percentage (%)
Gravel	3	0 to 3
Sand	25	59 to 67
Silt	48	27 to 39
Clay	24	2 to 8

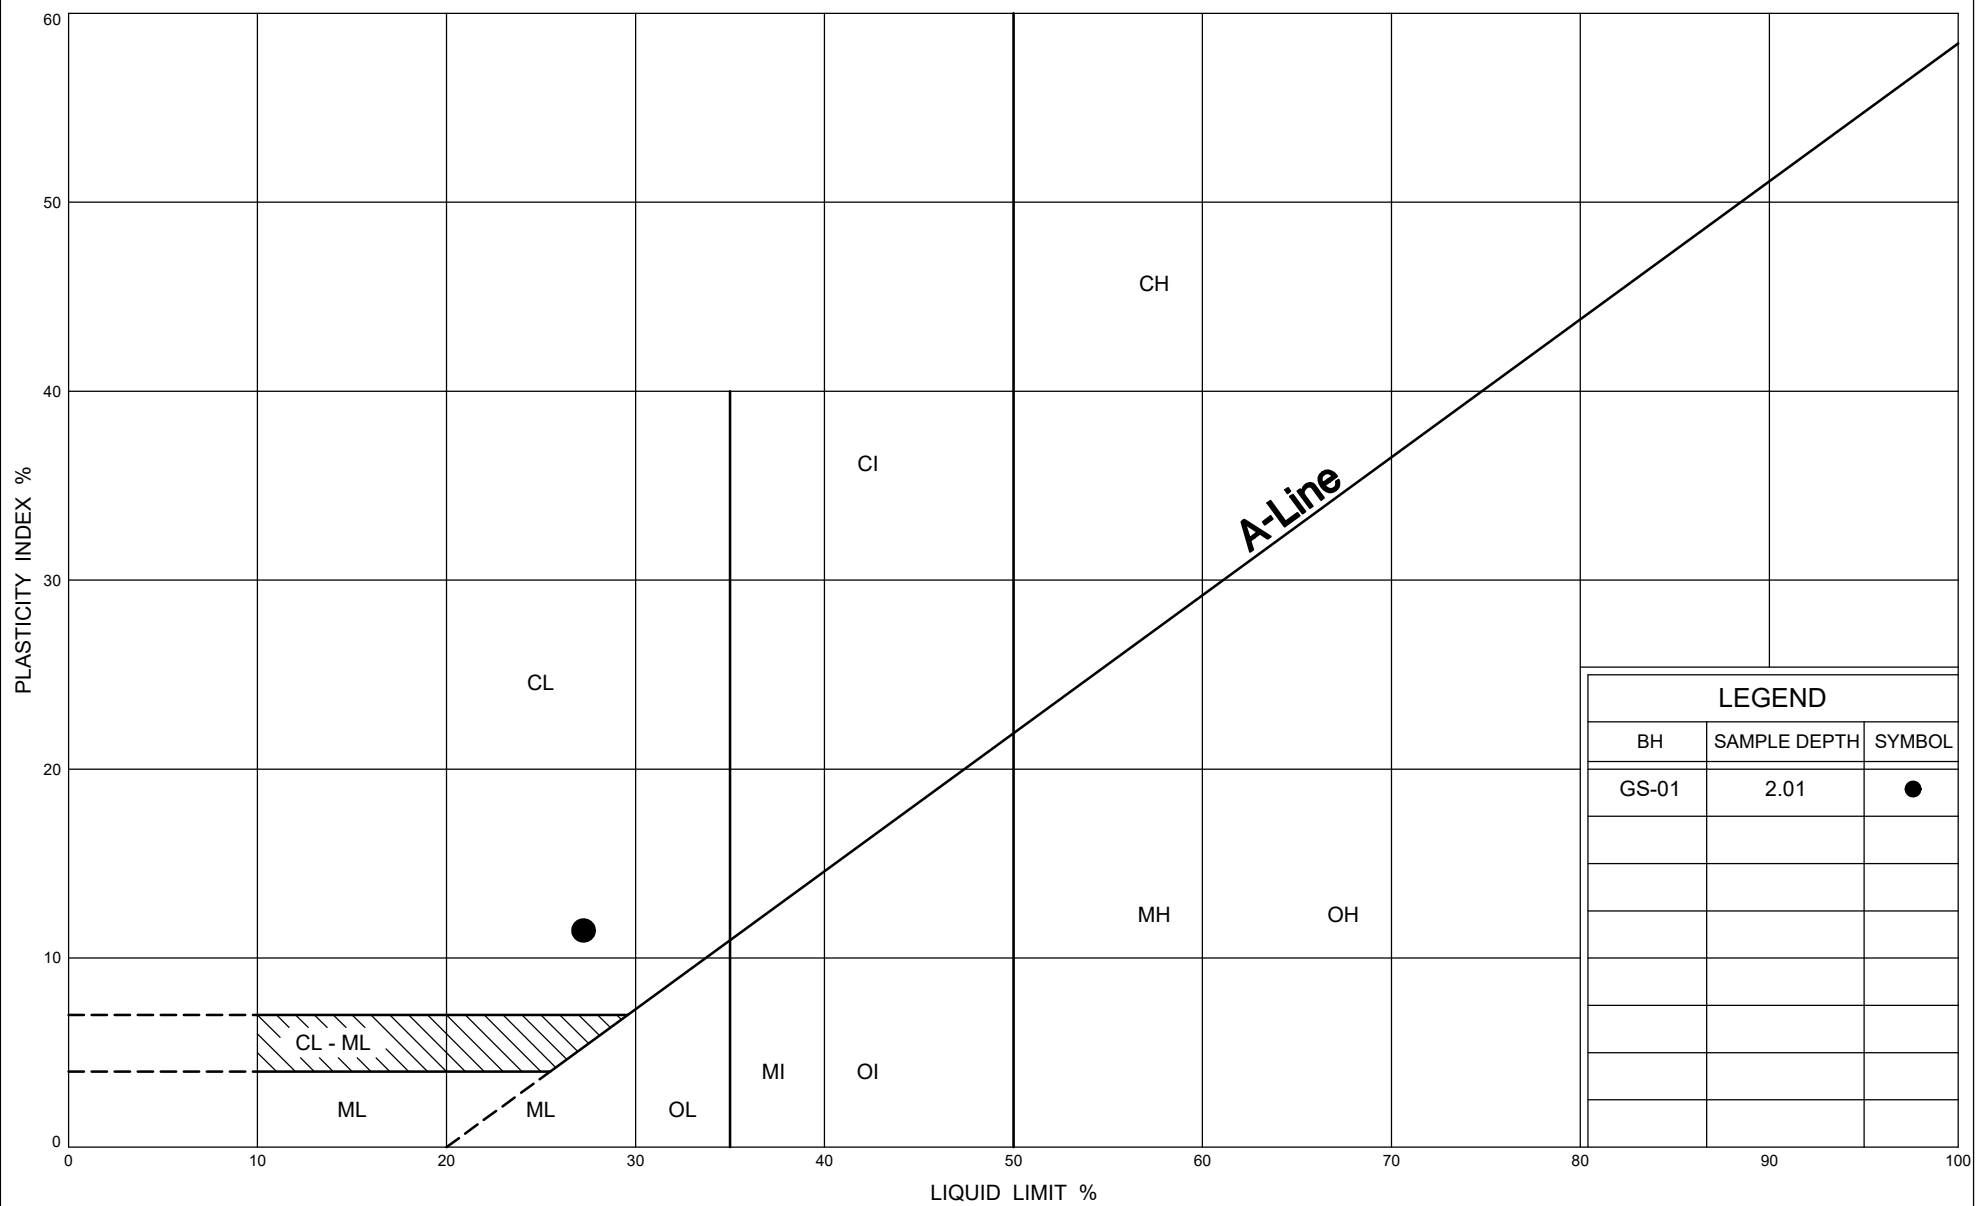
## PLASTICITY CHART

The results of an Atterberg Limits test carried out on a sample of the silty clay fill are presented on the Record of Borehole Sheets and Figure B3 in Appendix B, and are summarized below:

Soil Property	Percentage (%)
Liquid Limit	27
Plastic Limit	16
Plasticity Index	11

The results of the Atterberg Limit tests indicate that the silty clay till has low plasticity with a group symbol of CL

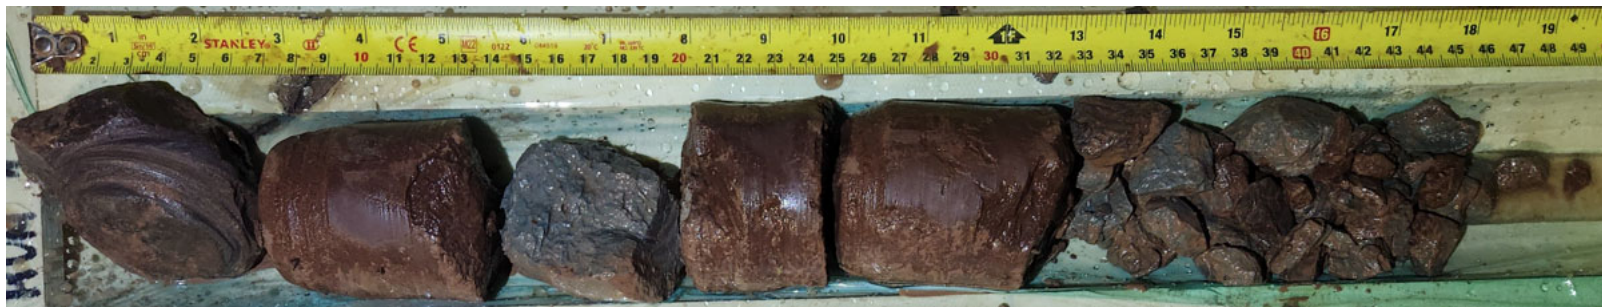
**RUN 1**

Rock core photos are presented in Appendix D.

It must be noted, however, that point load tests were possible only on less weathered shale. Typical weathered shale cores tended to be not suitable for point load testing. Broken (rubble) zones were observed within the cores at several depths.

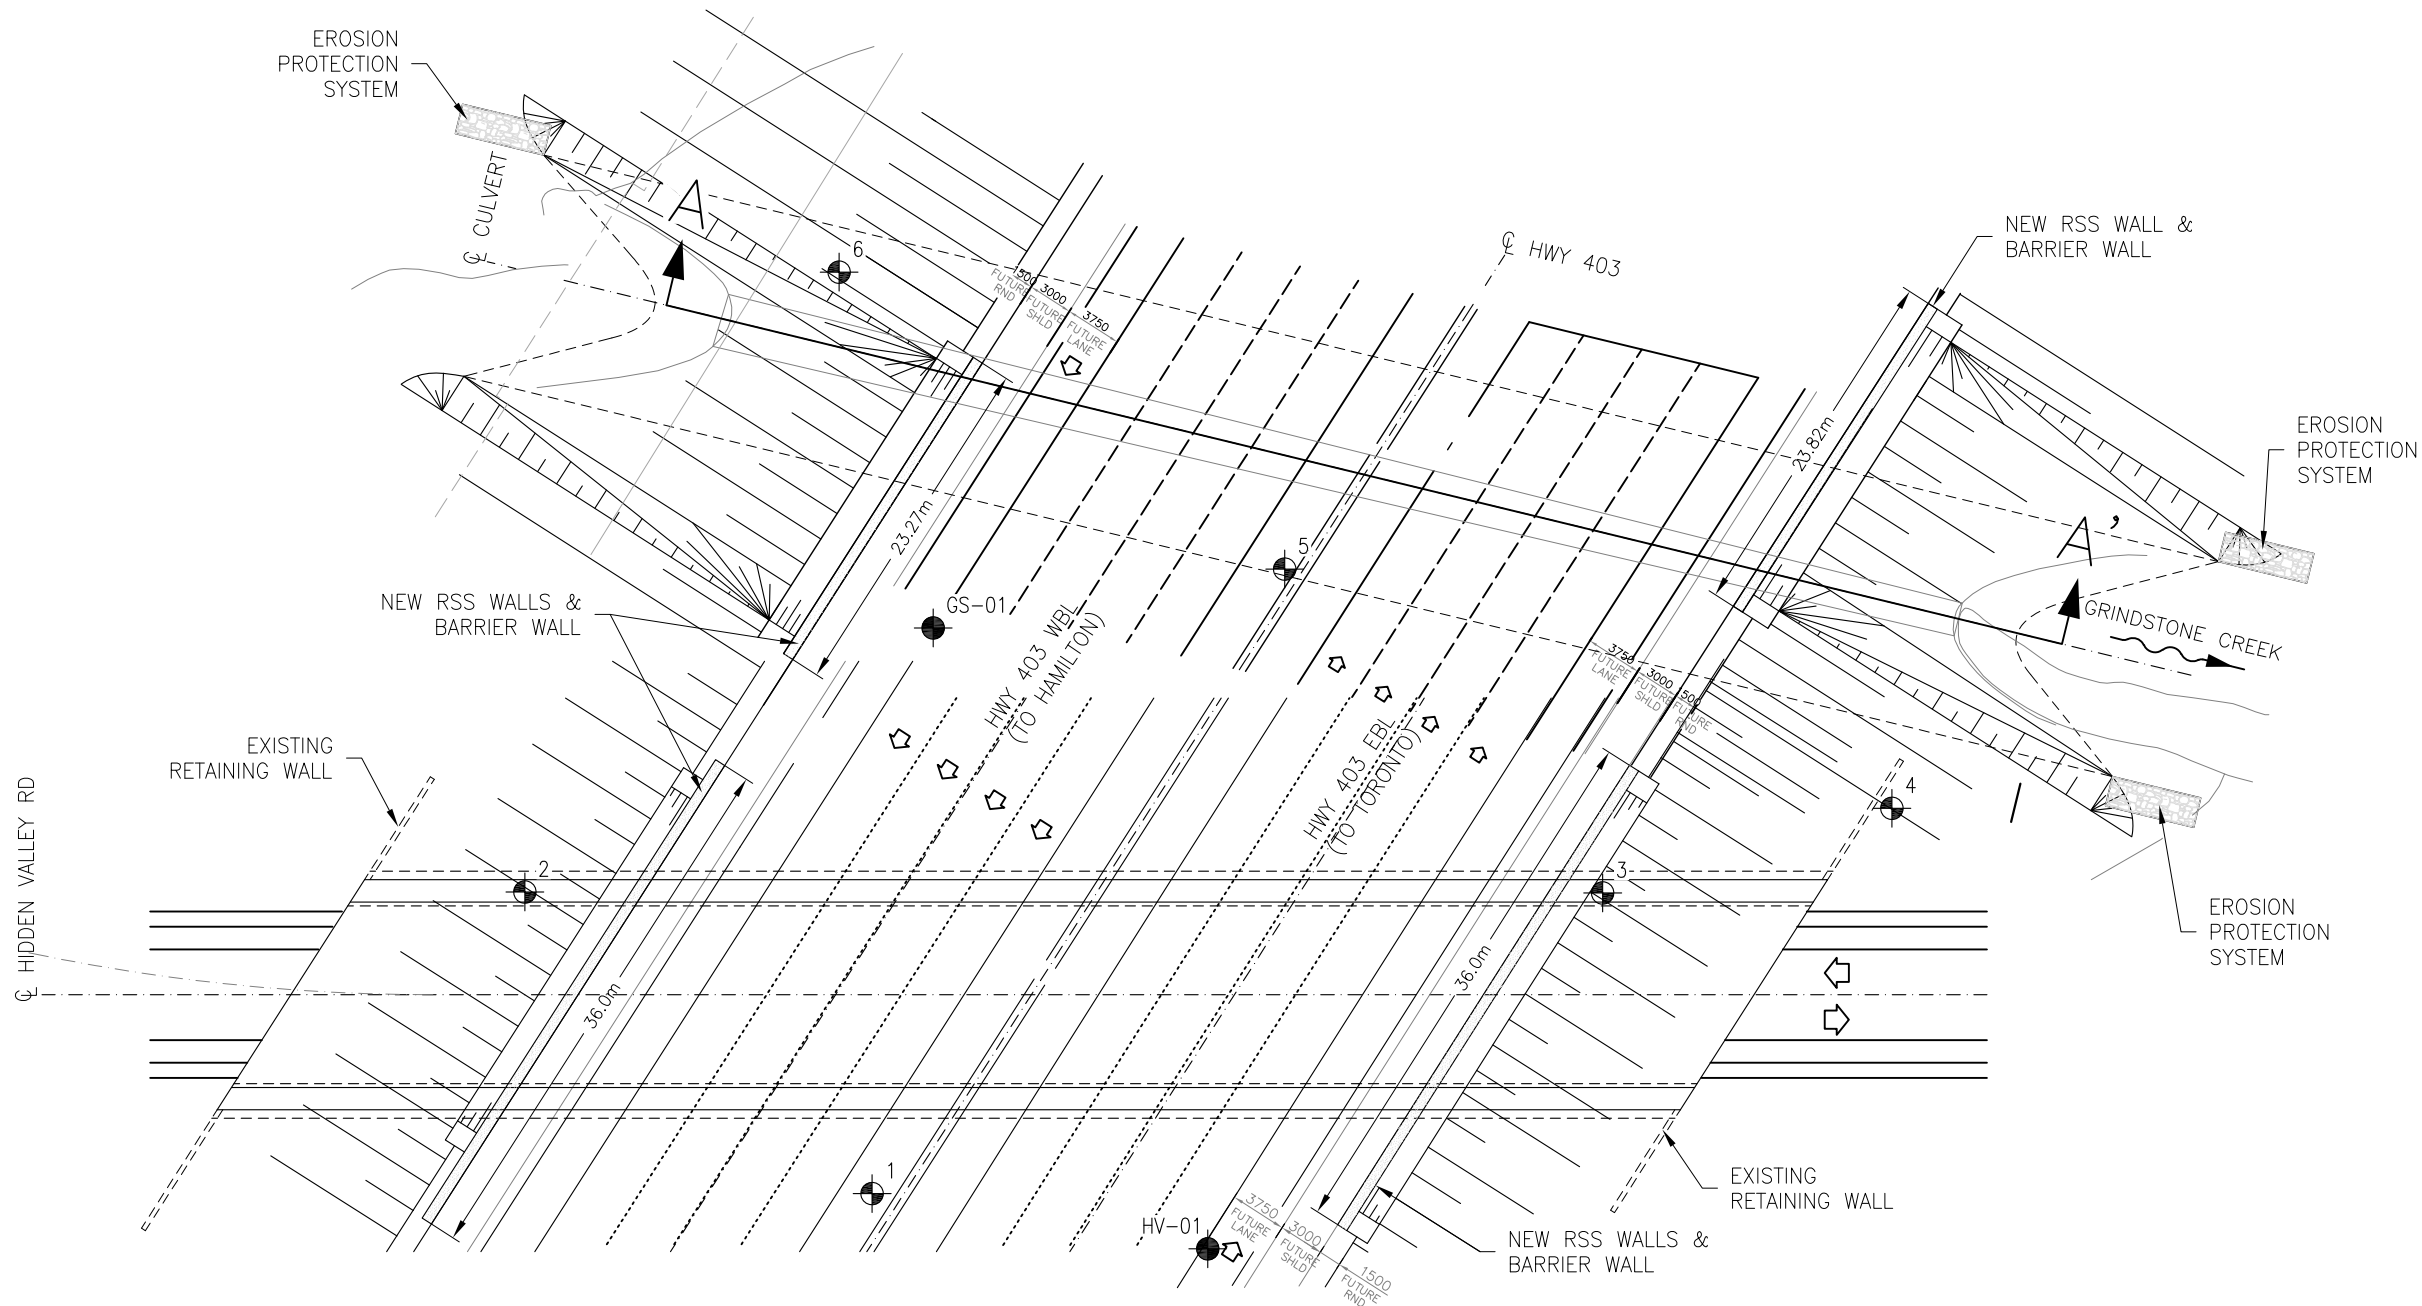
REVISIONS	DATE	BY	DESCRIPTION
DESIGN	RPR	CHK SKP	CODE
DRAWN	AN	CHK RPR	SITE 10-193/C/STRUCT
			LOAD
			DATE NOV 2023
			DWG 1

The approximate locations of all the boreholes (previous and present investigations) are shown on the Borehole Location and Soil Strata drawing in Appendix E.

Thurber surveyed Borehole GS-01 in the field, and obtained the borehole coordinates and ground surface elevation. The coordinates are related to MTM NAD 83 Zone 10. The survey equipment used was a Trimble R10 GNSS system with a horizontal precision of 3 mm and a vertical precision of 3.5 mm. The coordinates and elevations of the borehole are given on the Borehole Location and Soil Strata drawing in Appendix E and on the Record of Borehole Sheet in Appendix A.

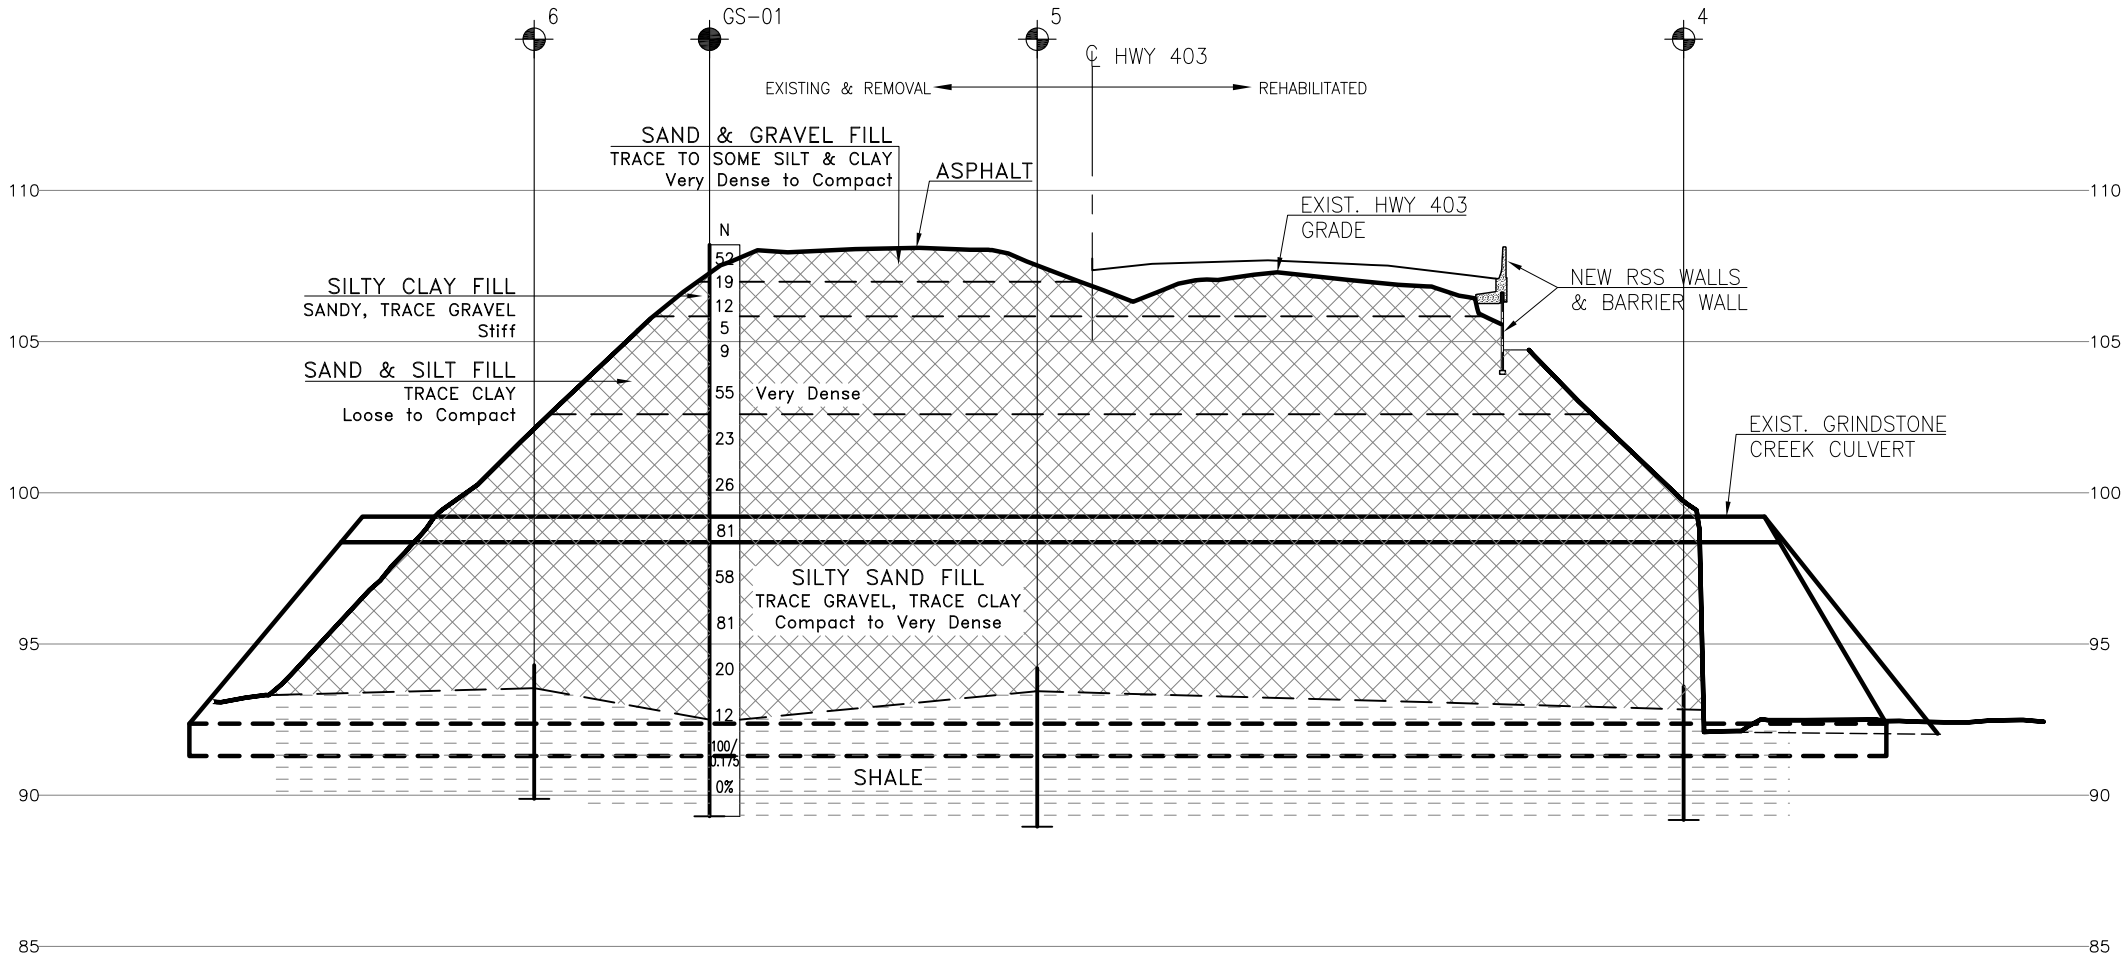
PROFILE ALONG GRINDSTONE CREEK CULVERT (A-A')

- The boundaries between soil strata have been established only at Borehole locations. Between Boreholes the boundaries are assumed from geological evidence.
- This drawing is for subsurface information only. Surface details and features are for conceptual illustration.
- Coordinate system is MTM NAD 83 Zone 10.

Details of the encountered subsurface stratigraphy are presented on the Record of Borehole sheet included in Appendix A, and on the Borehole Location and Soil Strata drawing in Appendix E. A
