**PRELIMINARY  
FOUNDATION INVESTIGATION AND DESIGN REPORT  
HIDDEN VALLEY CULVERT REHABILITATION  
HIGHWAY 403 AND HIGHWAY 6 INTERCHANGE  
HAMILTON, ONTARIO  
MTO SITE NO. 10-192/C  
WO#16-20004  
ASSIGNMENT NUMBER 2016-E-0027**

**GEOCRES NO. 30M5-360**

Date: November 6, 2023  
File: 25963

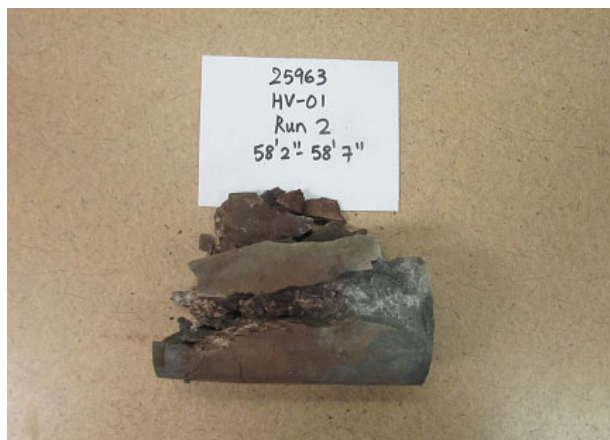
FRACTURED SPECIMEN

AVG. RATE OF STRAIN TO FAILURE:	0.250 MPa/s
MAXIMUM COMPRESSIVE LOAD:	49.6 kN
UNCONFINED COMPRESSIVE STRENGTH:	15.9 MPa

It must be noted, however, that UCS tests and point load tests were possible only on less weathered shale. Typical weathered shale cores tended to be not suitable for either test. Broken (rubble) zones were observed within the cores at several depths.

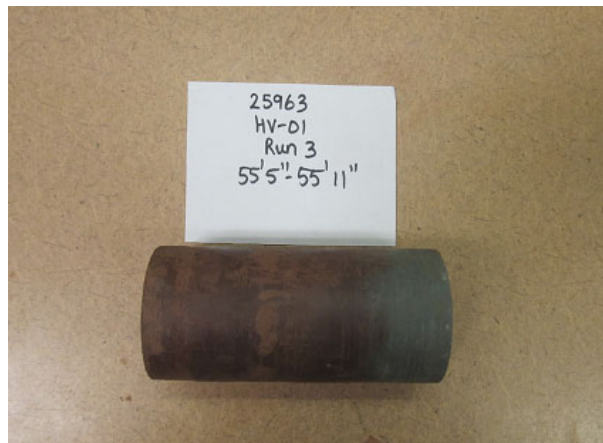
ORIGINAL SPECIMEN

Avg. Height (cm):	12.6	Weight (g):	1036.0
Avg. Diameter (cm):	6.3	Wet Density (kg/m <sup>3</sup> ):	2,638
H. to Dia. Ratio**:	2:1	Dry Density (kg/m <sup>3</sup> ):	2,553
Cross Sectional Area (cm <sup>2</sup> ):	31.17	Moisture Content* (%):	3.3
Sample Volume (cm <sup>3</sup> ):	392.77

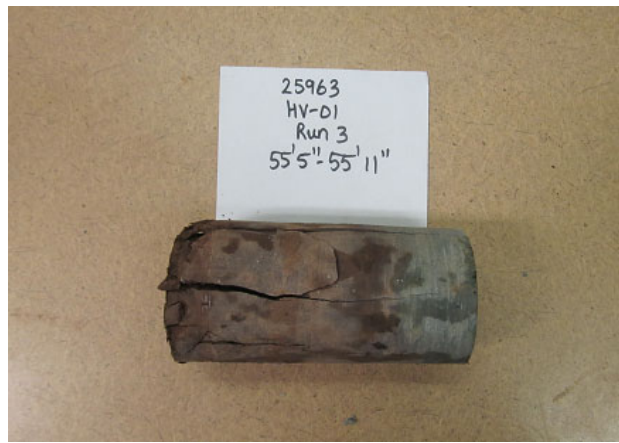
FRACTURED SPECIMEN

AVG. RATE OF STRAIN TO FAILURE:	0.250 MPa/s
MAXIMUM COMPRESSIVE LOAD:	77.1 kN
UNCONFINED COMPRESSIVE STRENGTH:	24.7 MPa

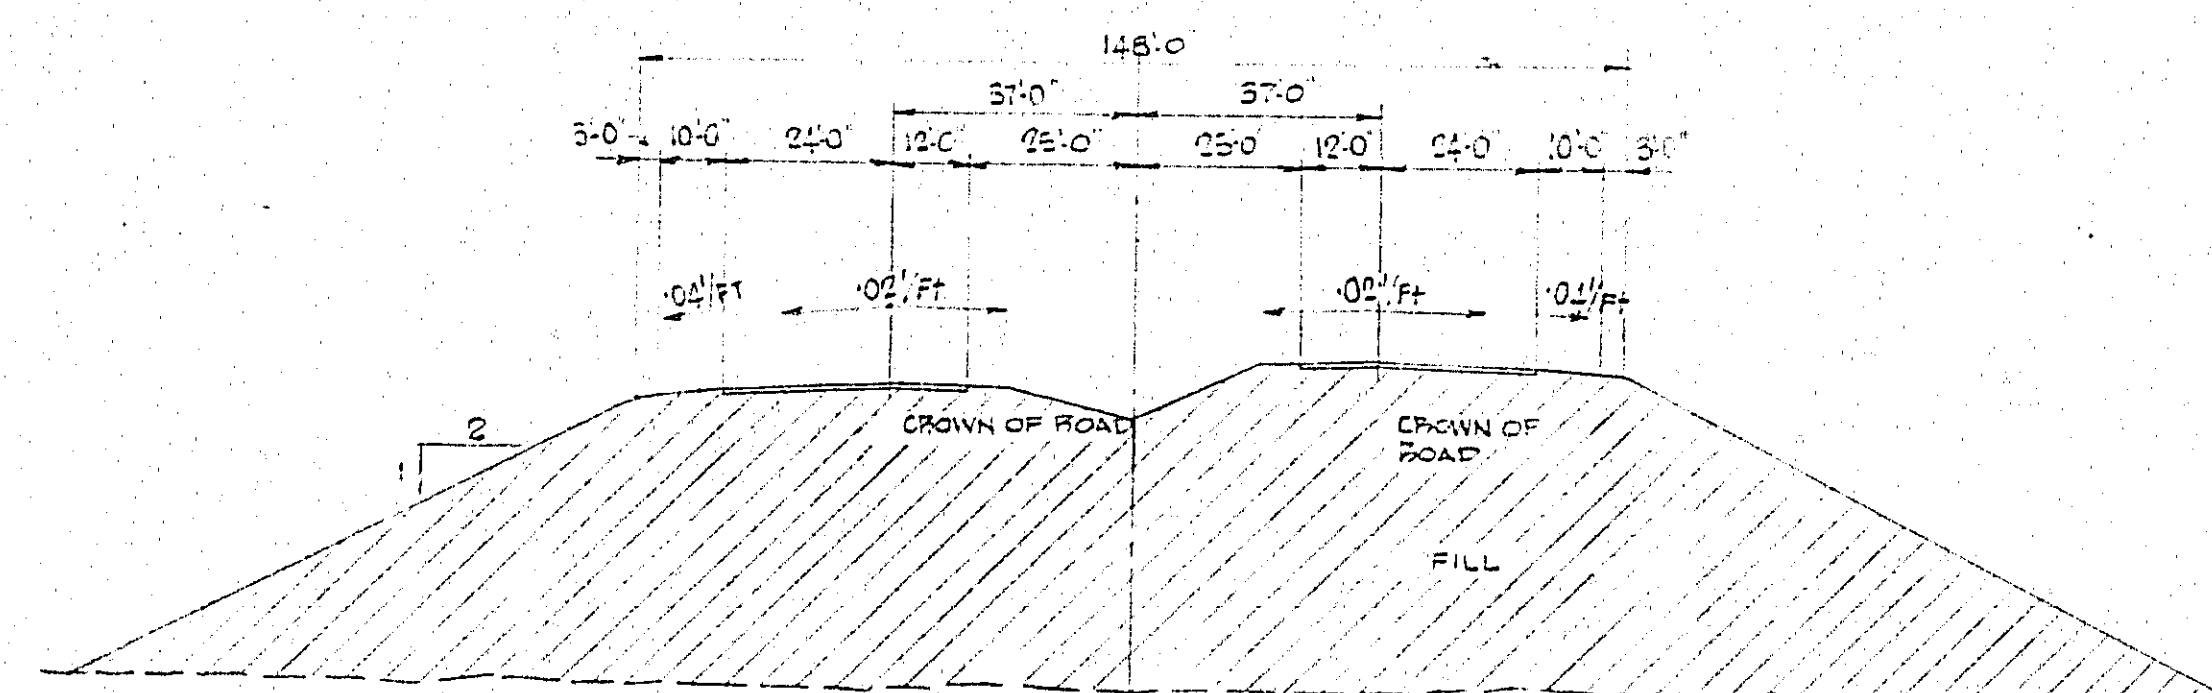
TYPICAL CROSS-SECTION  
THROUGH FILL NEAR STRUCTURE  
SCALE 30' TO 1"

ENGINEERS ARE: EAGER, MACGILLIVRAY & ASSOCIATES LTD - JUNE 1988  
ENGINEERS ARE FOR GENERAL INFORMATION ONLY, AND ARE NOT  
GUARANTEED BY THE DEPARTMENT. THE COMPLETE SOIL INVESTIGATION  
REPORT NR BA-42 MAY BE SEEN AT THE BRIDGE OFFICE DOWNSVIEW.  
THE DEPARTMENT DOES NOT GUARANTEE THE ACCURACY OF THIS  
REPORT NOR THE ABRIDGED VERSION SHOWN HERE.  
LEVEL OF EXISTING GROUND & PROFILE OF CONTROLLED ACCESS.  
HIGHWAY TAKEN FROM D.H.O. PLAN E-2395-1, DATED AUGUST 5, 1980.  
MAXIMUM ALLOWABLE SOIL PRESSURE FOR FOOTINGS = 7 1/2 TONS/50 sq. ft.

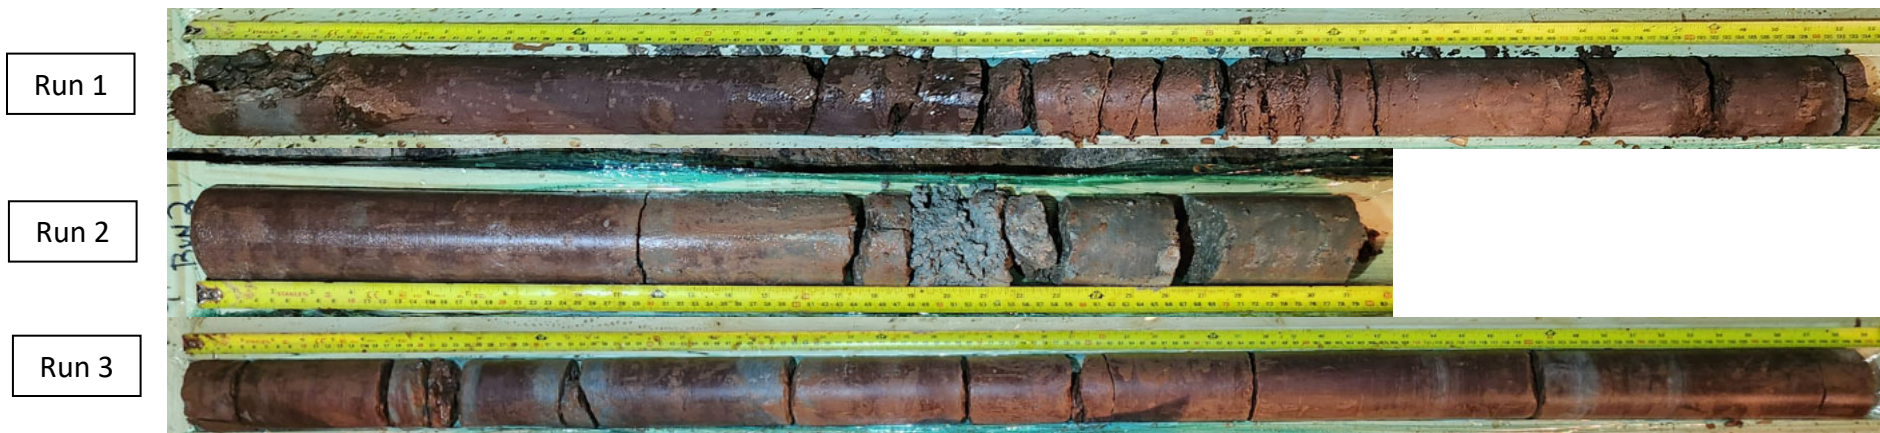
**PHOTOGRAPHS OF ROCK CORES - BOREHOLE HV-01**

**RUNS 1 to 3**

RQD values of 66 and 83 were recorded for Runs 1 to 3 indicating fair to good rock quality. Fracture Index (FI) of the rock, expressed as fractures per 0.3 m of core, ranged from 1 to 7.
