**PRELIMINARY
FOUNDATION INVESTIGATION REPORT
HIDDEN VALLEY CULVERT REHABILITATION
HIGHWAY 403 AND HIGHWAY 6 INTERCHANGE
HAMILTON, ONTARIO
MTO SITE NO. 10-192/C
WO#16-20004
ASSIGNMENT NUMBER 2016-E-0027**

GEOCRES NO. 30M5-360

Date: November 6, 2023
File: 25963

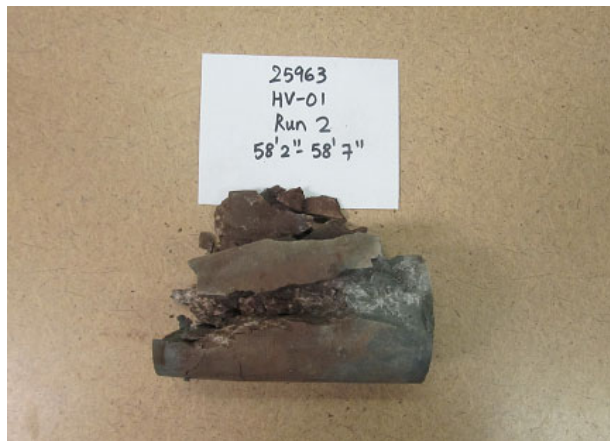
Avg. Height (cm):	12.0	Weight (g):	973.7
Avg. Diameter (cm):	6.3	Wet Density (kg/m ³):	2,603
H. to Dia. Ratio**:	1.9:1	Dry Density (kg/m ³):	2,506
Cross Sectional Area (cm ²):	31.17	Moisture Content* (%):	3.9
Sample Volume (cm ³):	374.07

AVG. RATE OF STRAIN TO FAILURE:	0.250 MPa/s
MAXIMUM COMPRESSIVE LOAD:	49.6 kN
UNCONFINED COMPRESSIVE STRENGTH:	15.9 MPa

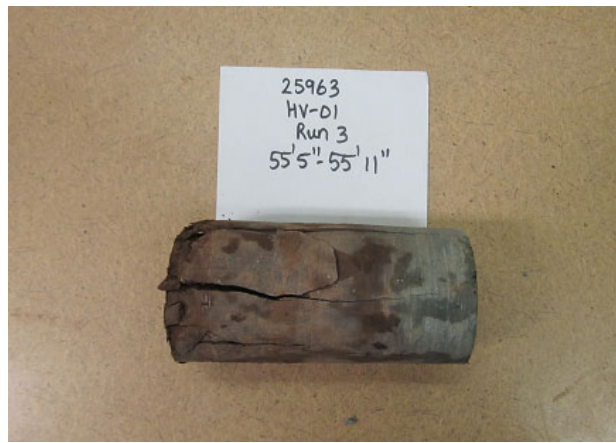
Avg. Height (cm):	12.6	Weight (g):	1036.0
Avg. Diameter (cm):	6.3	Wet Density (kg/m ³):	2,638
H. to Dia. Ratio**:	2:1	Dry Density (kg/m ³):	2,553
Cross Sectional Area (cm ²):	31.17	Moisture Content* (%):	3.3
Sample Volume (cm ³):	392.77

AVG. RATE OF STRAIN TO FAILURE:	0.250 MPa/s
MAXIMUM COMPRESSIVE LOAD:	77.1 kN
UNCONFINED COMPRESSIVE STRENGTH:	24.7 MPa

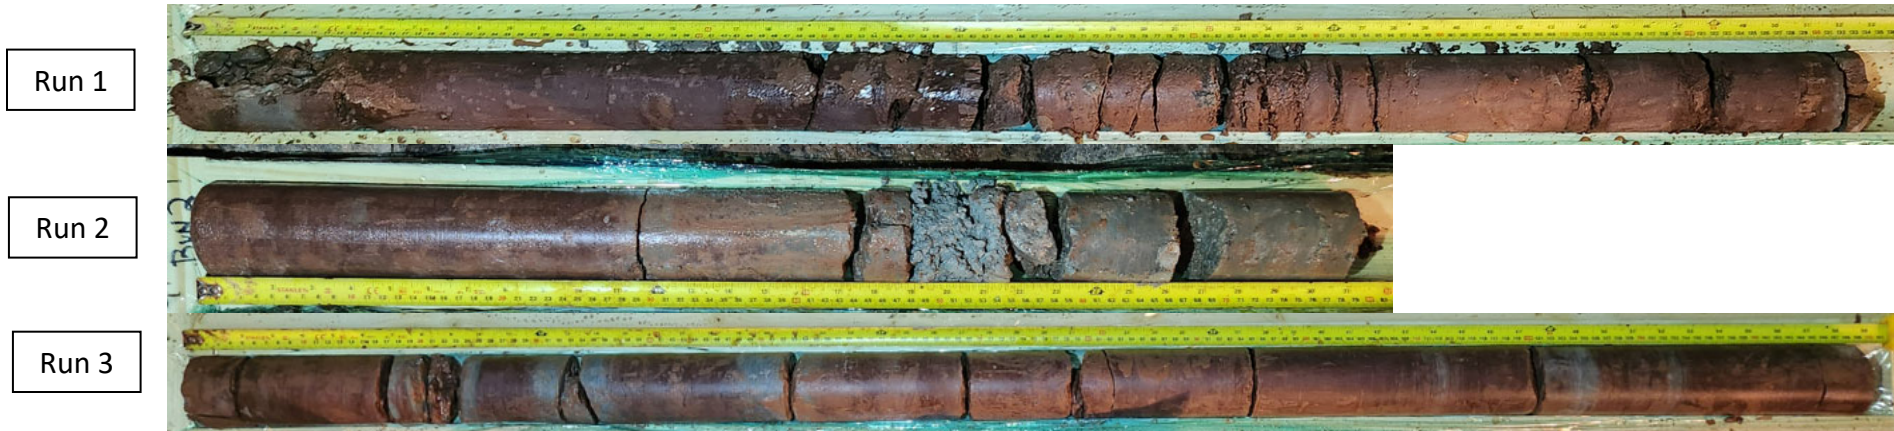
RUNS 1 to 3

PHOTOGRAPHS OF ROCK CORES - BOREHOLE HV-01

Core samples of the shale bedrock were carefully protected to prevent drying during transport to the laboratory. Unconfined compressive strength (UCS) tests and point load tests were carried out on selected samples of intact shale upon arrival at the laboratory to assist in evaluation of the compressive strength of the bedrock. Detailed results of UCS tests and point load tests are included in Appendix B and summarized results are presented on the Record of Borehole sheet in Appendix A. Rock core photos are presented in Appendix D.

RQD values of 66 and 83 were recorded for Runs 1 to 3 indicating fair to good rock quality. Fracture Index (FI) of the rock, expressed as fractures per 0.3 m of core, ranged from 1 to 7.

It must be noted, however, that UCS tests and point load tests were possible only on less weathered shale. Typical weathered shale cores tended to be not suitable for either test. Broken (rubble) zones were observed within the cores at several depths.
