FOUNDATION INVESTIGATION REPORT

STRUCTURAL CULVERT SITE NO. 30-674/C
TOWNSHIP OF RAMA
HIGHWAY 12 FROM GAMEBRIDGE TO RAMA ROAD 25

W.P. 365-98-00
Agreement # 2004-E-0070

08-1-IEG6-30-674/C

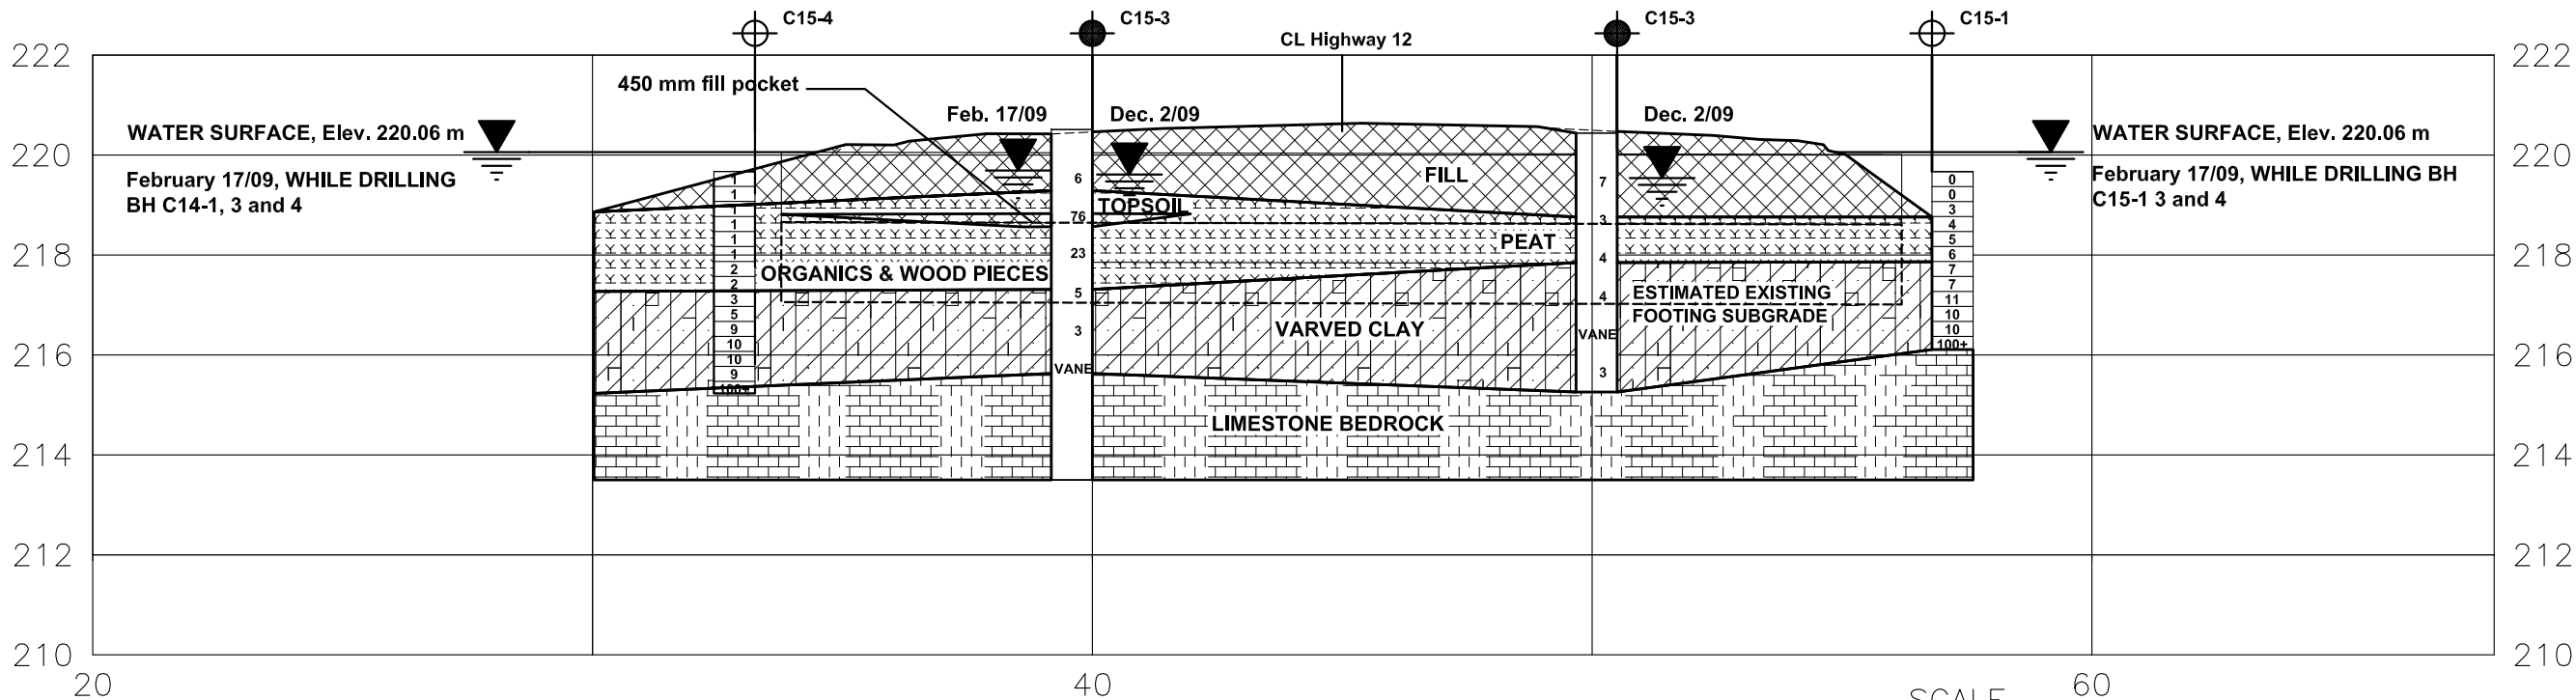
Drawing 1
Borehole Locations
And
Soil Strata

BOREHOLE LOCATION PLAN

SECTION A-A' - CENTERLINE OF CULVERT

Between December 2, 2008 and February 17, 2009, a CME 55 truck-mounted drill rig was supplied by London Soil Test Ltd. and used on site for drilling and Standard Penetration Testing (SPT, following the procedures of ASTM D 1586). Two (2) boreholes (Boreholes C15-2 and C15-3) were drilled and sampled to obtain data for foundation design of the proposed rehabilitation work and potential culvert replacement. Rock coring was carried out on February 17, 2009 adjacent to the original Borehole C15-3 location to provide geotechnical data as per the requirements of our proposal for this work. Hand-drilled boreholes cannot be completed at the location of Borehole C15-1 and C15-4 due to inundation of the area, and a series of dynamic cone penetration tests were carried out instead. The locations of the boreholes are shown on Drawing 1.

Reference is made to the Record of Borehole sheets (Appendix “A”) and Laboratory Test Results (Appendix “B”) for detailed subsurface soil and groundwater conditions encountered in the boreholes. The stratigraphic boundaries shown on the Record of Borehole sheets are inferred from non-continuous sampling and, consequently, represent transitions between soil types rather than exact planes of geological change. The soil profiles depicting the subsurface conditions on Drawing 1 will vary between and beyond the borehole locations.

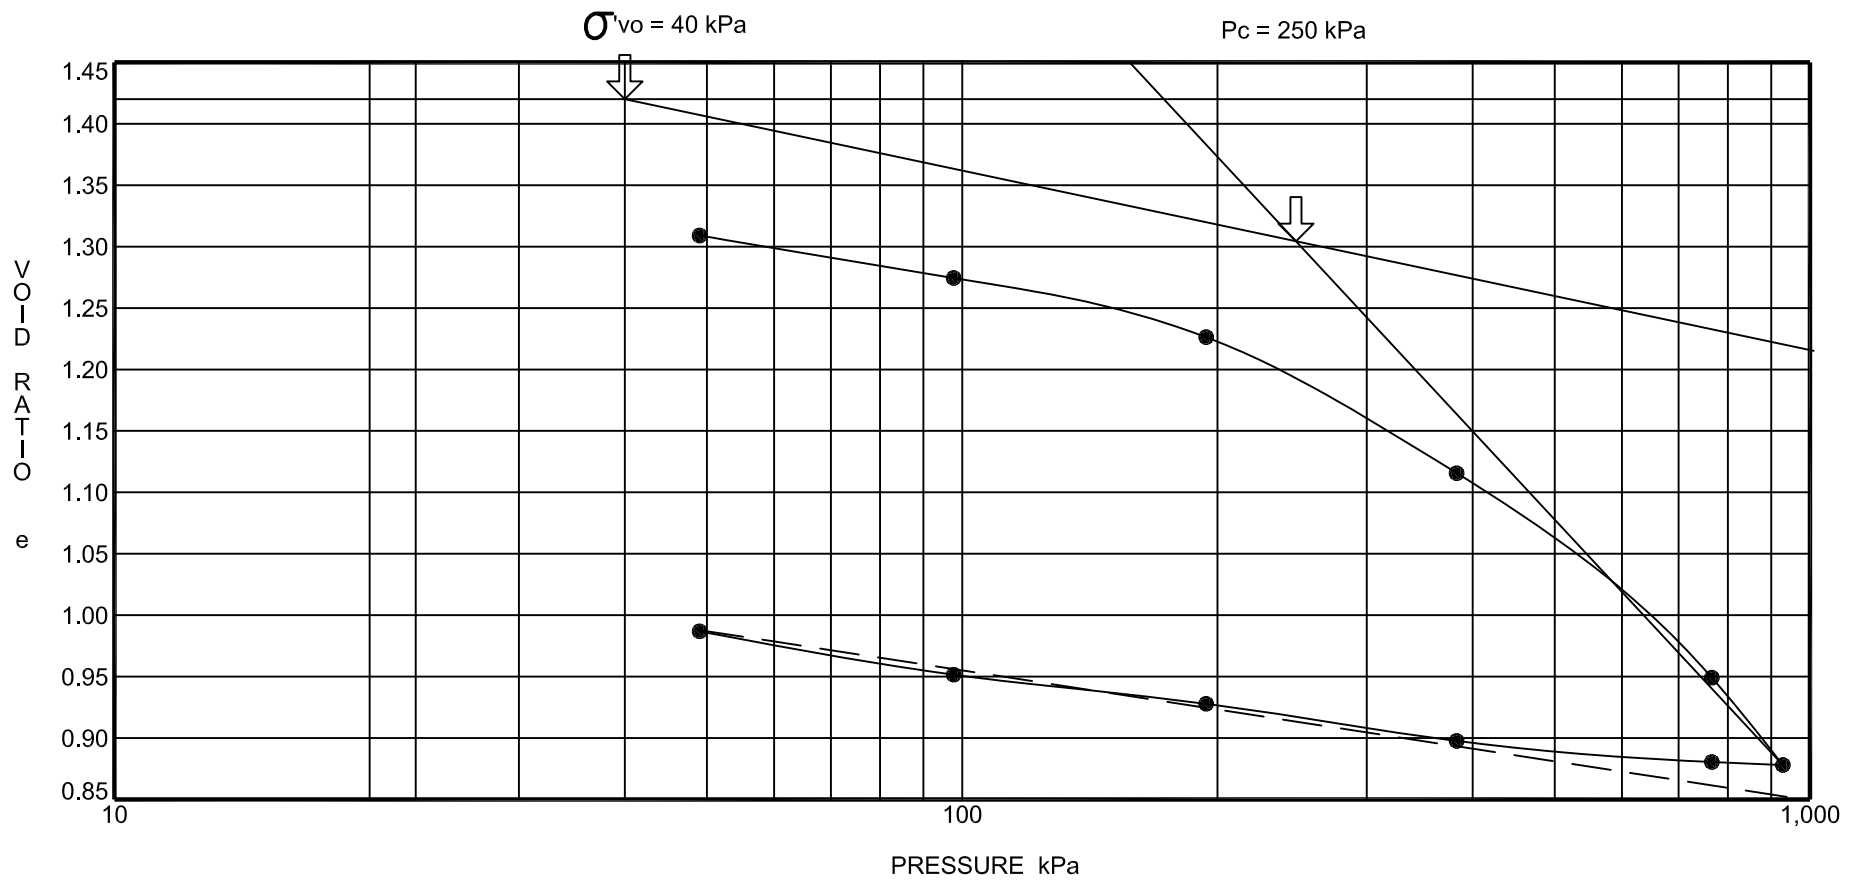
B H	DEPTH	ELEV.	WL	WP	W	CC	CR	σ'_{vo}	γ_d	Classification
● C15-3	3.50	217.01	57	28	49.3	0.742	0.106	40	11.0	VARVED CLAY, CH

A one-dimensional consolidation test (ASTM D 2435) was conducted on a relatively undisturbed thin-walled (Shelby tube) sample obtained from Borehole C15-3 at a depth of 3.20 m. These results are shown in Figure 6 of Appendix B and summarized below:

Sample Depth:	3.50 m
Elevation:	217.01 m
Liquid Limit (W_L)	57 %
Plastic Limit (W_P)	28%
Natural Moisture Content (W)	49%
Compression Index (C_C)	0.742
Recompression Index (C_r)	0.106
Pre-consolidation Pressure (σ_p)	250 kPa
Effective Overburden Pressure (σ_{vo})	40 kPa

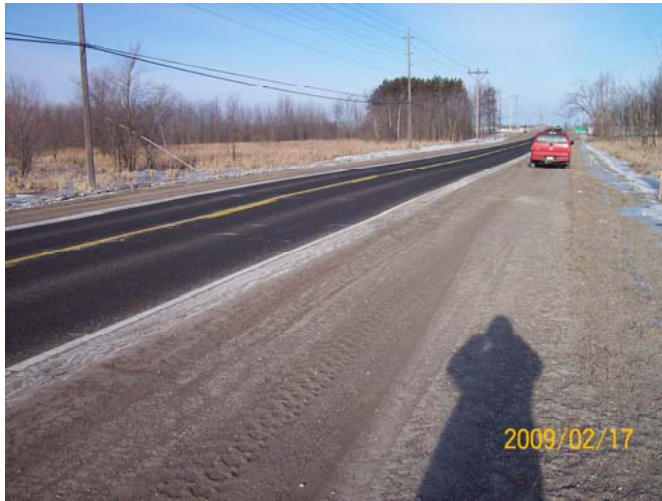
C15 - Station 20+674 - Looking North

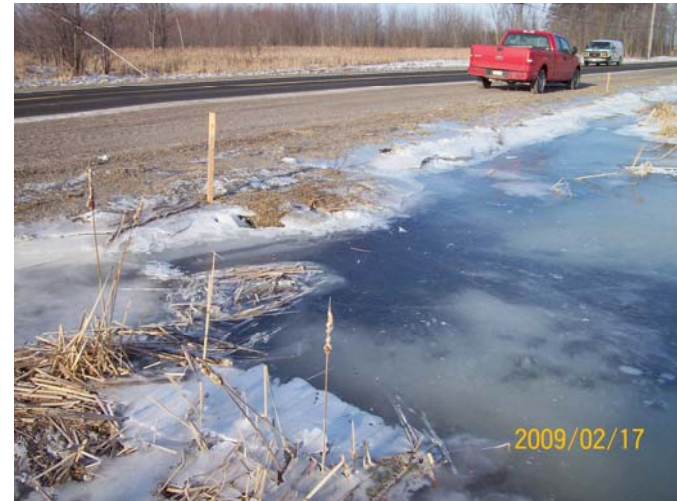
C15 - Station 20+674 - Looking Downstream (west)

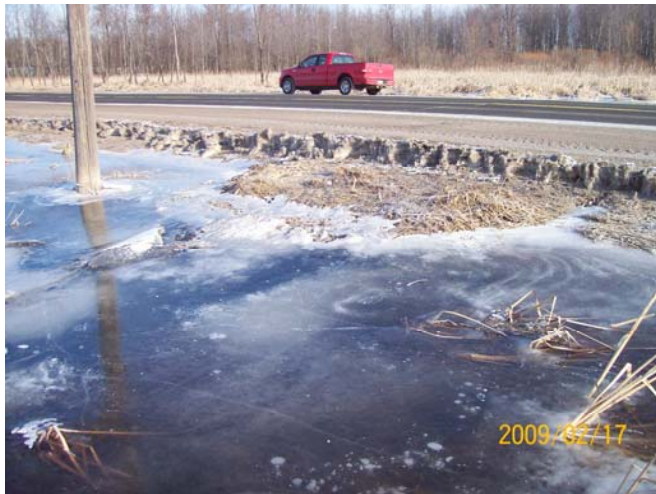
C15 - Station 20+674 - Looking Upstream (east)

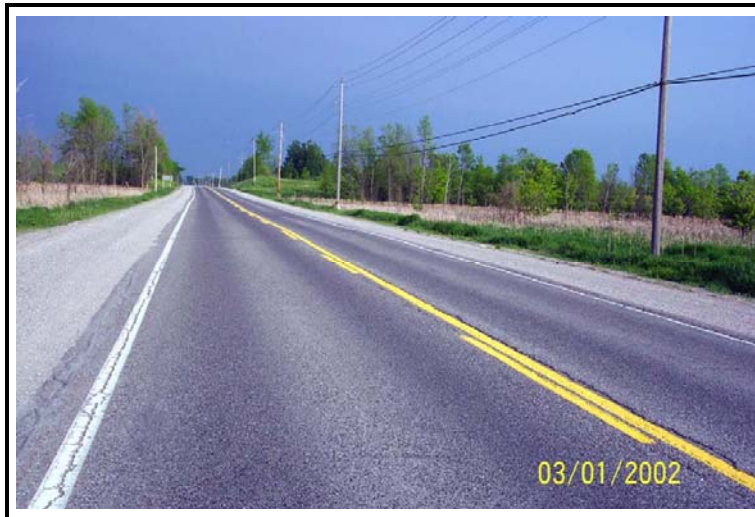
Photo 1 Roadway Above Culvert / South Approach Roadway

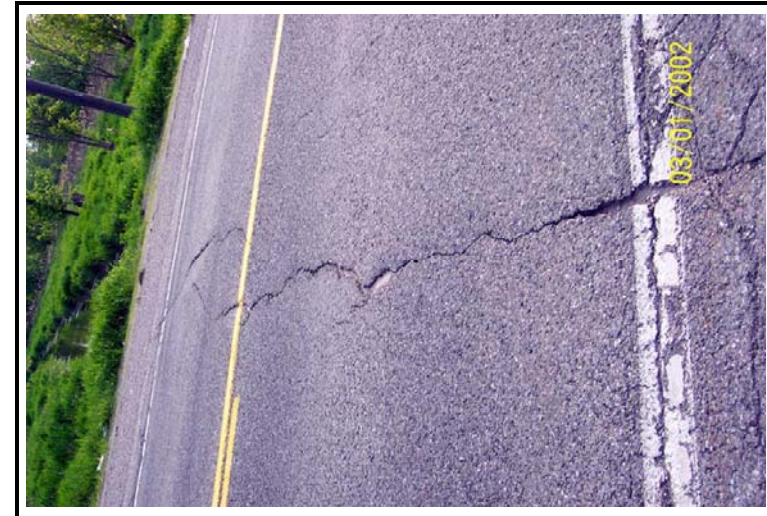
Photo 3 Asphalt Deterioration Along Roadway

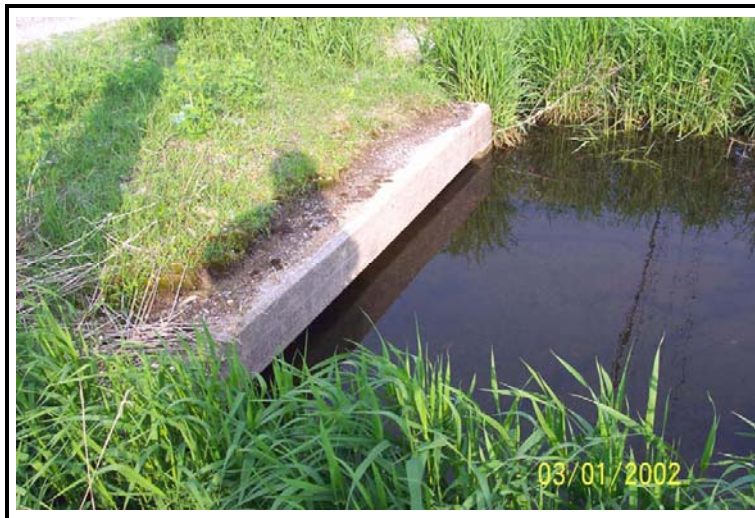
Photo 2 West Elevation

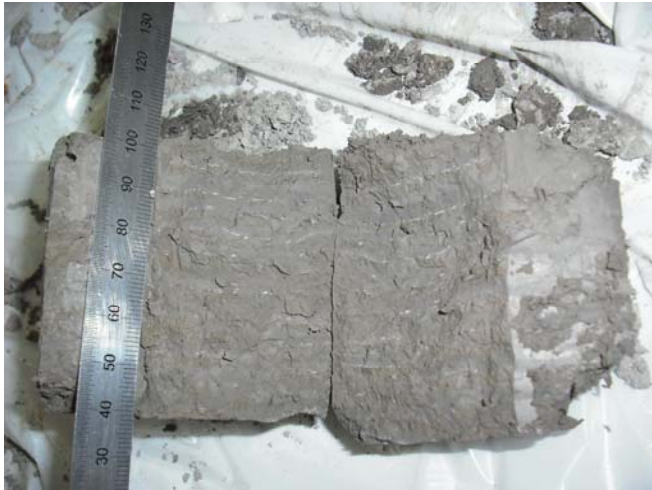
C15-3 Cut Section of Shelby Sample of Varved Clay

A stratum of grey varved clay was contacted below the peat and wood and extended to the limestone bedrock contacted between depths of 2.59 m and 3.20 m below the existing ground surface, at Elevations 217.85 m and 217.31 m, respectively at Boreholes C15-2 and C15-3. The varved clay is generally layered with frequent silt seams and pockets typical of a fluvial deposit. Based on microscopic examination of the Shelby tube sample, the layering within the varved clay has a varve cycle spacing in the order of 7 mm. The sub-millimeter silt seams are composed of white silica (quartz) grains. The clay layers consist of equal thicknesses (2 to 3 mm) of reddish-brown clay (winter deposition) and a dark-grey clay (summer deposition). Microscopic examination also indicate that clay varves contain a significant micaceous content which are aligned and may provide reinforcement to the clay which can breakdown upon disturbance. Photos of the Shelby Tube sample and microscopic examination of the Shelby sample taken between 3.2 m and 3.8 m from Borehole C15-3 are presented in Appendix E.

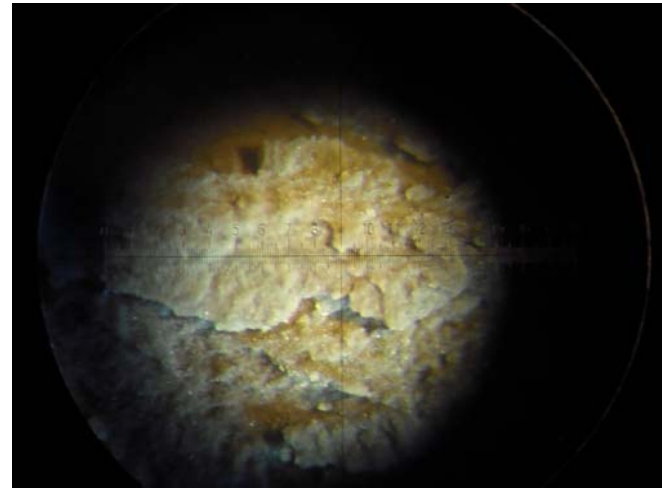
C15-3 .Microscopic Photo of Clay Varve, 1 div=11 μ m

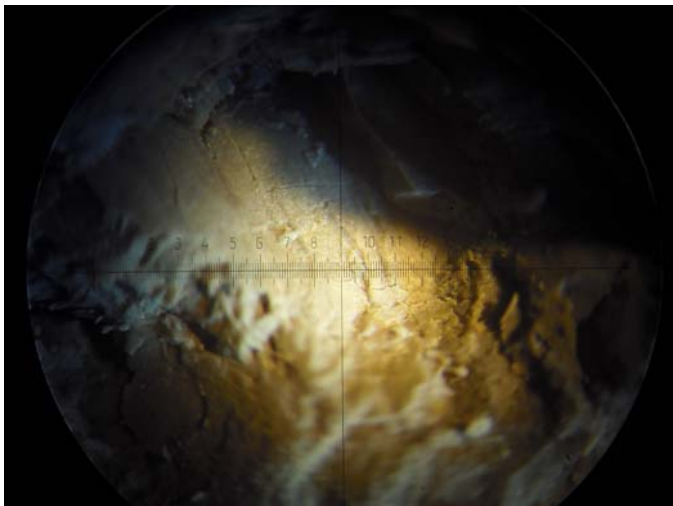
C15-3 .Microscopic Photo of Clay Varve, 1div=25 μ m

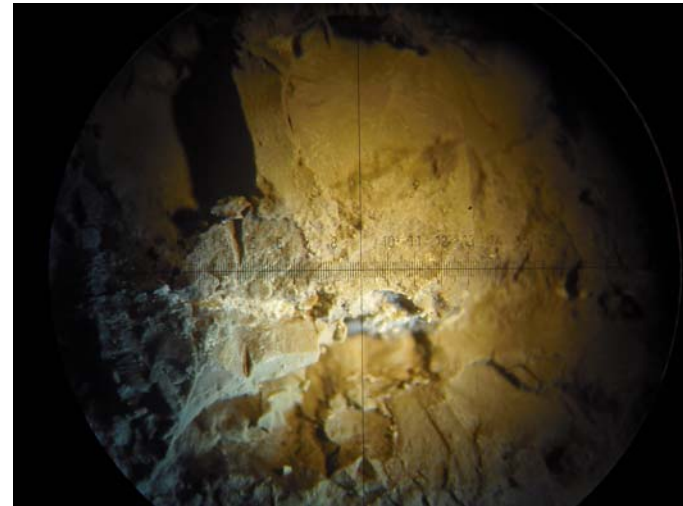
C15-3 .Microscopic Photo of Silt Varve, 1div=5 μ m
