FINAL FOUNDATION INVESTIGATION REPORT

Culvert 25, Highway 69 - 5.5 km South of Highway 7182

Rehabilitation of Highway 69 and Shawanaga River Bridge

G.W.P. 5246-18-00

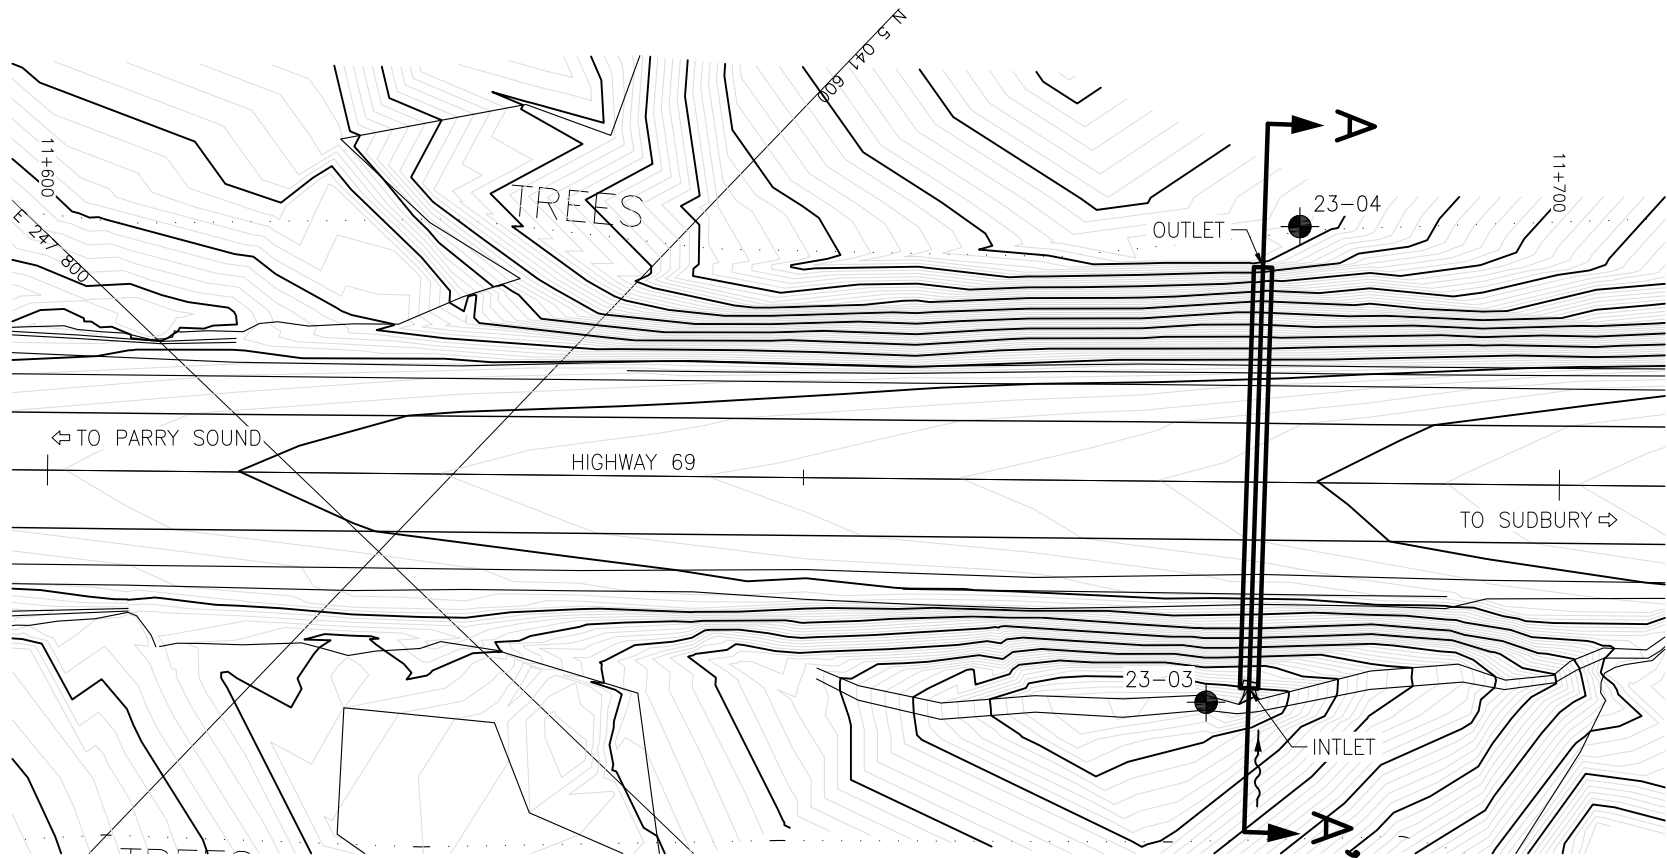
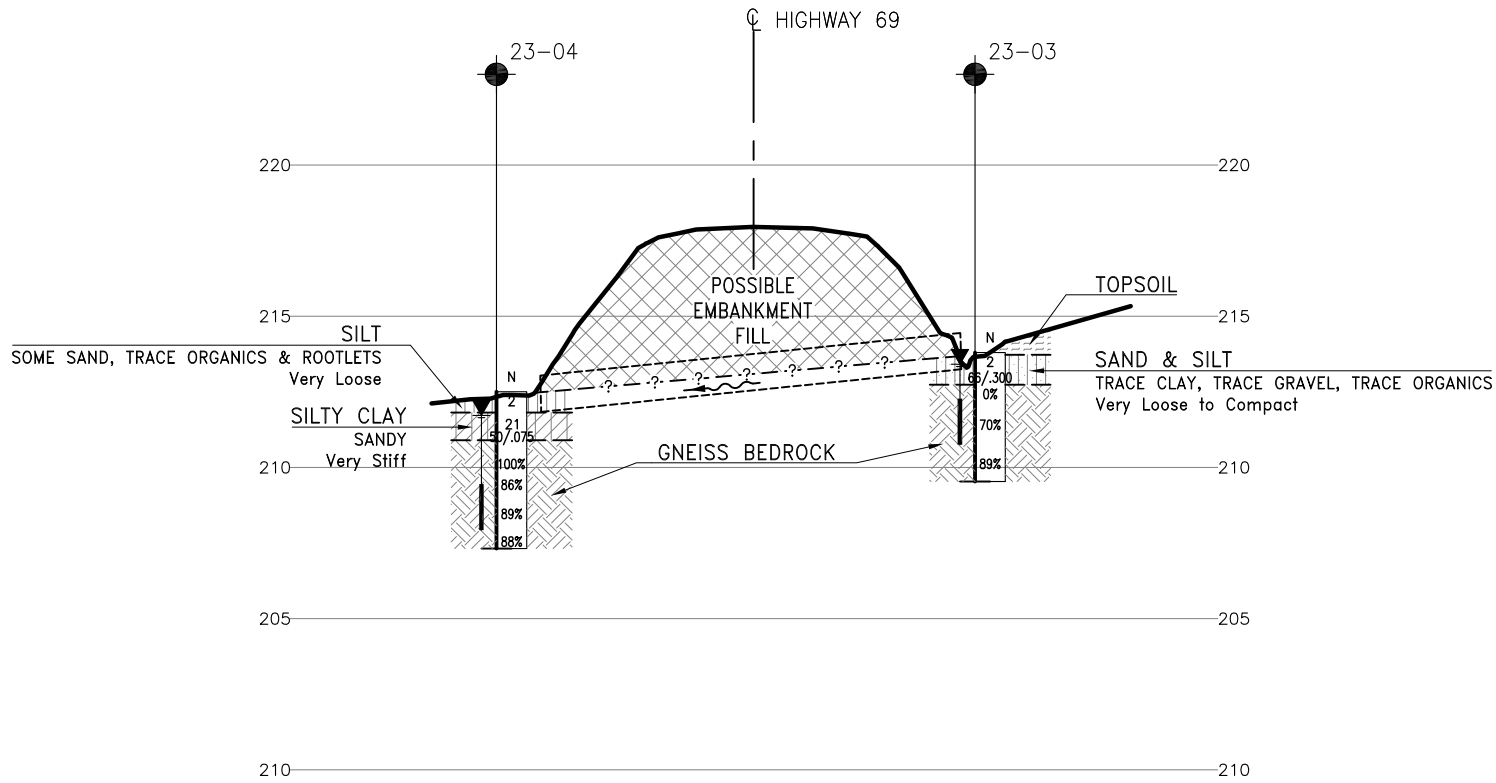
HIGHWAY 69
SHAWANAGA RIVER BRIDGE
CULVERT 25
BOREHOLE LOCATIONS AND SOIL STRATA

SECTION ALONG A-A'

Details of the encountered soil stratigraphy are presented on the Record of Borehole sheets included in Appendix B and on the Borehole Locations and Soil Strata drawing in Appendix A. A general description of the stratigraphy, based on the conditions encountered in the boreholes, is given in the following paragraphs. However, the factual data presented in the Record of Borehole sheets governs any interpretation of the site conditions. It must be recognized that soil conditions may vary between and beyond the borehole locations.

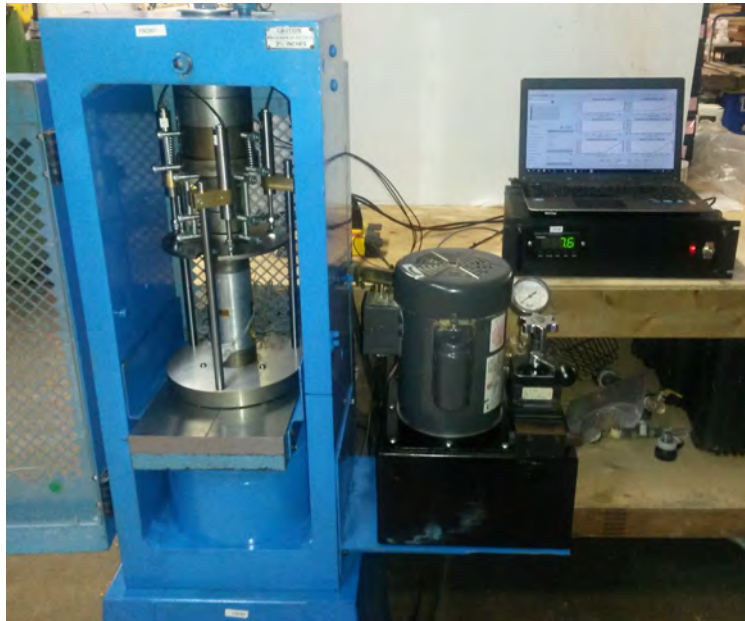
Figure 1: Forney loading frame setup for UCS testing.

This section summarizes the results of uniaxial compressive strength (UCS) testing. The testing was performed in Geomechanica's rock testing laboratory using a 150 ton (1.3 MN) Forney loading frame equipped with pressure-compensated control valve to maintain an axial displacement rate of approximately 0.05 mm/min (Figure 1). The preparation and testing procedure for each specimen included the following:

1. Unwrapping the core sample and inspecting it for damage.
2. Diamond cutting the core sample to obtain a cylindrical specimen with an appropriate length (length:diameter = 2:1) and nearly parallel end faces.
3. Diamond grinding the specimen to obtain flat (within ± 0.025 mm) and parallel end faces (within 0.25°).
4. Placing the specimen into the loading frame and axially loading the specimen to rupture while continuously recording axial force and axial deformation to determine the peak strength (UCS).

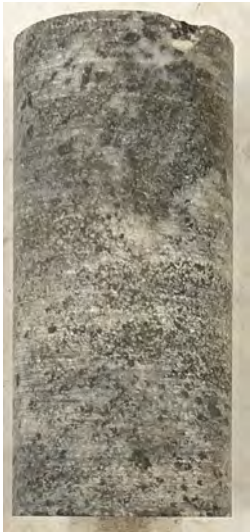
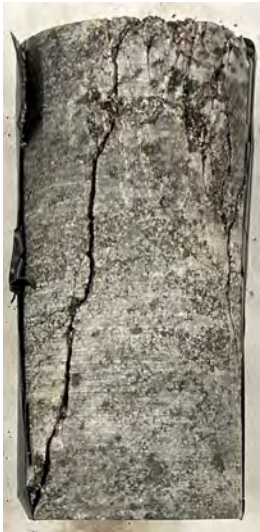
Client	Thurber Engineering Ltd.	Project	30351
Sample	BH23-01	Depth	32' 10" - 33' 10"
<div>Specimen parameters</div>		Prior to testing	After testing
Diameter (mm) ^a	60.80

Length (mm) ^a	129.90		
Bulk density ρ (g/cm ³)	2.769		
UCS (MPa)	90.5		
Lithology	Granite gneiss		
Failure description ^b	1, 2		
<div>^a Additional specimen measurement/details provided in accompanying summary spreadsheet.</div> <div>^b Failure description: ¹ Inclined shear failure; ² Partial hourglass failure;</div>			
Remarks: Loading Rate: 0.05mm/min.			
Performed by	SD	Date	2023-11-08

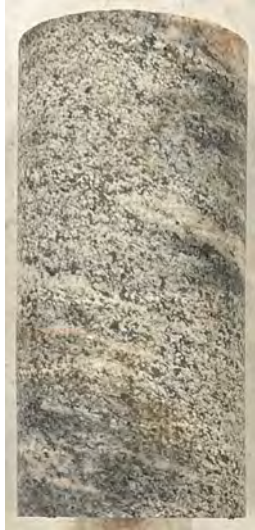
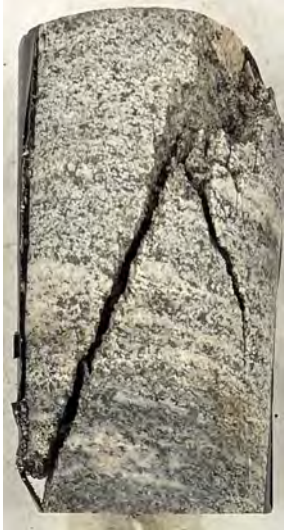
Client	Thurber Engineering Ltd.	Project	30351
Sample	BH23-02	Depth	2'3" - 3'2"
<div>Specimen parameters</div>		Prior to testing	After testing
Diameter (mm) ^a	62.92

Length (mm) ^a	129.18		
Bulk density ρ (g/cm³)	2.770		
UCS (MPa)	117.4		
Lithology	Granite gneiss		
Failure description ^b	1		
<div>^a Additional specimen measurement/details provided in accompanying summary spreadsheet.</div> <div>^b Failure description: ¹ Inclined shear failure;</div>			
Remarks: Loading Rate: 0.05mm/min. Specimen experienced pre-peak localized failure(s).			
Performed by	SD	Date	2023-11-08

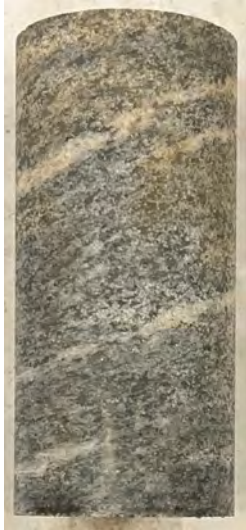
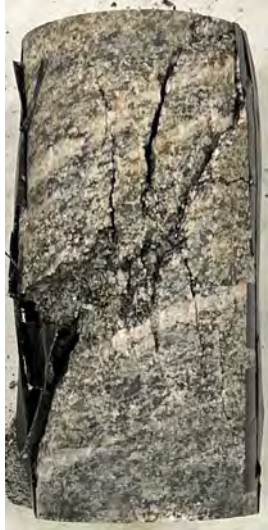
Client	Thurber Engineering Ltd.	Project	30351
Sample	BH23-03	Depth	3' 10" - 4' 8"
<div>Specimen parameters</div>		Prior to testing	After testing
Diameter (mm) ^a	60.75

Length (mm) ^a	129.54		
Bulk density ρ (g/cm ³)	2.792		
UCS (MPa)	118.4		
Lithology	Granite gneiss		
Failure description ^b	3		
<div>^a Additional specimen measurement/details provided in accompanying summary spreadsheet.</div> <div>^b Failure description: ³ Inclined shear fracture and axial splitting failure;</div>			
Remarks: Loading Rate: 0.05mm/min.			
Performed by	SD	Date	2023-11-08

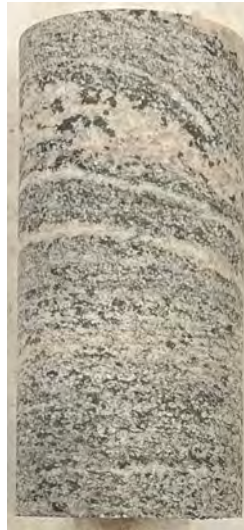
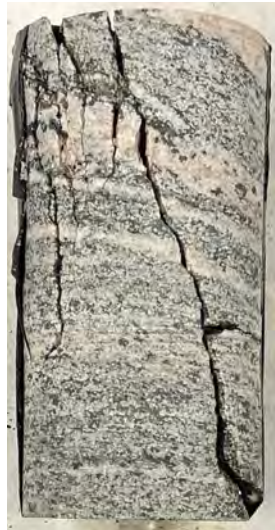
Client	Thurber Engineering Ltd.	Project	30351
Sample	BH23-04	Depth	8'0" - 8'10"
<div>Specimen parameters</div>		Prior to testing	After testing
Diameter (mm) ^a	61.85

Length (mm) ^a	129.19		
Bulk density ρ (g/cm ³)	2.753		
UCS (MPa)	101.2		
Lithology	Granite gneiss		
Failure description ^b	1		
<div>^a Additional specimen measurement/details provided in accompanying summary spreadsheet.</div> <div>^b Failure description: ¹ Inclined shear failure;</div>			
Remarks: Loading Rate: 0.05mm/min.			
Performed by	SD	Date	2023-11-08

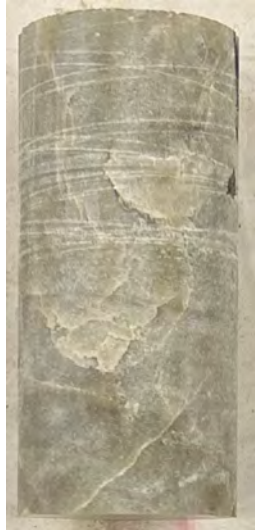
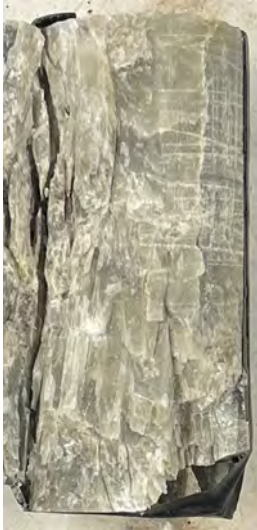
Client	Thurber Engineering Ltd.	Project	30351
Sample	BH23-05	Depth	21'0" - 22'11"
<div>Specimen parameters</div>		Prior to testing	After testing
Diameter (mm) ^a	47.52

Length (mm) ^a	102.95		
Bulk density ρ (g/cm ³)	2.646		
UCS (MPa)	117.3		
Lithology	Pegmatite		
Failure description ^b	4		
<div><div>^a Additional specimen measurement/details provided in accompanying summary spreadsheet.</div><div>^b Failure description: ⁴ Axial splitting failure;</div></div>			
Remarks: Loading Rate: 0.05mm/min. Specimen expereinced pre-peak localized failure(s).			
Performed by	SD	Date	2023-11-08

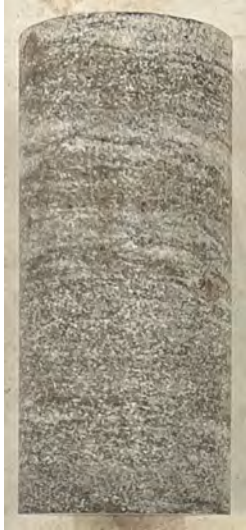
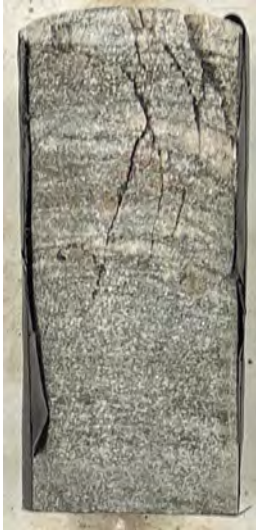
Client	Thurber Engineering Ltd.	Project	30351
Sample	BH23-07	Depth	13'5" - 14'4"
Specimen parameters		Prior to testing	After testing
Diameter (mm) ^a	46.74

Length (mm) ^a	103.86		
Bulk density ρ (g/cm ³)	2.746		
UCS (MPa)	90.2		
Lithology	Granite gneiss		
Failure description ^b	3		
^a Additional specimen measurement/details provided in accompanying summary spreadsheet.			
^b Failure description: ³ Inclined shear fracture and axial splitting failure;			
Remarks: Loading Rate: 0.05mm/min.			
Performed by	SD	Date	2023-11-08

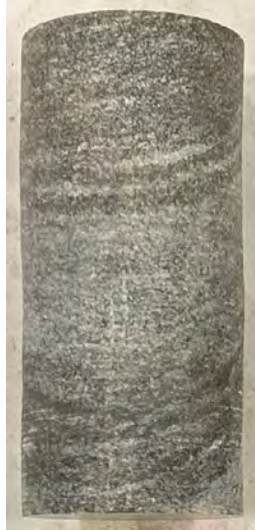
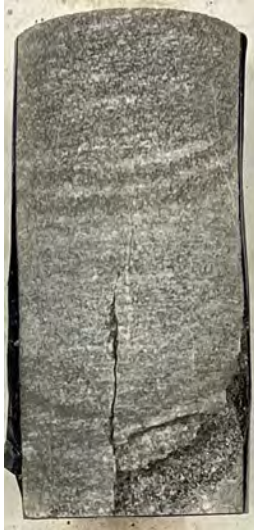
Client	Thurber Engineering Ltd.	Project	30351
Sample	BH23-09	Depth	7' 10" - 8' 5"
<div>Specimen parameters</div>		Prior to testing	After testing
Diameter (mm) ^a	48.54

Length (mm) ^a	103.59		
Bulk density ρ (g/cm ³)	2.753		
UCS (MPa)	113.8		
Lithology	Granite gneiss		
Failure description ^b	3, 5		
<div>^a Additional specimen measurement/details provided in accompanying summary spreadsheet. ^b Failure description: ³ Inclined shear fracture and axial splitting failure; ⁵ Failure partly along pre-existing structure;</div>			
Remarks: Loading Rate: 0.05mm/min.			
Performed by	SD	Date	2023-11-08

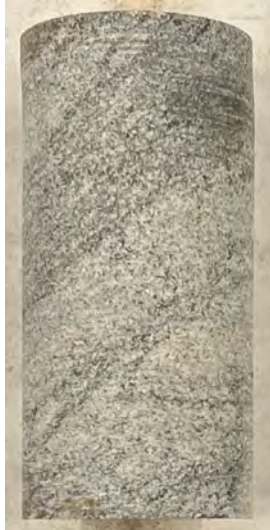
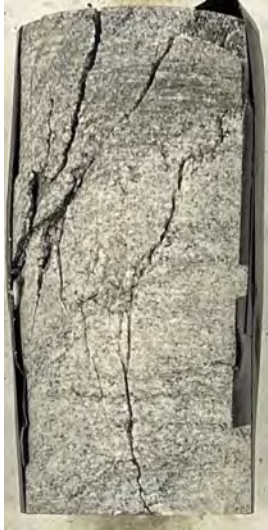
Client	Thurber Engineering Ltd.	Project	30351
Sample	BH23-10	Depth	27'6" - 28'5"
<div>Specimen parameters</div>		Prior to testing	After testing
Diameter (mm) ^a	50.08

Length (mm) ^a	103.01		
Bulk density ρ (g/cm ³)	2.661		
UCS (MPa)	129.2		
Lithology	Granite gneiss		
Failure description ^b	3		
<div>^a Additional specimen measurement/details provided in accompanying summary spreadsheet.</div> <div>^b Failure description: ³ Inclined shear fracture and axial splitting failure;</div>			
Remarks: Loading Rate: 0.05mm/min.			
Performed by	SD	Date	2023-11-08

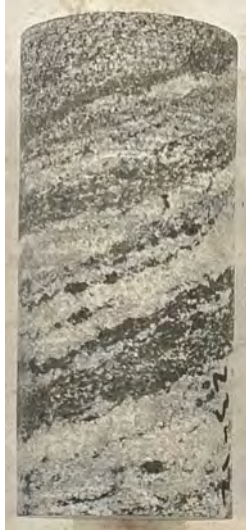
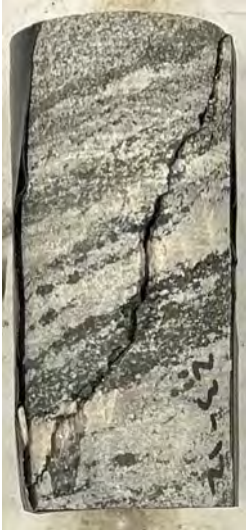
Client	Thurber Engineering Ltd.	Project	30351
Sample	BH23-12	Depth	21'5" - 22'4"
Specimen parameters		Prior to testing	After testing
Diameter (mm) ^a	46.99

Length (mm) ^a	103.61		
Bulk density ρ (g/cm ³)	2.775		
UCS (MPa)	86.7		
Lithology	Granite gneiss		
Failure description ^b	1		
^a Additional specimen measurement/details provided in accompanying summary spreadsheet.			
^b Failure description: ¹ Inclined shear failure;			
Remarks: Loading Rate: 0.05mm/min.			
Performed by	SD	Date	2023-11-08

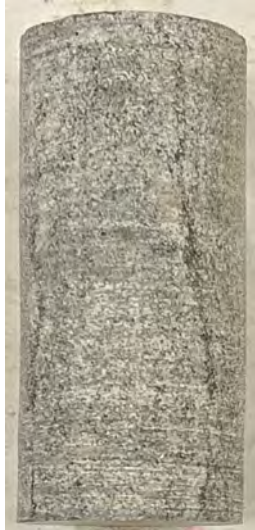
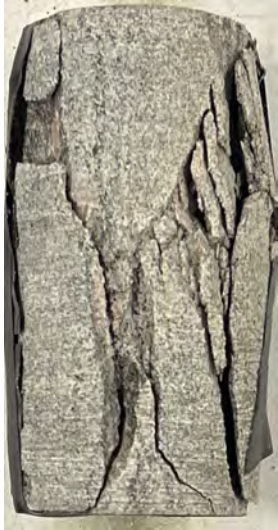
Client	Thurber Engineering Ltd.	Project	30351
Sample	BH23-13	Depth	6'6" - 7'2"
<div>Specimen parameters</div>		Prior to testing	After testing
Diameter (mm) ^a	48.89

Length (mm) ^a	103.89		
Bulk density ρ (g/cm ³)	2.674		
UCS (MPa)	129.4		
Lithology	Granite gneiss		
Failure description ^b	6		
<div><div>^a Additional specimen measurement/details provided in accompanying summary spreadsheet.</div><div>^b Failure description: ⁶ Hourglass failure;</div></div>			
Remarks: Loading Rate: 0.05mm/min.			
Performed by	SD	Date	2023-11-08

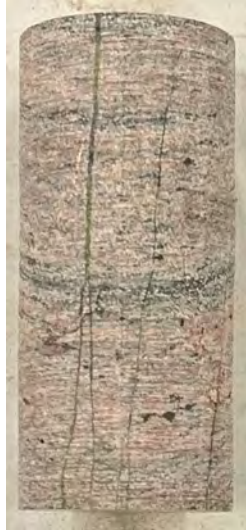
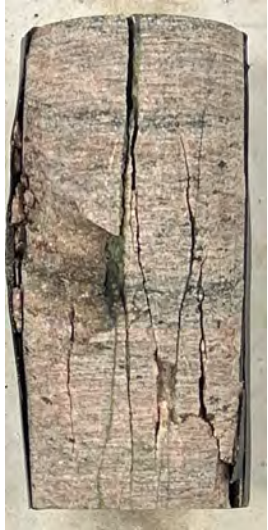
Client	Thurber Engineering Ltd.	Project	30351
Sample	BH23-15	Depth	17'2" - 17'10"
<div>Specimen parameters</div>		Prior to testing	After testing
Diameter (mm) ^a	49.61

Length (mm) ^a	103.77		
Bulk density ρ (g/cm ³)	2.416		
UCS (MPa)	98.6		
Lithology	Granite gneiss		
Failure description ^b	3, 5		
<div>^a Additional specimen measurement/details provided in accompanying summary spreadsheet.</div> <div>^b Failure description: ³ Inclined shear fracture and axial splitting failure; ⁵ Failure partly along pre-existing structure;</div>			
Remarks: Loading Rate: 0.05mm/min.			
Performed by	SD	Date	2023-11-08

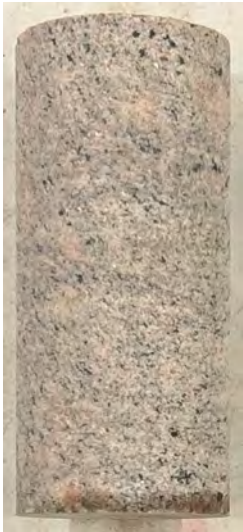
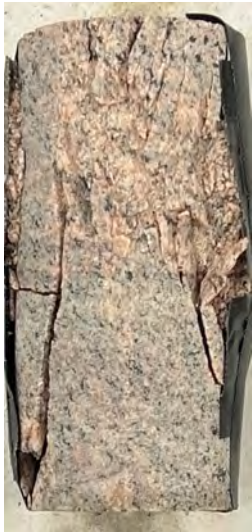
Client	Thurber Engineering Ltd.	Project	30351
Sample	BH23-16	Depth	7'3" - 7'11"
<div>Specimen parameters</div>		Prior to testing	After testing
Diameter (mm) ^a	47.11

Length (mm) ^a	103.57		
Bulk density ρ (g/cm ³)	2.648		
UCS (MPa)	147.0		
Lithology	Granite gneiss		
Failure description ^b	3, 2		
<div>^a Additional specimen measurement/details provided in accompanying summary spreadsheet. ^b Failure description: ³ Inclined shear fracture and axial splitting failure; ² Partial hourglass failure;</div>			
Remarks: Loading Rate: 0.05mm/min.			
Performed by	SD	Date	2023-11-08

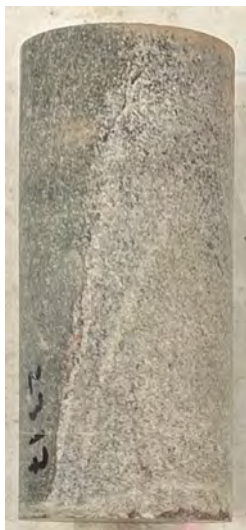
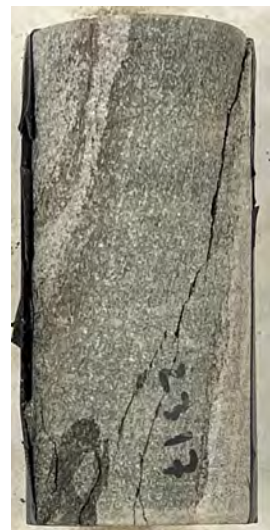
Client	Thurber Engineering Ltd.	Project	30351
Sample	BH23-17	Depth	12'6" - 13'5"
<div>Specimen parameters</div> <div><div>Diameter (mm) ^a</div><div>Length (mm) ^a</div><div>Bulk density ρ (g/cm³)</div><div>UCS (MPa)</div><div>Lithology</div><div>Failure description ^b</div></div>		<div>Prior to testing</div> <div>

</div>
<div><div>^a Additional specimen measurement/details provided in accompanying summary spreadsheet.</div><div>^b Failure description: ¹ Inclined shear failure; ⁵ Failure partly along pre-existing structure;</div></div>			
Remarks: Loading Rate: 0.05mm/min.			
Performed by	SD	Date	2023-11-08

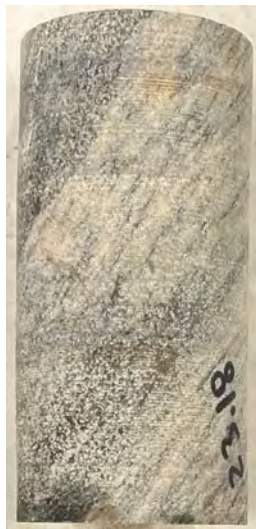
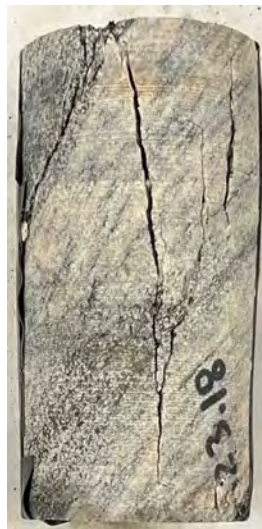
Client	Thurber Engineering Ltd.	Project	30351
Sample	BH23-18	Depth	28'7" - 29'7"
<div>Specimen parameters</div> <div><div>Diameter (mm)^a</div><div>Length (mm)^a</div><div>Bulk density ρ (g/cm³)</div><div>UCS (MPa)</div><div>Lithology</div><div>Failure description^b</div></div>		<div>Prior to testing</div> <div>

</div>
<div><div>^a Additional specimen measurement/details provided in accompanying summary spreadsheet.</div><div>^b Failure description: ³ Inclined shear fracture and axial splitting failure; ⁵ Failure partly along pre-existing structure;</div></div>			
Remarks: Loading Rate: 0.05mm/min.			
Performed by	SD	Date	2023-11-08

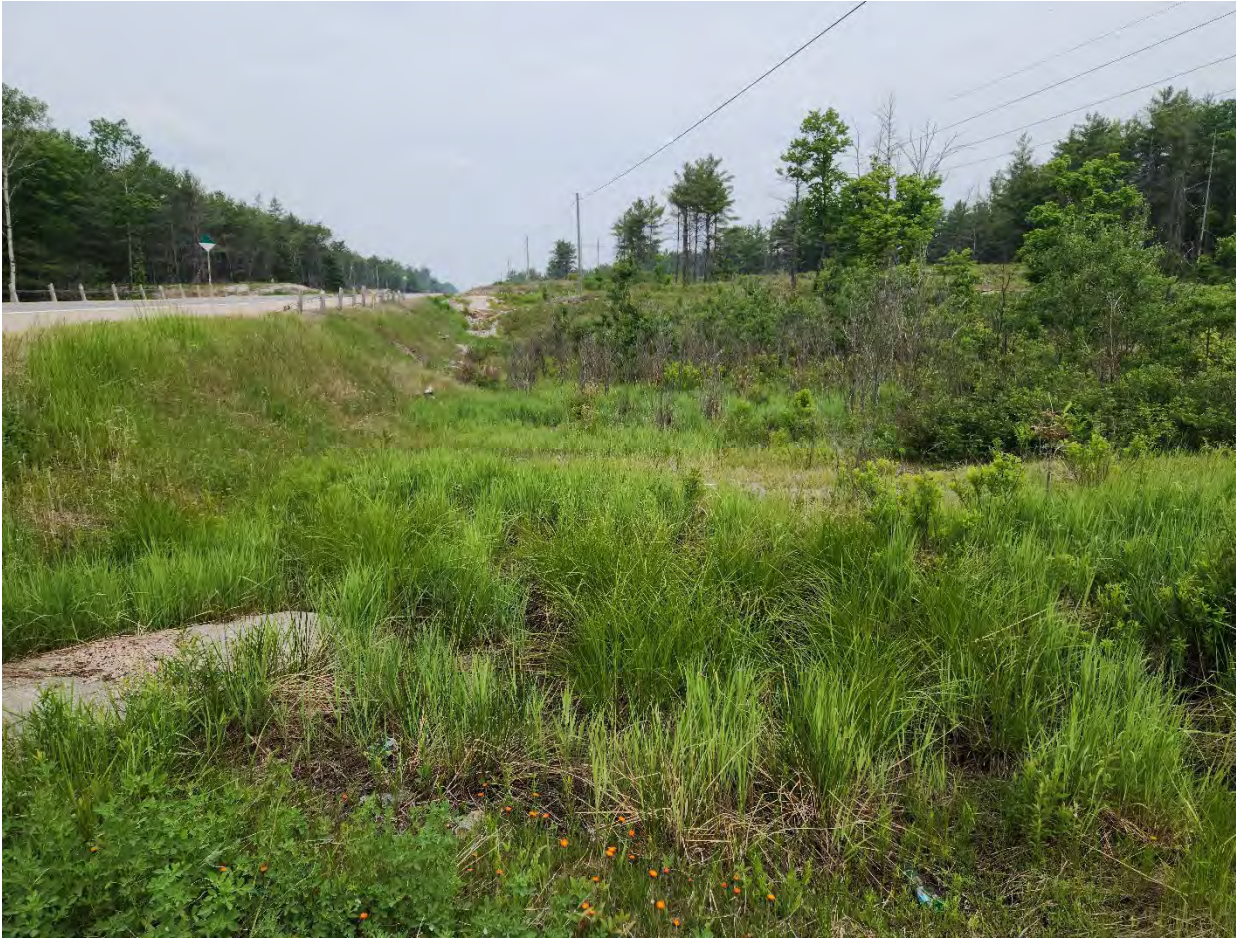
Photograph 2: Culvert 25 inlet, east embankment slope looking north.

At the time of the investigation, no water was observed flowing through the culvert. Small pools/puddles of stagnant water were noted near each end of the culvert and the ground was generally wet.

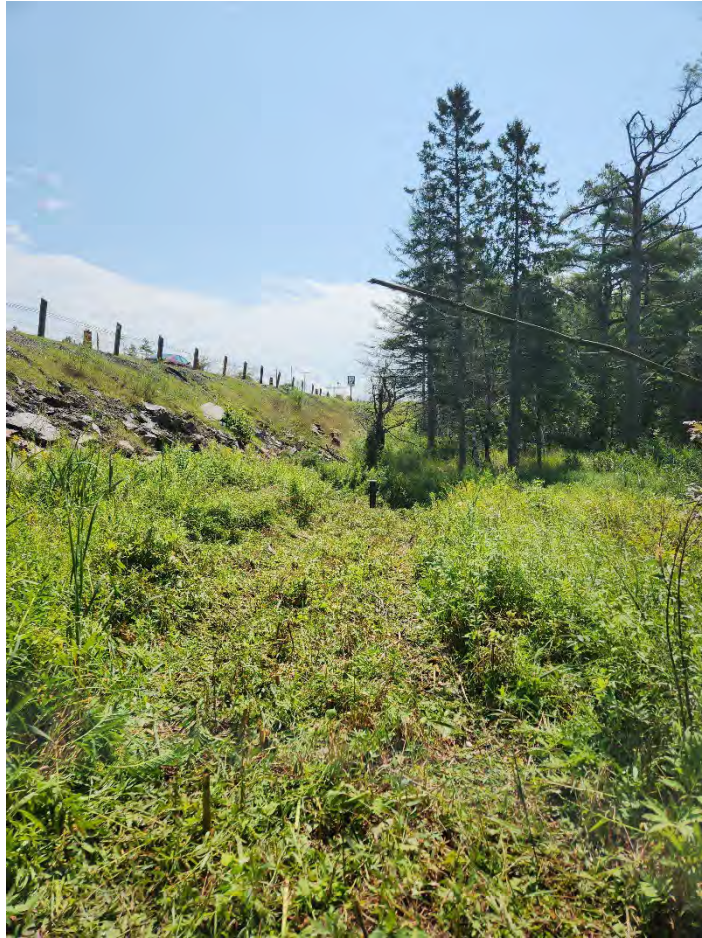
Photograph 3: Culvert 25 outlet, west embankment slope looking south.

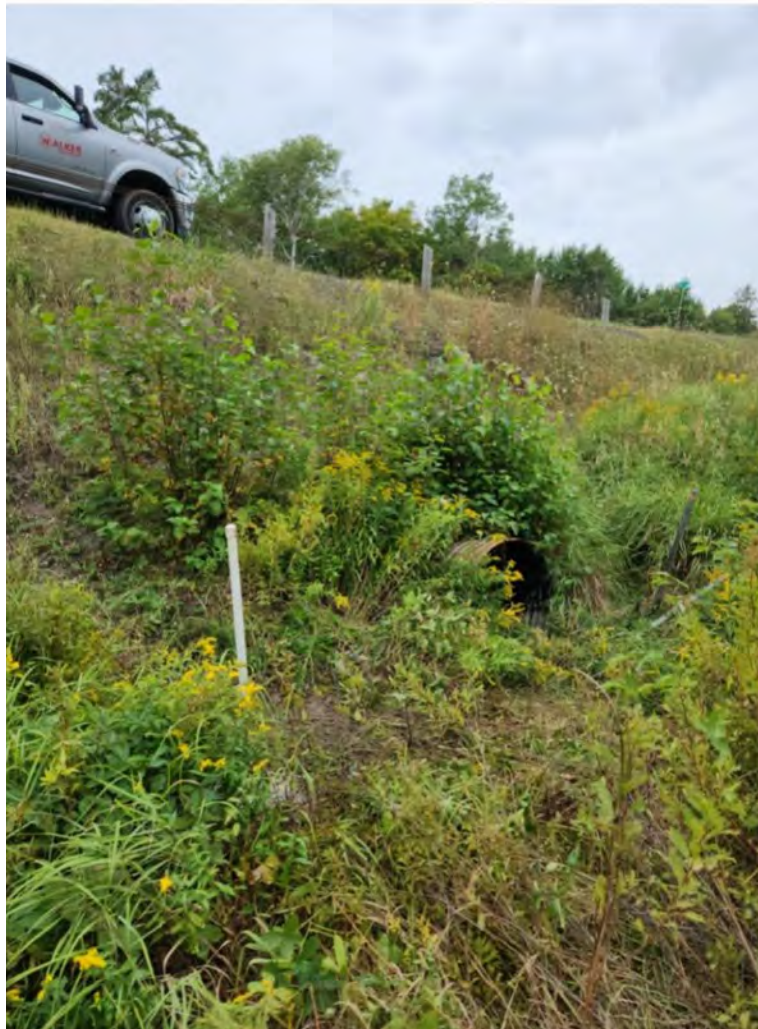
Photograph 4: Borehole 23-03 after completion.

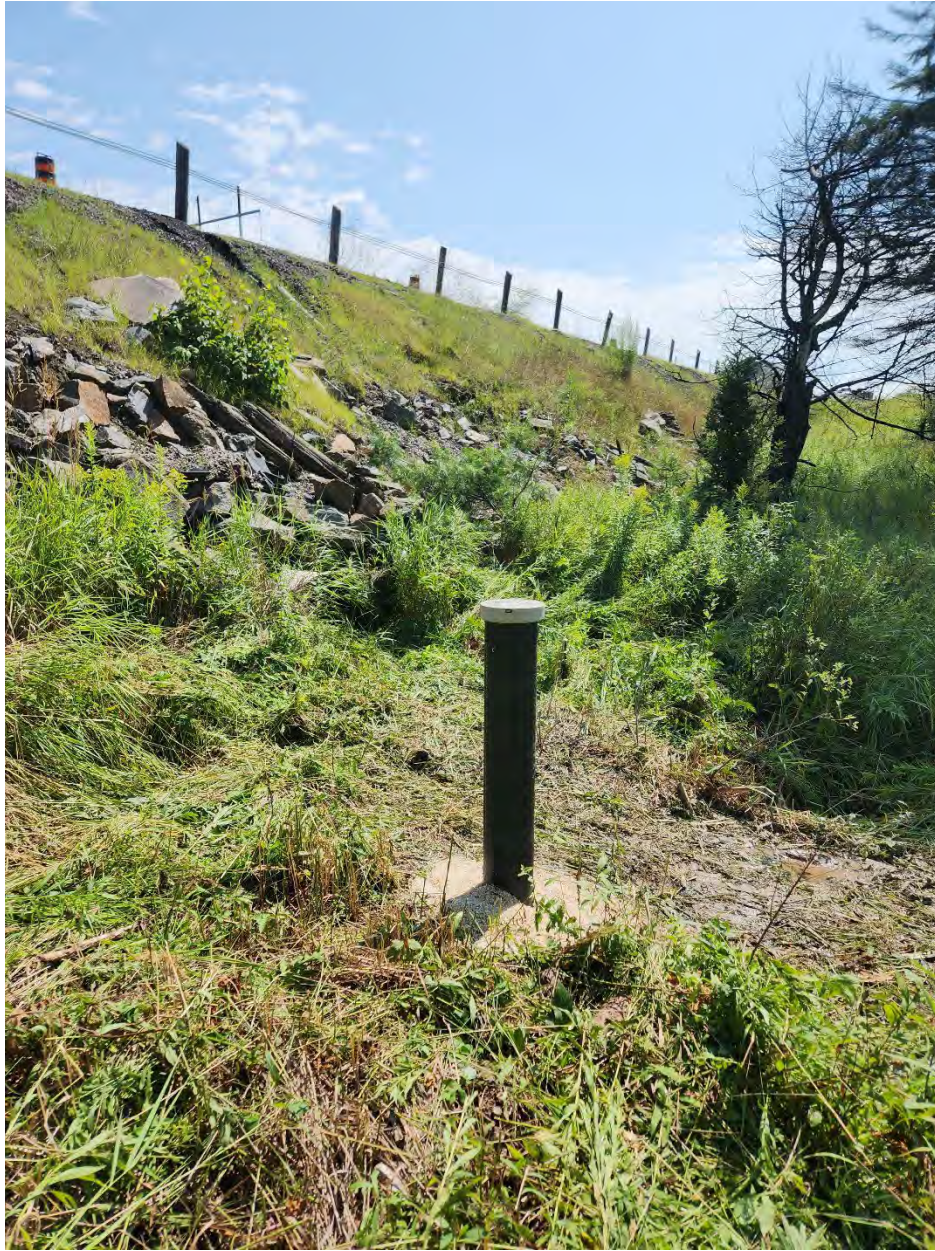
Photograph 5: Borehole 23-04 after completion.
