THURBER ENGINEERING LTD.

**CALAMITY CREEK SLOPE FAILURE INVESTIGATION
HIGHWAY 11, 2.9 KM NORTH OF HWY 65 JUNCTION
NEW LISKEARD, ONTARIO
5018-E-0010, WORK ITEMS #7 AND #11**

Ontario Ministry of Transportation

March 2022

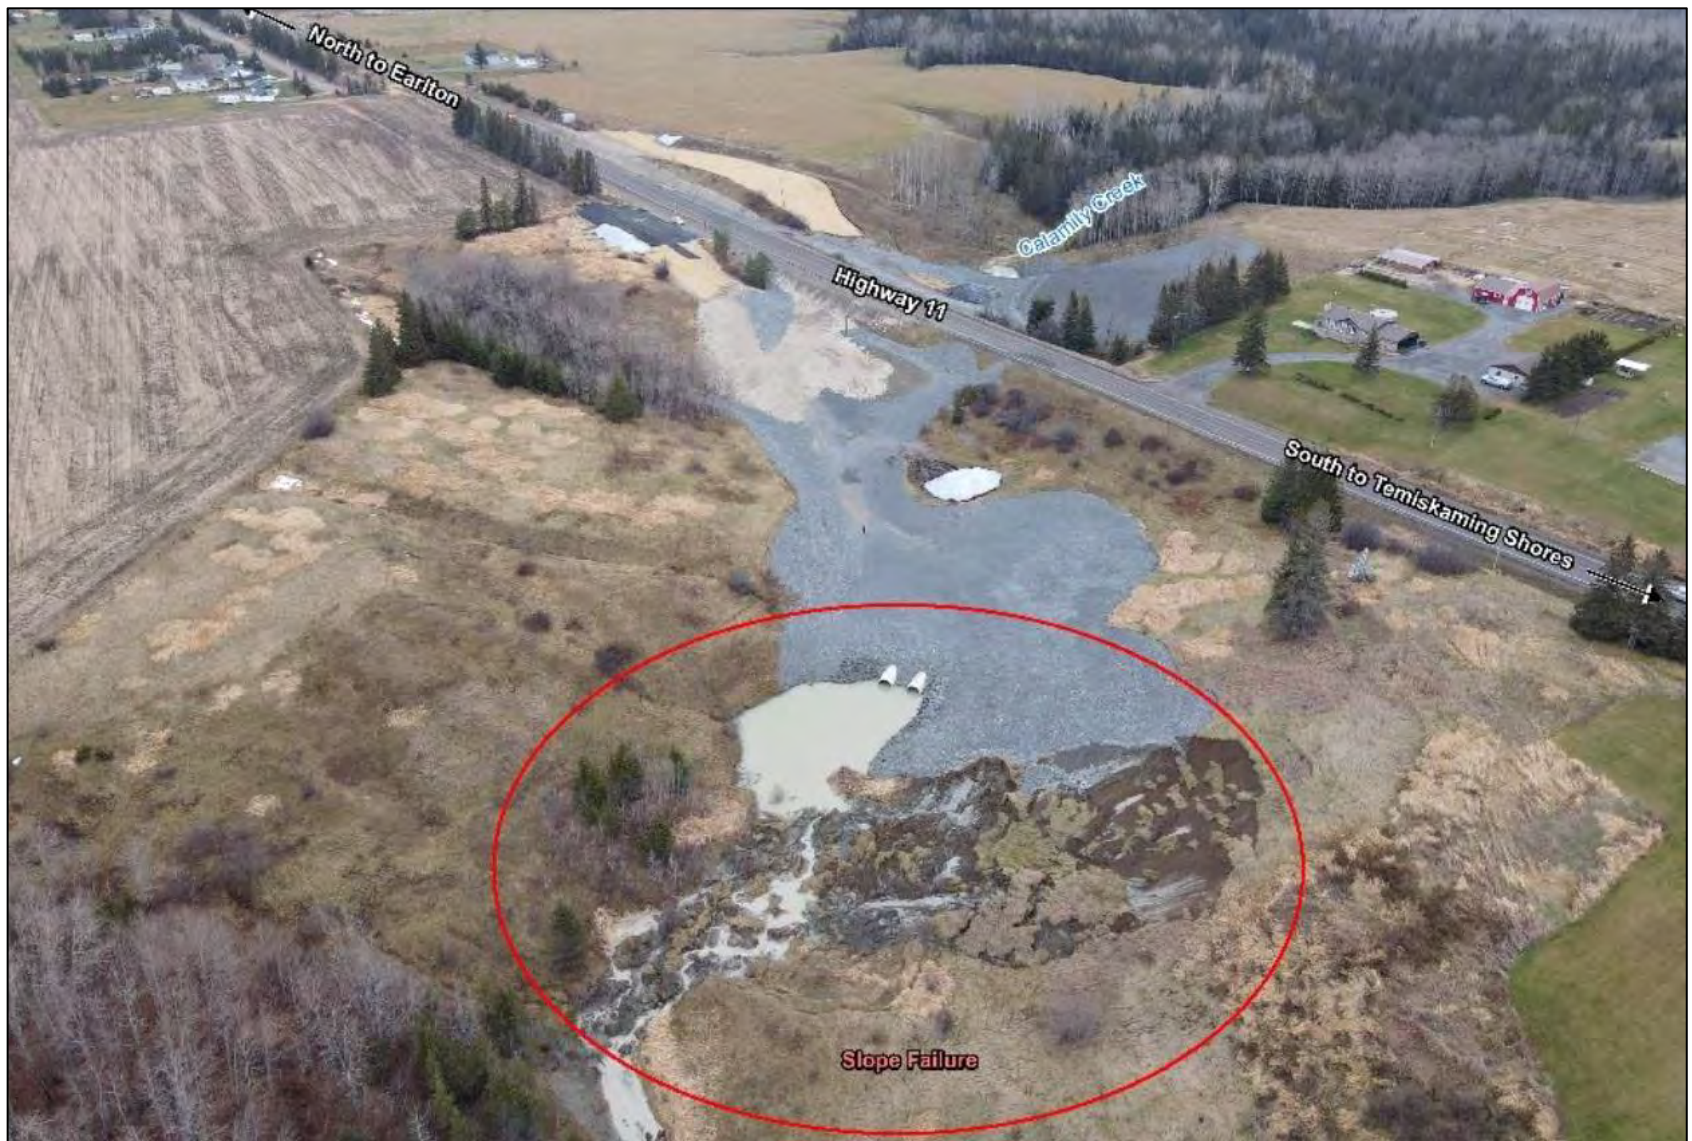
Photo 1: Aerial image from LGL Limited memo (dated November 18, 2020) showing the extent of the landslide on November 10, 2020. The head scarp of the slide has since retrogressed further to the southeast.

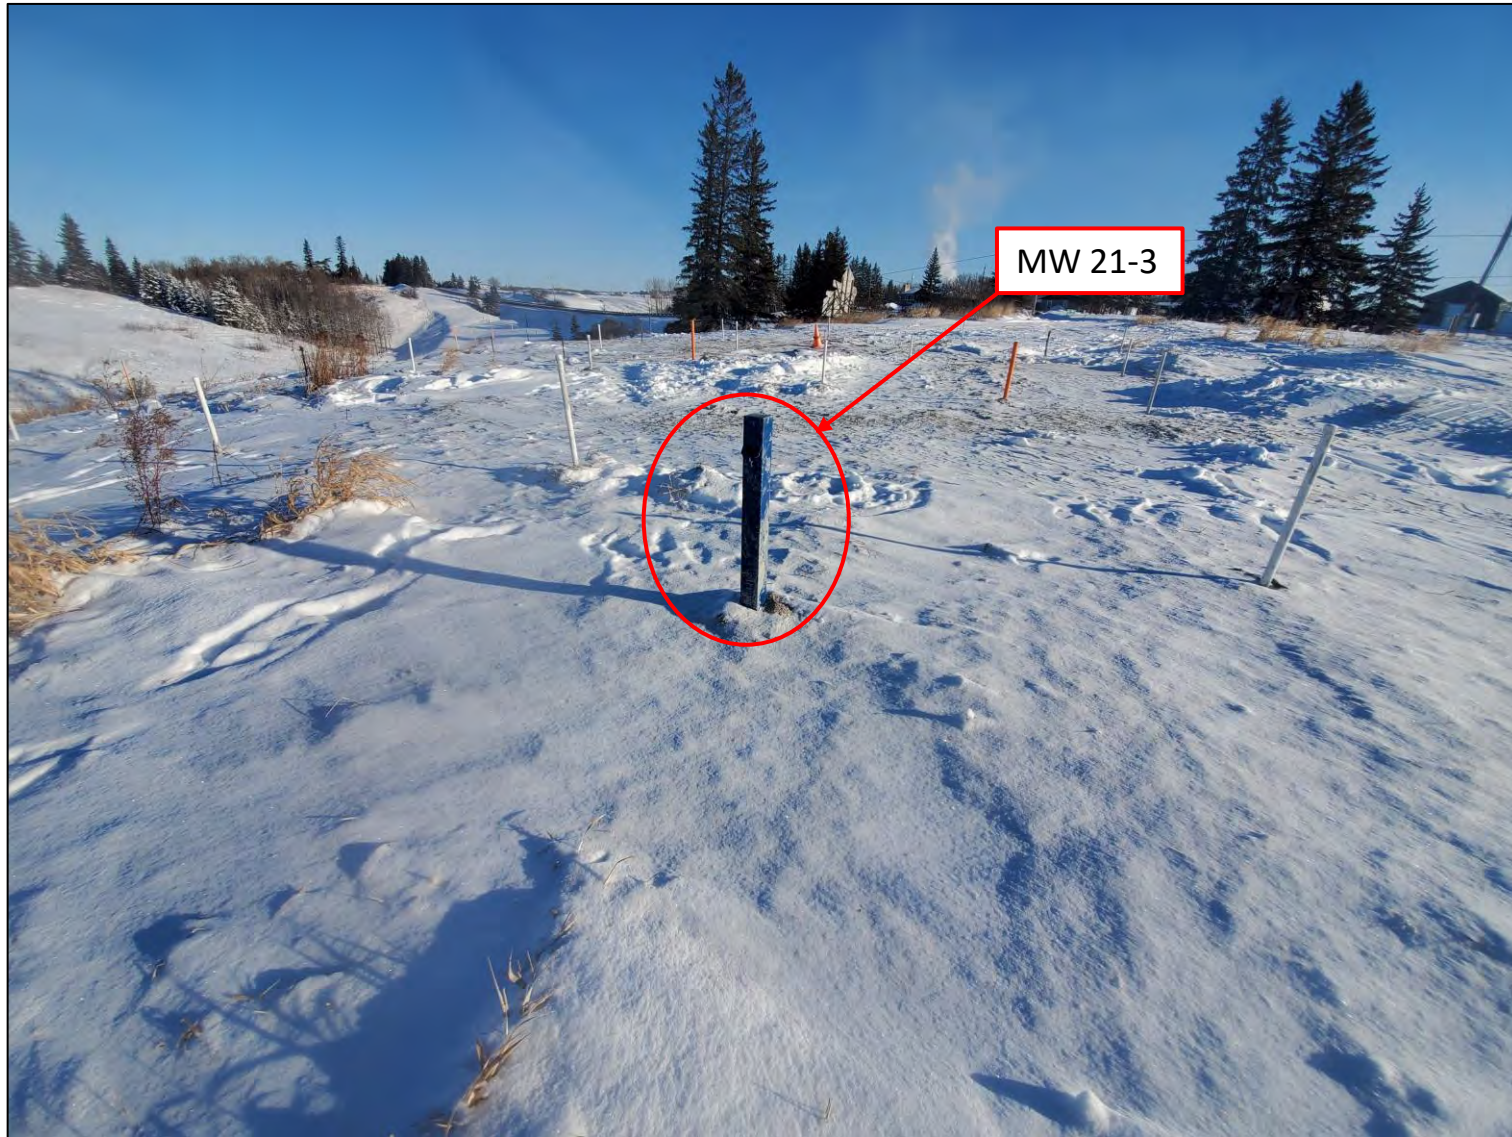
Photo 17: Monitoring well MW 21-3 installed in January, 2021.

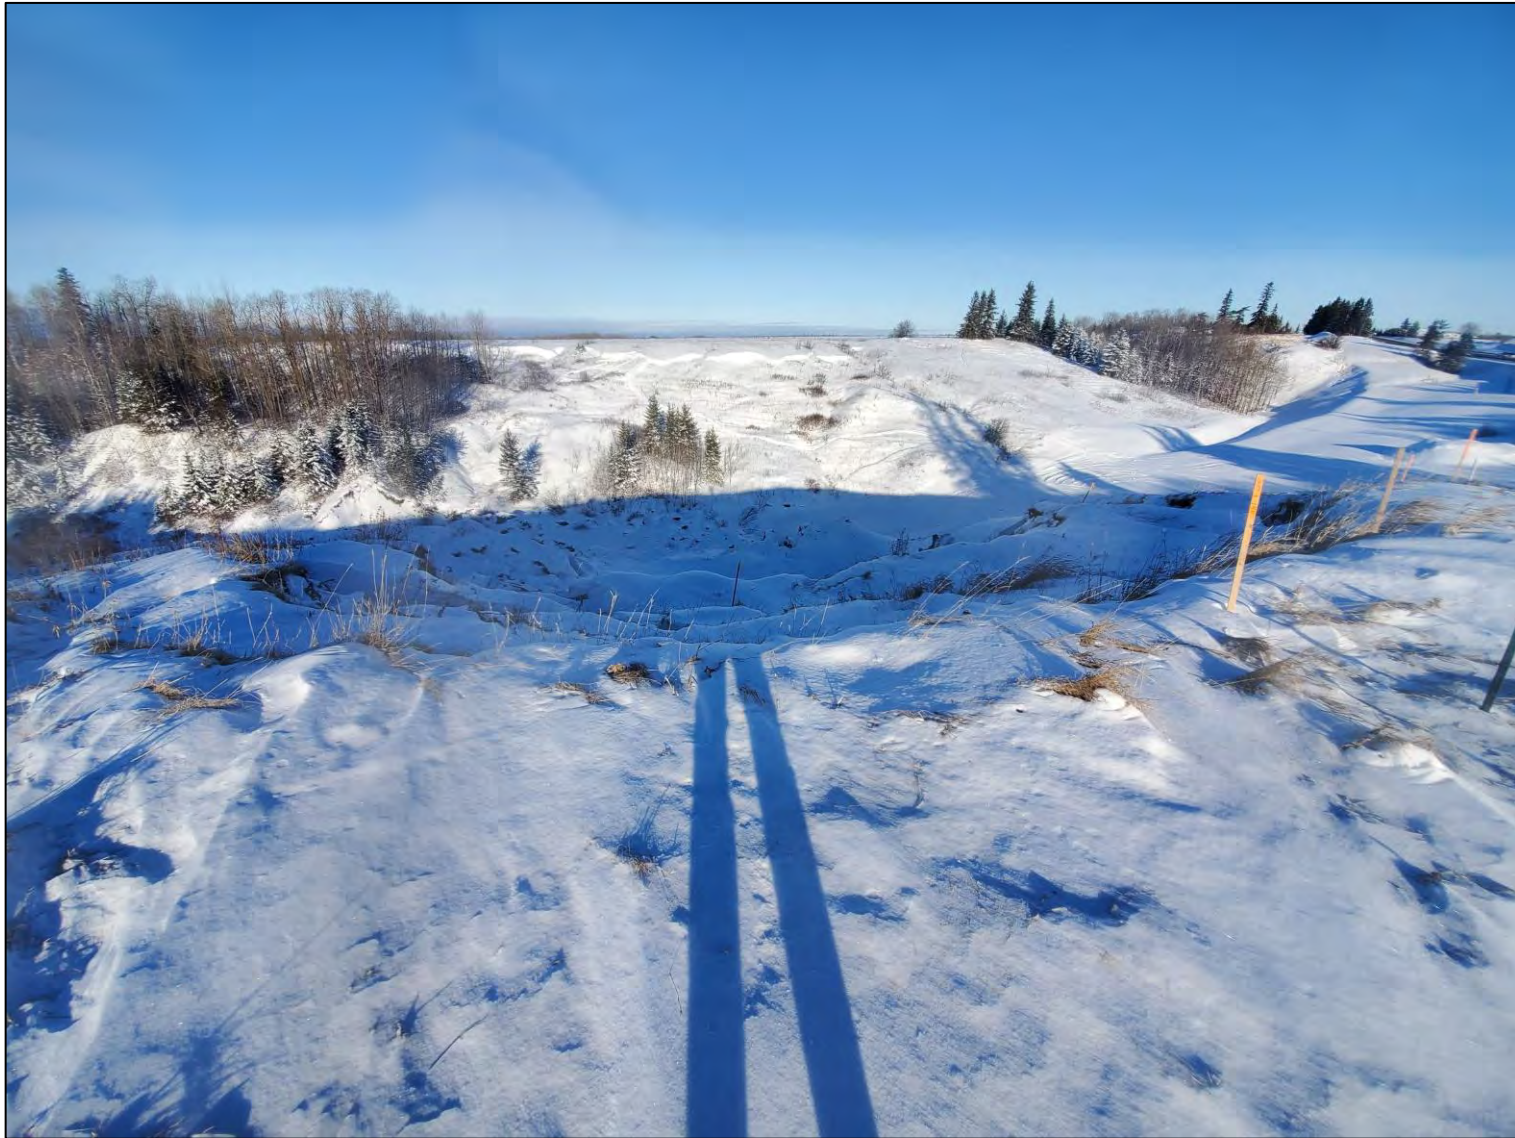
Photo 19: View looking north showing recent landslide on the north slope of the valley.
