Re: Feasibility Study Locating Hwy. 406 in the existing
Welland Canal

REPORT

FEASIBILITY STUDY

PORTION OF PROPOSED HIGHWAY 406 WITHIN WELLAND CANAL
STA. 800+00 TO STA. 1110+00

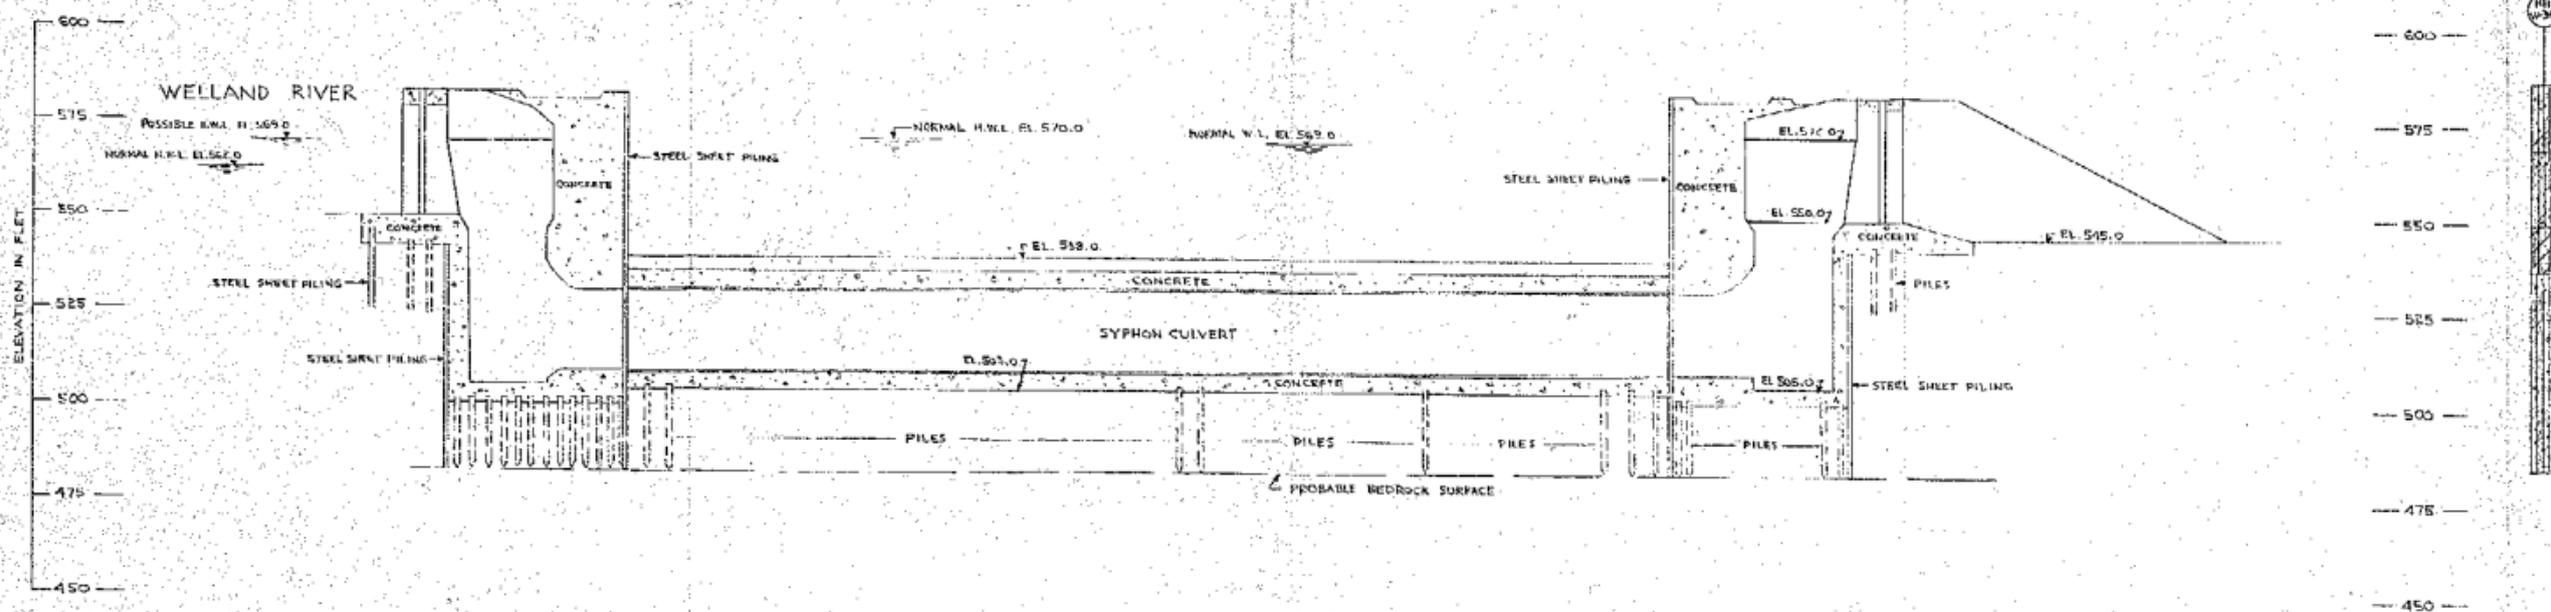
FIGURE 7

NOTE
ALL PILES DRIVEN TO PRACTICAL REFUSAL IN CLAY OR TILL.

SECTION ALONG CENTRELINE OF SYPHON
 (STA. 968+00)
 SHOWING FOUNDATION DETAILS

The syphon structure is of massive concrete and founded on timber piles apparently driven to refusal on rock. (Refer to Fig. 7). The possibility of drawdown of the canal causing movement of this structure seems small, but this is largely dependent on a structural analysis of the syphon.

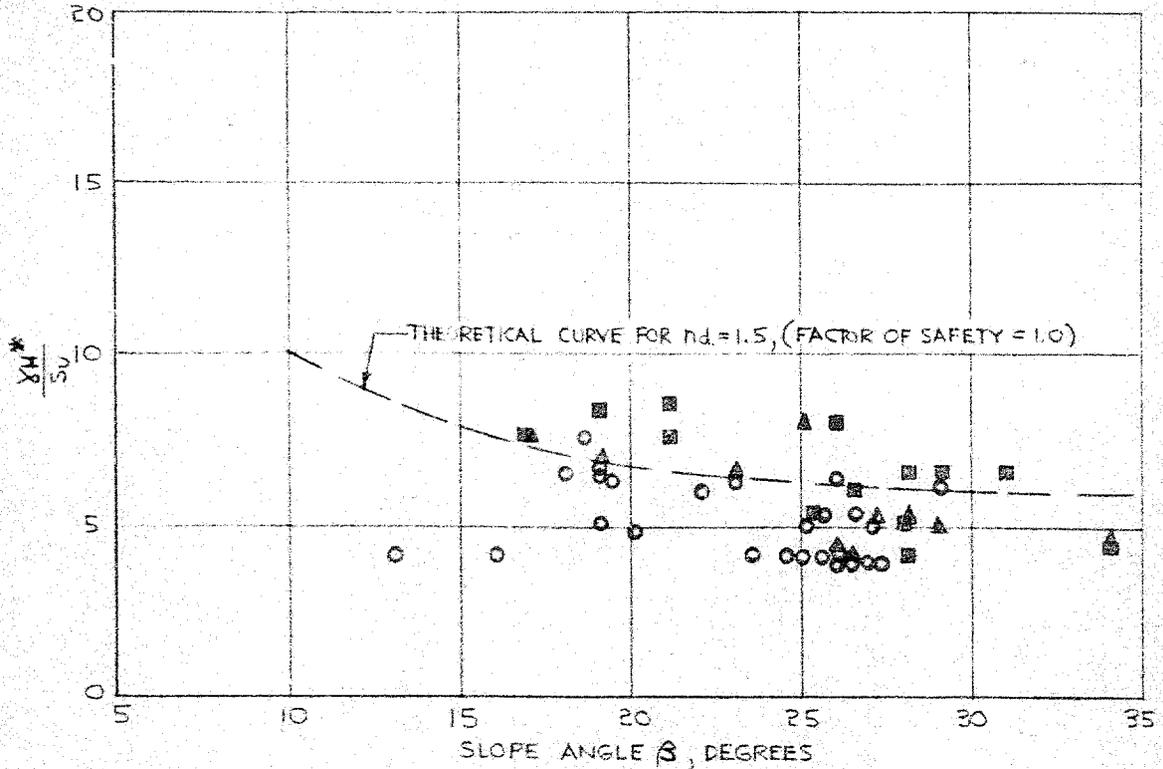
FIGURE 12

γ = TOTAL UNIT WEIGHT - LB./CU.FT.
 S_u = UNDRAINED SHEAR STRENGTH $\frac{qu}{2}$ LB./SQ.FT.

In Figure 12, the canal bank failures are plotted in terms of the dimensionless parameter, (N_s) , for $F = 1.0$, and the reported shear strength for the section in which the failure took place. It is apparent that for some of the slope failures, the in situ shear strength at failure must be less than that measured in unconfined compression tests. The reason for this may be due to the anisotropic nature of the stratified clay stratum, which, from previous studies (Report 6375, July, 1964), is known to have directional shear strength properties. For this material, the shear strength mobilized at failure is dependent on the orientation of preferred planes of apparent weakness. The average undrained shear strength along such "weak" layers was measured to be 500 lb/sq.ft.

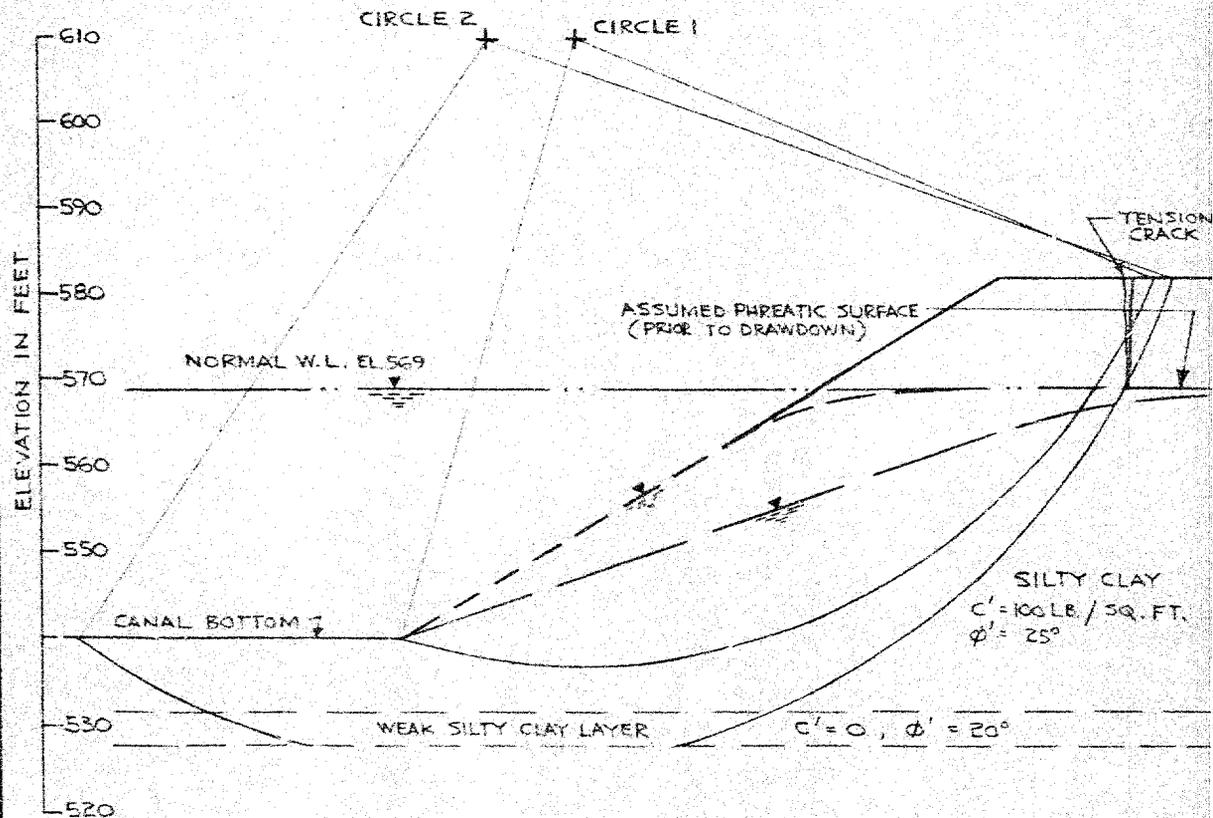
FIGURE 13

SUMMARY RESULTS OF EFFECTIVE STRESS STABILITY ANALYSES, WEST CANAL BANK CROSS-SECTION (STA. 990+00)

A summary of effective analyses of an existing typical section of the west bank in Section III (sta. 990+00) is given on Figure 13. The shear strength parameters assumed for the analyses were based on previous work in this area (Report 6375, July, 1964). The factor of safety, F , with respect to a deep failure through the lower "weak" layer is critical. F , prior to drawdown, is approximately 1.2*, making the assumptions concerning the shear parameters and piezometric levels given on the figure. On drawdown, if there is no dissipation of pore water pressures within the bank, the phreatic surface coinciding with the face of the slope, then F is reduced by over 33 per cent. If the rate of drawdown is slow, such that there is some drainage, the reduction in F is smaller. It is therefore important to examine what rate of dewatering of the canal can be considered slow enough to effect substantial drainage.

lower phreatic surface shown in Figure 13 indicate that F , (after drawdown) is of the order of 0.9 to 1.0, deep failures through the "weak" clay layer being most critical. This value of F is about 20 per cent greater than F for no pore water dissipation within the slope.

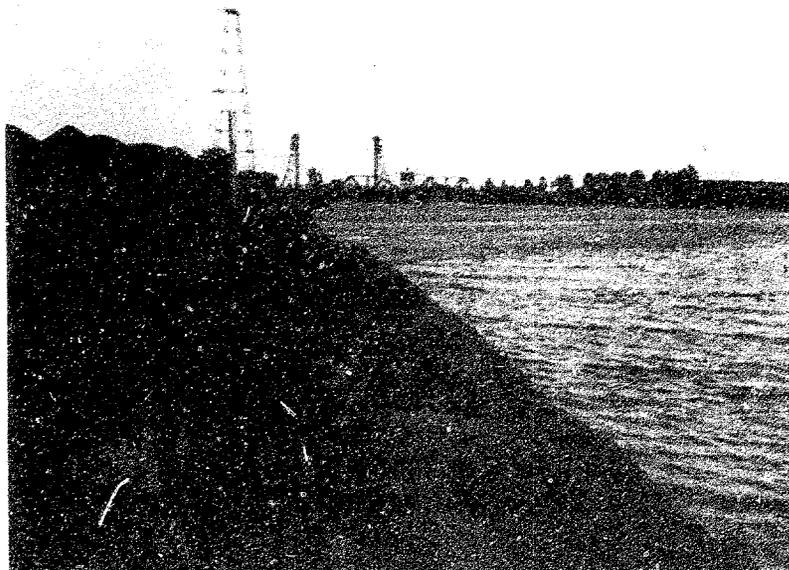
PHOTO 10

View of retaining wall on east bank of canal showing structural cracks in wall at approximately STA. 1012+00 looking south.

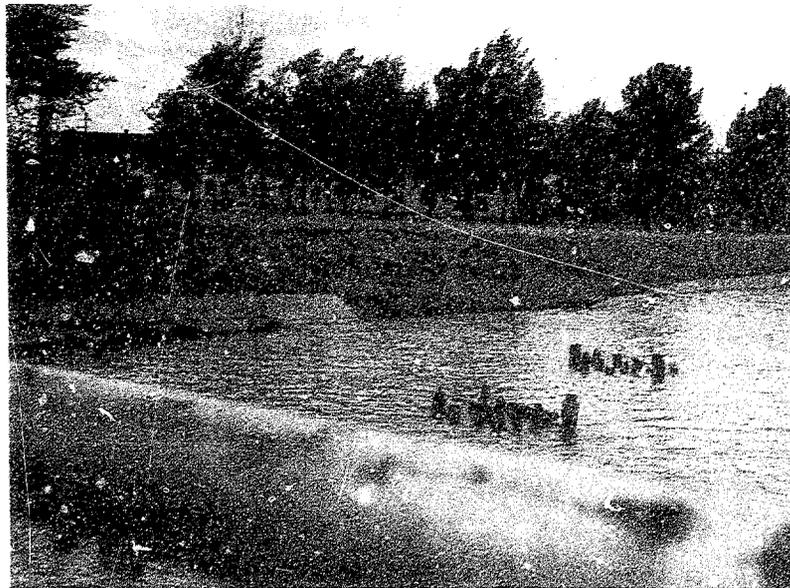
PHOTO 12

View of deep slope failure on west bank of canal at approximately STA. 1005+00 looking north - west

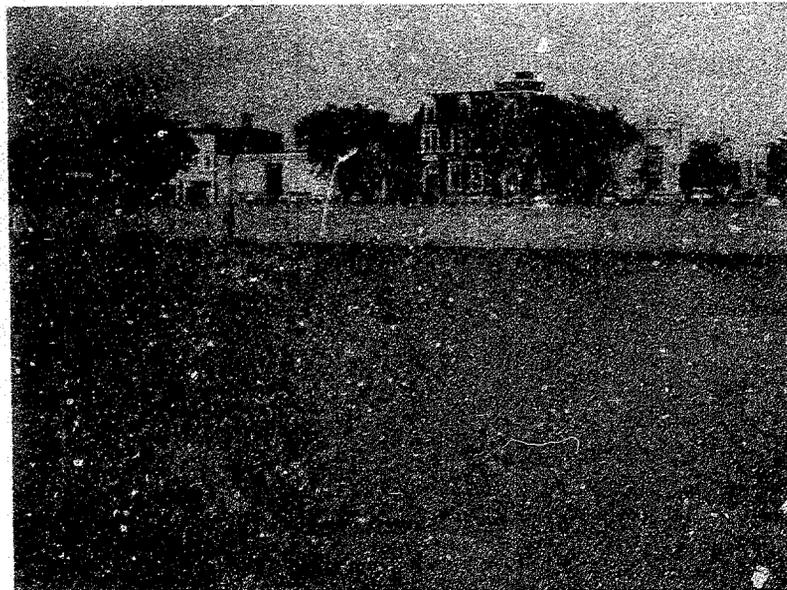
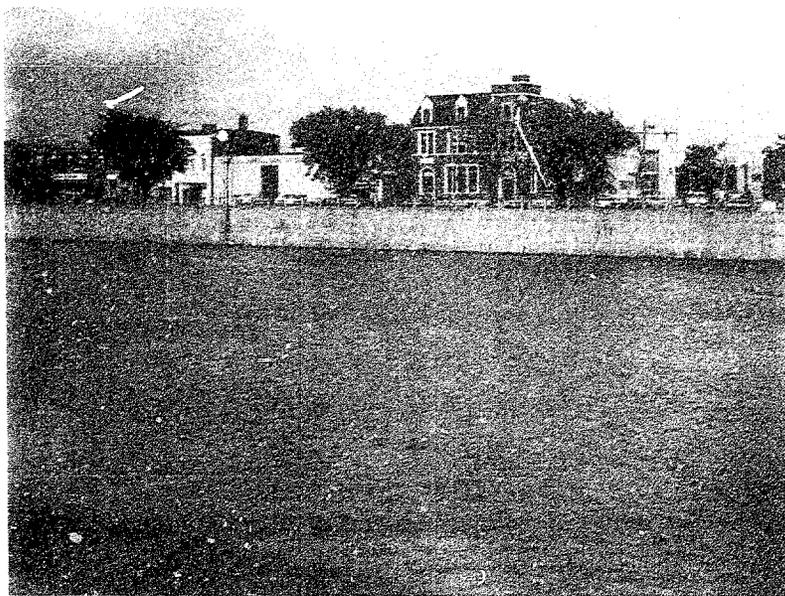
PHOTO 15

View of shallow slope failure on west bank of canal at approximately STA.993+00 looking south with Bridge No.14 in background.

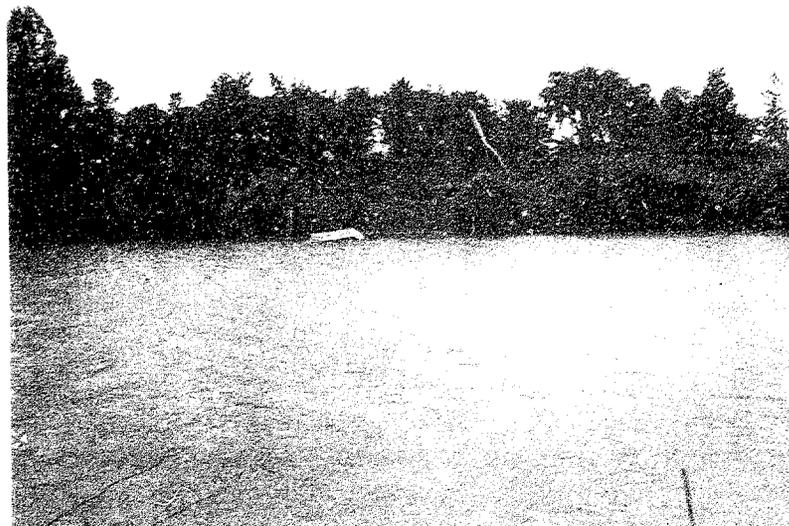
PHOTO 22

View of deep slope failure on west bank of canal at approximately STA. 932+50.

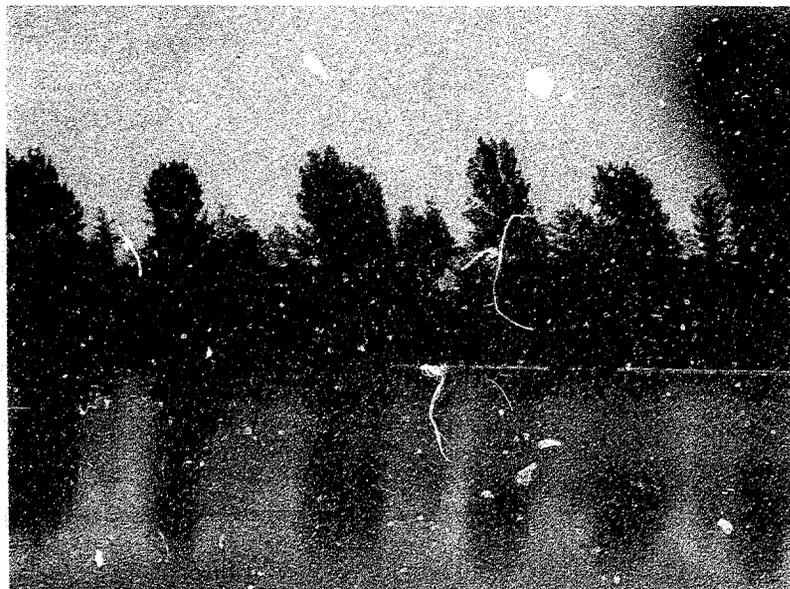
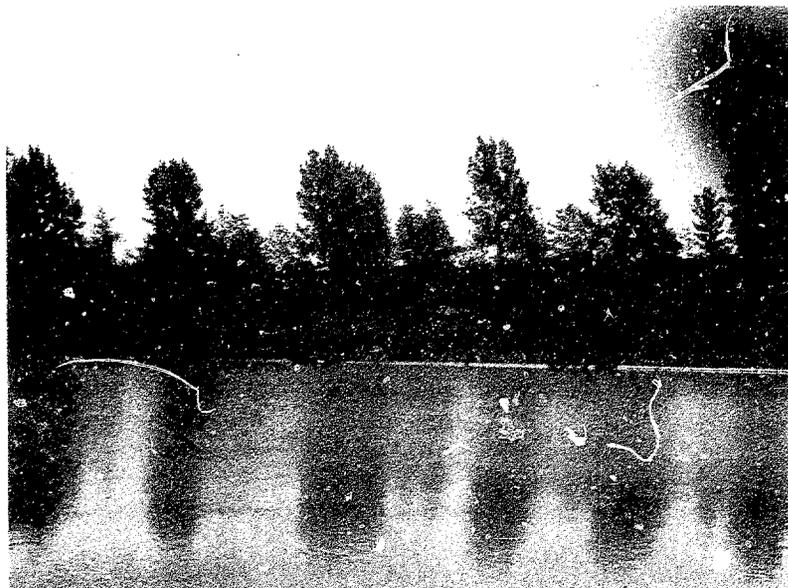
PHOTO 23

View of shallow slope failure on west bank of canal at approximately STA. 914 + 00 looking south.

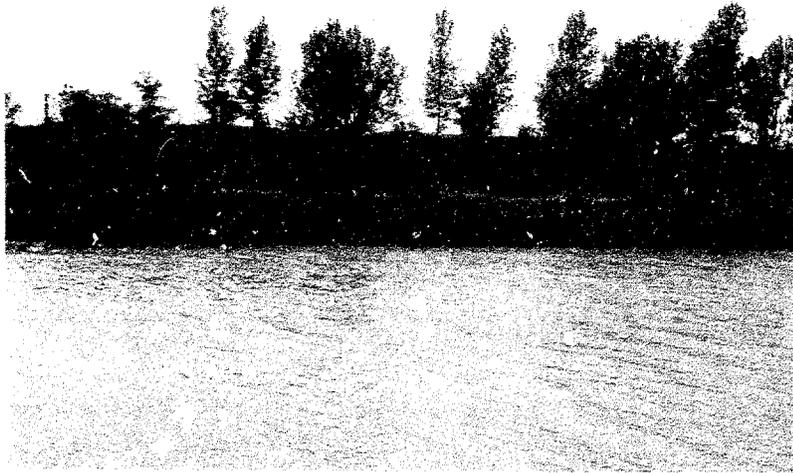
PHOTO 26

View of deep slope failure on east bank of canal at approximately STA.868+00.

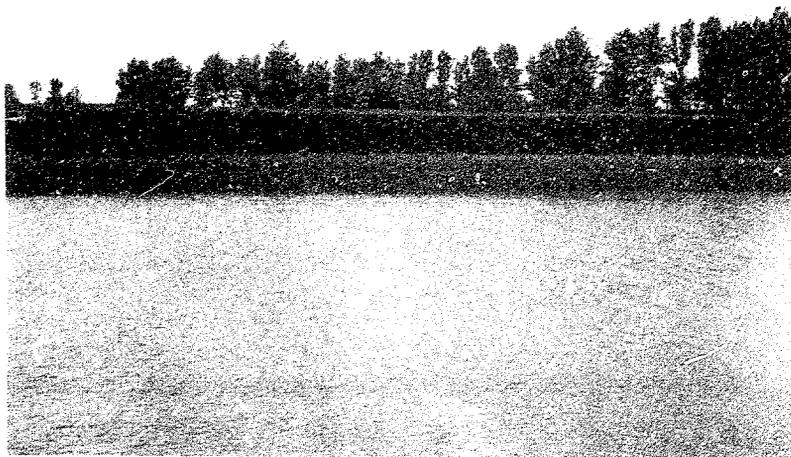
PHOTO 27

View of deep slope failure on east bank of canal at approximately STA. 868+00.

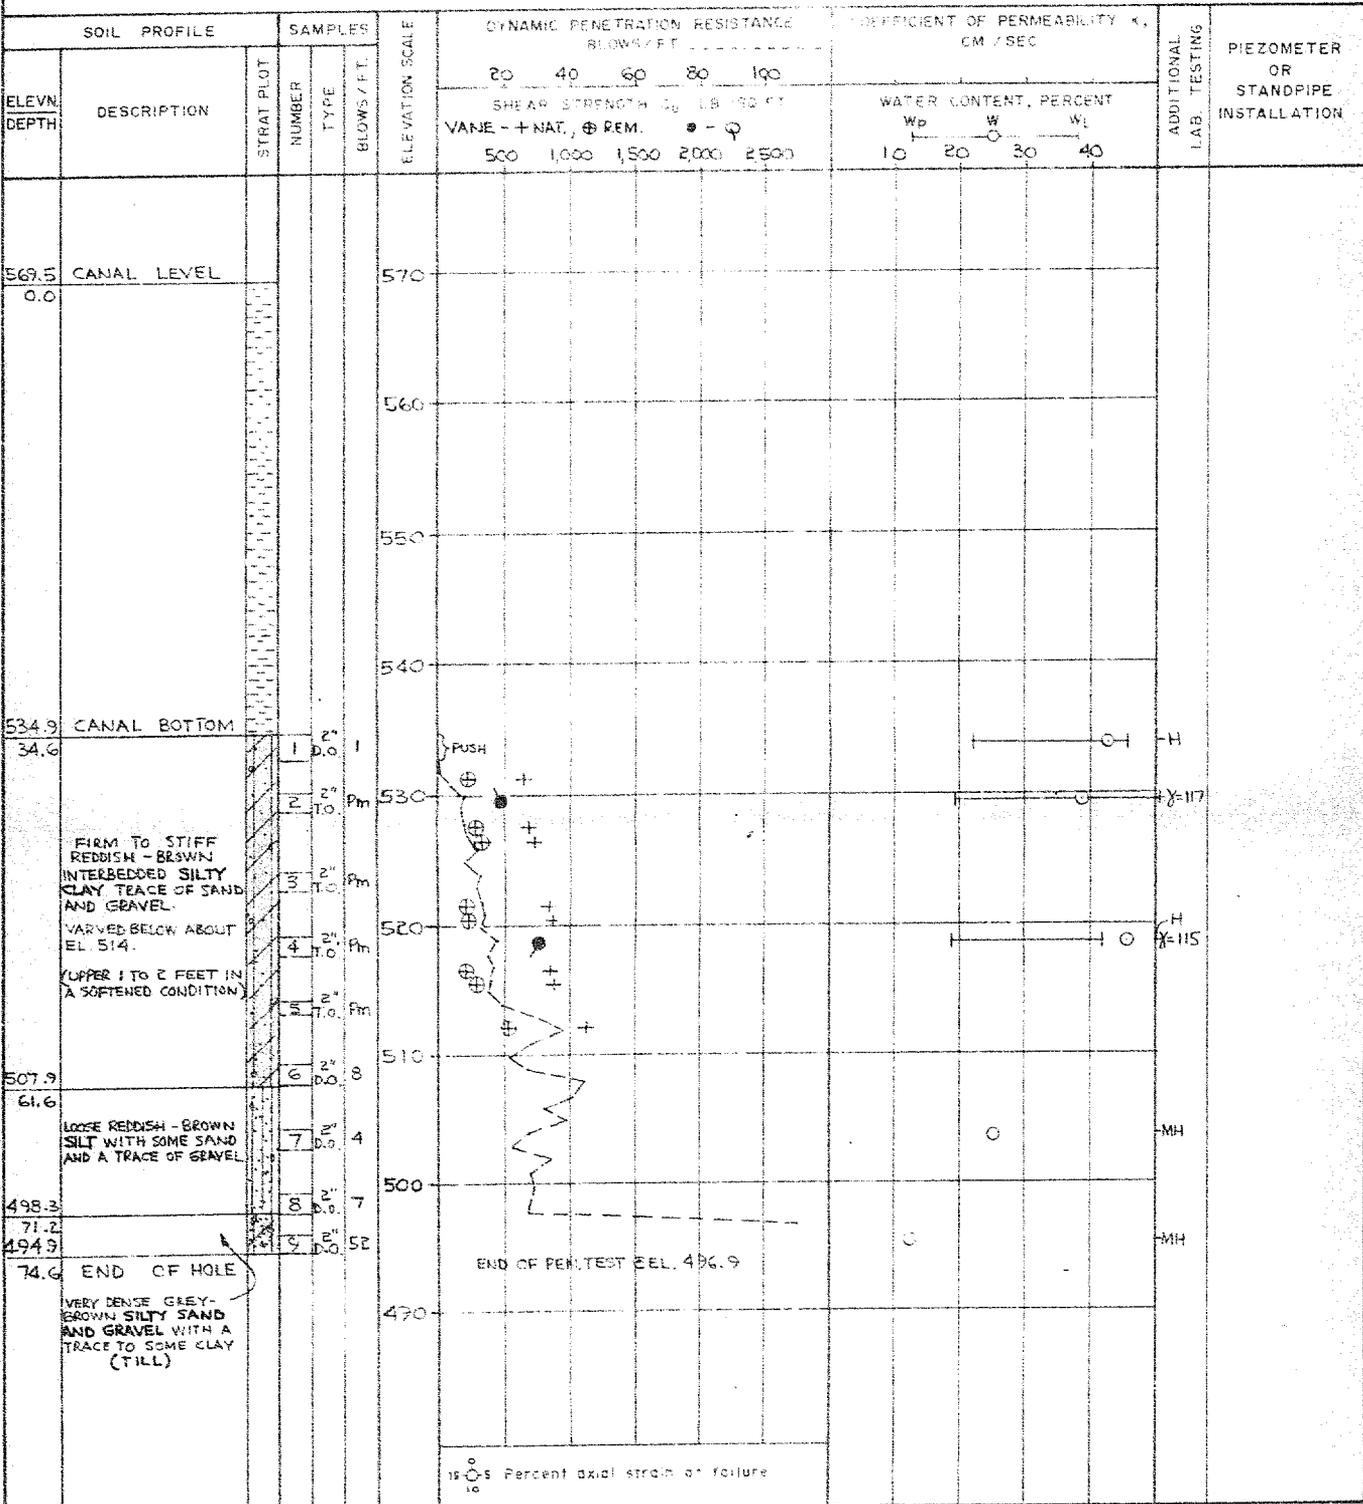
RECORD OF BOREHOLE C-1

LOCATION STA. 1099+60 - 2 CANAL See Figure 1 BORING DATE MARCH 10, 1967 DATUM GEODETIC
 BOREHOLE TYPE WASH BORING BOREHOLE DIAMETER NX CASING
 SAMPLER HAMMER WEIGHT 140 LB. DROP 30 INCHES PEN. TEST HAMMER WEIGHT 140 LB. DROP 30 INCHES

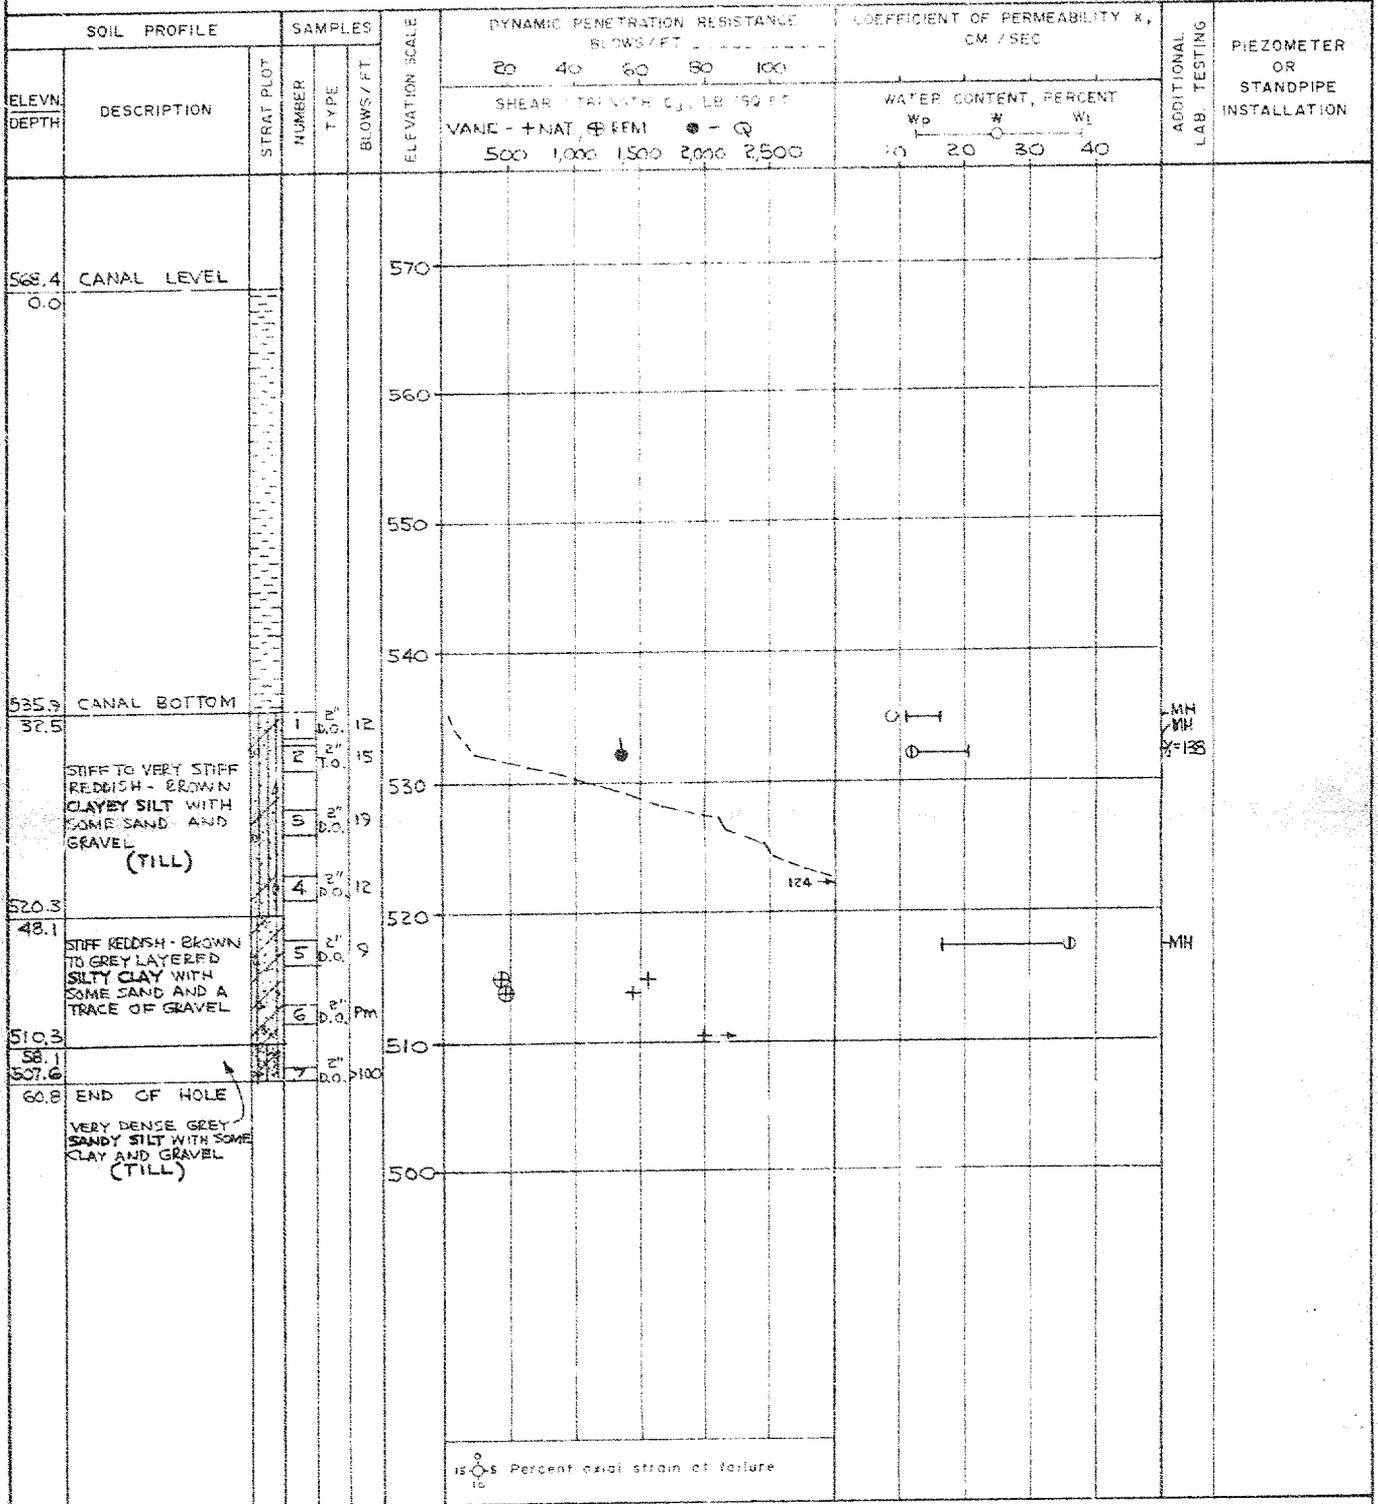
RECORD OF BOREHOLE C-5

LOCATION STA. 899+50 - ϕ CANAL See Figure 1 BORING DATE MARCH 12-14, 1967 DATUM GEODETIC
 BOREHOLE TYPE WASH BORING BOREHOLE DIAMETER NX CASING
 SAMPLER HAMMER WEIGHT 140 LB. DROP 30 INCHES PEN. TEST HAMMER WEIGHT 140 LB. DROP 30 INCHES

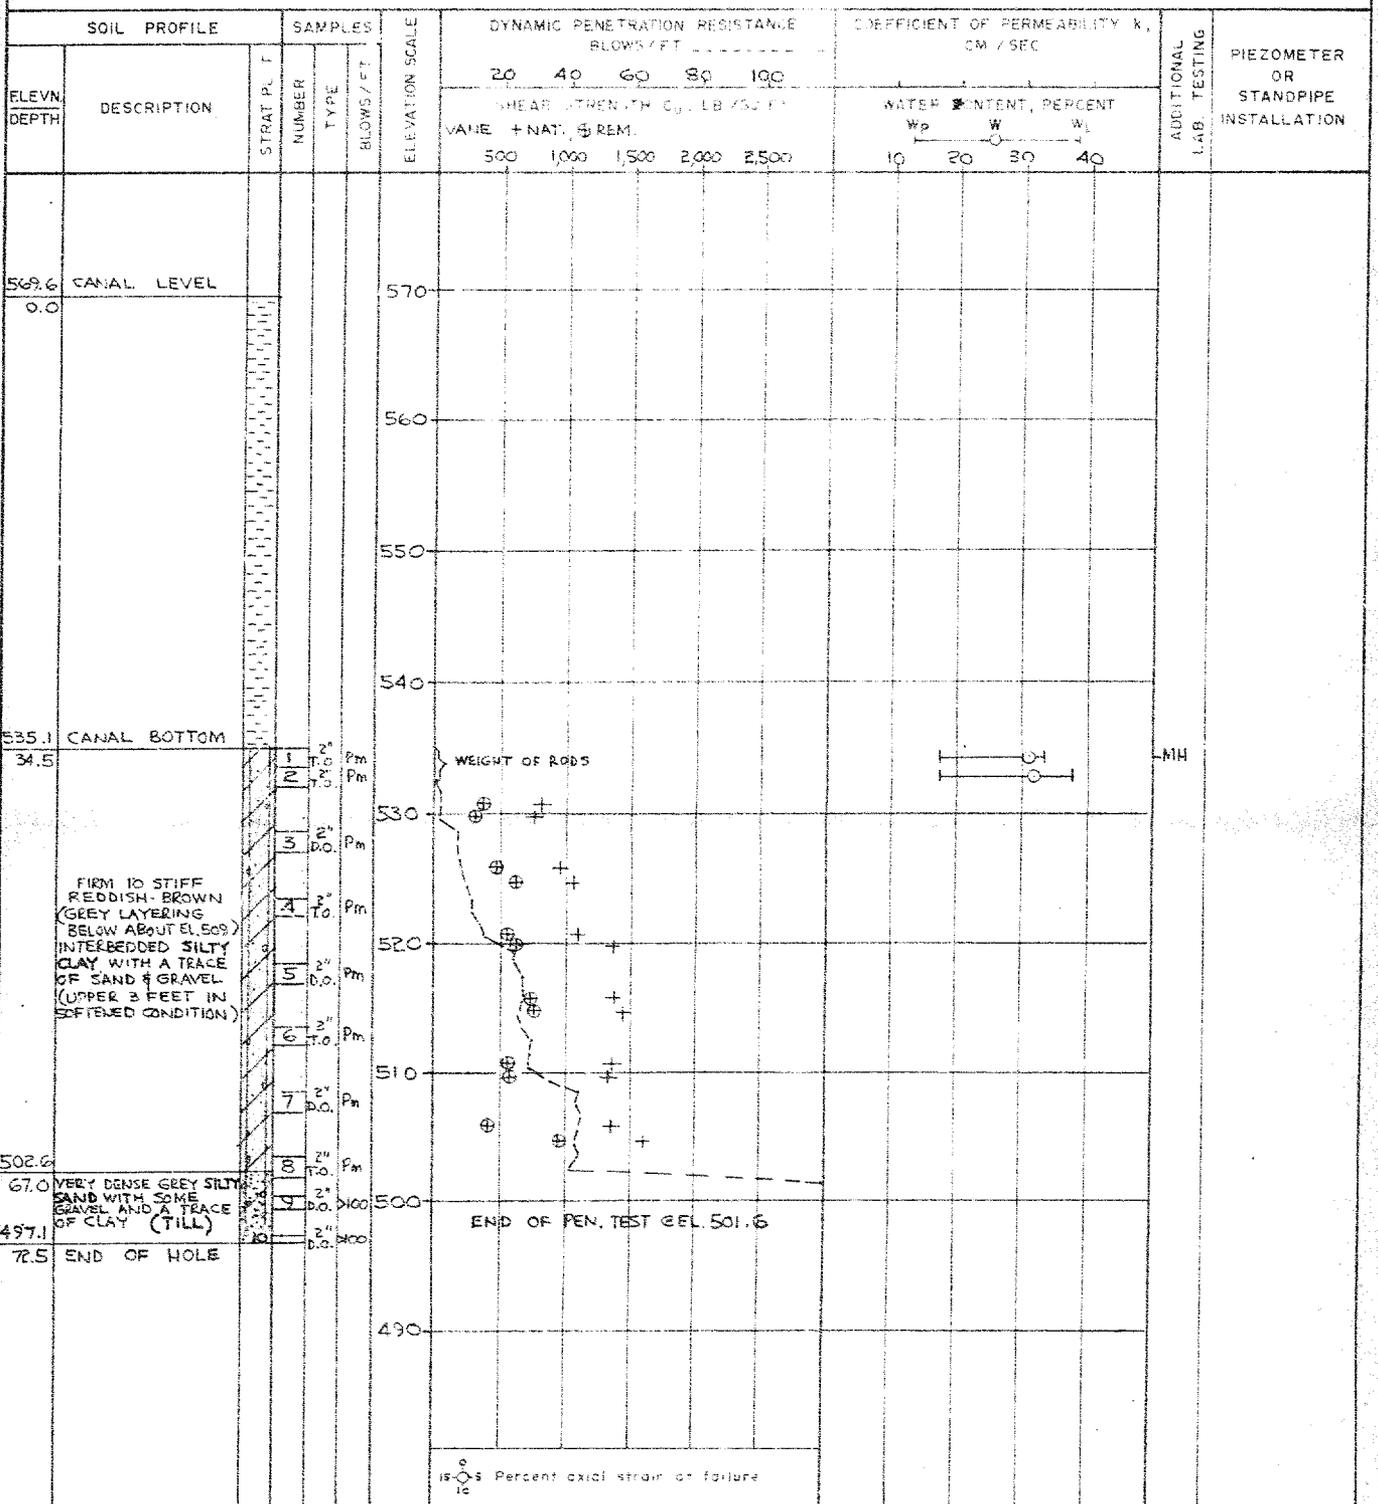
RECORD OF BOREHOLE C-7

LOCATION: STA. 975+00.0 CANAL See Figure 1
 BORING DATE: MARCH 29, 1967
 DATUM: GEODETIC
 BOREHOLE TYPE: WASH BORING
 BOREHOLE DIAMETER: NX CASING
 SAMPLER HAMMER WEIGHT 140 LB. DROP 30 INCHES
 PEN. TEST HAMMER WEIGHT 140 LB. DROP 30 INCHES

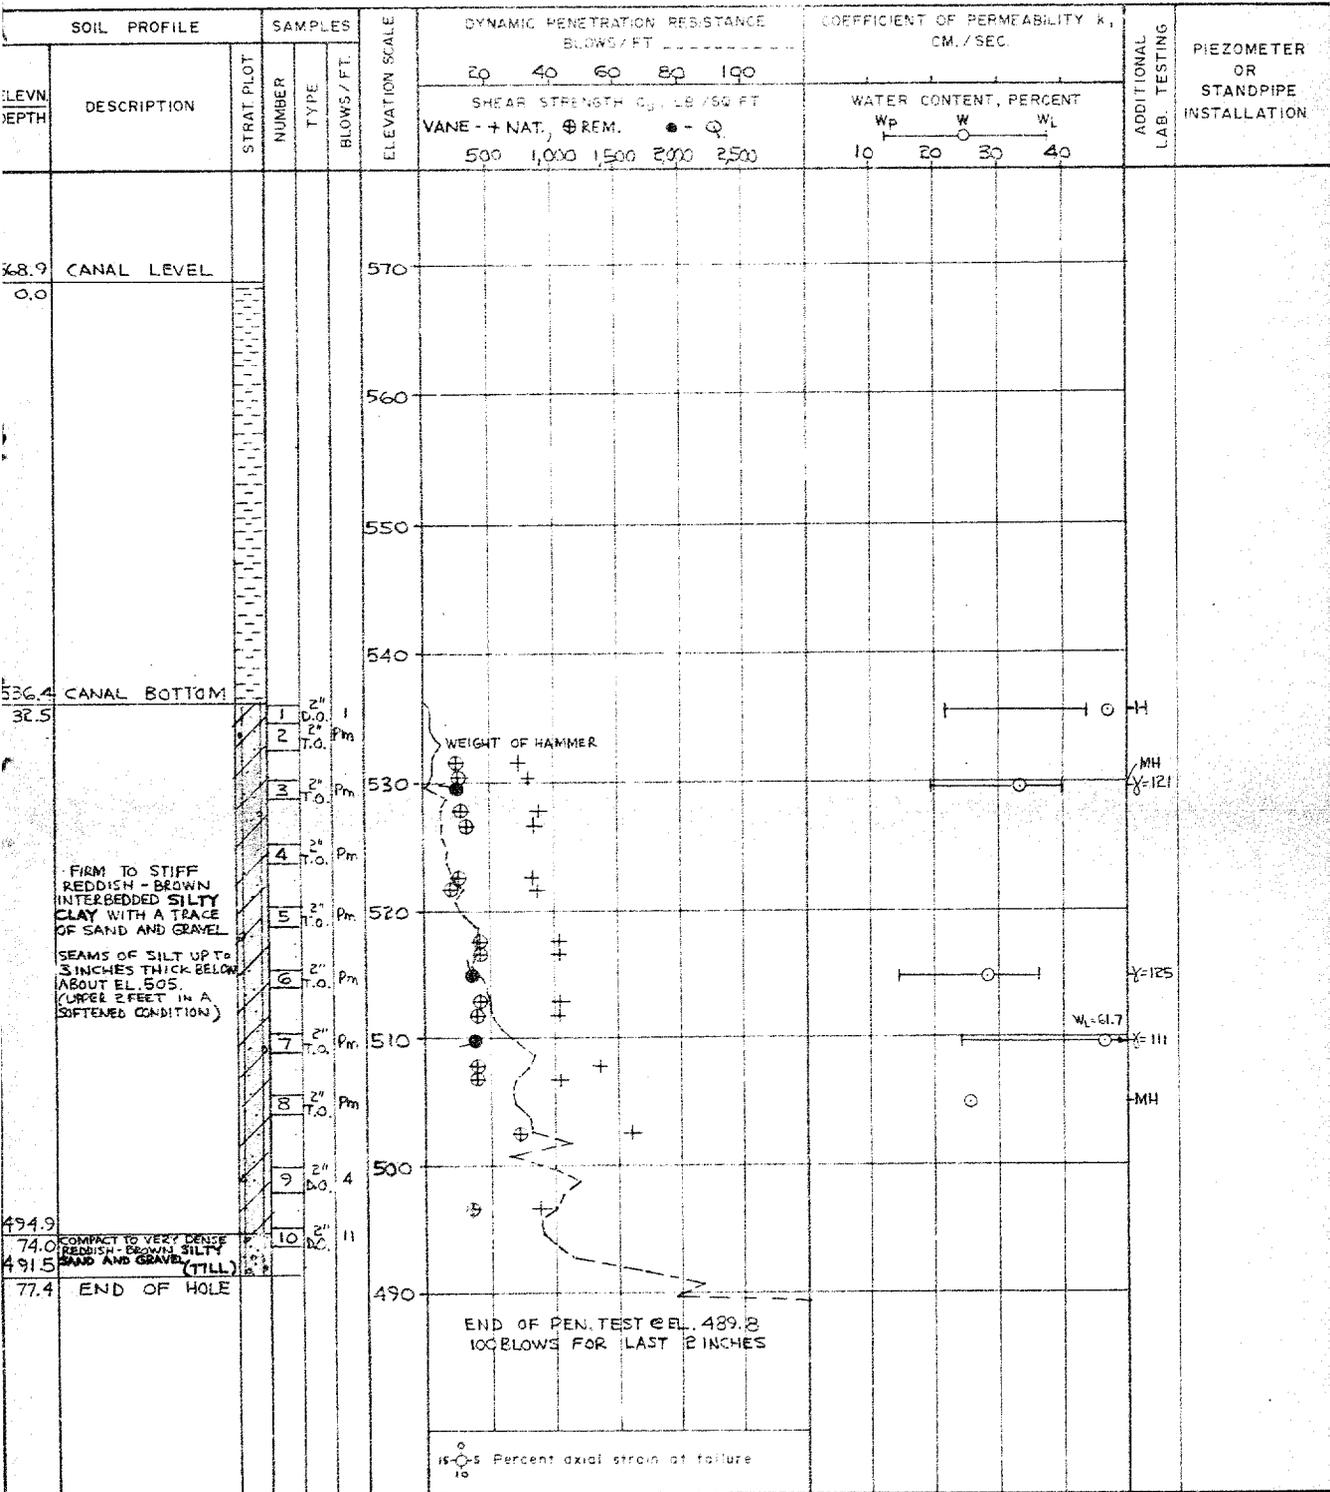
RECORD OF BOREHOLE C-3

LOCATION STA. 1000+00 - 6 CANAL See Figure 1
 BORING DATE MARCH 16-17, 1967 DATUM GEODETIC
 BOREHOLE TYPE WASH BORING BOREHOLE DIAMETER NX CASING
 SAMPLER HAMMER WEIGHT: 140 LB. DROP 30 INCHES PEN. TEST HAMMER WEIGHT 140 LB. DROP 30 INCHES

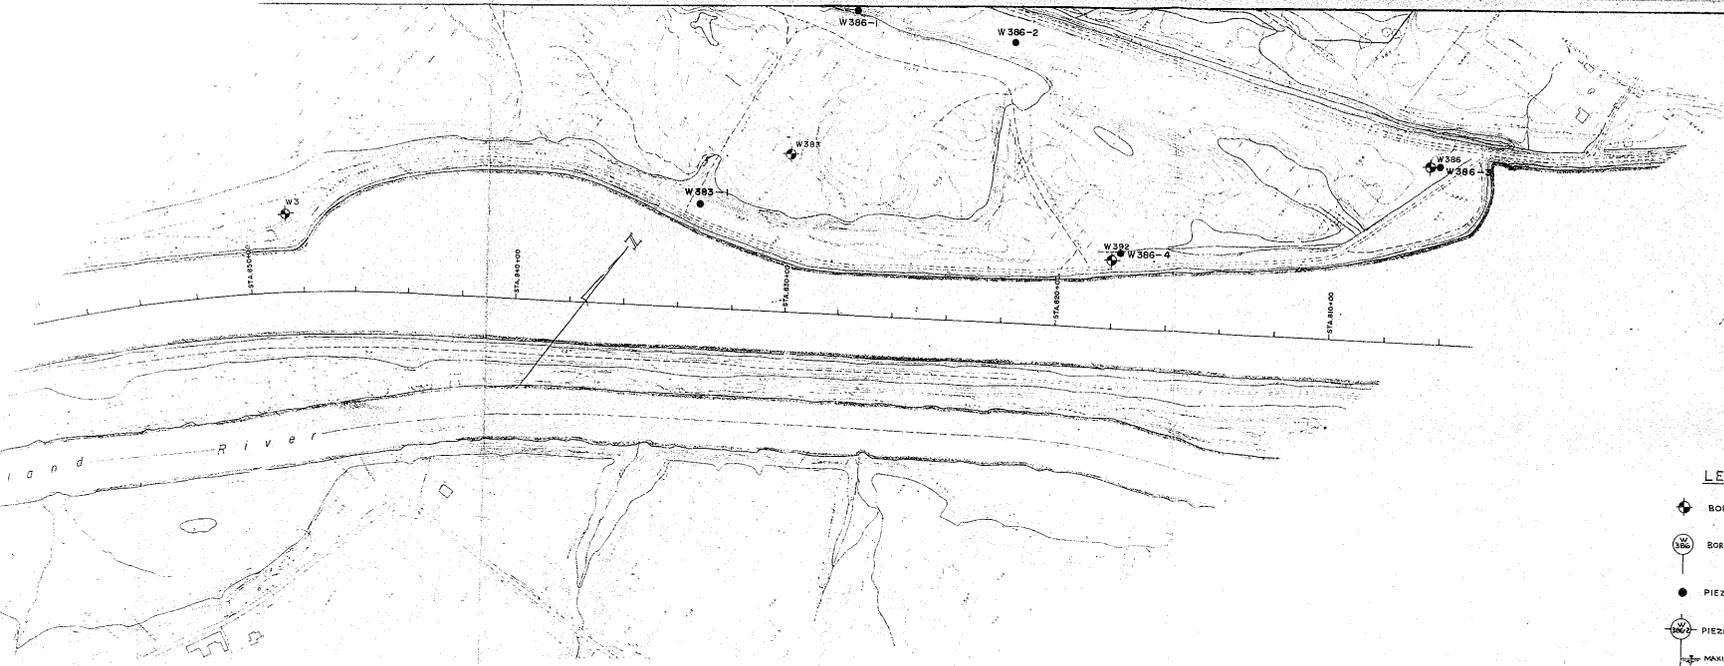
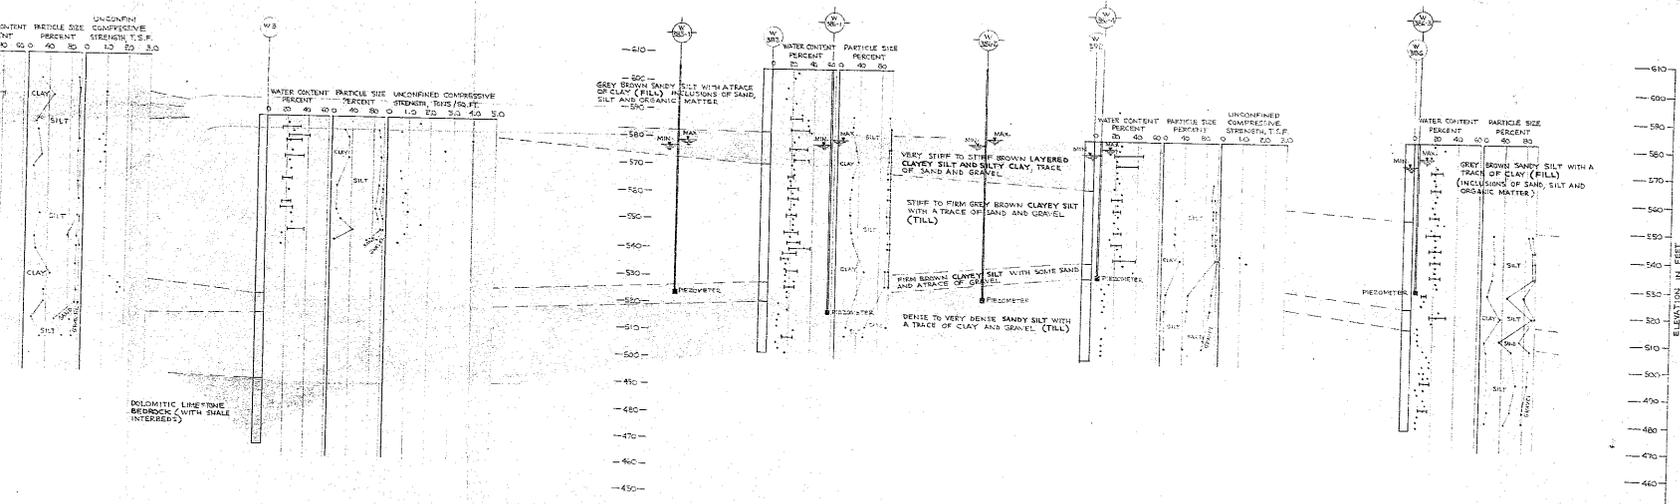
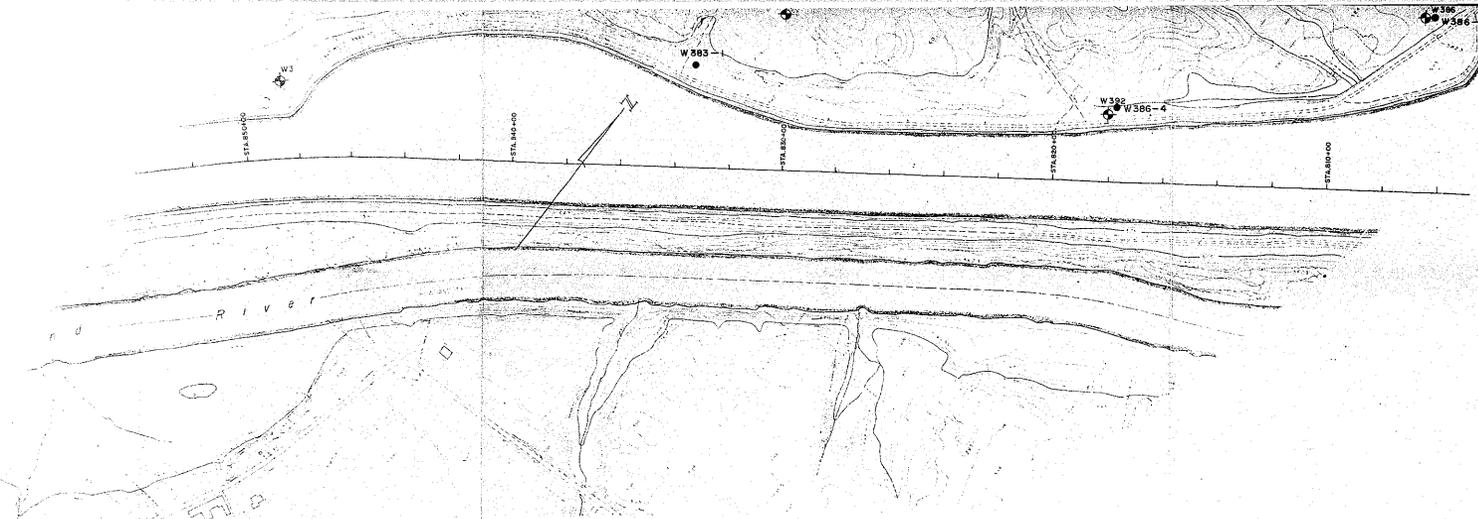
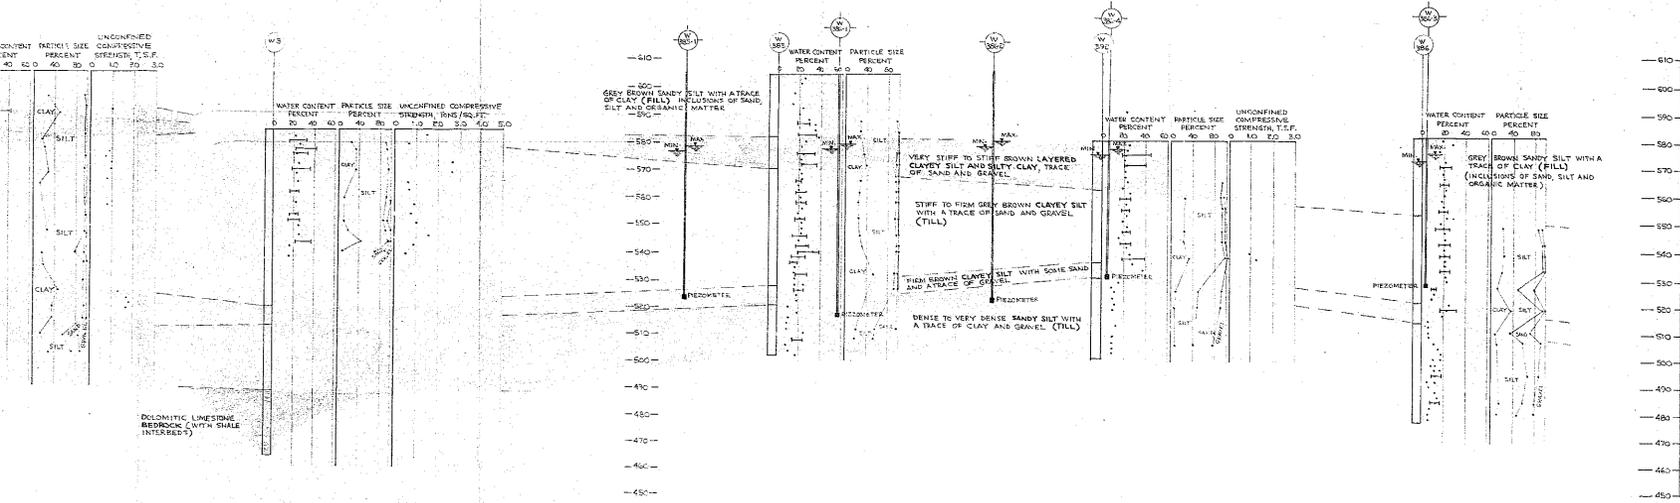
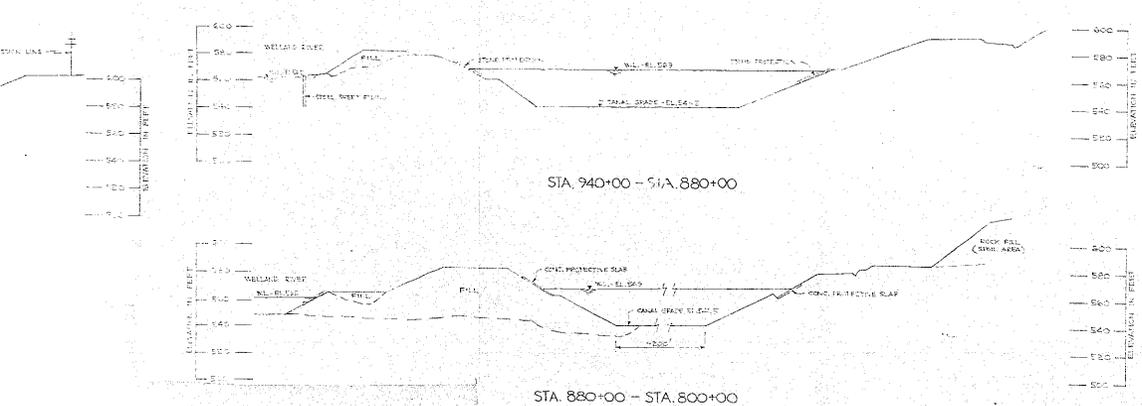
**BORING PLAN AND SUBSURFACE CONDITIONS
 WELLAND CANAL - STA. 810+00 TO 1110+00
 WELLAND, ONTARIO**

- BOREHOLE IN PLAN
- BOREHOLE IN ELEVATION
- PIEZOMETER INSTALLATION IN PLAN
- PIEZOMETER INSTALLATION IN ELEVATION
- MAXIMUM W.L. RECORDED
- PIEZOMETER
- DEEP FAILURES
- SHALLOW FAILURES

The piezometric groundwater conditions were determined during the previous investigations by installing piezometers in the overburden (mainly along the west bank). The pertinent installations are shown on Figure 2; also included on this figure are the results of readings taken in these piezometers.

The location and lateral extent of known and observed canal bank failures are shown in plan on Figure 2. From visual observation of the apparent geometry of these failures, the slides have been divided into two categories, namely:
