GEOCRES No. 30M3-211DIST. CR REGION W.P. No. 134-92-00CONT. No. W. O. No. STR. SITE No. 18-161HWY. No. QEWLOCATION GLENDAL AVENUEUNDERPASS - QEW WIDENINGNo of PAGES - =====  
OVERSIZE DRAWINGS TO BE INCLUDED WITH THIS REPORT. REMARKS:

**GEOTECHNICAL INVESTIGATION  
HIGH MAST LIGHTING POLES  
WP 134-92-00 QUEEN ELIZABETH WAY/HIGHWAY 405  
DISTRICT 6, CENTRAL REGION**

**June 15, 1998  
TG98051**

**Part 1 - Foundation Investigation Report**

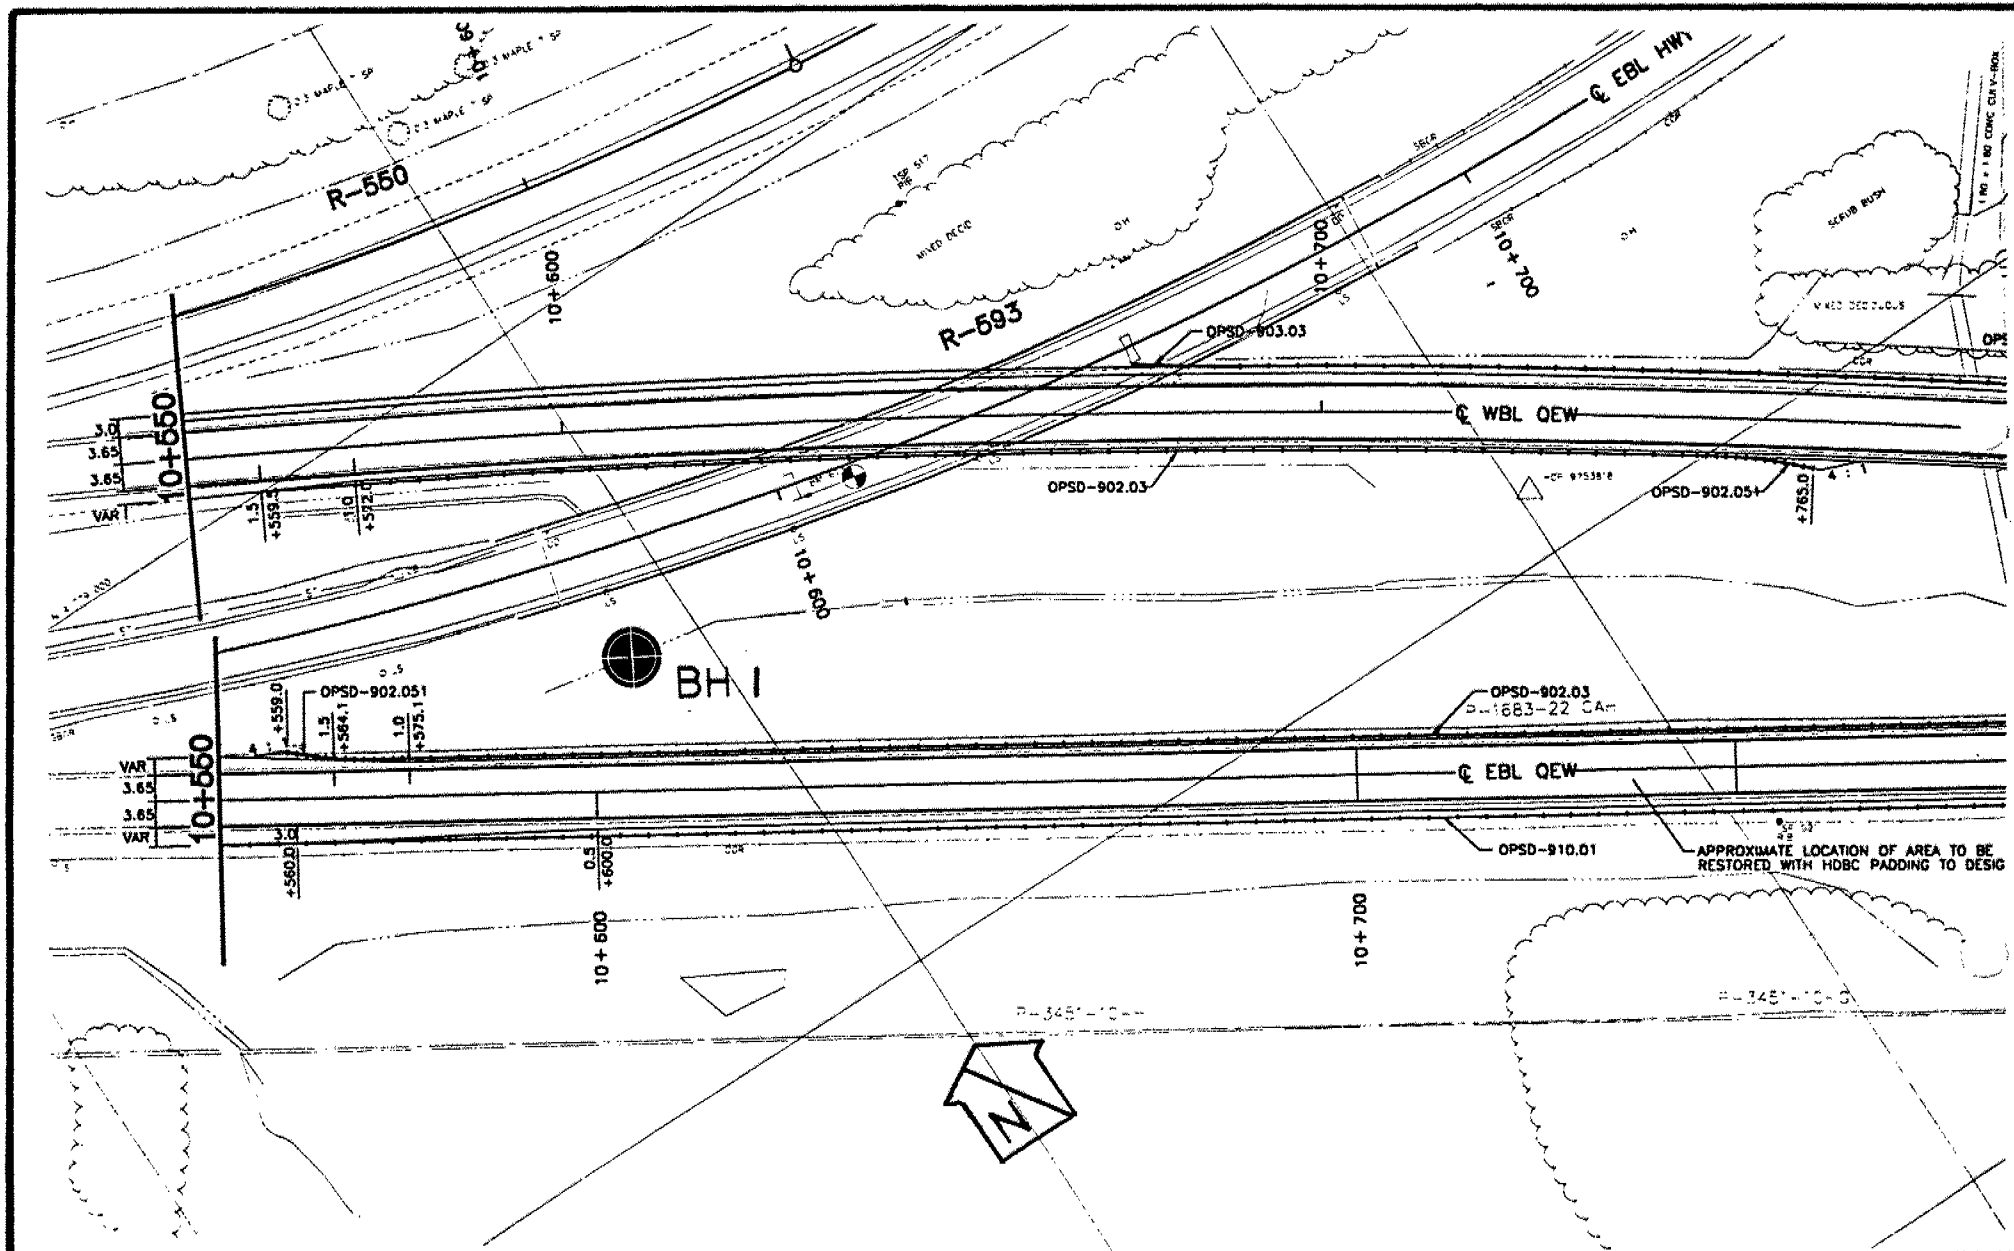
BOREHOLE LOCATION PLAN

For continuity, Part 1 of the report summarizes the factual information obtained from the field work carried out for all of the light poles, on 98 03 25. It consisted of advancing five boreholes to depths of between 9.3 and 9.6 metres, to provide soil parameters for foundation design. Borehole Location Plans are appended as pages A-3 to A-7 inclusive.

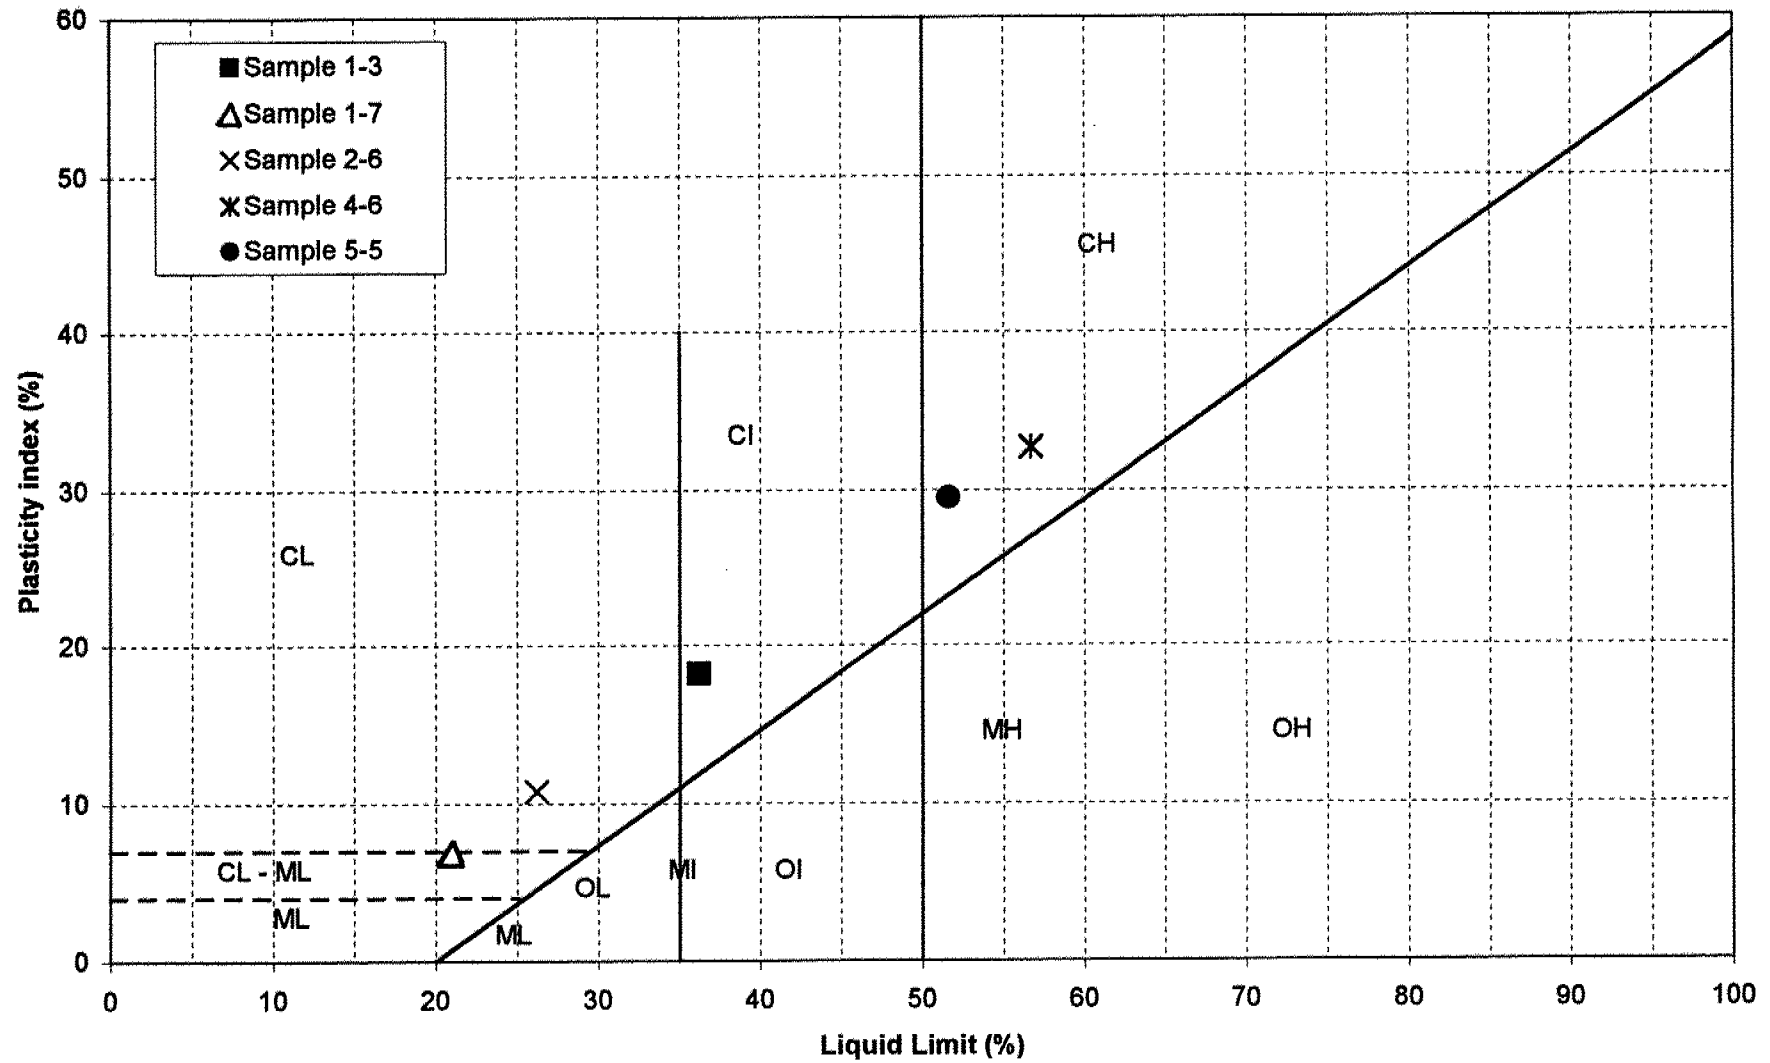
A-13  
TG98051

Index Properties	Range (%)
Moisture Content (w)	15 - 32
Liquid Limit ( $w_L$ )	26 - 57
Plastic Limit ( $w_p$ )	14 - 24
Plasticity Index ( $I_p$ )	11 - 33

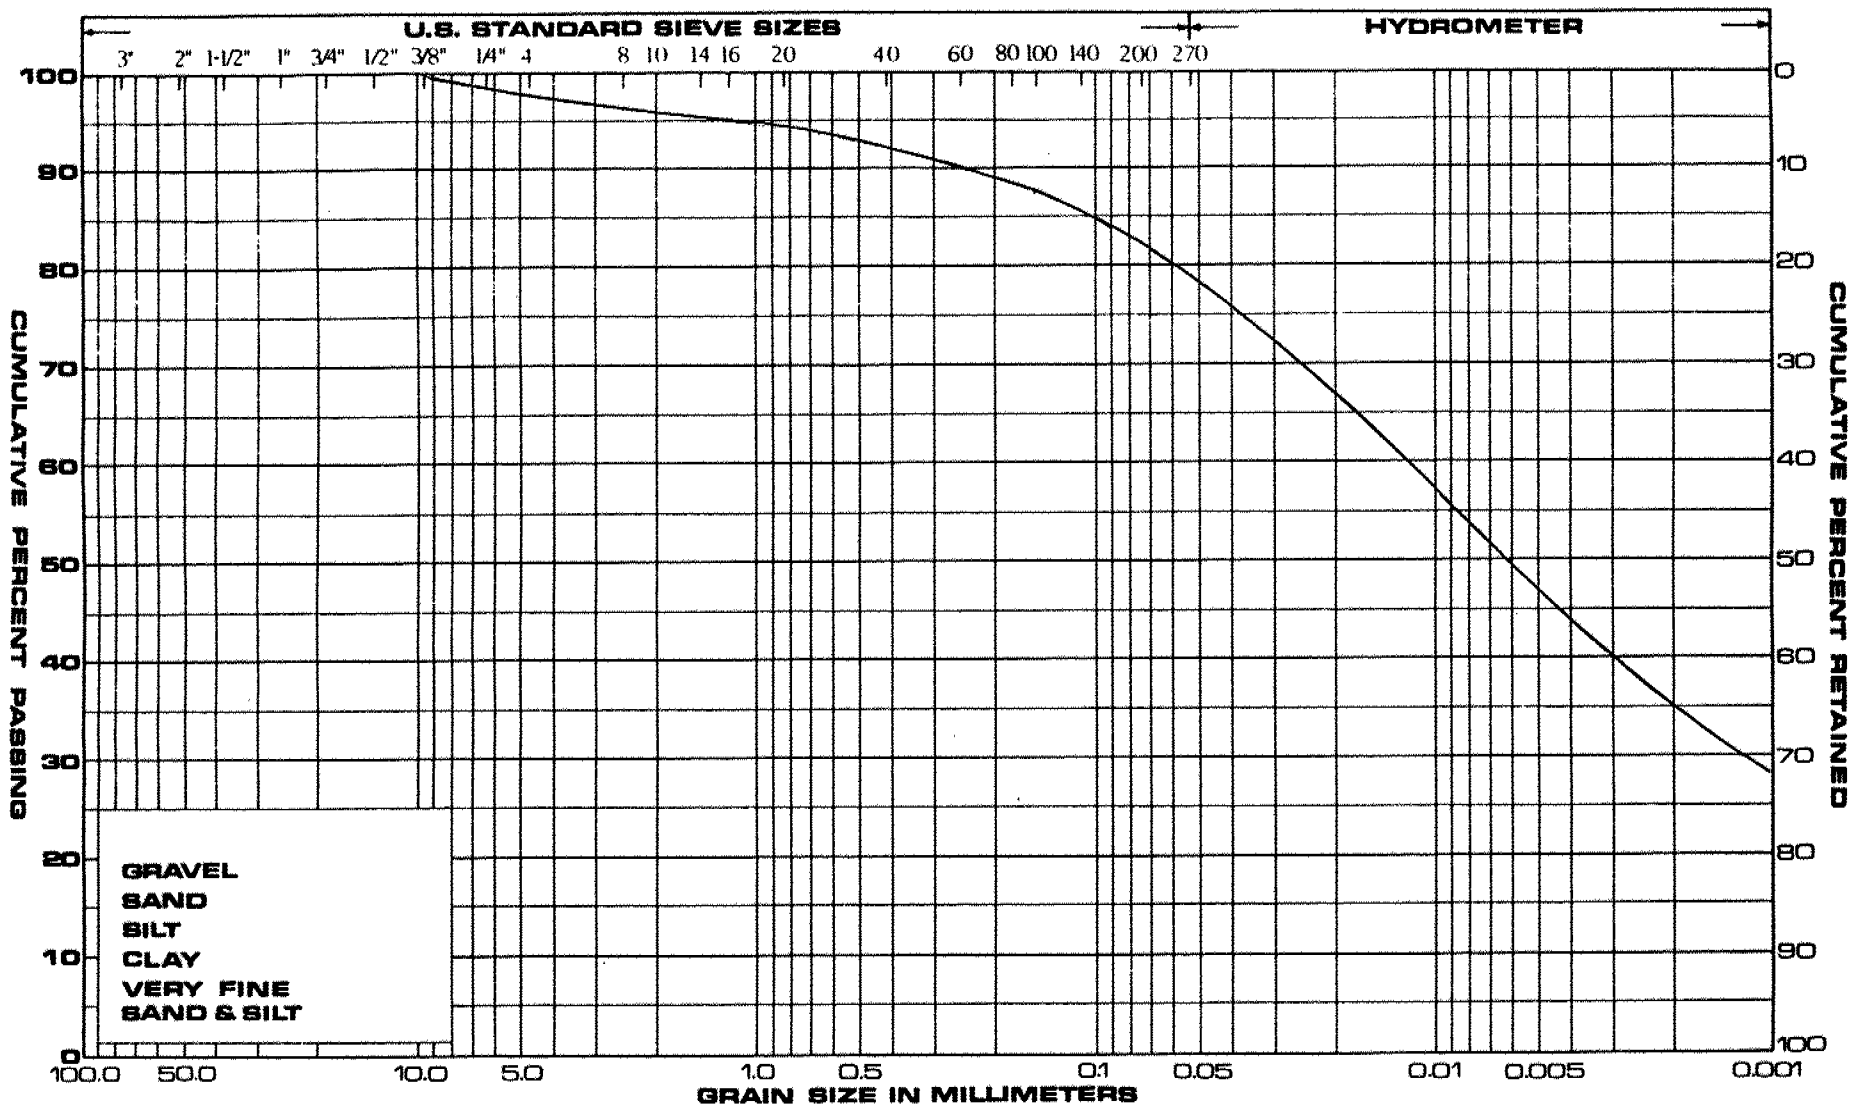
JOB NAME MTO WP 132-92-00 JOB NO. TG98050 HOLE NO. 1 SAMPLE NO. 3

DEPTH 3.1 - 3.5 m REMARKS Clay of Medim Plasticity

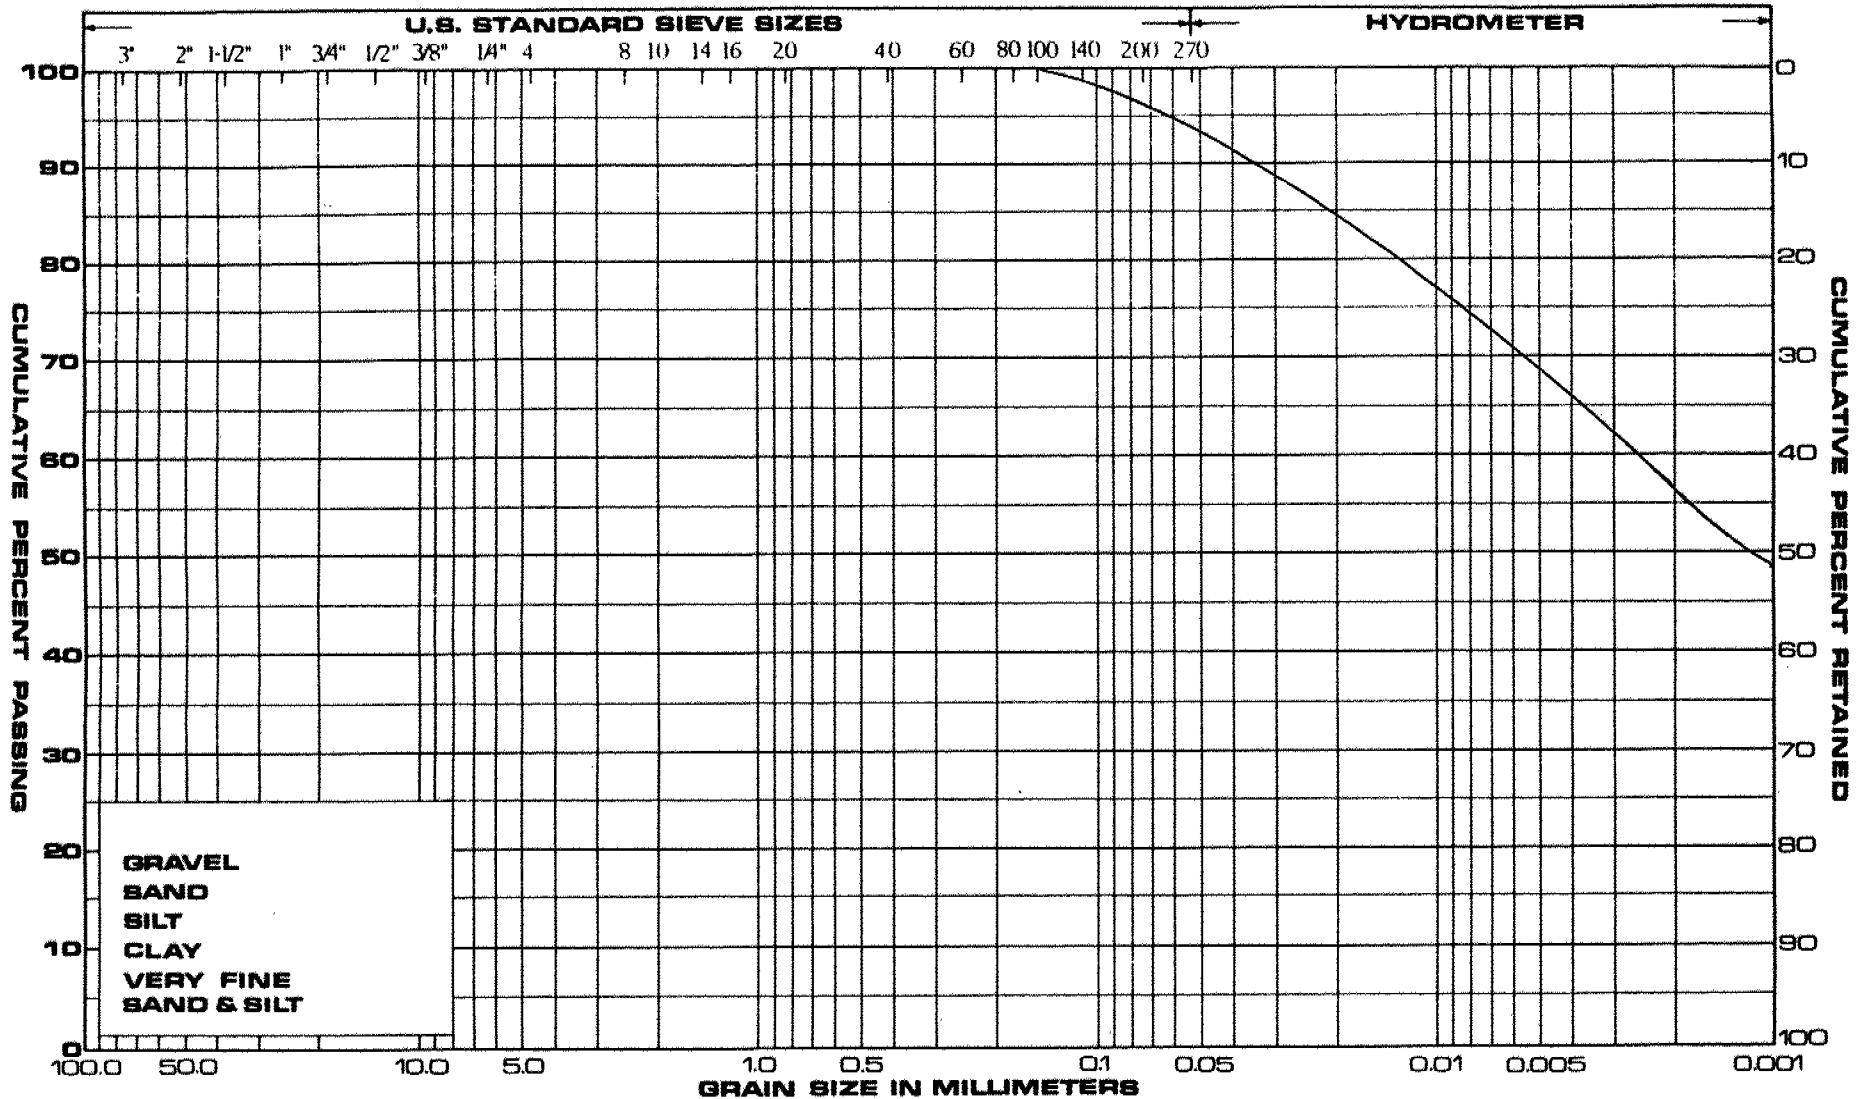
**PARTICLE SIZE DISTRIBUTION**

DEPTH 7.6 - 8.1 m REMARKS Clay of High Plasticity

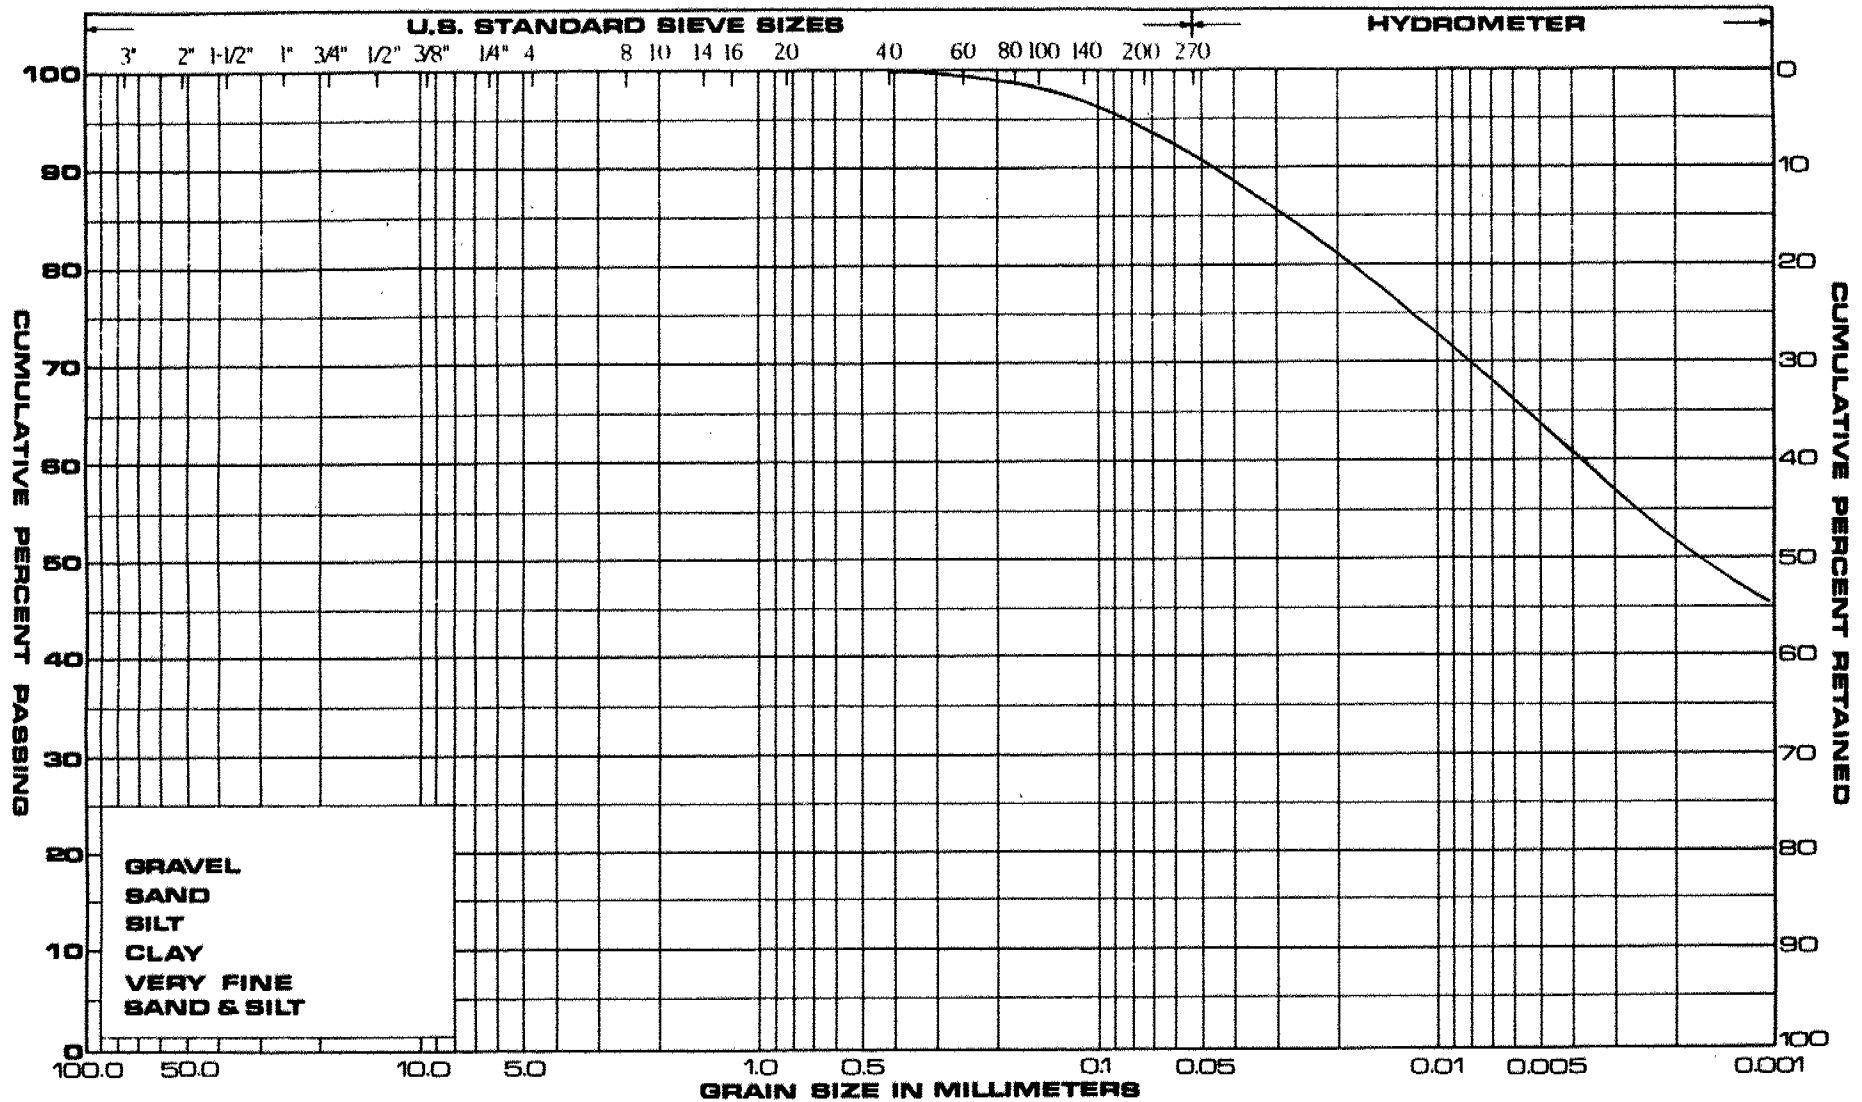
**PARTICLE SIZE DISTRIBUTION**

**JOB NAME** MTO WP 132-92-00    **JOB NO.** TG98051    **HOLE NO.** 5    **SAMPLE NO.** 5  
**DEPTH** 6.1 - 6.6 m    **REMARKS** Clay of High Plasticity

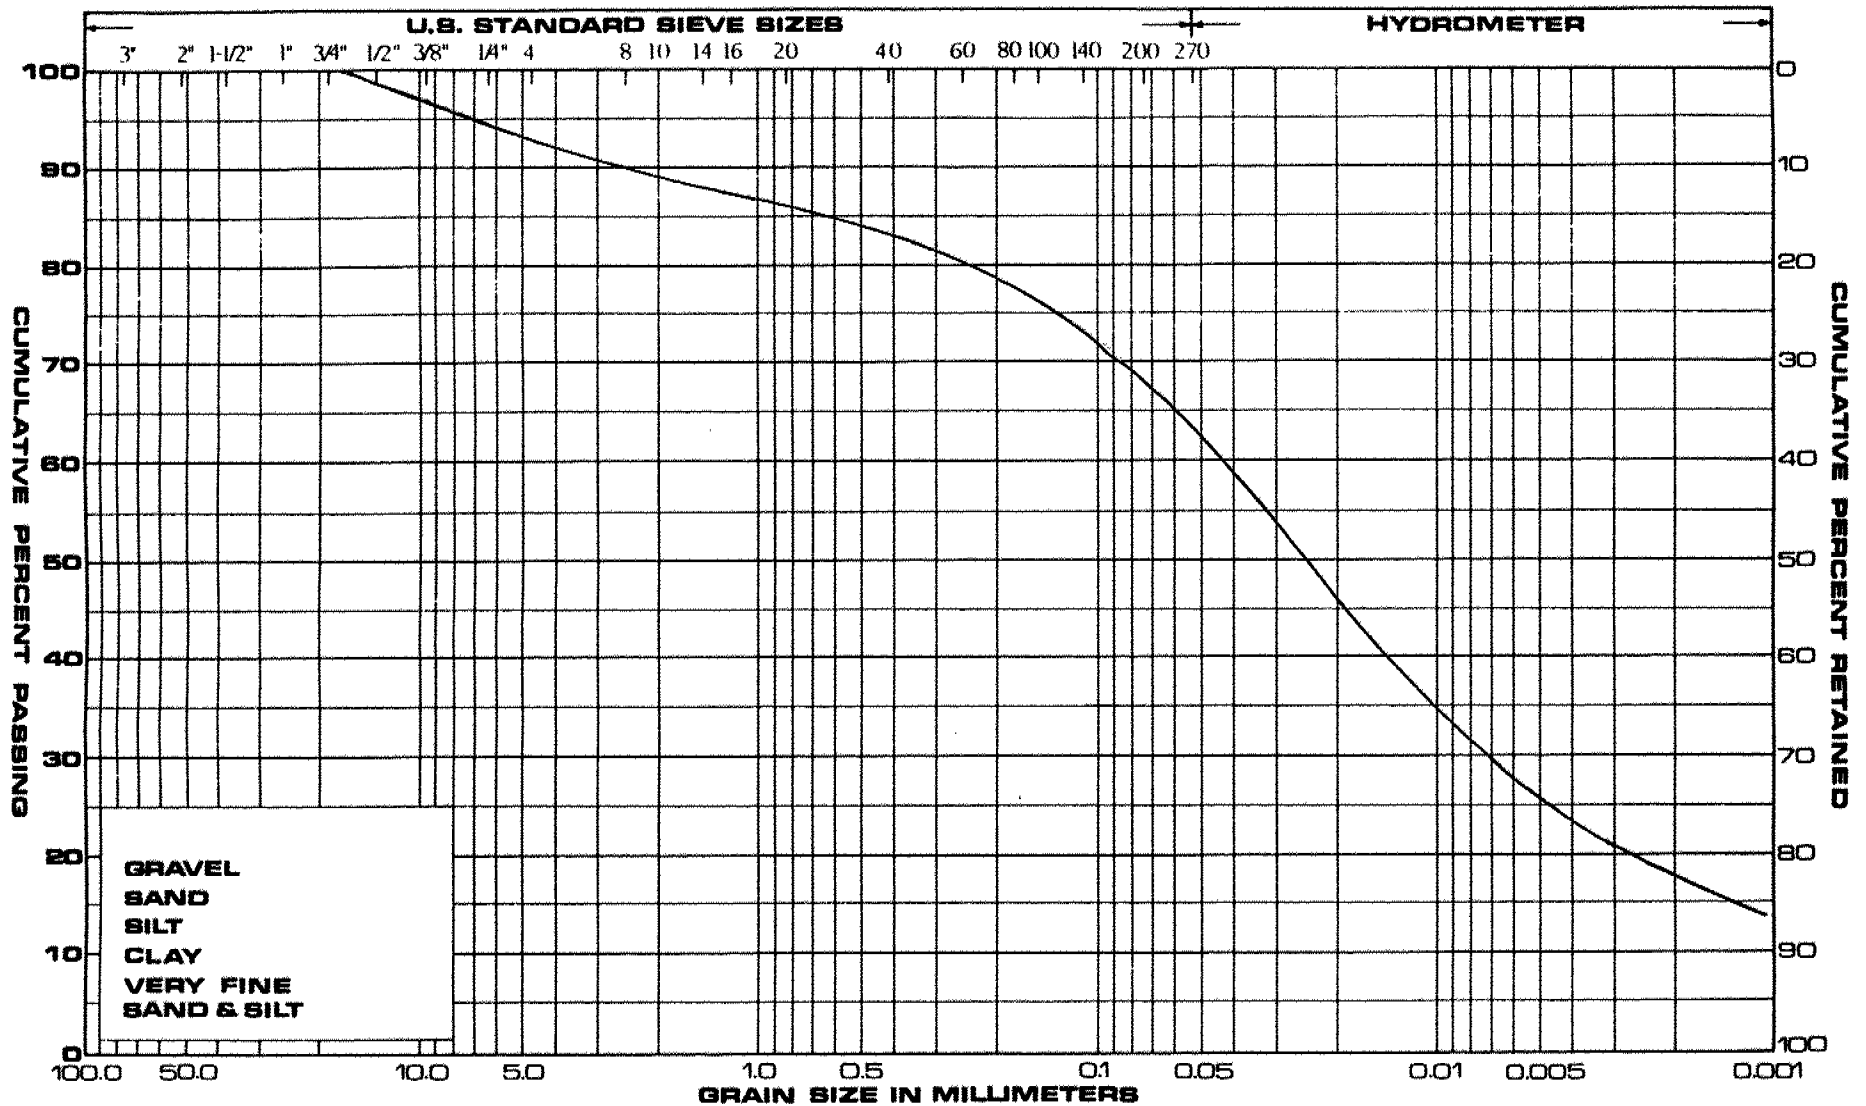
**PARTICLE SIZE DISTRIBUTION**

DEPTH 9.1 - 9.3 m REMARKS Inorganic Silty Clay

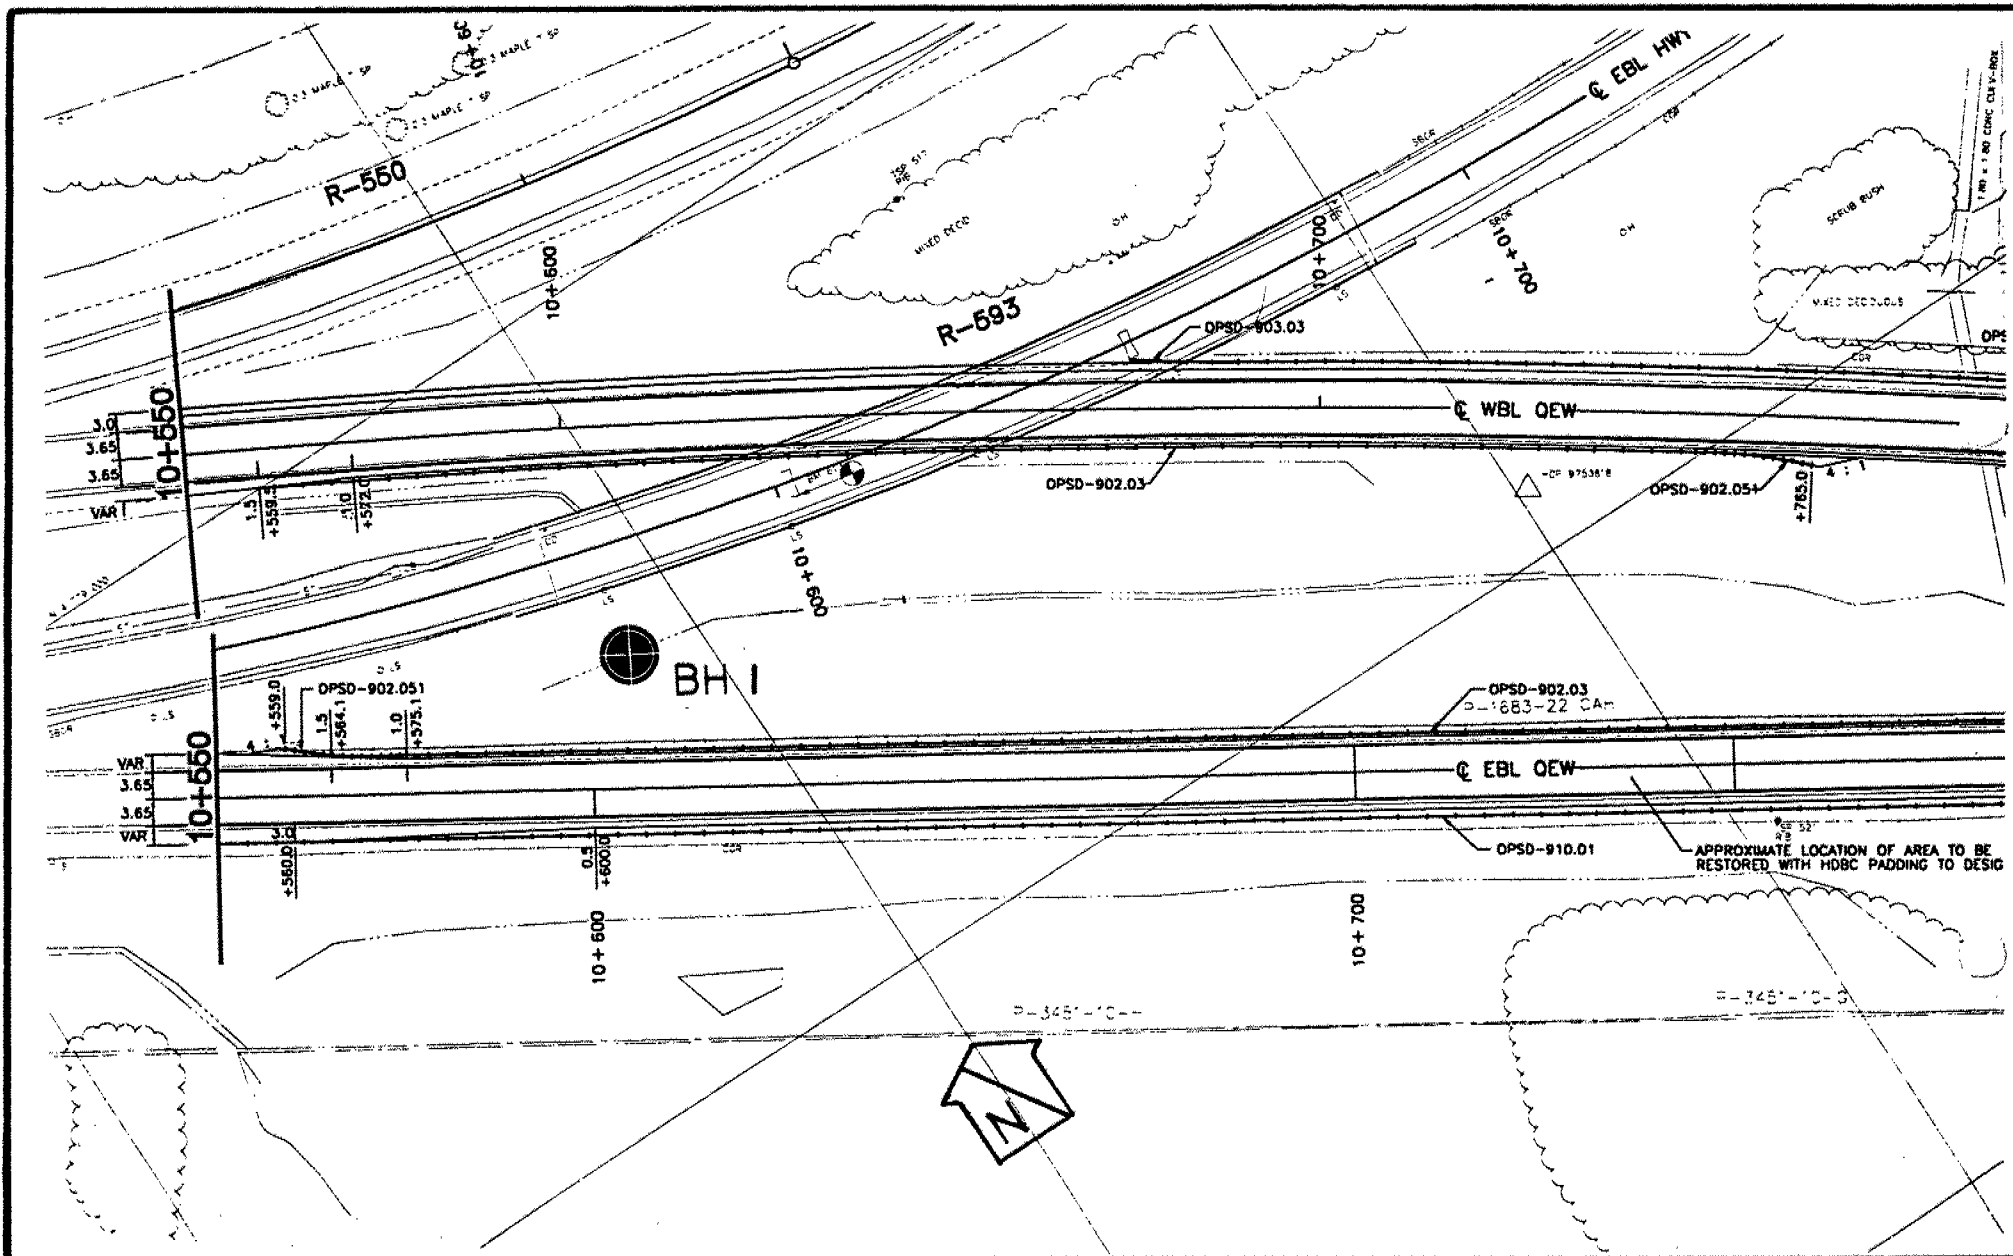
BOREHOLE LOCATION PLAN

For continuity, Part 1 of the report summarizes the factual information obtained from the field work carried out for all of the light poles, on 98 03 25. It consisted of advancing five boreholes to depths of between 9.3 and 9.6 metres, to provide soil parameters for foundation design. Borehole Location Plans are appended as pages A-3 to A-7 inclusive.

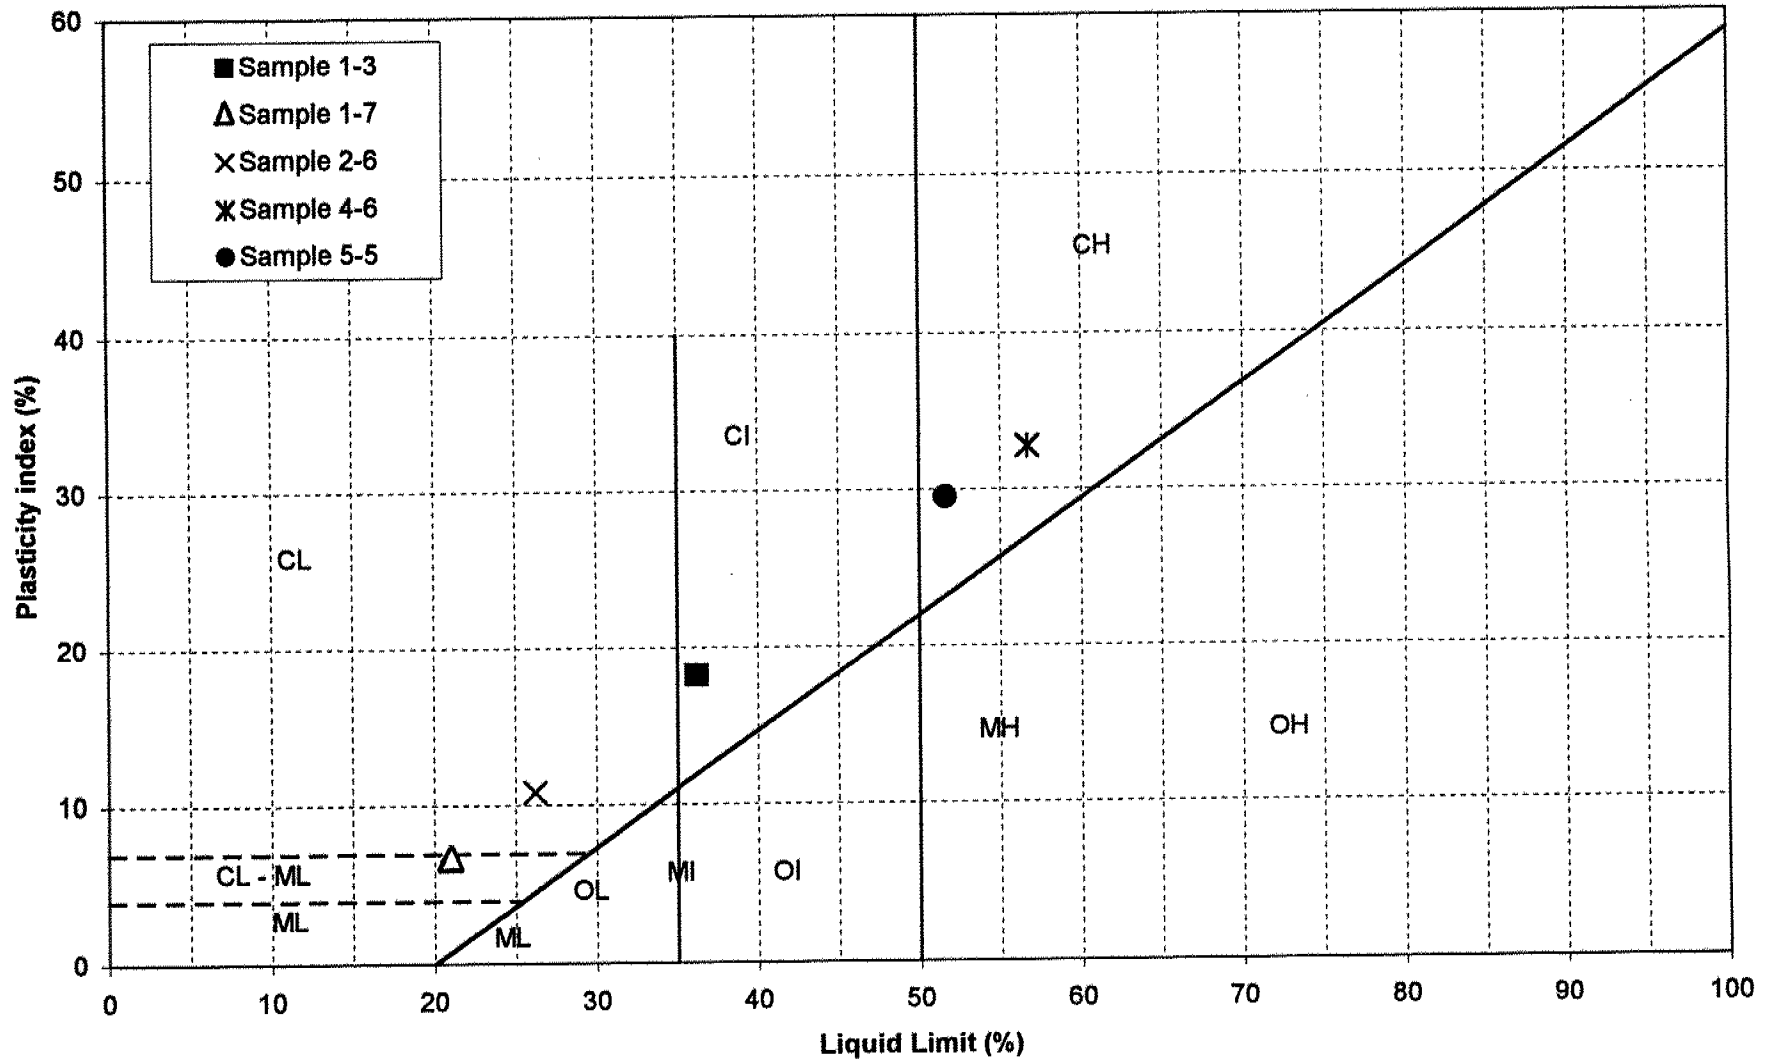
A-13  
TG98050

Index Properties	Range (%)
Moisture Content (w)	15 - 32
Liquid Limit ( $w_L$ )	26 - 57
Plastic Limit ( $w_p$ )	14 - 24
Plasticity Index ( $I_p$ )	11 - 33
