**FOUNDATION INVESTIGATION AND
DESIGN REPORTS, PROPOSED
WATERMAIN INSTALLATION, HIGHWAY
405 ENCROACHMENT AT ST. PAUL
AVENUE, TOWN OF NIAGARA-ON-THE
LAKE, ONTARIO, PROJECT NO. 091854**

**RE: Foundation Investigation and Design Report, Proposed Watermain Installation, Highway 405
Encroachment at St. Paul Avenue, Town of Niagara-on-the-Lake, Ontario, Project No. 091854**

FOUNDATION INVESTIGATION REPORT
PROPOSED WATERMAIN INSTALLATION
HIGHWAY 405 ENCROACHMENT AT ST. PAUL AVENUE
TOWN OF NIAGARA-ON-THE-LAKE, ONTARIO

FOUNDATION DESIGN REPORT

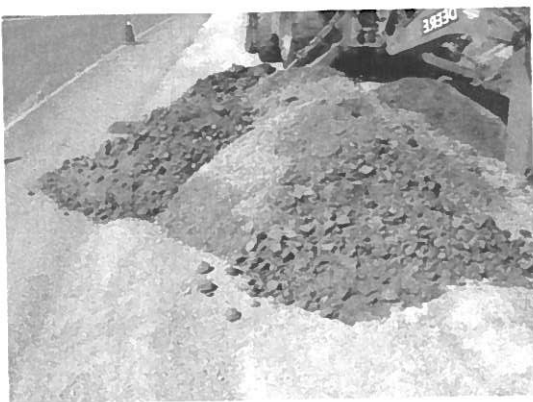
TEST PIT 1 (May 21, 2010)

Testpit 1 had only 100 mm of standing water just after the initial excavation, seepage was noted and water level was measured to be approximately 1.3 m below the top of the existing ground level after about 3.5 hrs. The depth of water in the testpit was approximately 800 mm.

As discussed in Part 1, the three testpits were put down along the alignment of the SBL piers or within a metre east of the face of the piers. The photographs in Appendix E show that the testpits remained open during the period of testpitting which varied from 4 to 4.5 hours. It should be noted that there was about an hour time lag between the completion of Testpit 3 and the start of Testpit 2 as a result of the need to change the flat bottom bucket of the backhoe to one with teeth to facilitate the excavation of the old pavement layer encountered with depth.

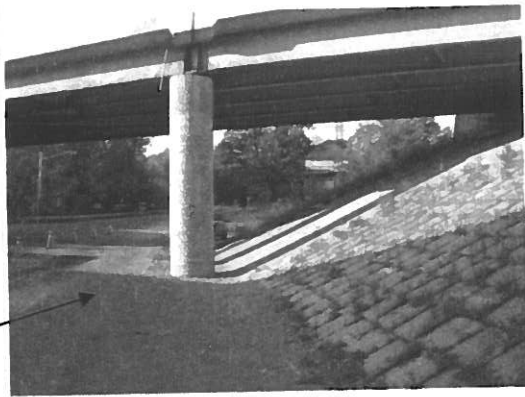
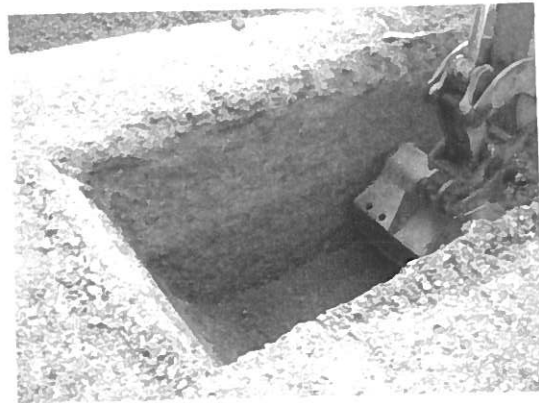
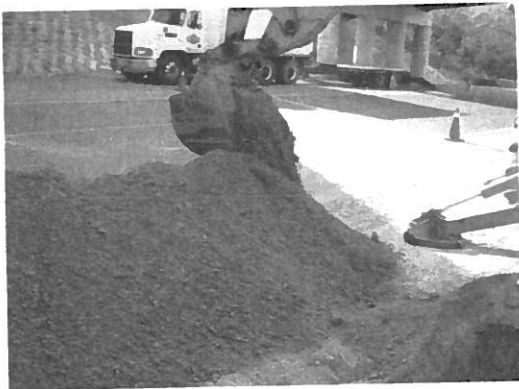
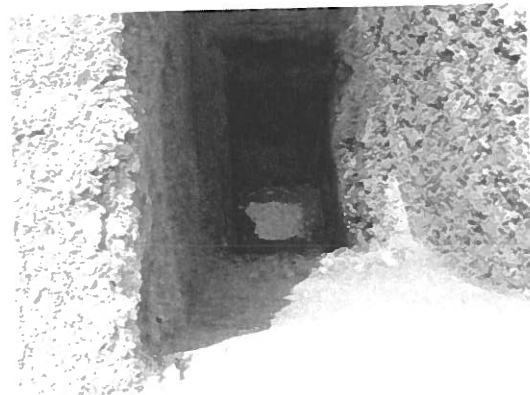
TEST PIT 2 (May 21, 2010)

At the Testpit 2 location, the granular fill, which was found underneath the old pavement layer, continued to the termination elevation of the testpit, which was about 3.1 m below the ground surface.

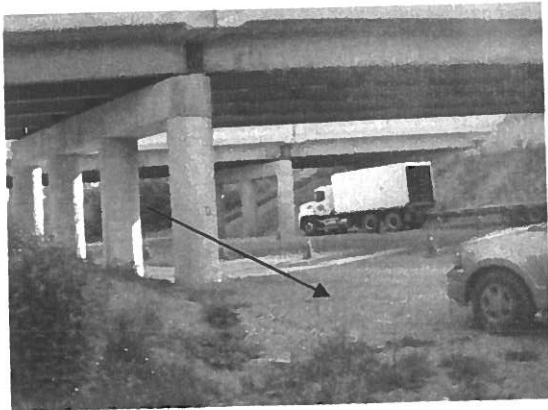
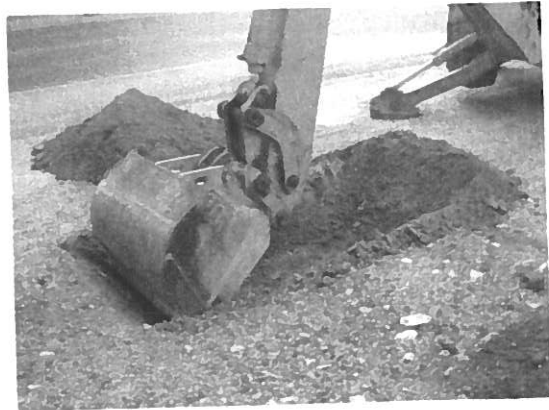
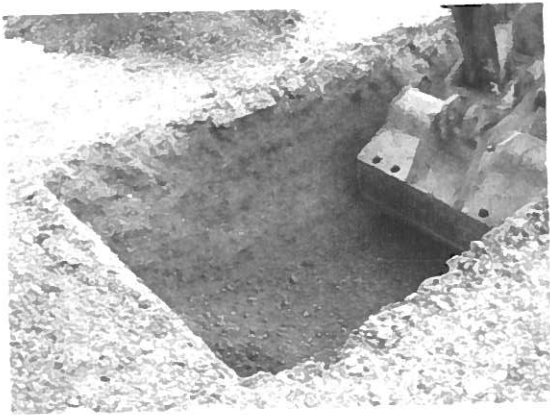
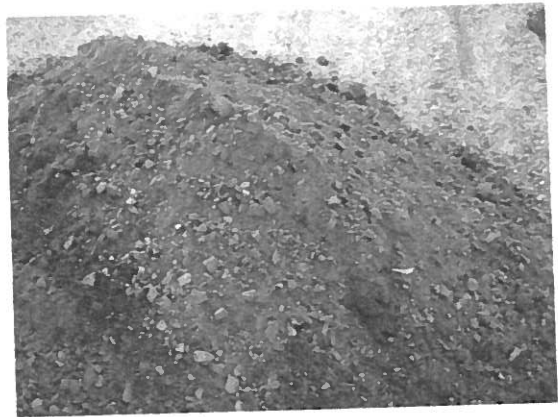
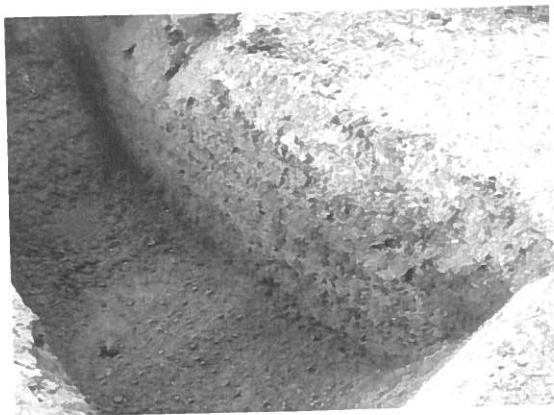
TEST PIT 3 (May 21, 2010)

In Testpit 3, seepage noted at approximately 1.9 m below the ground level during the excavation, with water level at approximately 2.5 m below ground level after approximately 2.5 hours. The depth of water in the testpit was less than about 100 mm.
