C.E.C. FOUNDATION INVESTIGATION

Re: King St. Overhead & Church Avenue Overhead  
for Chedoke Expressway.

# FOUNDATION INVESTIGATION

King St. Overhead & Church Access Overhead for  
Chedoke Expressway.

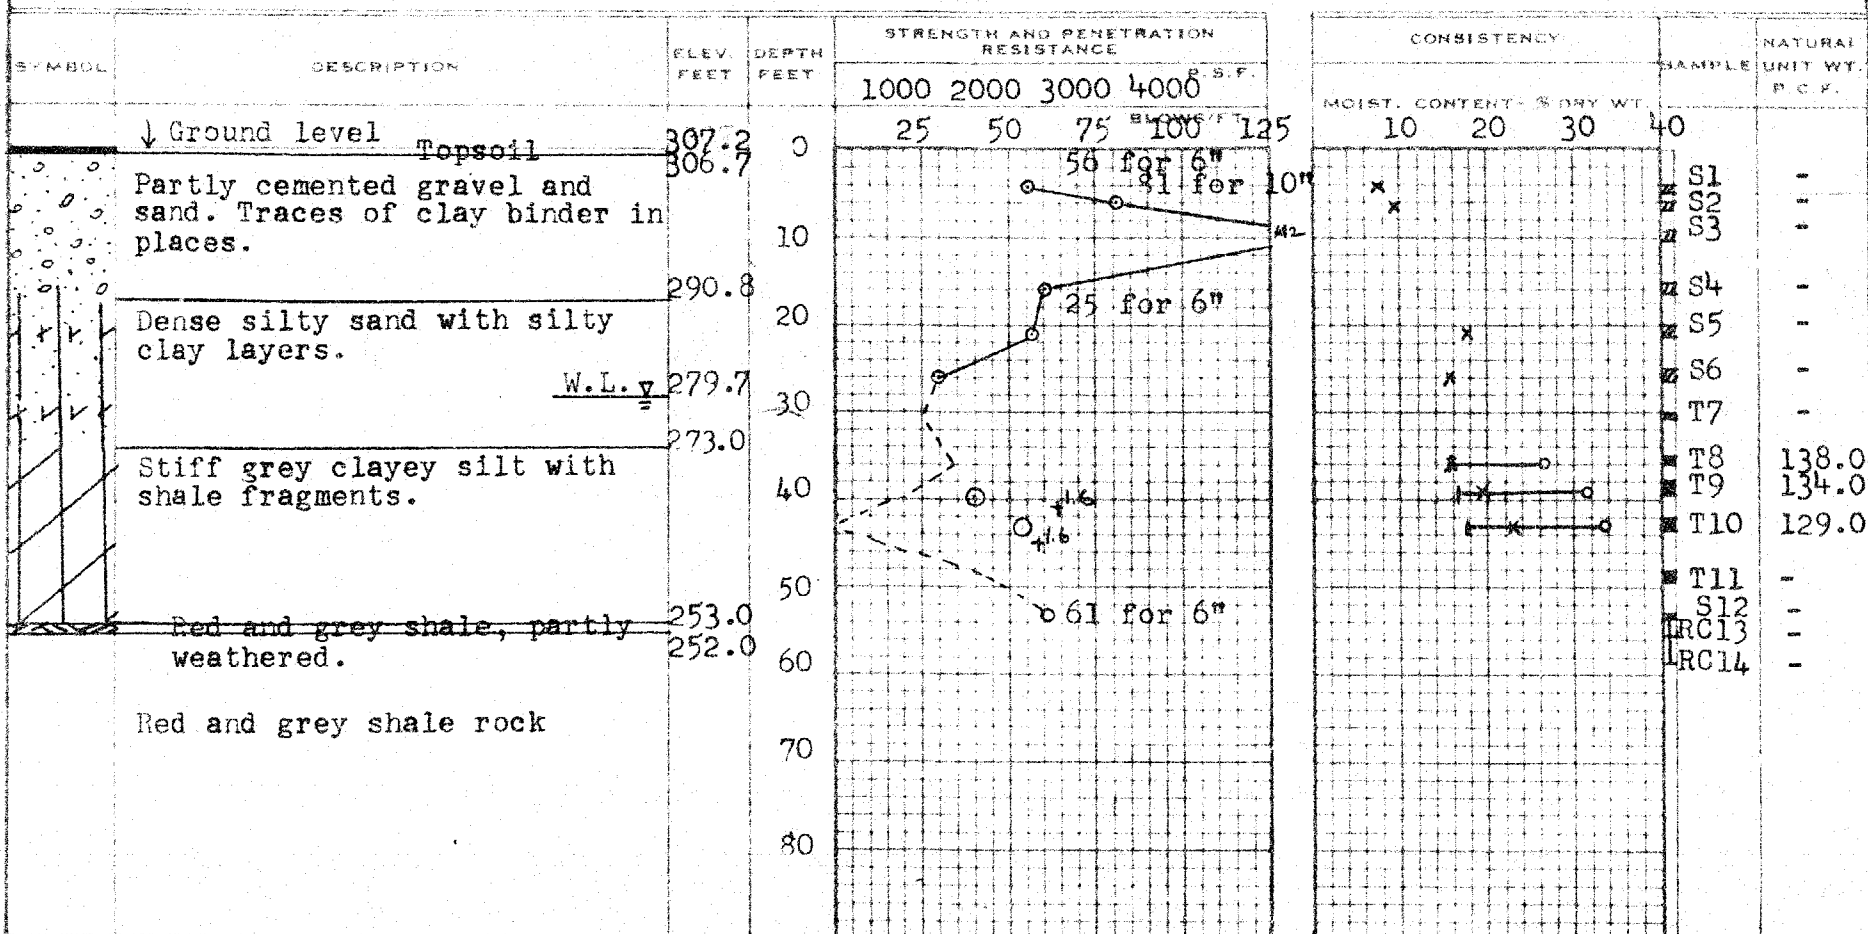
W.P. 192-60 BORE HOLE NO. 1  
JOB 60-F-25 STATION See Drawing  
DATUM 307.2' COMPILED BY B.K.  
BORING DATE Mar. 1/60 CHECKED BY T.S.

Upon receipt in the laboratory, samples were visually examined and identified. Routine index tests were performed on selected, representative samples. Field and laboratory test results have been presented in the borehole logs and detailed under Appendix I. The location plan and subsoil profile are presented together in Dwg. No. 60-F-25A.

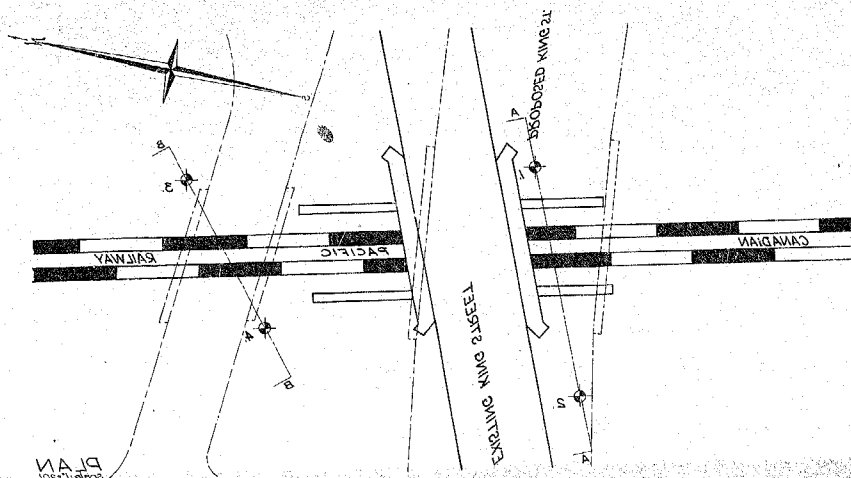
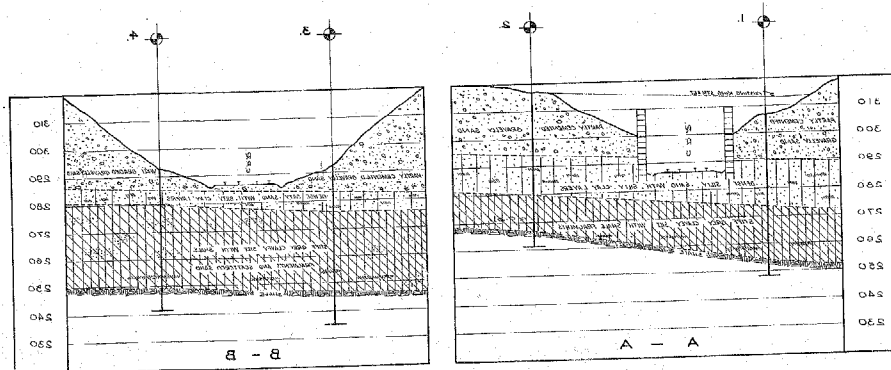
LEGEND	
BOKE & PENETRATION HOPE	
HOPE NO.	LEGEND
1	307.50
5	317.50
3	521.20
4	523.50

THE BOUNDARIES BETWEEN THE NEIGHBORHOODS HAVE BEEN WELL ESTABLISHED ONLY AT SOME POINTS. LOCATION BETWEEN NEIGHBORHOODS THE BOUNDARIES ARE GENERALLY FROM NEIGHBORHOODS. DISTANCE AND MAY BE SUBJECT TO CONSIDERABLE ERROR.
