**FOUNDATION INVESTIGATION REPORT
PRELIMINARY DESIGN AND ENVIRONMENTAL ASSESSMENT
QEW BRIDGE TWINNING OVER CREDIT RIVER
MISSISSAUGA, ONTARIO
W.O. 08-20008, ASSIGNMENT NO. 2008-E-0025**

GEOCREC Number: 30M12-341

May 18, 2012
File: 19-1351-174

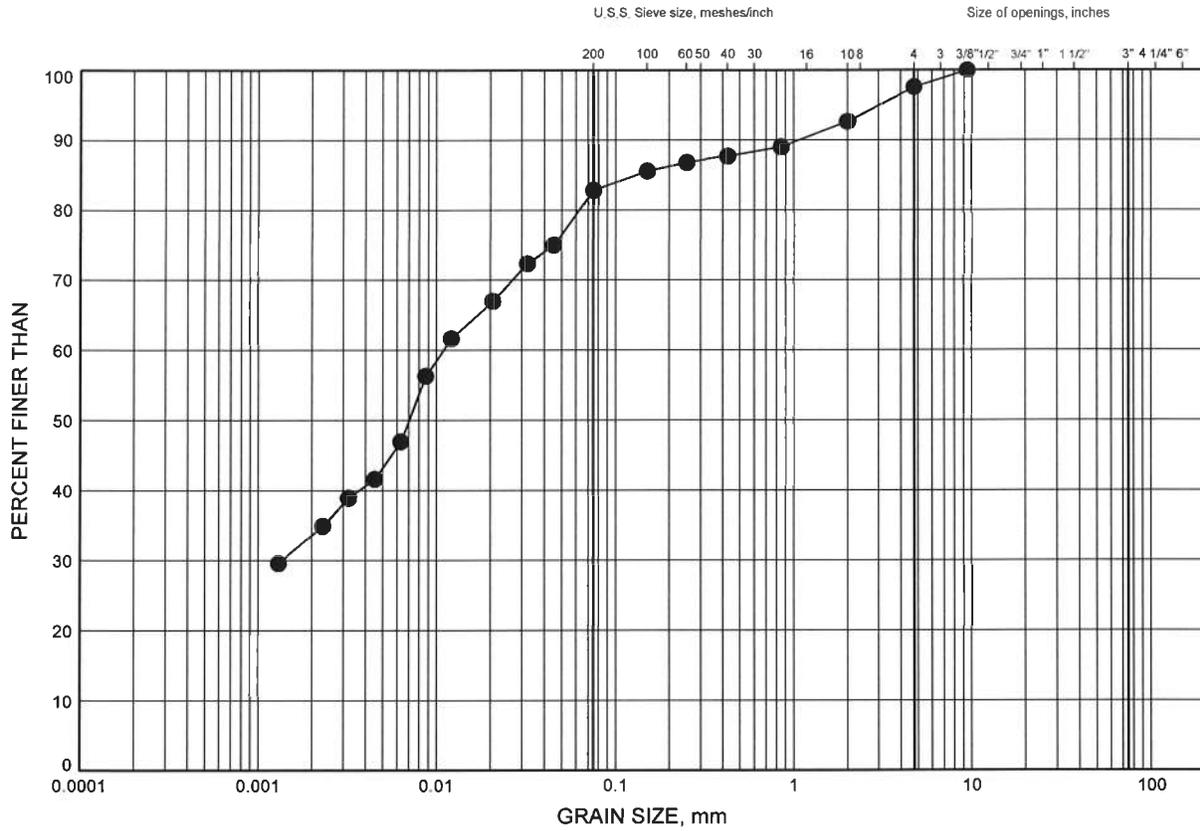
FIGURE B1

SILTY CLAY

Grain size analysis conducted on a sample of this soil is presented in Figures B1. The results indicate that the silty clay contains approximately 2% gravel, 15% sand, 49% silt and 34% clay. Atterberg Limits test was also conducted on a sample from this stratum and the results are presented in Figure B3. The silty clay sample had a measured plasticity index of 17% and a corresponding liquid limit of 38%. These values are indicative of a cohesive soil of intermediate plasticity (group symbol of CI).

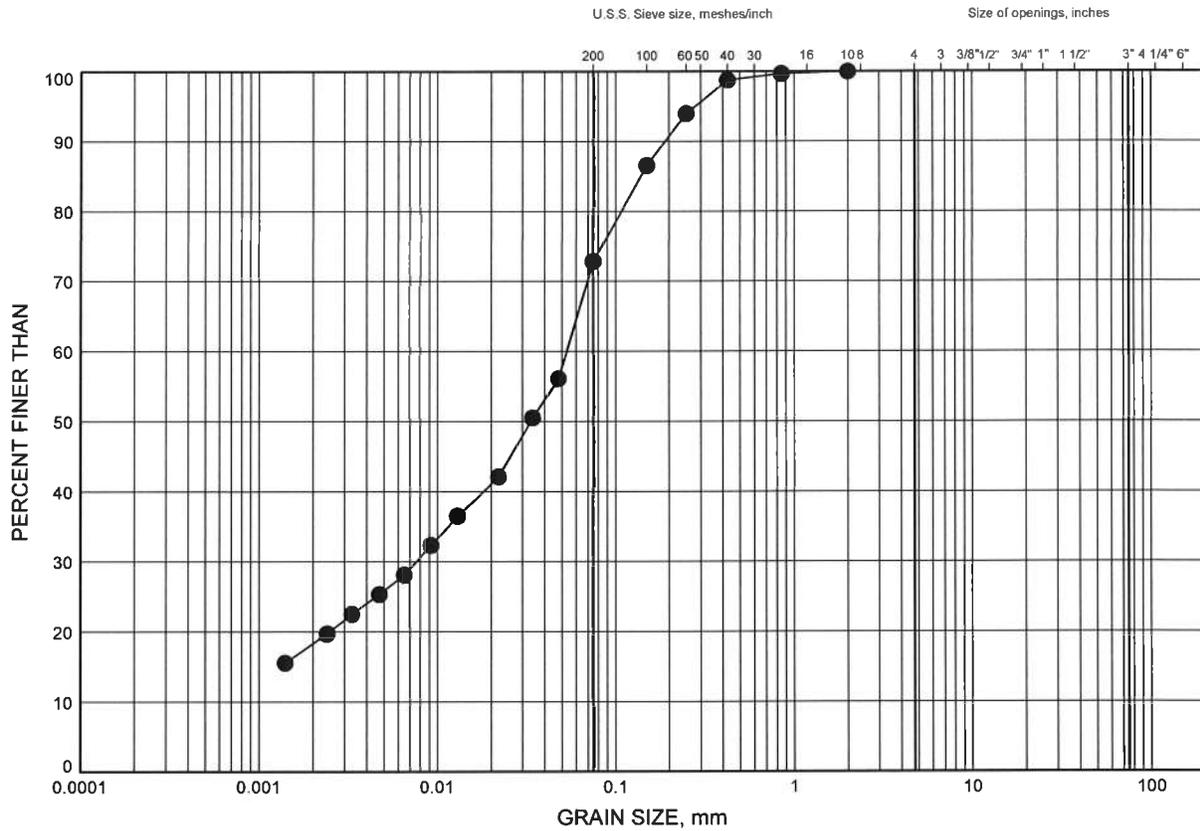
FIGURE B2

CLAYEY SILT

Grain size analysis conducted on a sample of the clayey silt is presented in Figure B2. The results indicate that the clayey silt contains approximately 0% gravel, 27% sand, 55% silt and 18% clay.

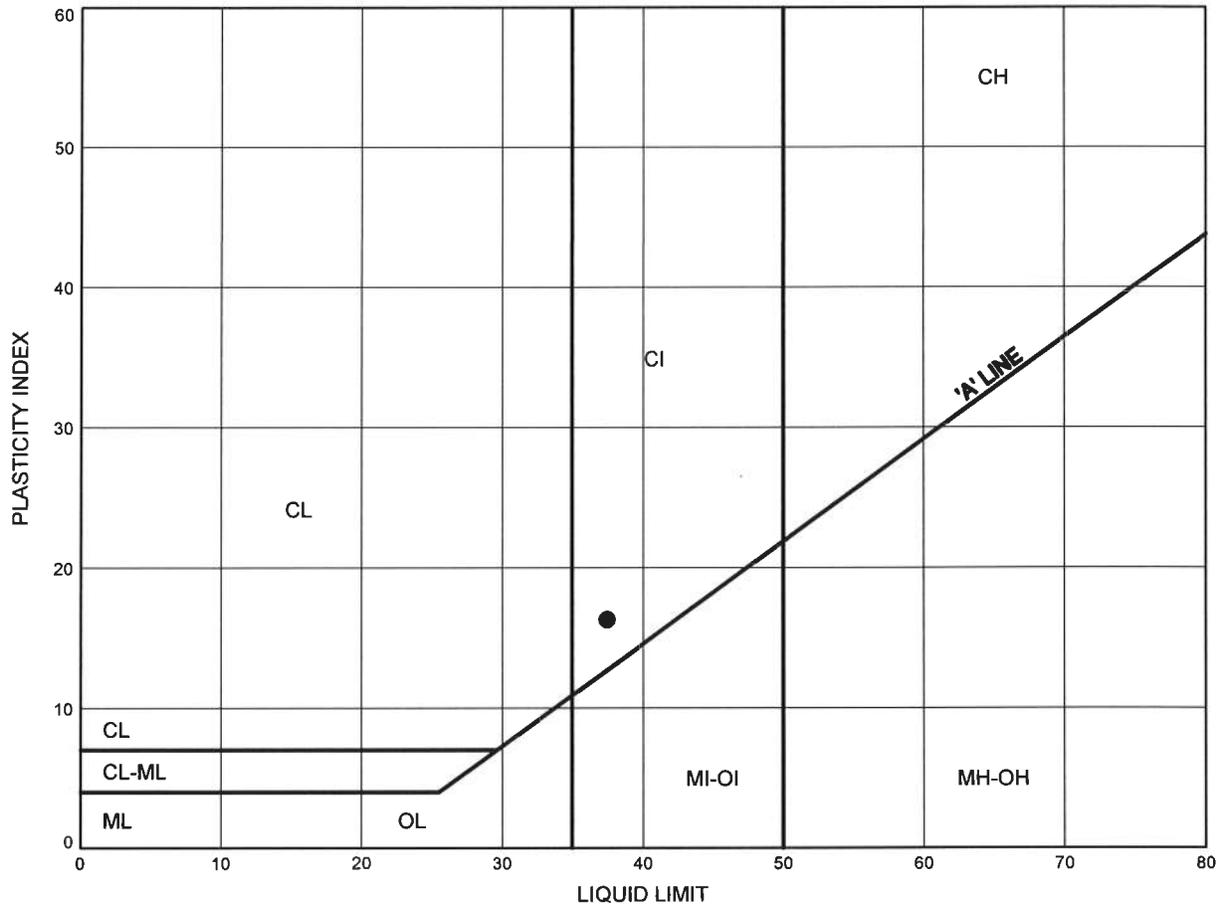
FIGURE B3

SILTY CLAY

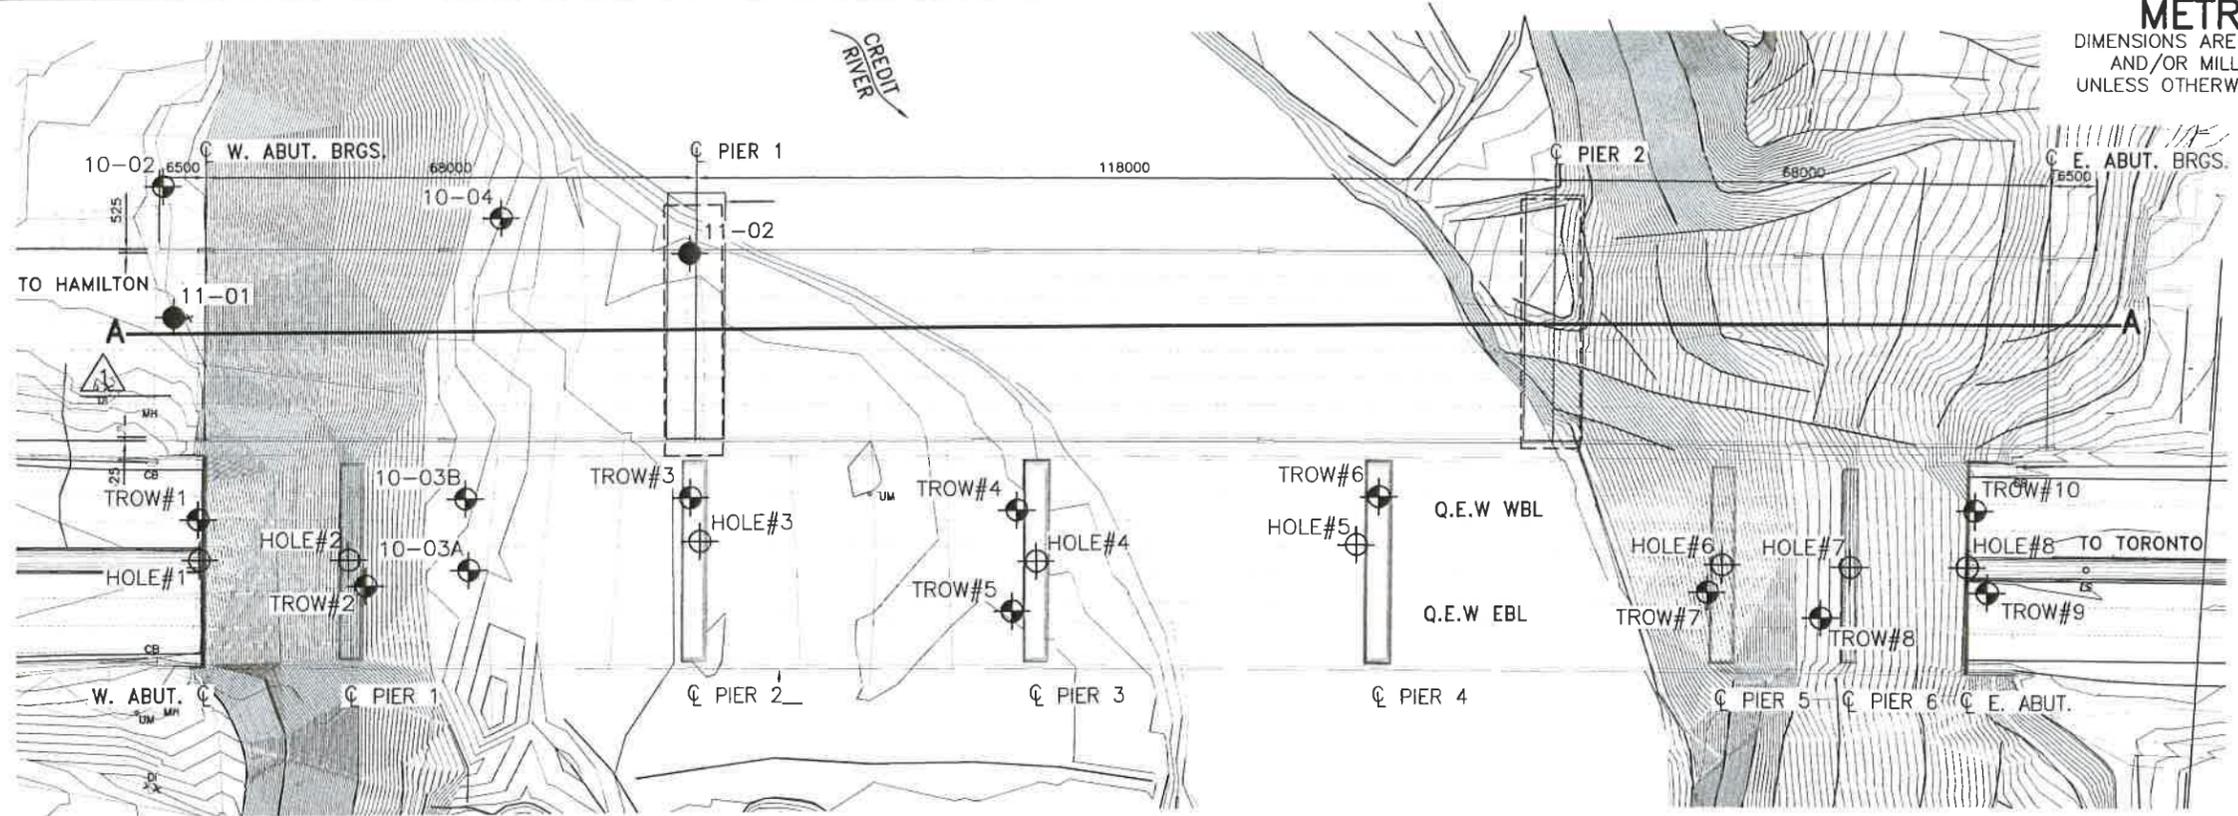
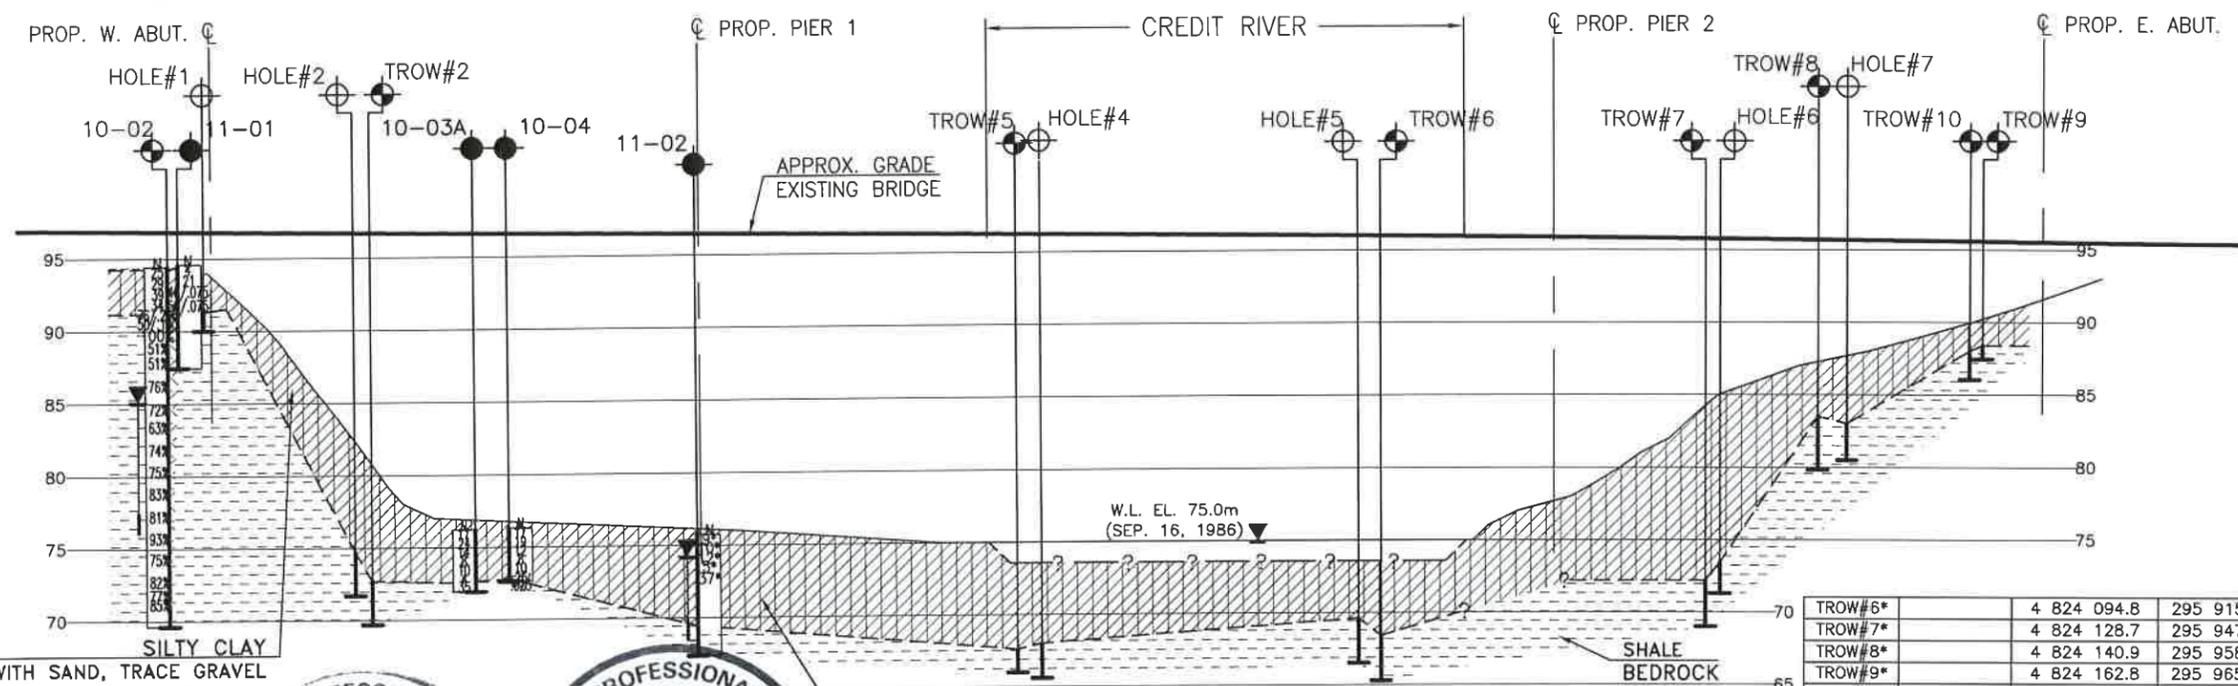
LOAD | DATE MAY 2012
STRUCT | DWG 19-1351-174-1

- 1) The boundaries between soil strata have been established only at borehole locations. Between boreholes the boundaries are assumed from geological evidence.
- 2) This drawing is for subsurface information only. Surface details and features are for conceptual illustration.
- 3) Boreholes from Trow & Dept. of Highways are located on the alignment of the existing bridge, and are offset from the alignment of the proposed bridge.

Reference is made to the Record of Borehole sheets in Appendix A. Details of the encountered soil and rock stratigraphy are presented in these records and on the "Borehole Locations and Soil Strata"

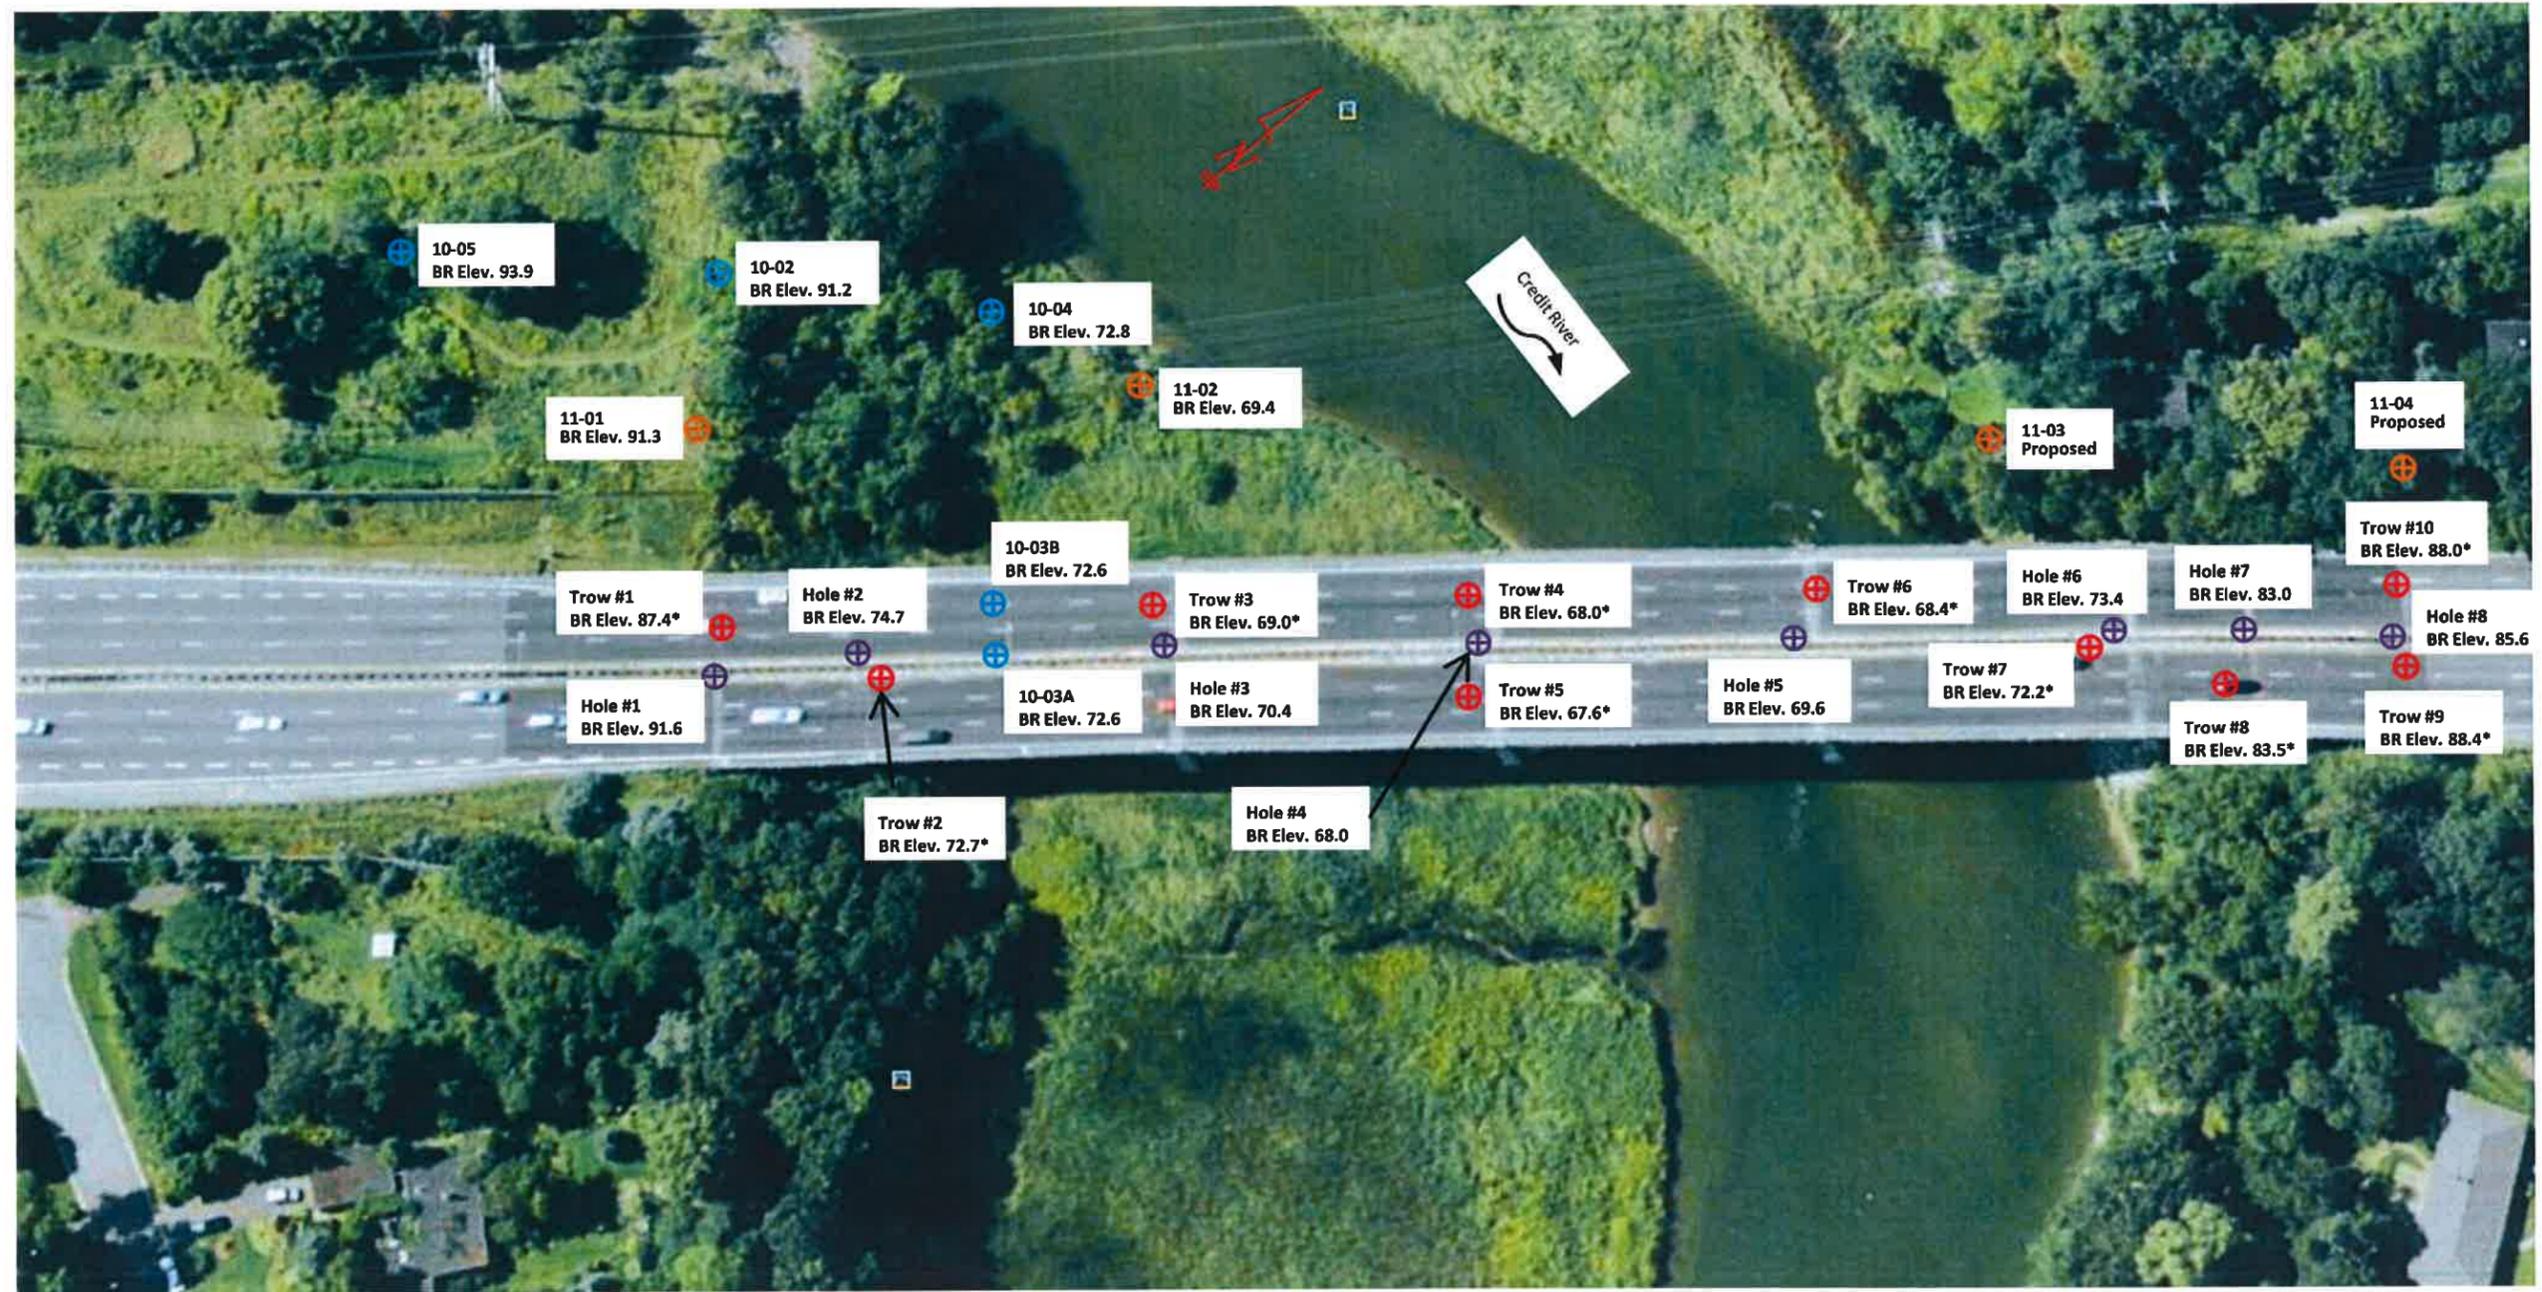
| NTS | | 19-1351-174-2 | |

- ⊕ Existing BH – Dept of Highways 1933
- ⊕ Existing BH – Trow 1958
- ⊕ Existing BH – Thurber 2010 (Access Road)
- ⊕ Existing/Proposed BH – Thurber 2011 (Current Investigation)

drawing in Appendix C. A summary of bedrock information from current and previous boreholes is shown on an aerial photograph of the site included in Appendix C. A 1933 bridge plan and profile showing the original 1933 boreholes is also included in Appendix C. General description of the stratigraphy based on boreholes advanced during the current and past investigations is given in the following paragraphs. The factual information established at the borehole locations governs any interpretation of site conditions.
