**FOUNDATION INVESTIGATION AND DESIGN REPORT  
DEEP FILL CULVERT  
HIGHWAY 101, 7.3 KM EAST OF HIGHWAY 672 JUNCTION,  
STA. 12+700, HOLLOWAY TOWNSHIP  
ASSIGNMENT NO. 5018-E-0010, WORK ITEM NO. 9**

**GEOCRES NO.: 32D-36**

January 2022  
Thurber File No.: 31935

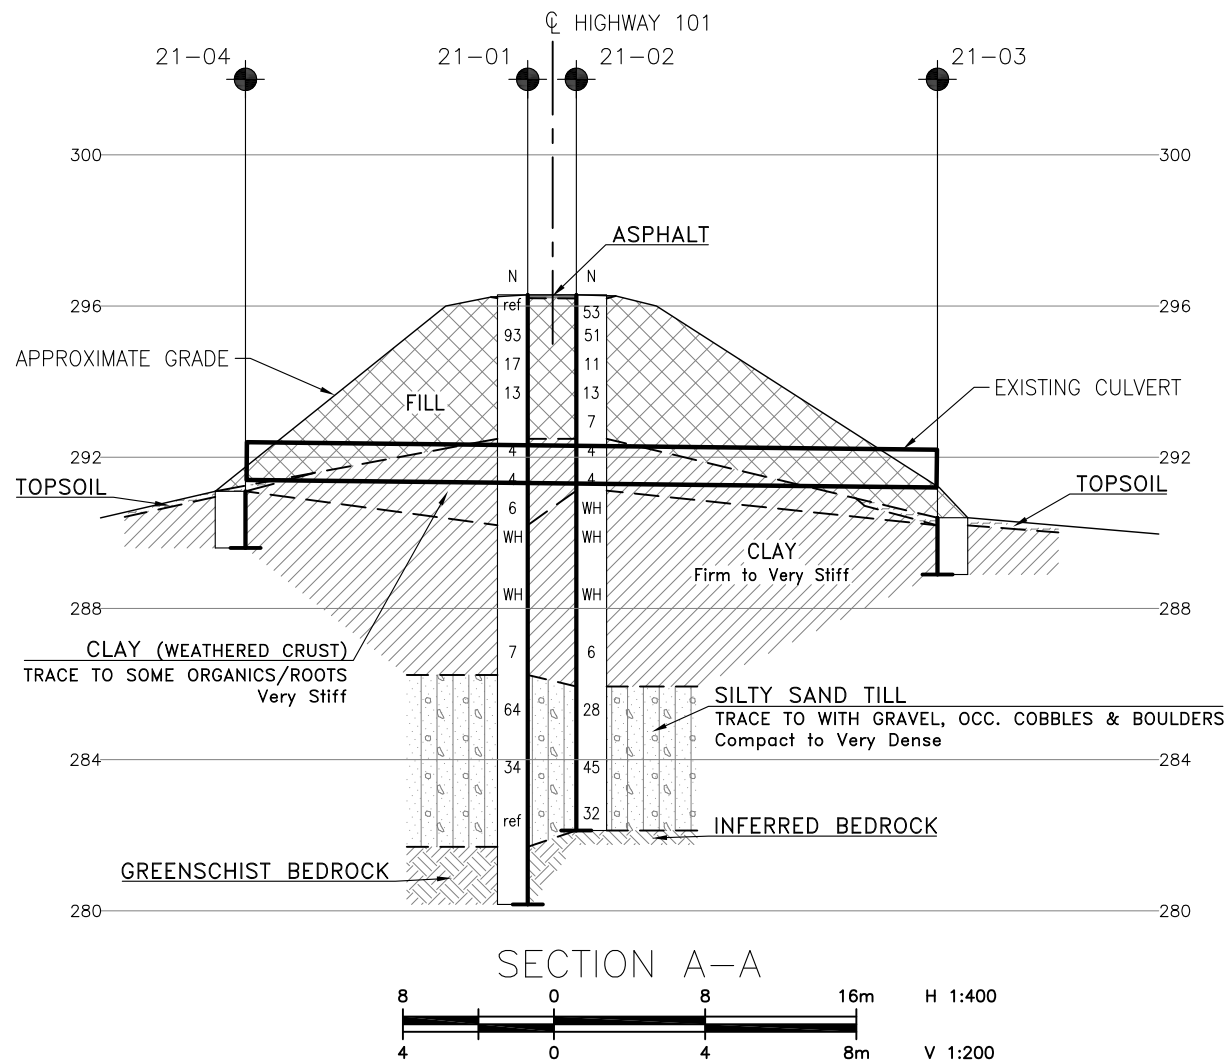
HIGHWAY 101  
DEEP FILL  
CULVERT REPLACEMENT  
BOREHOLE LOCATIONS AND SOIL STRATA

The approximate borehole locations are shown on the Borehole Locations and Soil Strata Drawing included in Appendix A. The coordinates and elevations of the boreholes are provided on this drawing, Table 3-1 above, and on the Record of Borehole sheets included in Appendix B.

Details of the encountered soil stratigraphy are presented on the Record of Borehole sheets included in Appendix B and the Borehole Location and Soil Strata drawing included in Appendix A. A general description of the stratigraphy, based on the conditions encountered in the boreholes, is given in the following paragraphs. However, the factual data presented on the Record of Borehole sheets takes precedence over this general description for interpretation of the site conditions. It must be recognized that the soil, bedrock and groundwater conditions will vary between and beyond borehole locations.

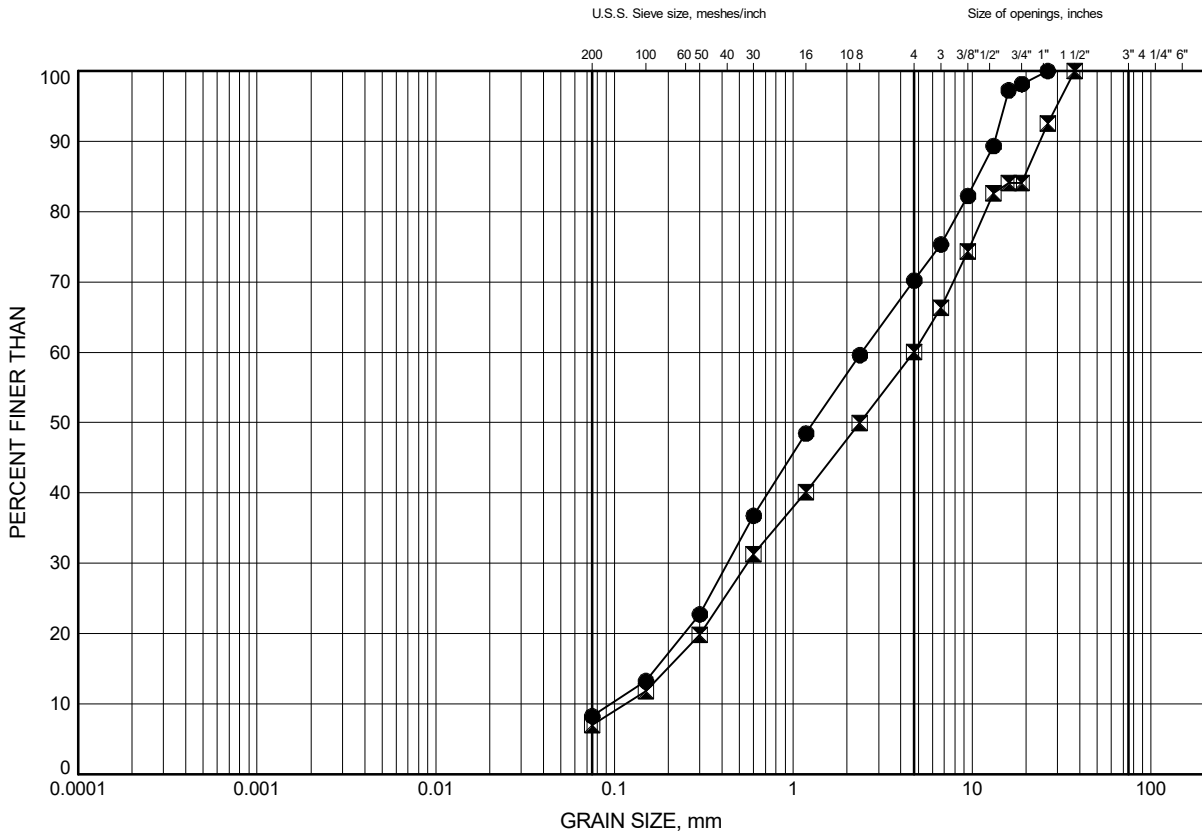
FIGURE C1

## GRAVELLY SAND FILL

Recorded moisture contents of the granular fill ranged from 4 to 20%. The gradation analyses completed on two samples of the granular fill are illustrated on Figure C1 of Appendix C. The results of the tests are summarized below and are presented on the corresponding Record of Borehole sheets in Appendix B.

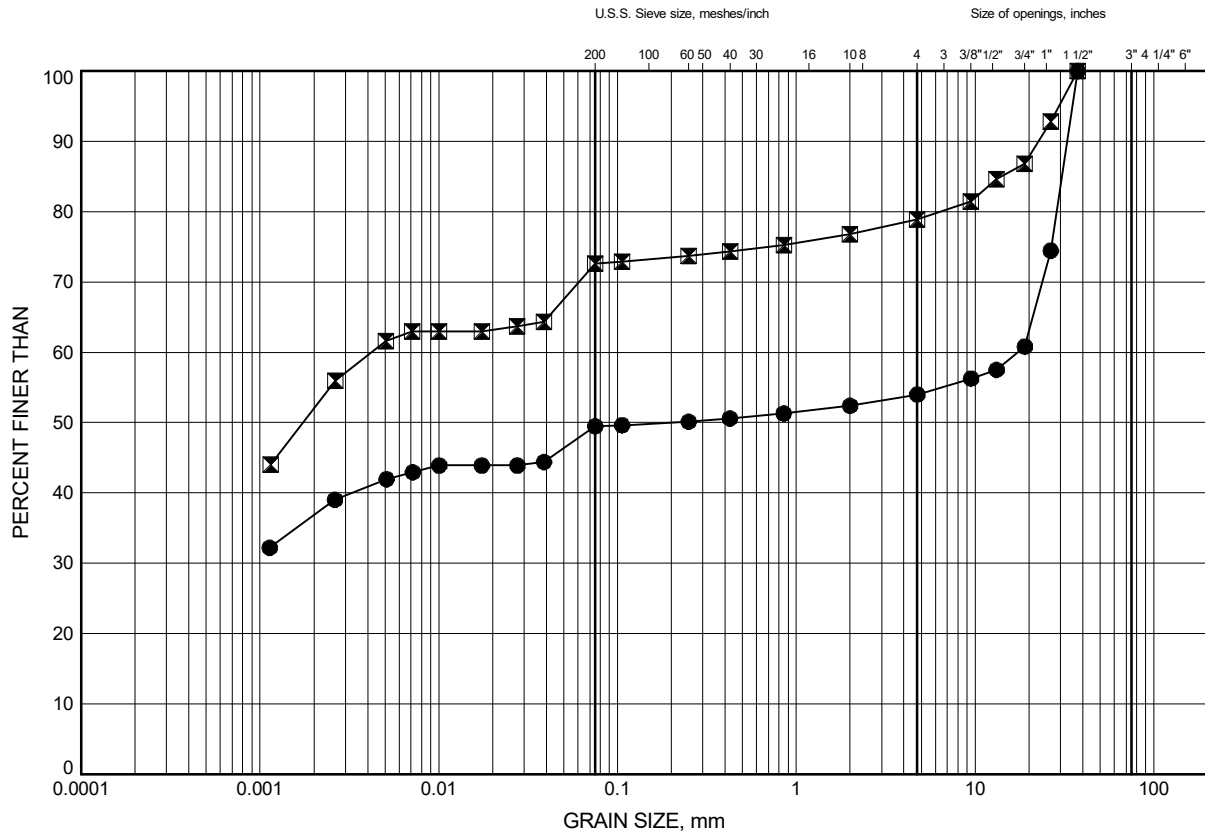
FIGURE C2

## CLAY with gravel FILL

The gradation analyses completed on two samples of the clay fill are illustrated on Figure C2 of Appendix C. The results of the tests are summarized below and are presented on the corresponding Record of Borehole sheets in Appendix B.

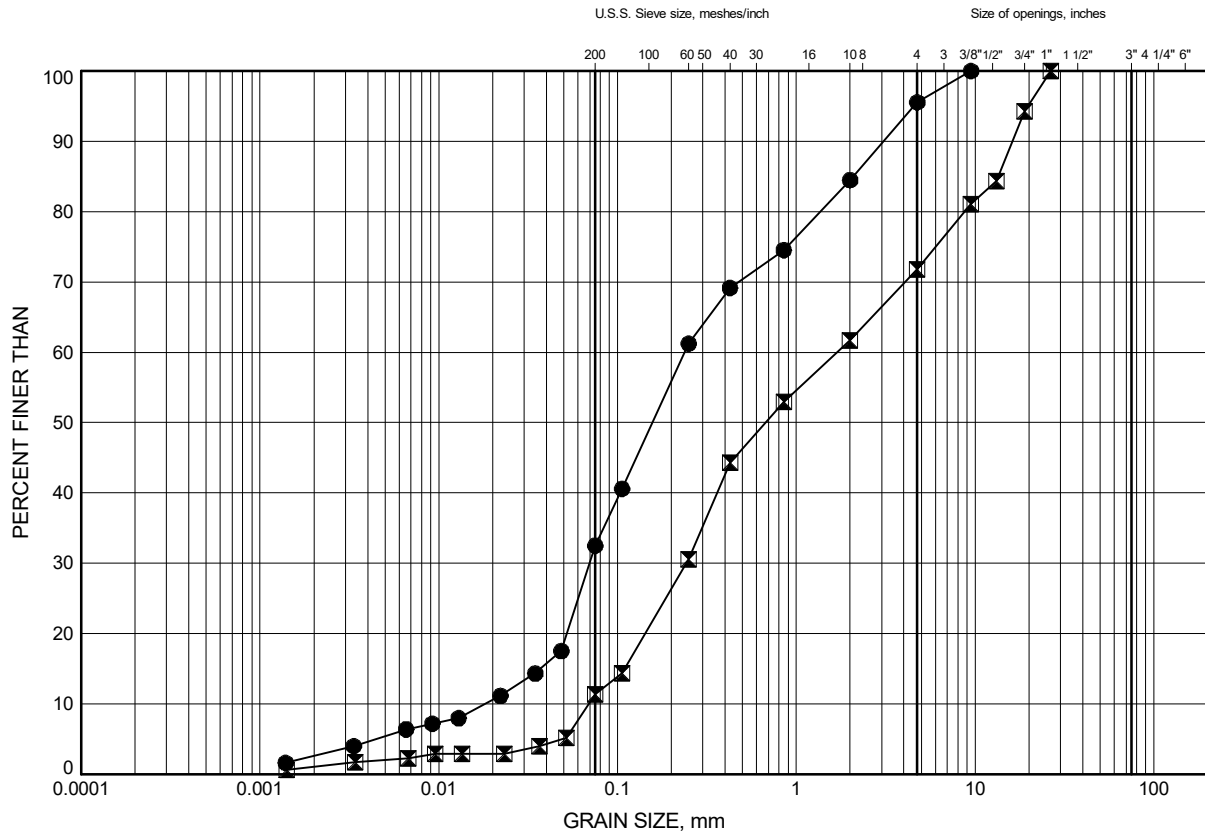
FIGURE C4

## SAND with silt and gravel (TILL)

The results of a grain size analysis completed on two samples from this deposit are illustrated on Figure C4 of Appendix C. The results are summarized below and are presented on the corresponding Record of Borehole sheets in Appendix B.

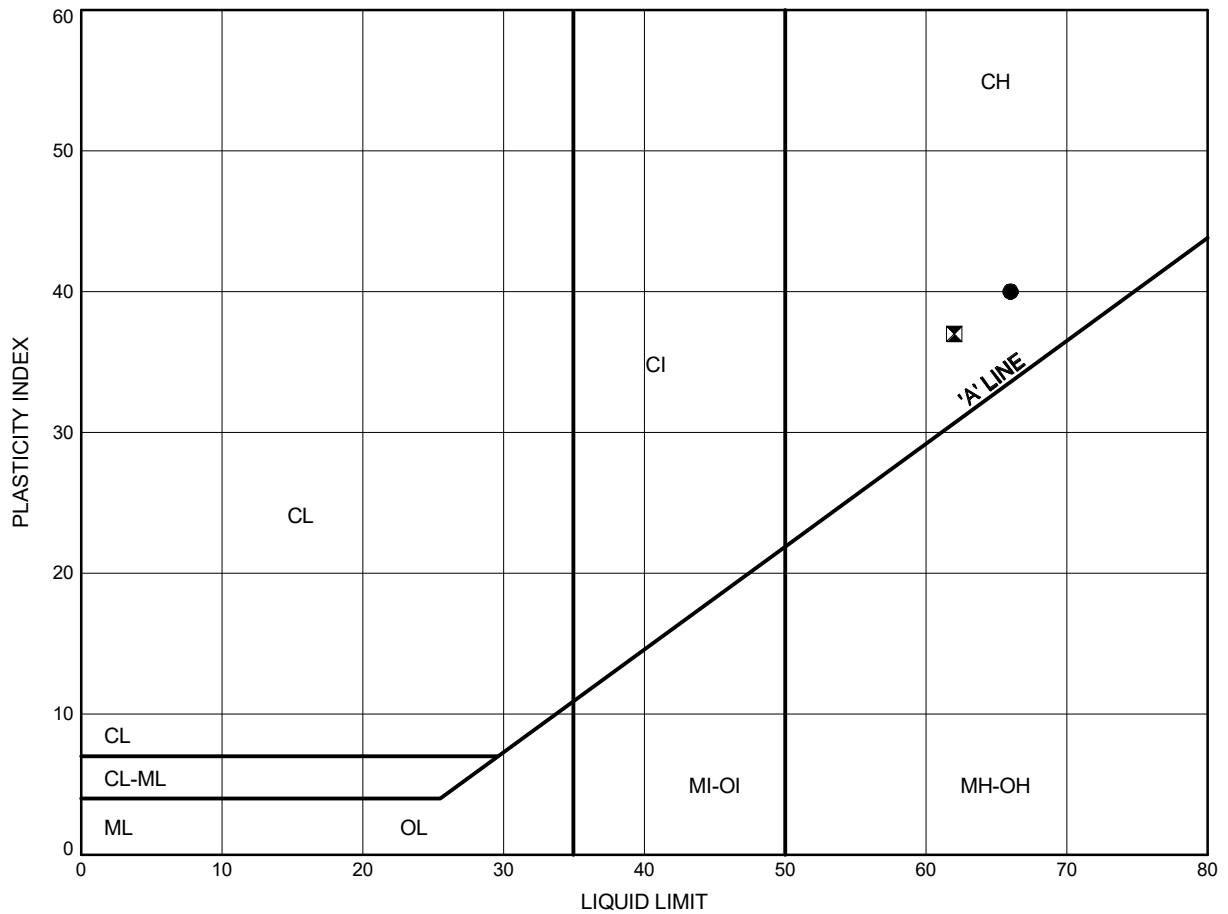
FIGURE C5

### CLAY FILL

SYMBOL	BOREHOLE	DEPTH (m)	ELEV. (m)
●	21-01	2.6	293.7
⊠	21-02	1.8	294.5

Atterberg Limit testing was completed on two samples of the clay fill. The results of the Atterberg Limit testing are summarized below and are illustrated on Figure C5 in Appendix C. The test results are also presented on the corresponding Record of Borehole sheets in Appendix B. The laboratory results indicate that the clay fill samples that were tested are of high plasticity.

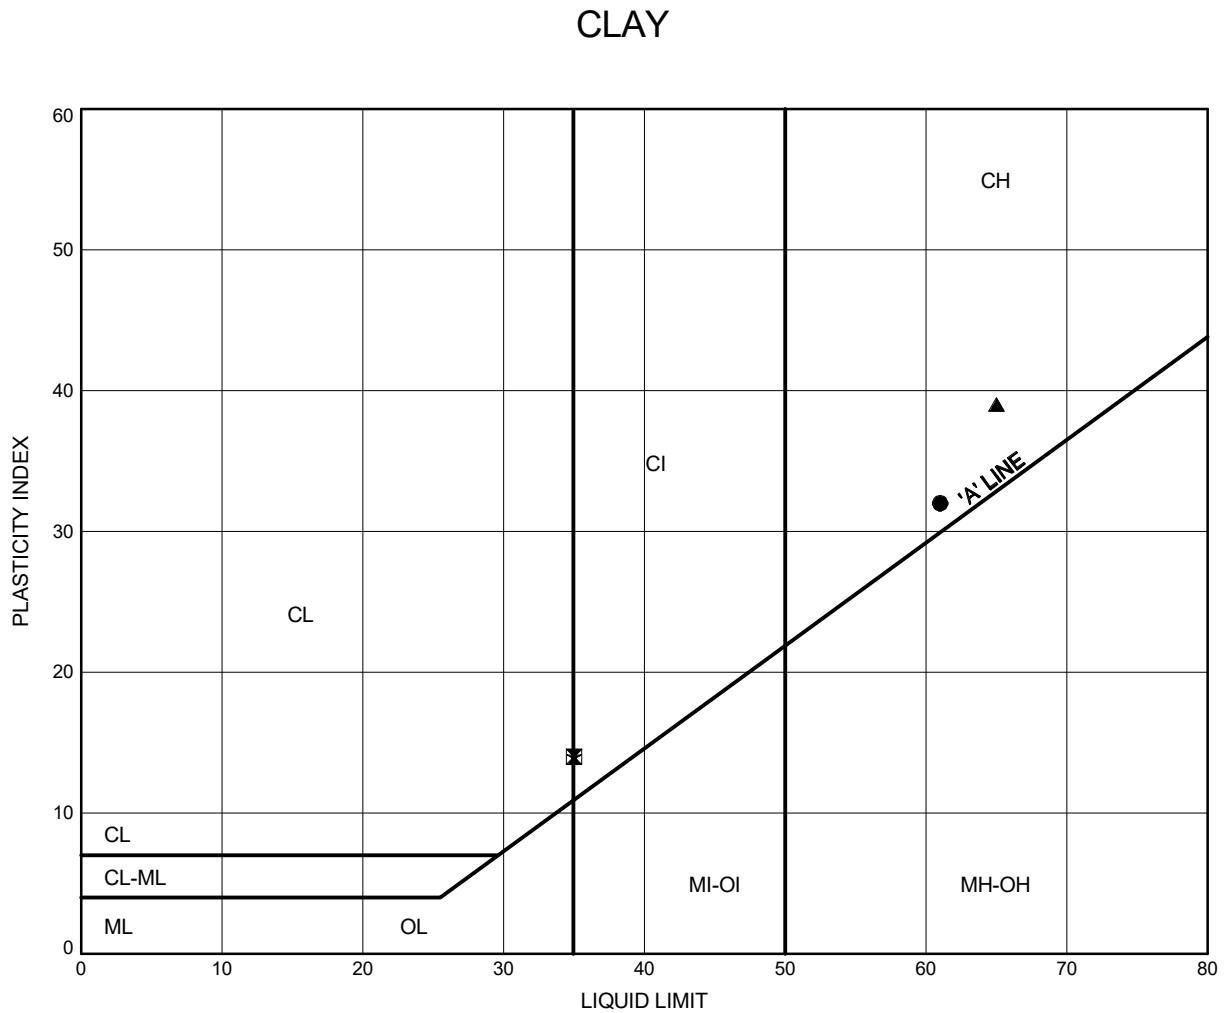
FIGURE C6

# Highway 101 Deep Fill Culvert ATTERBERG LIMITS TEST RESULTS

SYMBOL	BOREHOLE	DEPTH (m)	ELEV. (m)
●	21-01	4.9	291.4
⊠	21-01	7.9	288.4
▲	21-02	4.1	292.2
★	21-02	7.9	288.4

Atterberg Limit testing was completed on four samples of the clay (two on the weathered crust and two on the unweathered grey clay). The results of the Atterberg Limit testing are summarized below and are illustrated on Figure C6 in Appendix C. The test results are also presented on the corresponding Record of Borehole sheets in Appendix B. The laboratory results indicate that the clay samples that were tested are of intermediate to high plasticity (CI/CH).

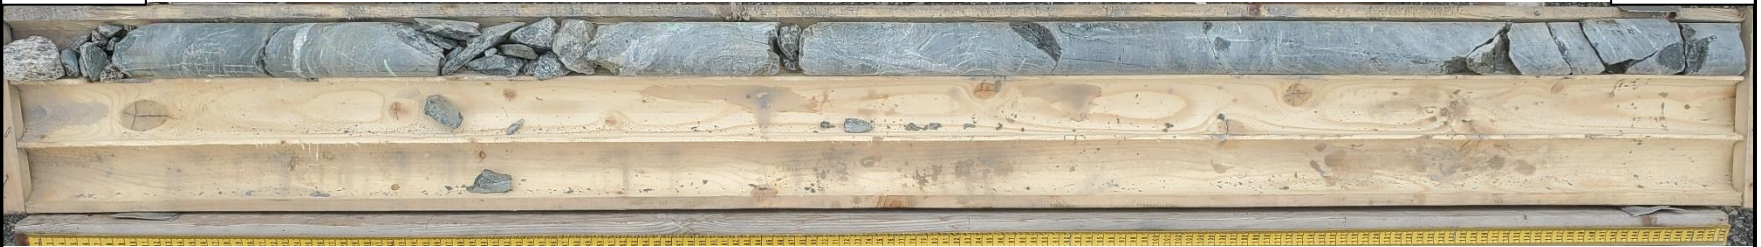
Run 1 Start  
elev. 281.7m

Run 1 End  
elev. 280.2m

The bedrock encountered consisted of fresh greenschist. The Total Core Recovery (TCR) measured on the recovered bedrock core was 98%, the Solid Core Recovery (SCR) was 62% and the Rock Quality Designation (RQD) was 62%. Based on the measured RQD values, the bedrock quality is classified as fair. Photographs of the bedrock core are provided in Appendix C.

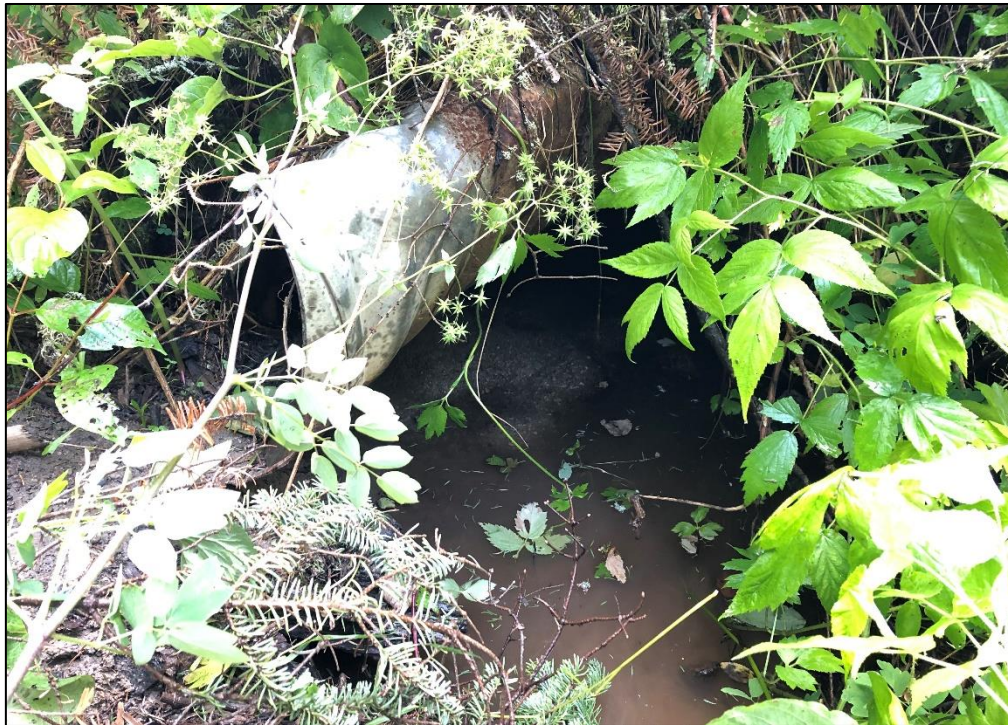
**Photo 1. Void under upstream culvert inlet. [July 20, 2021]**

The depth of water in the creek was approximately 20 mm at the time of the investigation. An erosion-derived void was present approximately 250 mm below the upstream invert, and it appears that surface water flow from the creek was flowing through the embankment rather than the culvert. The pipe inlet was also significantly deformed. No other signs of distress were

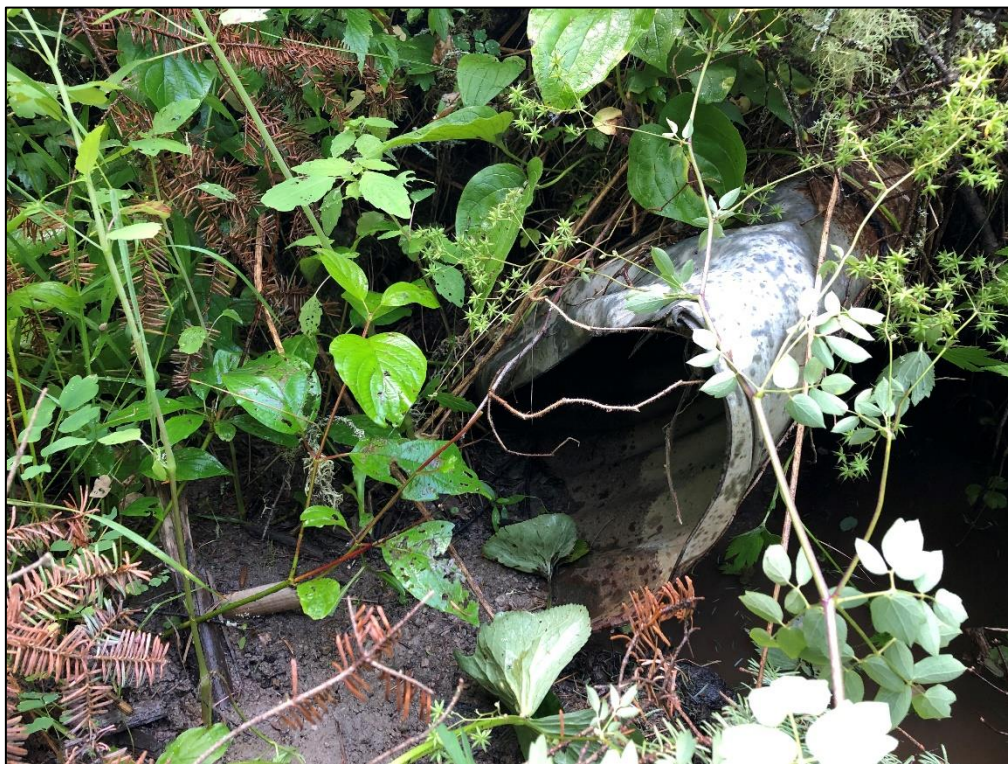
**Photo 2. Culvert deformed at inlet. [July 20, 2021]**

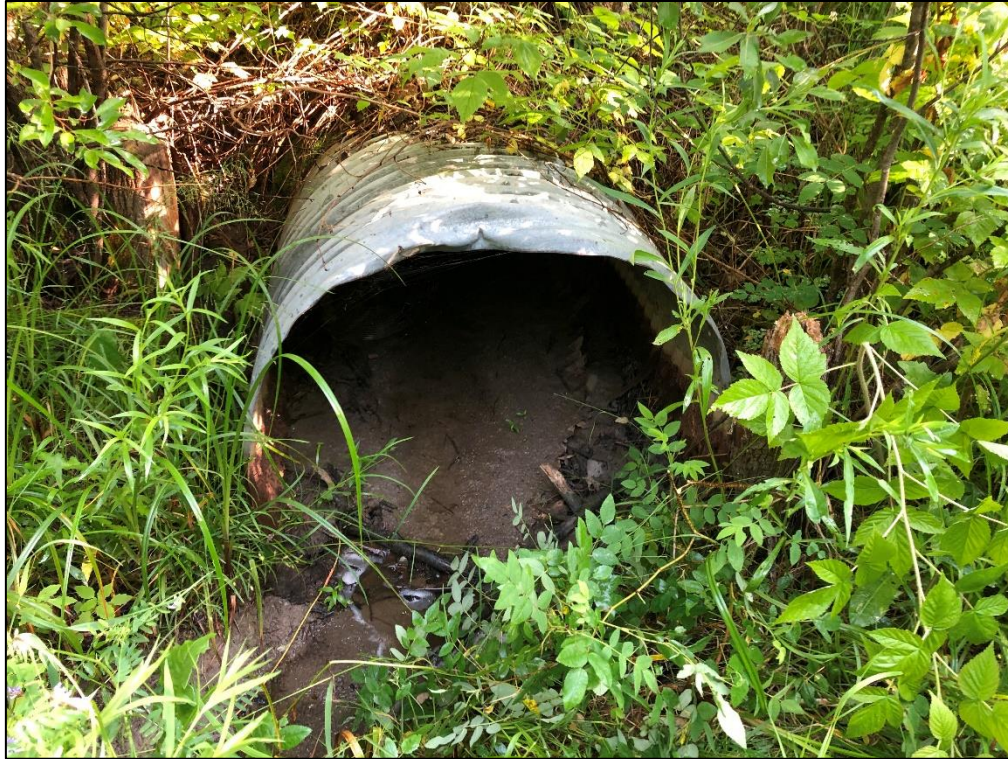
**Photo 3. Culvert outlet [July 20, 2021]**

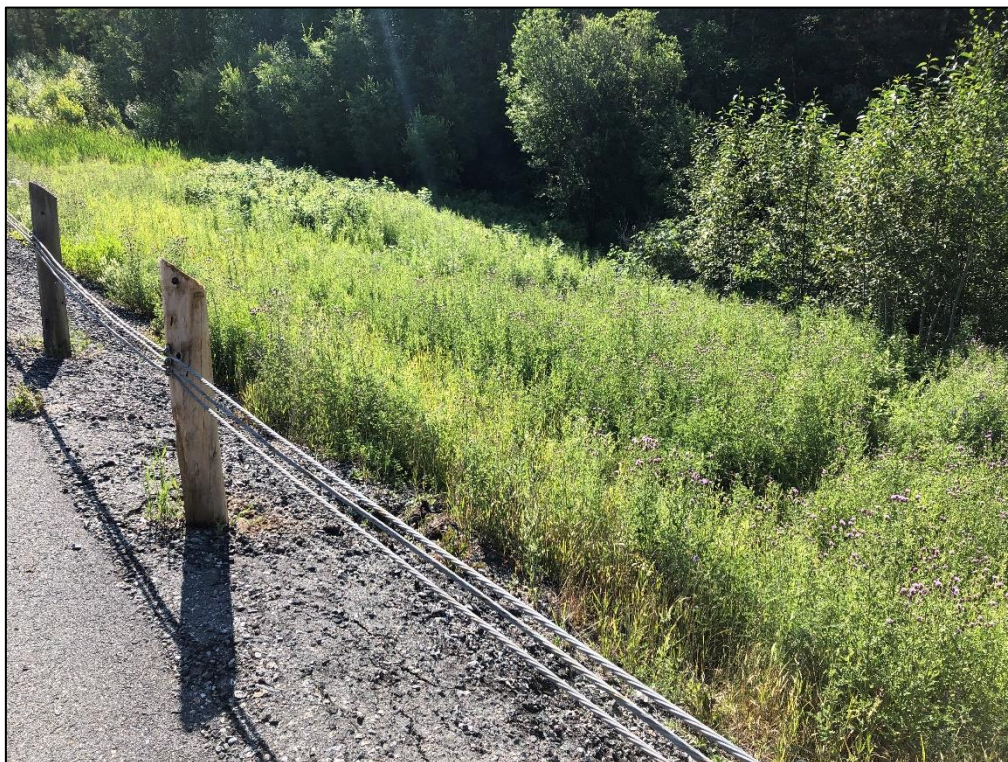
**Photo 4. South (downstream) embankment slope. [July 20, 2021]**

The existing culvert is described as a 37 m long corrugated steel pipe (CSP) with a diameter of 900 mm. The embankment at this location is approximately 5.2 m high and the side slopes are inclined at approximately 2.5H:1V to 3H:1V.

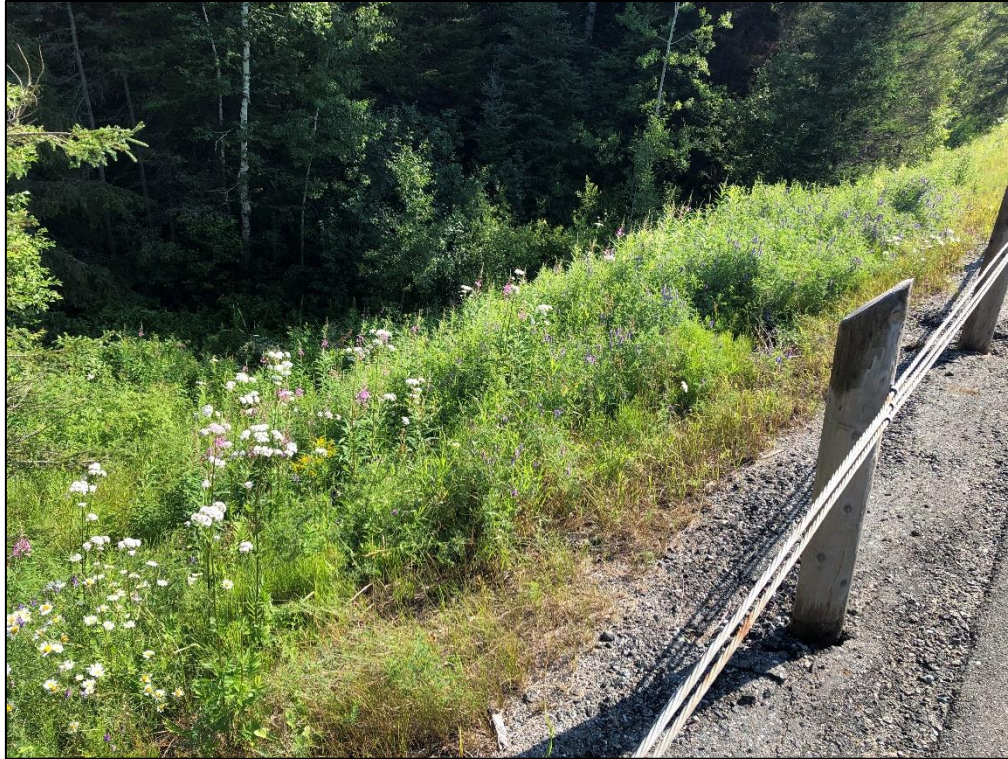
**Photo 5. North (upstream) embankment slope. [July 20, 2021]**
