GEOCRES No. 31D-298

Hwy. 400 Over Holland Marsh
Embankment Distress Study

FOUNDATION INVESTIGATION REPORT
FOR
HWY. 400 OVER HOLLAND MARSH
EMBANKMENT DISTRESS STUDY
W.P. 7-82-01, DISTRICT 6, TORONTO

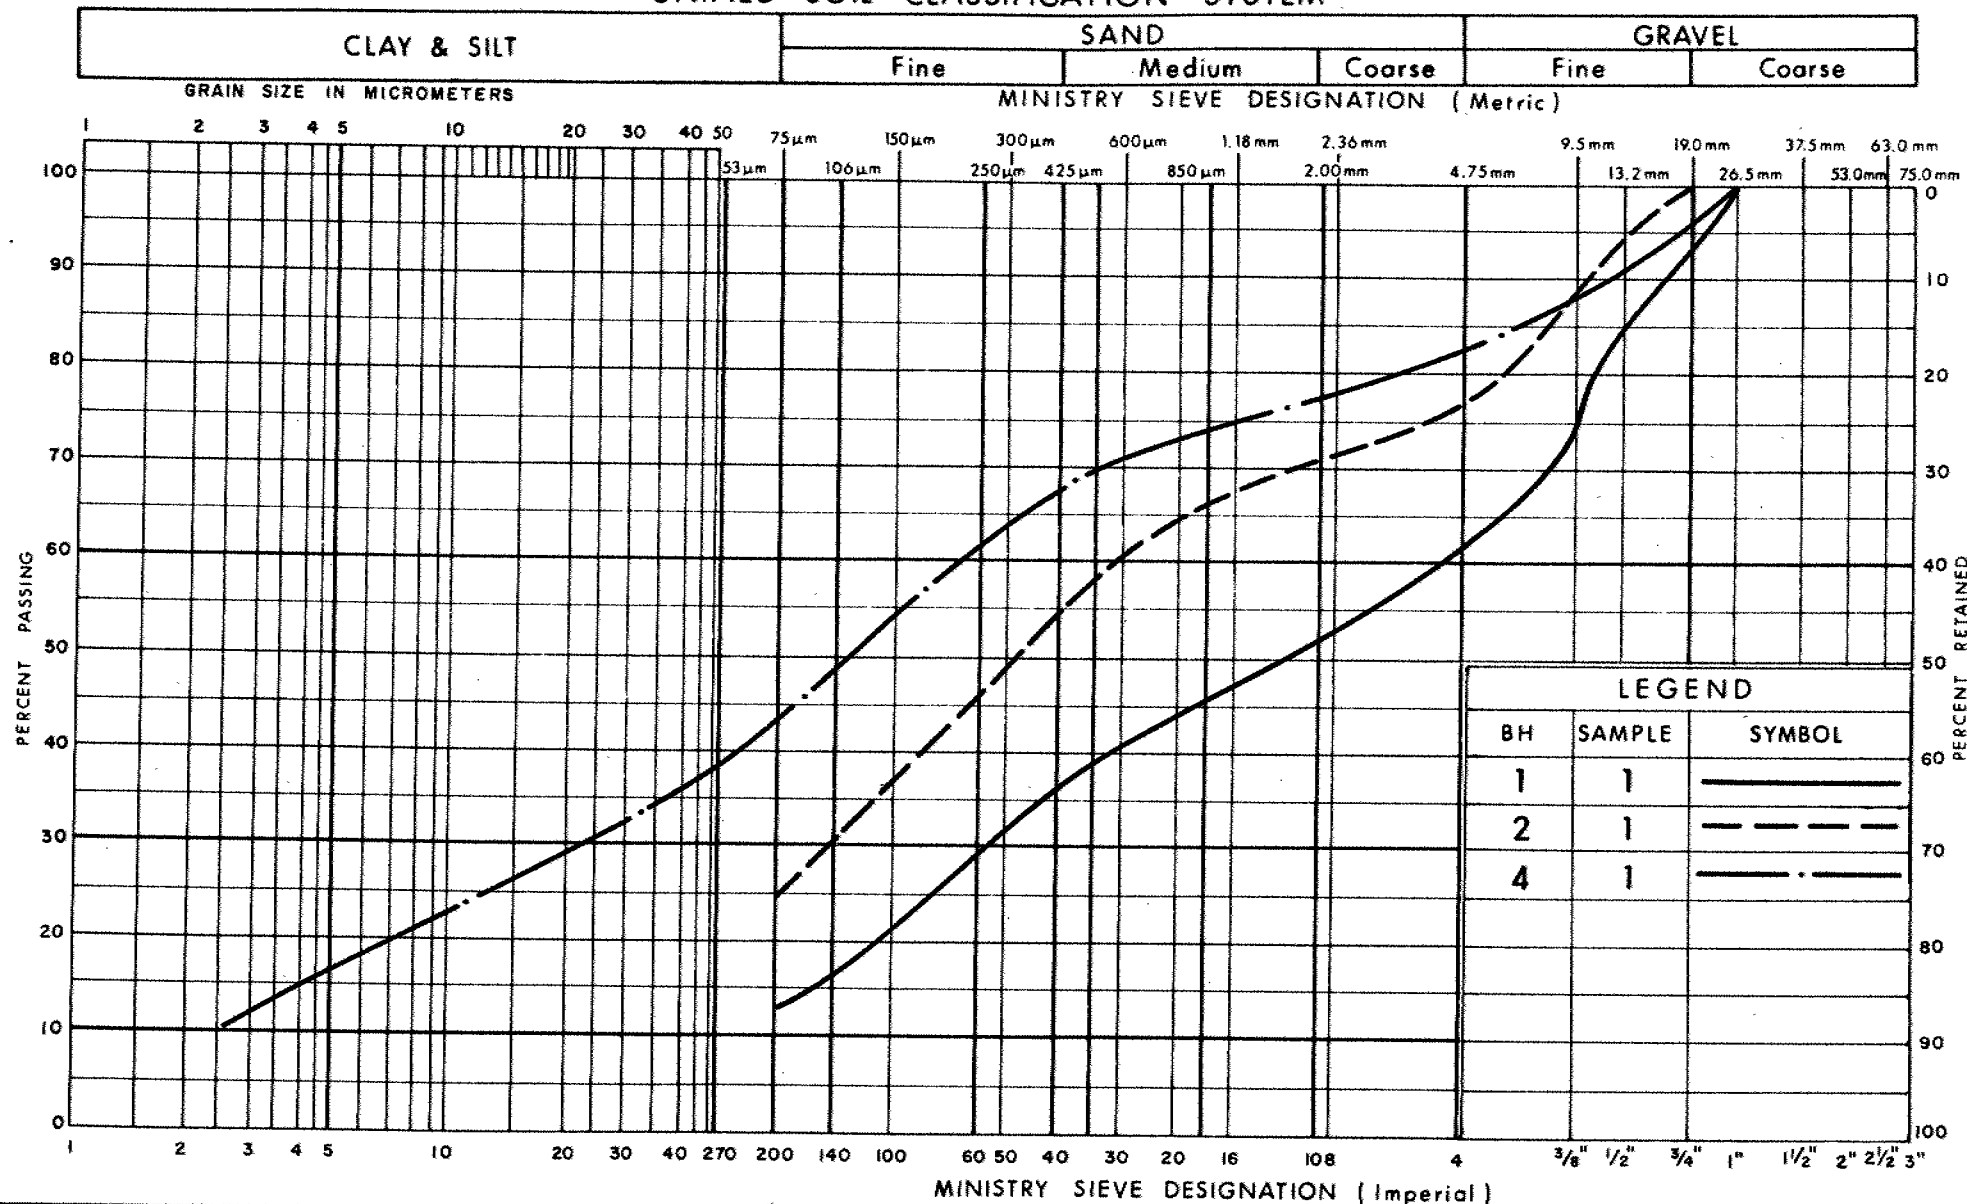
GRAIN SIZE DISTRIBUTION
FILL
GRAVELLY SAND TO SAND WITH SILT & GRAVEL

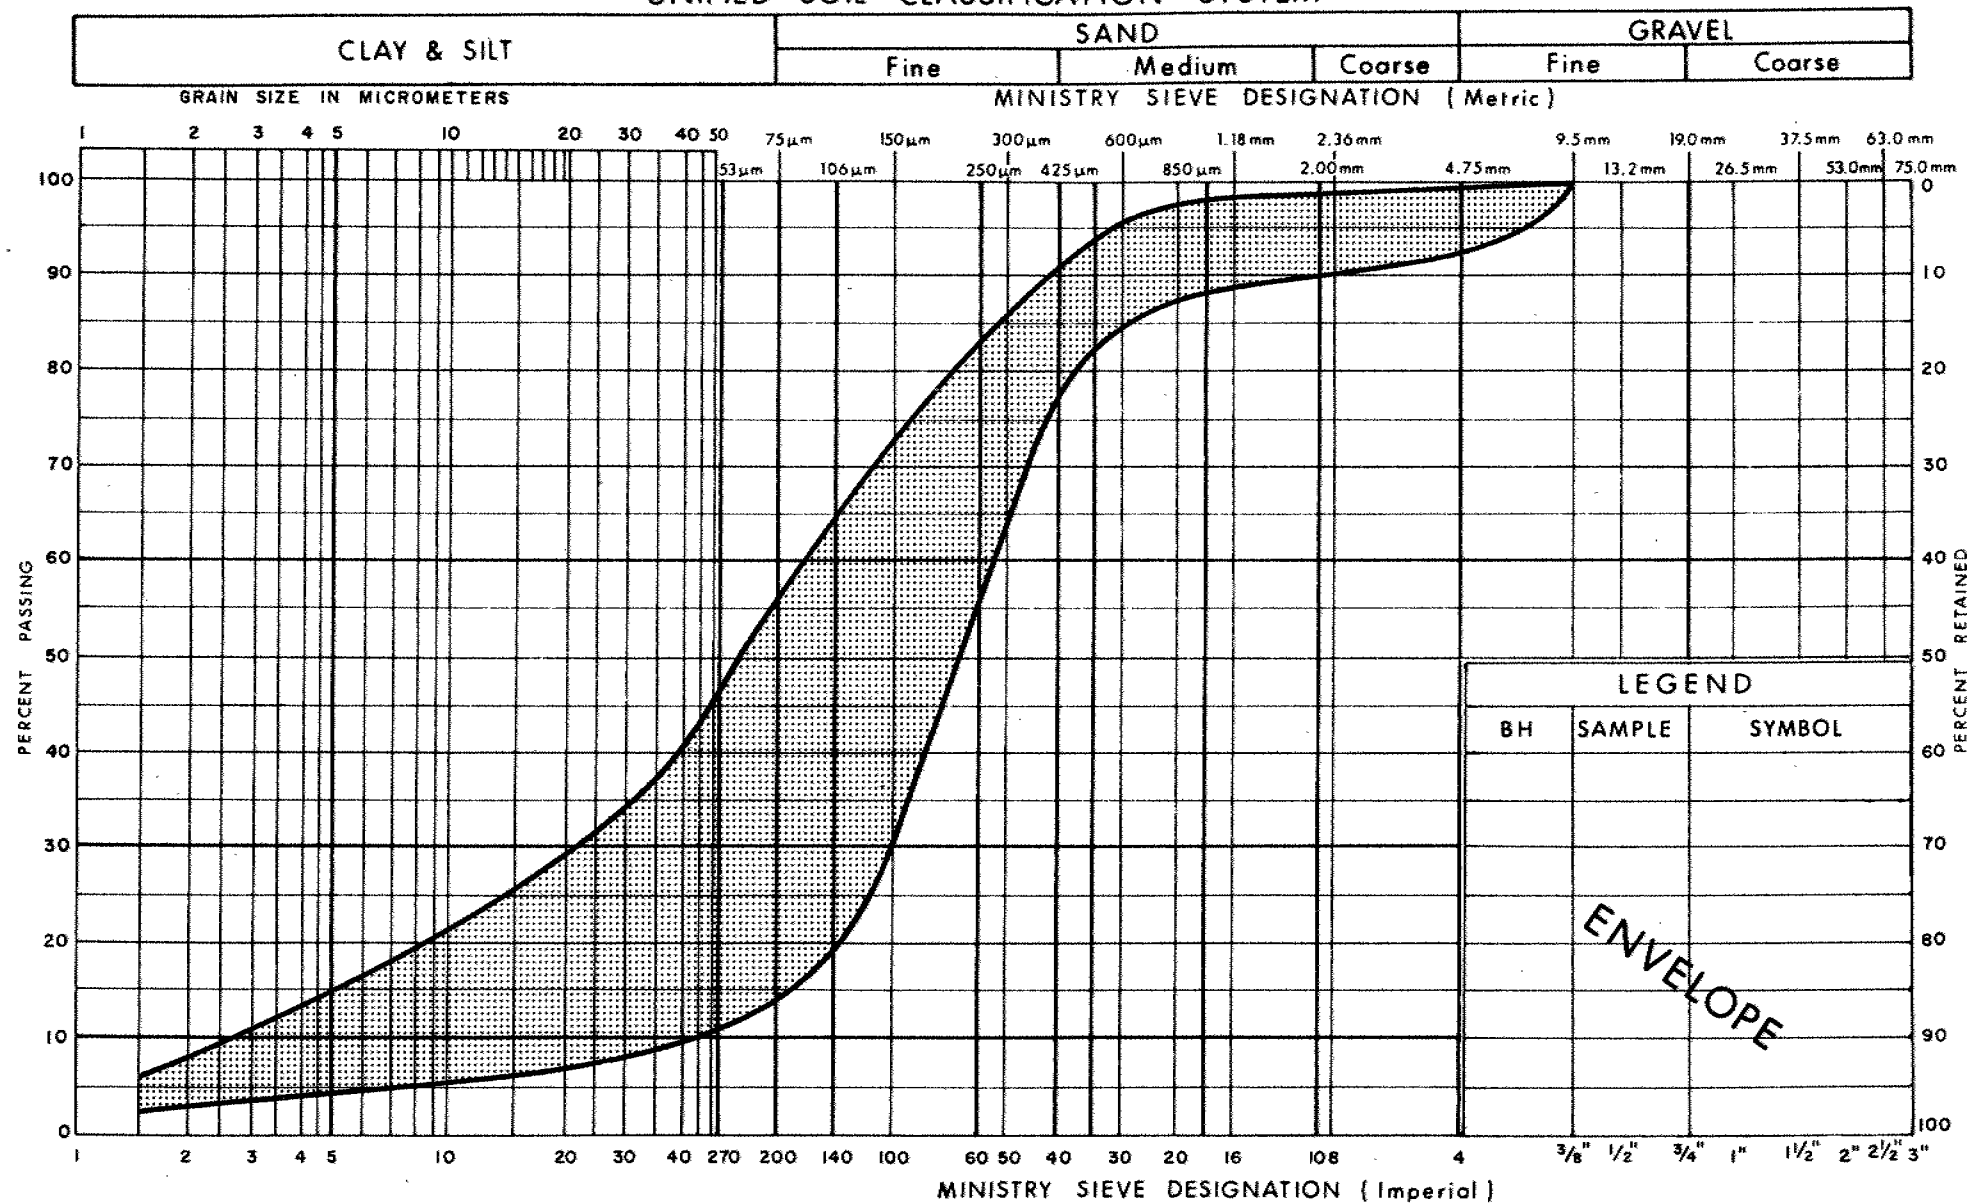
FIG No 2

GRAIN SIZE DISTRIBUTION
FILL
SAND TO SILTY SAND

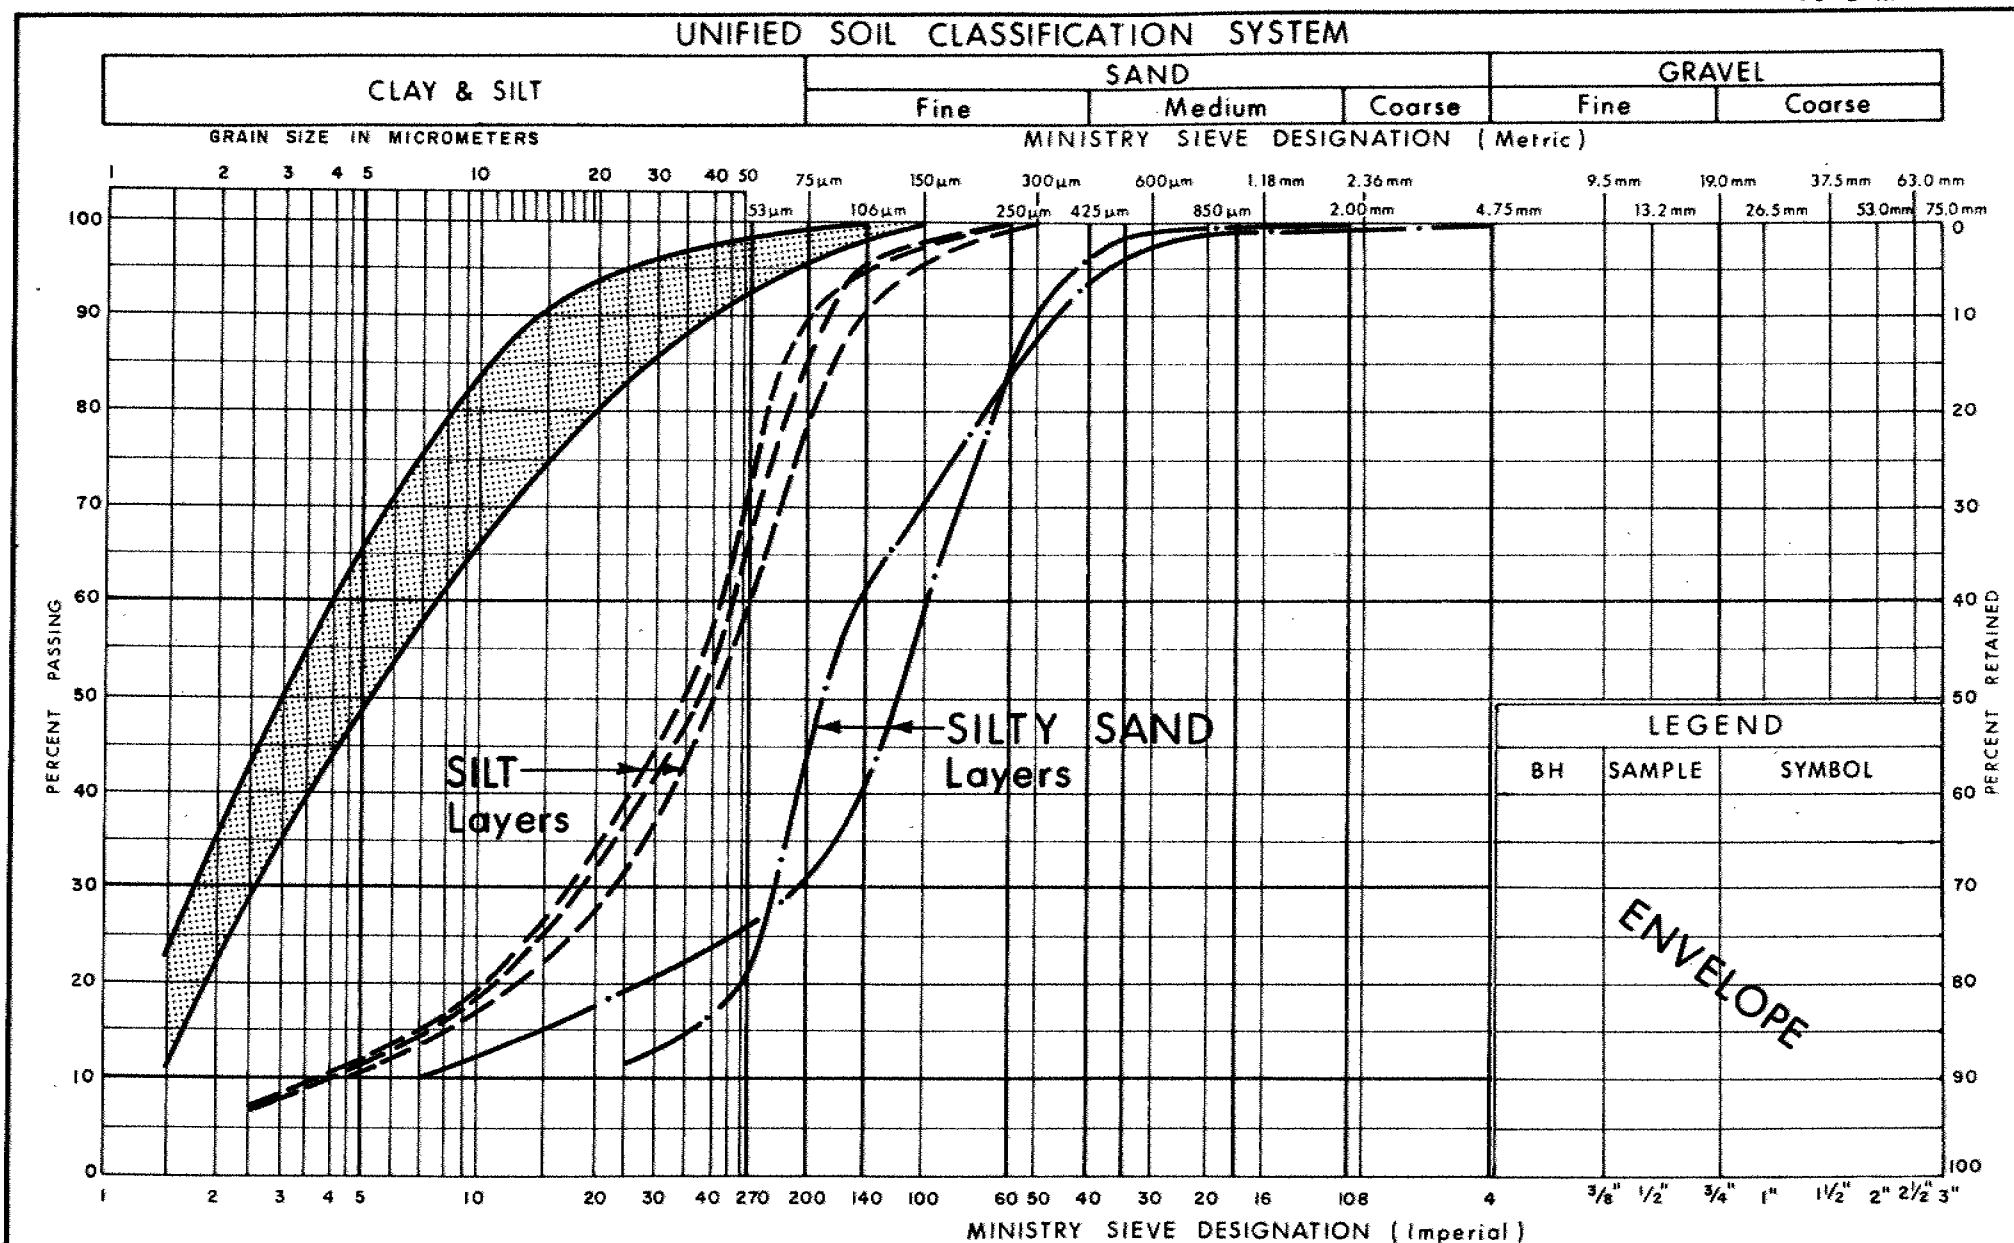
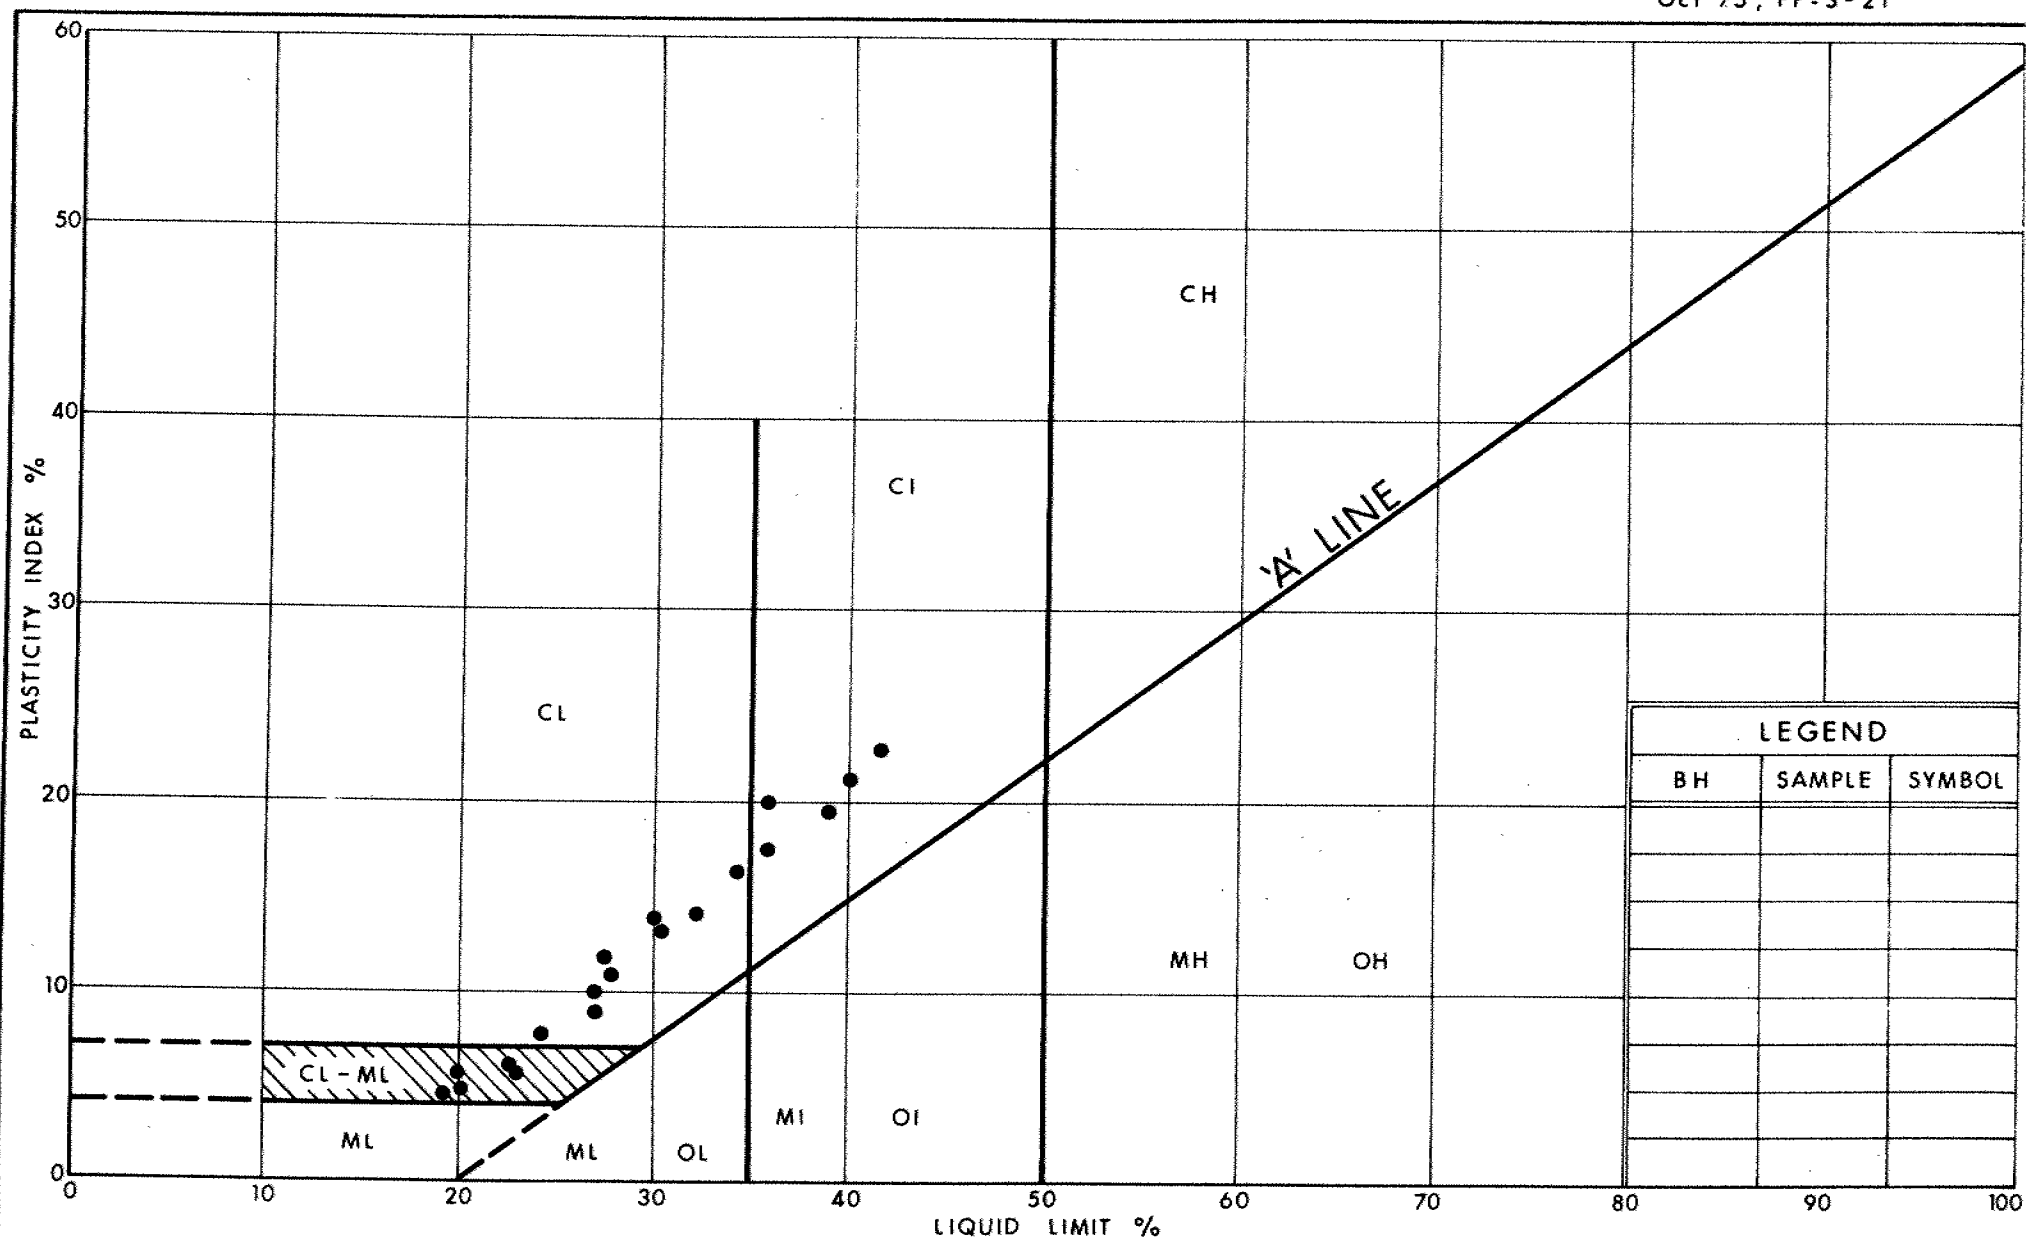
PLASTICITY CHART
INTERBEDDED SILTY CLAYS
OF LOW TO INTERMEDIATE PLASTICITY

The results of index testing are plotted on the plasticity chart, Figure 4. A typical void ratio V.S. pressure curve representative of the consolidation behaviour for the silty clay deposit is plotted on Figure 5.

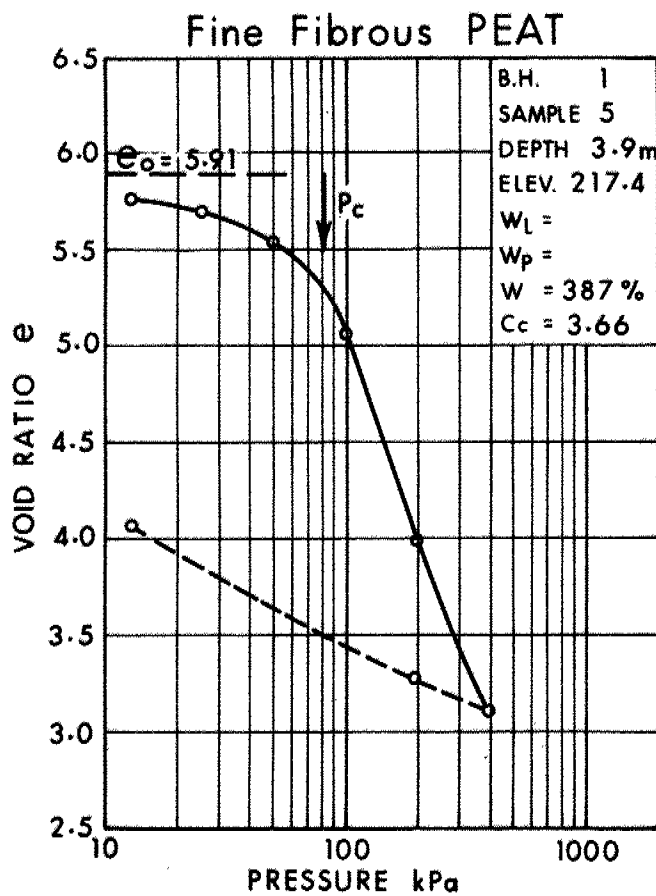
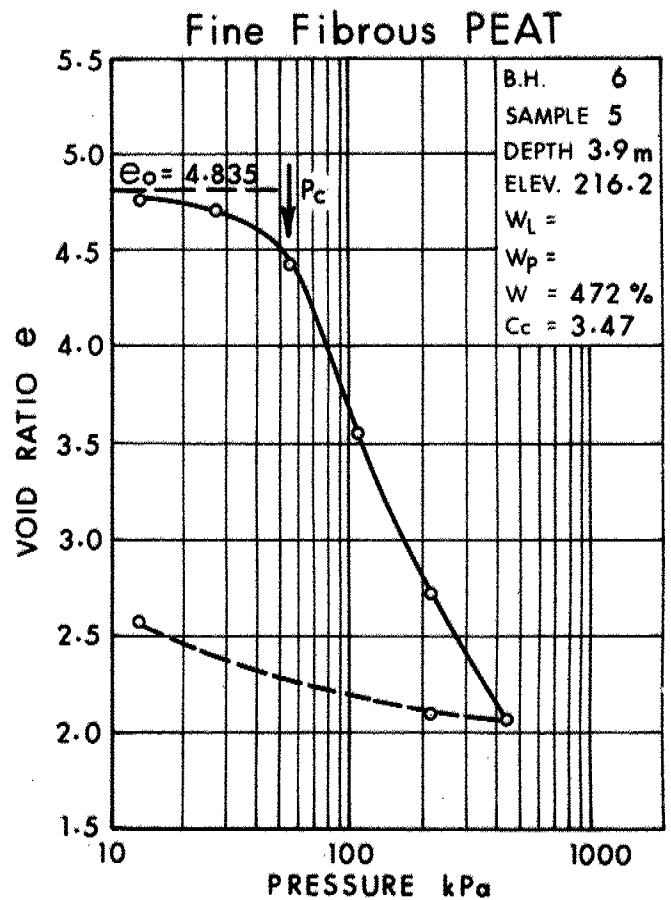
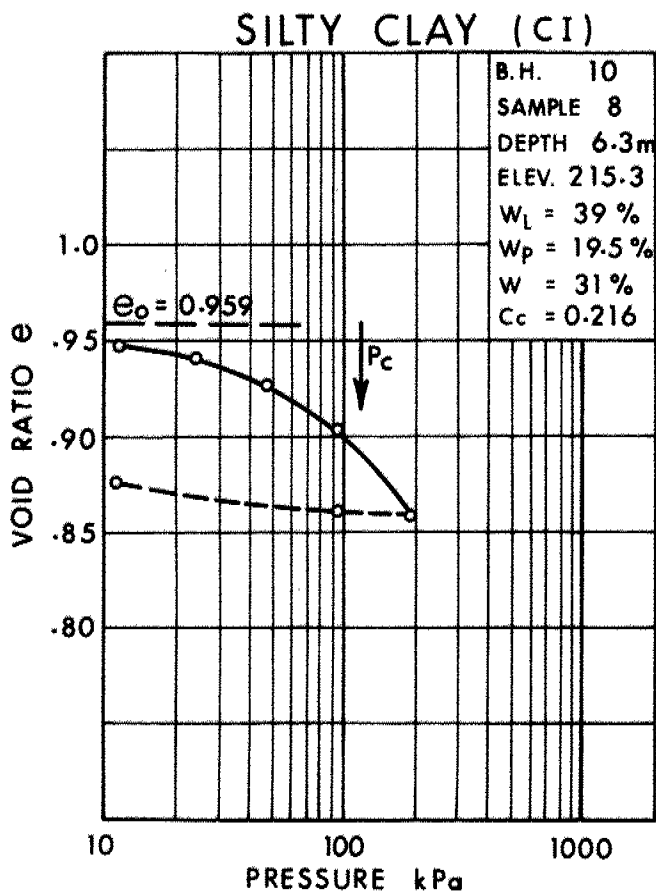
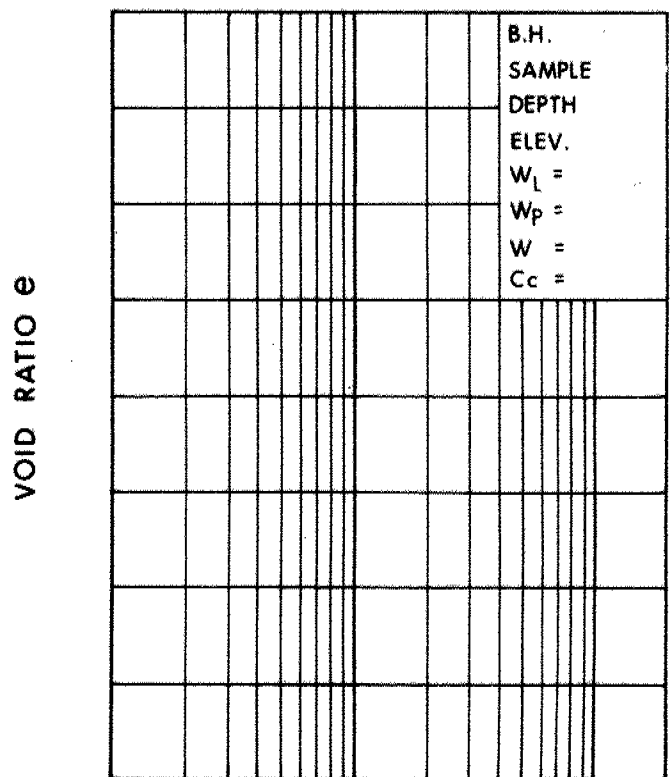
VOID RATIO - PRESSURE CURVES

All samples have undergone embankment loading

Results of laboratory testing of the 'virgin' peat, outside the embankment influence, are detailed for comparison in Chart 1. Typical consolidation curves for two samples are plotted on Figure 5.

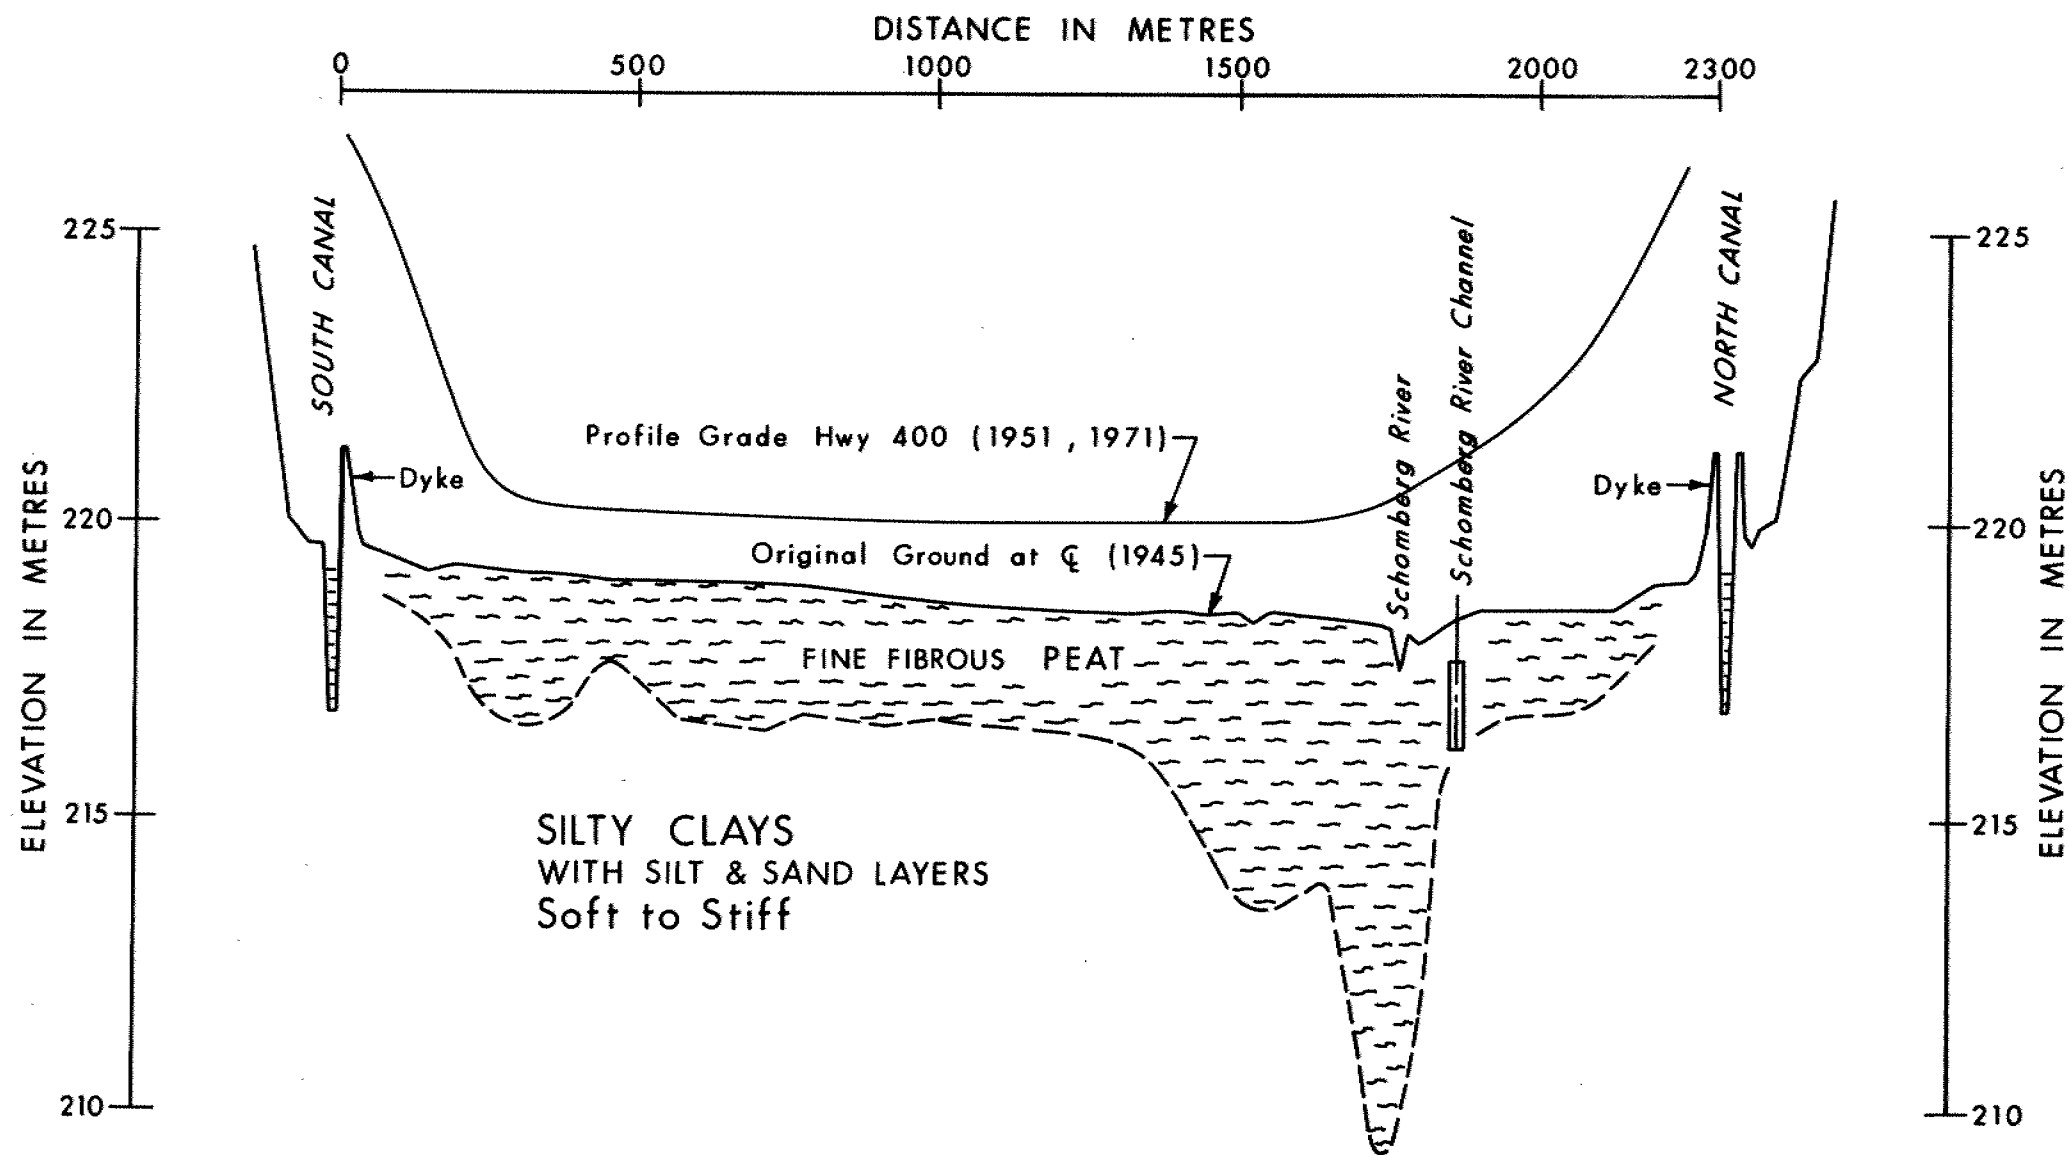
Fig 6 : Hwy 400 Profile Showing Peat Depths (1945 Soundings)

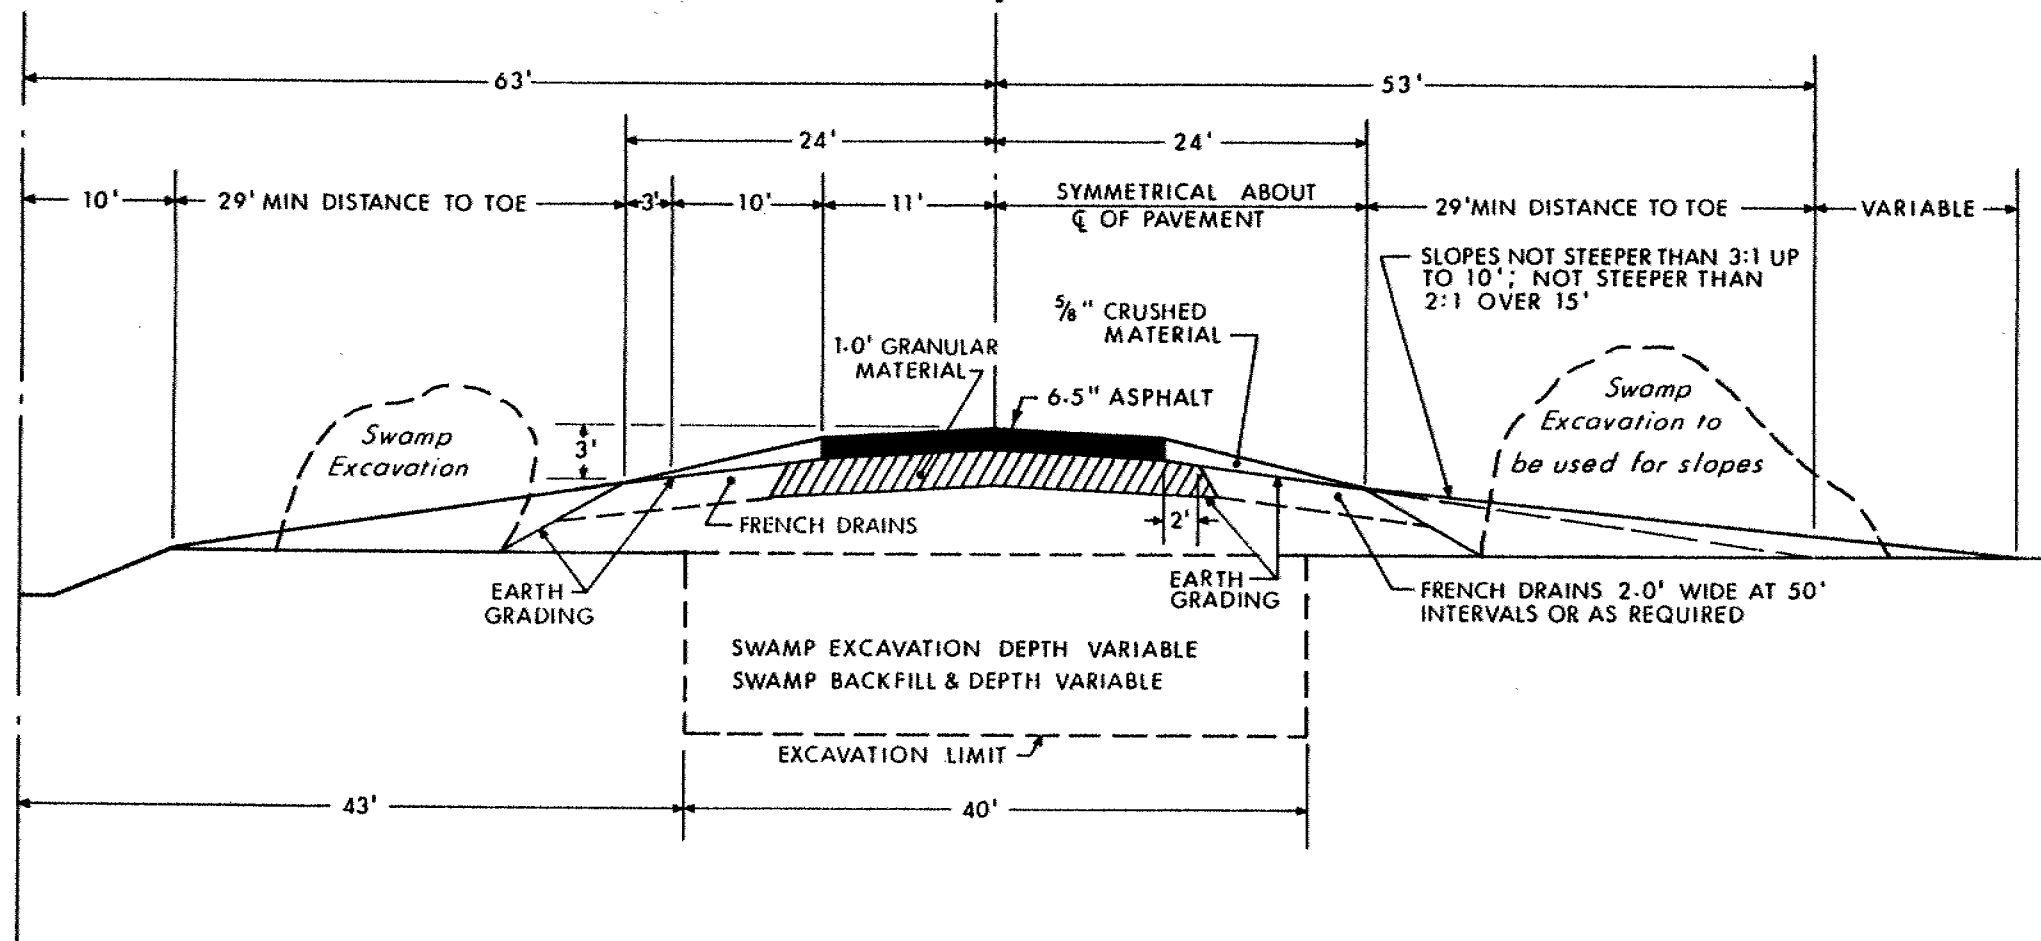
Fig 7 : Cross-Section Showing Limits of Peat Excavation and Pavement Structure under Contract 46-14

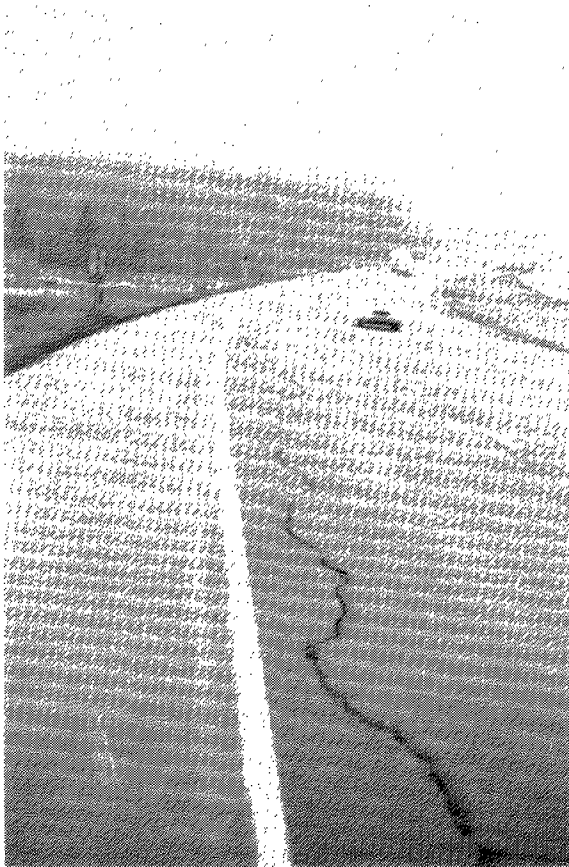
Photo 1

Very severe
meandering crack

Sta. 10 + 360 N.B.L.
looking south.

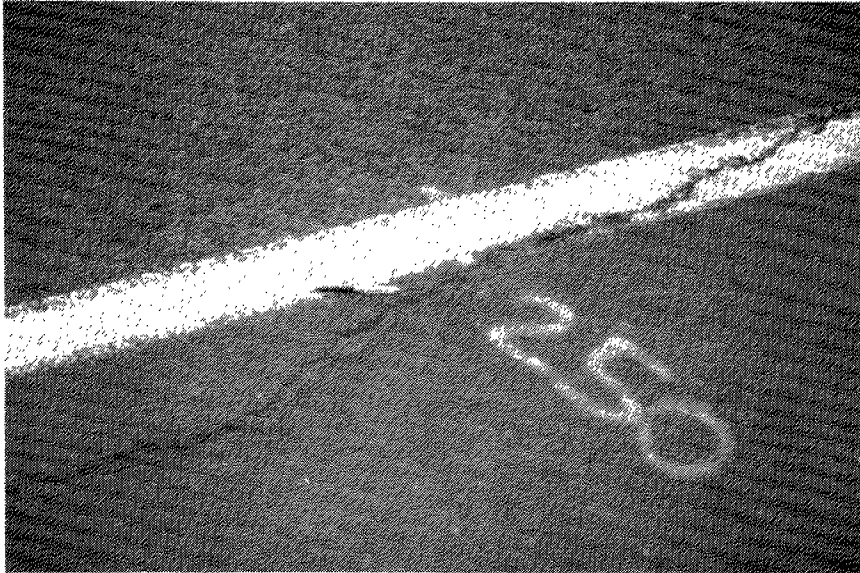
Photo 3

Very severe meandering outside edge crack

Sta. 10 + 250 N.B.L.

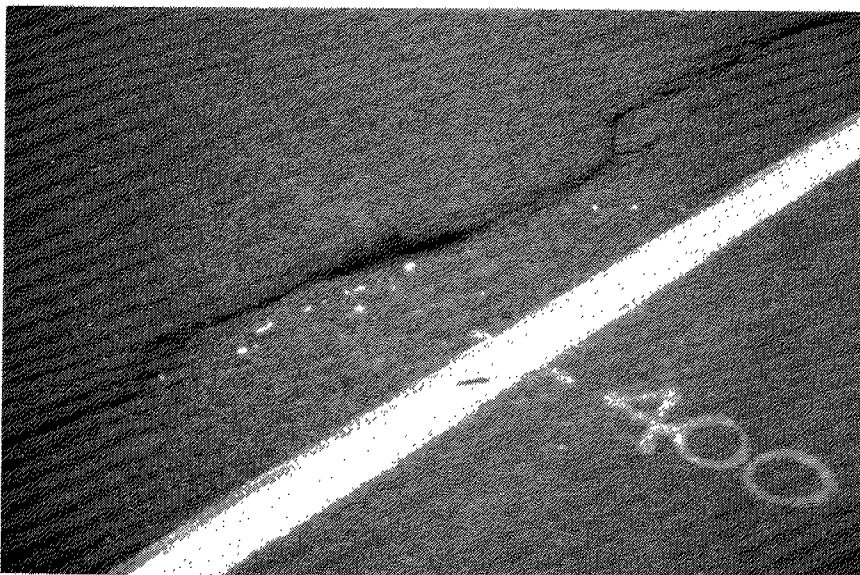
Photo 4

Very severe single meandering outer wheel track crack

Sta. 10 + 400 N.B.L.

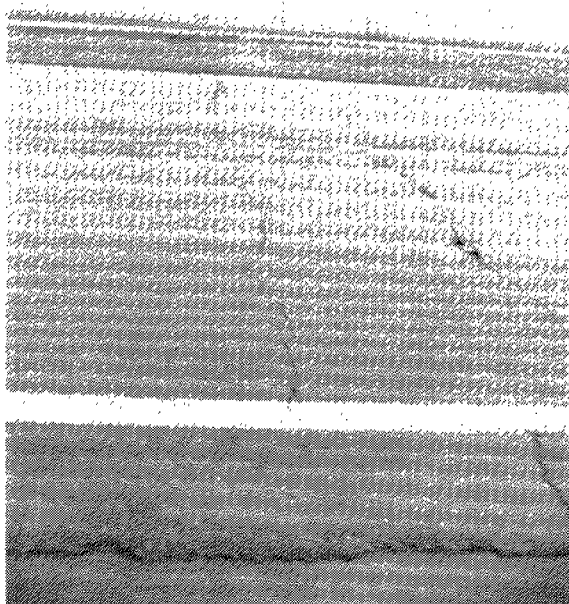
Photo 5

Severe to very
severe transverse
cracking with
moderate outside
lane distortion

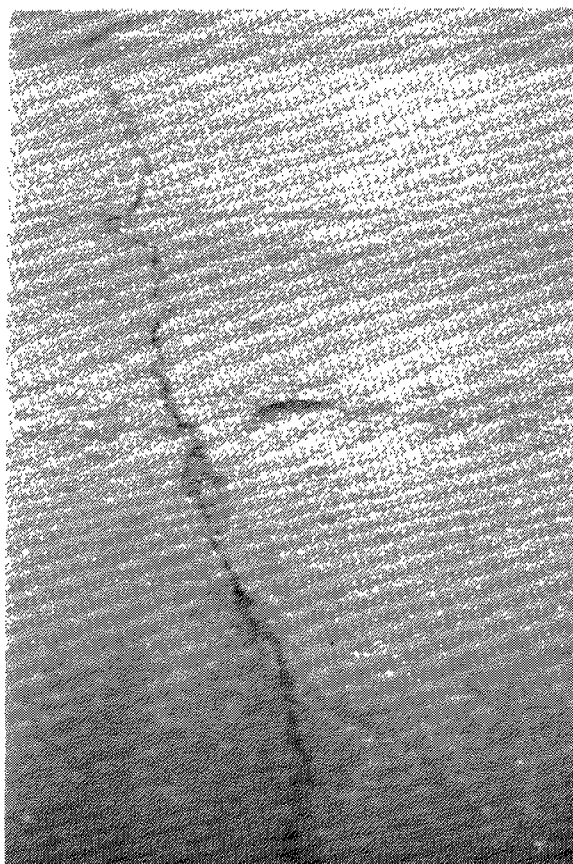
Severe transverse
crack beside pavement
core hole.

Note, moderate
ravelling of pavement
surface.

Sta. 11 + 110 S.B.L.

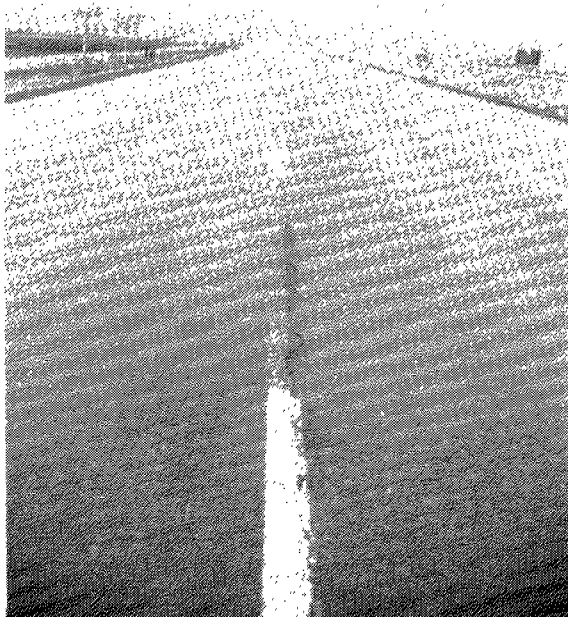
Photo 7

Very severe
longitudinal outside
centreline crack

Briefly, the long term differential consolidation settlements between the original and widened portions of Hwy. 400 have predominately manifested themselves in severe continuous longitudinal cracking (photos 7 & 8) generally between the middle and outside lanes and severe stepped meandering cracks through the outside paved shoulders and driving lane. (Photos 1 to 4). Distortions indicative of differential settlements range up to ± 50 mm across the major cracks. In addition, moderate to severe random and transverse cracking (Photos 5 & 6) is apparent throughout most of the paved surface. Sectional remedial patching has resulted in an undulating longitudinal grade (refer to Figure 10, for profiles) with pavement edge stepping of up to ± 50 mm. (Photos 11 & 12). This extensive patching has resulted in an uneven, non-uniformly textured wearing surface exhibiting reduced driver comfort and safety characteristics.

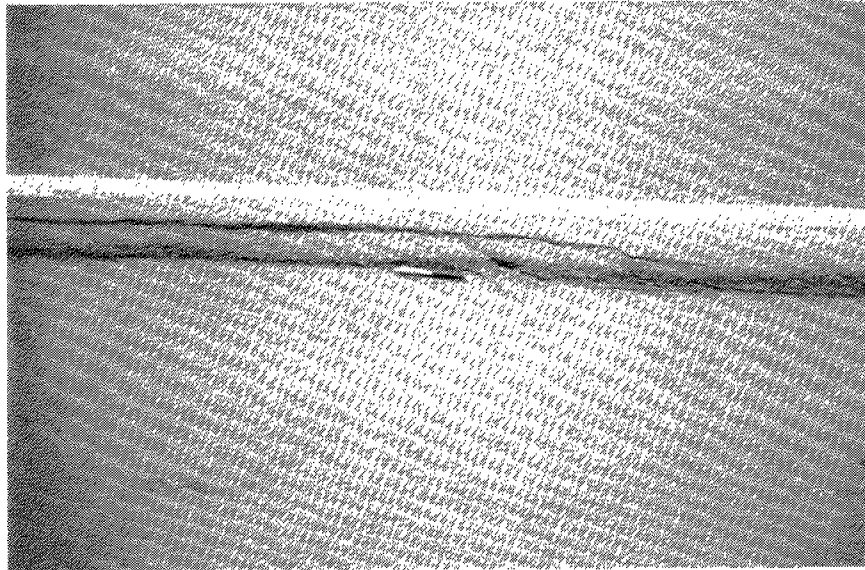
Photo 11

Severe stepping along outside edge of recently patched pavement section

Sta. 10 + 665 N.B.L.

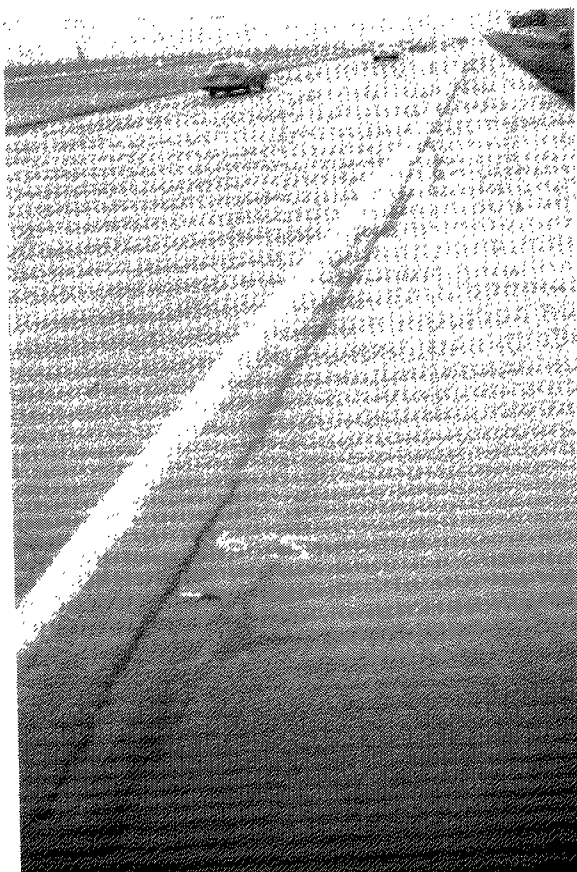
Photo 12

Hot mix patched section showing edge stepping

Note, reflection cracking through recent patch.

Sta. 10 + 675
N.B.L.
