GEOCRES No. 31D-298

Hwy. 400 Over Holland Marsh
Embankment Distress Study

FOUNDATION INVESTIGATION REPORT
FOR
HWY. 400 OVER HOLLAND MARSH
EMBANKMENT DISTRESS STUDY
W.P. 7-82-01, DISTRICT 6, TORONTO

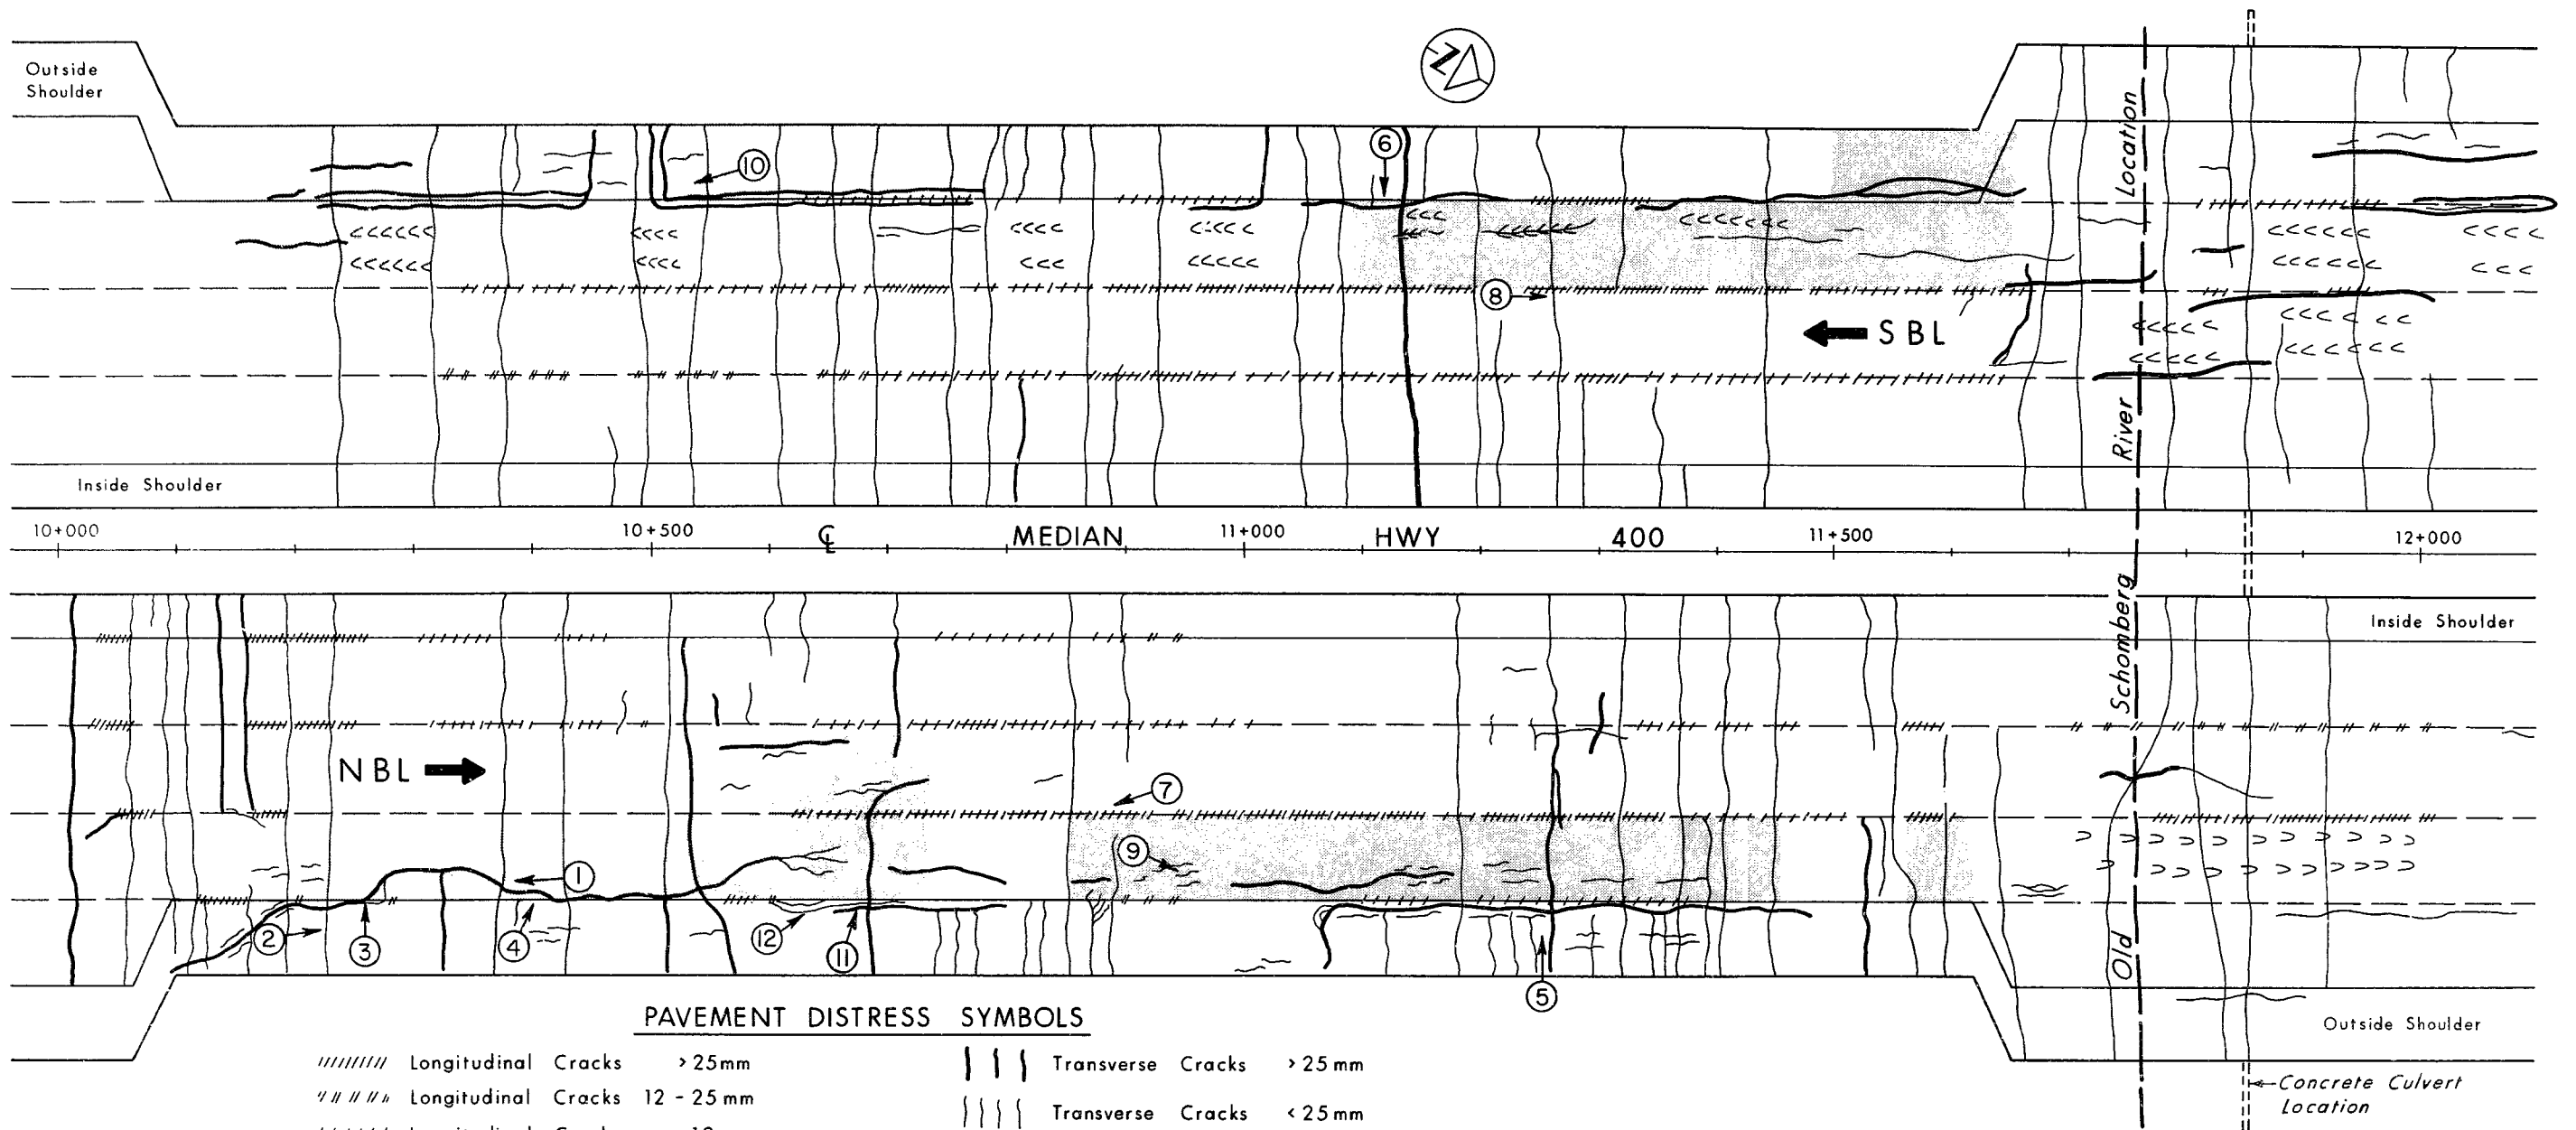
////////	Longitudinal Cracks	> 25mm		Transverse Cracks	> 25mm
"" ""	Longitudinal Cracks	12 - 25 mm		Transverse Cracks	< 25 mm
/////	Longitudinal Cracks	< 12 mm		Rutting	
~~~~~	Random Cracks	> 25mm		Recent Patching	
~~~~~	Random Cracks	< 25mm			
~~~~~	Meandering Cracks	> 25mm	⑦ →	Photograph number and location	(refer to appendix for photos)
~~~~~	Meandering Cracks	< 25mm

HWY 400 OVER HOLLAND MARSH PAVEMENT CONDITIONS SURVEY	
CO OF SIMCOE TWP OF W GWILLIMBURY	REG MUN OF YORK TWP OF KING
DATE 1983 01 26	WP 7-82-01 DIST 6 Figure 9

As part of the investigation program a comprehensive pavement condition survey was undertaken across the Holland Marsh Crossing. Details of the survey, showing all major distress features, are presented in schematic form on Figure 9. In addition, outside lane edge of pavement profile elevations were taken for comparison against the "as constructed" profile grades and plotted on Figure 10 to illustrate the amount of longitudinal distortion evident. Repaving operations have actually raised the existing profile grade along the southern portion of the northbound lanes. Photographs illustrating the various types of cracking and pavement distress encountered are appended to the back of this report.
