**FOUNDATION INVESTIGATION REPORT
REHABILITATION OF STRUCTURAL CULVERT No. 29-155/C
HIGHWAY 60 DOUGLAS CREEK CULVERT
TOWNSHIP OF ADMASTON, ON
G.W.P. 4076-13-00
AGREEMENT NUMBER: 4016-E-0014**

GEOCRES NUMBER: 31F-203

**AUGUST 2018
20479**

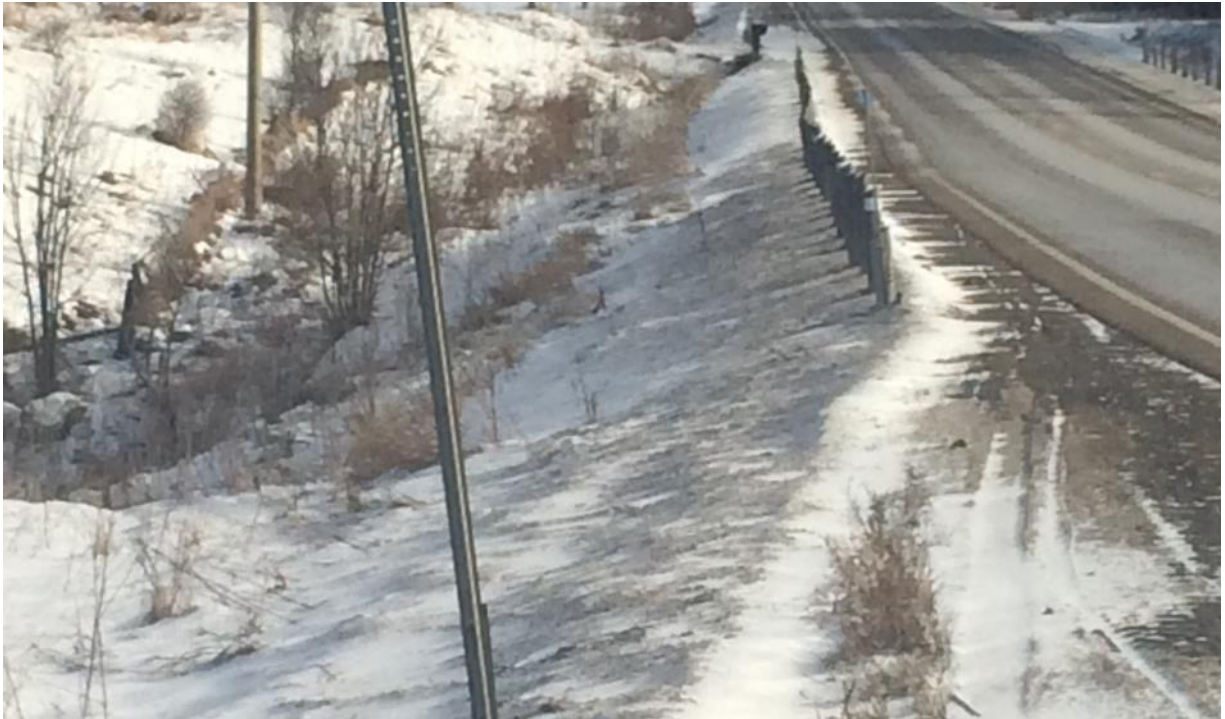
**Photograph 1: Looking east along the north embankment towards the culvert inlet
(2017/12/20)**

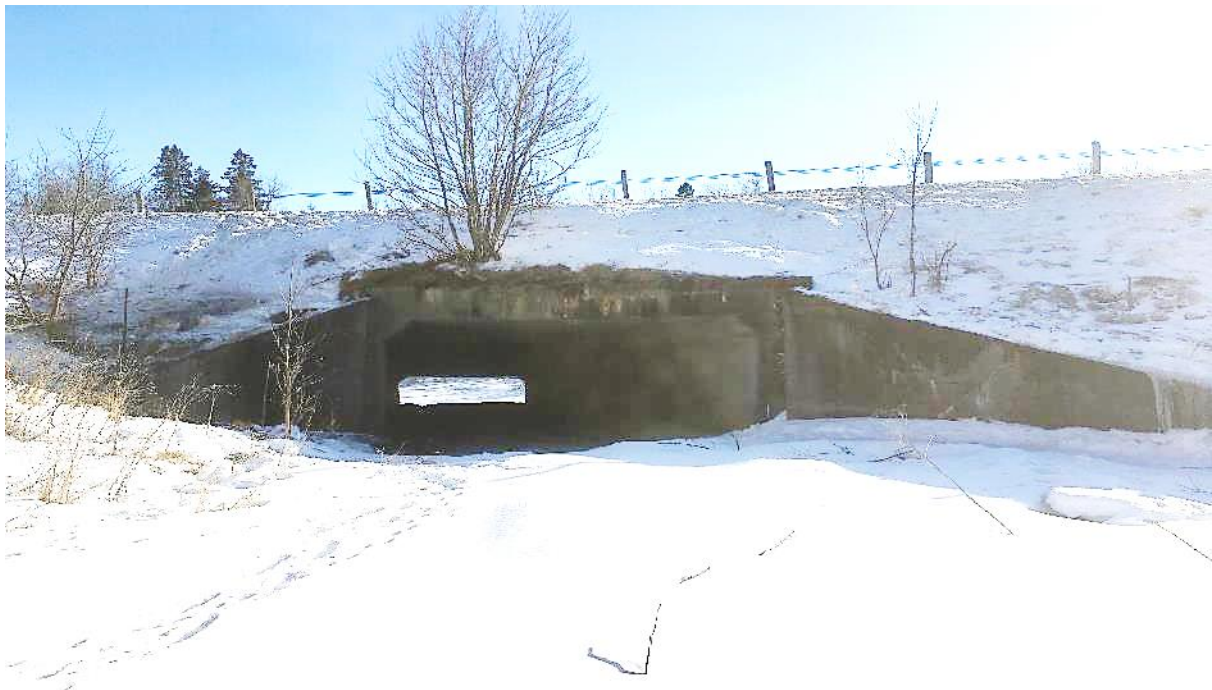
Photograph 2: Looking downstream towards the culvert inlet (2017/12/20)

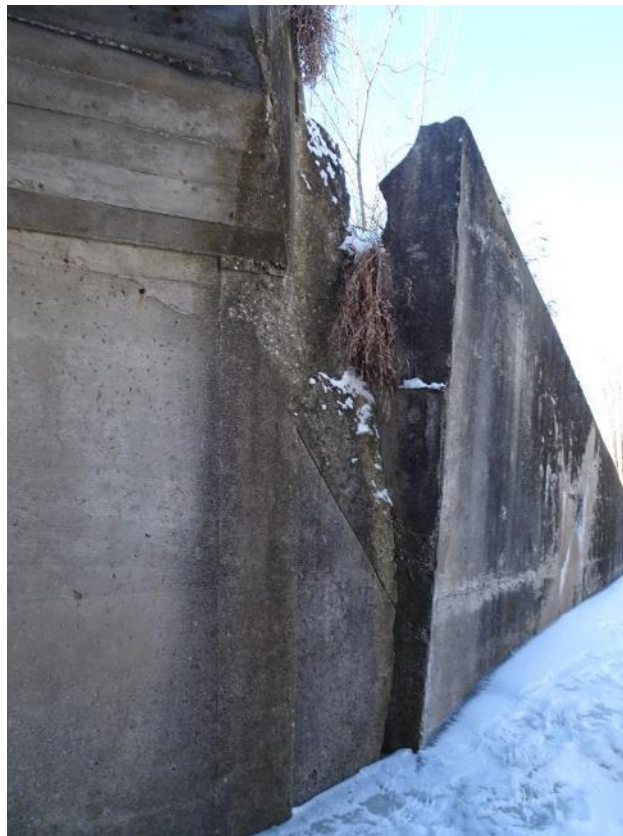
At the time of Thurber's investigation, the northwest wingwall was noted as having rotated significantly from the culvert (see Photographs 3 and 4 provided in Appendix D) and some rotation of the northeast wingwall was also noted (see Photograph 5).

Photograph 4: Rotation of northwest wingwall (2018/02/16)

The results of the Ministry's 2011 and 2015 inspection reports indicate that both the northeast and northwest wingwalls at the Douglas Creek Culvert inlet have rotated away from the culvert and should be replaced.

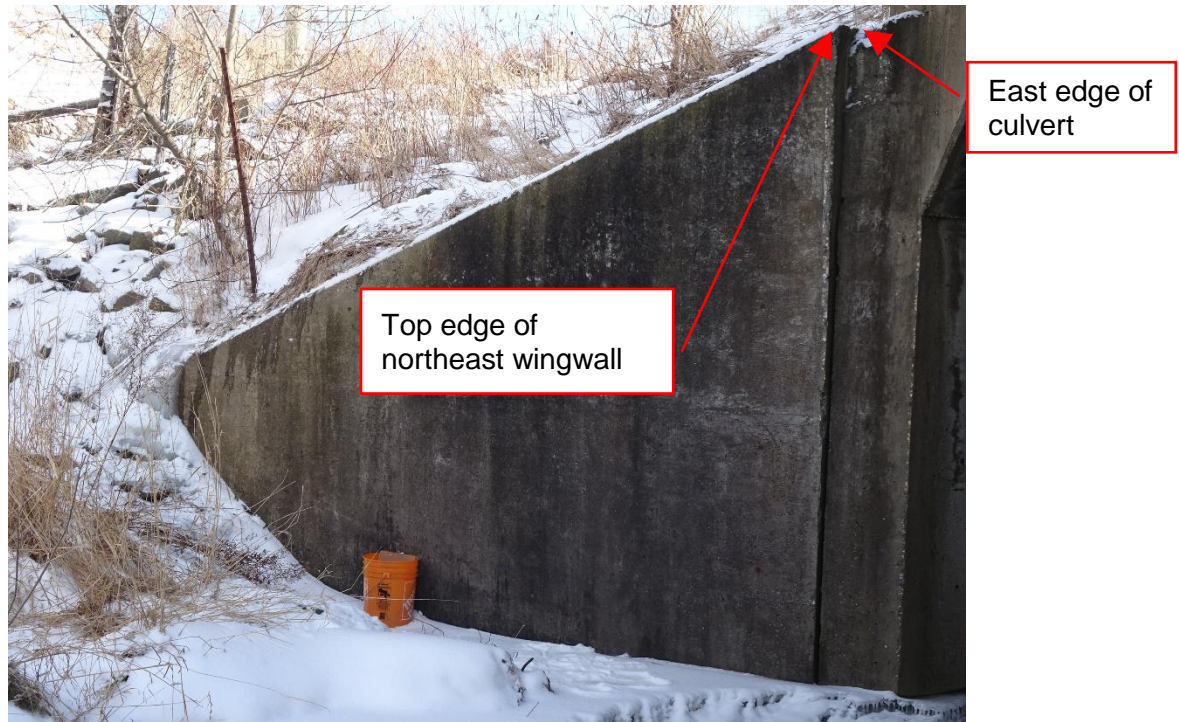
Photograph 5: Rotation of northeast wingwall (2017/01/17)

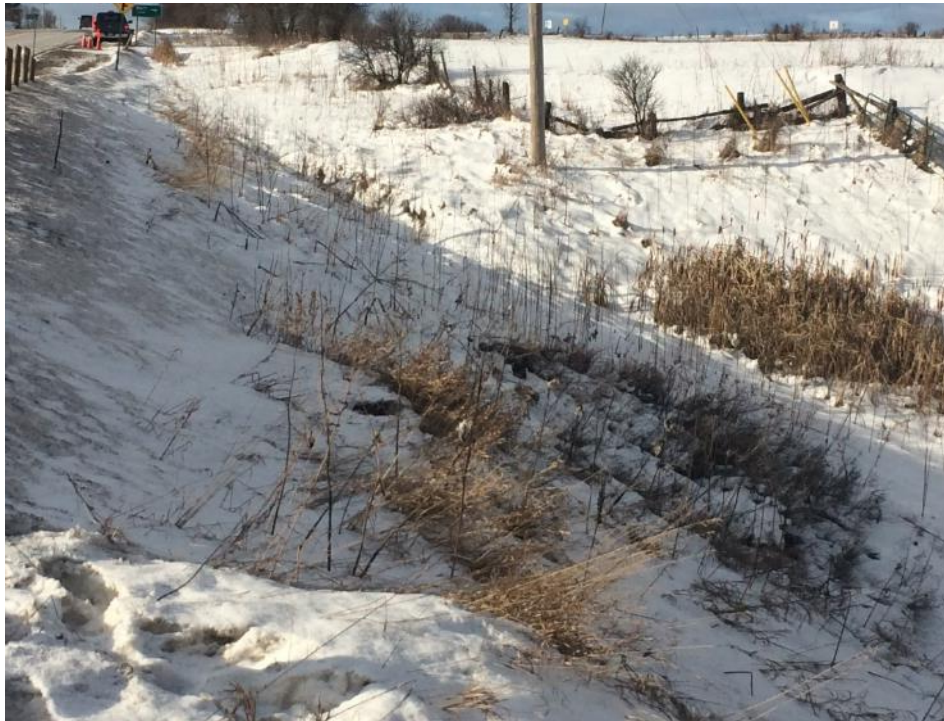
Photograph 6: Looking west along embankment behind northwest wingwall (2017/12/20)

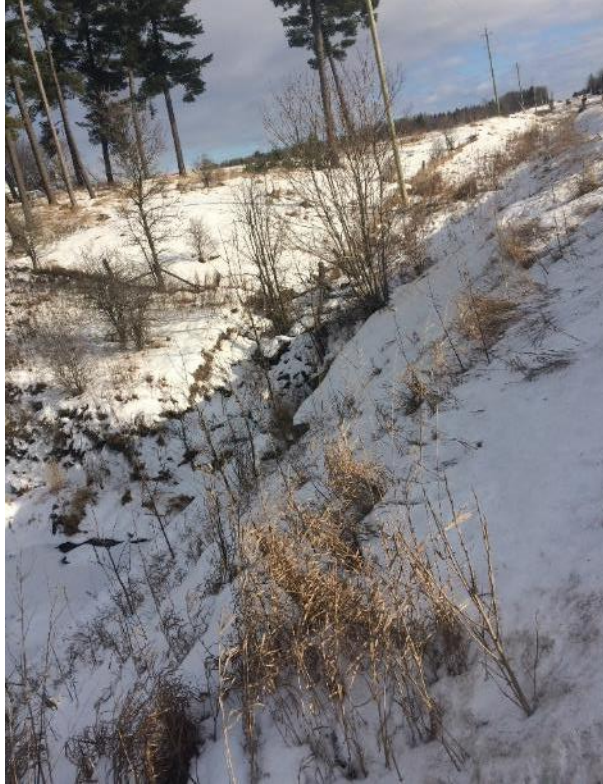
Photograph 7: Looking east along embankment behind northeast wingwall (2017/12/20)

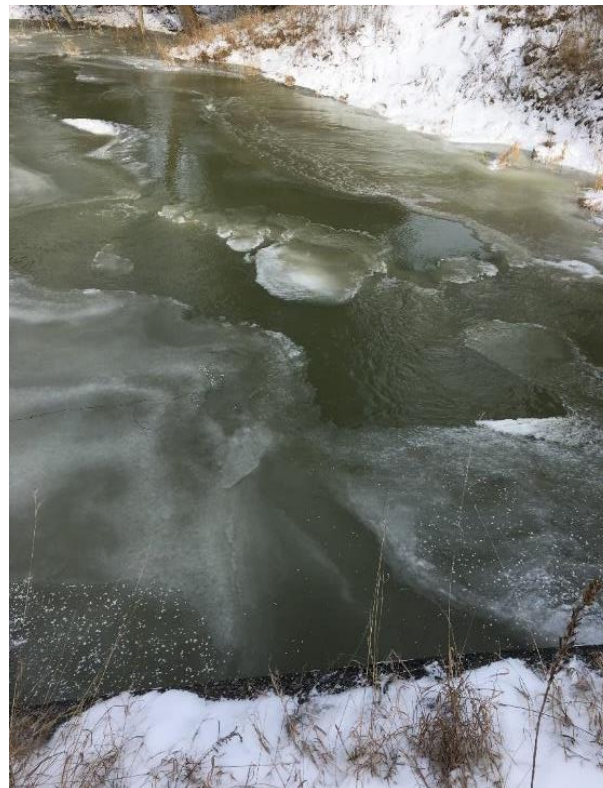
Photograph 8: Looking upstream north of the inlet (2018/01/15)
