**FOUNDATION INVESTIGATION REPORT  
TRENCHLESS UTILITY CROSSING OF HIGHWAY 401 EBL AND WBL  
AT PITT STREET, CORNWALL, ON  
GWP. 4003-14-00  
AGREEMENT NUMBER: 4014-E-0014**

**GEOCRES NUMBER: 31G-264**

**APRIL 2018  
19-5161-263**

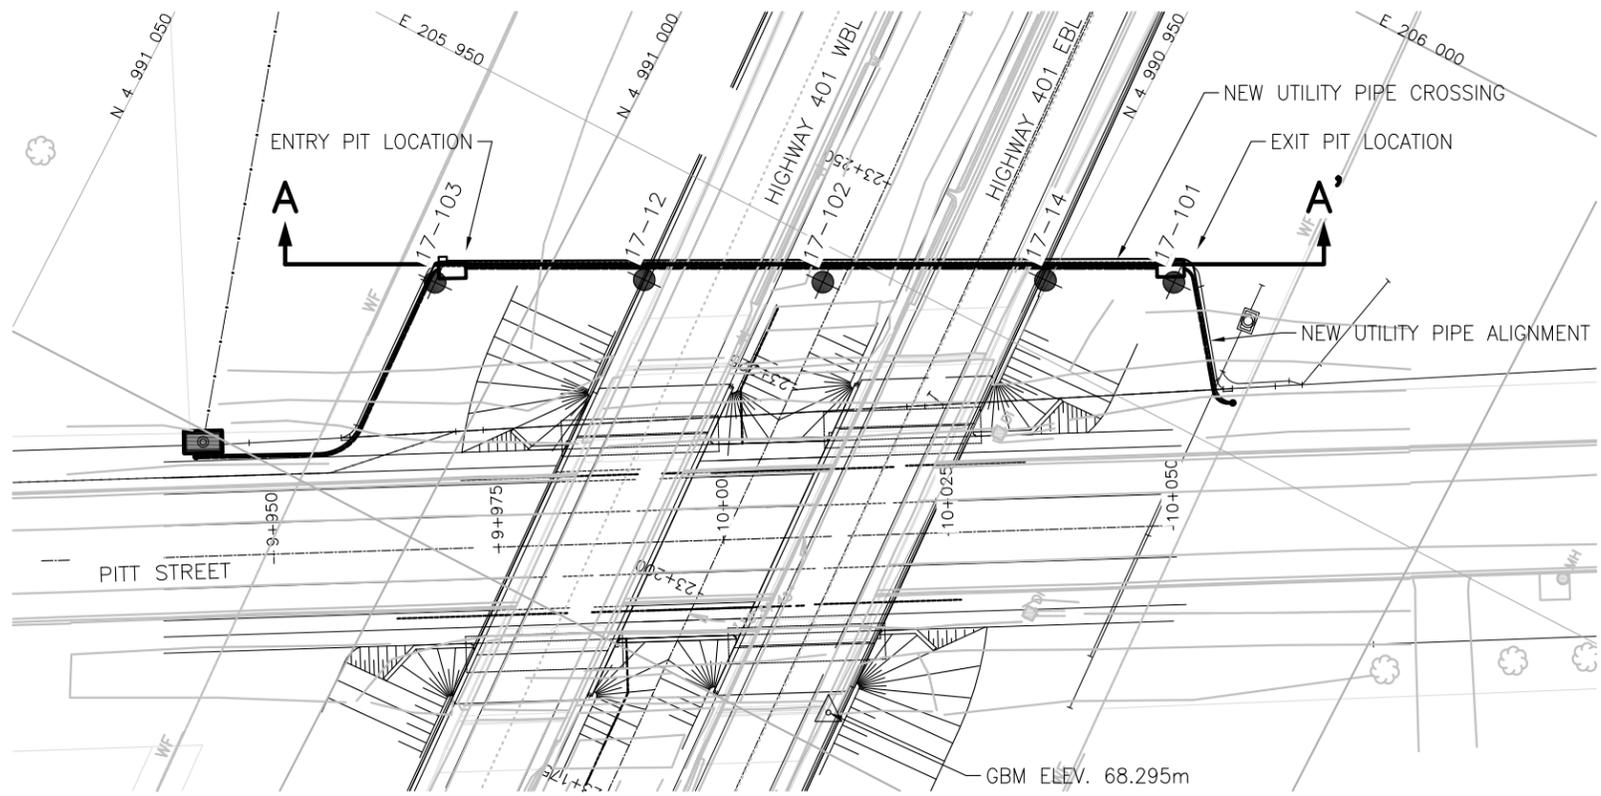
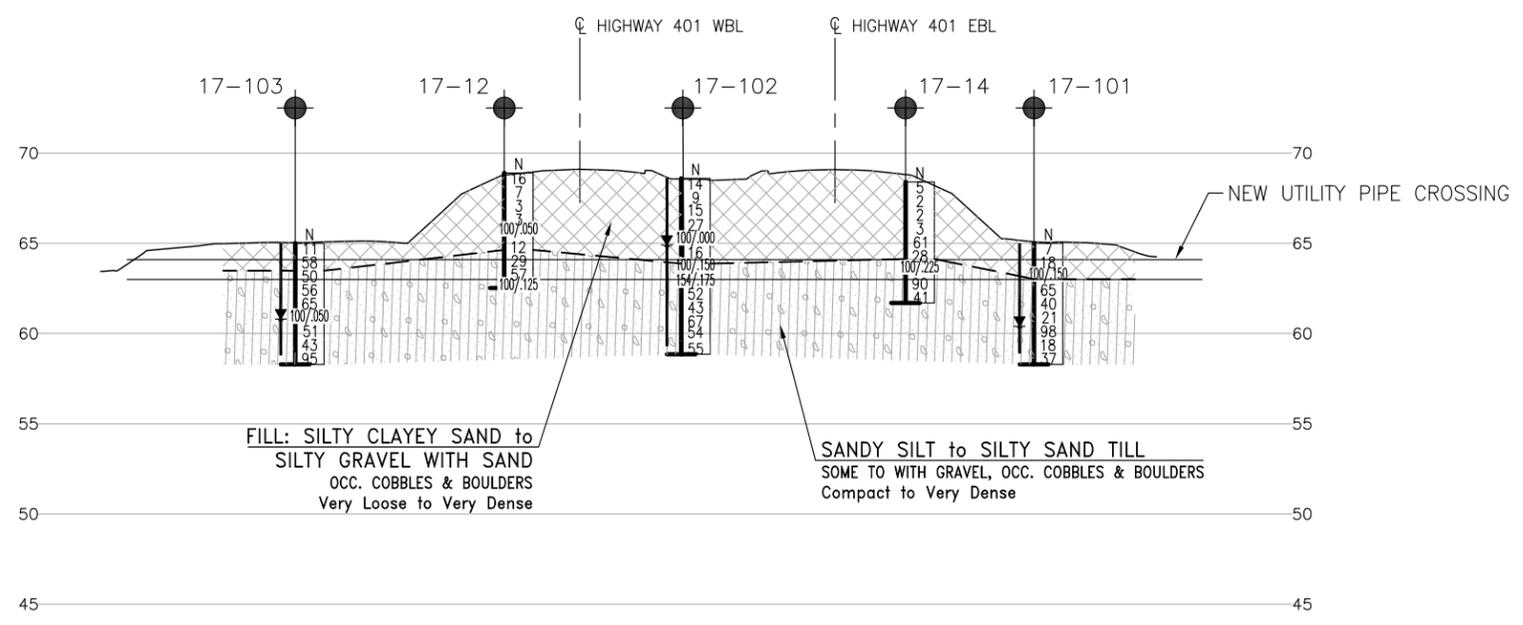
DRAWN	CHK	SITE	STRUCT	DWG
MFA	JG			1

PLAN  
SCALE 1:800

PROFILE A-A'  
H 1:800  
V 1:400

HIGHWAY 401  
TRENCHLESS UTILITY INSTALLATION  
AT PITT STREET  
BOREHOLE LOCATIONS AND SOIL STRATA

The Highway 401 overpass structures of Pitt Street (Sites 31-211/1 and 31-211/2) are located approximately 1.4 km east of the Brookdale Avenue (Highway 138) / Highway 401 Interchange in Cornwall, Ontario. The location of the structures and the area of the proposed utility alignment are shown on the inset Key Plan on Drawing No. 1 in Appendix A.

The field investigation plan was finalized after discussion with the MTO Foundations Section. The field investigation for this site included advancing three boreholes between December 13 and December 19, 2017. The approximate locations and elevations of the boreholes from the current investigation and for Boreholes 17-12 and 17-14 from the adjacent bridge investigation are shown on Drawing No. 1 provided in Appendix A and are summarized in Table 3-1.

The as-drilled locations of the boreholes and ground surface elevations at the borehole locations were surveyed by WSP relative to the geodetic benchmark (GBM) identified on the plans provided by WSP, located on the southwest wall of the eastbound bridge abutment. The GBM has a geodetic elevation of 68.295 m. The location of the GBM is indicated on Drawing No. 1 in Appendix A.

Reference is made to the Record of Borehole sheets in Appendix B for details of the soil stratigraphy encountered in the boreholes. Stratigraphic profiles for the site are presented on Drawing No 1 in Appendix A for illustrative purposes. An overall description of the stratigraphy is given in the following paragraphs; however, the factual data presented in the Record of Boreholes governs any interpretation of the site conditions.

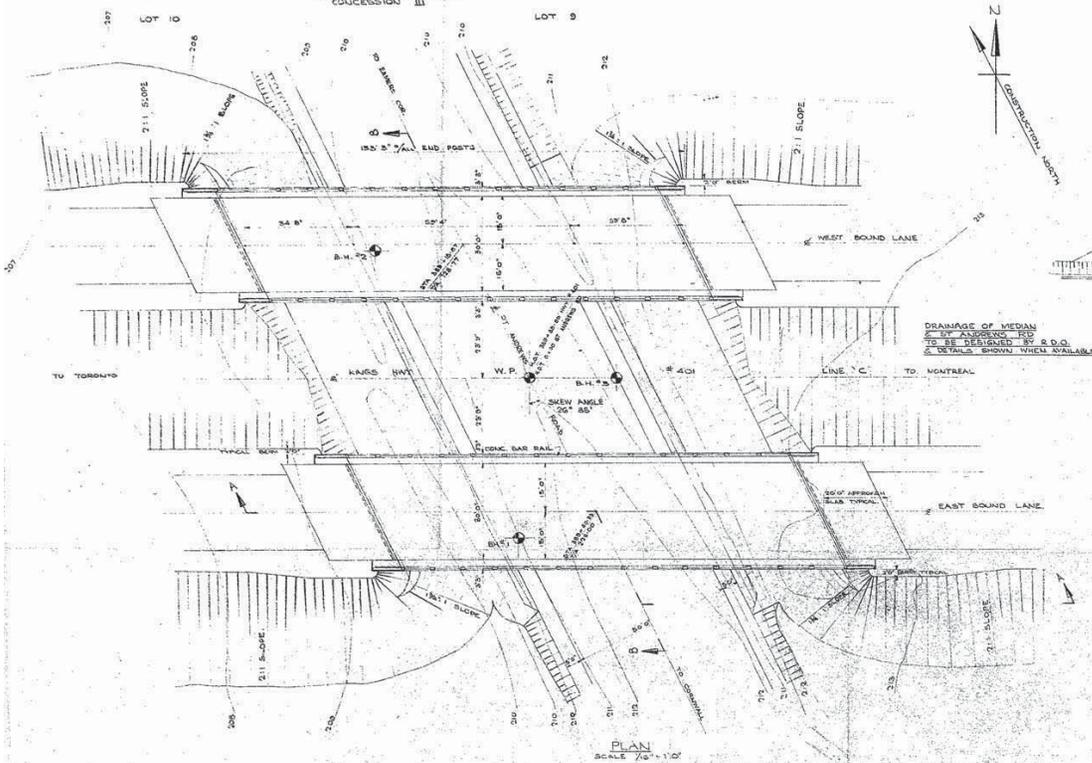
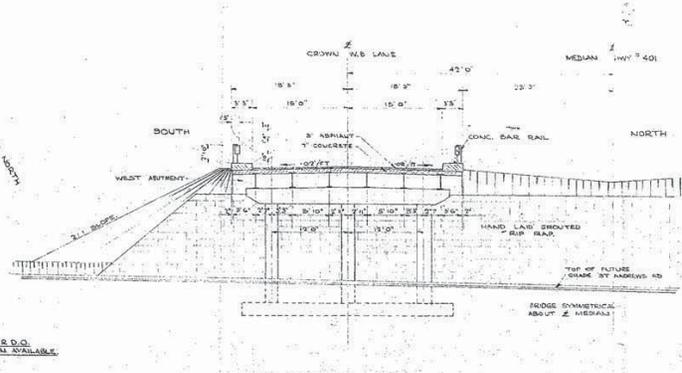
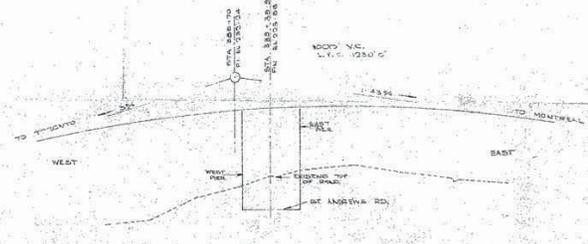
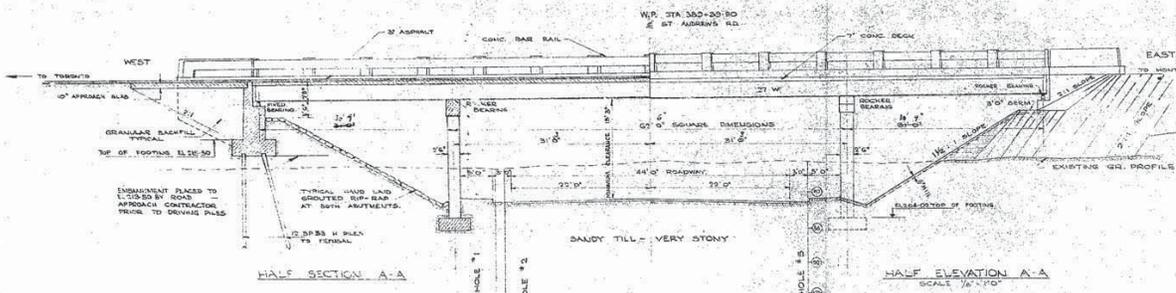
PLAN  
SCALE 1/8" = 1'-0"

HALF SECTION B-B  
SCALE 1/8" = 1'-0"

PROFILE AT CROWN OF FINISHED PAVEMENT HWY #401  
SCALE - HORIZ. 1" = 100' VERT. 1" = 10' 0"

HALF ELEVATION A-A  
SCALE 1/8" = 1'-0"

A GEOCREC report is available for this bridge site (Report 31G00-128, 1955). This investigation was carried out for the design and construction of the current Pitt Street overpass structures and included three boreholes. A copy of the borehole location plan and the Record of Boreholes from the historical investigation are provided in Appendix C.

The stratigraphy in the area of the bridges is generally characterized as a dense to very dense sandy glacial till with frequent cobbles and boulders. The boreholes were terminated within stoney till material and bedrock was not encountered during the 1955 geotechnical investigation.

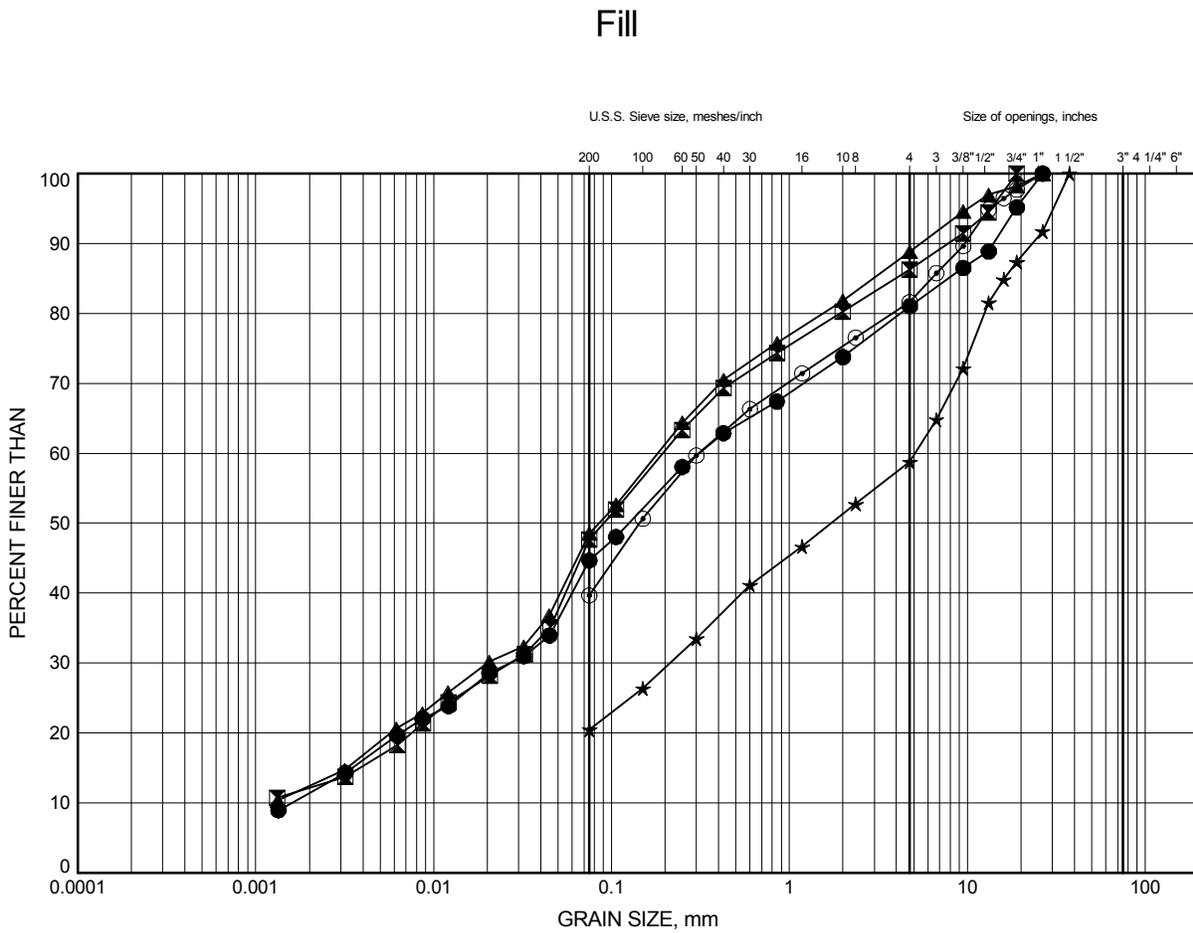
FIGURE 1

Trenchless Utility Installation Highway 401 at Pitt Street  
**GRAIN SIZE DISTRIBUTION**

The moisture content of the samples tested ranged from 9% to 38%. The results of grain size analysis completed on samples of this material indicated a gravel content of 11% to 41%, sand content of 36% to 42%, and fines content (combined silt and clay size particles) of 21% to 49%. The results of the grain size analysis are illustrated on Figure 1 in Appendix D.

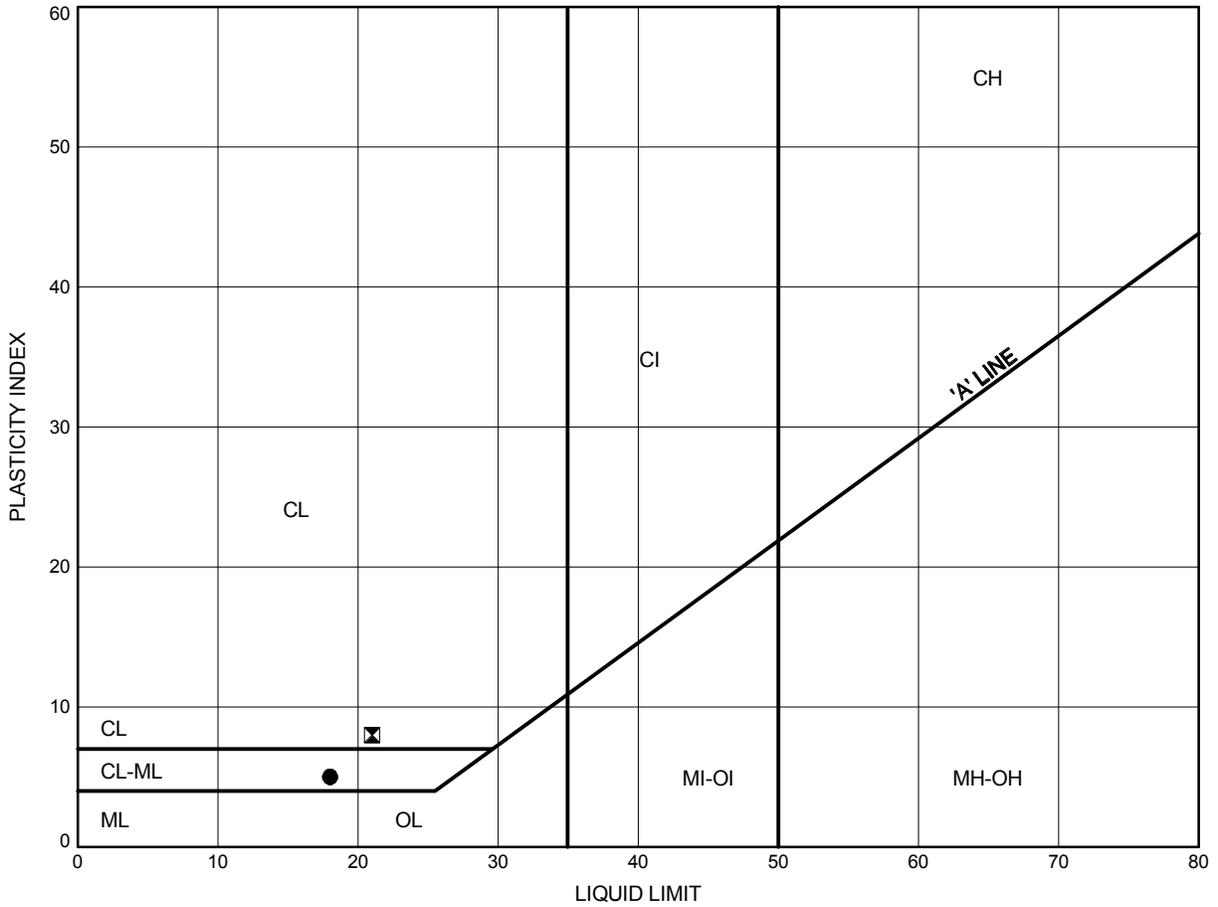
FIGURE 2

Trenchless Utility Installation Highway 401 at Pitt Street  
**ATTERBERG LIMITS TEST RESULTS**

SYMBOL	BOREHOLE	DEPTH (m)	ELEV. (m)
●	17-101	1.07	63.97
⊠	17-102	1.83	66.73

The results of Atterberg Limits testing completed on samples of the fines of this material indicated a plastic limit of 18 and 21, a liquid limit of 13, and a plasticity index of 5 and 8, indicating a fines ranging from low plastic to non-plastic. Atterberg Limits analysis results are illustrated on Figure 2 in Appendix D.

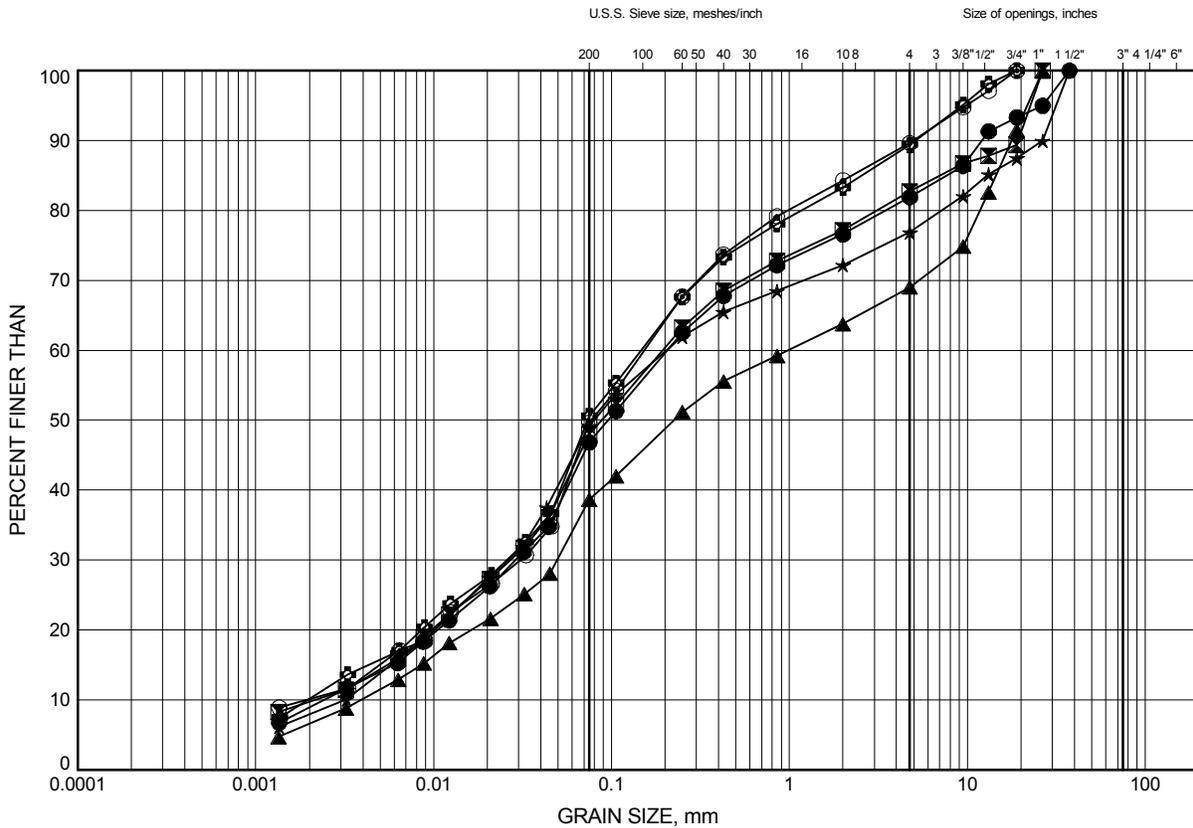
# GRAIN SIZE DISTRIBUTION

Till - Sandy Silt some Gravel to Silty Sand with Gravel

The moisture contents of the samples tested ranged from 9% to 13%. The results of grain size analysis completed on samples of this material indicated a gravel content ranging from 10% to 31%, sand content of 28% to 40%, a silt content ranging 32% to 41% and a clay content ranging from 7% to 10%. The results of the grain size analysis testing are illustrated on Figure 3 in Appendix D.

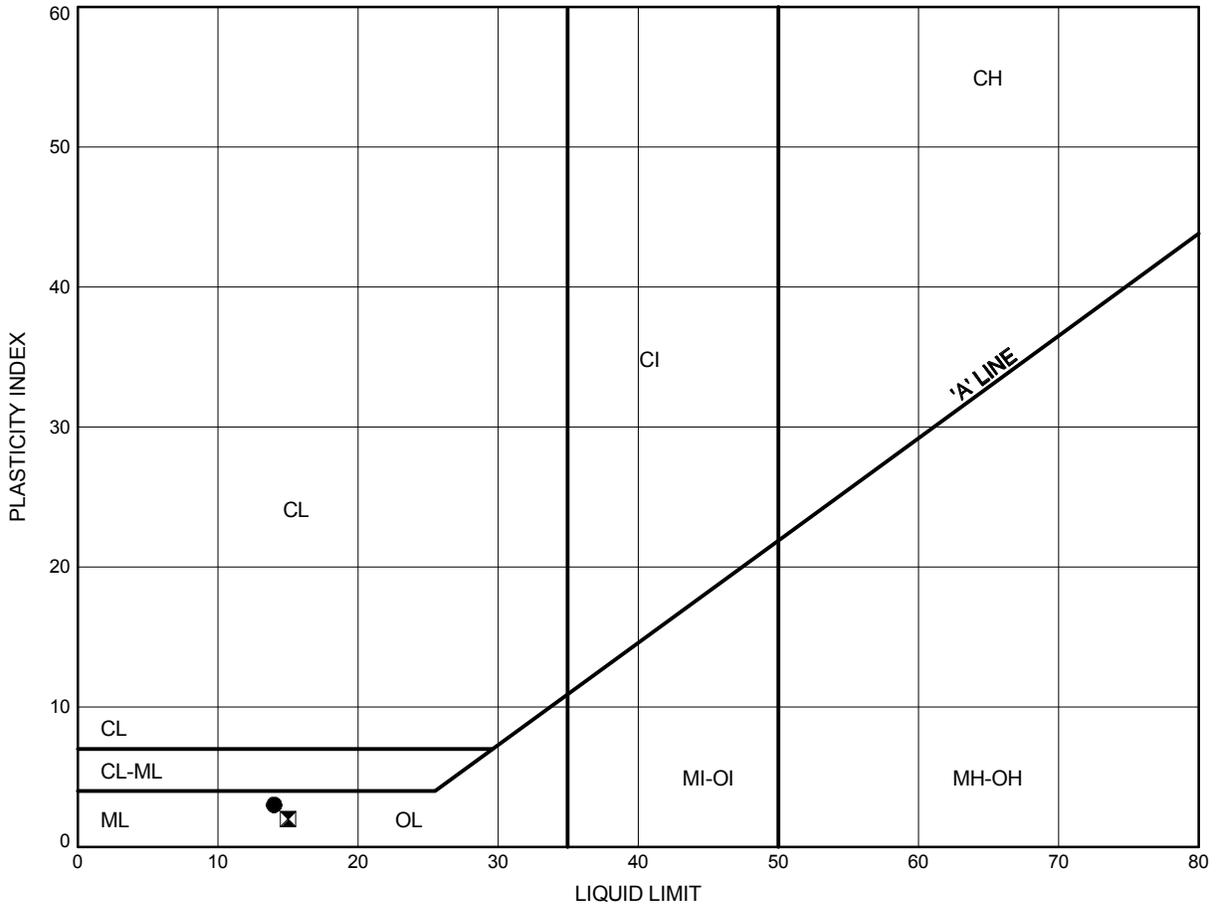
FIGURE 4

Trenchless Utility Installation Highway 401 at Pitt Street  
**ATTERBERG LIMITS TEST RESULTS**

SYMBOL	BOREHOLE	DEPTH (m)	ELEV. (m)
●	17-101	4.88	60.16
⊠	17-12	5.61	63.25

Based on the results of Atterberg Limits testing the fines content is generally classified as non-plastic silt (ML). The Atterberg Limit results are illustrated on Figure 4 in Appendix C.

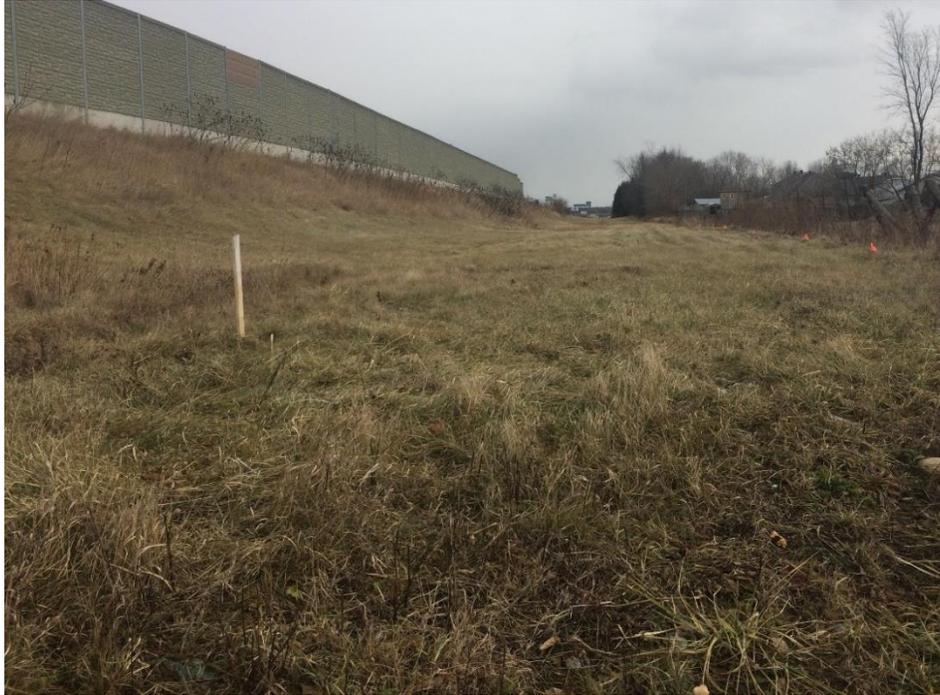
**Photograph 1 : Exit pit location (south end of alignment) looking east.**

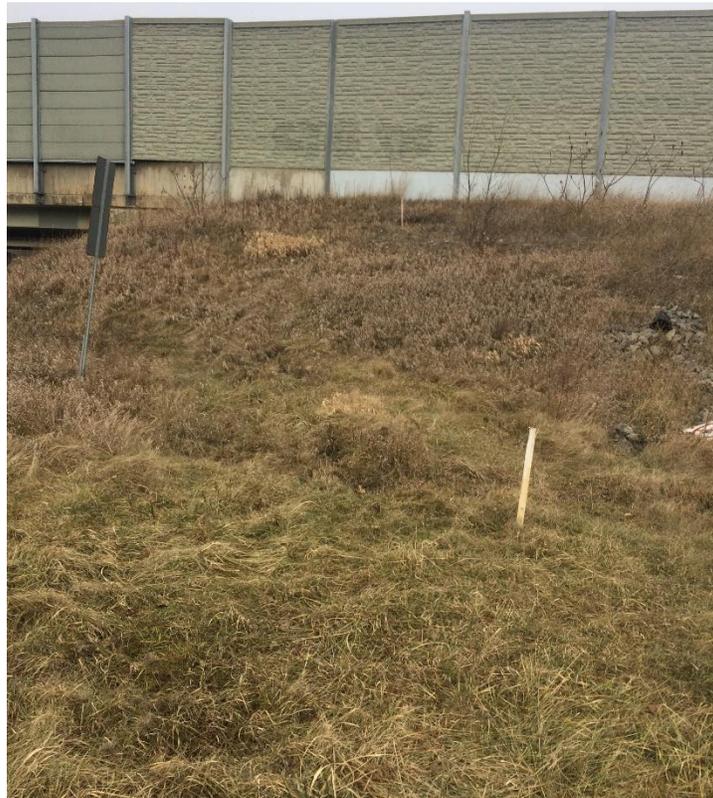
**Photograph 2: Exit pit location (south end of alignment) looking north towards Highway 401 embankment**

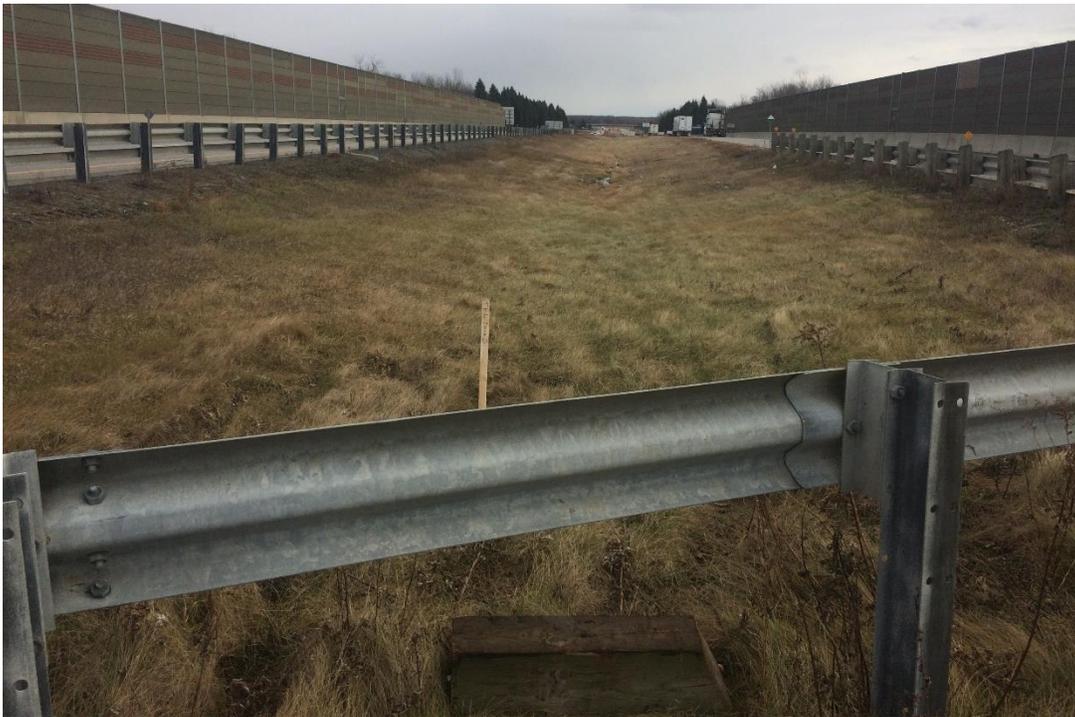
**Photograph 3: Looking east towards Borehole 17-102 along Highway 401 median**

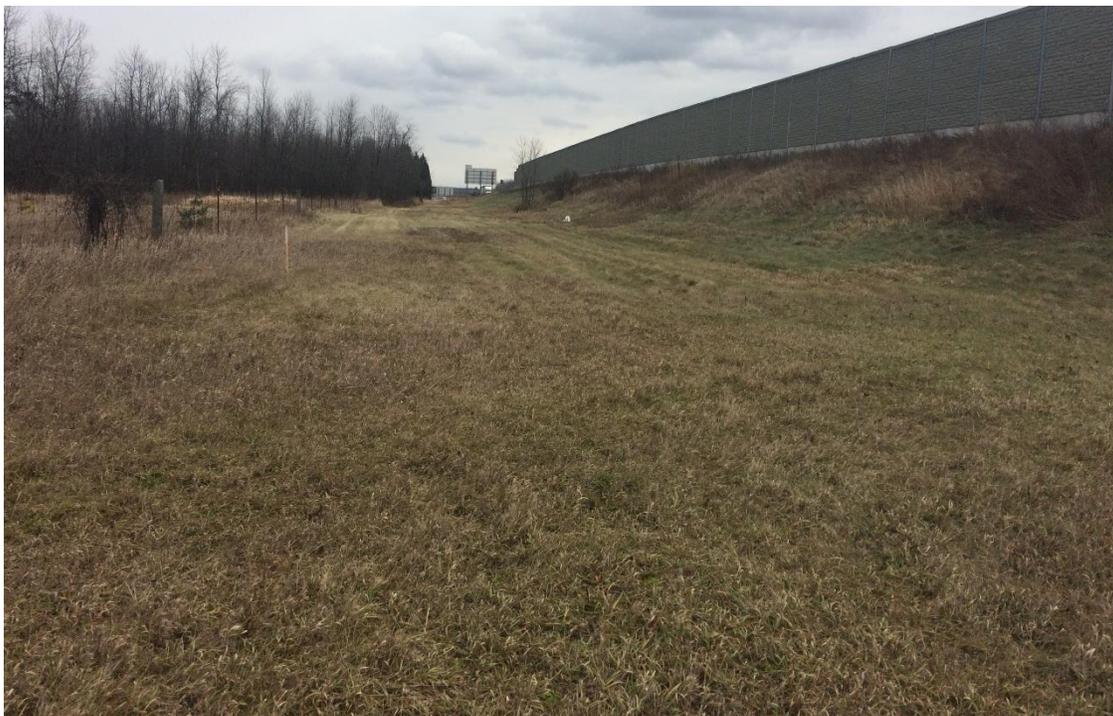
**Photograph 4: Entry pit location (north end of alignment) looking east**
