#58-F-221-C

OTTAWA,

QUEENSWAY &

## Foundation Investigation - Structure No. 5

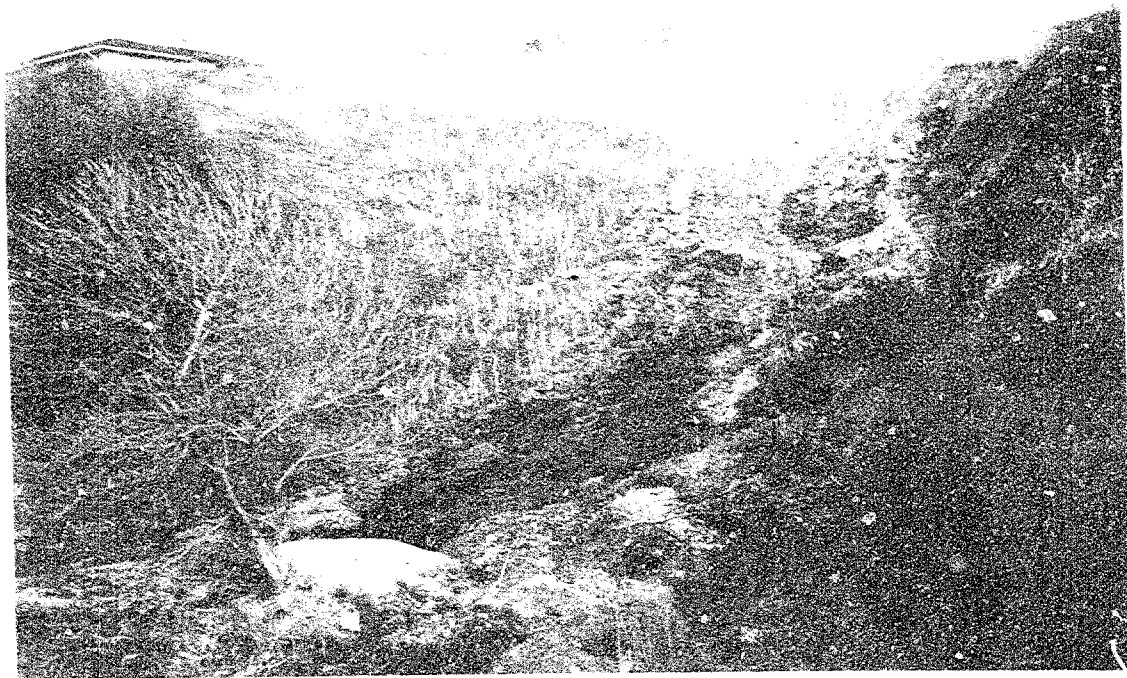
Photograph #1

Taken from C.N.R. tracks in S.E. direction.

Stake in top left centre is Station 4400. C.I.P. at 3460 approx.

Showing wedge of fill dumped over bank. Removal recommended (4000 c.y. approx.) material on natural slope (not suitable for fill) to be stripped to depth of 3 feet.

Material in narrow ridge on left acceptable

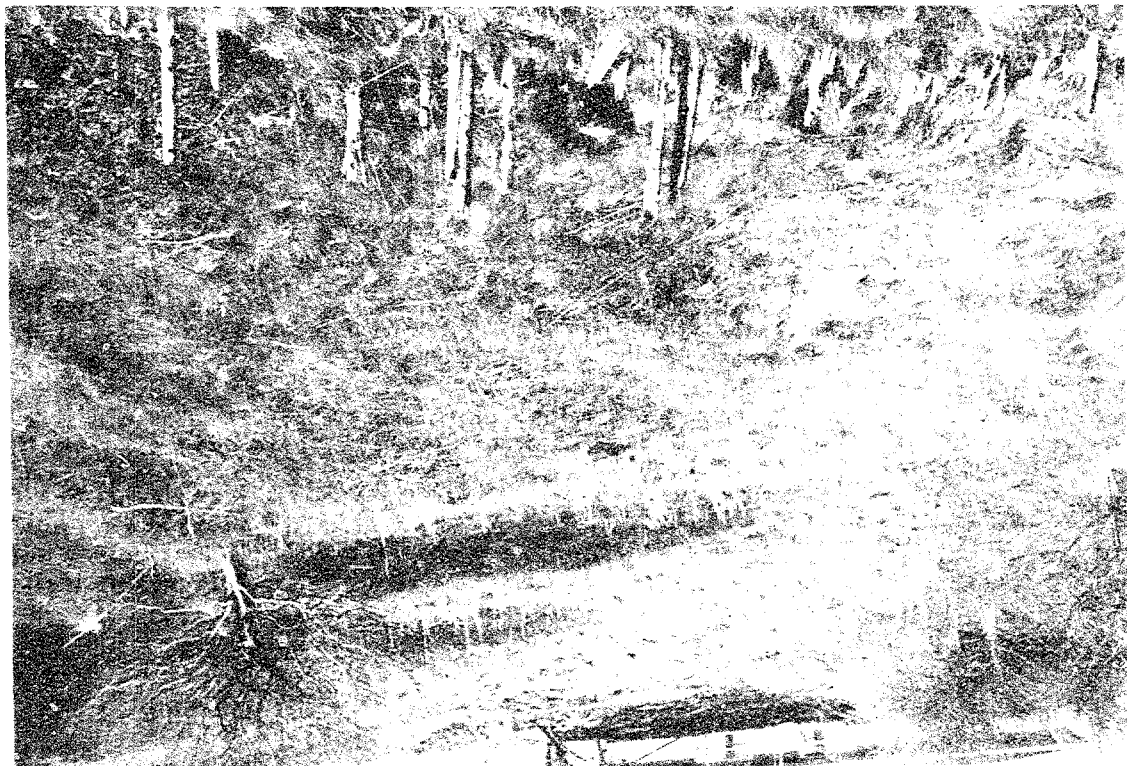
## Photograph #2

Taken from C.N.R. tracks in  
S.E. direction.

Stake Lt. centre is 6/00 E  
Showing ~~area~~<sup>of</sup> loose wet fine to  
very fine sandy loam material which  
is recommended to be stripped to a  
depth of 3 feet. Material not suit-  
able for fill.

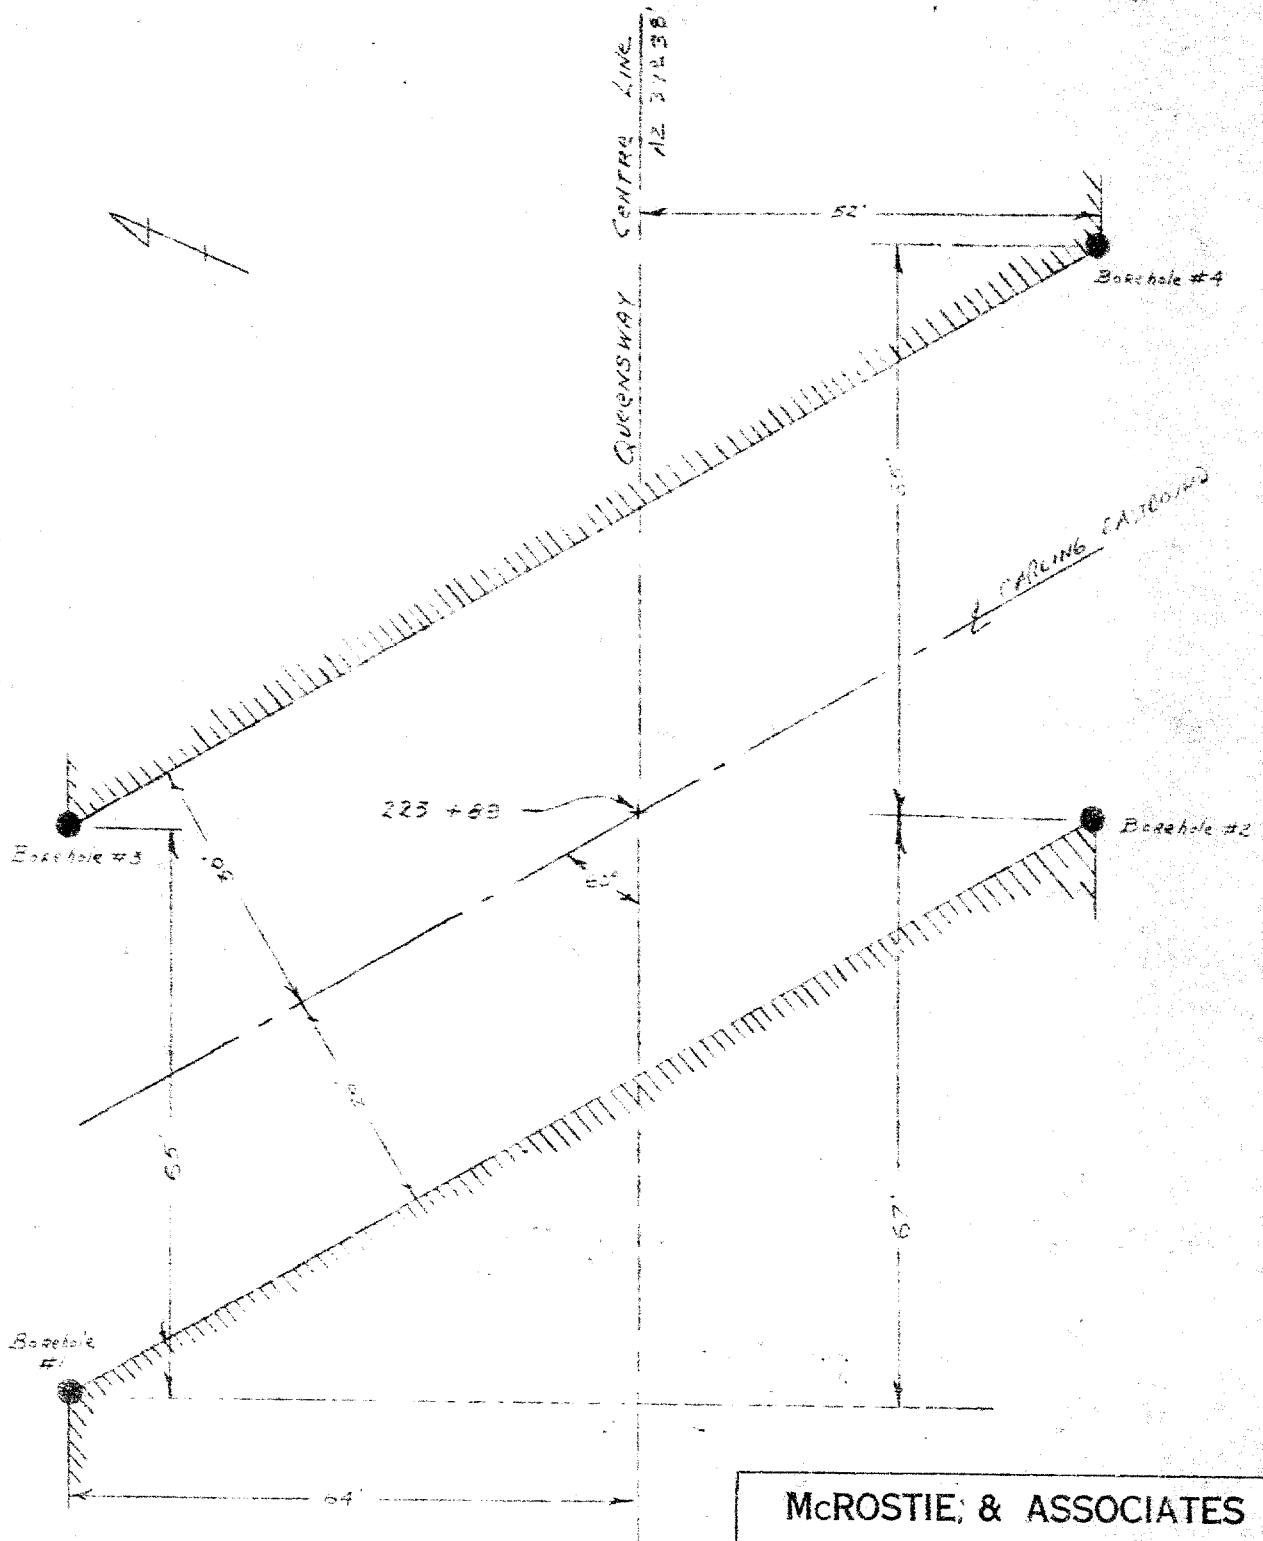
PLATE 1

Four boreholes were made at the site with our test drilling rig in the locations shown on Plate One. Two inch split barrel samples were taken in the soil layers, standard penetration tests made, and samples visually classified.

**BOREHOLE LOCATIONS**  
Queensway & Carling Ave (Eastward)  
Bridge #5
