**FOUNDATION INVESTIGATION AND DESIGN REPORT
WABIGOON RIVER BRIDGE REHABILITATION
HIGHWAY 17, UNORGANIZED KENORA DISTRICT, ONTARIO
AGREEMENT 6020-E-0025, WORK ORDER 1
G.W.P. 6117-17-00, SITE NO. 41S-0042/B0
LATITUDE: 49.815093°, LONGITUDE: -92.873885°**

Report

MORRISON HERSHFIELD

Date: January 20, 2023
File: 34752

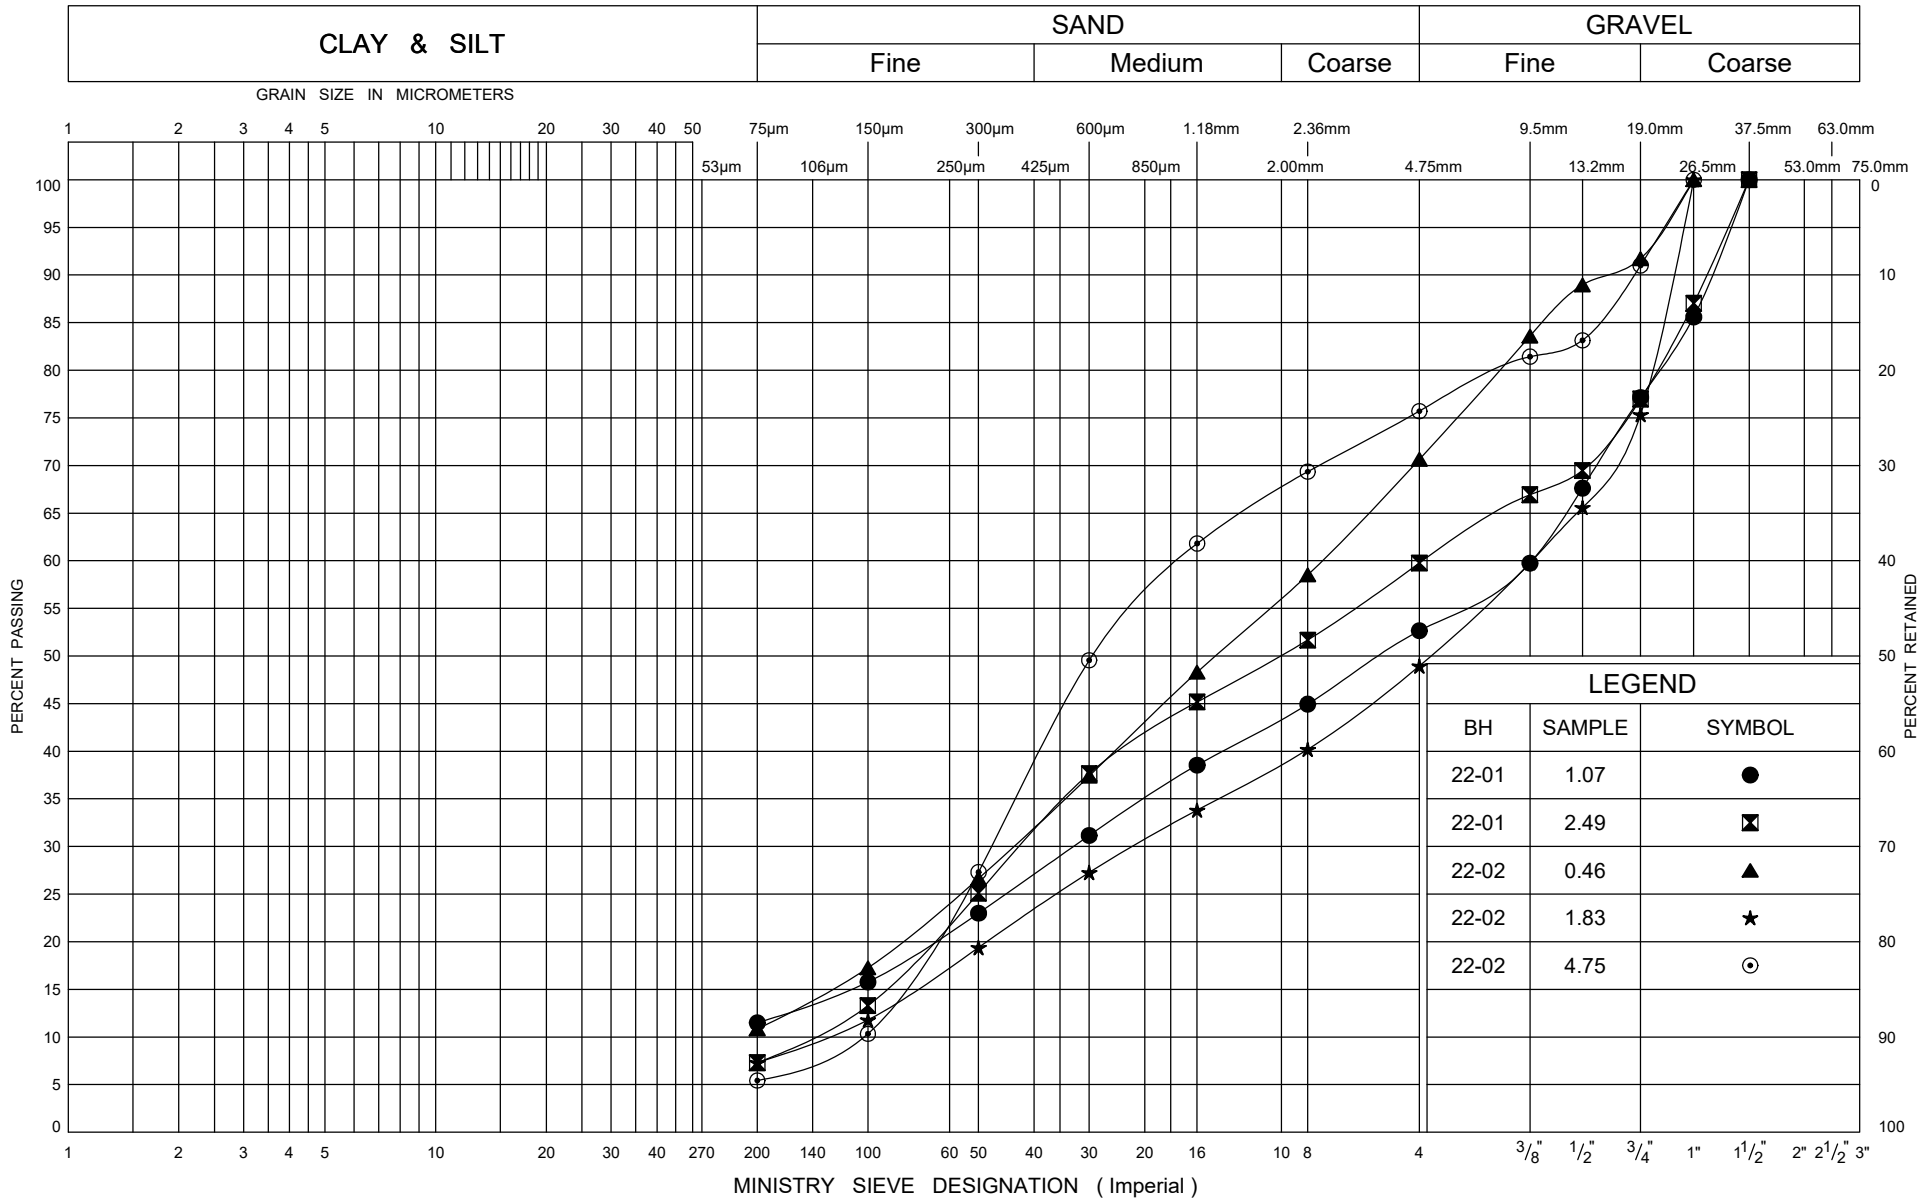
Laboratory Test Results

The results of grain size analyses conducted on selected samples of the sand and gravel to gravelly sand fill are provided on the Record of Borehole sheets in Appendix A and plotted on Figure B1 in Appendix B. The results are summarized as follows:

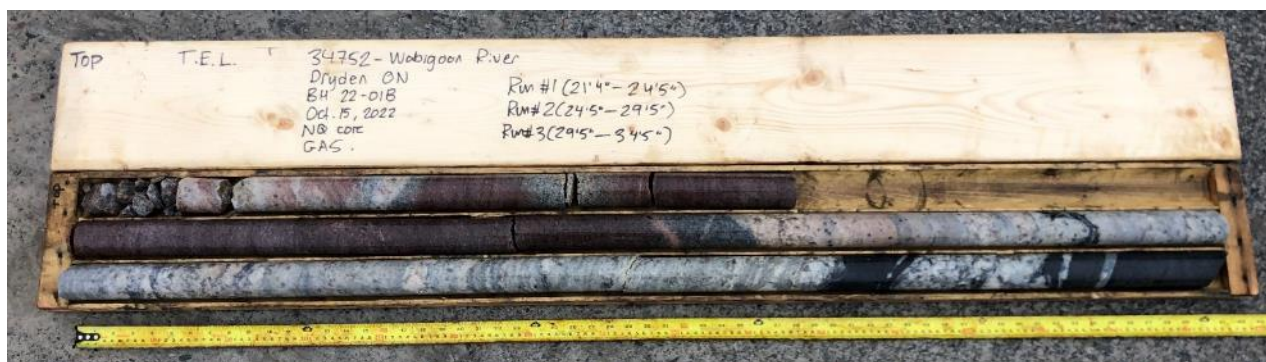
Borehole 22-01 Bedrock Core: Runs 1, 2 and 3

Total Core Recovery (TCR) in the bedrock ranged between 98% to 100% throughout all runs, and Solid Core Recovery (SCR) ranged between 81% to 100%. The Rock Quality Designation (RQD) measures from the recovered cores ranged between 66% and 100%, which indicates fair to excellent rock quality; typically excellent. The Fracture Index (FI) of the rock, expressed as fractures per 0.3 m of core ranged from 0 to 3.

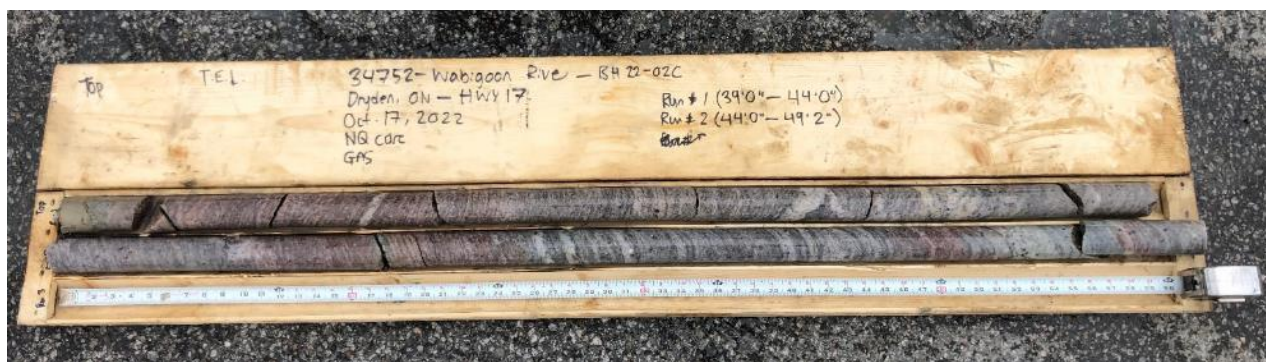
Borehole 22-02 Bedrock Core: Runs 1 and 2

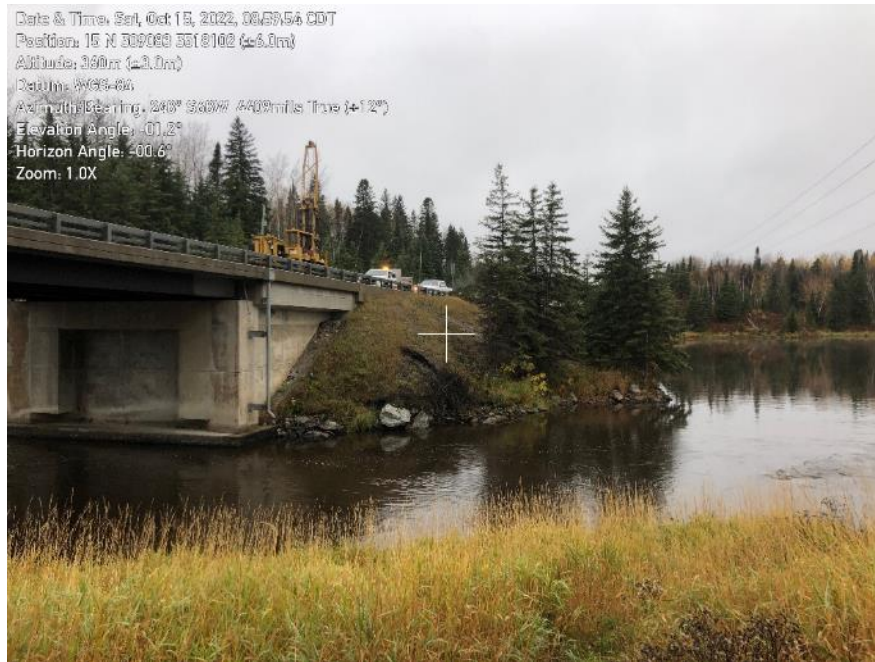
**Photo 5: Looking southwest at northwest corner of bridge (embankment toe erosion)
(October 2022)**

Areas of surficial erosion and vegetation loss were observed on the approach embankments to the bridge, particularly at the toe of the northwest approach embankment where loss of soil has occurred near the river (Appendix C, Photos 5 to 7). Surficial vegetation loss was observed at the southwest and southeast approach embankments (Photos 9 and 10). An area of slide activity was also observed beyond the toe of slope of the southwest approach embankment (Photo 8). In this area, a slide has occurred on the south bank of the south ditchline.

The affected areas along the Highway 17 embankments should be repaired. These and any other disturbed or regraded earth slopes must be provided with erosion protection in accordance with OPSS.PROV 804. Additional erosion protection measures such as rip rap or rock protection may be required to prevent future loss of material where the embankment is in contact with the river. Erosion protection measures must be designed by specialists with experience in this field.

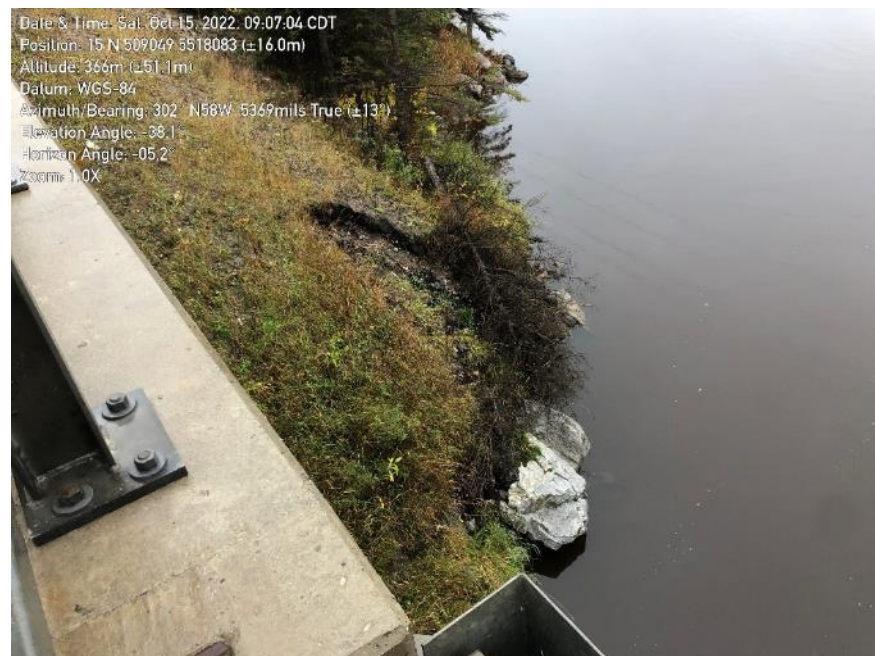
Photo 6: Looking down at toe erosion at northwest corner of bridge (October 2022)

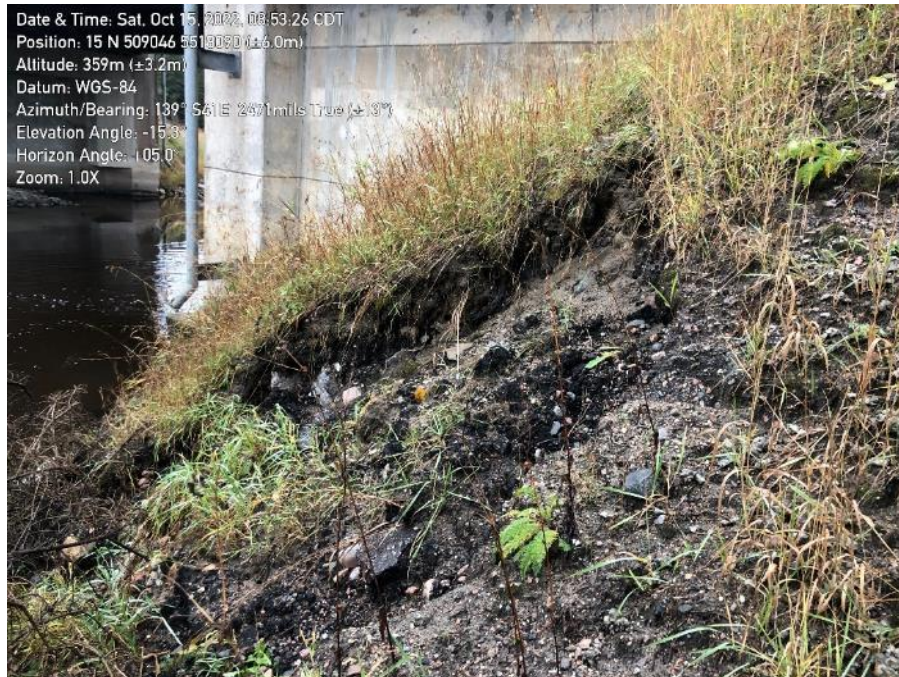
Photo 7: Looking southeast at toe erosion at northwest corner of bridge (October 2022)

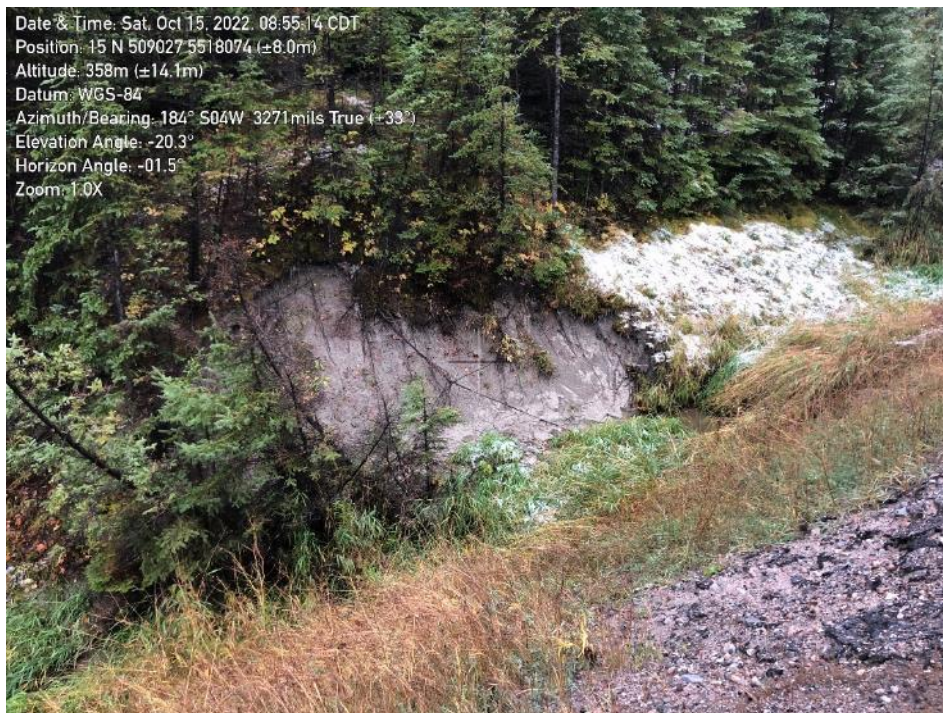
Photo 8: Looking south towards slide beyond ditch at southwest corner of bridge (October 2022)

The area of slide activity beyond the southwest ditchline should be observed for signs of future impact to the Highway 17 embankment toe, or potential blockage of the ditch.

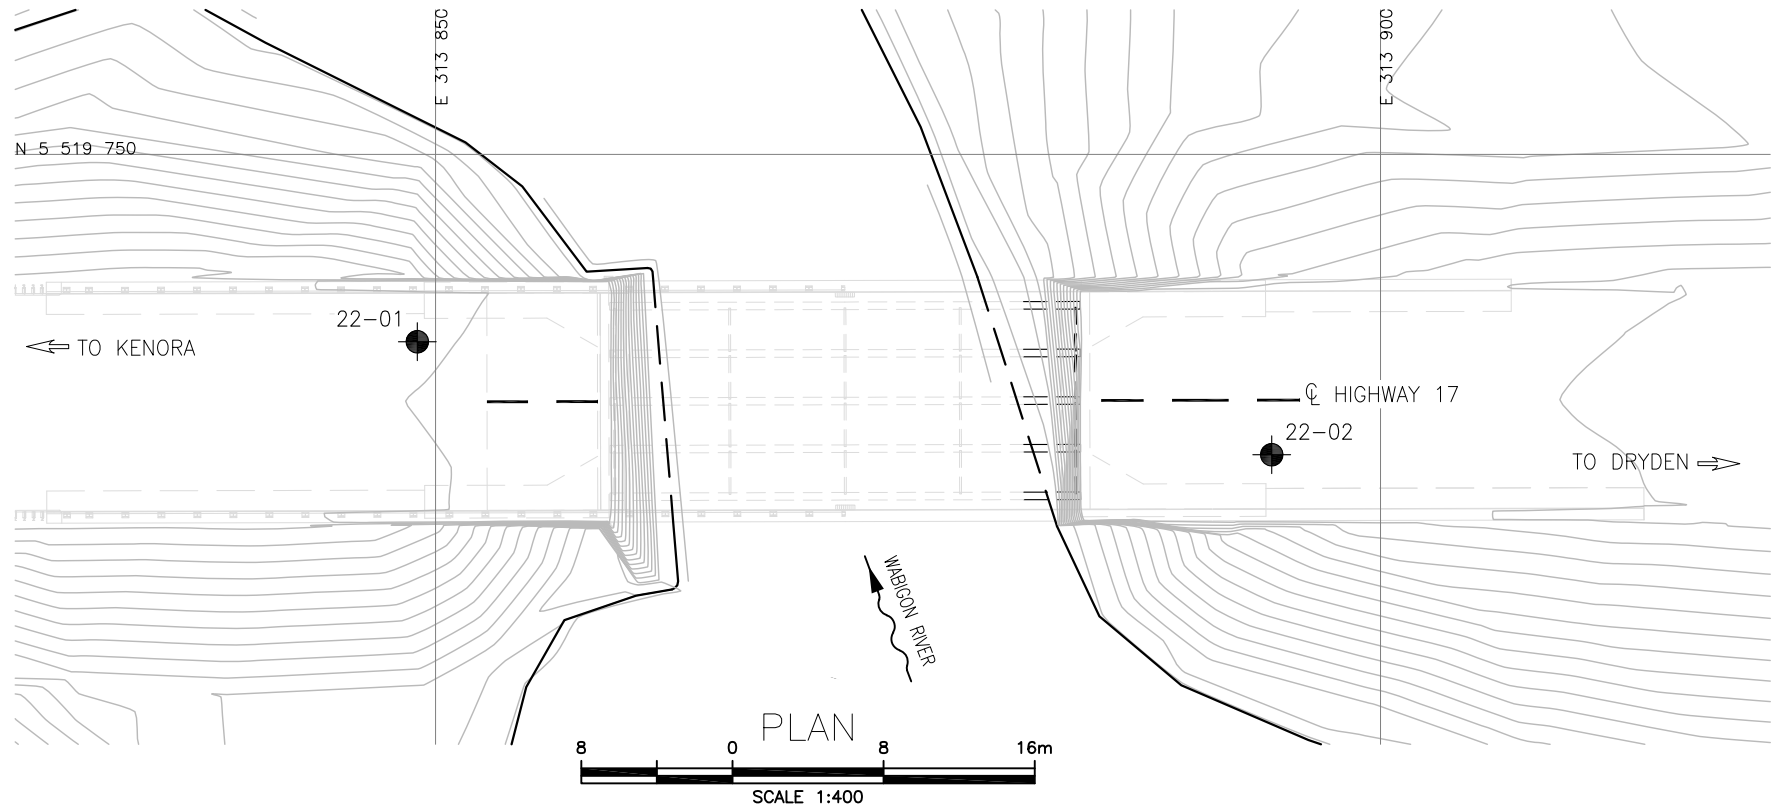
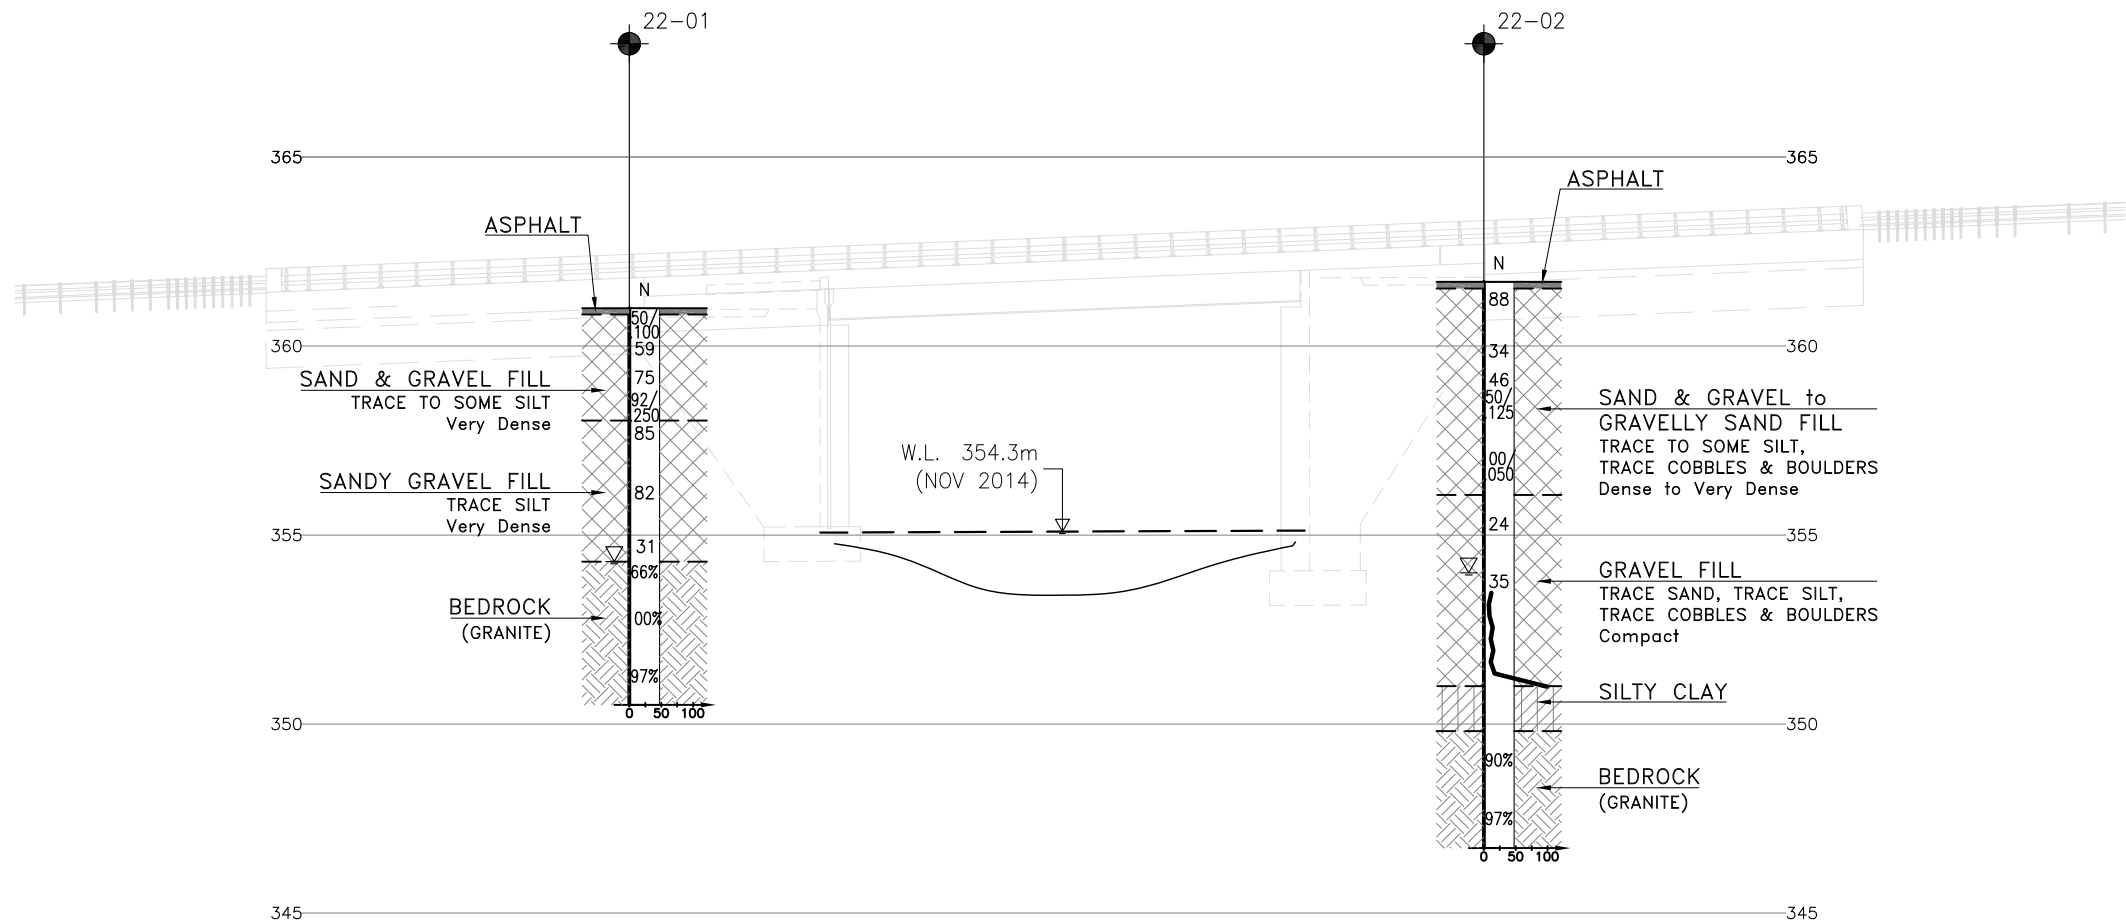
HIGHWAY 11
WABIGOON RIVER BRIDGE
REHABILITATION
BOREHOLE LOCATIONS AND SOIL STRATA

Borehole Locations and Soil Strata Drawing

The site investigation and field-testing program for this project was carried out from October 13 to 17, 2022. The field program consisted of drilling and sampling two (2) boreholes, 22-01 and 22-02, to depths of 10.5 and 15.0 m below the ground surface (Borehole termination Elevation 350.5 and 346.7 m), respectfully. Both boreholes were drilled through the paved portion of Highway 17 at the approaches to the bridge. Borehole 22-01 was drilled near the proposed west TPS location and Borehole 22-02 was drilled near the proposed east TPS location. The Record of Borehole sheets are included in Appendix A. The approximate locations of the boreholes are shown on the Borehole Locations and Soil Strata Drawing included in Appendix D.

Reference is made to the Record of Borehole sheets included in Appendix A. Details of the encountered soil stratigraphy are presented on the Record of Borehole sheets and on the Borehole Locations and Soil Strata drawing in Appendix D. A general description of the stratigraphy, based on the conditions encountered in the boreholes, is given in the following paragraphs. However, the factual data presented in the Record of Borehole sheets governs any interpretation of the site conditions. It must be recognized that soil conditions may vary between and beyond the borehole locations.

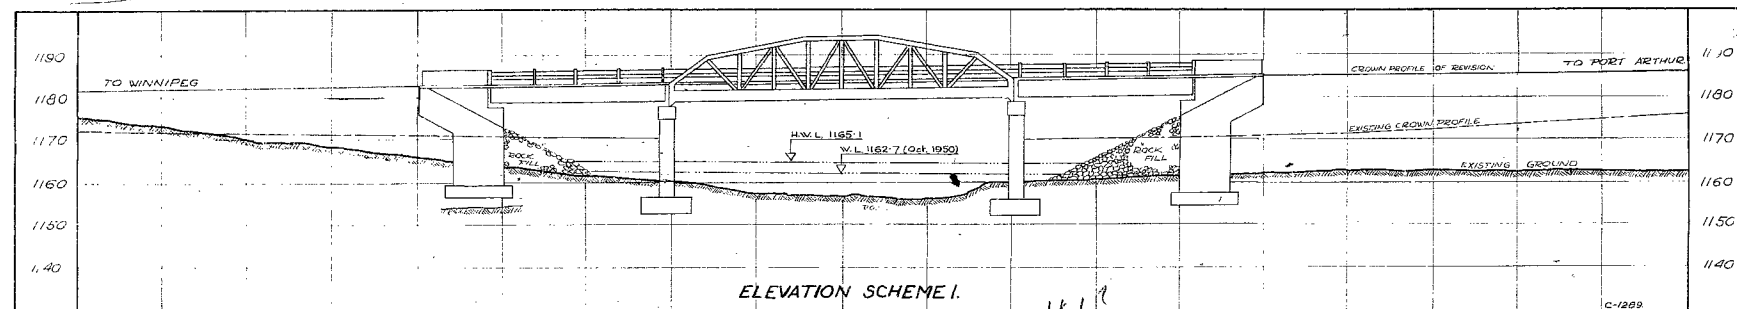
Stratigraphic Profile Drawing from Geocres 52F00-007

Based on an existing Geocres report (52F00-007) from 1960, the subsurface soils near the project site were anticipated to consist of mainly sand and gravel/rock embankment fill, underlain by old paper mill refuse fill mixed with sand and silt (in a very loose or liquid state), and thin layers of clay and sand and gravel overlying bedrock. The bedrock surface was anticipated to generally slope downwards from the west to east approaches to the bridge. The stratigraphic profile drawing showing the paper mill refuse fill is included in Appendix E.
